Specialist Ecological Report:

Construction of a 132 kV power line from the proposed Tshatane switching substation to the existing Lesideng substation within Fetakgomo, Greater Tubatse and Makhudutamaga Local Municipalities of Sekhukhune District.

Dr Wynand Vlok (BioAssets)

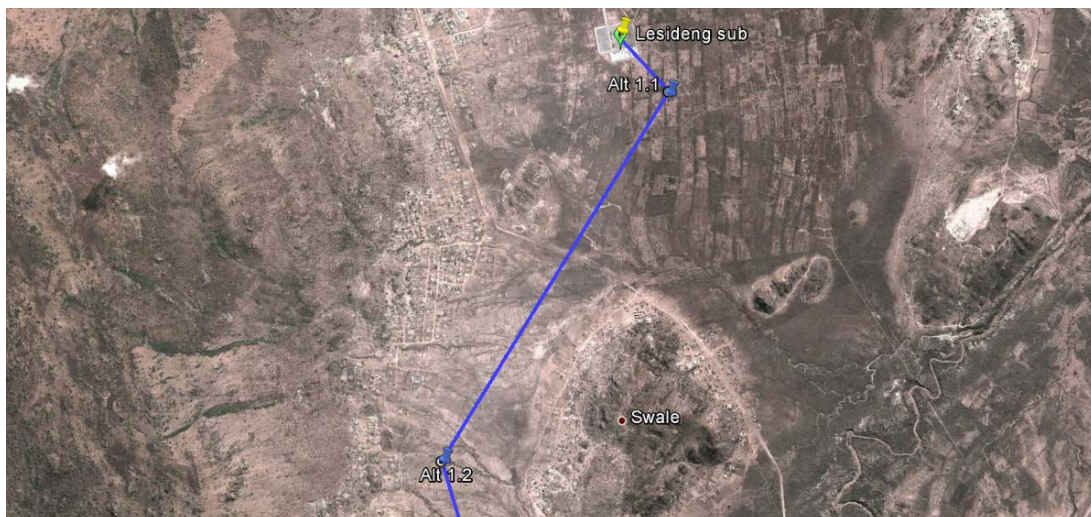
Figure 8: Aerial view of sector – note land use and erosion present.

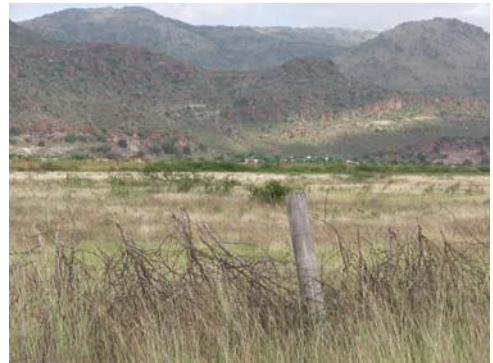
Figure 11: View southeast of the sub – modified natural vegetation and deep erosion gullies (arrow).

A concern is the number of erosion gullies present and these must be considered as sensitive. Along with the streams and drainage lines, no vehicles must drive through it,

unless there is a road. Part of the EMP must include regular inspection and maintenance during construction.

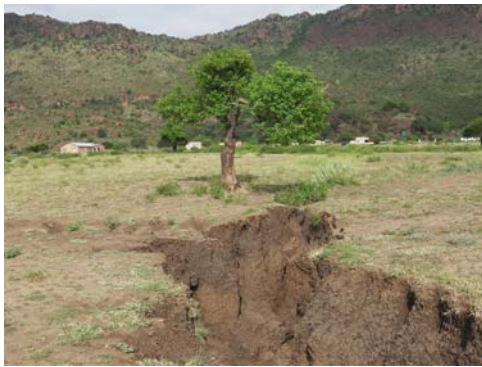
Figure 15: Example of poor land use resulting in erosion.

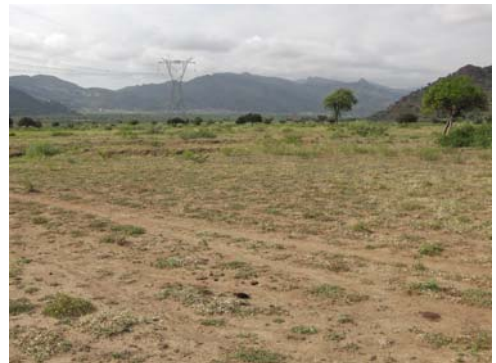
Figure 16: Over grazing along the corridor evident.

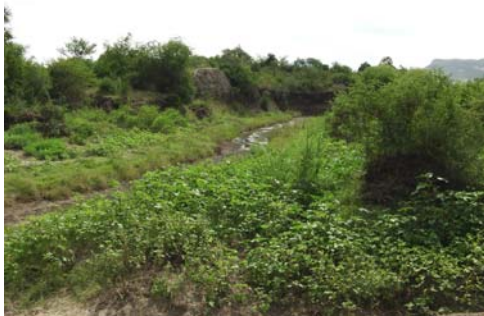
Figure 21: Impacts around the streams visible – vegetation modification, trampling and sand mining.

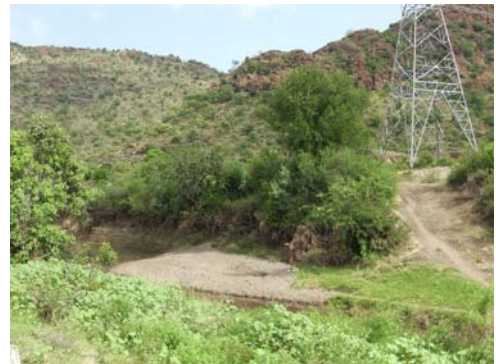
Figure 22: Some riparian trees present, but mostly modified and replaced by low shrubs and forbs – many invasives present.

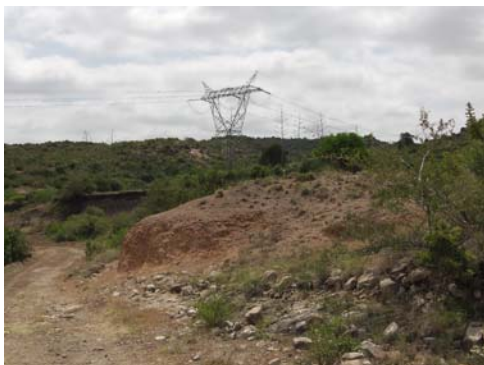
Figure 39: Sand mining a problem in streambeds in the area.

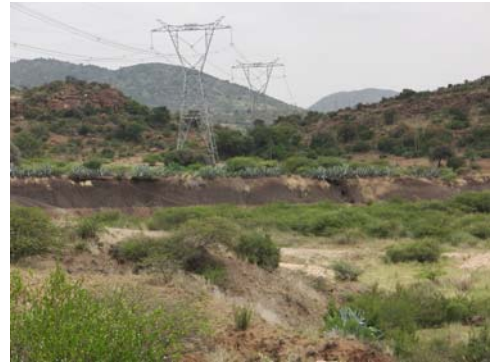
Figure 42: Over grazing, wood harvesting, trampling and alien invasives modified the natural vegetation near the Tshatane substation.

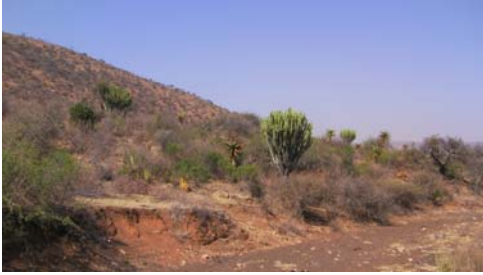
Figure 49: Some trampling and sand mining impact on streams – erosion visible.

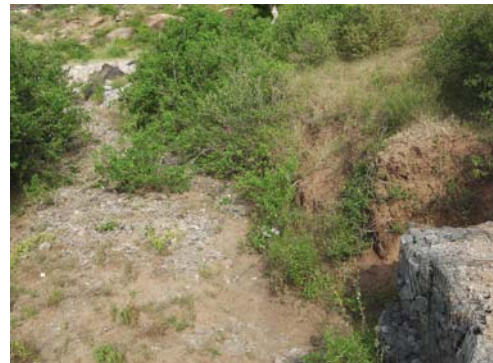
Figure 72: Overgrazing and encroachment modified the natural vegetation.

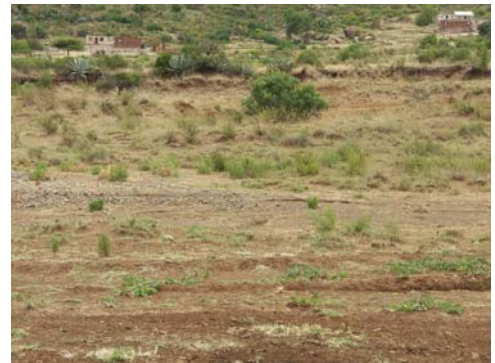
Figure 91: Severe erosion a problem in the area.
