APPENDIX B: **SITE PHOTOGRAPHS**

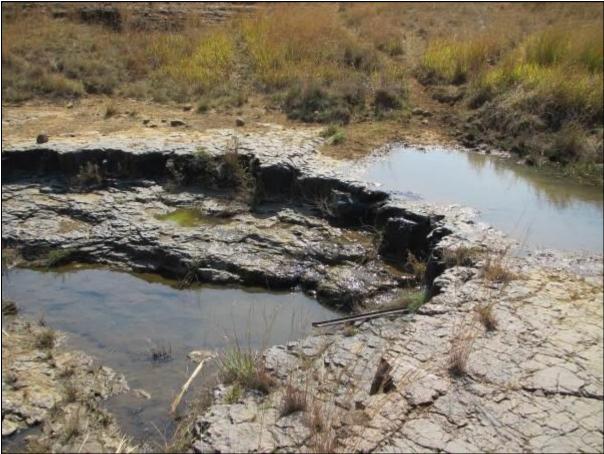
Plate 1. Feeder wetland systems leading into the Sunday's River. These systems are highy degraded and eroded.

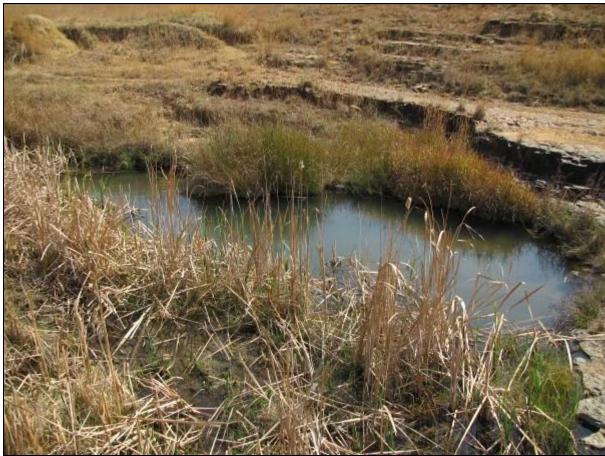
Plate 2. Arundinella nepalensis and Typha capensis growing in the feeder wetland system adjacent the Sundays River.

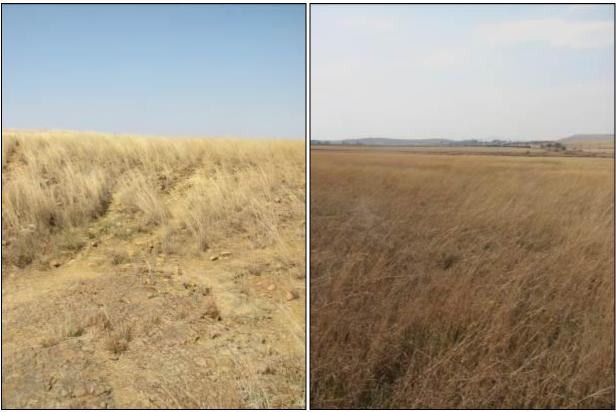
Plate 3. Eroded grassland areas

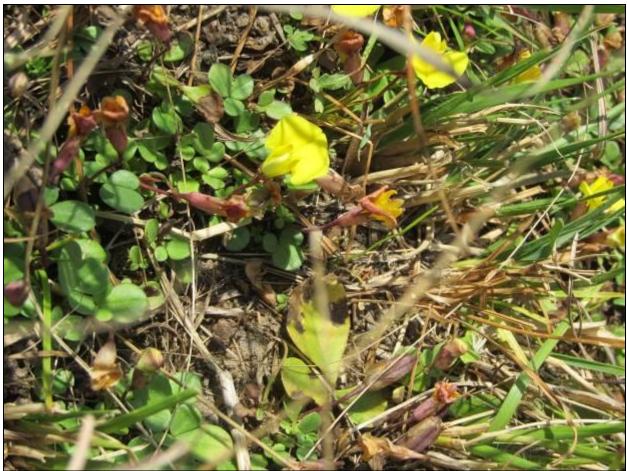
Plate 5. Lotononis solitudinis considered to be relatively rare and recorded from a few localities.

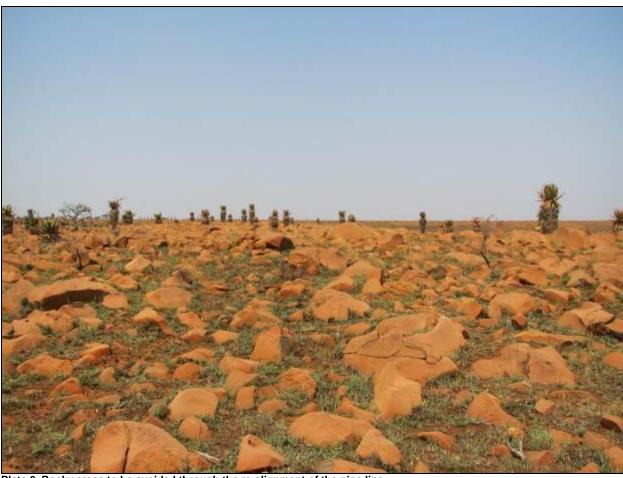
Plate 6. Rocky areas to be avoided through the re-alignment of the pipe line

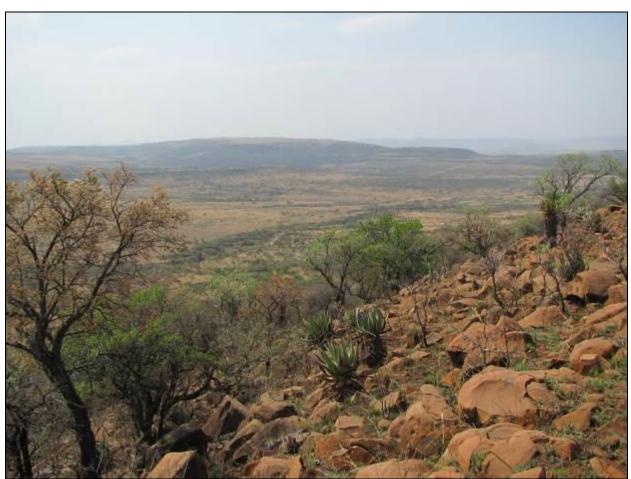
Plate 7. Steep sided escarpment to be avoided through the re-alignment of the pipe line, resulting in lower impacts.

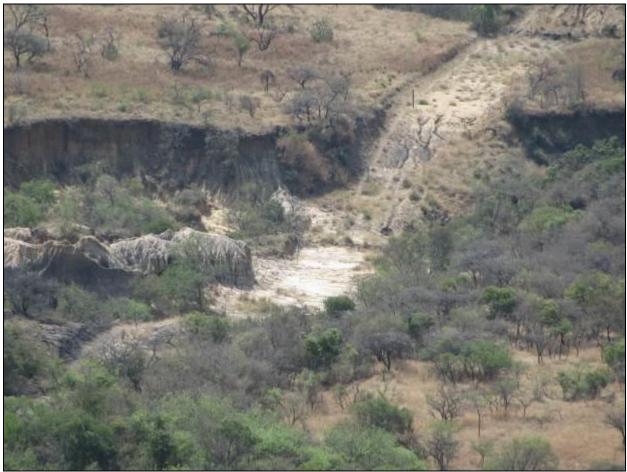
Plate 9. Erosion is a significant threat which will need to be considered during constrcution and rehabilitation of pipe line.

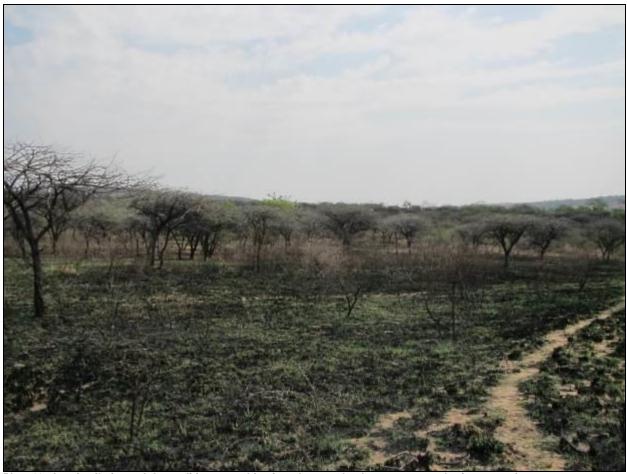
Plate 10. Acacia nilotica and A. natalitia encroaching into the grassland areas as a result of over-grazing.

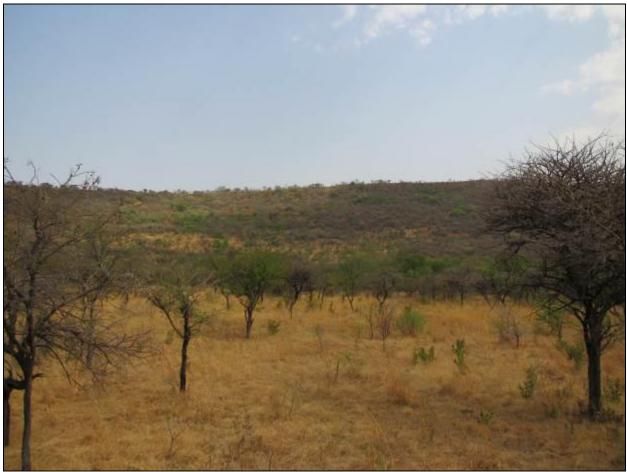
Plate 11. Grassland areas being encroached upon by woody vegetation, most notably *Acacia* species.

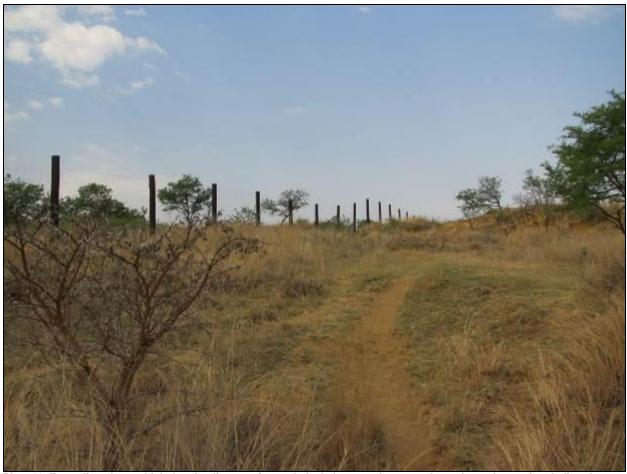
Plate 12. Fence line along which the pipe line runsfor a relatievly long portion, note the paths and associated disturbance

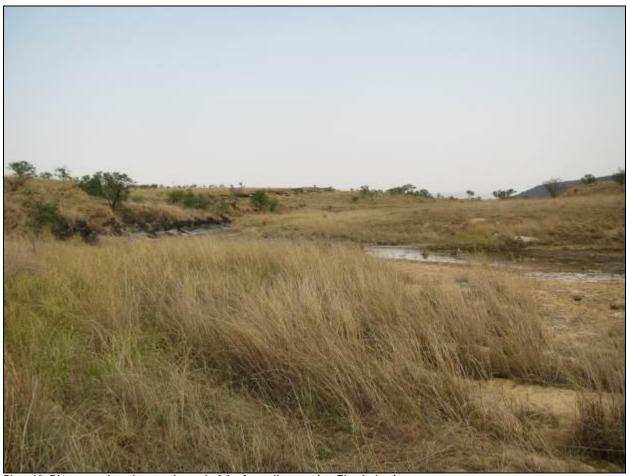
Plate 13. River crossing close to the end of the fence line nearing Ekuvhukeni.
