Southeast Trees:

A Multi-Site Tree Planting and Evaluation Project in Southeast Los Angeles County

Part 1. Introduction and El Dorado East Regional Park

DONALD R. HODEL

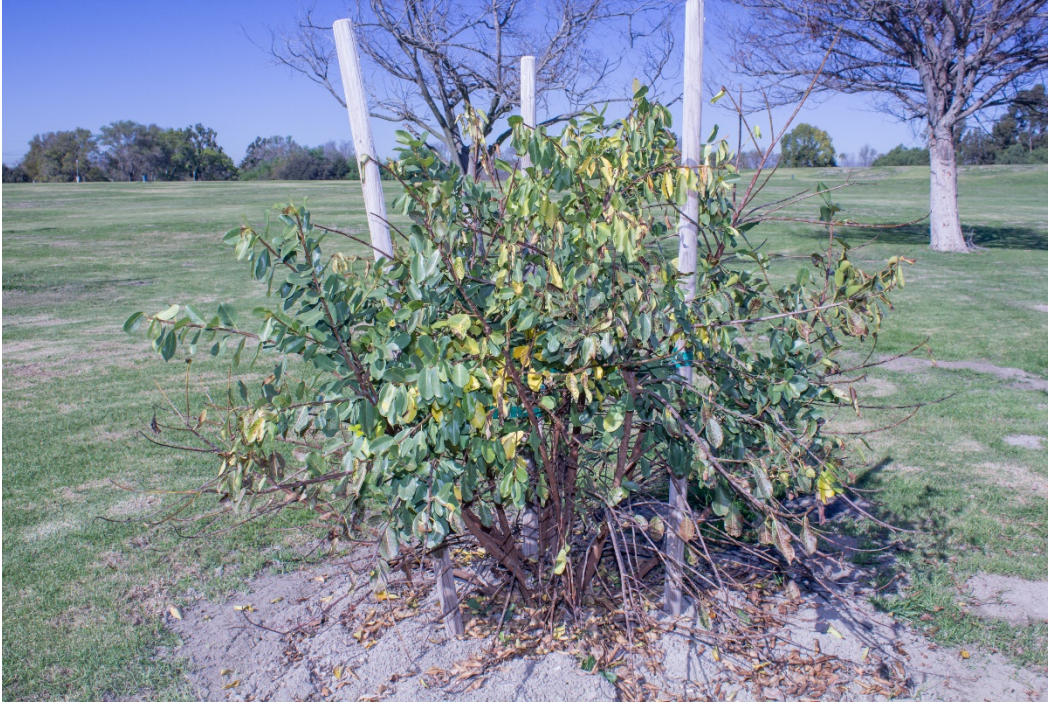
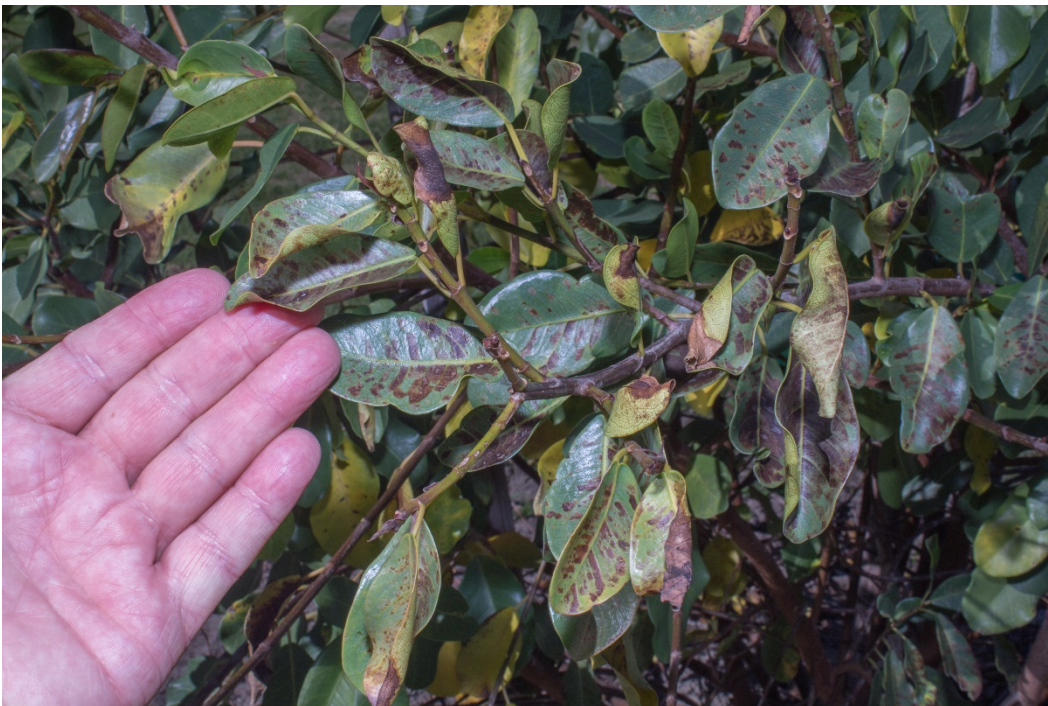
4. *Ficus natalensis* (2016-06-ED38) shows cold damage, January 2019.

5. Cold damage on *Ficus natalensis* (2016-06-ED38) , January 2019.

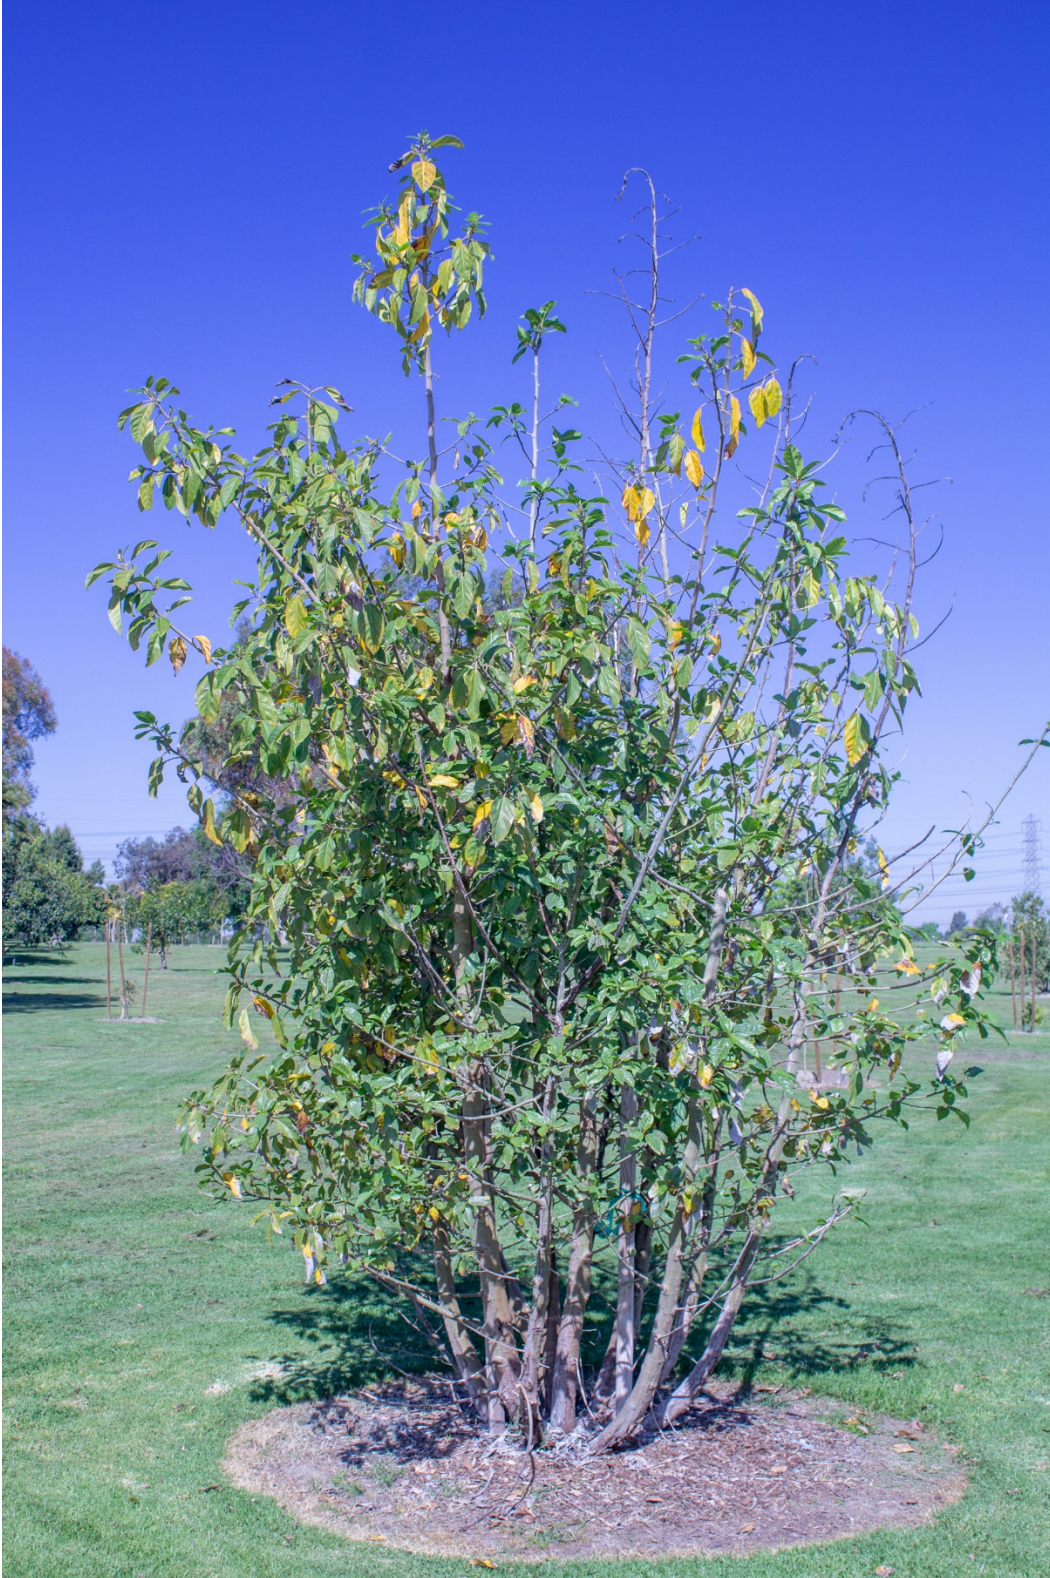
Notes: This handsome plant grew extremely fast initially, despite having been killed to the ground by cold its first two winters (2016–2017 and 2017–2018), each time recovering during the following growing season from basal sprouting and growing to two m tall by August. In 2017 I selected one of the basal sprouts as the new leader, removing the rest, but in the winter of 2017–2018 cold again killed it to the ground. It resprouted from the base in 2018 and no further serious cold damage occurred. In late 2019, though, it had extensive defoliation and associated shoot tip death and was diagnosed with a pathogenic fungal complex causing branch dieback. I will try to propagate it from cuttings and plant in a warmer location at the site.

36. *Ficus racemosa* in 2020, showing growth of basal sprouts after being killed to the ground from cold in the winter of 2017/2018. I will select one for the new trunk. Note the dieback from a foliar fungal disease.

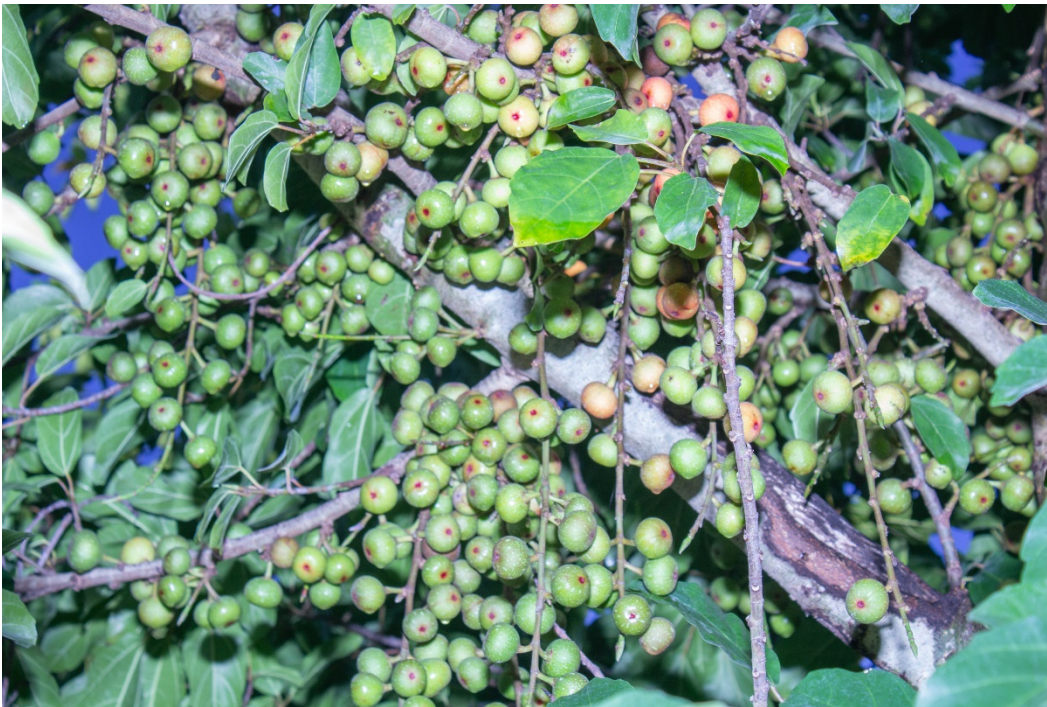
45. *Ficus sur* showing profuse production of figs on specialized leafless branchlets hanging from main branches and the trunk. Note old damaged bark from squirrels in lower right.

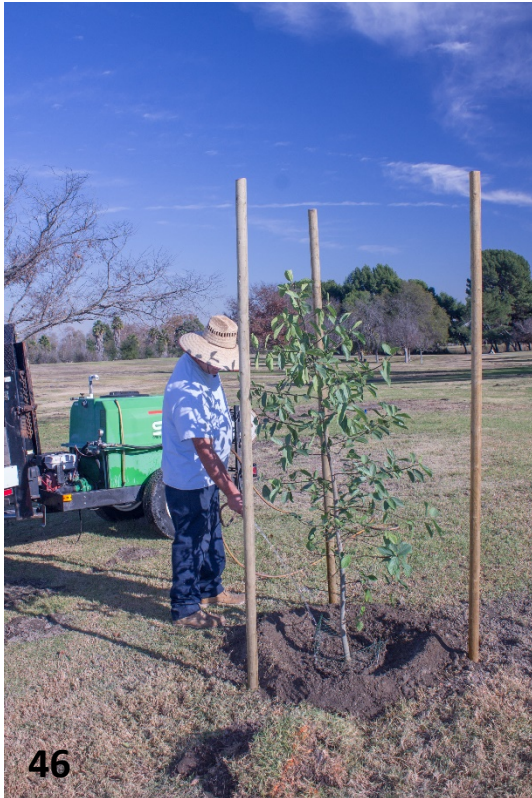
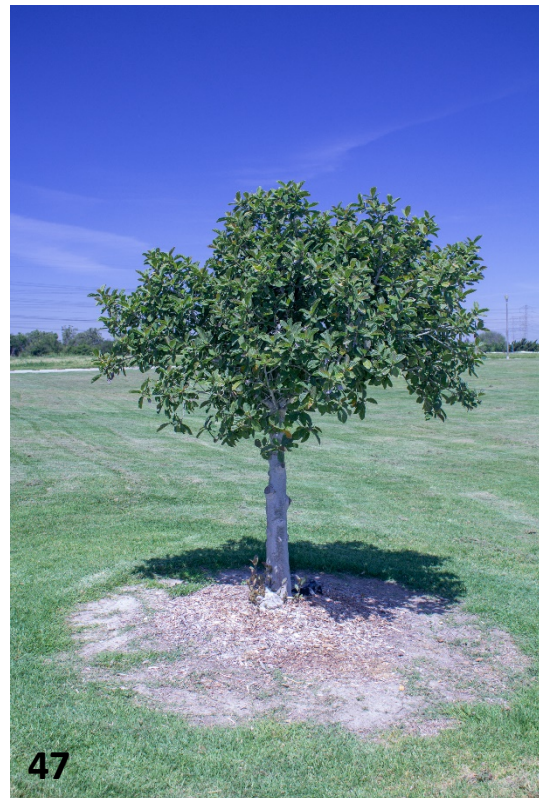
Notes: This handsome, cutting-grown plant grew extremely fast initially, despite having been killed to the ground by cold its first two winters (2015–2016 and 2016–2017), each time recovering during the following growing season from basal sprouting and growing to two m tall by August. Each time I had to select one of the basal sprouts as the new leader, removing the rest, and after doing so in late 2017, no further serious cold damage occurred but the plant

slowed remarkably over the last two years, perhaps from gophers that breached the gopher basket and tunneled around the base of the tree. This plant is the *Ficus cocculifolia* form, considered a synonym of the highly variable *F. sycomorus* and characterized by a strong central leader and upright growth, whitish bark with an attractive greenish tinge, and leaves uncannily like those of the alder, *Alnus rhombifolia*.

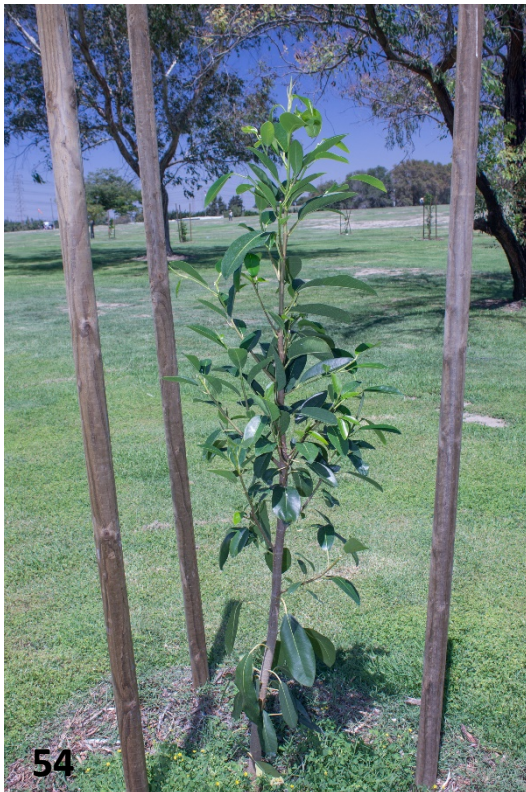
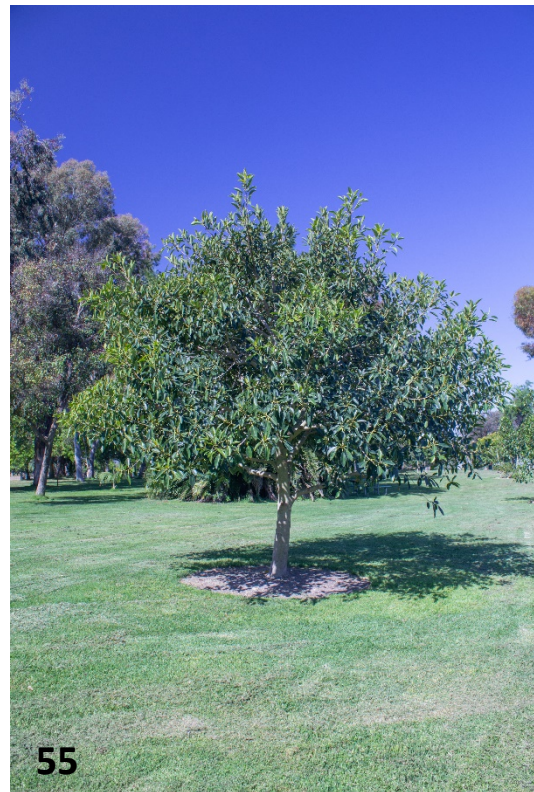
Notes: This handsome plant has grown moderately for four years and has had no problems although gophers have breached the gopher basket and piled up soil around the trunk. It attained maturity and had staminate flowers in late 2019.

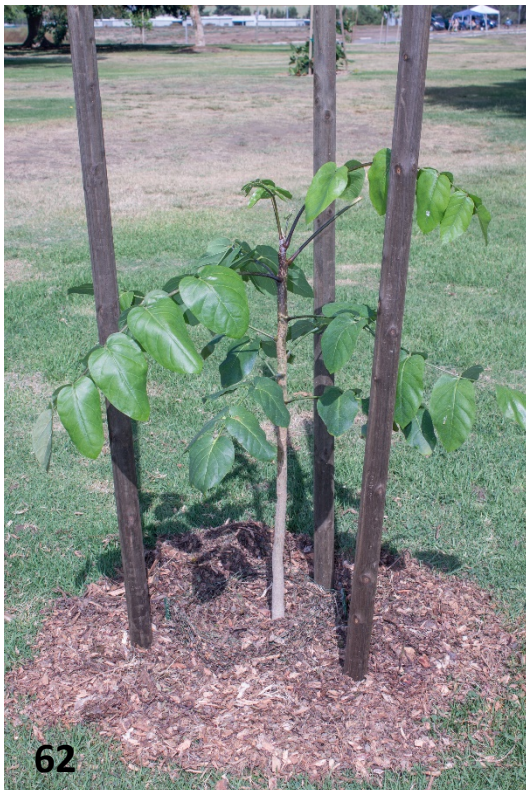
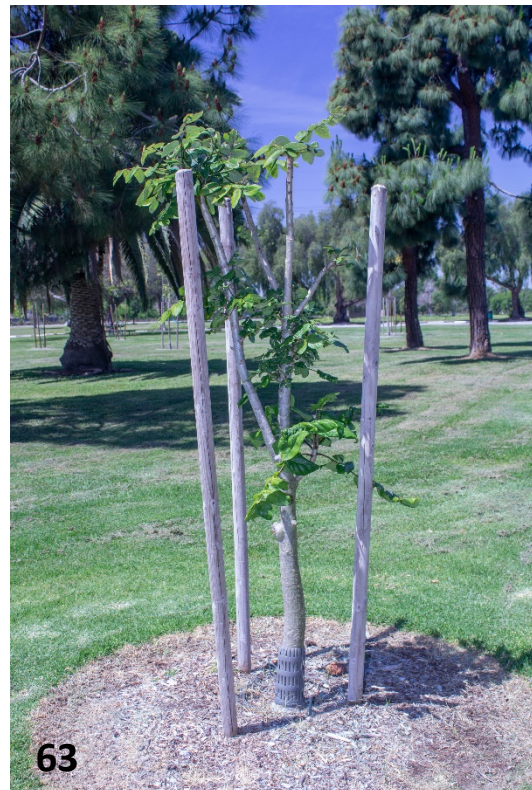
Notes: This Hawaiian endemic, a purchased plant and formerly known as *Munroidendron racemosa*, has been a steady, moderate grower. New growth is often stunted and distorted, likely from eriophyid mites in the vegetative buds.
