River Rehabilitation Works 2013 Ovens River; Germantown Reach

Upper Ovens Valley Landcare Group

Prepared by Riparian Management Services

March 2013

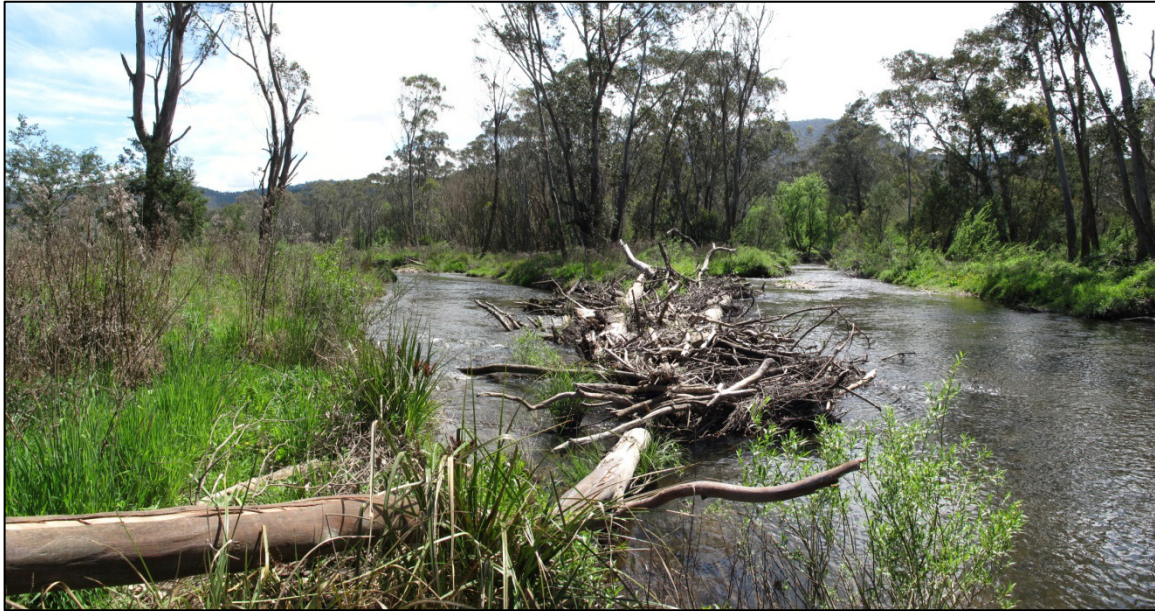
As outlined in section 2.1, the multiple channels that have developed 570m downstream of Germantown Bridge represent behaviour that is inconsistent with this river style. From examination of the 2010 aerial photograph it appears that many of these channels have developed since that time – probably as a consequence of the sequence of floods from late 2010, 2011 and March 2012 (see flow hydrograph at appendix 2). A new secondary channel has developed along a former bank-side vehicular track and multiple channels now convey even relatively low flows out across the left hand floodplain (see photos 1 – 3 on the following pages). The almost complete absence of riparian vegetation, either on the bank or across the floodplain, has facilitated the development of these channels

Photo 1. Taken 550m downstream of the Germantown Bridge, the main channel divides. Currently the main flow is to the right, but if the flood wrack across the entrance to the left channel should move, this situation could soon be reversed.

and there is a real risk that an avulsion could occur during future floods that will see the main channel move out across this unprotected, low floodplain. This would have economic consequences in terms of damage to the recently re-planted pine plantation as well as creating a significant erosion issue as flows would be directed out across loose, unconsolidated floodplain deposits. It is likely that such a channel, should it develop, would be quite unstable and prone to significant lateral movement with the potential to re-work much of the floodplain.

The plan map sheets contain recommendations aimed at alleviating the risks outlined in the previous section. The possible major channel avulsion at the top of the project area should be discussed with the current land managers (Hancock Victorian Plantations) with a view to developing a detailed program of works aimed at reducing the likelihood of this channel shift occurring. Some basic steps would include:

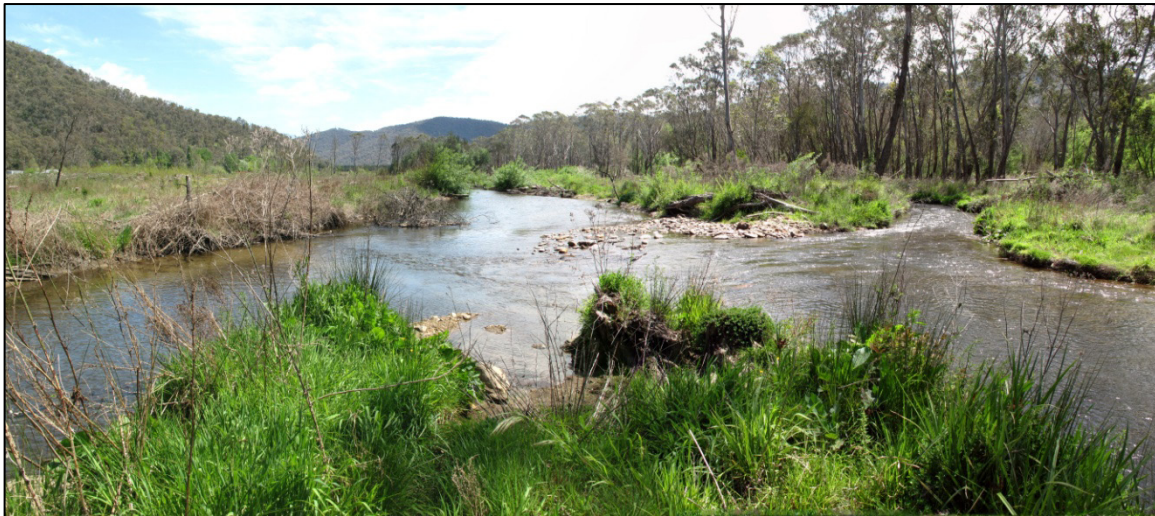
Photo 2. Taken 60m downstream of photo 1, the channel divides again. The channel to the right follows an old vehicular track that used to run parallel with the main channel. The left hand channel soon splits into multiple channels that fan out across the floodplain. A possible major channel avulsion could take place in this area that would see the main channel move from the right of the floodplain to the left through the pine plantation.

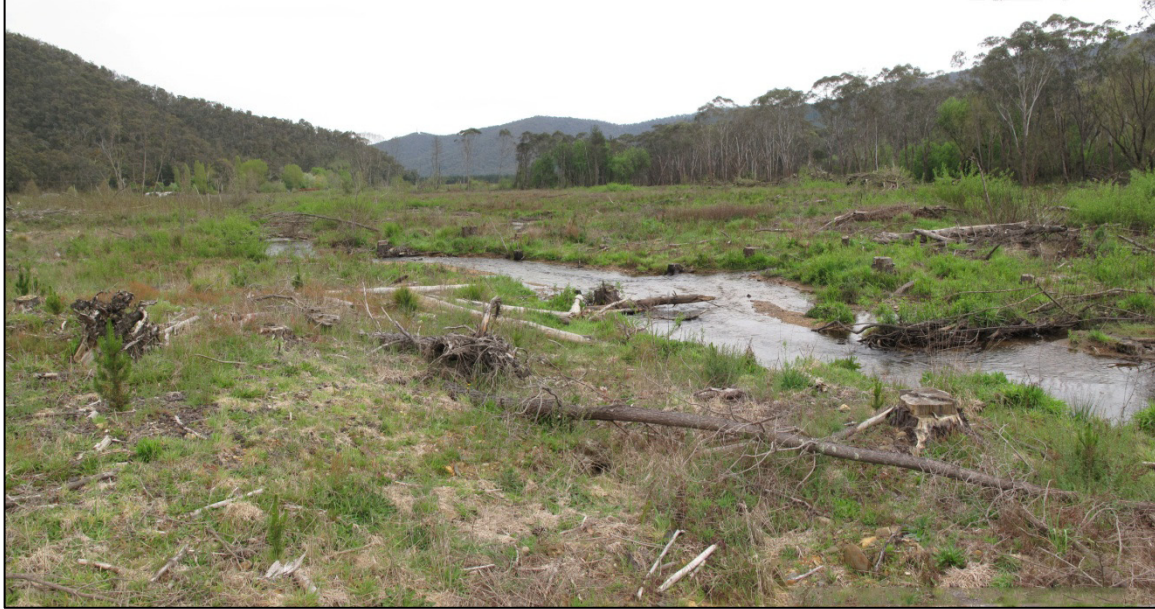
Photo 3. Taken just downstream from photo 2, the channel in the foreground is a branch off the left hand channel shown in photo 2 (i.e. the 3rd division since the main channel split shown in photo 1). An avulsion of the main channel across this cleared floodplain should be avoided if at all possible.

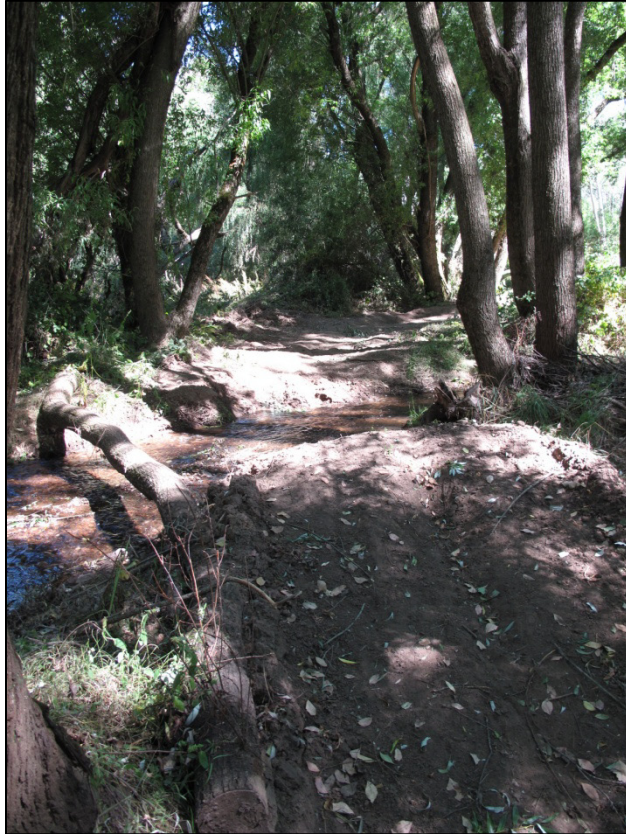
Photo 4. The motorcycle trail bike track on the Owens floodplain. A 'jump' has been created across German Creek. Extensive stands of mature Crack Willow provide both bed & bank erosion protection in this area.

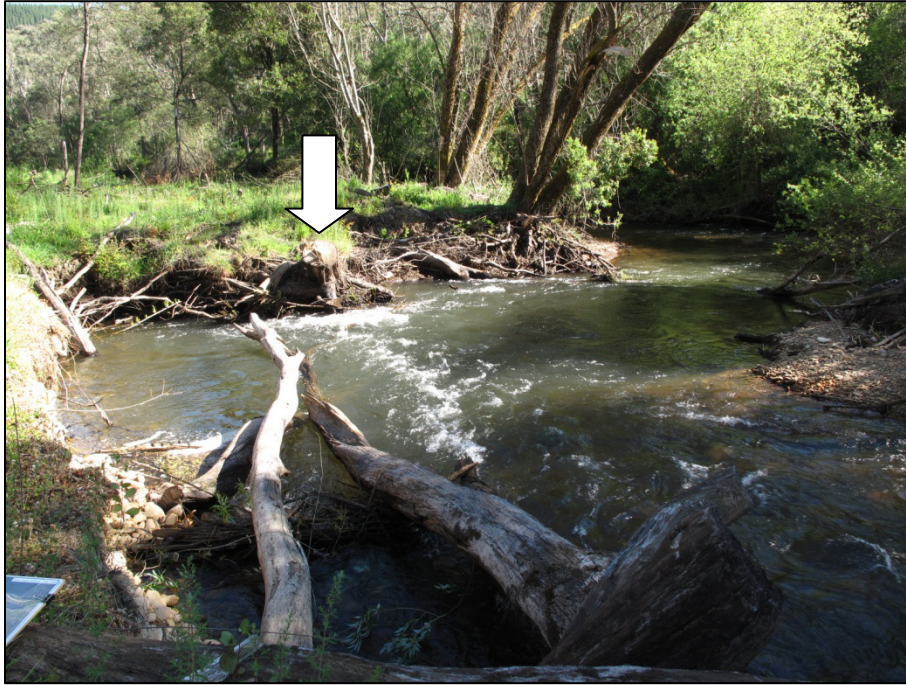
Photo 5. This bend has been eroding and now has a very unstable alignment. The floodplain on the left has been cleared of willows, including those on the bank that were providing some erosion protection (NB the stump indicated by the arrow). This bend now forms a classic 'break out point' where flood flows are free to leave the main channel and short circuit the bend. Floodplain stripping or chute cutoff development are risks at this site.

Poorly aligned eroding bends that are potential breakout points where chute cutoff channels may develop have been marked on the map sheets. A range of 'off-the-shelf' erosion control designs exist^{8&9} to rehabilitate sites like this and these should be addressed as a matter of priority. Photo 6 shows an example of the sort of bend re-alignment works that can be used. This project was designed and installed by the author of this report in the late 1990s. In addition, appendix 3 contains RMS "standard designs" for typical bank and bed erosion control structures that would be suitable for use within the project reach.

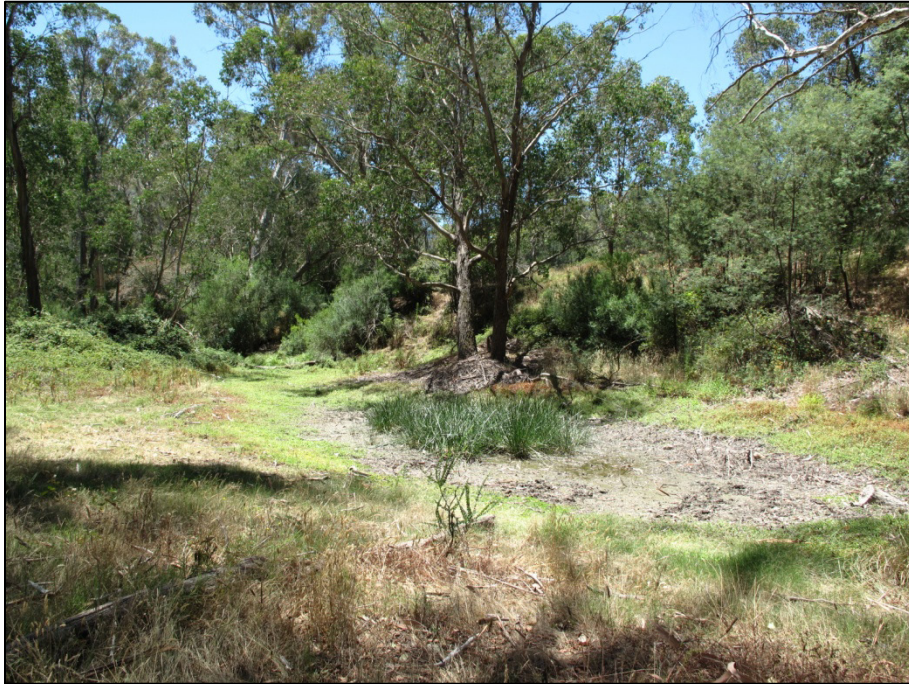
Photo 7. A small 'dredge hole' wetland at the valley margin. This artificial wetland type, a left over from the gold mining era, typically hold water for many months of the year with some of them being near permanent and fed by groundwater. This one holds water most winters but tends to dry out over summer, which suits the Tall Spike-rush which was just starting to die back when this photograph was taken in January.

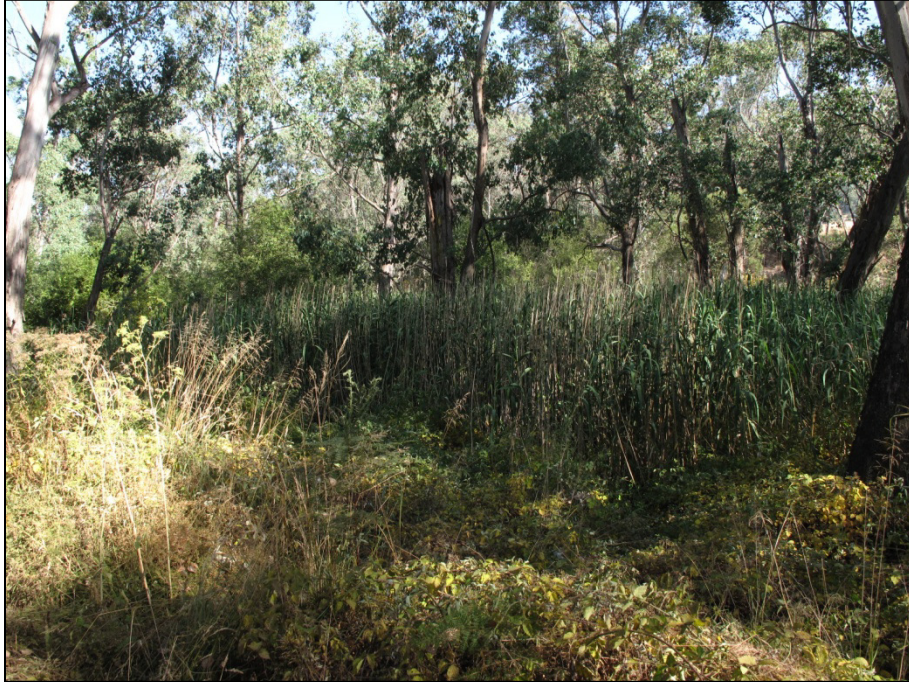
Photo 8. Common Reed dominated 'Tall Marsh' wetland at the valley margin. Limited species diversity (more or less Common Reed only in this case) and no tree component is typical of this wetland type. Note the Pussy Willow encroaching on the margins of the wetland (background).

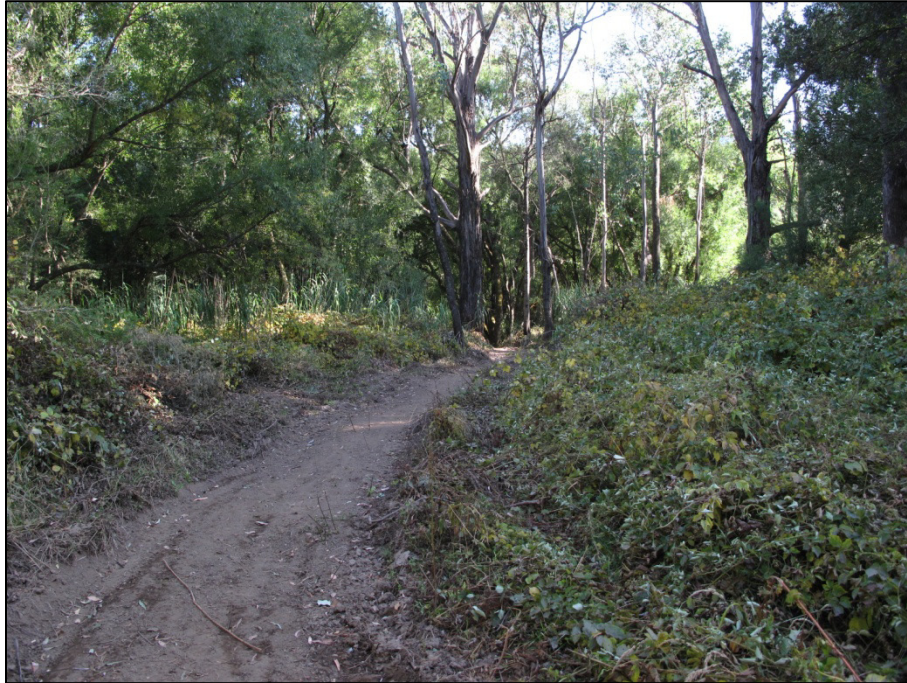
Photo 9. Much of the low lying floodplain country on the right side of the valley is willow infested with a Blackberry understorey, as here along the motorcycle track. Occasional eucalypt 'emergents' can be found through these areas.

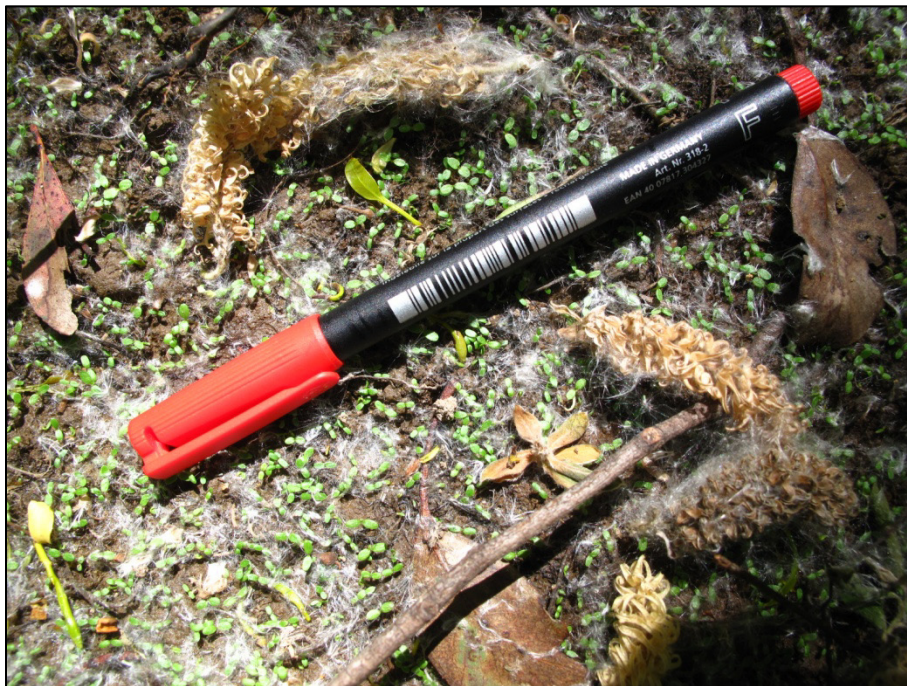
Photo 10. Willow seedlings on damp alluvial soil within the project reach. Wind blown willow seeds are believed to be able to disperse as far as 50 – 100km so ongoing follow-up will be required as long as there are 'parent' plants in the district¹⁰.
