"Ann Cuffe Fitzgerald"
Report author
Peter Cox
Project Manager

Funded by Heritage Council Grants 2010

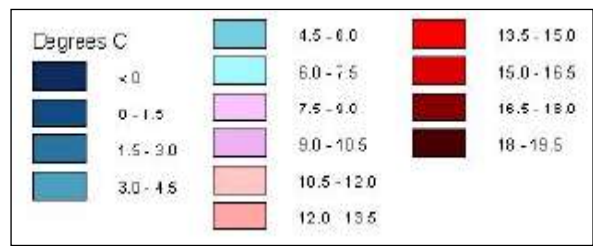
General increases of approximately 2°C are apparent with highest values to be found inland away from north and west facing coasts.

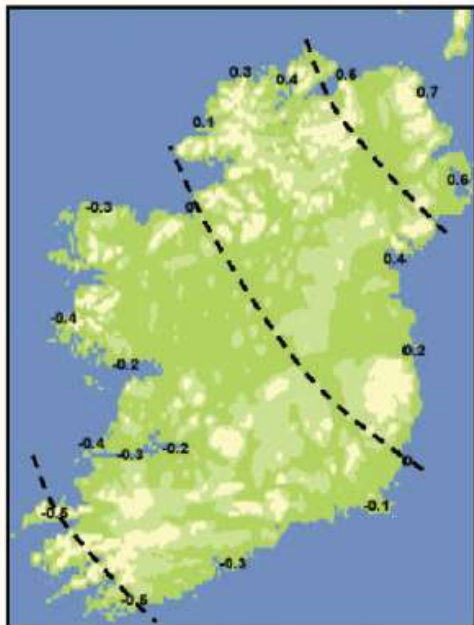
‘Determining future changes in sea level around the Irish coast is complex due to isostatic rebound, i.e. post-glacial changes in the elevation of the land relative to the sea. During the last glaciation, a large ice dome was centred on the north of the island depressing the Earth’s crust. The melting of this large ice mass during the early Holocene caused the land surface to uplift or rebound. Rebound is continuing with the highest rates in those locations where the greatest mass of ice originally lay, approximately north of a line from north Wexford to south Donegal (Edwards & O’Sullivan, 2007). South of this line rebound rates are slight or negative.’ Kelly B. and Stack M. 2009

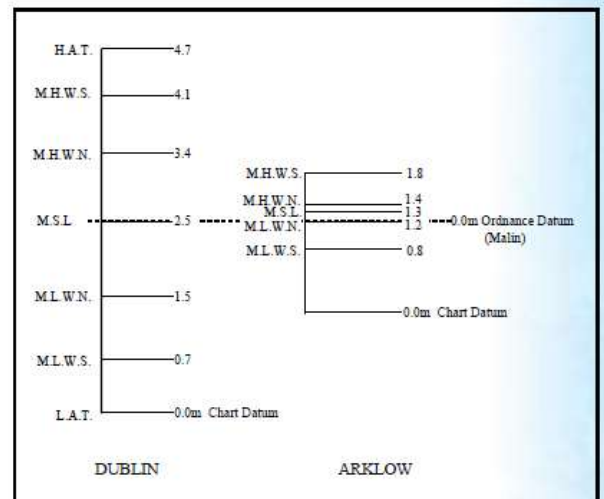
Once every 18.6 years the sun and moon are so aligned that their forces result in the highest and lowest astronomical tides possible. These tides are referred to as HAT and LAT.

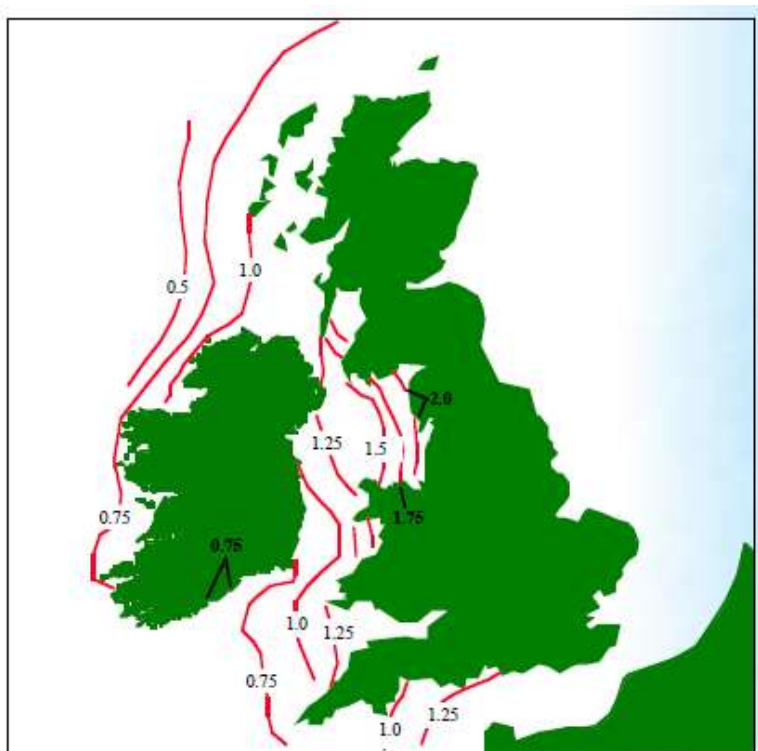
Fig. A1.2.28 - Estimate of the 1 in 50 year positive storm surge elevation in metres [33].

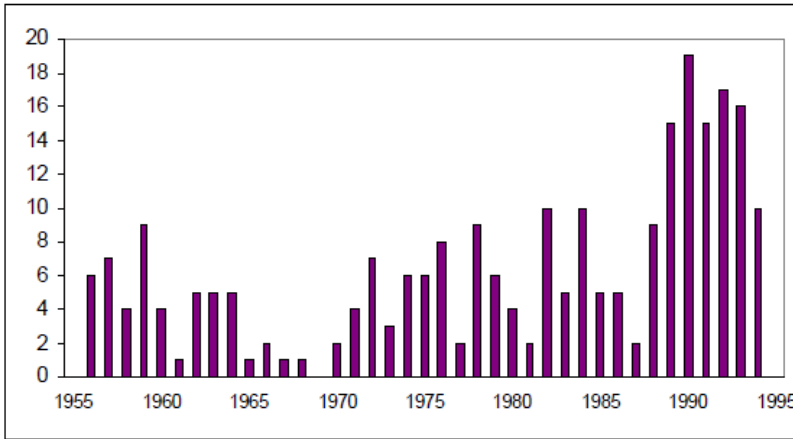
Number of North Atlantic low pressure systems with pressure less than 950hPa. Source: Deutscher Wedderdienst 1994. These storms appear to be causing more powerful waves. A study carried out for Wexford Co Council by RPS Engineers-entitled *Coastal Erosion Winter 2006/7 Wind Wave and Storm surge conditions, IBE0086/AKB/Feb07* notes that in high tide or storm surge conditions, the offshore banks on the East coast fail to diminish wave force as usual. This study revealed that a storm surge of 0.6m was experienced three times in the winter 2006-07 which hitherto had been predicted to occur once every two years; wave intensity was much greater than average winter 1989-2004. Water rose to 1.2m above MSL at Rosslare and 1.0 m at Courtown. None coincided with a spring or astronomical tide this lessened the impact.

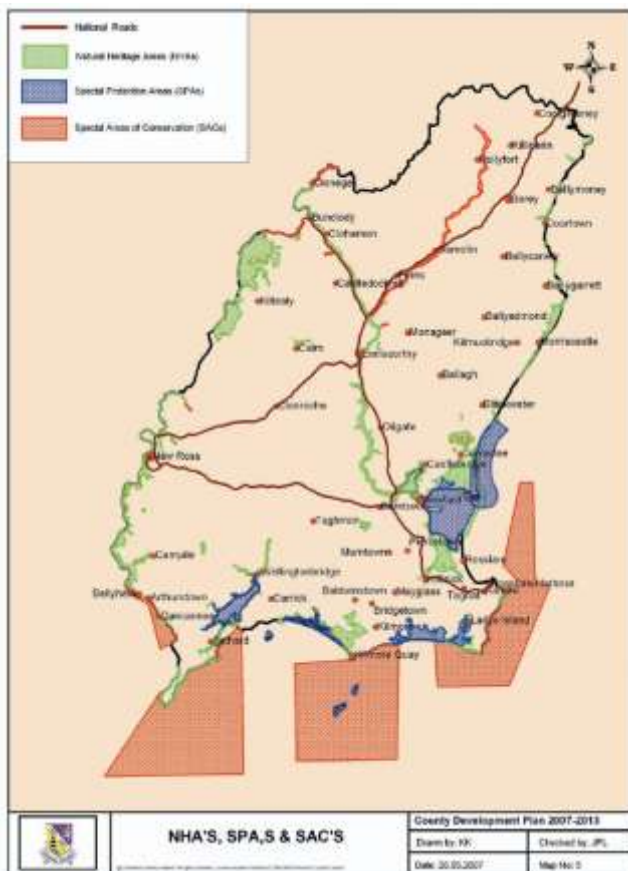
EU legislation requires that coastal areas designated as NHAs SPAs or SACs must be protected from erosion. As can be seen from the map below much of the coast of Wexford is so designated.

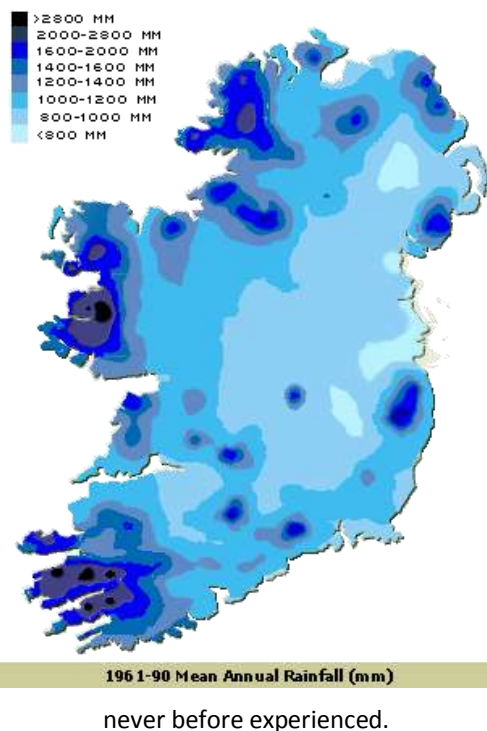
1. Erosion of site as many clay soil areas are located on the long soft east coast, especially behind the dune barrier which is under increasing erosion threat.
2. Storm events with higher wind force may damage thatch particularly if in poor condition.
3. In flood events, clay is very vulnerable to being washed away, and becoming saturated with groundwater salts which will break it down and cause it to become hygroscopic retaining damp as per *Sikka, S. and Chaudhry, C. 'Earth Structures Vulnerability'*
4. Increased insect, mould and fungal threat to thatch as less frost days are very likely.
5. Material for thatch such as oat and wheat straw may become less available depending on climatic conditions, thus diluting the historic character of the structure.
6. Extreme drought may lead to subsidence of clay soils where

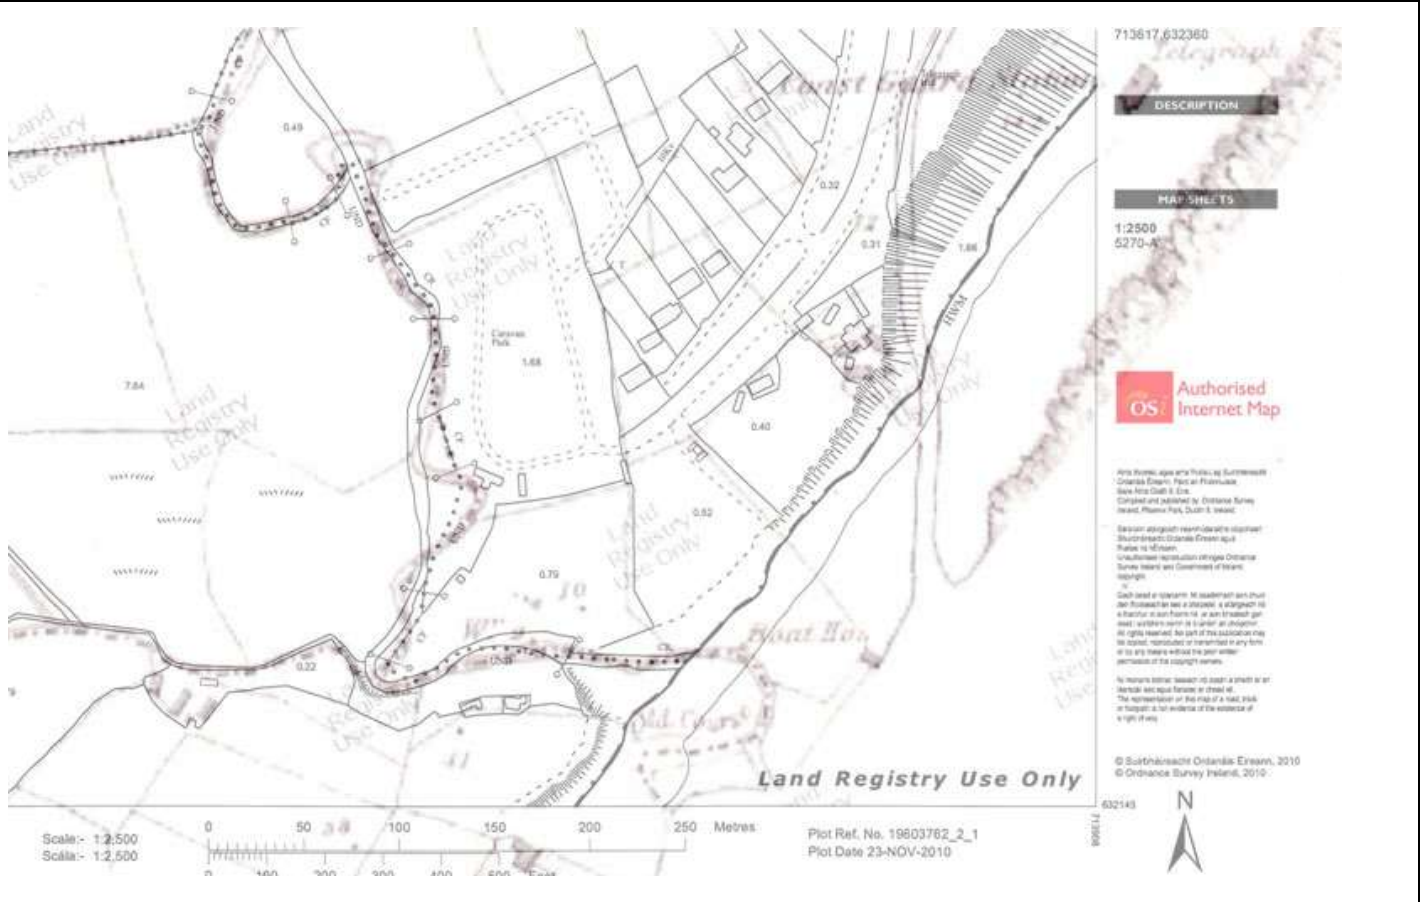
FIG D1 NE COAST: SOFT: BLACKWATER/ CURRACLOE SUPERIMPOSED MAPS: SEVERE RECESSION
 Vulnerable shore: this map shows a section of coast at Curracloe /Blackwater and superimposes the first Ordnance Survey, this area surveyed in 1840, irregular scallops show shore; with the current O.S. surveyed in 2008, regular parallel lines show dune line. Recession of the order of 150m may be noted see scale at base of map; an entire Coastguard Station has been lost at Telegraph Hill. A sizeable group of thatched vernacular houses lie behind the dune line; Ballyconnigar, Curracloe, Blackwater

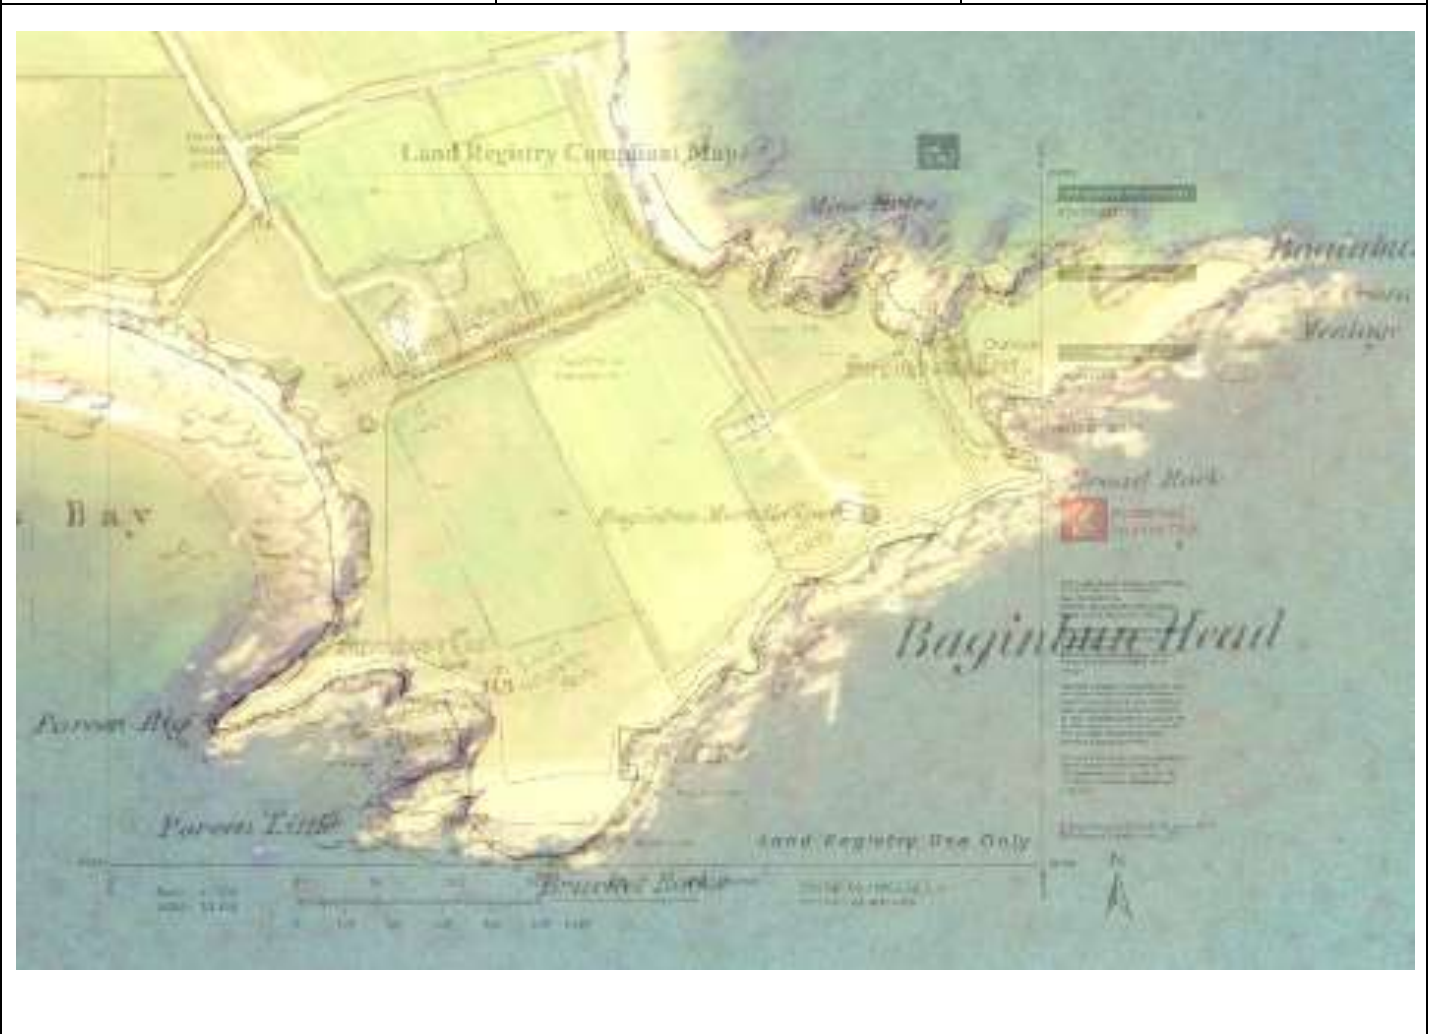
FIG D9 SE COAST: ROCKY HEAD: BAGINBUN SUPERIMPOSED MAPS:SOME RECESSION
 This headland on the south coast S. of Fethard has a promontory fort, earthworks two sets of ditch and bank were altered as AngloNorman defences – it is a National Monument subject to Preservation Order- no. WX050-015002-
 Despite the rocky siting, recession is notable to the west end of 'Strongbow's Entrenchment' see photo below, and also to each end of the north south fosse on the eastern promontory. This condition is also found at Duncannon, below

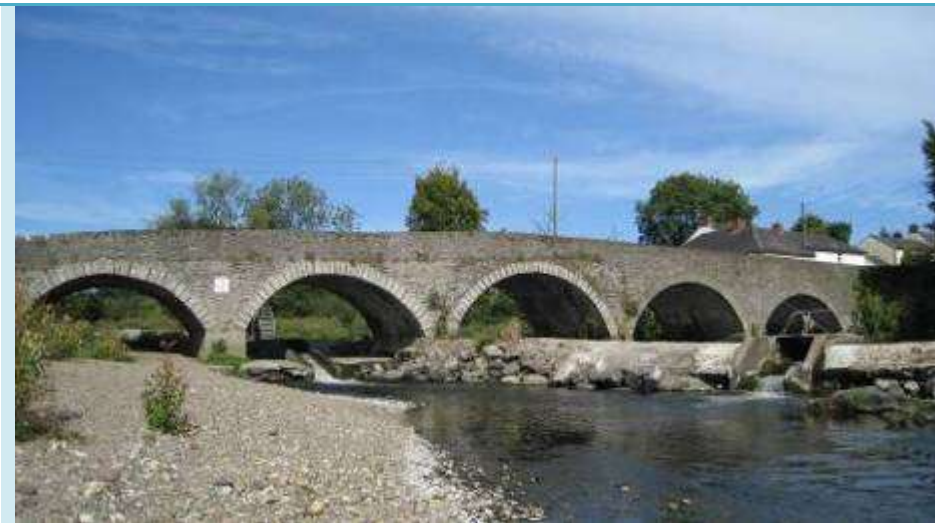
Clohamon Bridge 2/09/10: good cutwater feature to piers, already concrete repairs some loss of heritage value

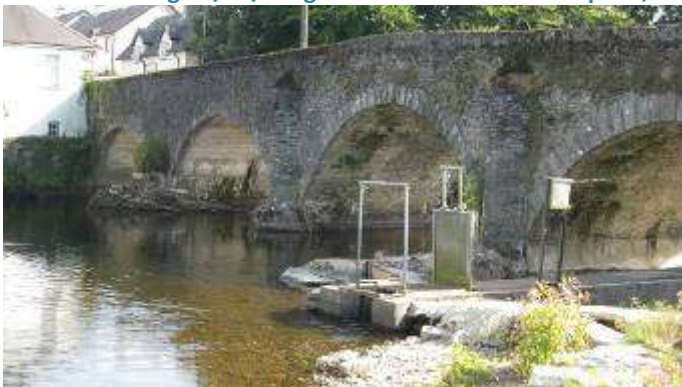
Clohamon bridge 2/09/10 from upriver showing debris, concrete reinforcing to 2 arches close to village(E)
