**KOEBERG – ANKERLIG 132KV POWER LINE:  
FAUNA AND FLORA PRECONSTRUCTION WALK-THROUGH REPORT**

**PRODUCED FOR SAVANNAH ENVIRONMENTAL  
ON BEHALF OF ESKOM HOLDINGS SoC LIMITED**

**June 2016**

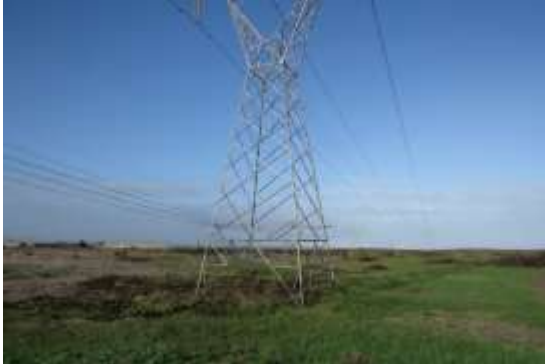
Pylon	Habitat condition/Species	Image	Avoidance & Mitigation
25	Start of the deviation

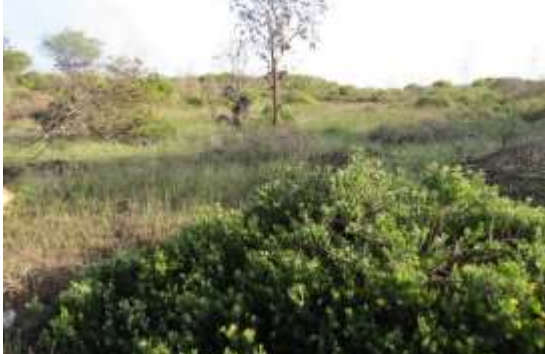
Not applicable
24	<p>Disturbed area dominated by <i>Ehrharta villosa</i>, <i>Cynodon dactylon</i>, <i>*Acacia saligna</i> and <i>*Raphanus raphanistrum</i>. Additional species include <i>Searsia laevigata</i>, <i>Osteopermum moniliferum</i>, <i>Trachyandra ciliata</i>, <i>Euphorbia mauritanica</i>, <i>Searsia glauca</i> and <i>Brunsvigia orientalis</i>.</p>

Suitable site
23	<p>Moderate to dense infestations of <i>*Acacia cyclops</i> with partial clearing carried out. Intact vegetation occurs with infestations of <i>Acacia cyclops</i> at varying levels of cover density. Species: <i>Searsia laevigata</i>, <i>Trachyandra ciliata</i>, <i>Albica</i> sp., <i>Putterlickia pyracantha</i>, <i>Euphorbia mauritanica</i>, <i>Ruschia indecora</i> (ENDANGERED) and <i>Thamnochortus spicigerus</i>. Note that <i>Ruschia indecora</i> also occurs in the surrounding habitat. Thus moving the pylon would not mitigate impacts.</p>

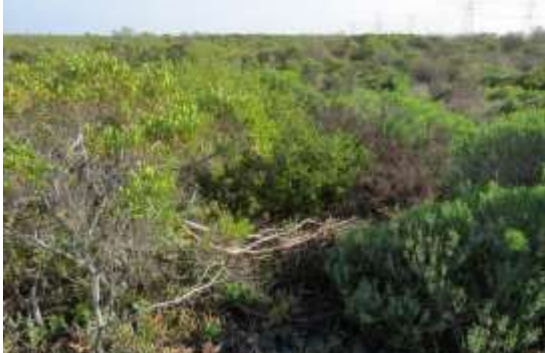
22	<p>Intact, good condition Cape Flats Dune Strandveld located on a dune. Dominant species include <i>Searsia laevigata</i>, <i>Euphorbia mauritanica</i>, <i>Ruschia indecora</i> (ENDANGERED) and <i>Euclea racemosa</i>. Additional species: <i>Carpobrotus acinaciformis</i>, <i>Searsia glauca</i>, <i>Putterlickia pyracantha</i>, <i>Ficinia</i> sp. and <i>Ruschia macowanii</i>.</p>

Construction of a service road through this vegetation will have a High Impact.

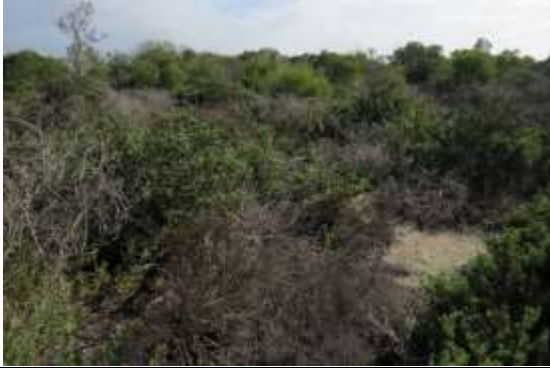
<p>21</p>	<p>Dense patch of <i>Ruschia indecora</i> (ENDANGERED) along with additional species such as <i>Searsia laevigata</i>, <i>Trachyandra ciliata</i> and <i>Trachyandra</i> sp., <i>Zygophyllum</i> sp. and <i>Babiana</i> cf. <i>tubulosa</i> (VULNERABLE).</p> <p>Since the general area supports high numbers of <i>Ruschia indecora</i> there is no leeway to reposition the pylon.</p>

Pylon 21 is within intact dense patch of *Ruschia indecora* (ENDANGERED) along with additional species such as *Searsia laevigata*, *Trachyandra ciliata* and *Trachyandra sp.*, *Zygophyllum sp.* and *Babiana cf. tubulosa* (VULNERABLE) and is highly likely to have some impact on protected species. This pylon cannot be relocated within a radius of ca 50m as it is located within a much broader patch of *Ruschia indecora*. As a result, the impact of this pylon should be mitigated on-site during construction. The following mitigation and avoidance measures should be implemented during the construction of the pylon and power line within the intact fragment at Pylon 21:

<p>No leeway to reposition the pylon. The surrounding habitat is the same.</p>
<p>20</p>	<p>Degraded area overrun with *<i>Acacia cyclops</i> and *<i>Acacia saligna</i> and dominated by <i>Ehrharta villosa</i>. Additional species include <i>Zygophyllum morgsana</i>, <i>Trachyandra ciliaris</i>, <i>Asparagus capensis</i> and <i>Searsia laevigata</i>.</p>

- No formal vegetation clearing should be done on-site. This will allow geophytes, forbs and more tolerant perennials to persist within the disturbed area which should largely recover after the disturbance if the soil is not disturbed. Only the actual footprint of the pylon, where excavation is required, should be disturbed.
- Where possible, the mature specimens of *Ruschia indecora* should not be disturbed.

- The work area should be demarcated by an ecologist prior to construction and enforced by the ECO during construction. This area should be demarcated with construction tape or similar and no activity should be allowed outside of this area.
- Due to the uncertainties involved in the footprint, it is difficult to provide precise estimates of the number of individuals of protected species that would be impacted by the development. The numbers estimated are those likely to be impacted by the construction of the pylons and it is assumed that sufficient avoidance can be implemented along the access route to minimise significant impact due to access.
- Based on the observations made to date and assuming a worst-case scenario, the following numbers of individuals are indicated as appropriate for the CapeNature permit application:

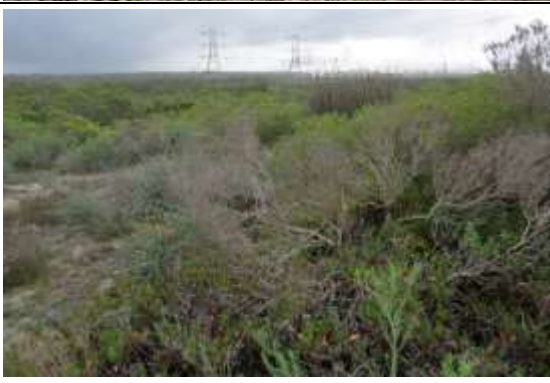
<p>Suitable site</p>
<p>19</p>	<p>Intact, good condition Cape Flats Dune Strandveld of the same type at Pylon 22.</p>

<p>Construction of a service road through this vegetation will have a High Impact. Moving the site to waypoint 001 (33°36'20.80"S; 18°27'29.82"E) would be slightly less harmful since the vegetation is in a semi-intact condition at this point.</p>

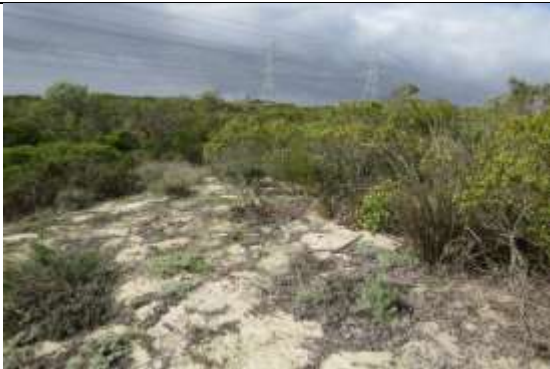
<p>18</p>	<p>Semi-intact to intact vegetation located on top of a dune. The vegetation is dominated by <i>Euclea racemosa</i>, with open patches containing low-growing species including cf. <i>Arctotis</i> sp. and <i>Jordaniella dubia</i>. Additional species include <i>Asparagus capensis</i>, <i>Euphorbia mauritanica</i>, <i>Limonium peregrinum</i>, <i>Ruschia indecora</i> (ENDANGERED), <i>Searsia glauca</i> and <i>Romulea flava</i>.</p>

<p>No leeway to reposition the pylon. The surrounding habitat is the same.</p>

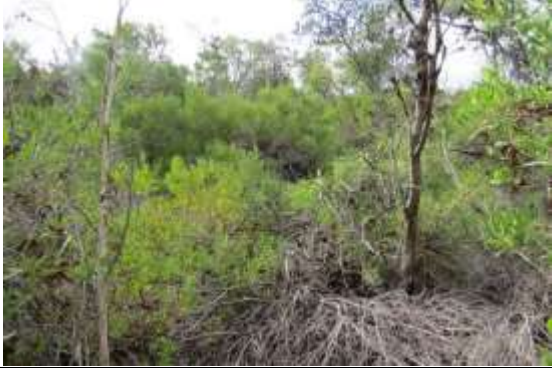
17	<p>Area heavily infested with <i>*Acacia saligna</i> and <i>*Acacia cyclops</i>. Area needs to be cleared of Invasive Alien Plants (IAPs).</p>

<p>Suitable site</p>
16	<p>Mosaic or disturbed open patches covered with <i>Ehrharta villosa</i> and <i>Jordaaniella dubia</i> and large shrubs including <i>Searsia glauca</i> and several <i>Euclea racemosa</i> plants. Additional species include <i>Thamnochortus spicigerus</i> and <i>Cotyledon orbiculata</i>.</p> <p>Note shrubs are important habitat refuge and should be avoided.</p>

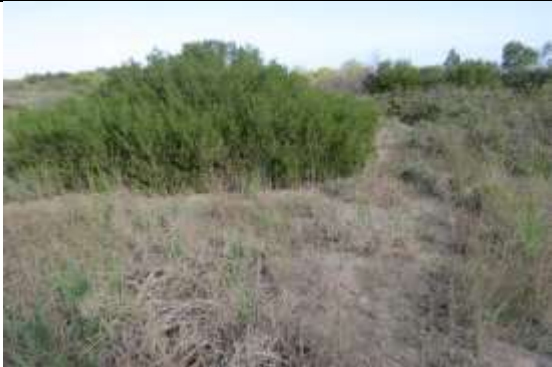
<p>The shrubs could be avoided by moving the pylon 10 m south.</p>
15	<p>Disturbed area dominated by <i>Ehrharta villosa</i>, with a large <i>Searsia glauca</i> plant. Additional species include <i>Albucca</i> sp. and <i>Ruschia macowanii</i>.</p>

<p>Avoid large <i>Searsia</i> shrubs if possible</p>
14	<p>Same habitat as Pylon 12 with additional species including <i>Limonium peregrinum</i> and <i>Euphorbia mauritanica</i>.</p>

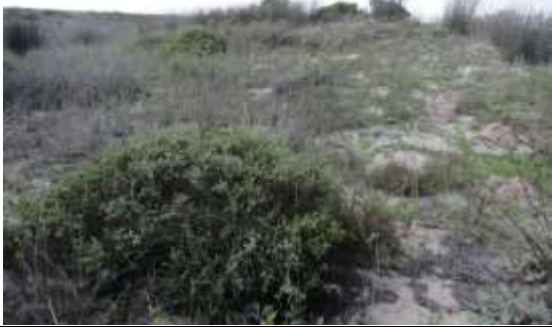
13	<p>Semi-intact to intact vegetation with a mosaic of shrubs and open patches. The open patches are dominated by <i>Ehrharta villosa</i>, <i>Jordaaniella dubia</i> and cf. <i>Arctotis</i> sp. The dominant shrubs and restioids include <i>Thamnochortus spicigerus</i>, <i>Pelargonium</i> sp., <i>Metalasia muricata</i> and <i>Ruschia indecora</i> (ENDANGERED).</p>

<p>The pylon would have less impact if positioned closer to the fenceline at the industrial area to the south-east.</p>
12	<p>Intact vegetation on top of a dune. Dominant species include <i>Thamnochortus spicigerus</i>, <i>Ehrharta villosa</i> and <i>Joordaaniella dubia</i>. Additional species include <i>Lachenalia rubida</i>, <i>Muraltia spinosa</i>, <i>Searsia glauca</i>, <i>Euclea racemosa</i>, <i>Metalasia muricata</i> and <i>Olea exasperata</i>.</p>

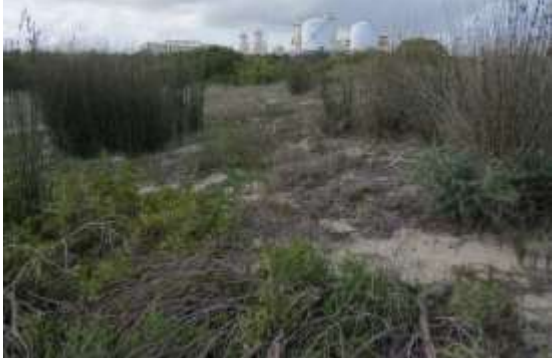
11	<p>Semi-intact vegetation with the same array of species at Pylon 12.</p>

<p>Suitable site</p>
10 to 6	<p>Transformed area located within Ankerlig Power Station (APS).</p>

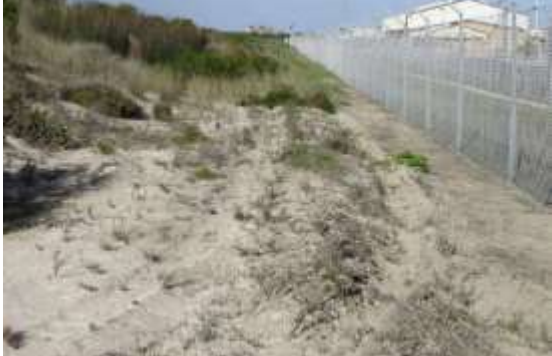
<p>Suitable sites</p>
5 to 3	<p>Located on almost flat ground along disturbed edge near rehabilitated dune/embankment. The area is highly degraded and covered mostly with alien grasses.</p>

<p>Suitable sites</p>

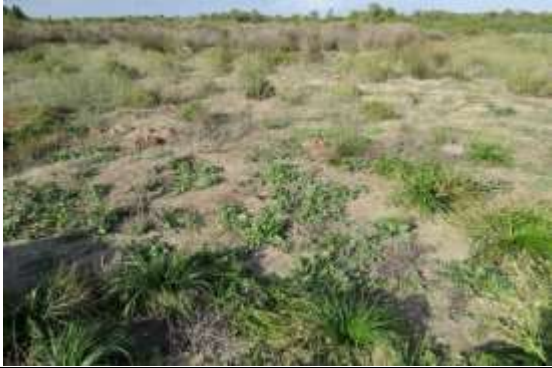
2	Degraded area where rehabilitation was not been implemented properly (i.e. no follow up weed management, seeding and replanting) dominated by <i>Tetragonia fruticosa</i> , * <i>Raphanus raphanistrum</i> and <i>Trachyandra divaricata</i> . Additional species include <i>Salvia cf. lanceolata</i> , <i>Ruschia macowanii</i> , <i>Cynodon dactylon</i> , <i>Hellmuthia membranacea</i> and <i>Zygophyllum sp.</i>

Suitable site
1	Same habitat as Pylon 2
