B. C. TAP WATER ALLIANCE

Caring for, Monitoring, and Protecting
British Columbia's Community Water Supply Sources

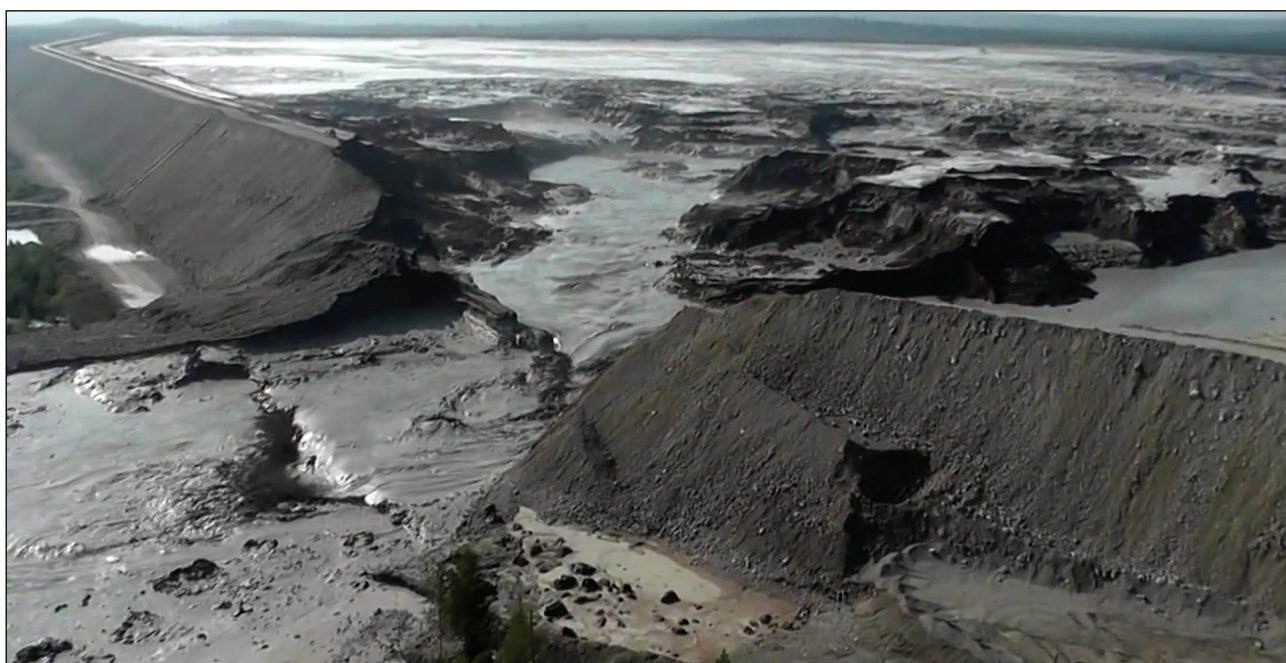
The “In Perpetuity” Mandate

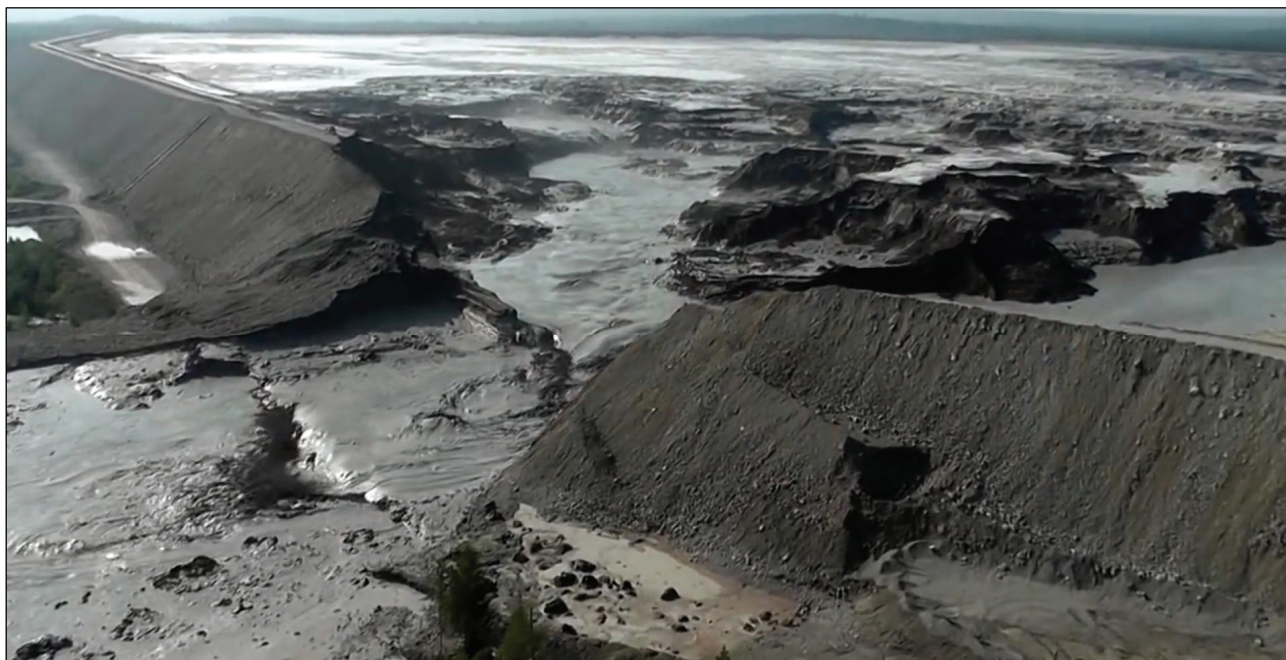
The “In Perpetuity” Mandate

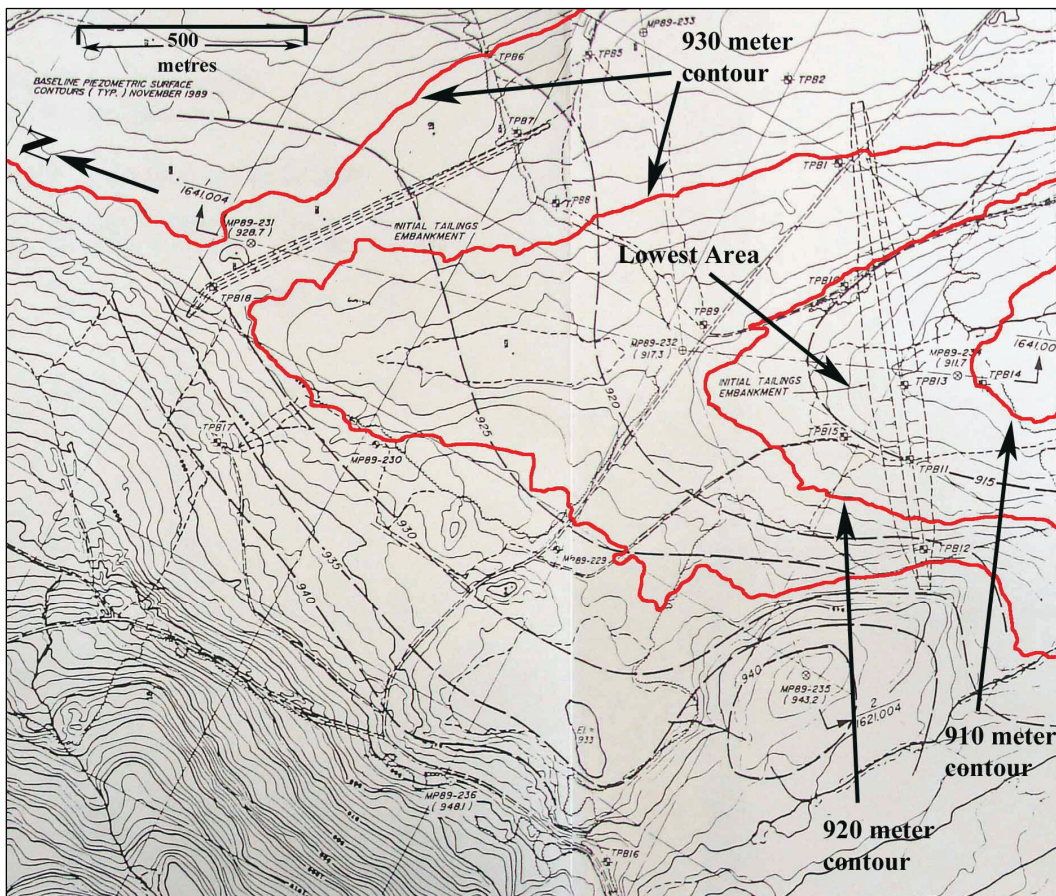
Left: Figure 4-9, Area B Test Pit and Borehole Plan, from Volume One of the 1990 Assessment report. The highlighted red lines show the original contour elevation locations of the Tailings Storage Facility. They show the flow regime of the Edney Tributary #1 watershed. The top left area between the “930 meter contour” areas is the divide for the location of the Perimeter Embankment, where the August 4, 2014 dam failure occurred.

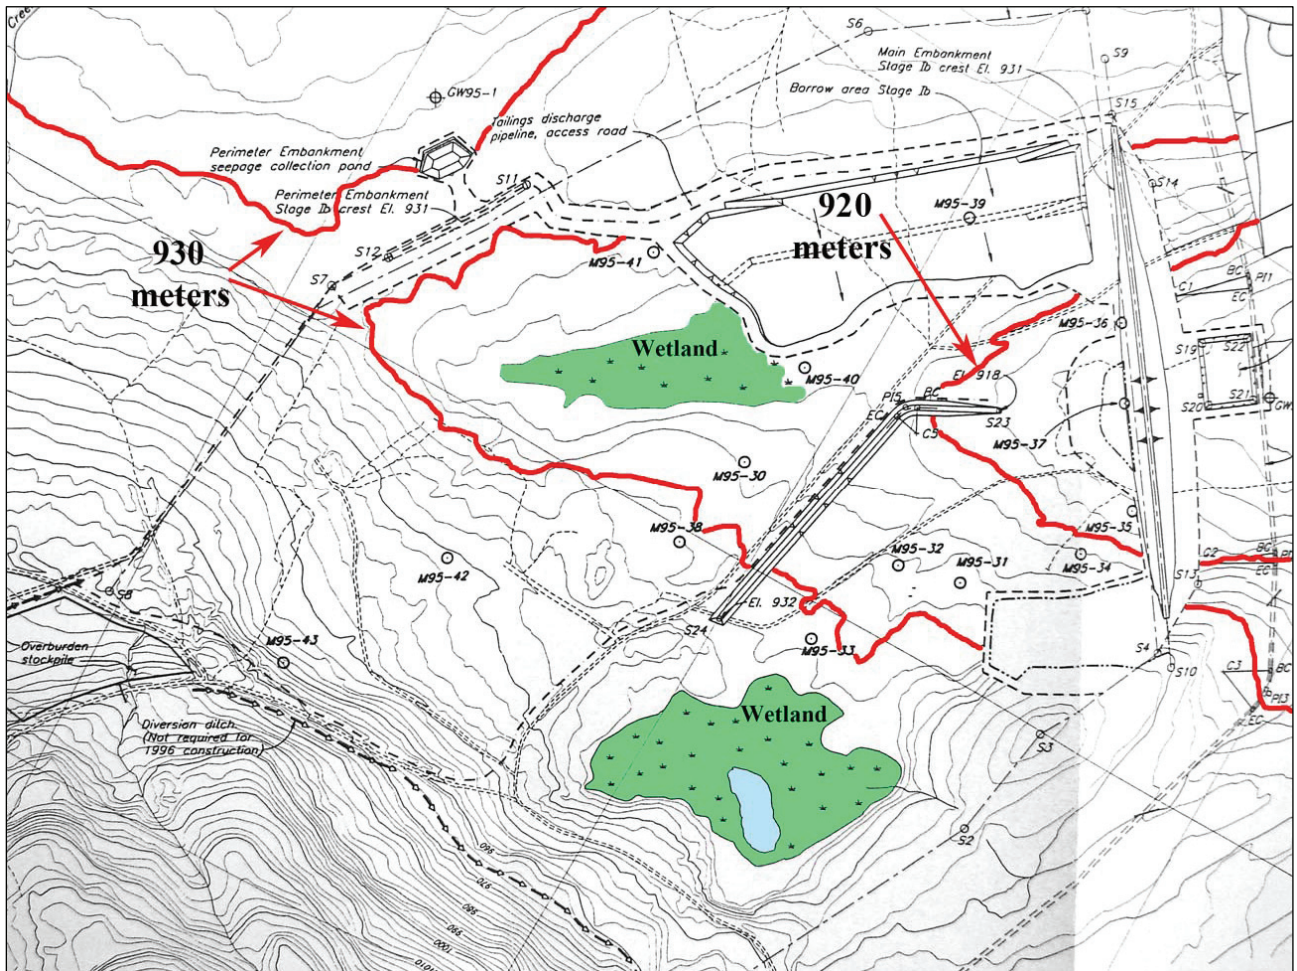
Above: Adaptation from Figure 2.2, *Soil Test Pit Locations of the Tailings Storage Facility*, in the 1996 *Mount Polley Mine Project Reclamation Plan*. The drawing shows the locations of two former wetland areas, a former pond within one of those wetlands (referred to as the “Tailings Bog”), and the original contours of the present Tailings Storage Facility (TSF) area. The lowest elevation point in the TSF is at 914 meters, about the middle of the proposed Main Embankment location.

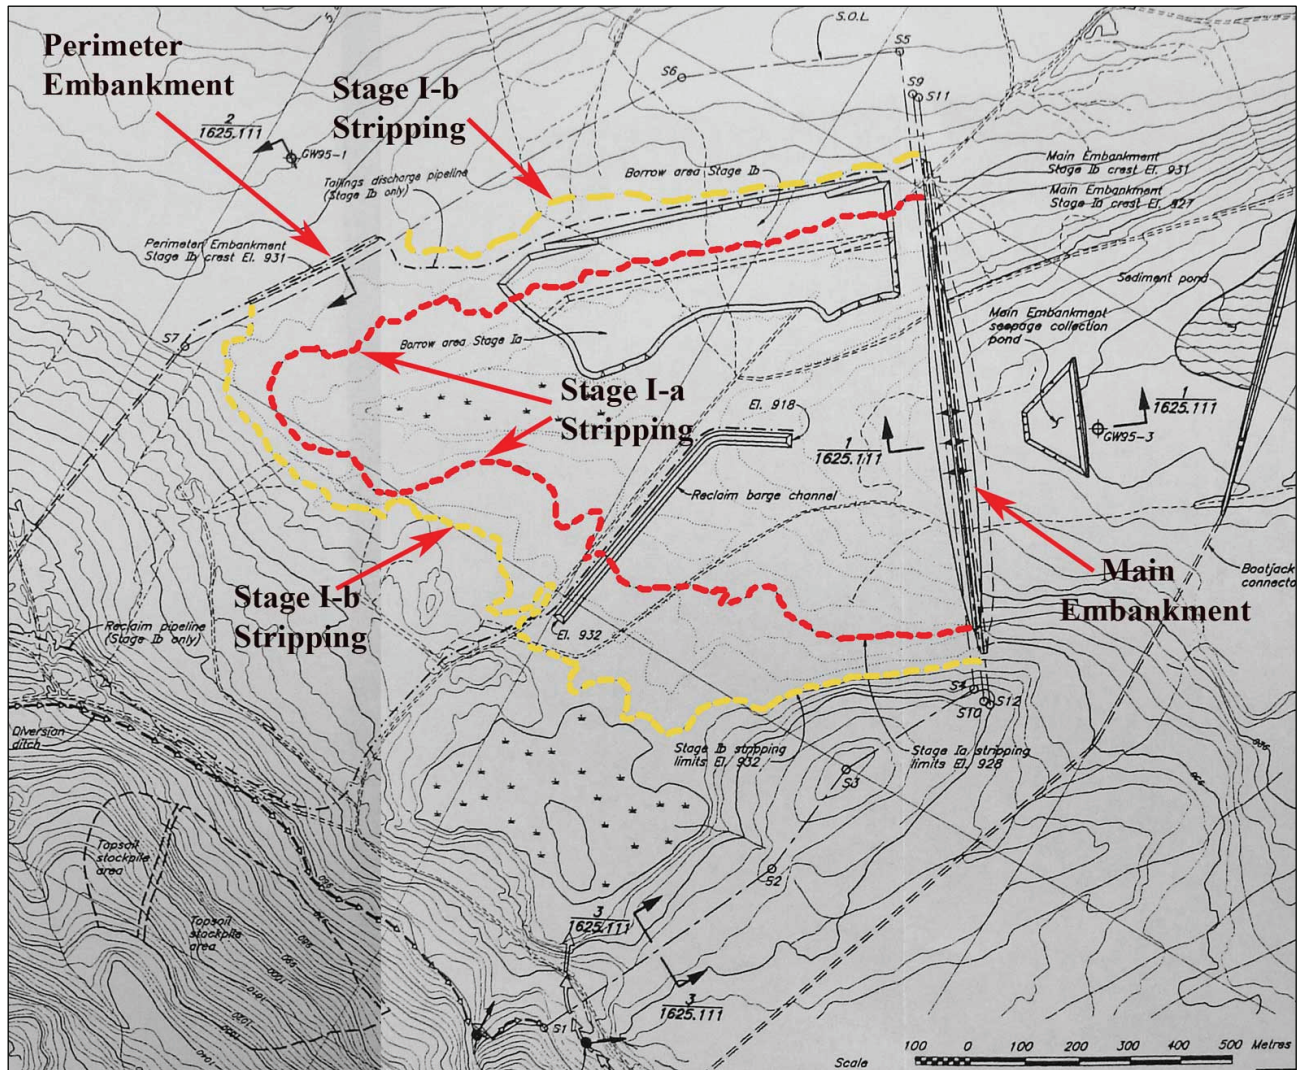
Above: Figure 3.15, *Stage Ia / Ib Tailings Impoundment General Arrangement*, in the 1996 Mount Polley Reclamation report. The red dotted line indicates elevation 928 meters, and the yellow dotted line indicates elevation 932 meters. Stage Ia embankment crest was set at 927 meters for the Main Embankment, and Stage Ib crest was set at 931 meters for the Main and Perimeter Embankments. The height of the Perimeter Embankment for Stage Ib was about one meter, and about 16 meters in height for the Main Embankment for Stage Ib, a difference of about 15 meters in elevation between the two embankments.

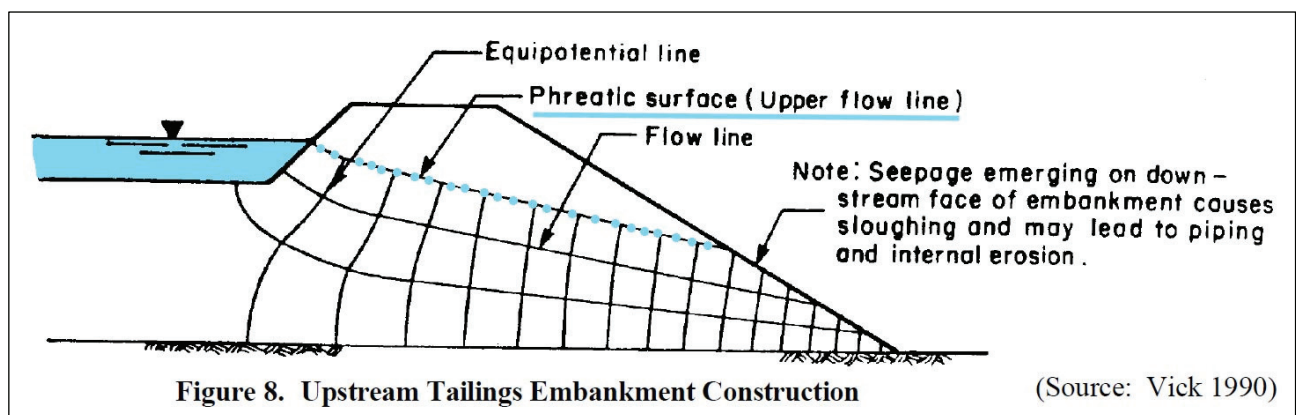
Above: Diagram from EPA's 1994 report, *Design and Evaluation of Tailings Dams*. The blue zone is the location of water (supernatant, accumulating) in a tailings facility, and the dotted blue line is the Phreatic (water table) upper surface zone emanating through gravity from the supernatant (decant) water held in the facility.

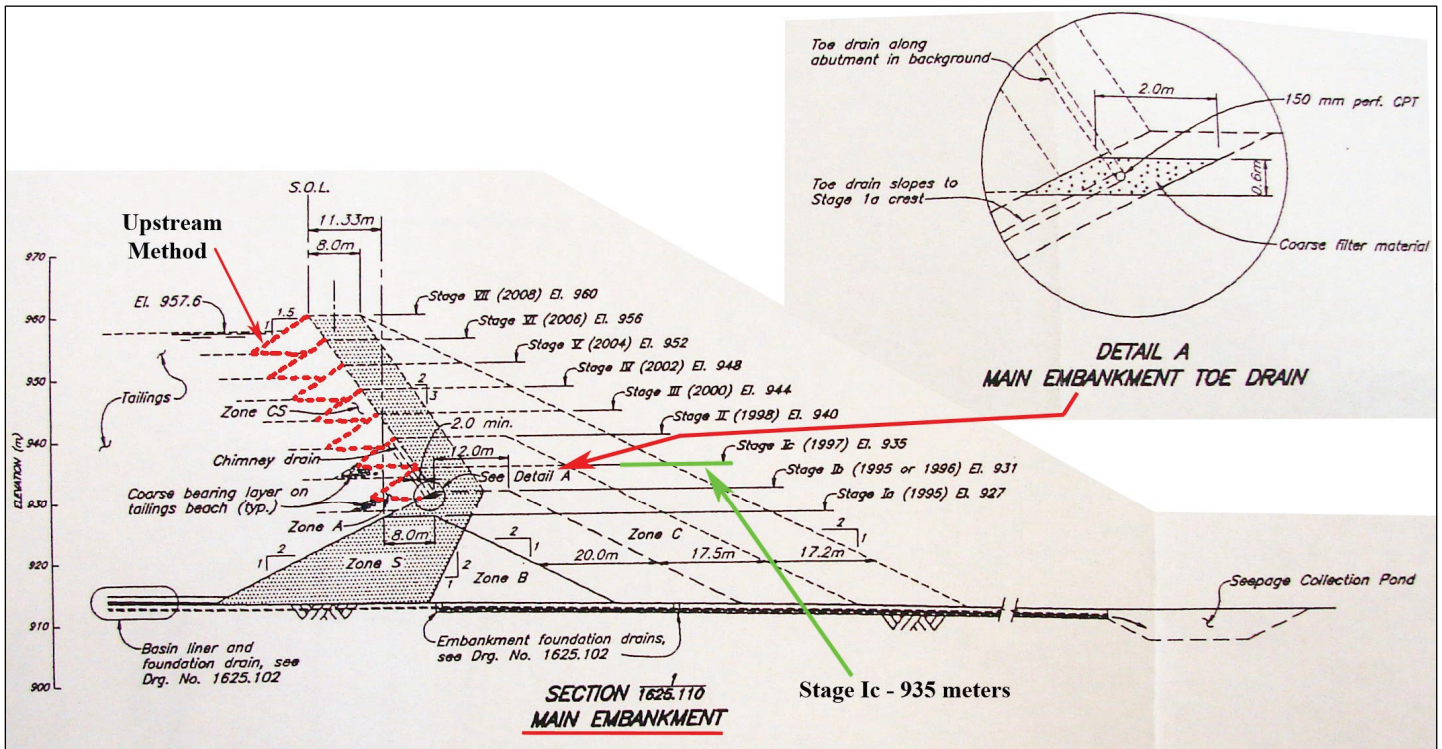
Above: Figure 3.18 from 1996 Reclamation Plan report. The red dotted lines show the Upstream Type method stages for the Main Embankment. Note the height in meters of Stage Ic elevation, and the large area below built up primarily of Centreline Type method, a much stronger foundation area than provided for the Perimeter Embankment foundation.

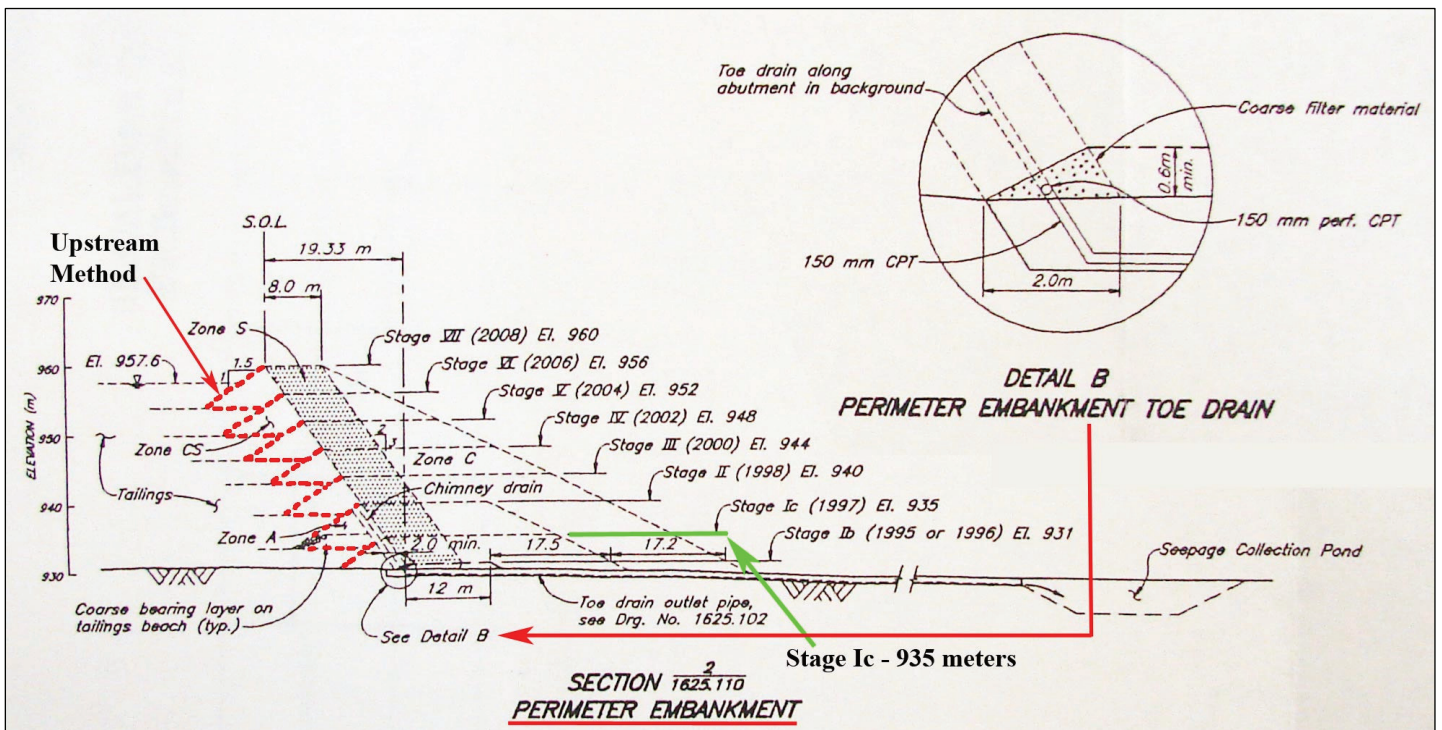
Right: Figure 3.16, *Tailings Storage Facility Final Arrangement*, from the 1996 *Final Reclamation* report. The locations of the three embankments are named, showing the ‘conceptual’ location of the supernatant waters (in blue-green) well away from the higher Perimeter and Main Embankments (plenty of “freeboard”). In the area of exposed tailings are small indicators showing the integrated locations of tailings spigots (along the outer perimeter of the tan color area).

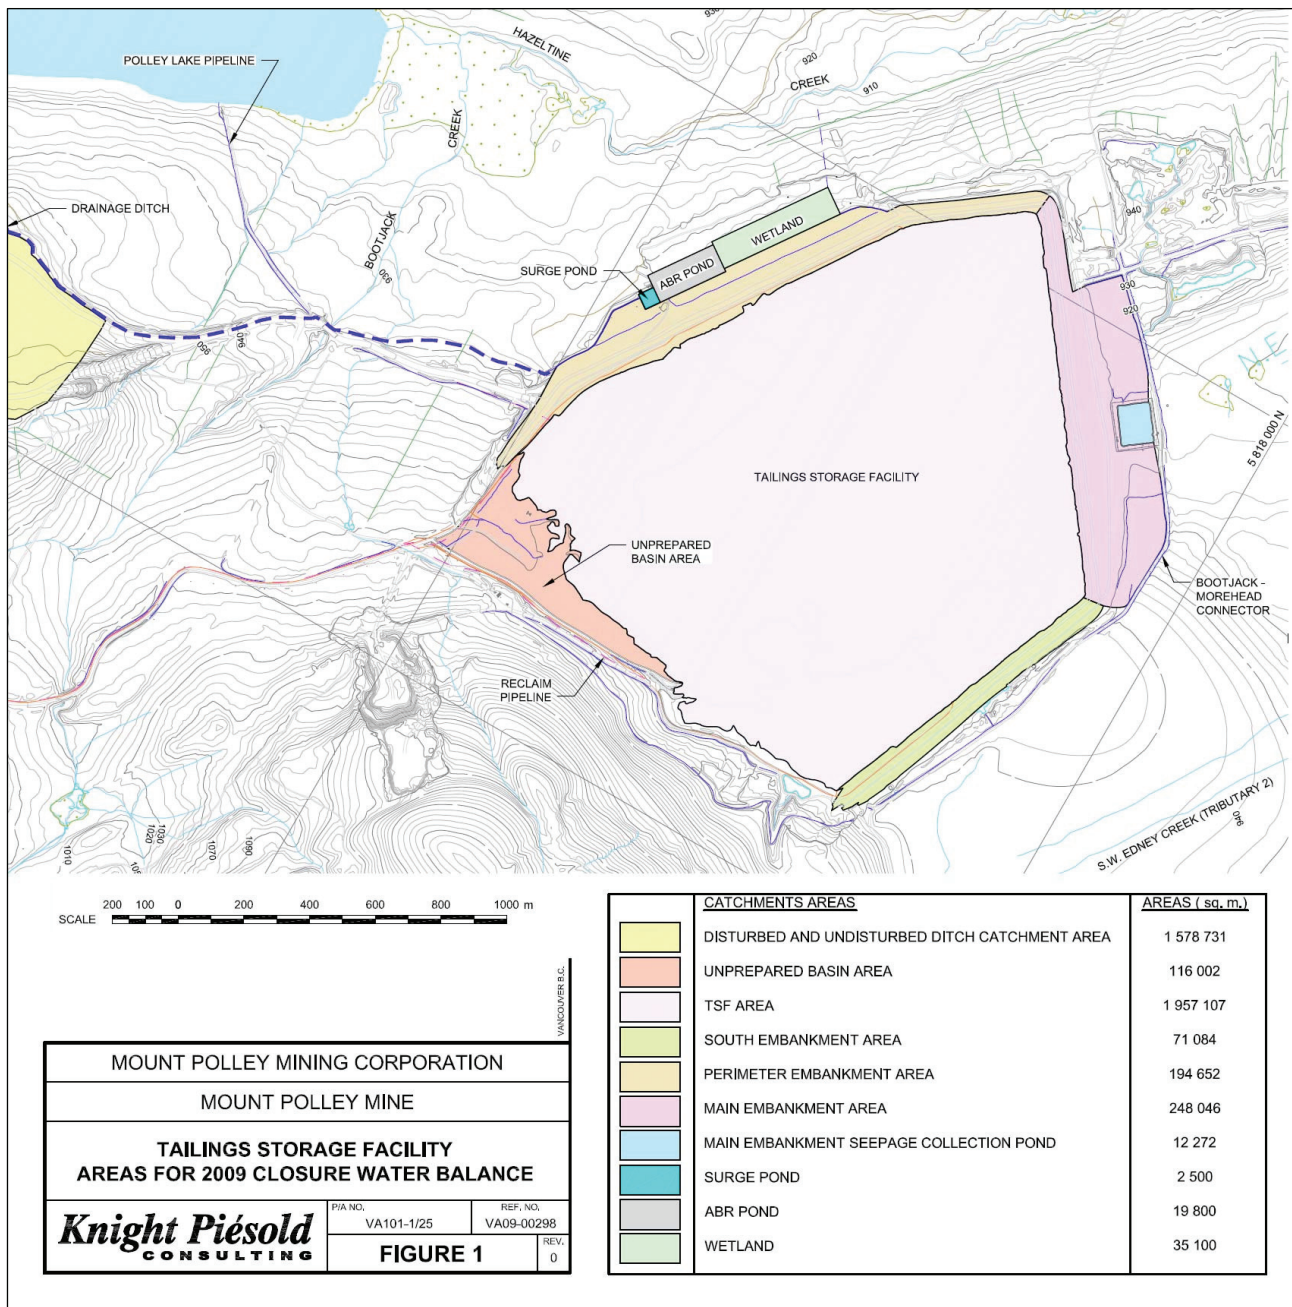
Above: Cut-out from Figure 1 of Knight Piésold’s map in Appendix G, *Details of Proposed Discharge*, from the July 2009 *Technical Assessment* report. The map and legend provide areas in square meters of the Tailings Storage Facility and its components: i.e., by conversion, the TSF Area is 195.7 hectares in area, the Perimeter Embankment area is 19.5 hectares, etc.

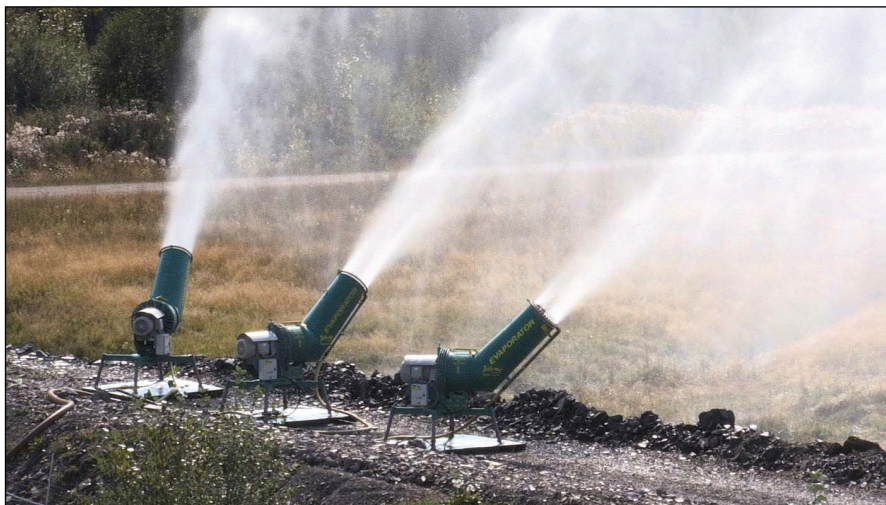
Though “evaporating enhancing techniques” were originally included as part of the permit license in the

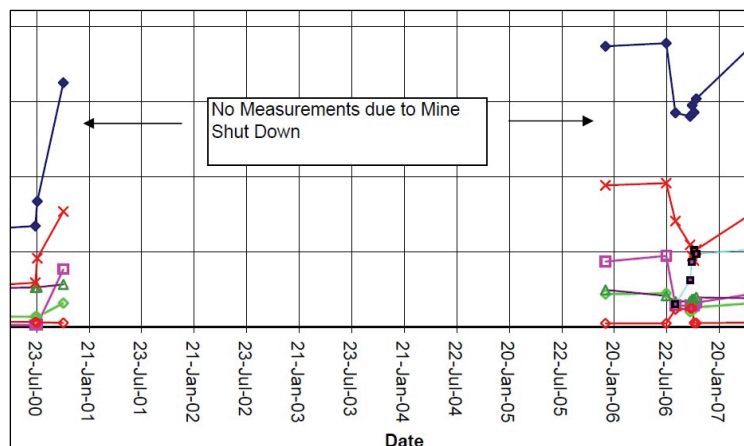
The 2008 TSF inspection report failed to properly contextualize or adequately describe in a devoted section of that report the instrumentation recording oversights and problems which had evidently been accumulating and occurring on Mount Polley's TSF from 2001 through to 2008, as they are only noted in isolated and disjointed sections of the annual report.

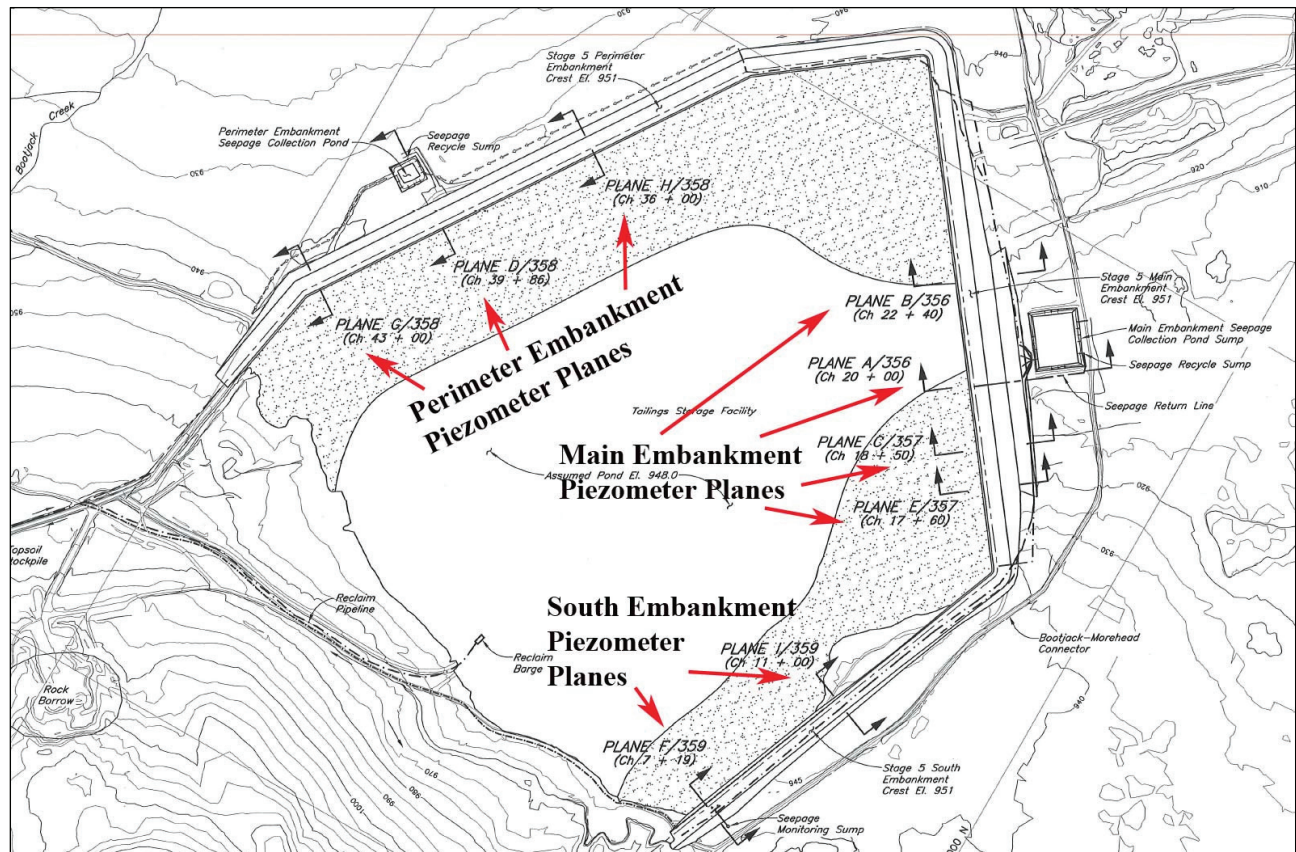
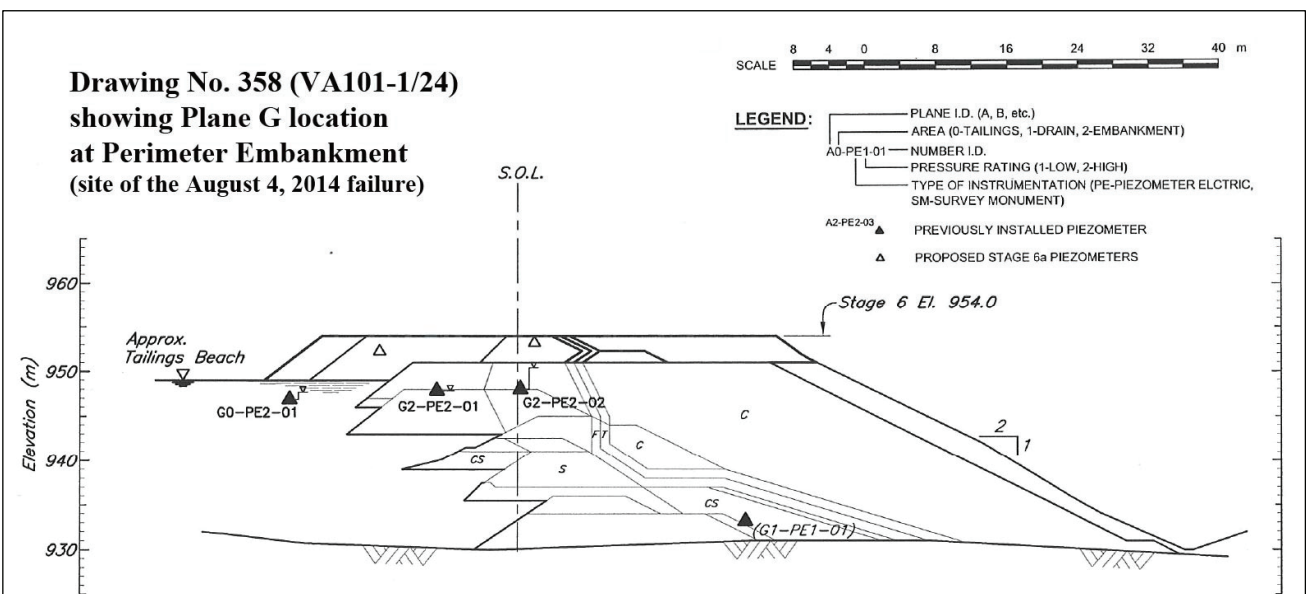
Above: One of the three Planes from the Main Embankment. Unlike the following two drawings, the approximate location of the Phreatic (water table) line is not shown/presented for the Perimeter Embankment. The 2:1 slope for the above drawing appears to be less steep than the actual slope as photographed by the author on September 16, 2014.

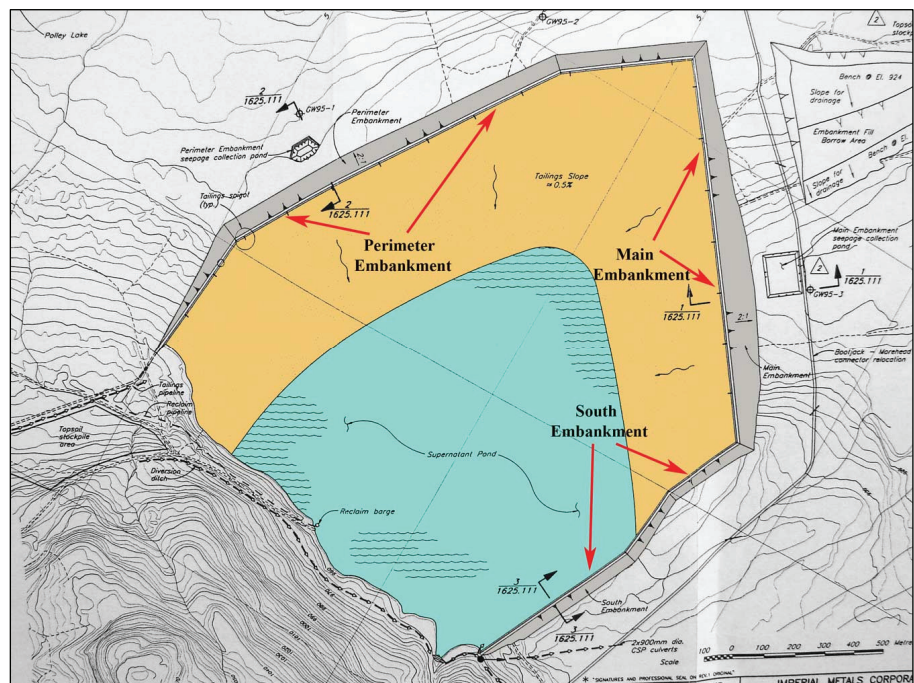
⁶⁴ Page 10, *Appendix F, Response Document, Mount Polley Mining Corporation: Response to Topics of Concern to the Community of Likely, British Columbia as Expressed During a Public Meeting of August 13th, 2007 at the Mount Polley Mine and in Subsequent Letters to the Mine*, in *Consultation report, PE-11678 Amendment Application*, July 2009.

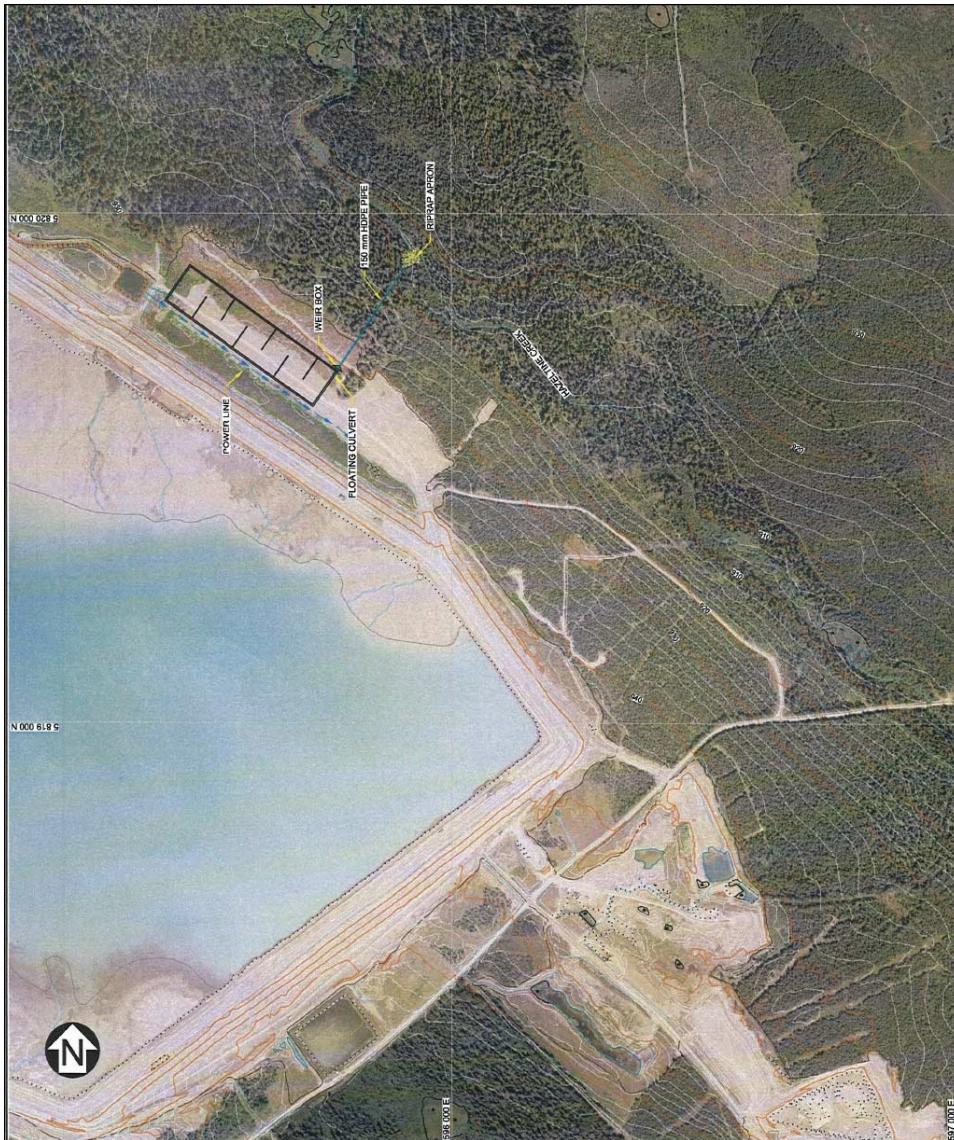
Left: Photo from Figure 1, Sediment / Polishing Pond General Arrangement, in Appendix G, Details of the Proposed Discharge, from the July 2009 Technical Assessment Report for Effluent Permit PE-11678. the image shows the eastern half of the Mount Polley TSF, where the supernatant pond has been pushed up against most of the Main Embankment and against the eastern most section of the Perimeter Embankment. In August 2010, a grader operator noticed a long, thin tension crack along the crest of the eastern extent of the Perimeter Embankment.

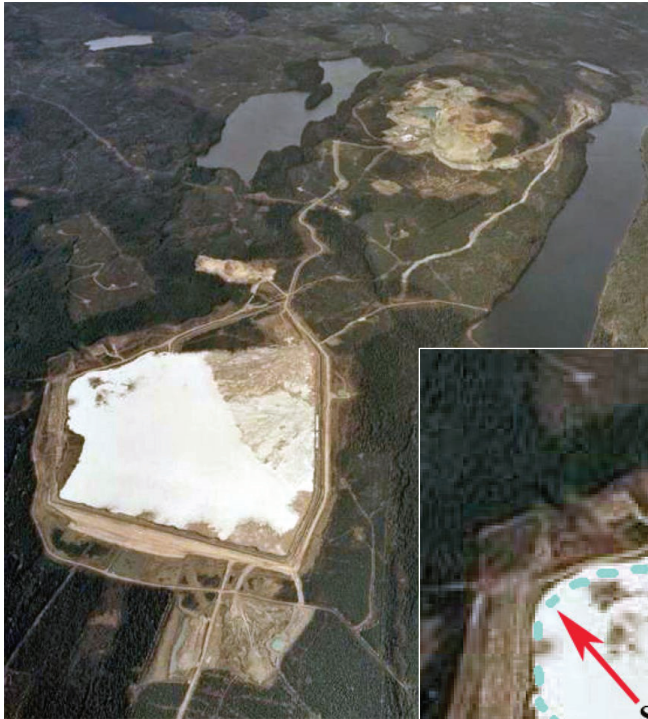
Aerial Photo, October 2005, and cut-out close-up, as shown in Figure 1.1 of Knight Piésold’s 2008 TSF inspection report. The concerns about supernatant pond location movement due to concentrated tailings deposition from single-point or uneven spigot discharging from the three Embankments go back to the “Care and Maintenance” years. In October 2005, the crest elevation of the dam was about 951 meters.

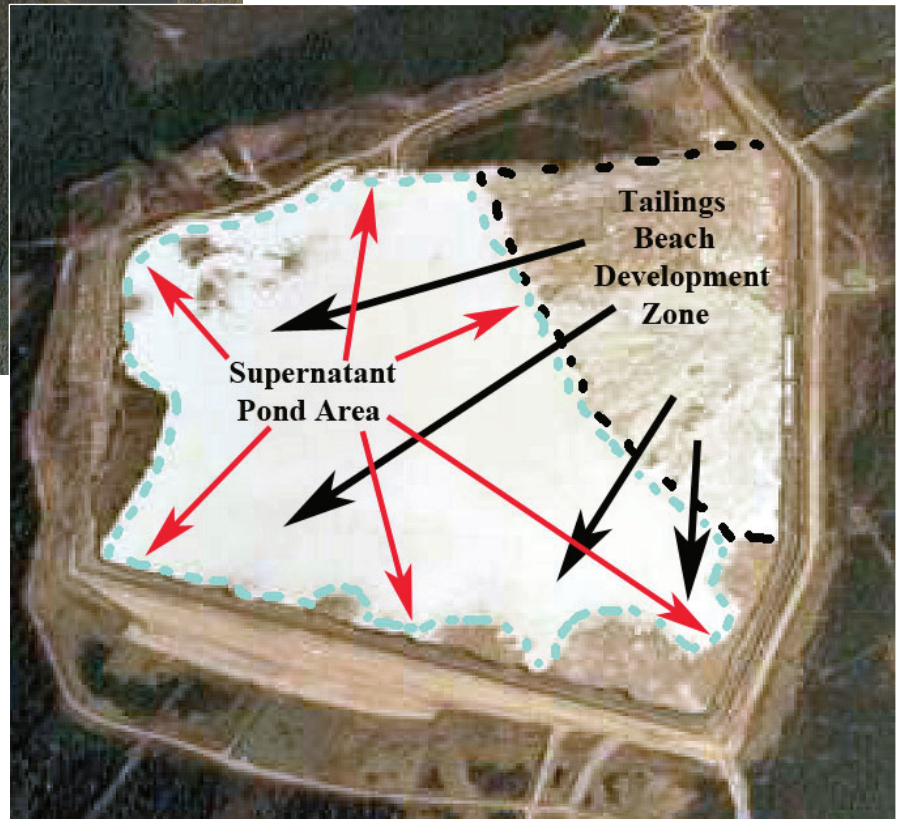
despite being told otherwise both verbally (on and off site) and in official reports by both the Ministry of Mines and by its Engineer of Record advisors.

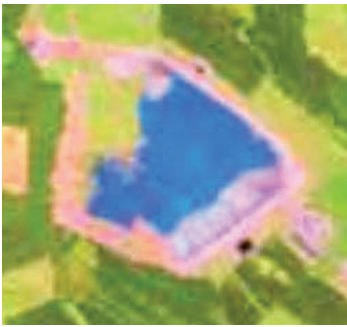
For instance, the following satellite images, published by the BC Tap Water Alliance on September 1, 2014, *The Mount Polley "Tailings Storage Facility": Landsat 8 Satellite Imagery, 2009-2014*. They show the shifting locations of the 'pond' area over time, butting up against the Embankments.

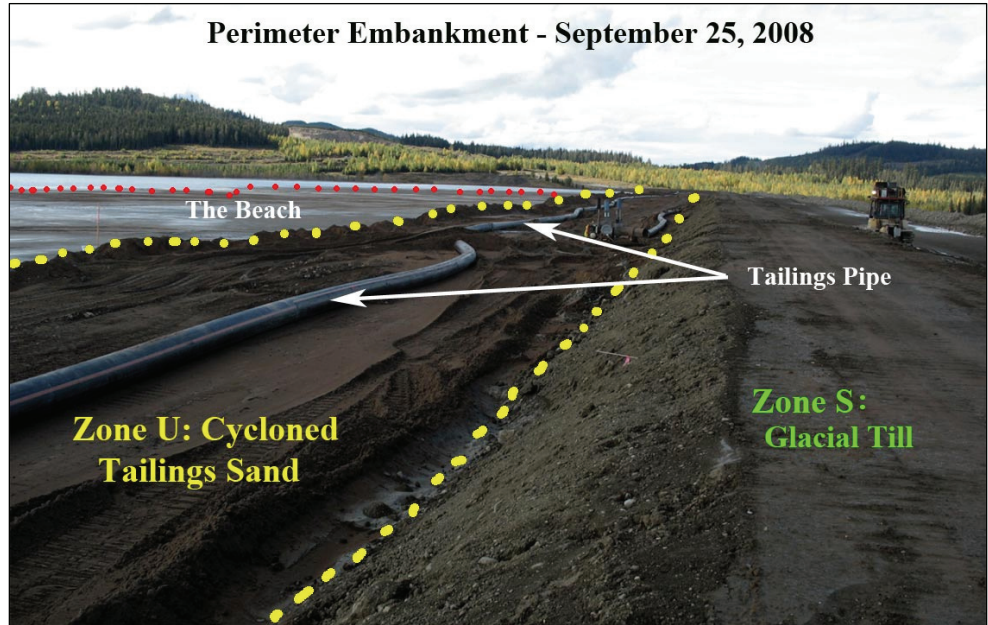
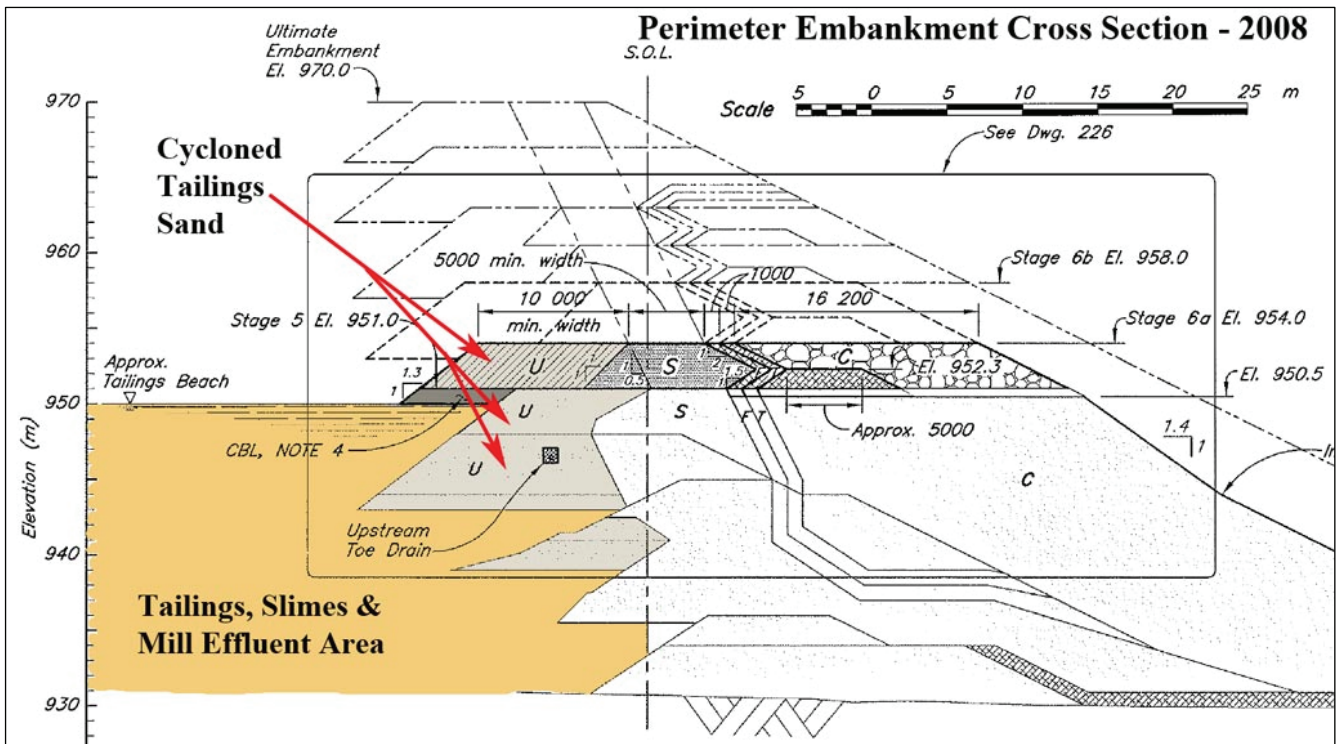
Right: Photo from 2008 TSF inspection report showing construction staging activities on the Perimeter Embankment.

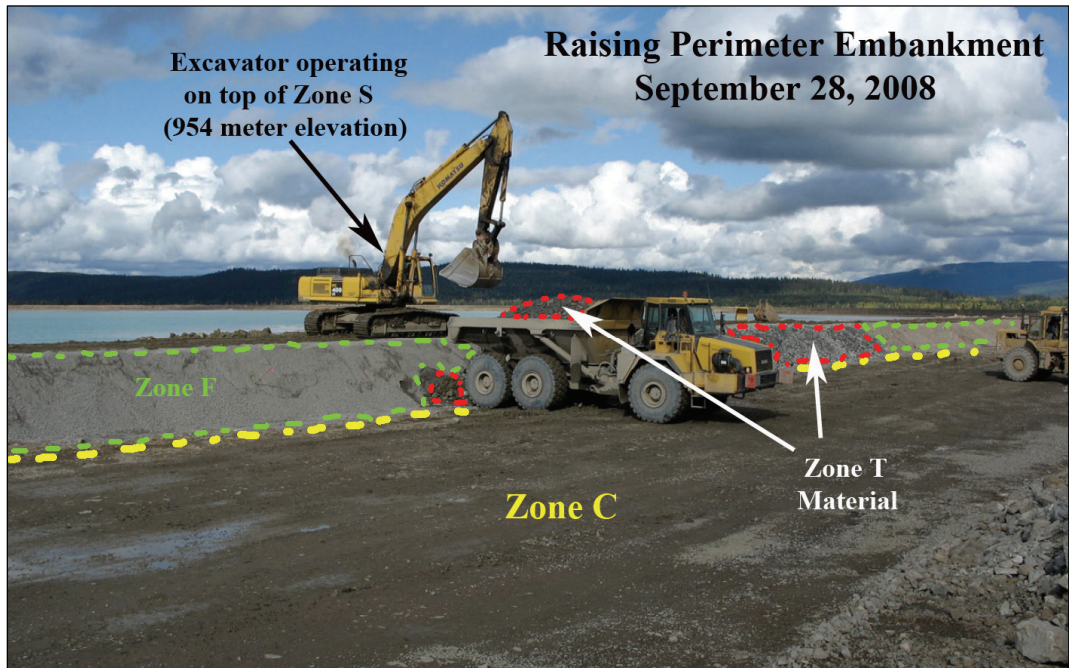
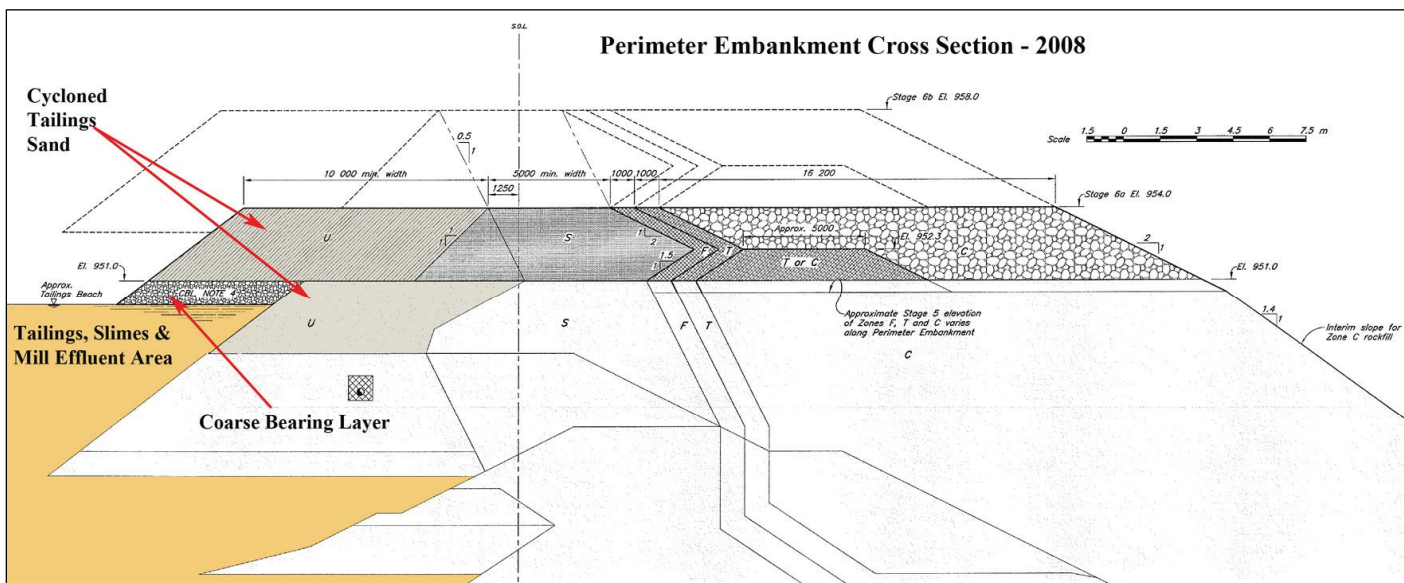
Use of the upstream raising method, however, is limited to very specific conditions and incorporates a number of inherent disadvantages. Factors that constrain the application of the upstream method include phreatic surface control, water storage capacity, and seismic liquefaction susceptibility.

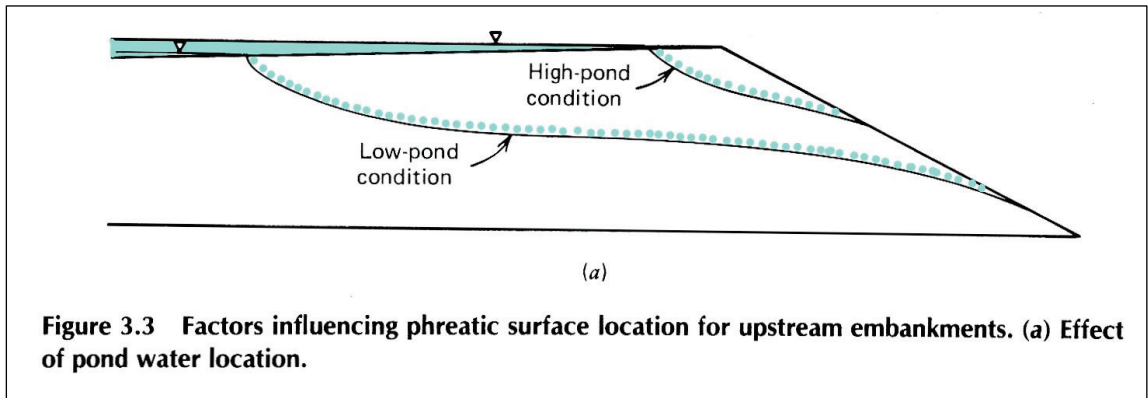
As shown in Figure 3.3a, pond water encroachment on the tailings beach produces very high phreatic conditions near the embankment face, which endanger stability. In extreme cases, overtopping and consequent embankment breaching result. Many if not most failures of upstream embankments can be attributed to inadequate separation distance between the decant pond and the embankment crest. Pondered water can be pushed back from the embankment crest during operation by proper tailings spigotting and decant procedures. Increase in decanting rates lowers the pond elevation and increases pond-crest separation distance.

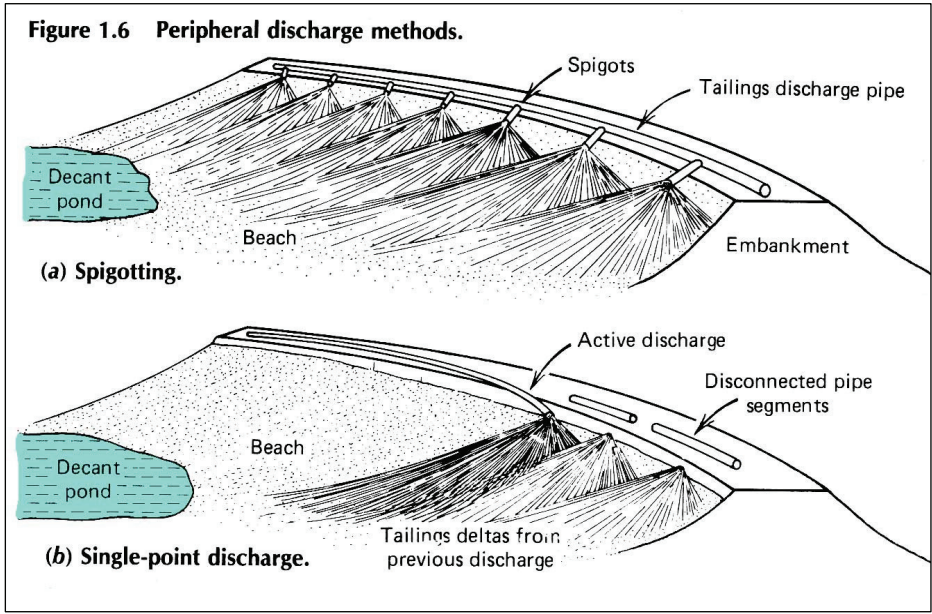
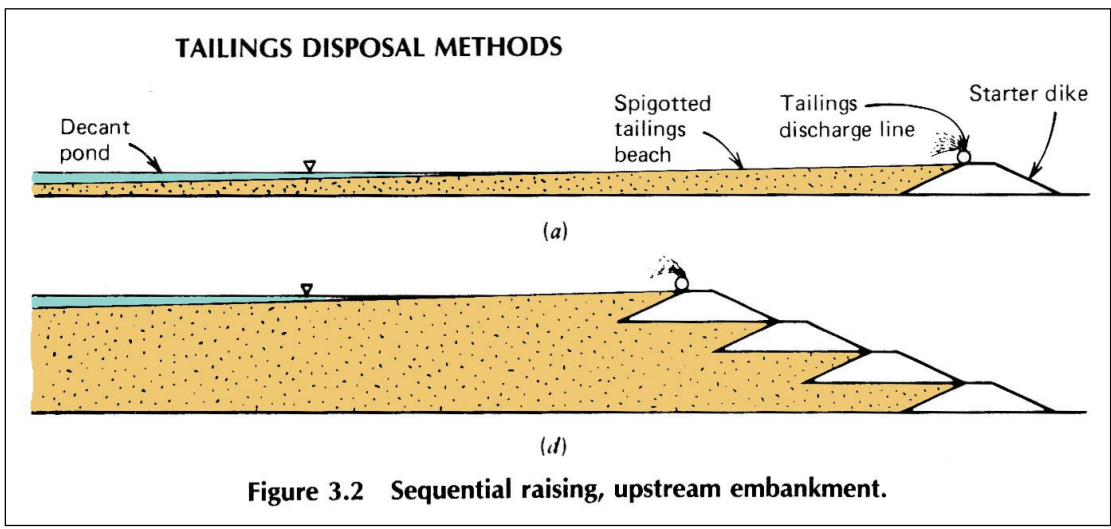
(Page 2, *Characterization of pore pressure conditions in upstream tailings dams*, by T.E. Martin)

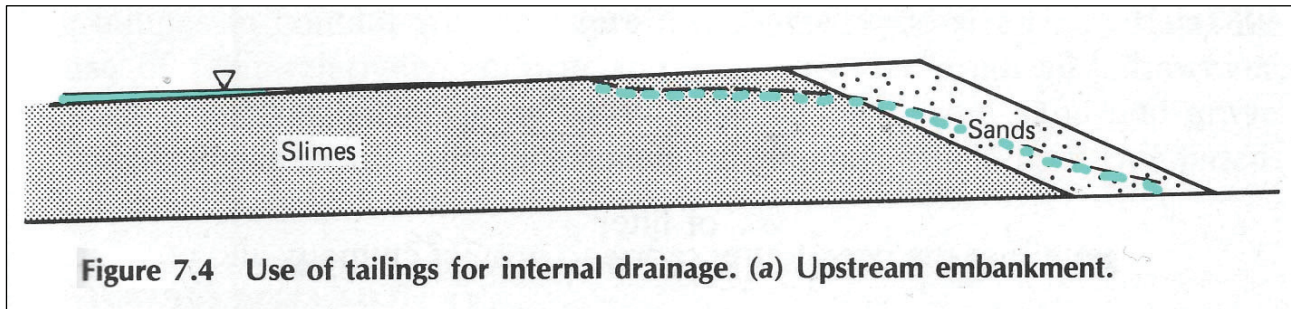
While these water-control measures can be effective during normal operation, **control of ponded water and its effects on the phreatic surface is difficult under the influence of appreciable flood or normal runoff inflows.** For example, assuming a typical 1% tailings beach slope, each one foot rise in the elevation of ponded water will produce 100 feet of pond water encroachment on the beach. For this reason, upstream embankments are poorly suited to conditions where water accumulation is anticipated due to flooding, long-term accumulation of seasonal runoff, or high rates of mill water accumulation. **In general, upstream embankments cannot be used for water retention.** [Bold and underline emphasis] Near-total diversion of runoff and flood inflow is essential for this raising method.
