B. C. TAP WATER ALLIANCE

Caring for, Monitoring, and Protecting
British Columbia's Community Water Supply Sources

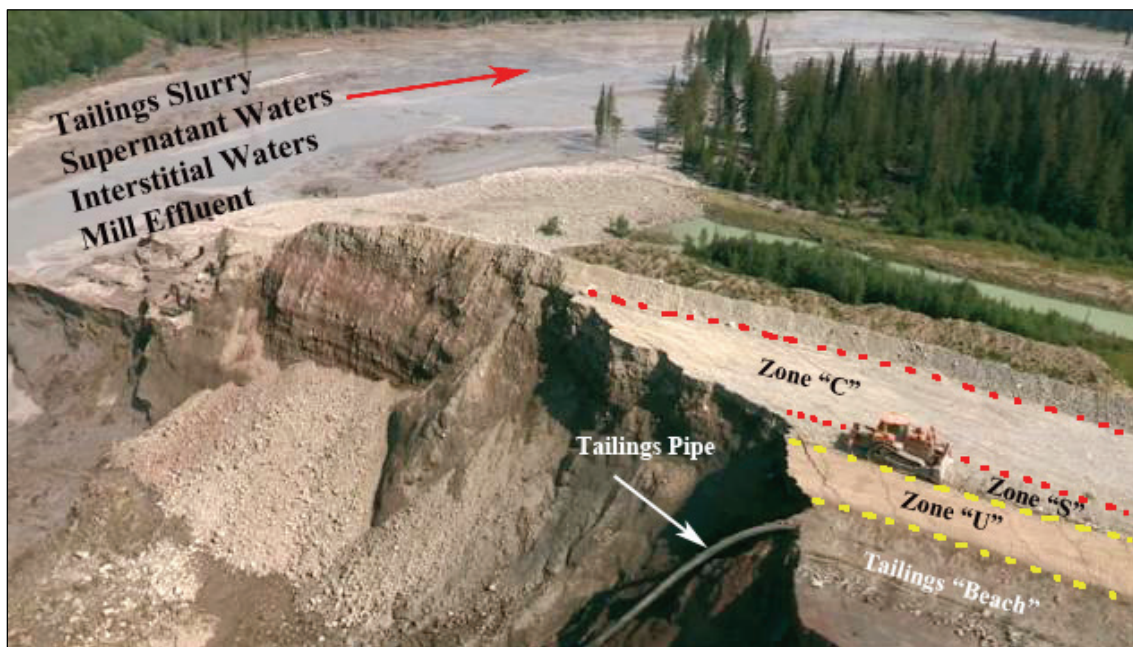
Upstream embankments, while providing the simplest and least costly raising method, are subject to a number of **very critical constraints.** Proper use of the method can be justified only when those constraints are thoroughly investigated and satisfied.⁶⁸ [Bold emphases throughout]

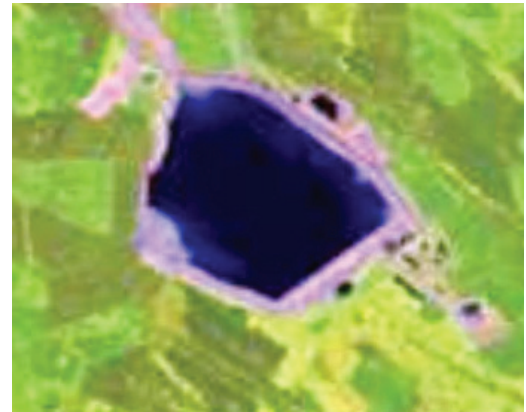
for the functional and environmental safety of its Upstream Type

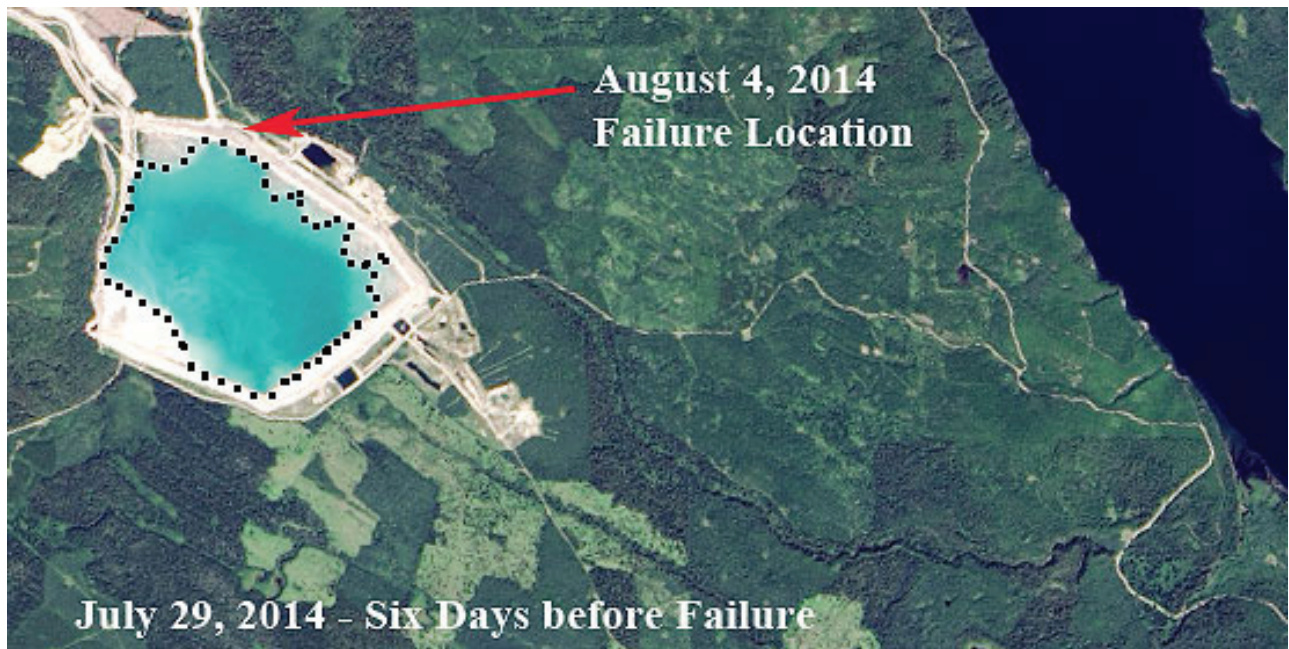
*Lack of control of the hydrological regime is one of the most common causes of failure. Of the cases reported here, the majority of failures were due to overtopping, slope instability, seepage and erosion; all caused by a lack of control of the water balance within the impoundments.*⁷⁰

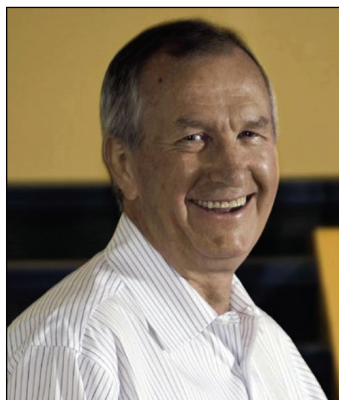
Former Knight Piésold president, Jeremy Haile. Photo source: Summer 2012 edition of CFReview.

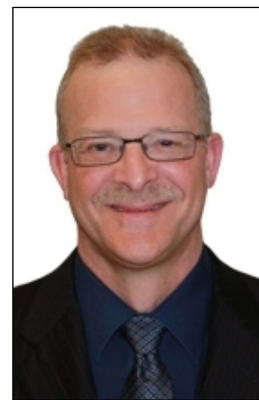
Current Knight Piésold president, Ken Brouwer. Photo source: Knight Piésold website.

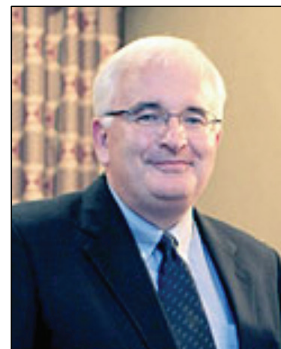
In a telephone conversation on the afternoon of October 2, 2014 with the subsequent Chief Inspector of Mines, Al Hoffman, I specifically asked for official confirmation on whether / if a second DSR had been conducted for Mount Polley’s TSF. Hoffman replied that he was not aware of such an audit report. In an email sent the following day to Hoffman, asking for clarification on this matter - “was there a 2011, or thereafter, DSR conducted for the Mount Polley TSF?” - the following reply was sent by email:

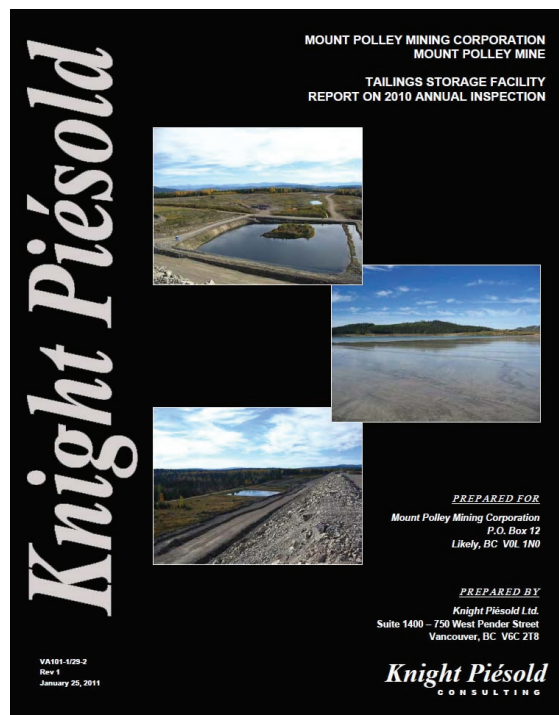
⁸⁰ Previous Knight Piesold annual Mount Polley TSF inspection reports of 2001, 2002, 2004, 2005 and 2007 are still unavailable for review.

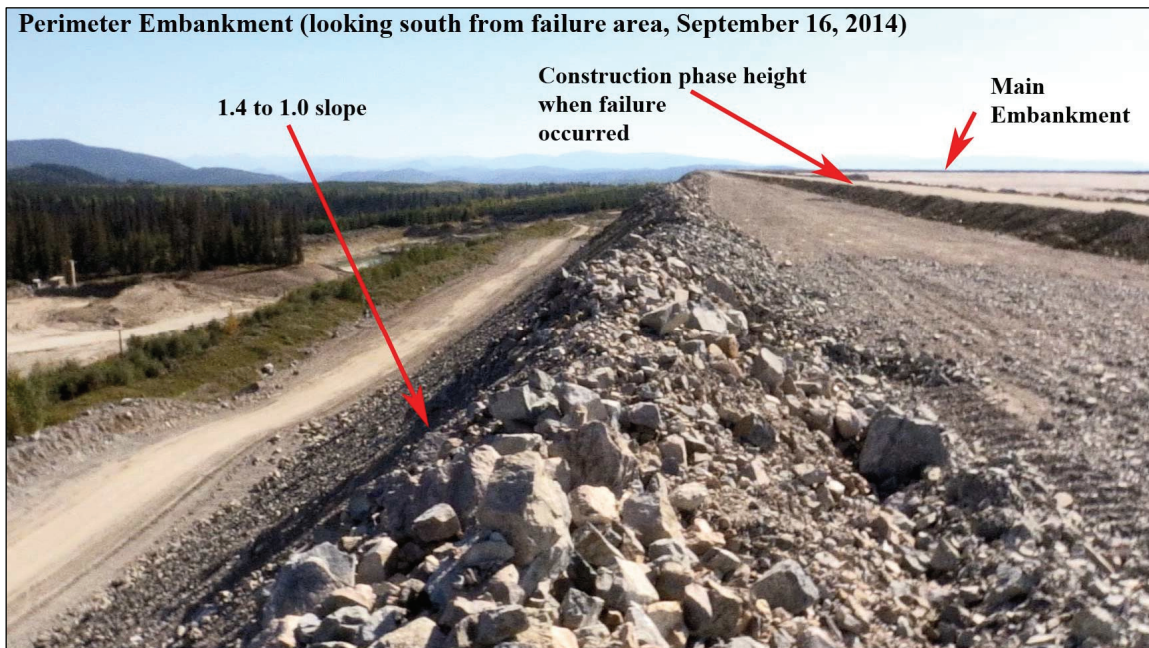
3. Because of slight deviations in the Main Embankment monitored by an inclinometer a few years previous, it resulted in a “stability assessment” recommendation to construct a buttress “downstream of the Main Embankment.” MPMC, however, failed to implement Knight Piésold’s recommendation to do so before MPMC’s construction schedule to raise the TSF crest from elevation 954 meters to elevation 958 meters, “which did not happen.”
4. Knight Piésold noted that MPMC was “single point discharging tailings near the northwest corner of the TSF” during the inspection day of October 7, 2010. As described in the Blooper-Natant chapter of this report, the single-point discharging was “migrating” the

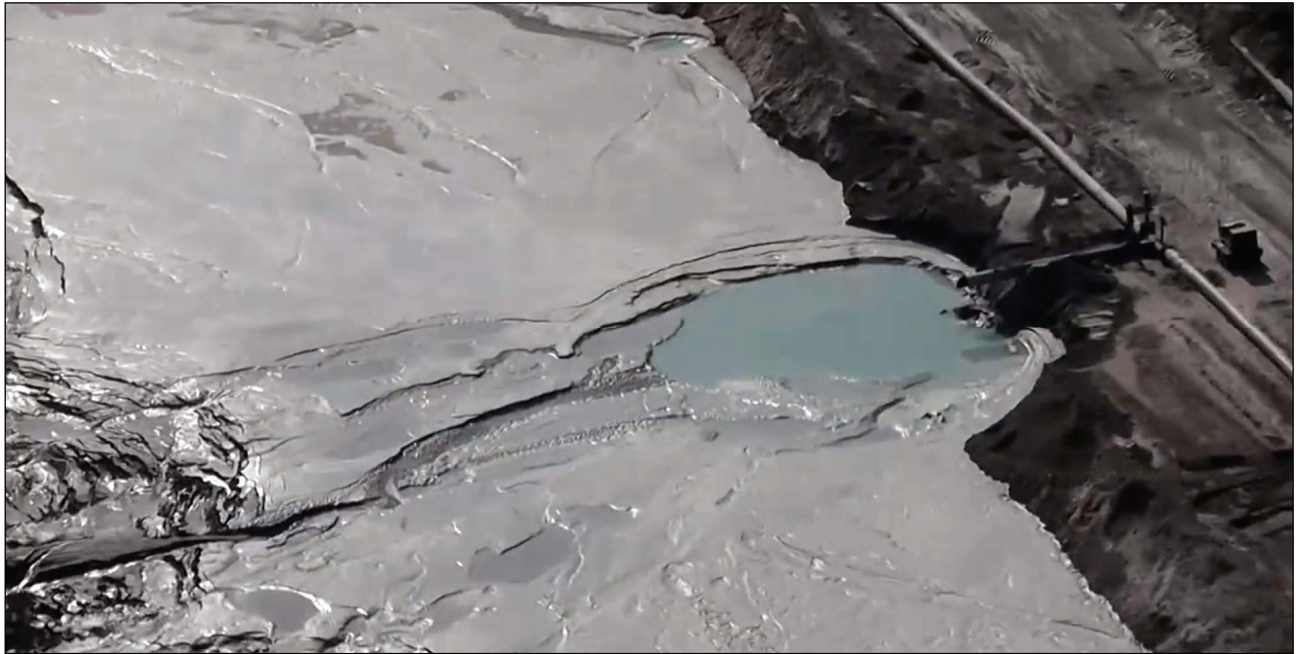
Photo from August 4, 2014 helicopter flight, showing a close-up of one of the many tailings spigots, this one located on the South Embankment.

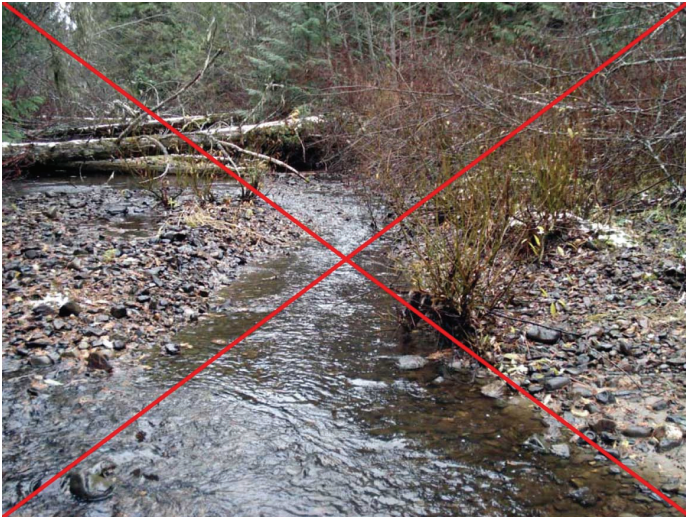
For mining and processing operations tailings typically represent the most significant environmental liability, which obligates a polluting party to pay for any and all damage it causes to the environment. The environmental liability that mining companies and their insurers may be exposed to is highlighted by the 1998 Aznalcollar -Los Frailes spill and an excellent summary is provided by WISE (2013) using Spanish media reports. The spill occurred on 25 April 1998, and in August 2002 it was estimated that the

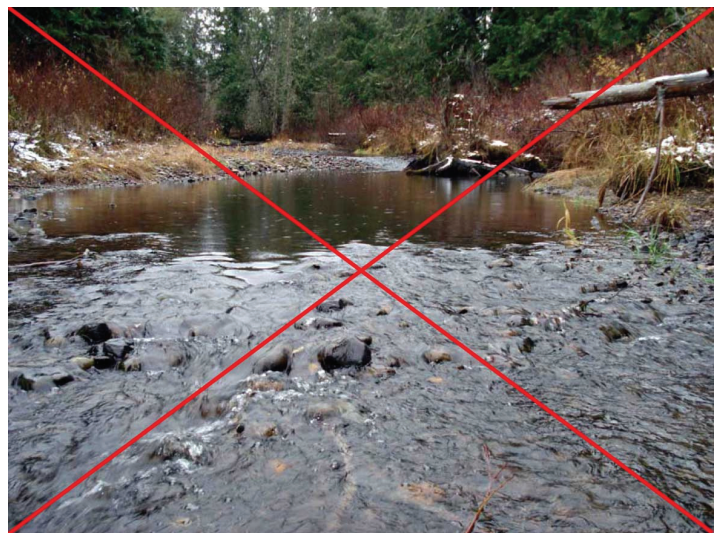
(Mine Tailings Dams: Characteristics, Failure, Environmental Impacts, and Remediation. D. Kossoff, et. al., in Applied Geochemistry 51 (2014). pages 229-245)

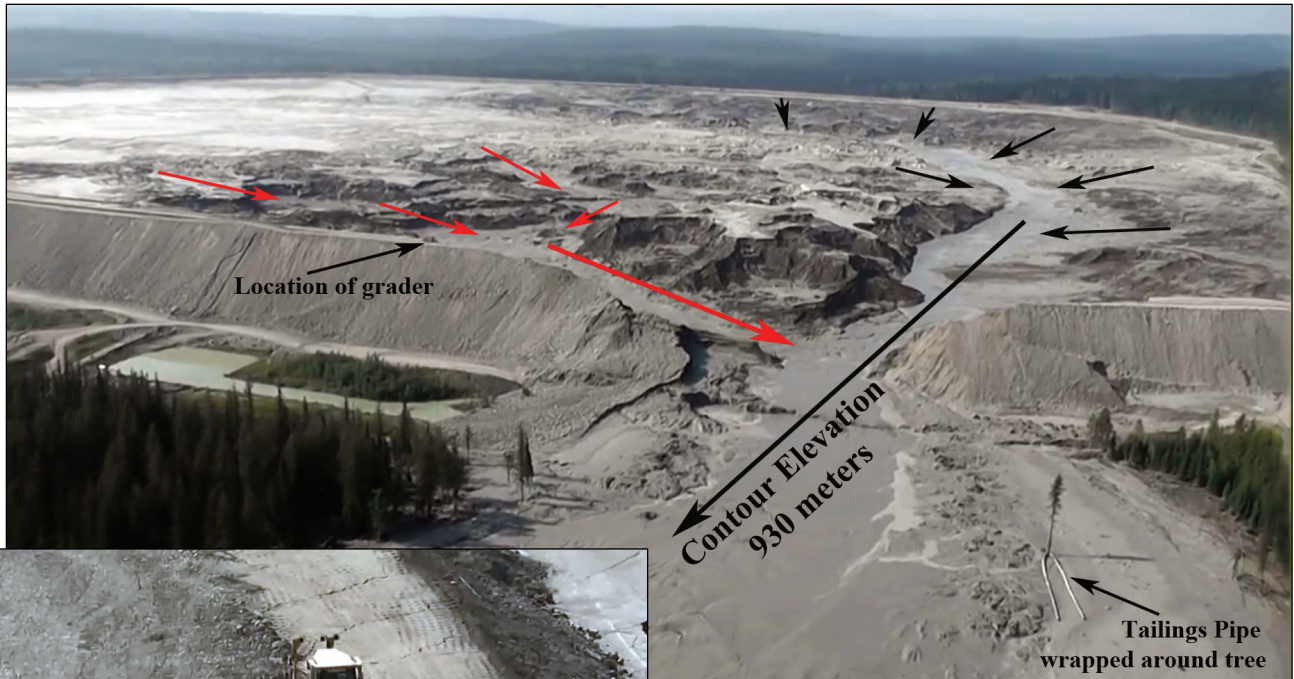
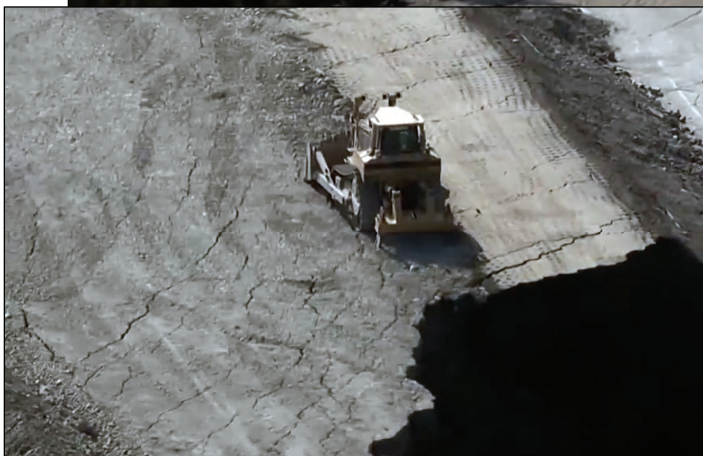
August 4, 2014 helicopter flight images. *Above*: initial breach flow path (black arrows) along 930 meter contour, with subsequent breach flow in red. *Left*: tension cracks surrounding abandoned grader on Perimeter Embankment. *Below*: three stages of breach drainage flows: white arrows, first stage; red arrows, second stage; black arrows, third, slower drainage stage.

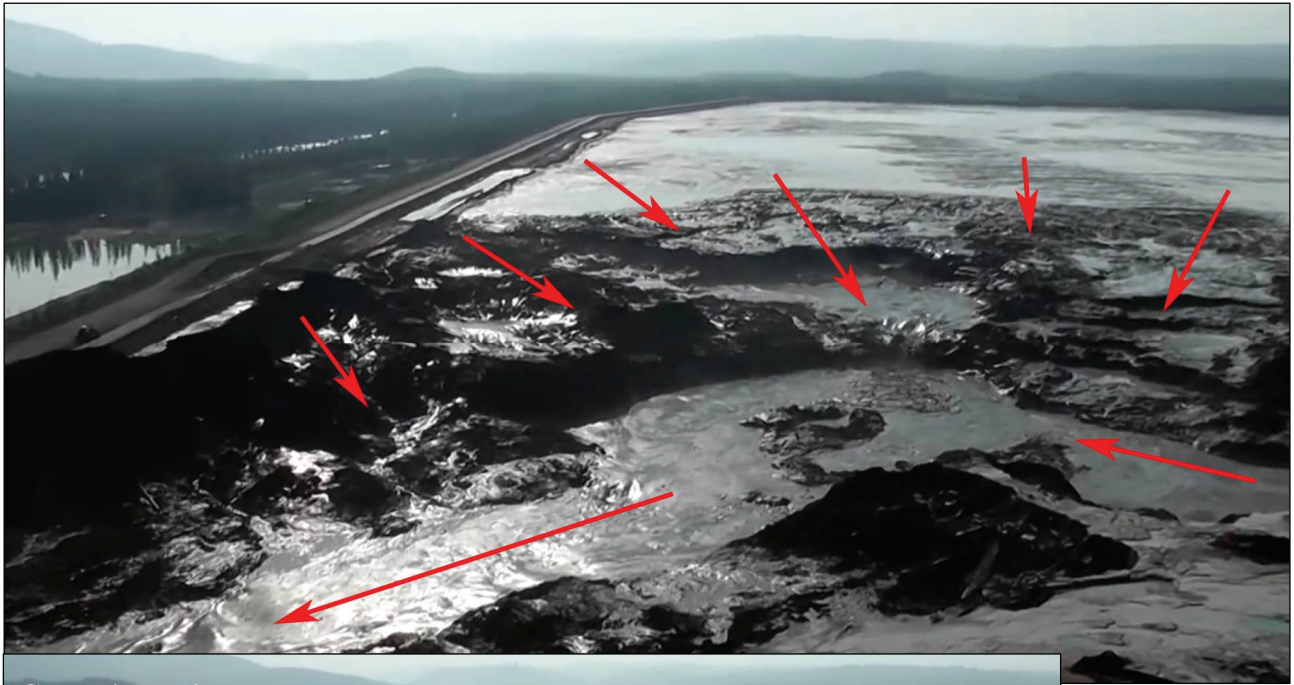
Cascading Failure Events
of
Saturated Tailings Mass

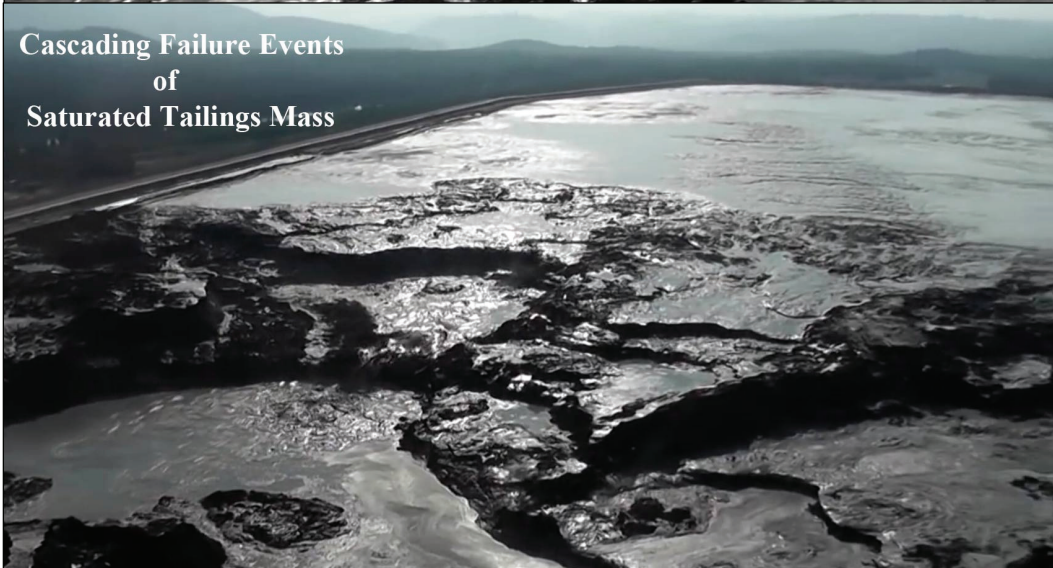
Images from August 4, 2014 helicopter flight. They show the state of the disaster about 5 hours after the breach occurred, during the second phase of draining, cascading physical collapsing of the saturated tailings mass, the forces of which affected the integrity of the 3 embankments.

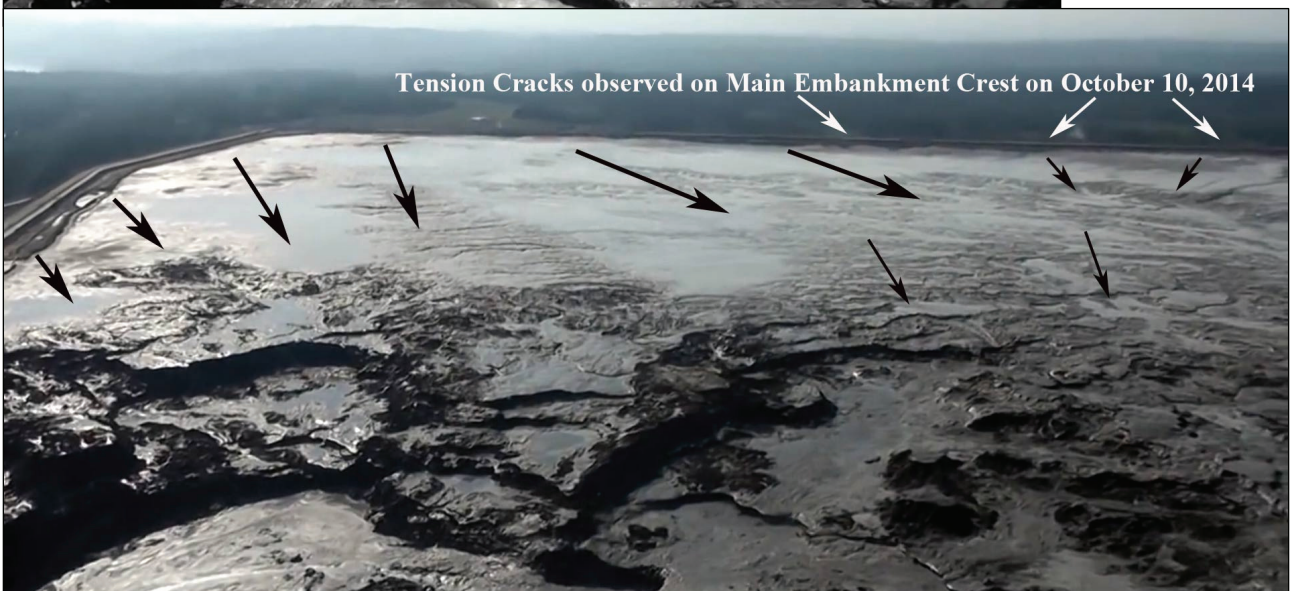
Tension Cracks observed on Main Embankment Crest on October 10, 2014

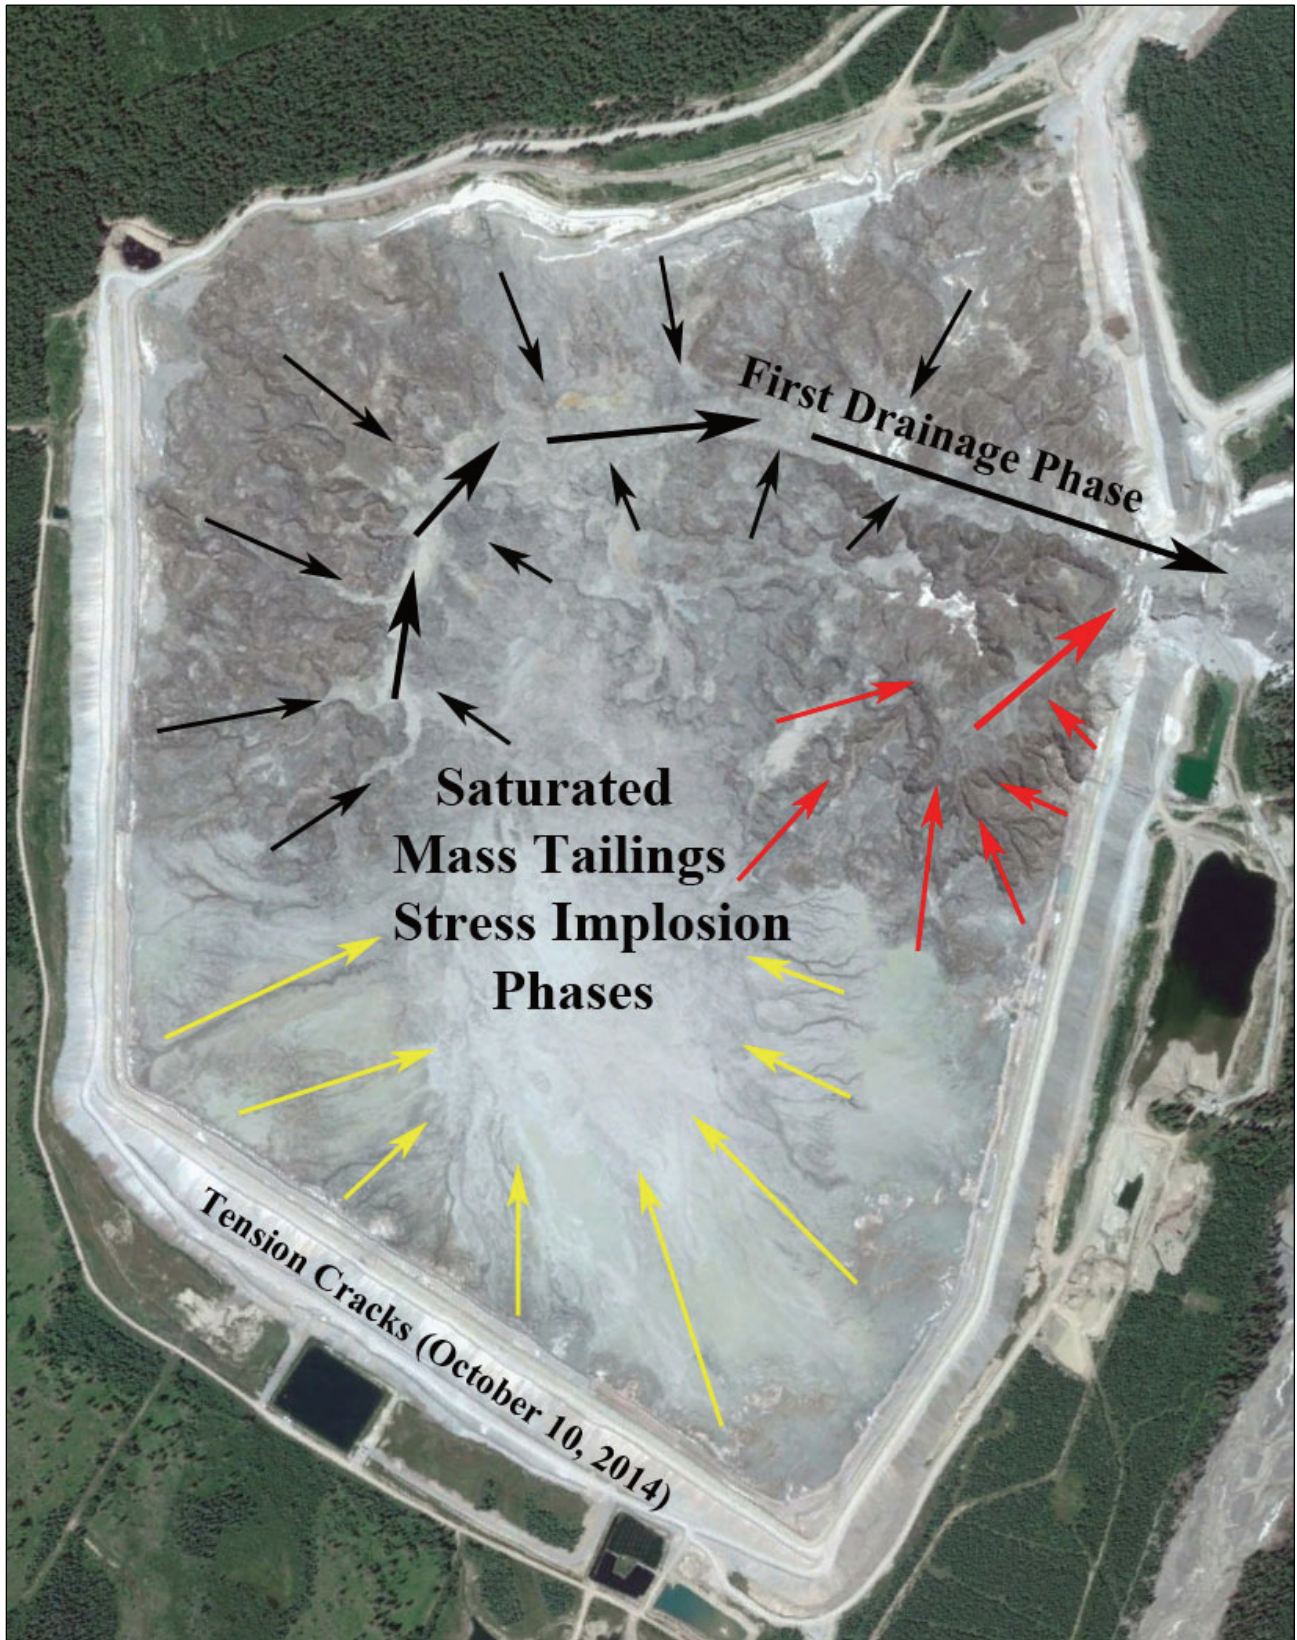
August 9, 2014 Google Earth Satellite Imagery showing a much-interstitial-water drained Mount Polley TSF. The black arrows indicate the initial burst phase and mass tailings movement, which primarily drained along the original curved 930 meter land base elevation contour line. The red arrows indicate the second mass tailings phase, after the initial phase subsided, causing more cascading events of the heavily laden saturated tailings. As both phases of the draining TSF evolved, the third phase, yellow arrows, began draining the farthest reaches of the tailings mass situated about 1.4 kilometres distant by the Main Embankment, the stresses of which most likely initiated tension cracks on its crest.

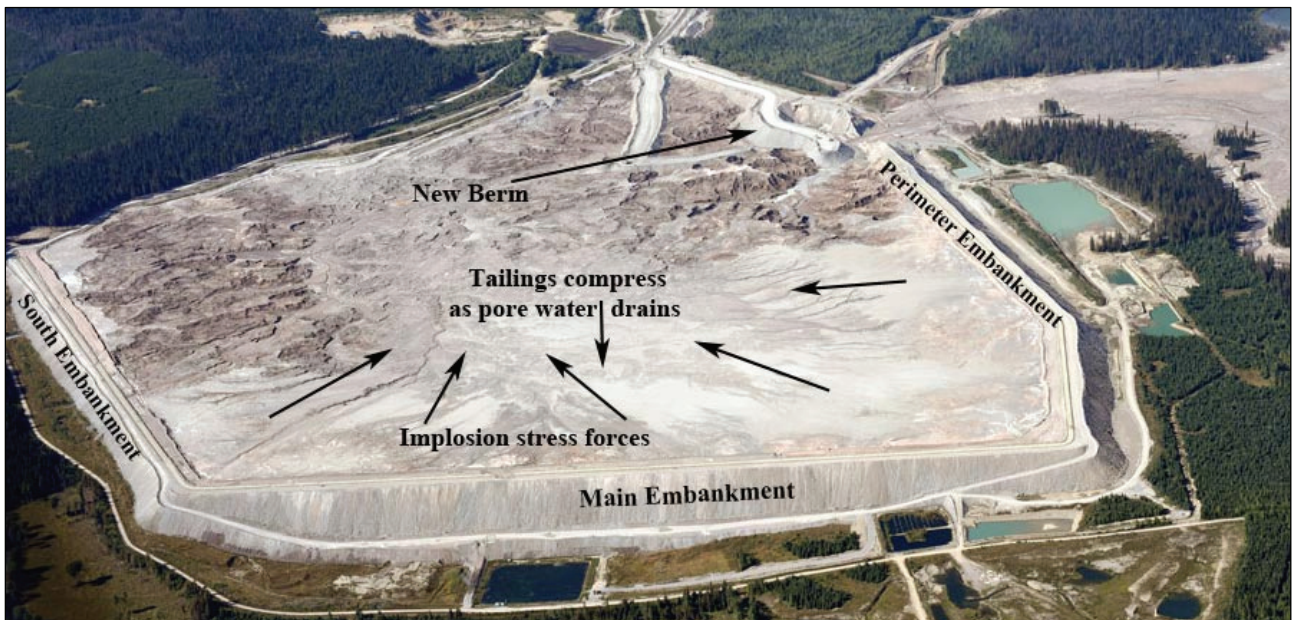
Below: Recent oblique photo of the Mount Polley TSF by Terrasaurus, used here to show the lateral and downward stress forces from retreating and drained interstitial / pore waters.

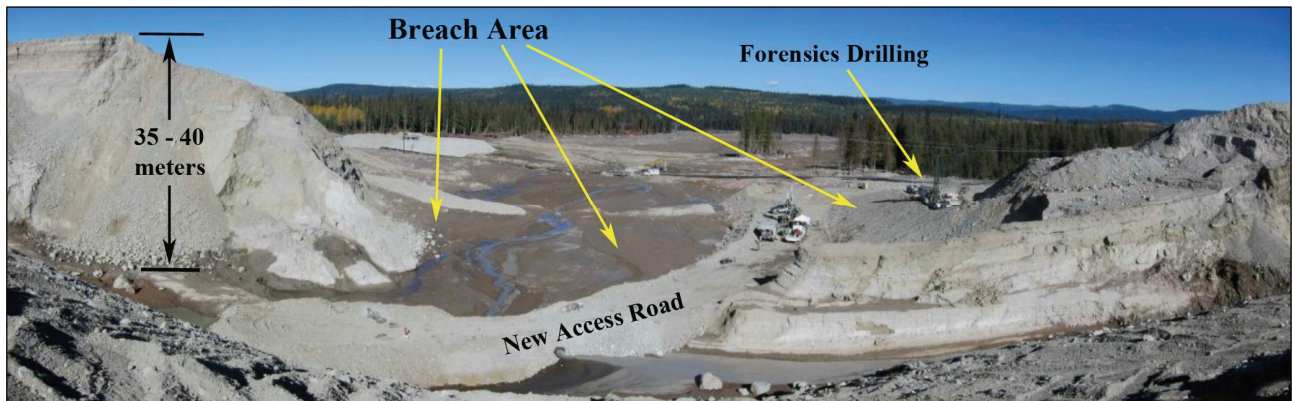
Given the very high stakes of who might ultimately be to blame for the tailings disaster, if it could be determined that the disaster had nothing to do with the company's mismanagement of the TSF over time, then everyone gets off the proverbial hook.
