Bell Bend Project Site: Supplemental Field Assessments for PPL Riverlands

January 2010

Prepared for: **PPL Bell Bend Nuclear Power Plant** Salem Township, Luzerne County, PA

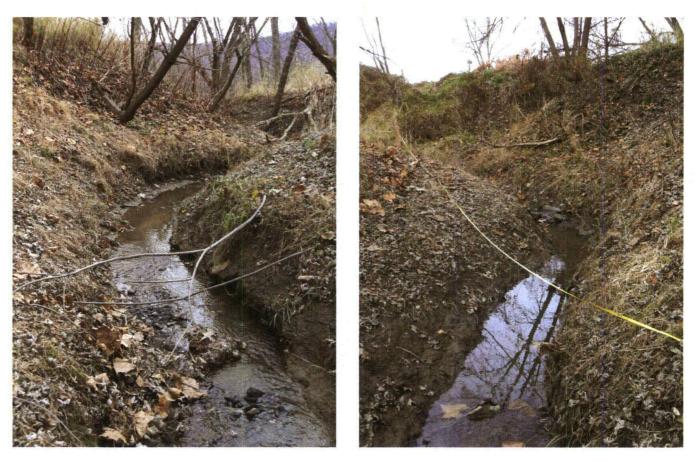
Stream facing downstream towards the Susquehanna River (left) and upstream towards the North Branch Canal (right).

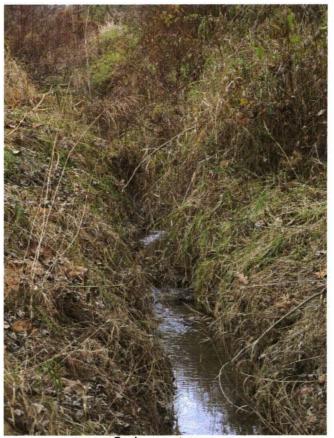
Facing upstream.

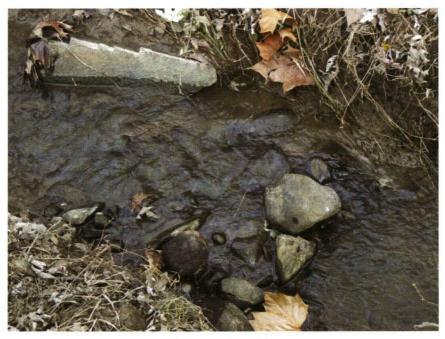
Substrate in riffle.

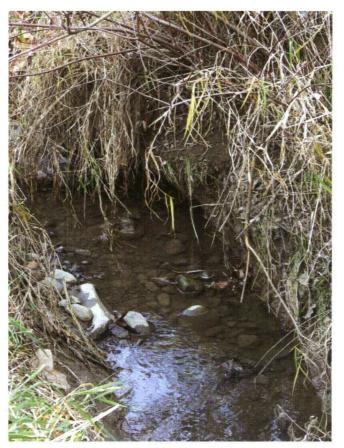
Substrate downstream in the outlet channel.

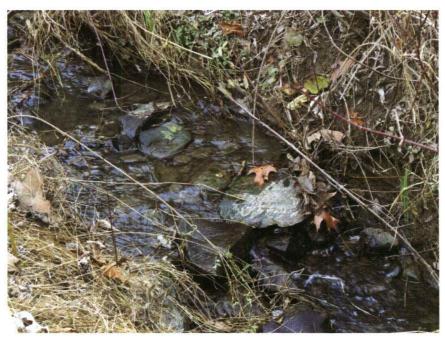
Substrate in riffle.

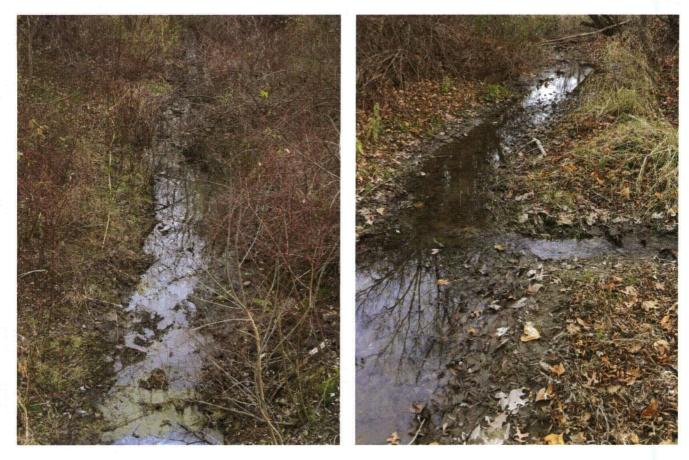
Stream facing upstream (left) and downstream (right). A tributary joins the main channel in the photo on the right. This water is seeping through the earthen dam at the North Branch Canal.

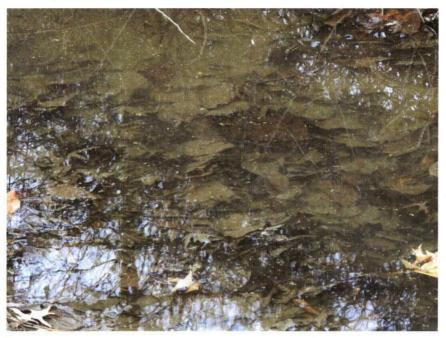
The upper reach of the stream was just below the weir of the discharge canal. This reach was typically run habitat, with an average stream width of 4.3 ft and an average water depth of 0.3 ft. This reach had high substrate embeddedness, with an average embeddedness rating of 1.6 (Table 2). The stream substrate was dominated by a combination of silt and gravel, with sand and clay also present. Gravel and cobble comprised an average of 24.2 percent of the stream bottom.

Substrate characteristic of the upstream section of the outlet channel.

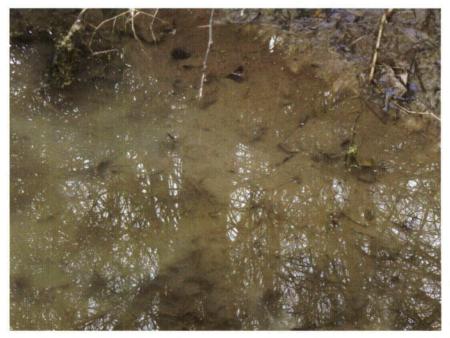
Silt causes turbid water in the upstream section of the outlet channel.

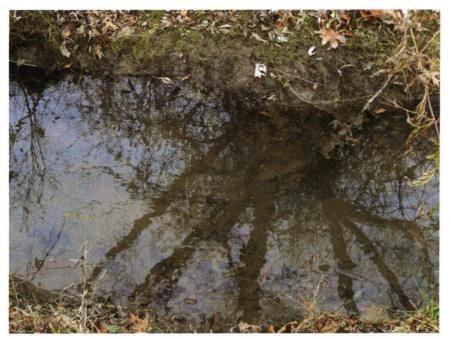
Substrate characteristic of the upstream section of the outlet channel.

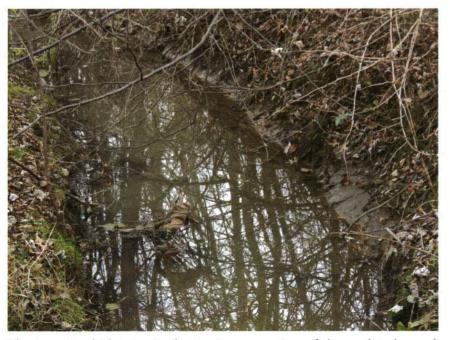
Silt causes turbid water in the upstream section of the outlet channel.

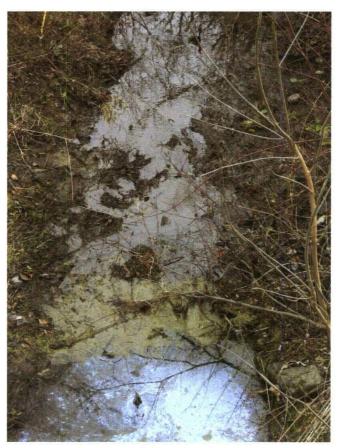
Stream channel just below weir.

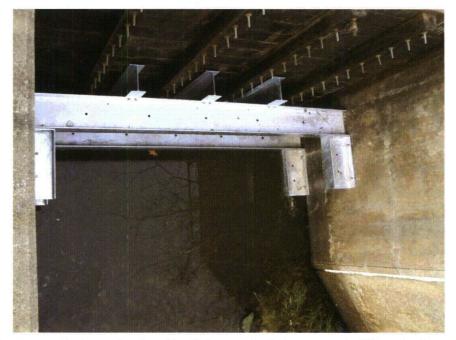
Weir that controls the water level in the canal and the amount of flow in the outlet channel.
