UNITED STATES OF AMERICA  
NUCLEAR REGULATORY COMMISSION

In the Matter of )  
 )  
UNION ELECTRIC COMPANY )  
 )  
(Callaway Plant, Unit 1) )

Docket No. STN 50-483

JOINT INTERVENORS' ANSWER TO APPLICANT'S  
AND STAFF'S MOTIONS FOR SUMMARY DISPOSITION

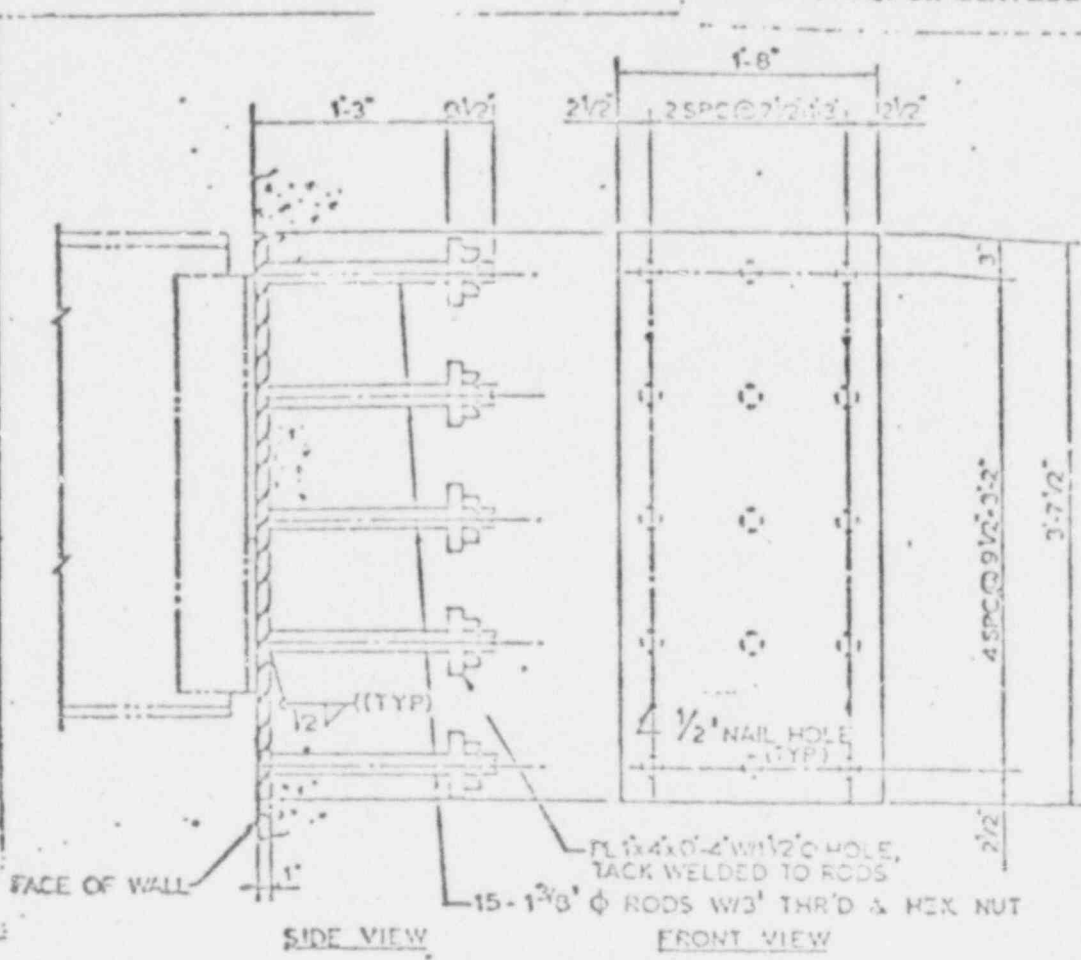
It has been shown that the weld profile obtained in practice, results from the configuration of the detail. A perfect weld according to AWS D1.1 would not be obtainable with available production methods and techniques. However, it has also been demonstrated that the weld obtained, with its minor deviations from code, is technically acceptable and has in fact been the industry standard for a number of years.

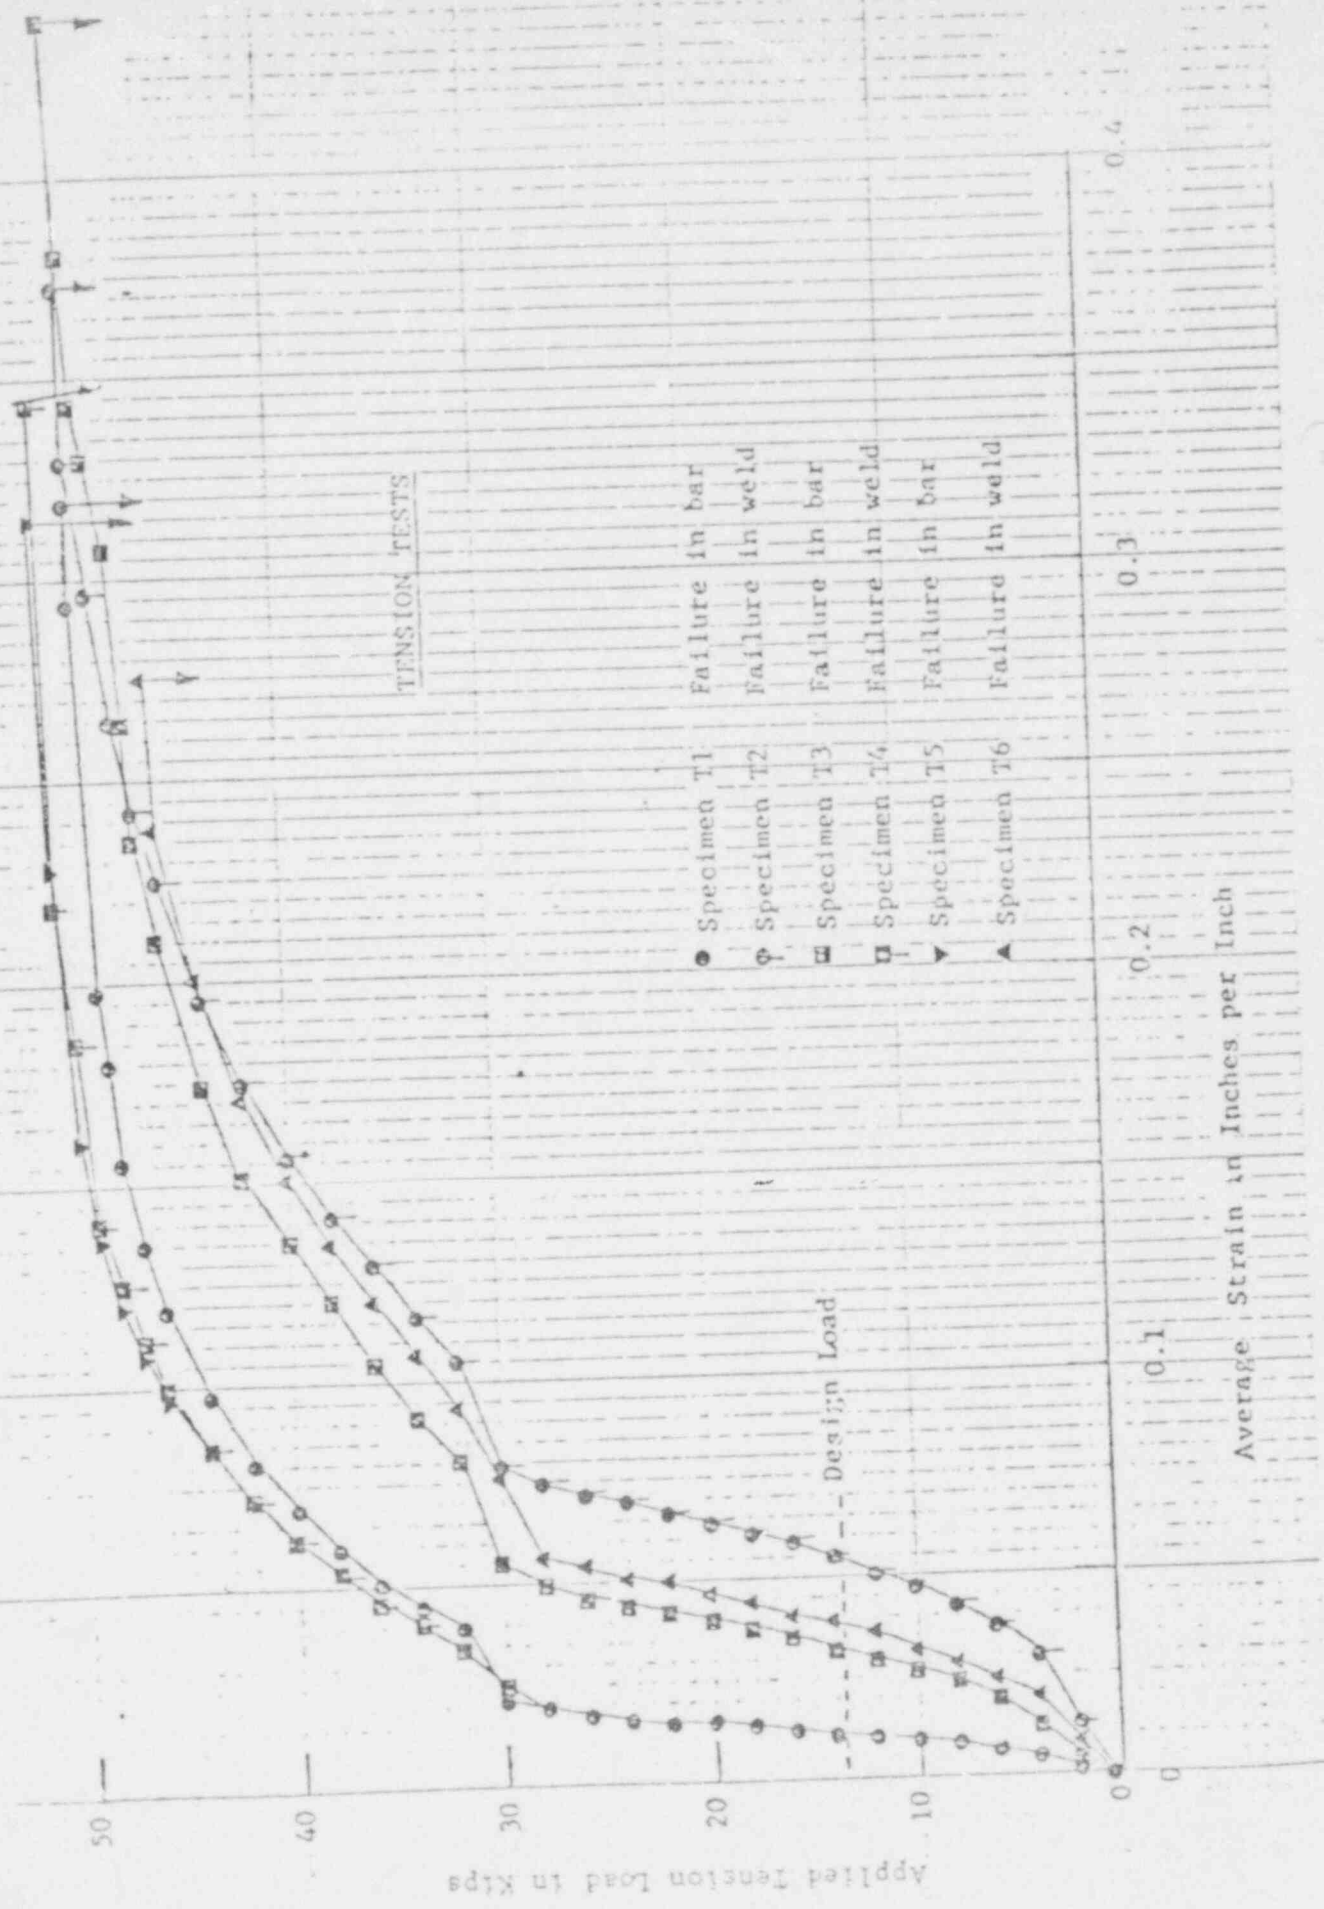
Test Report on Anchor and Stud Welding: FIG. 2

This testing program included bend and tension tests on single manually welded anchor rods and proof load tests of embedded plates with machine welded studs. The following conclusions have been derived from the test results.

1. Manual welds are sufficient to develop the full bending strength of the bars even though visual inspection of the welds reveals that welds are undersize in some areas of the circumference.
2. Manual welds with undersized welds (believed to represent worst case condition) are sufficient to develop the full yield strength of the anchor rods. Test specimens exhibited satisfactory ductility well beyond the yield limit even though three specimens failed in the weld.
3. Weld failures in the tension tests were not of any significance since the failure loads were approximately the same as the ultimate capacity of the anchor rods.
4. Plates with machine welded studs, tested in place, were sound and exhibited only the expected amount of deflection at the maximum design load.
