**Pacific Highway Sapphire to Woolgoolga Upgrade
Threatened Flora Monitoring
Annual Report 5**

**Prepared for NSW Roads and Maritime Services
Peter Richards
March 2016**

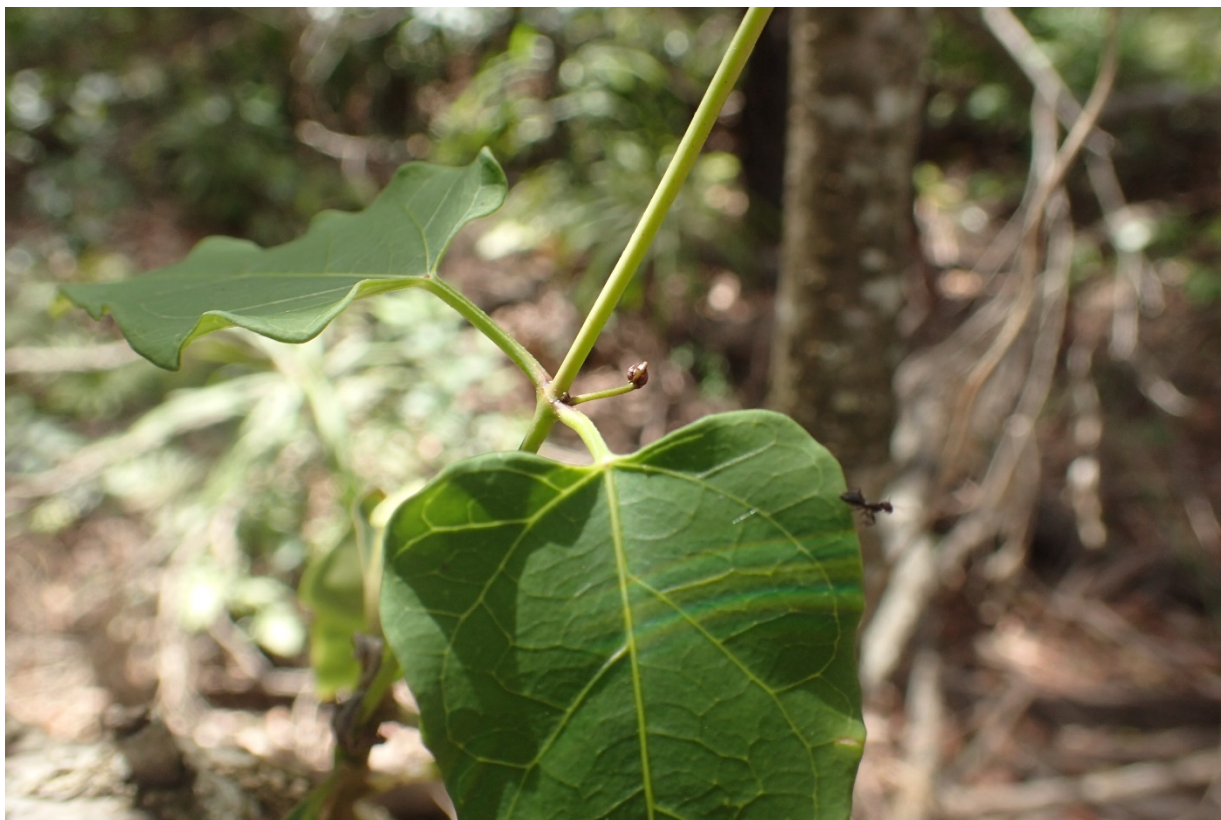
The current survey of *in situ* Slender Marsdenia resulted in a total of 293 flagged plants now being monitored across all sites, with 254 plants (86.7%) recorded as alive and bearing aerial stems and leaves. This high proportion of living plants may be due to the fact that any previously flagged plant at Split Solitary Road that had its flagging removed and had died back would not have been counted in the current survey, resulting in an inflated proportion of living plants recorded this year. Of the live plants observed this current survey, over 80% were assessed as in good to excellent condition (condition classes 3 to 5). Two plants at the Split Solitary Road site were in bud (**Figure 8**).

Figure 3: Slender Marsdenia in bud at the Split Solitary Road *in situ* site, March 2016.

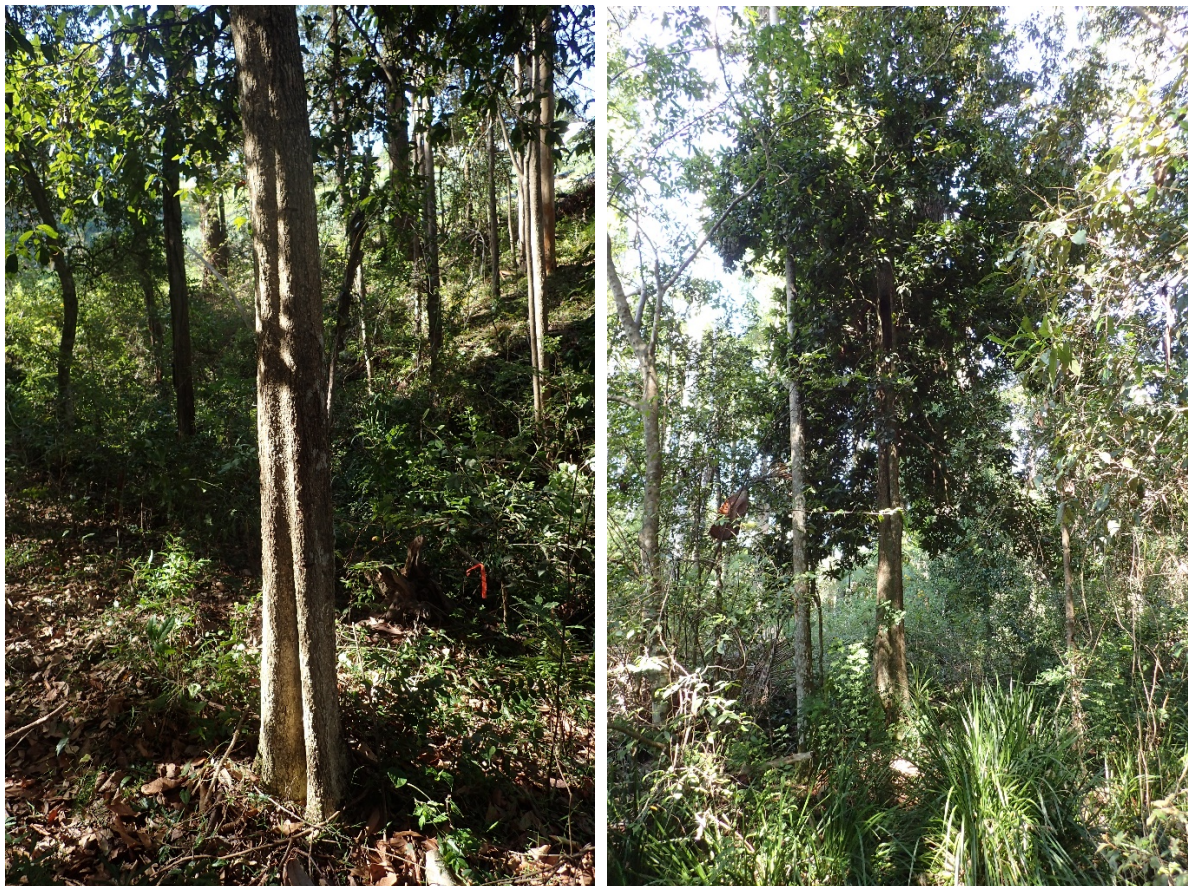
Figures 4 and 5: Two large Rusty Plums, showing the characteristic fluted trunk of mature trees. These plants, along with another 22 Rusty Plums, were newly recorded at the Moonee Beach South *in situ* site in March 2016, and may lie outside the road reserve boundary in adjoining private property.

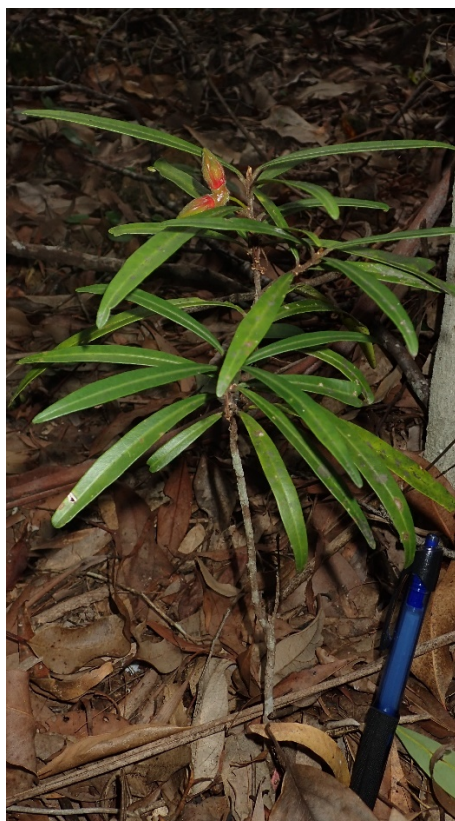
Rusty Plum NW0125). All plants were in good to excellent health (**Table 4**), with five plants at Sapphire North bearing fruit (**Figure 6**) and a number of plants at Moonee Beach South suckering vigorously in response to stem damage by tree fall debris (**Figure 7**).

Figure 6 (left): A *Quassia* sp. B plant bearing fruit. **Figure 7 (right):** *Quassia* sp. B plant suckering from beneath tree fall debris at Moonee Beach South site.

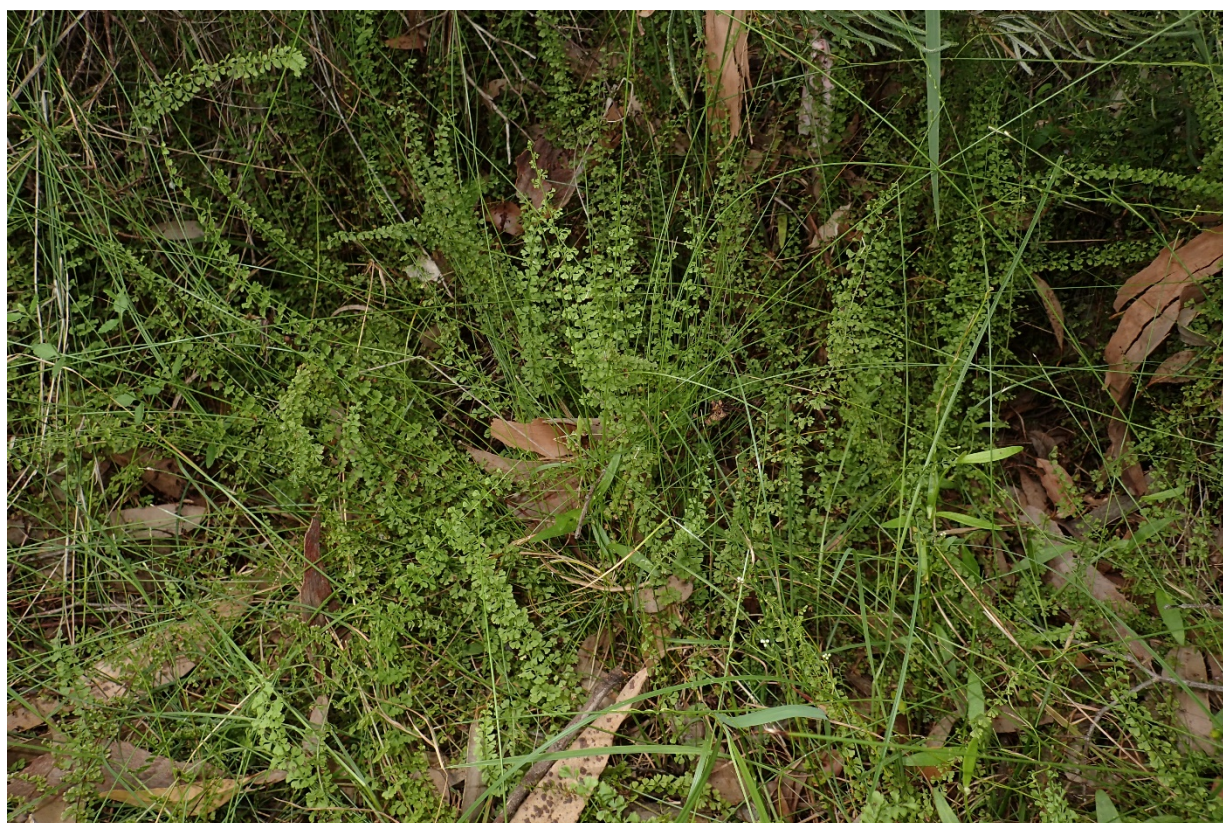
An increase in crown cover, and maintenance of excellent overall plant condition of the *in situ* *L. incisa* was recorded in March 2016 (**Table 5, Figure 8**). **Table 5** below provides comparative mean cover and condition scores since October 2013 (**Appendix 1**). The increase in mean canopy cover from November 2014 to March 2016 was not quite statistically significant ($t = 2.1573$; P value equals 0.0972).

Figure 8: Stand of healthy, fertile *Lindsaea incisa* fronds at Orara East SF *in situ* site March 2016.

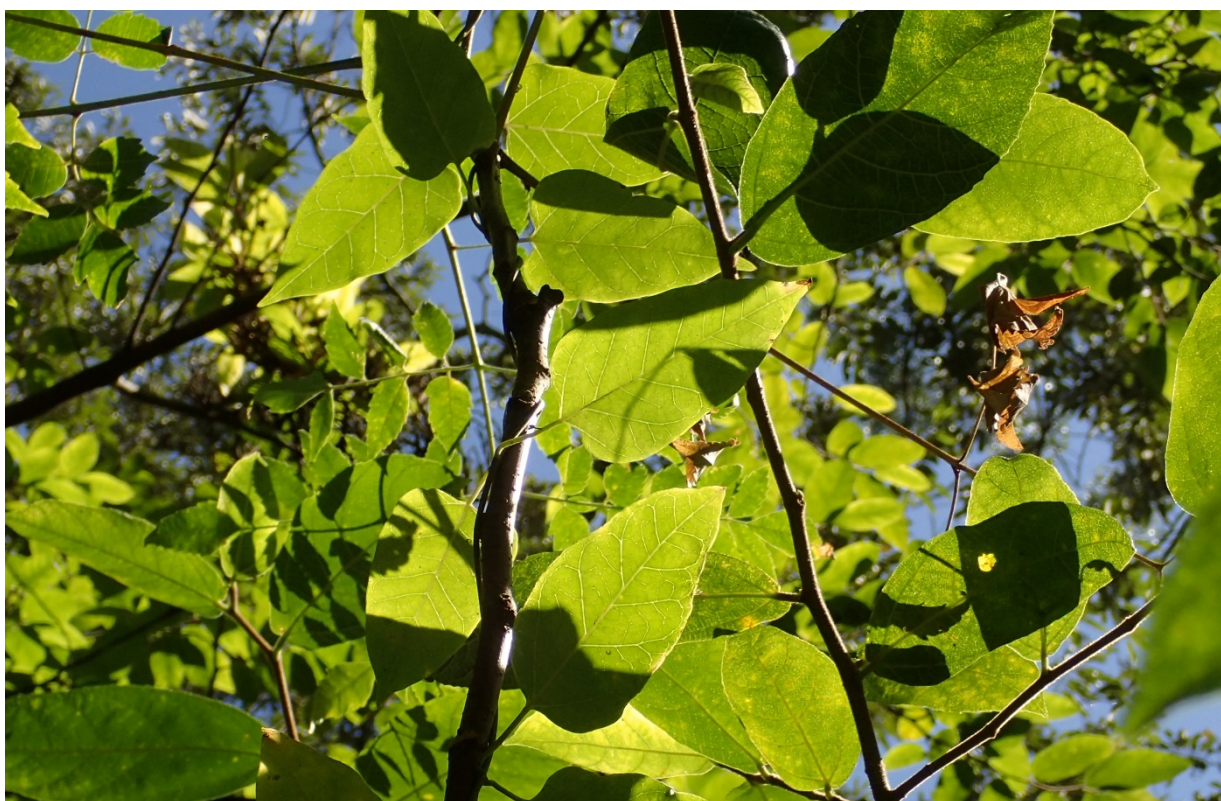
In October 2012 two Slender Marsdenia plants were recorded as bearing living aerial material. In October 2013 only one translocated Slender Marsdenia plant, ML143_1 (ML6), was observed to have above-ground vegetative growth. In March 2014, after below-average spring-summer rains, three translocated Marsdenia plants were recorded with vegetative growth. In October-November 2014 the same three plants remained alive and all had grown since March 2014. The current survey recorded only plant, ML6, with aerial stems (**Figure 9; Table 6**).

Figure 9: Slender Marsdenia transplant ML6 growing on White Cedar and Sandpaper Fig at Translocation Area 2, Wedding Bells State Forest, February 2016.

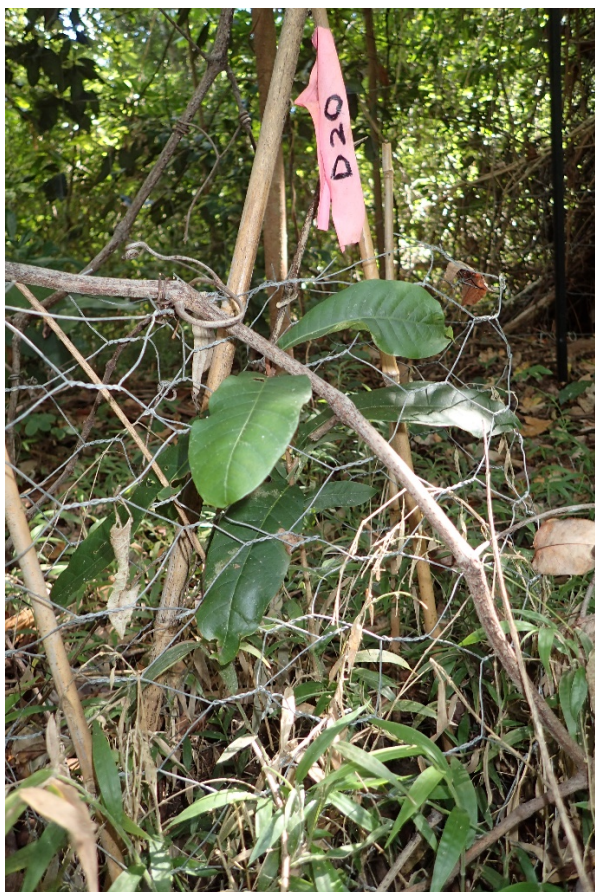
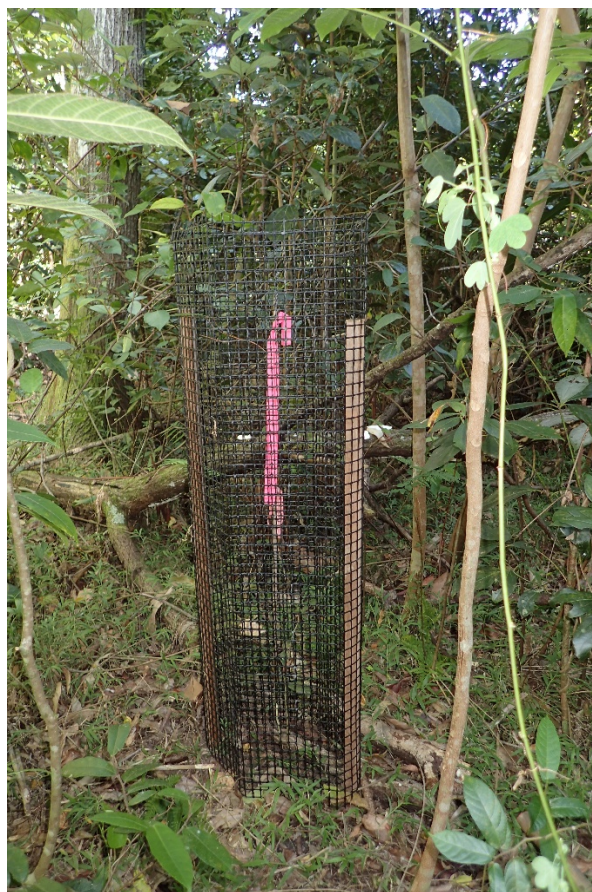
As described above, during the current survey of TA2 the original wire wallaby guards, which had started restricting the growth of many Rusty Plum enhancement plantings, were removed and replaced with 1.2m high by 40cm wide plastic mesh guards supported by hardwood stakes (**Figures 10 and 11**).

Figure 10 (left): Rusty Plum D20, a direct-seeded transplant, in original wire wallaby guard. **Figure 11 (right):** a replacement 1.2m high plastic mesh guard.

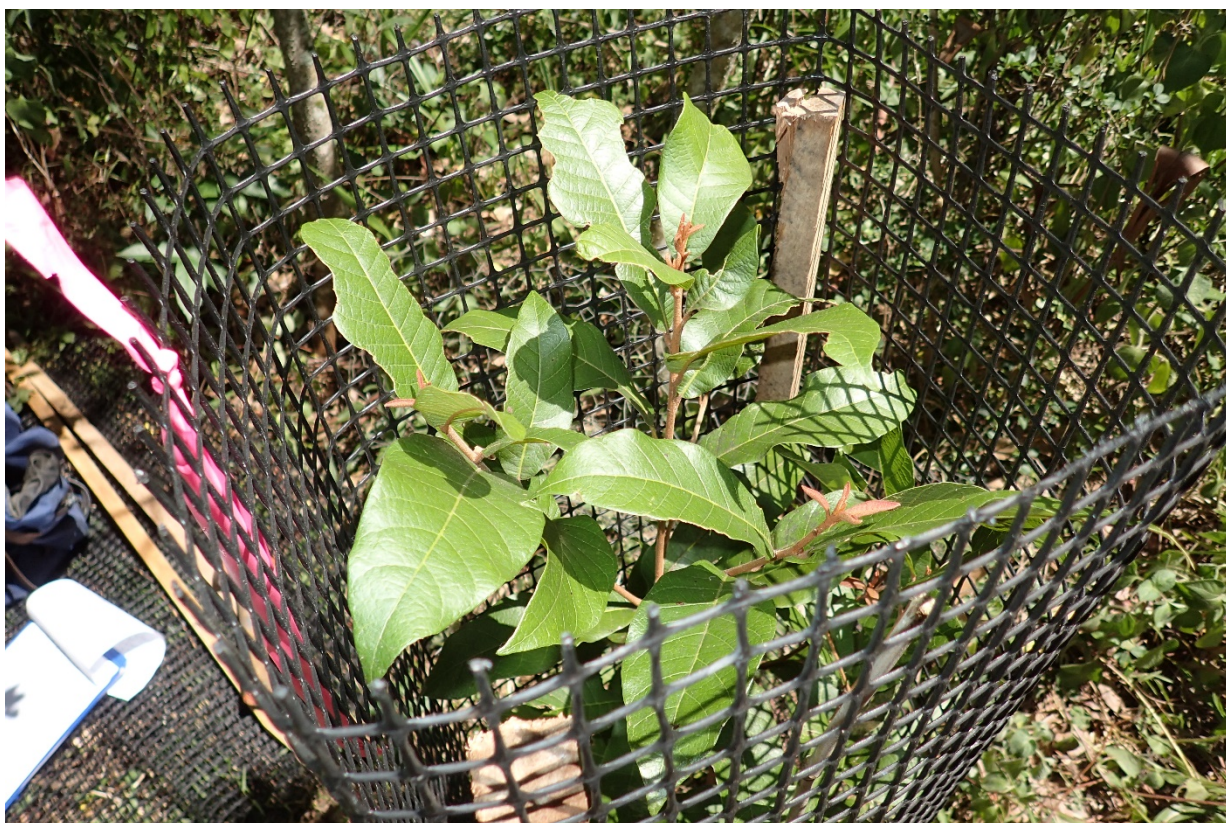
Figure 12: Rusty Plum P16, a pot-germinated transplant, showing excellent growth and vigour in a new mesh wallaby guard.

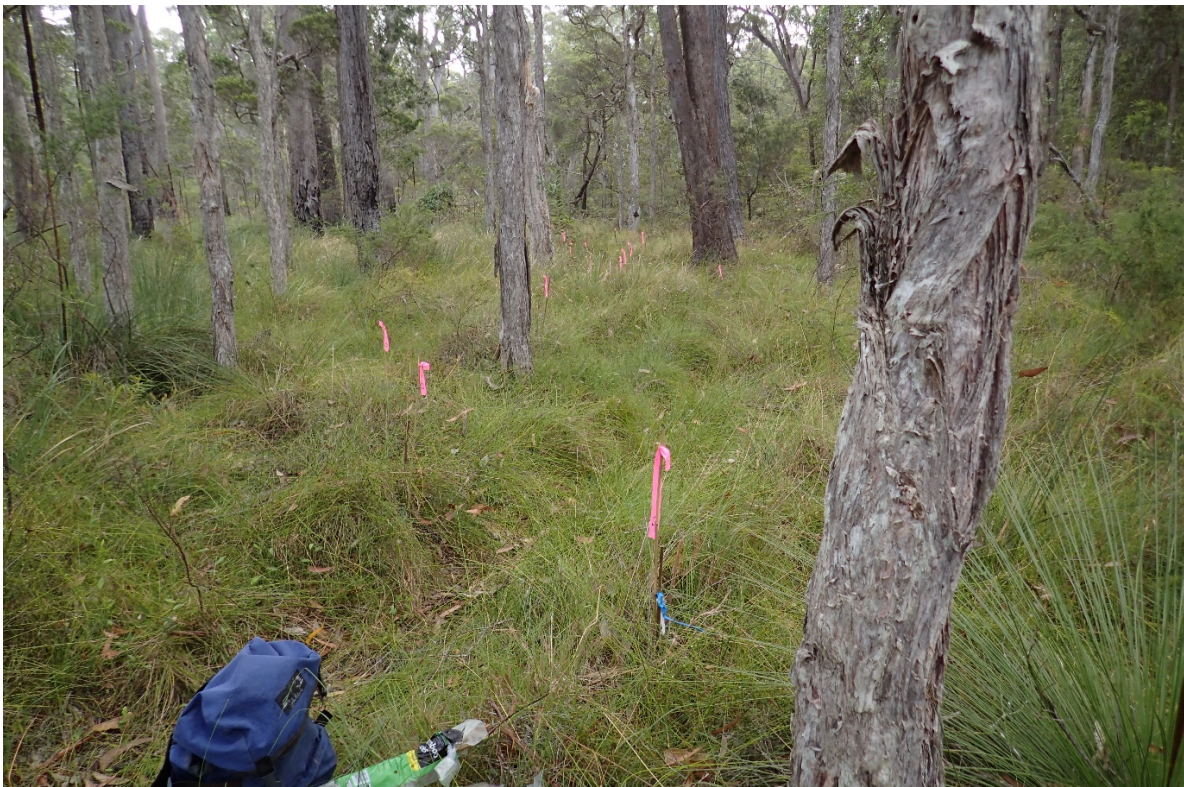
Figure 14: *Lindsaea incisa* transplant quadrats – Area 1, Line C. March 2016.

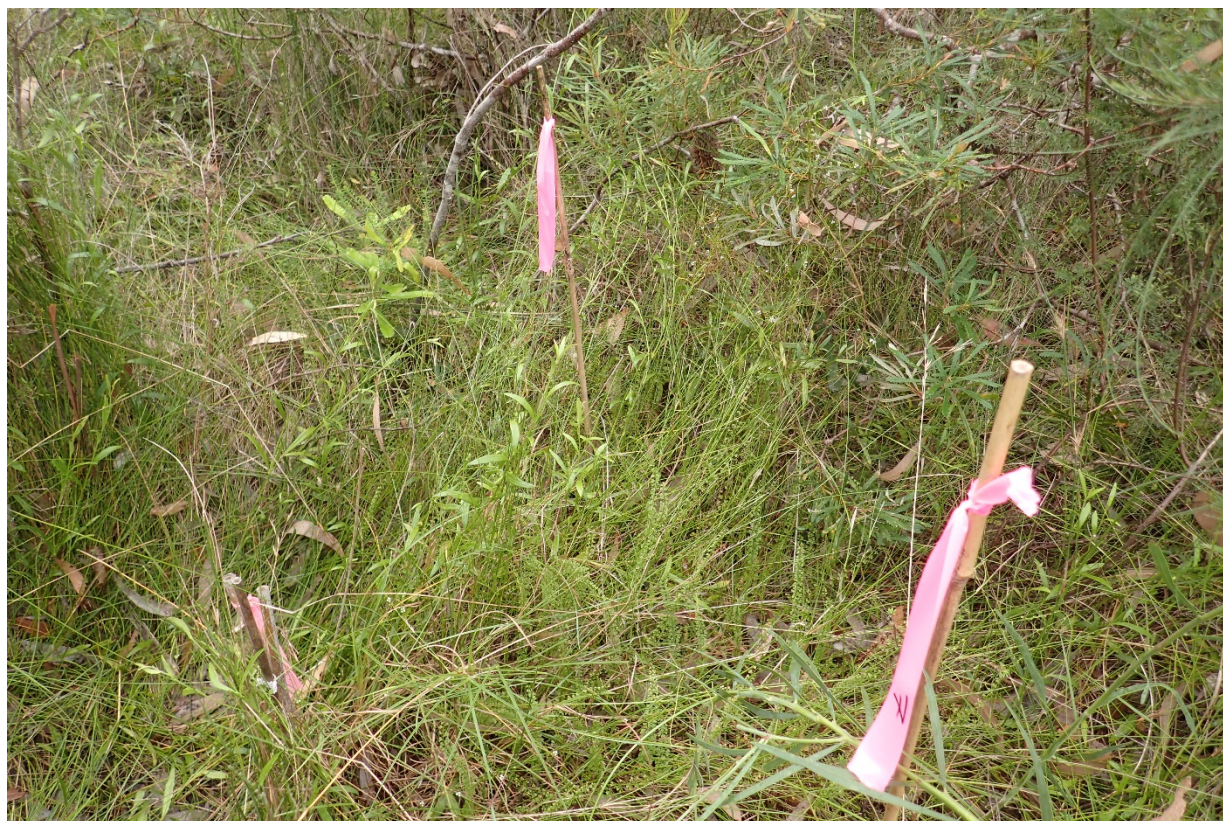
Figure 16: *Lindsaea incisa* transplant growing vigorously and extending beyond Quadrat 7 on Line 1 of Area 2, March 2016.
