DALYUP AND WEST DALYUP RIVERS

ACTION PLAN

WATER AND RIVERS COMMISSION
WATER RESOURCE MANAGEMENT SERIES
REPORT NO WRM 34
DECEMBER 2002

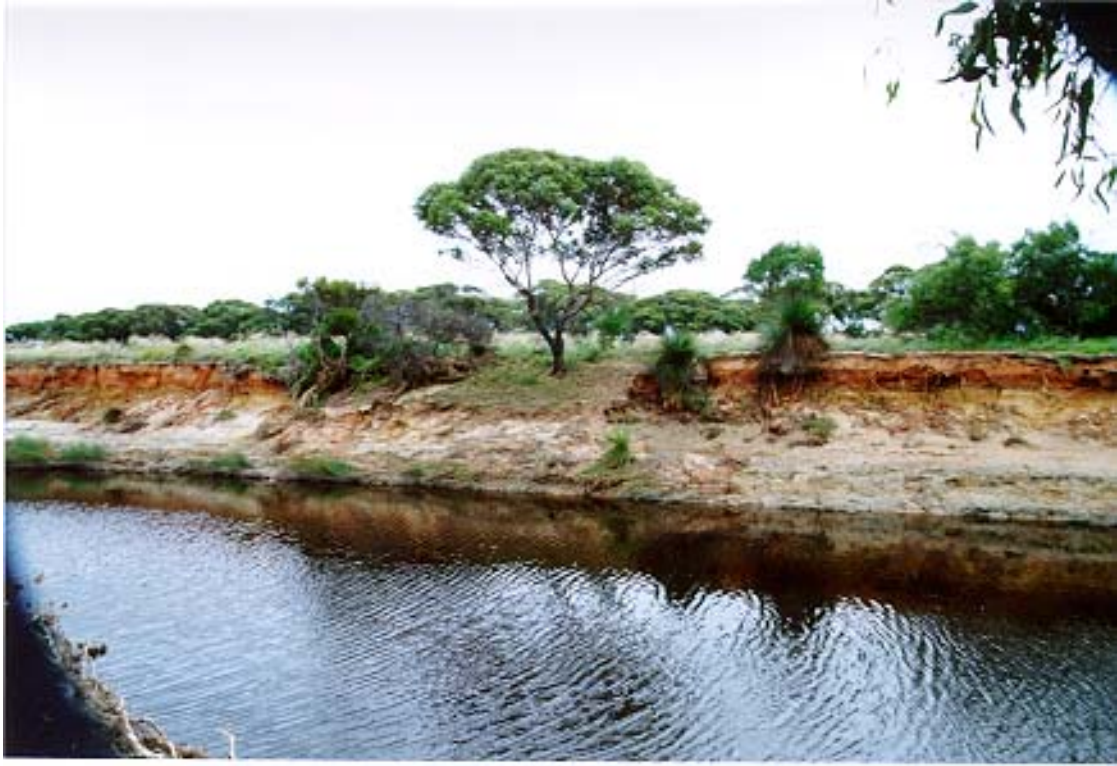
Bank of the Dalyup River showing a channel that is incising and becoming deeper. Note the Yate and how it has retained some of the soil in its root system (photograph Kaylene Parker).

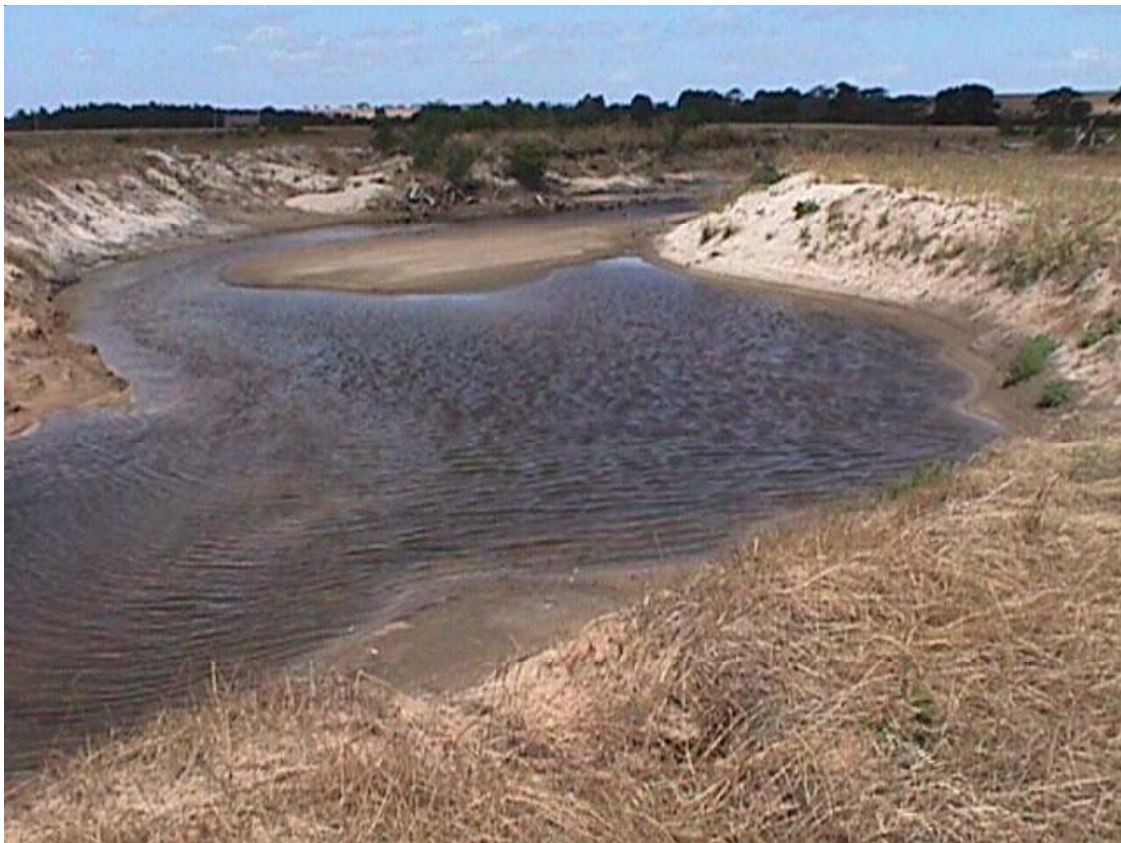
The West Dalyup River – showing widening and braiding. There is little or no vegetation to help stabilise the banks (photograph Kaylene Parker).

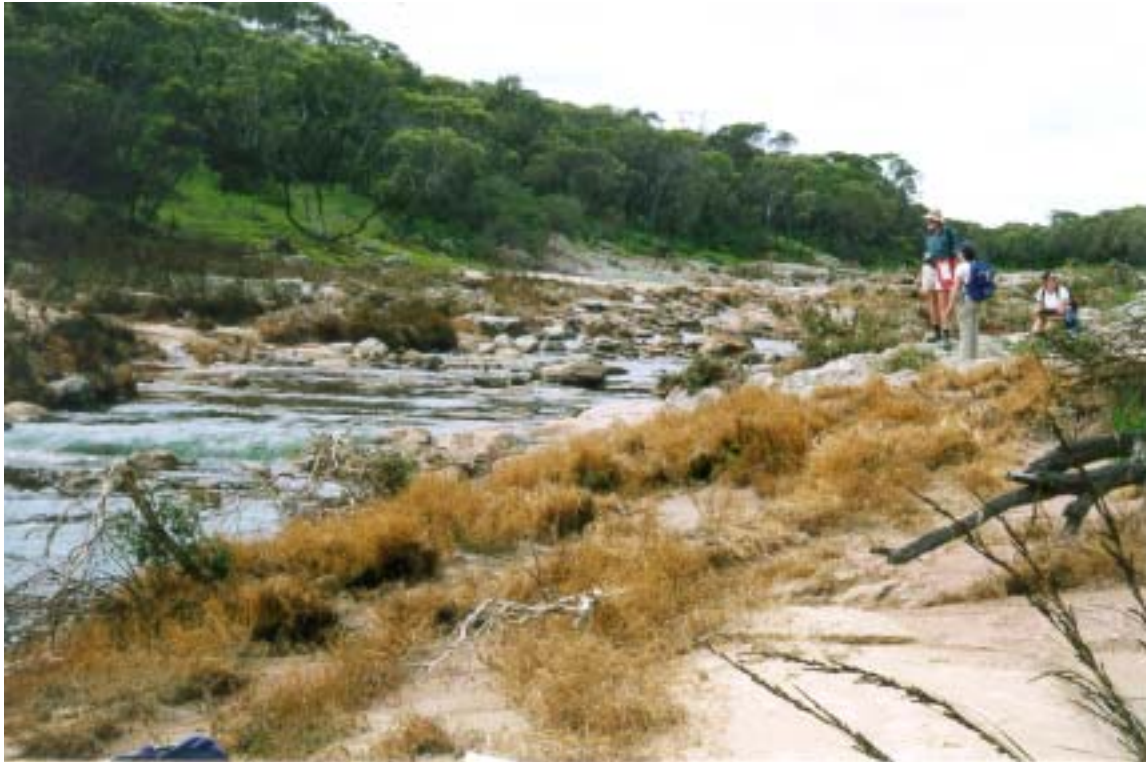
B Grade vegetation of the Dalyup River – note the odd weeds along the edge of the channel (photograph Kaylene Parker, WRC)

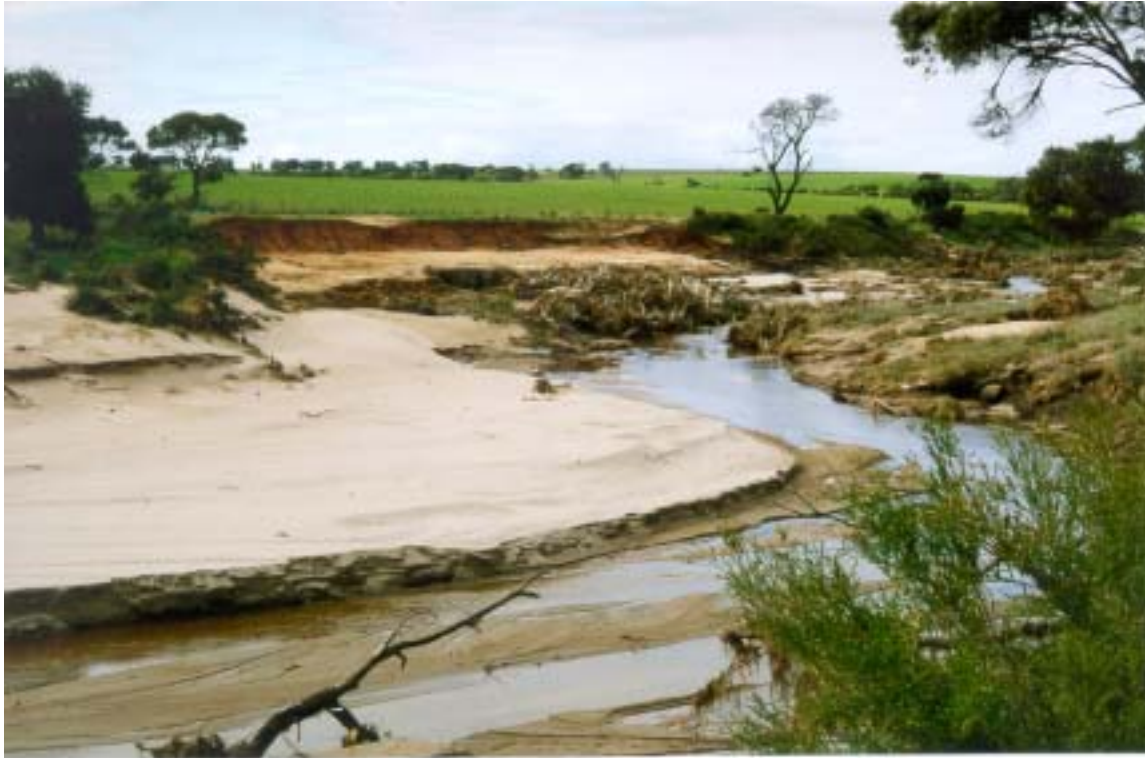
C grade – note the erosion and lack of understory

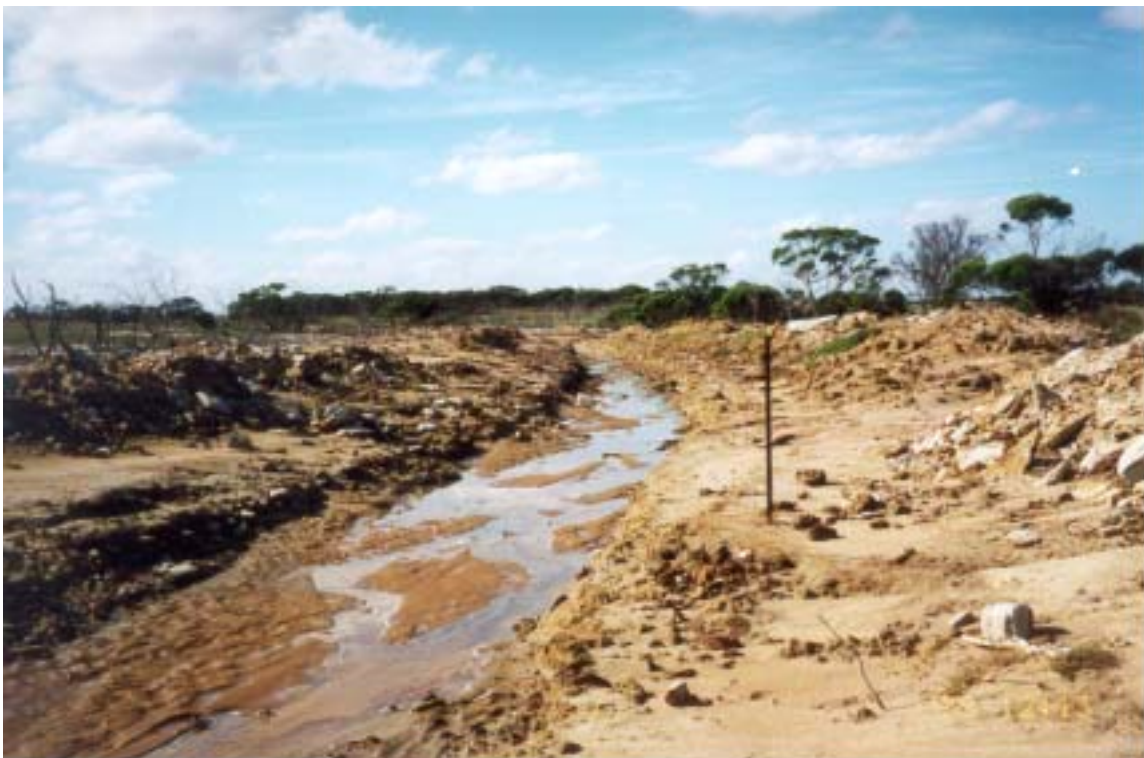
D Grade vegetation condition – note the lack of vegetation and erosion.
