Waterway assessment for the Lockhart River: Lake Kurrencutten to the Camm River confluence

Water resource management series

Report No. WRM 55

December 2008

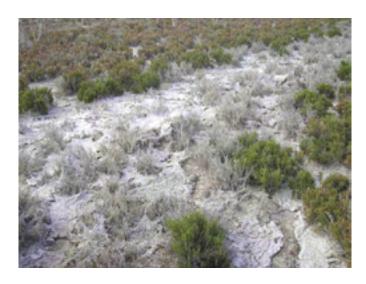
Many areas surveyed were grazed by livestock for part of the year, particularly summer and autumn to fill the feed gap at that time. Damage to the soil surface, which leads to erosion, was observed, which compounds the soil structural decline that has resulted from increased salinity. Natural regeneration is also likely to be affected by livestock grazing. Faeces and urine are likely to be adding to the nutrient loads in the waterways. An example of this was seen in LR03 (Larke's), where samphire appears to have been killed as a result of being smothered by an algal bloom after the last floods (Photo 1).

Photo 1Samphire killed after being smothered by an algal bloom (Larke's LR03)

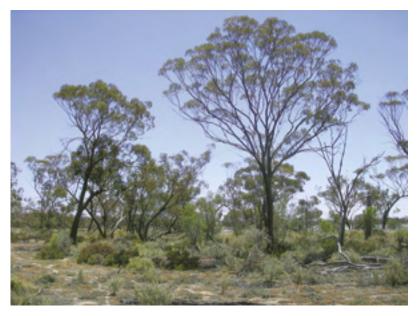
Photo A1.1: LR01
Good condition vegetation
association 1: Eucalyptus
salmonophloia, E. salubris
and E. loxophleba very open
woodland.

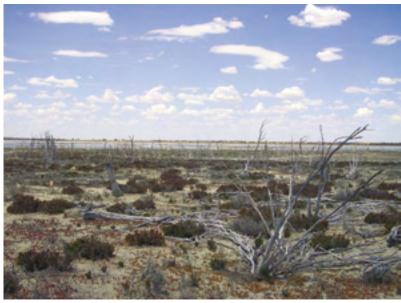
Photo A1.2: LR01
Degraded condition vegetation association 2: Halosarcia spp. sparse shrubland.

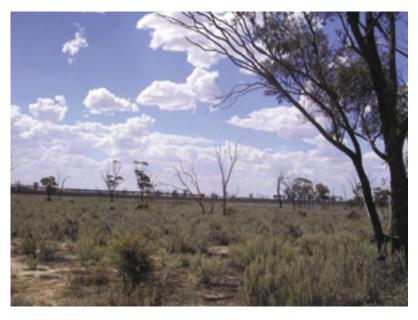
Photo A1.3: LR01 Very good condition vegetation association 3: Eucalyptus myriadena very open woodland.
