Public Document Pack

ADDITIONAL CIRCULATION

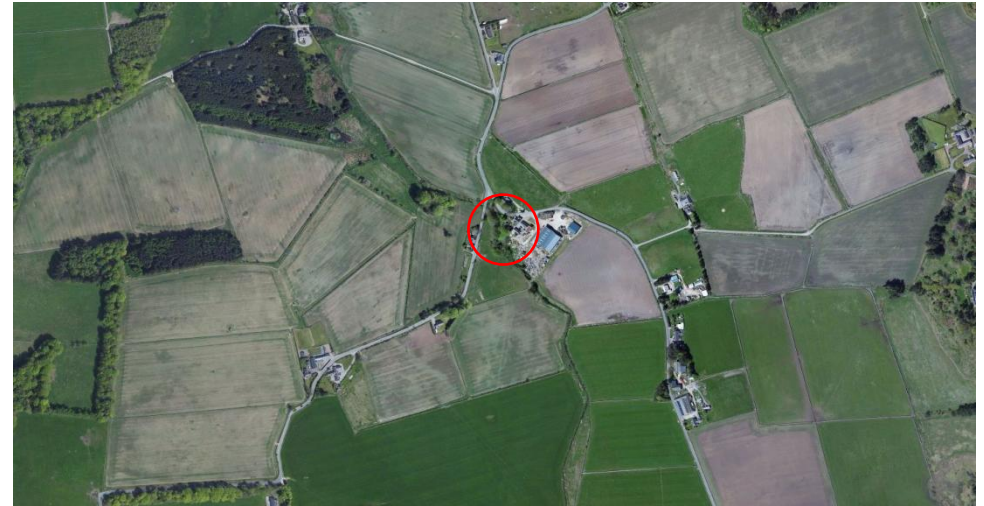
The habitat in the area provides ideal foraging for bats. The Littlemill burn runs through the site southeast - northwest and is lined with deciduous trees providing foraging and commuting routes to and from larger areas of woodland to the west and northwest. Tyrebagger wood is approximately 1.4km northeast from the site which has some connectivity to Littlemill.

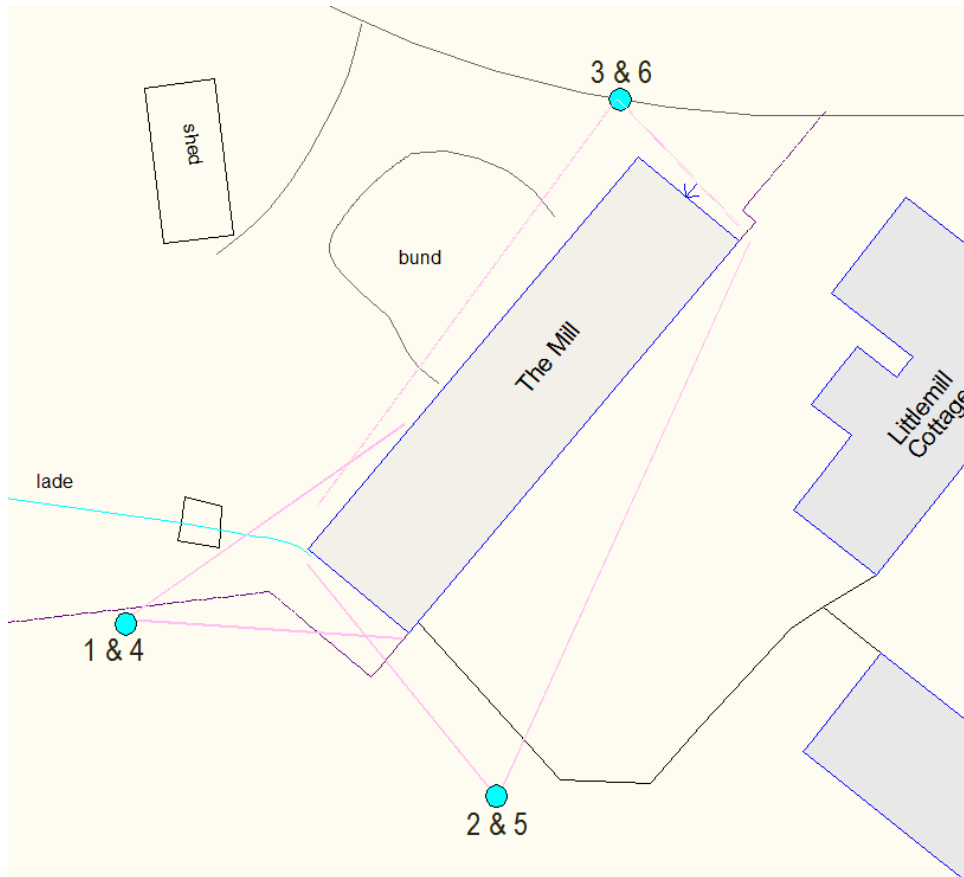
Dusk Emergence Survey 22nd June

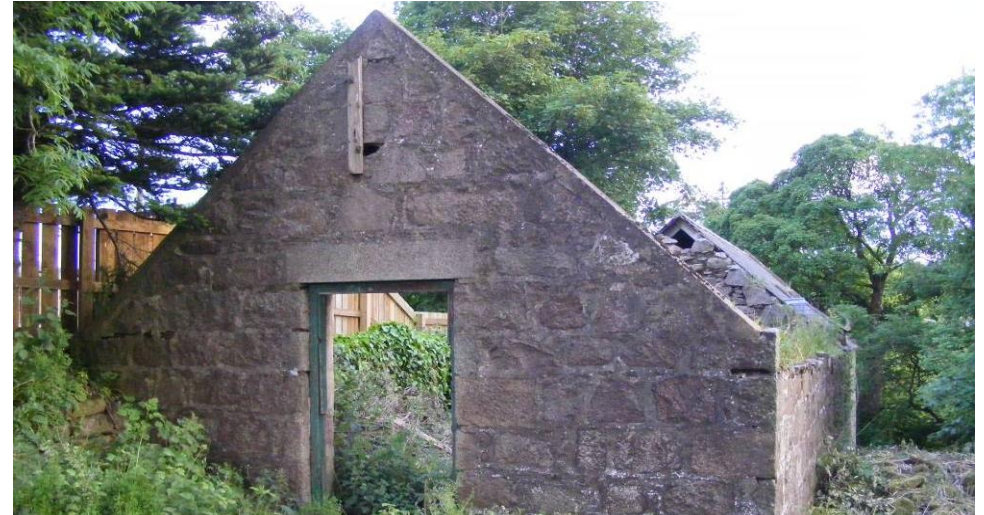
Photo 1: North gable of ruin. In good condition other than large crack next to wooden board. No evidence of bats.

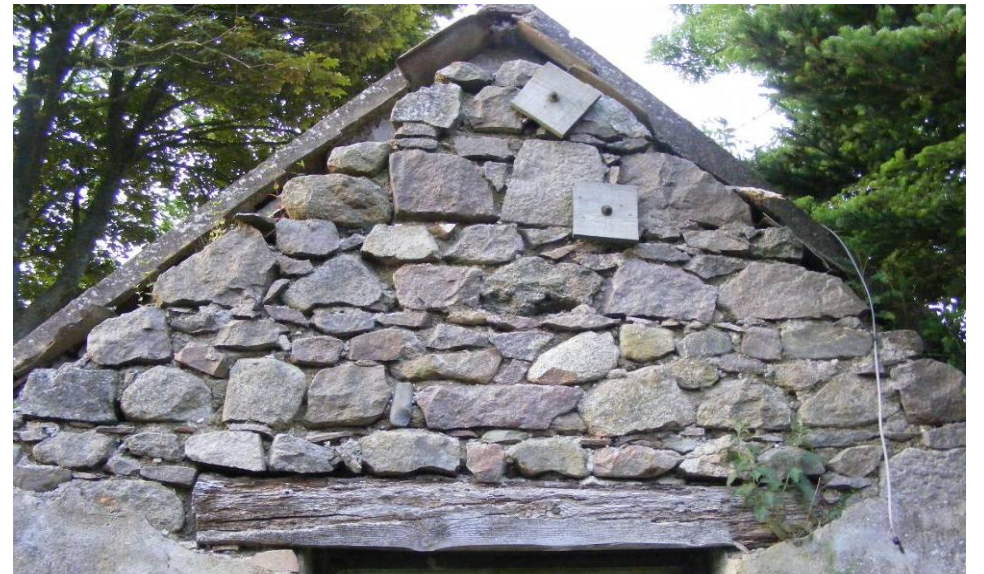
Photo 2: 'Inside' of north gable of ruin. Some gaps but not used by bats as nettles and other weeds are growing from them.

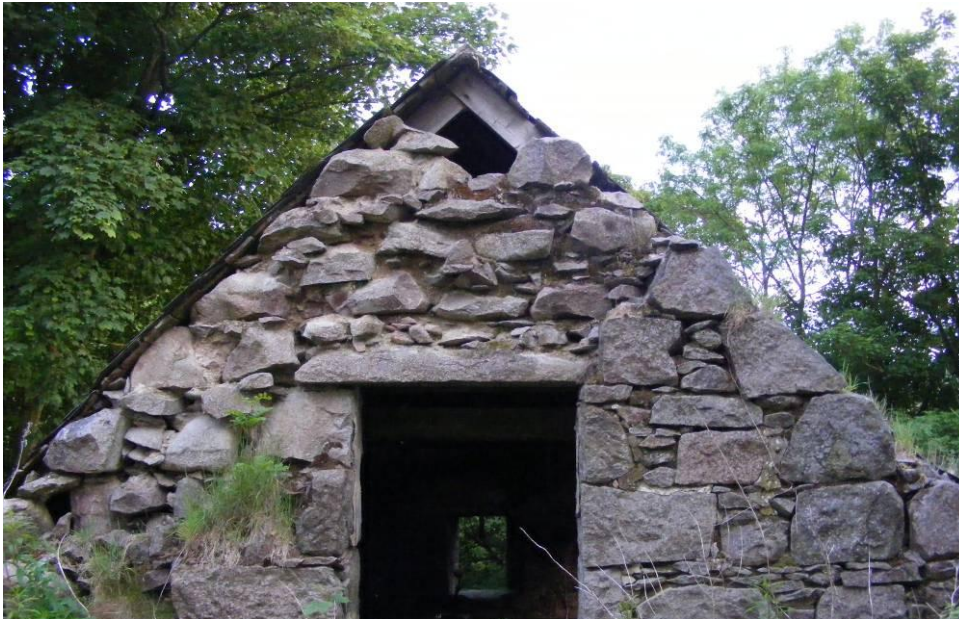
Photo 4: North elevation. Wall in poor condition, with large gap at the ridge. Large cracks are shallow and offer no bat roost potential. No evidence of bats.

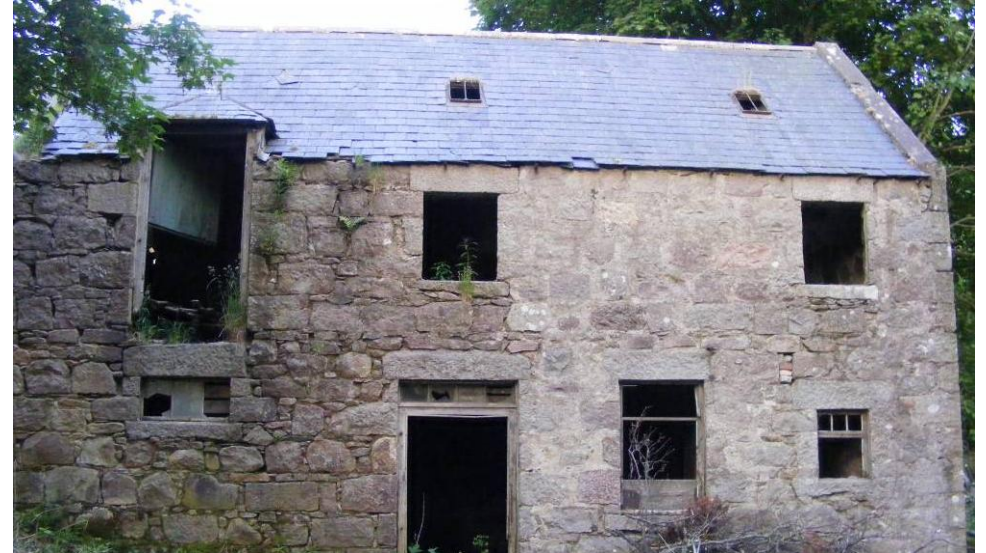
Photo 5: West elevation of mill. Plants are growing from cracks in places show wall is damp. Some loose and missing slates on roof provide limited bat roost potential. No evidence of bats found.

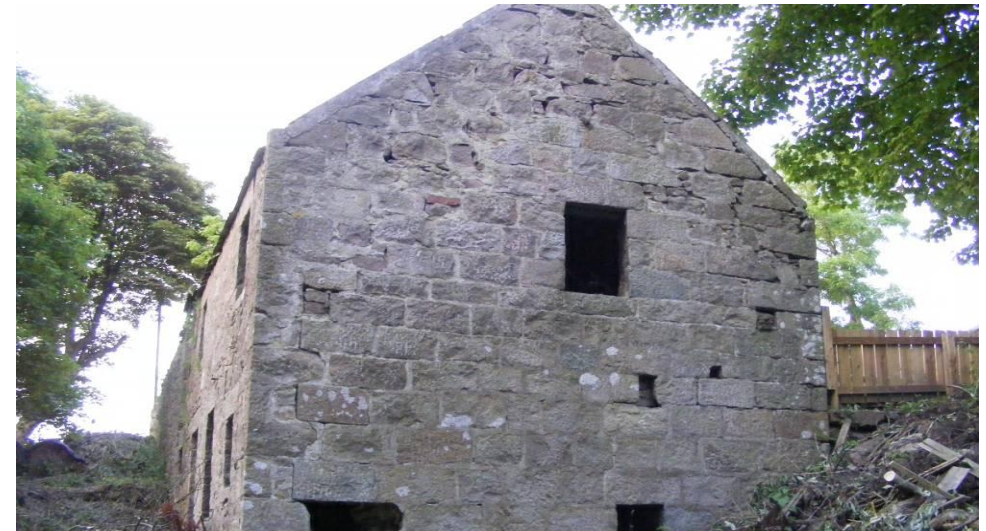
Photo 7: South elevation of mill. Some large holes in wall which had some cracks, however, no evidence of bats were found. Small, shallow cracks near top of mill could provide limited roosting potential. No evidence of bats was found.

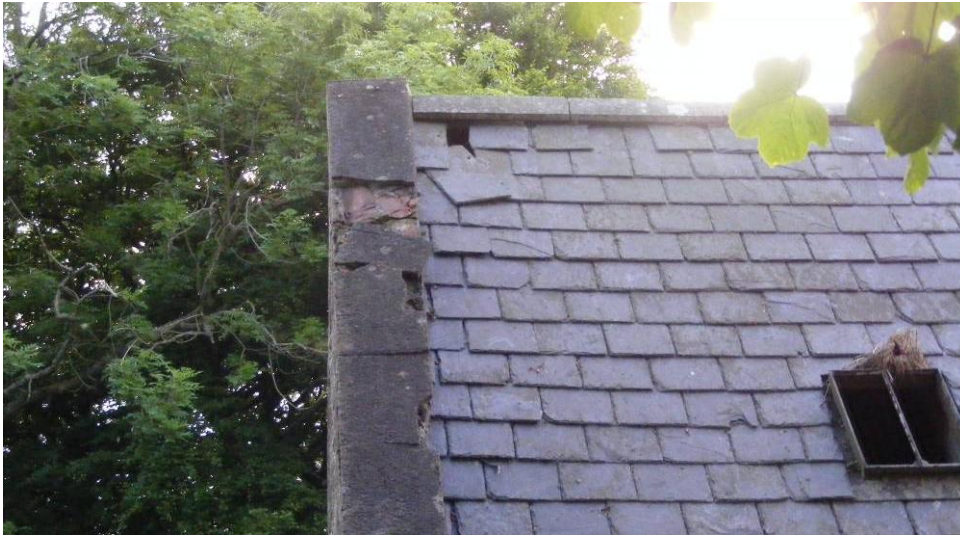
Photo 8: South gable end. A loose slate has caused a small hole in the roof contributing to the dampness inside the mill and in the roof. Lifted and missing slates provide limited roosting potential. No evidence of bats was found.

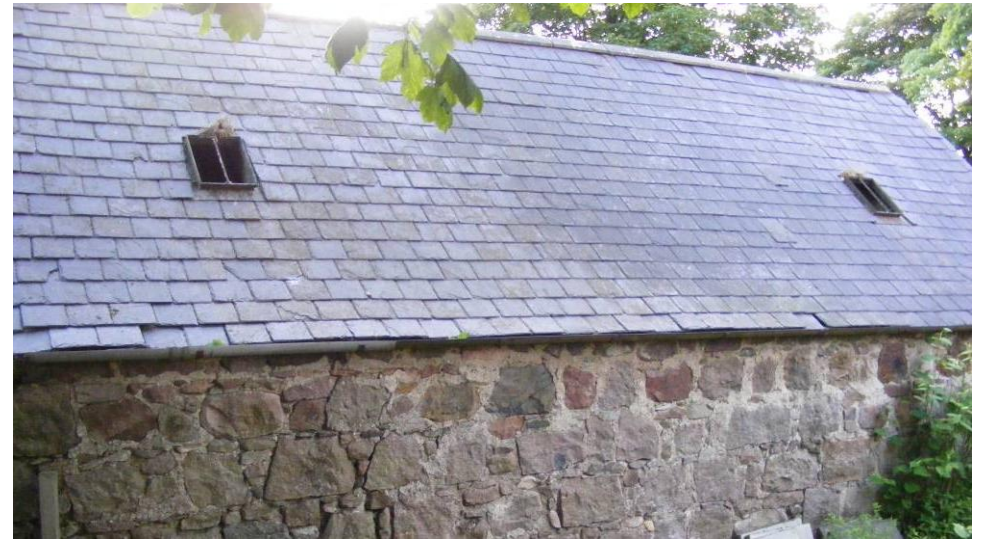
Photo 10: Eastern elevation of Mill building. Roof has several missing slates but is mainly in good condition. Windows are broken allowing water inside contributing to the damp. Ridge appears intact.

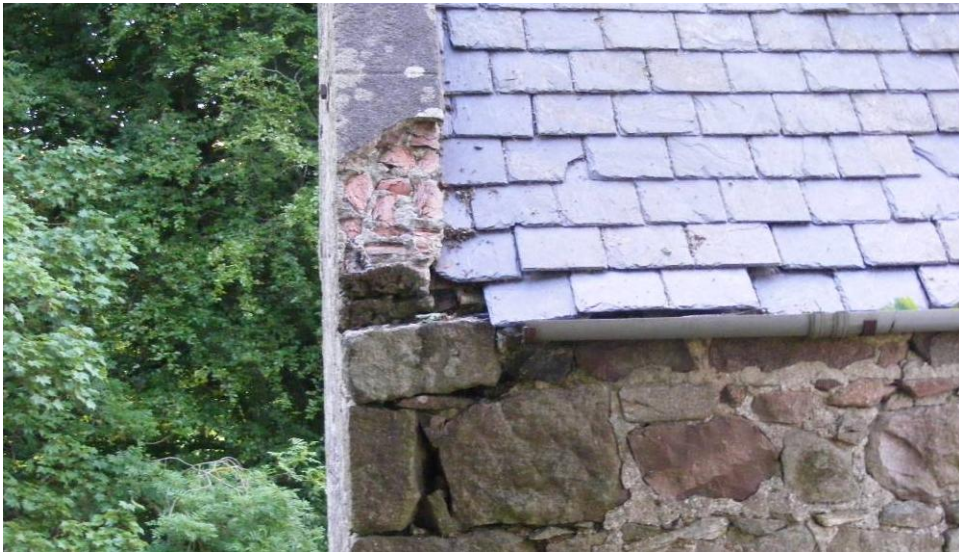
Photo 9: Southeast corner of building. Damage to wall and a missing slate has caused a large crack to form. This has no bat roosting potential and no evidence of bats was found.

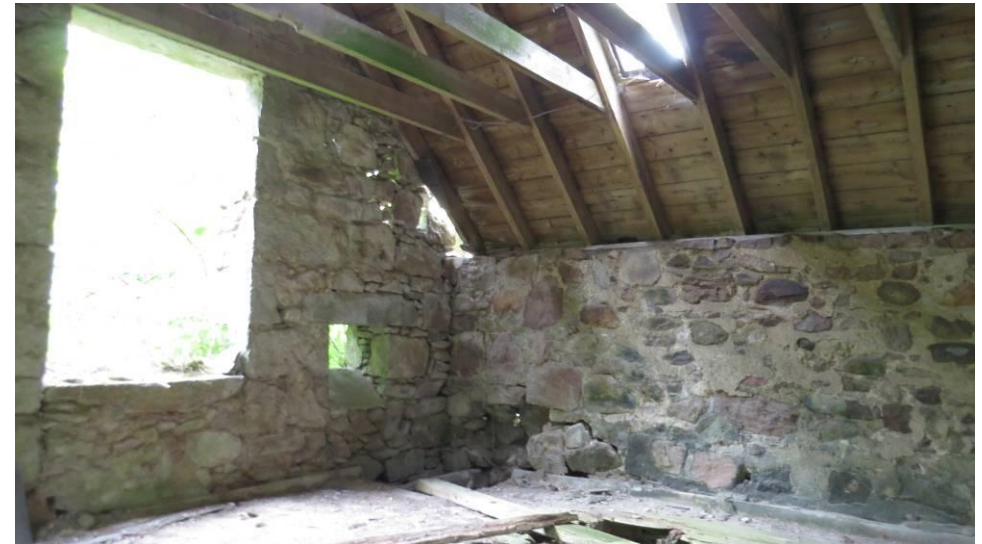
Photo 11: North gable. Large hole in northeast corner of the wall. Roof and floor rotten in places. The building is in poor condition and becoming dangerous.

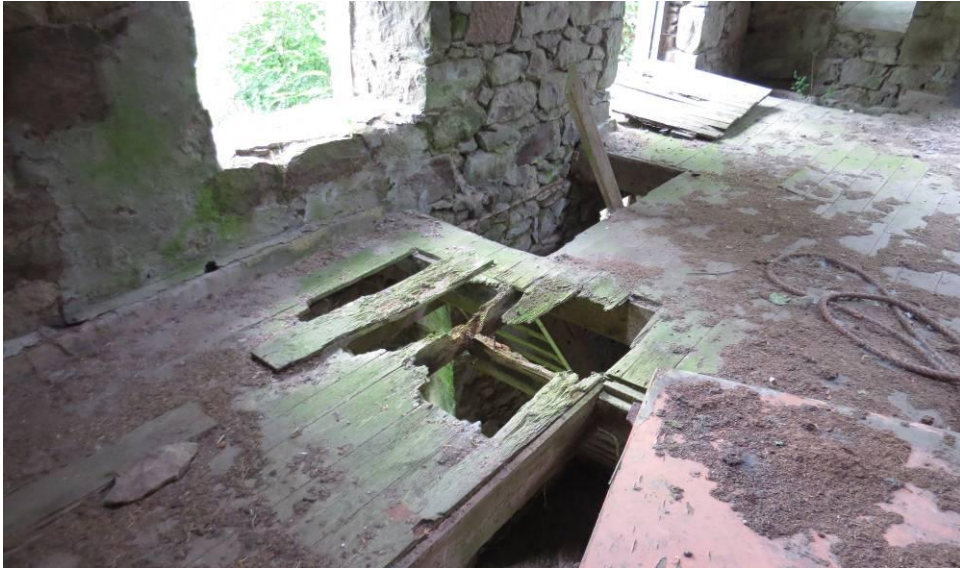
Photo 12: View of staircase from ground floor to lower ground floor. Area is dangerous with rotten floorboards and some joists are not attached to the wall.

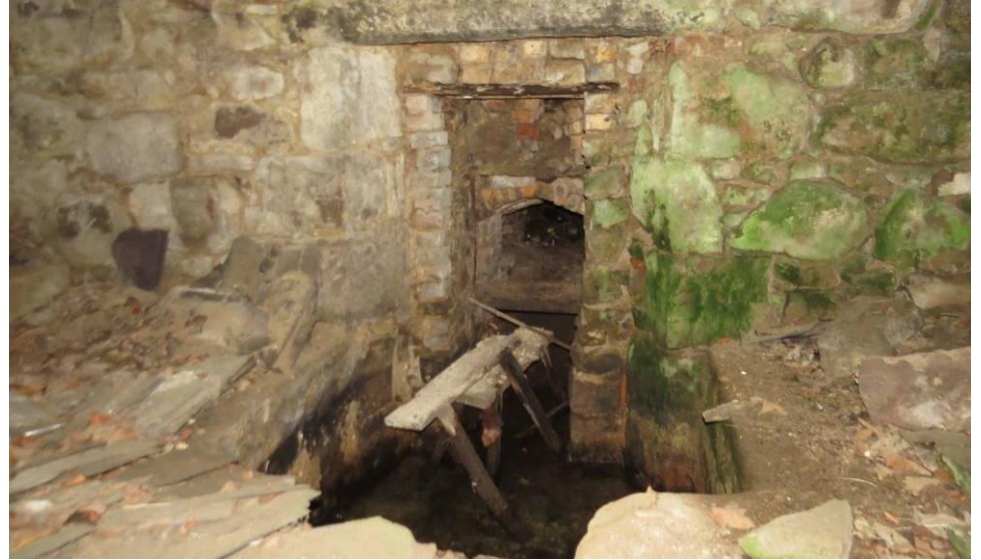
Photo 14: Lower floor, north gable of main building. Grain drying kiln floor has fallen in. The walls are damp and have no cracks. The grain kiln has a collapsed chimney. Inspection showed no evidence of bats

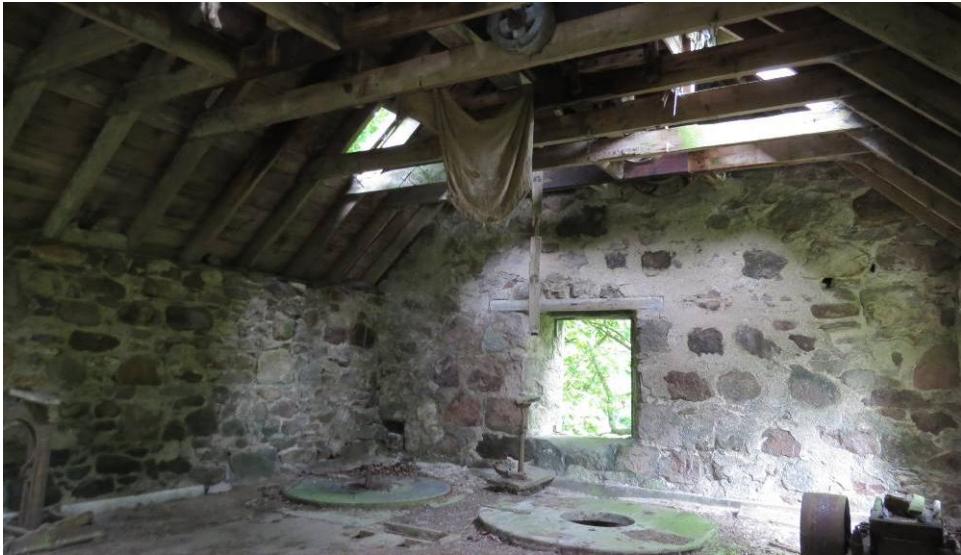
Photo 13: South gable. Roof rotten and collapsing in places. Algae on floor and walls are further evidence of damp with rainwater entering the building. There is no enclosed roof space and limited bat roost potential.
