# Geologic Reconnaissance of Possible Powersites at Tye, Eagle, and Spur Mountain Lakes, Southeastern Alaska

By JAMES E. CALLAHAN and ALEXANDER A. WANER

GEOLOGY OF WATERPOWER SITES IN ALASKA

G E O L O G I C A L S U R V E Y B U L L E T I N 1 2 1 1 - B

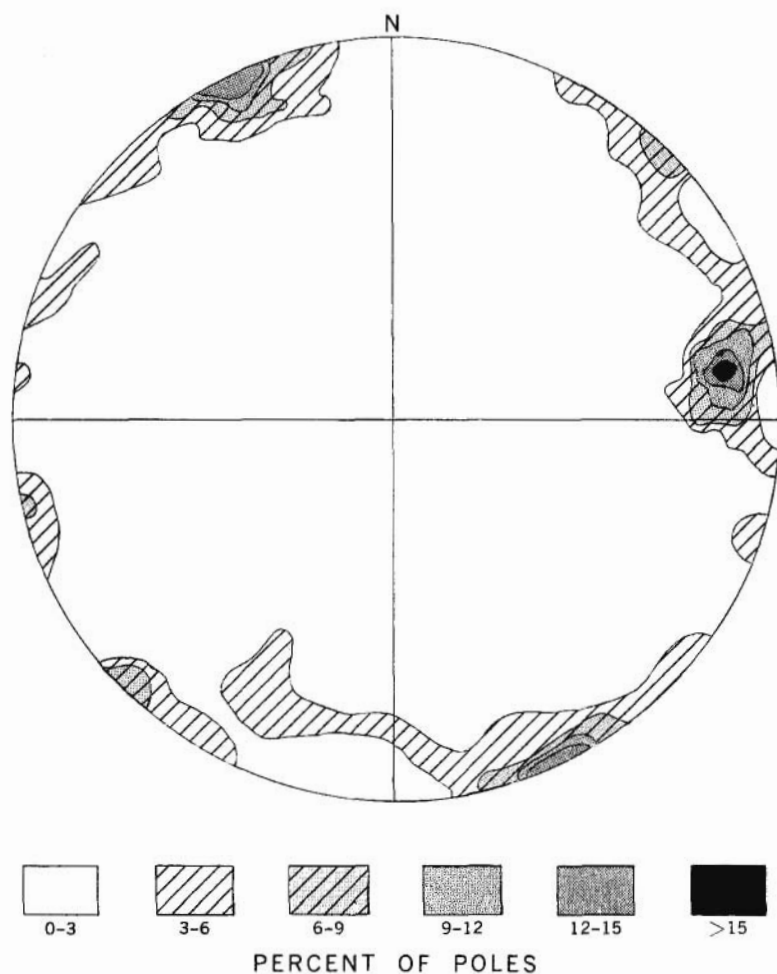
Joints are steeply dipping to vertical. Figures 2, 3, and 4 are contour diagrams of poles plotted to joints measured at Spur Mountain Lake, Tyee Lake, and Eagle Lake, respectively. The joint systems at Spur Mountain Lake and Eagle Lake are similar; two major sets strike N. 65° E. and N. 10° W., respectively, and dip vertically or near vertically. The northeasterly striking set is also present at Tyee Lake.

FIGURE 2.—Contour diagram of poles of 120 joints measured in the Spur Mountain Lake powersite area. Poles plotted on lower hemisphere. Contoured on percent of poles. (Billings, 1954, p. 108-114.)

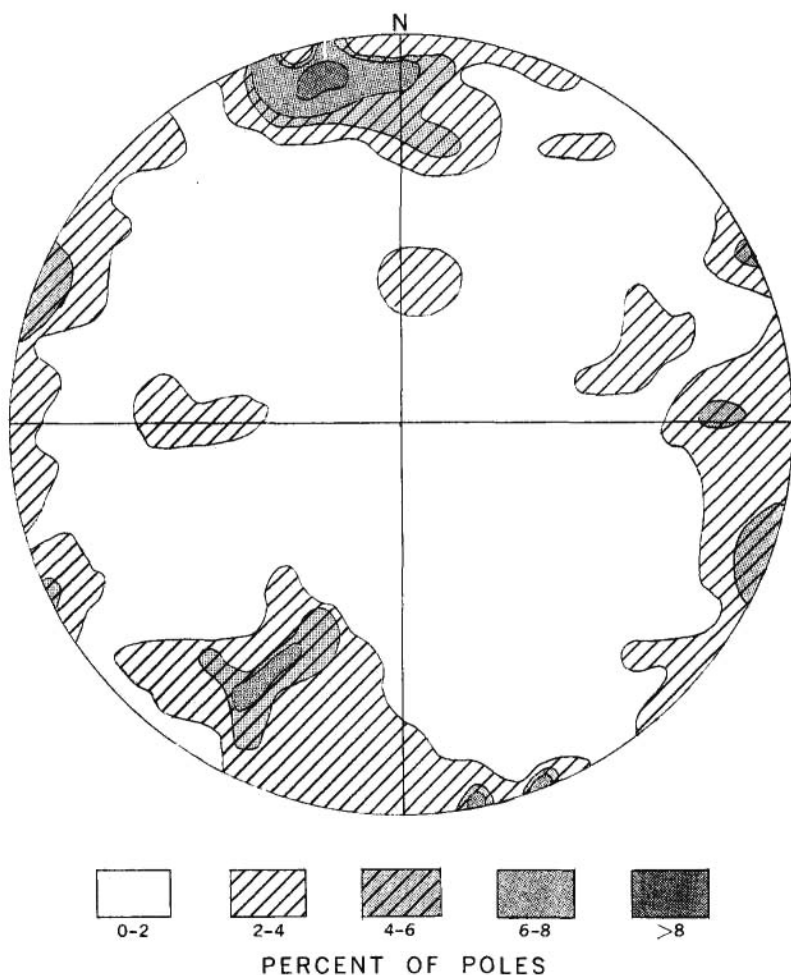
FIGURE 3.—Contour diagram of poles of 127 joints measured in the Tye Lake powersite area. Poles plotted on lower hemisphere. Contoured on percent of poles. (Billings, 1954, p. 108-114.)

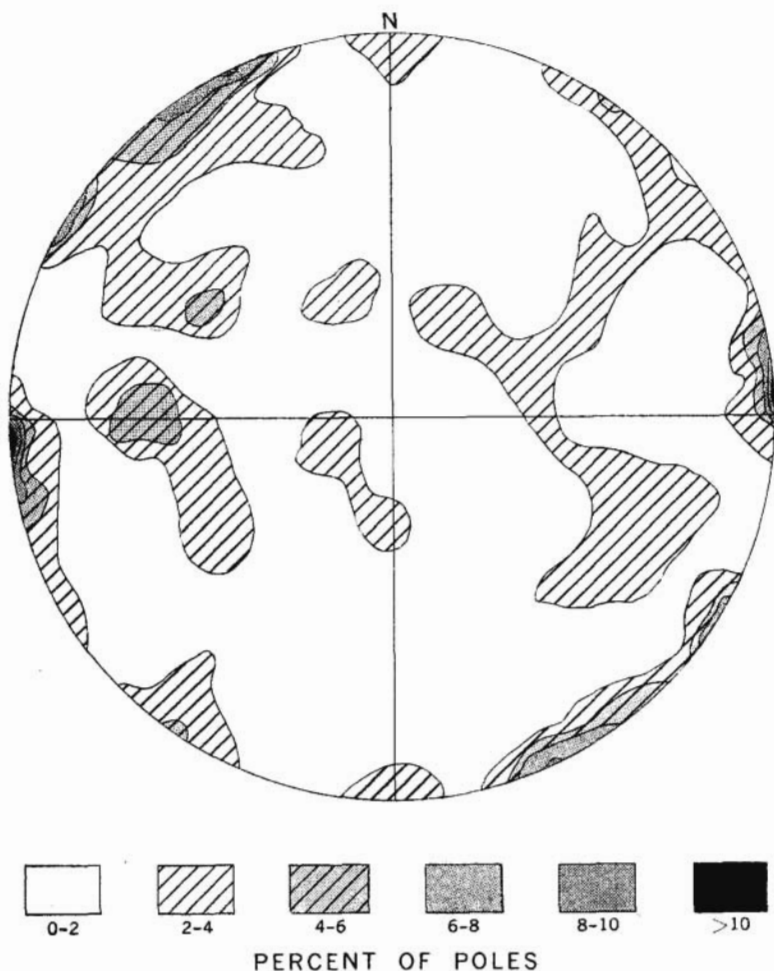
FIGURE 4.—Contour diagram of poles of 96 joints measured in the Eagle Lake powersite area. Poles plotted on lower hemisphere. Contoured on percent of poles. (Billings, 1954, p. 108-114.)
