# Proposed Discharge Evaluation:

## Coonderoo River Wetlands

This report was prepared for:  
**Simcoa Operations Pty Ltd (Moora)**  
December 2011

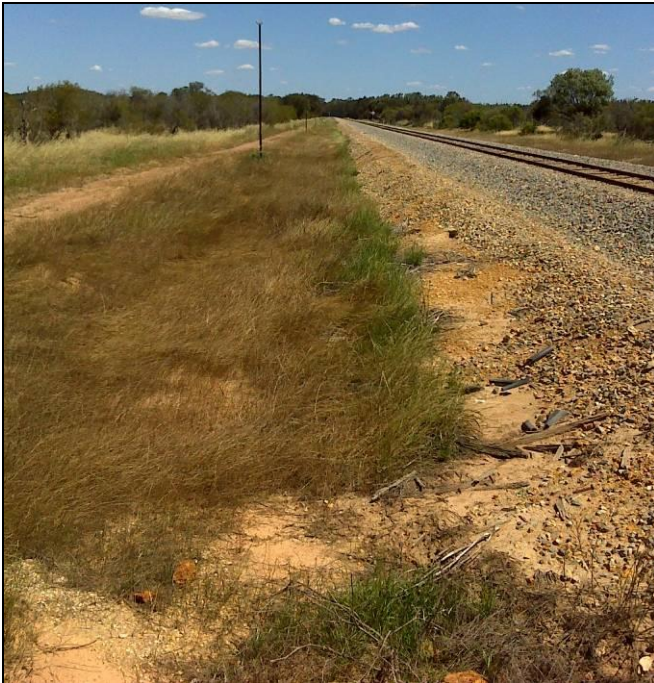
**Figure 4** - WP95 to South

This site was beside a railway embankment. The surrounding vegetation consisted of *Eucalyptus* sp., *Casuarina* sp., and *Acacia* sp. over *Hakea preissii*, Quandong and *Calothamnus* sp.

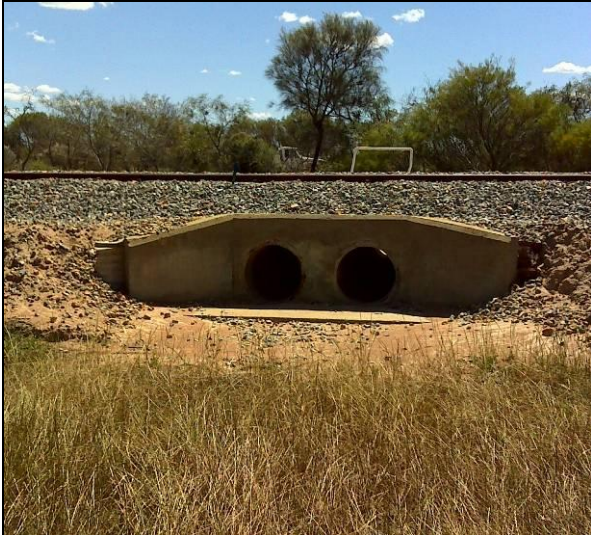
**Figure 6** - WP97 culvert

This was a culvert beneath the railway embankment and also beneath the road – it appeared to carry water from the wheat paddock back towards WP97. The vegetation here was open *Acacia* spp. over *Xanthorrhoea* sp. and *Dianella* spp. with many exotic grasses, including wild oats.

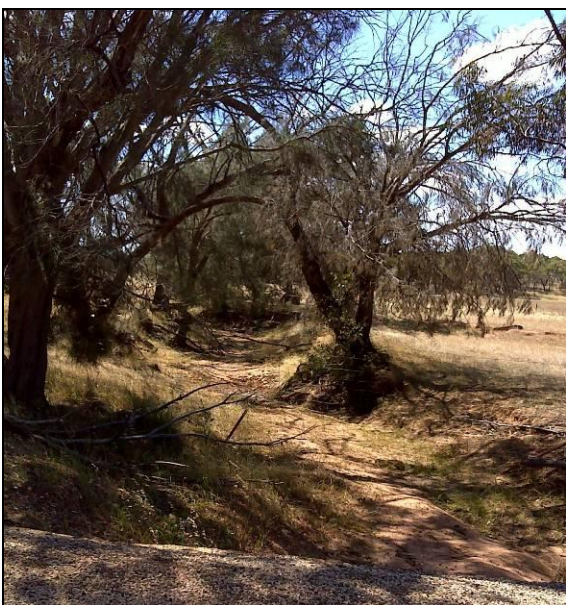
**Figure 7** - WP98 creek culvert

This was a creek culvert beneath the road. Vegetation consisted of *Casuarina* sp. and *Eucalyptus* sp. with no obvious understorey – exotic grass species.

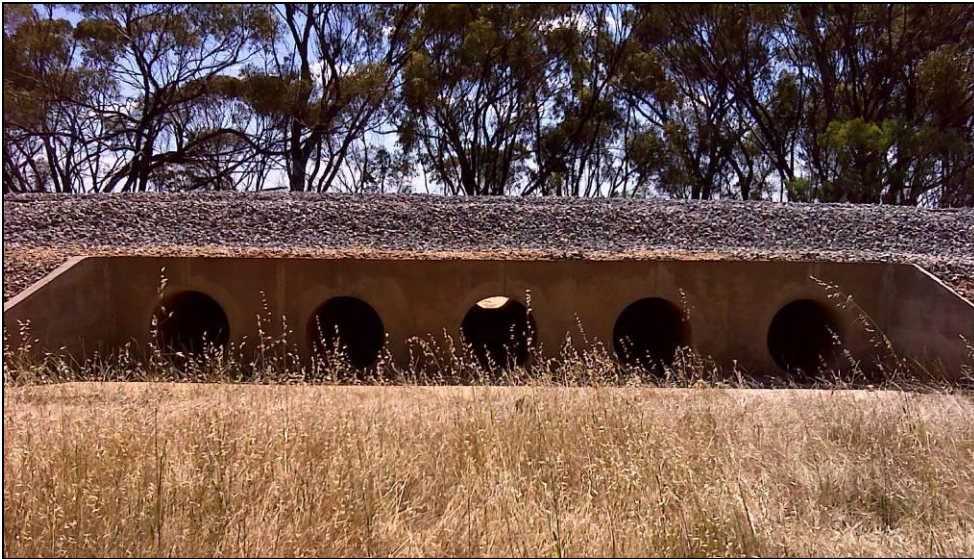
**Figure 8** - WP99 culvert beneath railway

This site was a culvert beneath the railway and the road. As at WP97 it appears that water comes from the wheat paddock on the other side of the road and flows back through the culverts. The vegetation was *Eucalyptus* sp. over exotic grasses.

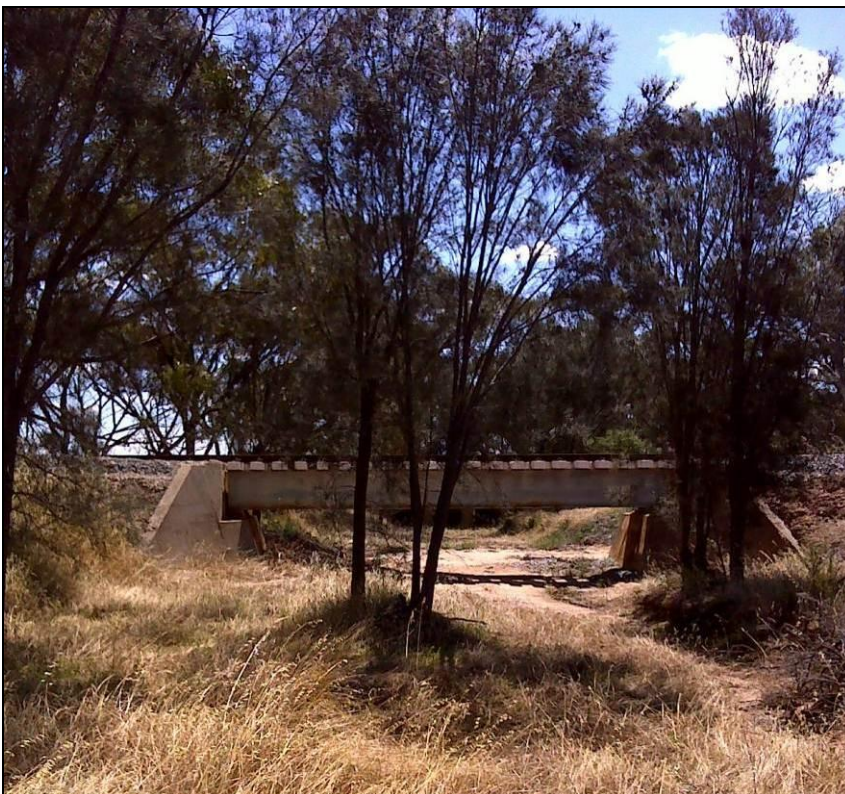
**Figure 9** - WP100A railway over Kiaka Creek

This site was the main creek (Kiaka Creek) beneath the railway and the road. The vegetation was *Casuarina* sp. and *Eucalyptus* sp. over sparse understorey which was mostly exotic grasses with some *Enchylaena* sp. and other shrubs.

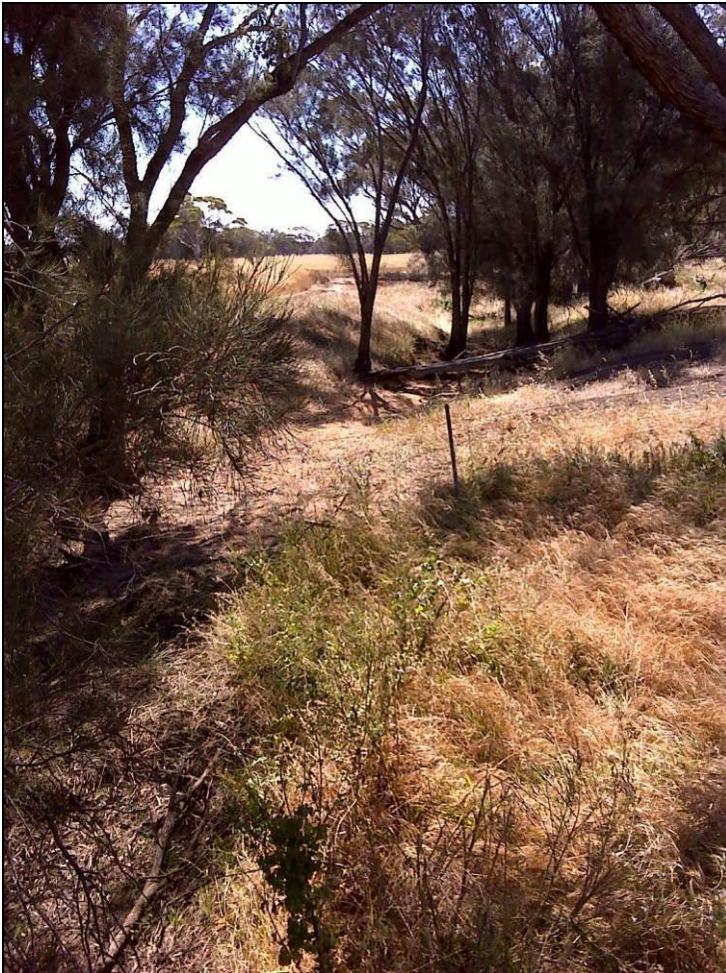
**Figure 10** - WP100B Kiaka Creek at road culvert

This was the same site as 100A but was the road culvert. The vegetation was *Casuarina* sp. and *Eucalyptus* sp. with no understorey, only exotic grasses.

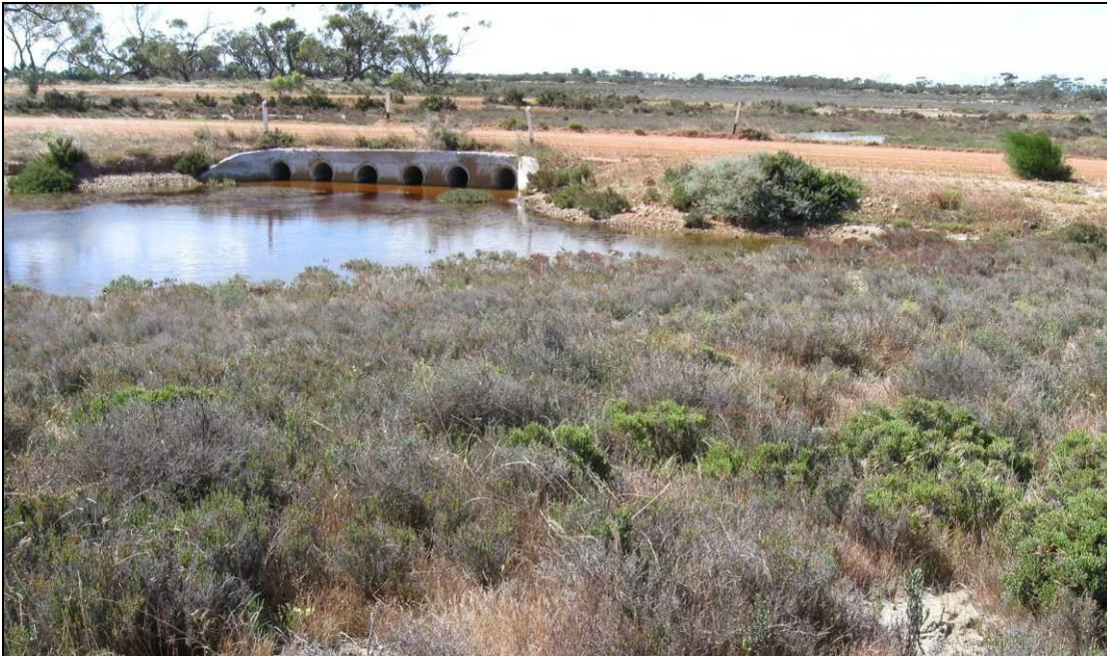
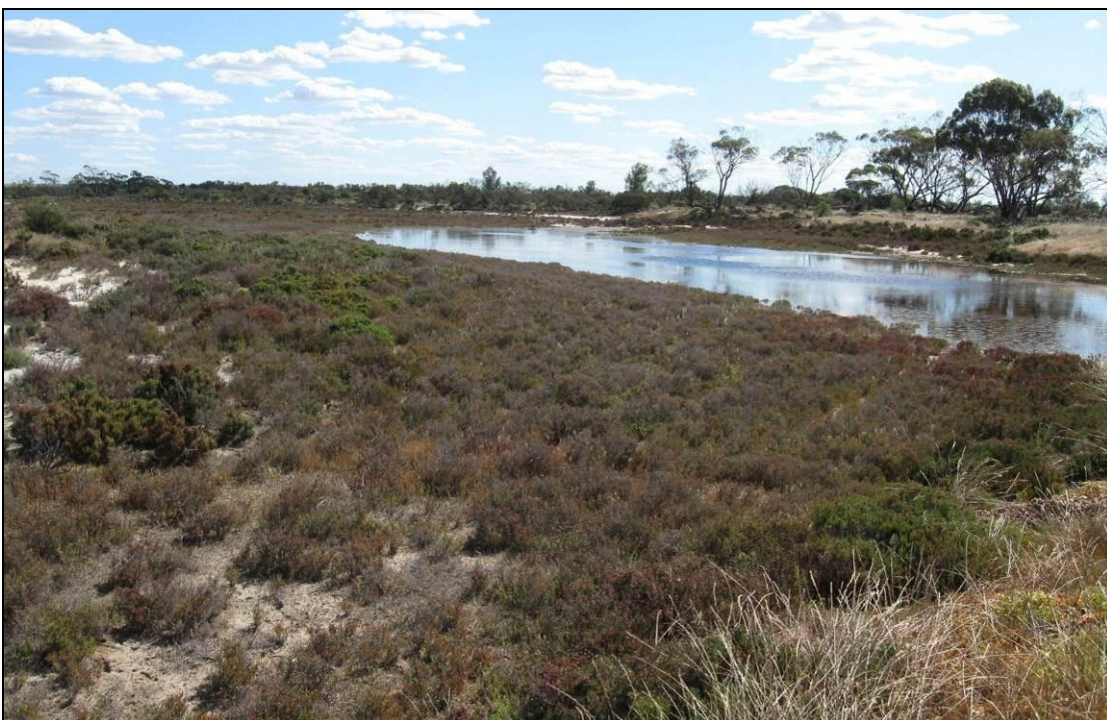
**Figure 11** - WP104 main channel Coonderoo River wetlands

This site is the main drainage line of the Coonderoo River wetland system – there is a culvert beneath the road at this point. The wetland system is a historic saline system – perhaps somewhat affected by secondary salinization but not recently. The few dead trees surrounding the wetlands have been dead a number of years. As seen at WP103 samphires grow in zones from the wettest point to the highest point. There were no trees near the site but shrubs of *Hakea preissii* were at the highest point with *Enchylaena* sp., *Mesembryanthemum nodiflorum*, *Tecticornia indica* ssp. *bidens*, *T. doleiformis*, *Frankenia* sp., *T. halocnemoides* ssp. *tenuis*, *T. undulata*, *T. syncarpa*, *T. peltata*, *T. pergranulata* and *Tecticornia moniliformis* (?) in descending order. There was a large amount of *Ruppia* (Eelgrass) in the water.

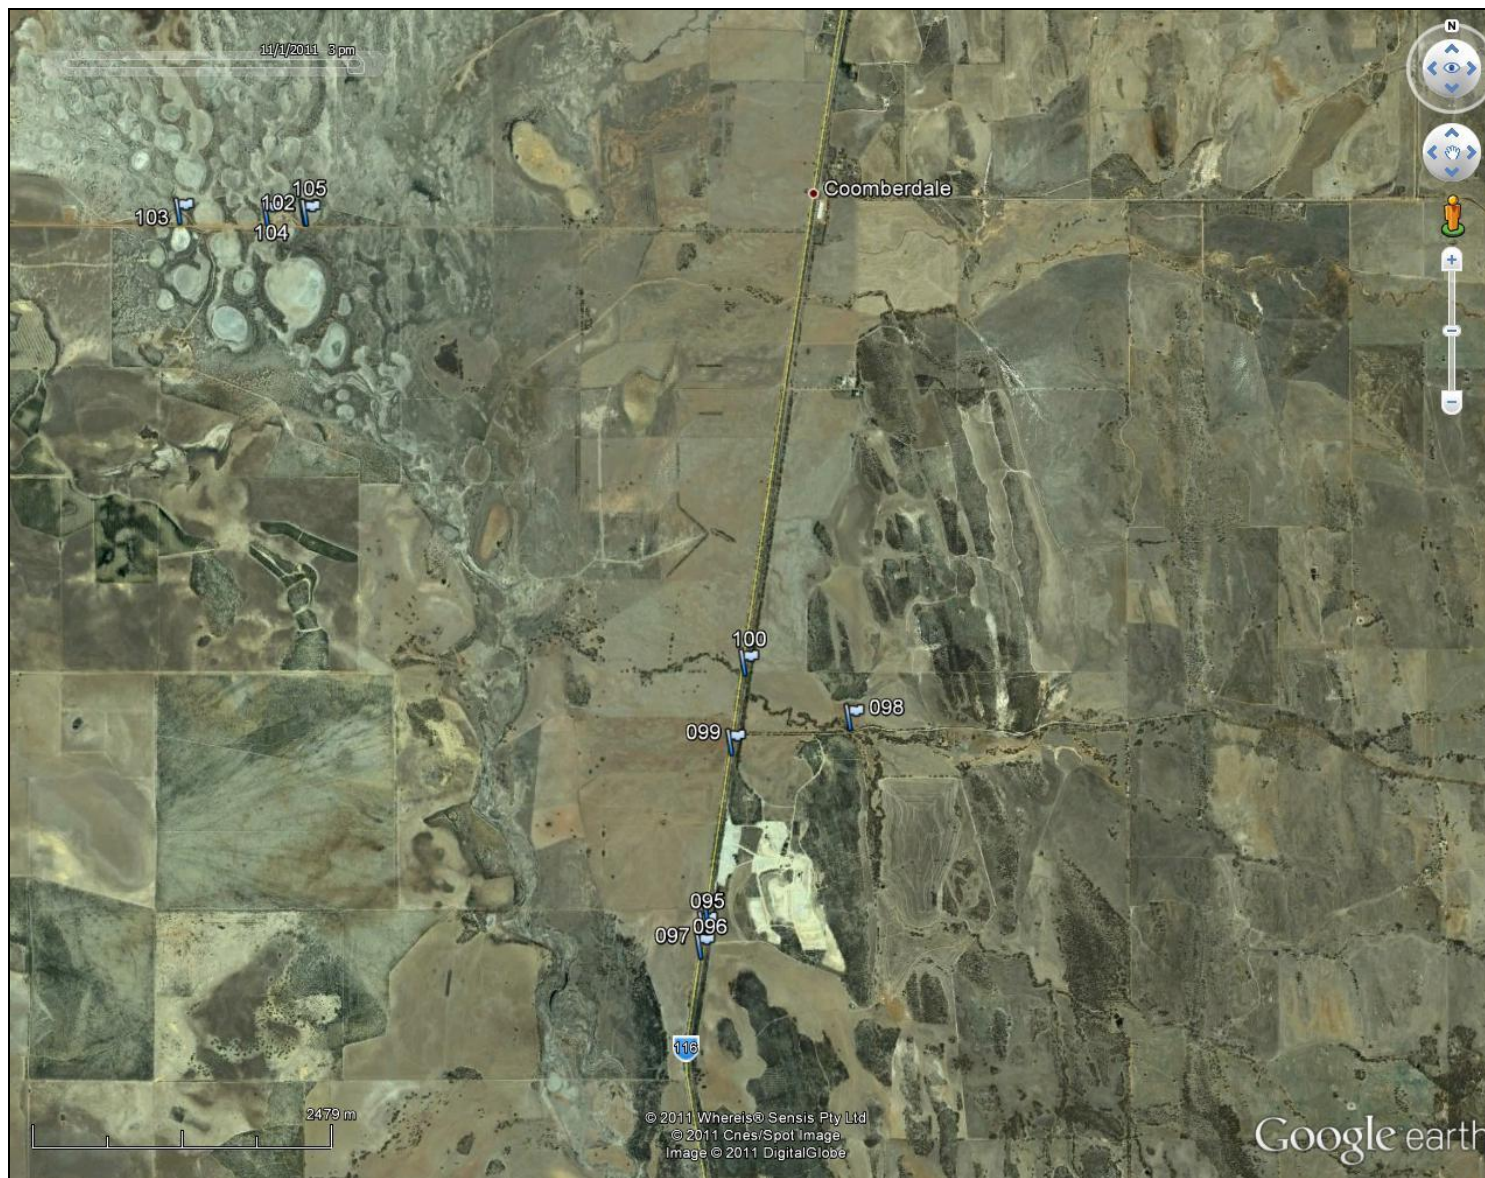
**Figure 19 - Way Point Sites and Coonderoo River Wetland System**
