DRAFT  
FEASIBILITY REPORT  
DELIVERY PACKAGE

# Caño Martín Peña Ecosystem Restoration Project

SEPTEMBER 2015

DRAFT  
Feasibility Report  
& Environmental  
Impact Statement  
for the  
**Caño  
Martín  
Peña  
Ecosystem  
Restoration  
Project**

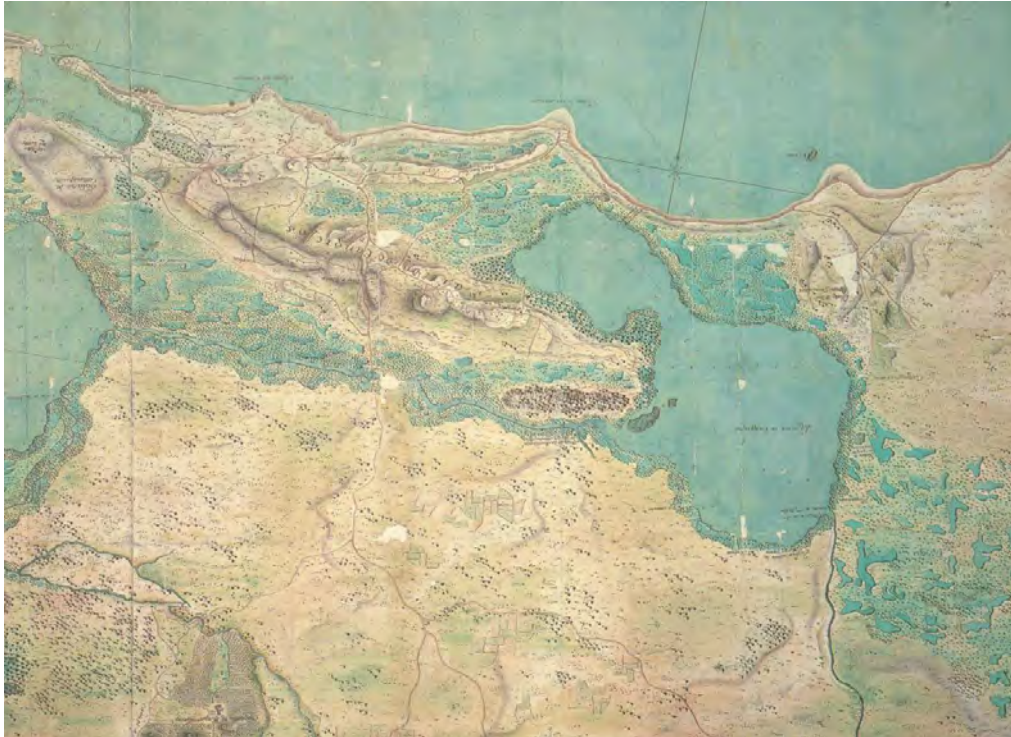
**Figure 1-3. Close up look of Study Area as depicted on map drafted in 1776 by Juan de Villalonga, Ramón de Villalonga and Thomas O'Daly (Sepúlveda, 1989).**

In 1776, Thomas O'Daly drafted a map of San Juan, which is one of the earliest and best detailed descriptions of most of the SJBE and adjacent uplands. This map shows the CMP fringed by mangrove forests next to a marsh of considerable size at its northwestern half, as well as a chain of haystack hills or "mogotes" in its northeastern side. The western half of the CMP is shown to have been between 10 and 14 feet in depth, while the eastern segment is shown with a depth varying between 5 and 10 feet. The San José Lagoon, named at that time as Laguna de Cangrejos, was fringed by mangroves, the biggest stand found to its north. Extensive marshes appeared to the northwest and southeast of the lagoon. The lagoon was depicted as not exceeding 9 feet in depth (O'Daly, 1776) (Figure 1-3).

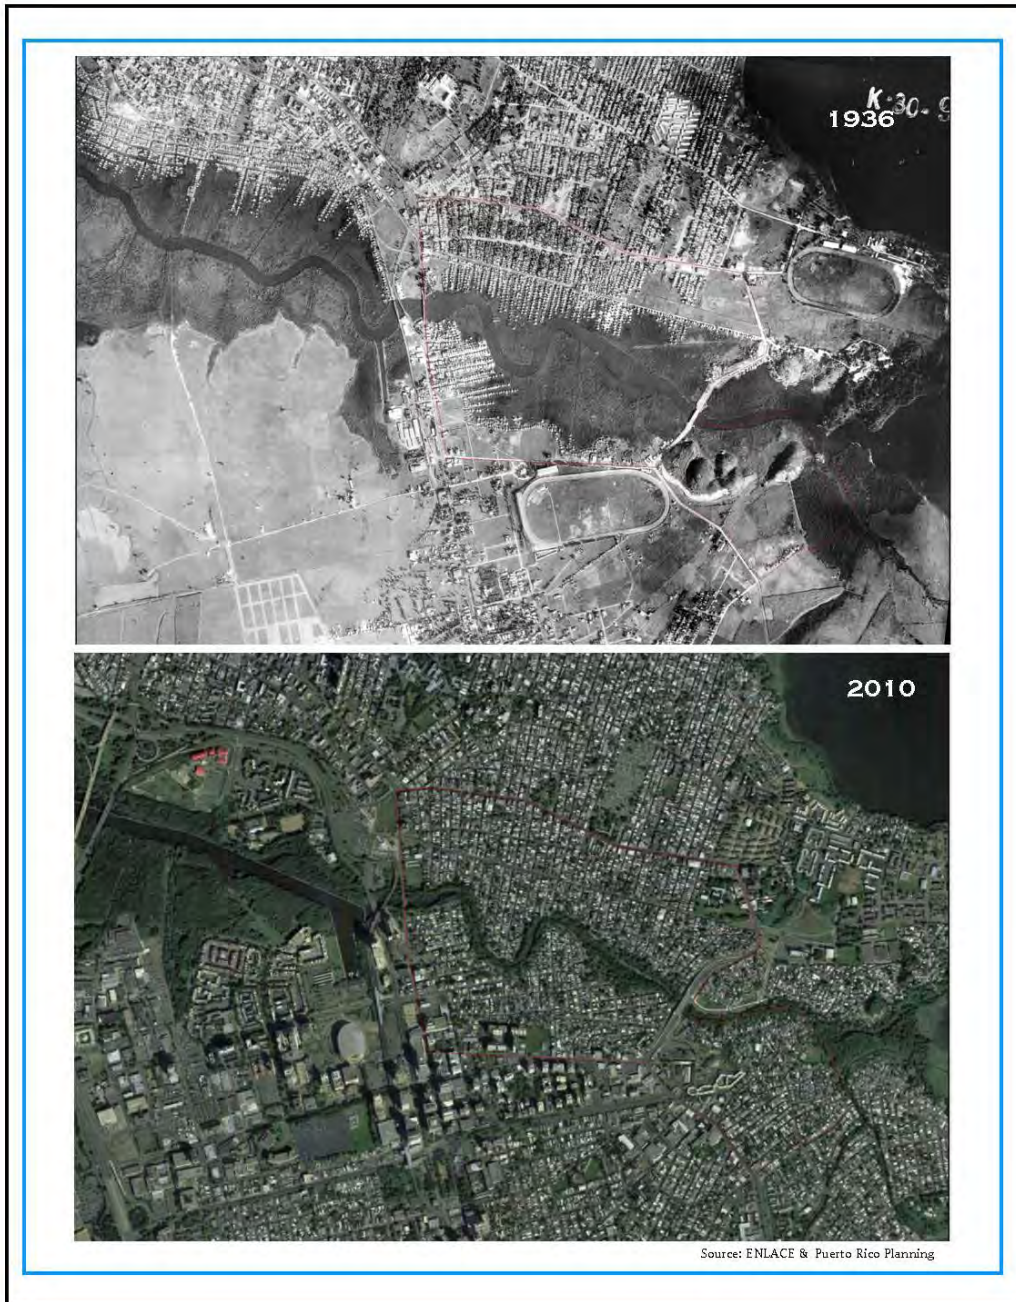
**Figure 1-5. Historic and recent conditions of the CMP**

*Today, the canal's ability to convey flows has been almost completely blocked as a result of siltation, trash and debris accumulation, and structure encroachments along the eastern segment. Recent subsurface investigations in the canal and both banks along the eastern half of Caño Martín Peña found trash and debris up to 9 ft below the surface. As a result of the progressive clogging, there is very little tidal exchange between the San José Lagoon and the San Juan Bay and the water quality is very poor (USACE, 2004).*

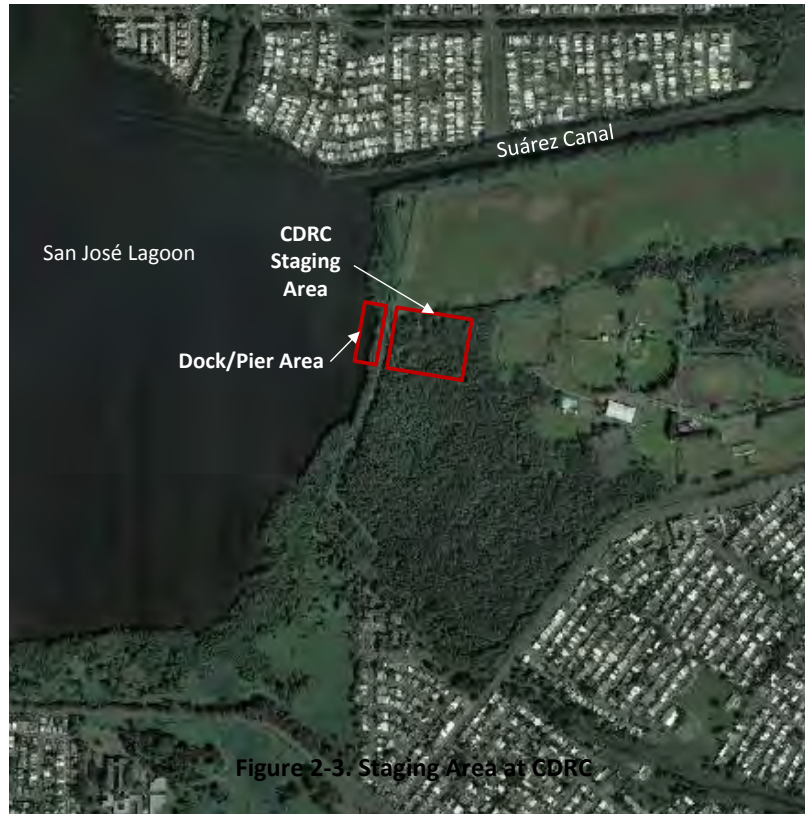
As presented in the Bailey et al. (2002) report, the artificial depressions (pits) within the San José Lagoon were analyzed to potentially serve as CAD sites for the CMP dredged sediments not

encapsulated with geotextile containers. These pits are identified as San José 1 (SJ1), San José 2 (SJ2), San José 3/4/5 (SJ3/4/5), and another identified as Los Corozos (LLC). Any combination of these artificial depressions could serve as potential CAD site for the CMP-ERP's dredged sediments (see Figure 2-3).

These four man-made depressions found within, or adjacent, to the Project Area have been identified as sources of water quality problems in the CCMP for the SJBE (SJBEP, 2000 p. 96). Filling these man-made depressions has been recommended as one of the most cost-effective alternatives for improving the water and sediment quality in the Project Area (USACE, 2000; SJBEP, 2000). In fact, the SJBEP's CCMP identified the filling of all these pits as a priority and urgent action needed to improve the water quality and habitat conditions of the entire estuarine system (Action WS-6) (SJBEP, 2000). Therefore, the use of the CAD alternative is attractive because it would give the dredged material a beneficial reuse.

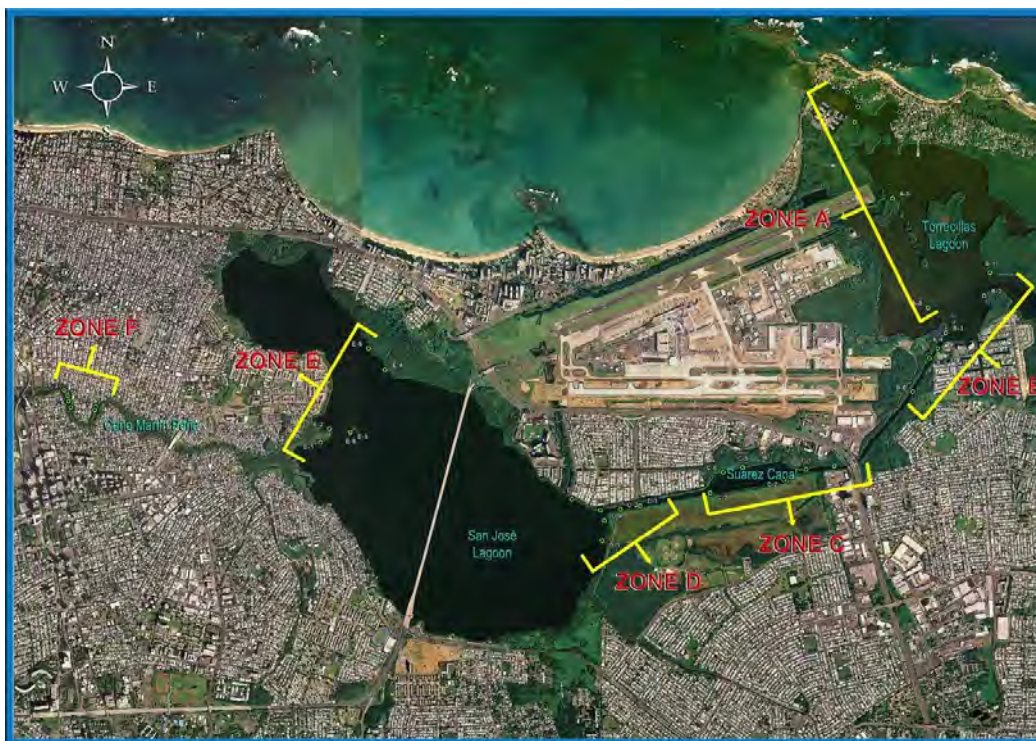
Figure 3-4. Mangrove prop root habitat sampling segments (Atkins, 2011b)

In the phyla Crustacea and Annelida, a decreasing trend in percent cover was evident along a gradient related to distance from the Ocean, from Zone A to Zone C, with no individuals found in Zones D, E, and F (see Figure 3-4). In essence, barnacles and polychaetes, which were abundant on the red mangrove prop roots in La Torrecilla Lagoon (Zone A) and the Suárez Canal (Zone C), were not found on those examined in San José Lagoon (Zone E) nor the CMP (Zone F). In the phylum Mollusca, the greatest coverage was in the Suárez Canal (Zone C) and numbers declined moving toward both the La Torrecilla and San José lagoons. Presently, a single species of bivalve, the false

Sponges were only found in La Torrecilla Lagoon, which is closest to the source of tidal flushing. Stations located farther from the tidal flushing (Zones B, C, D, E, and F) had no sponges living in the red mangrove prop roots (Atkins, 2011b).

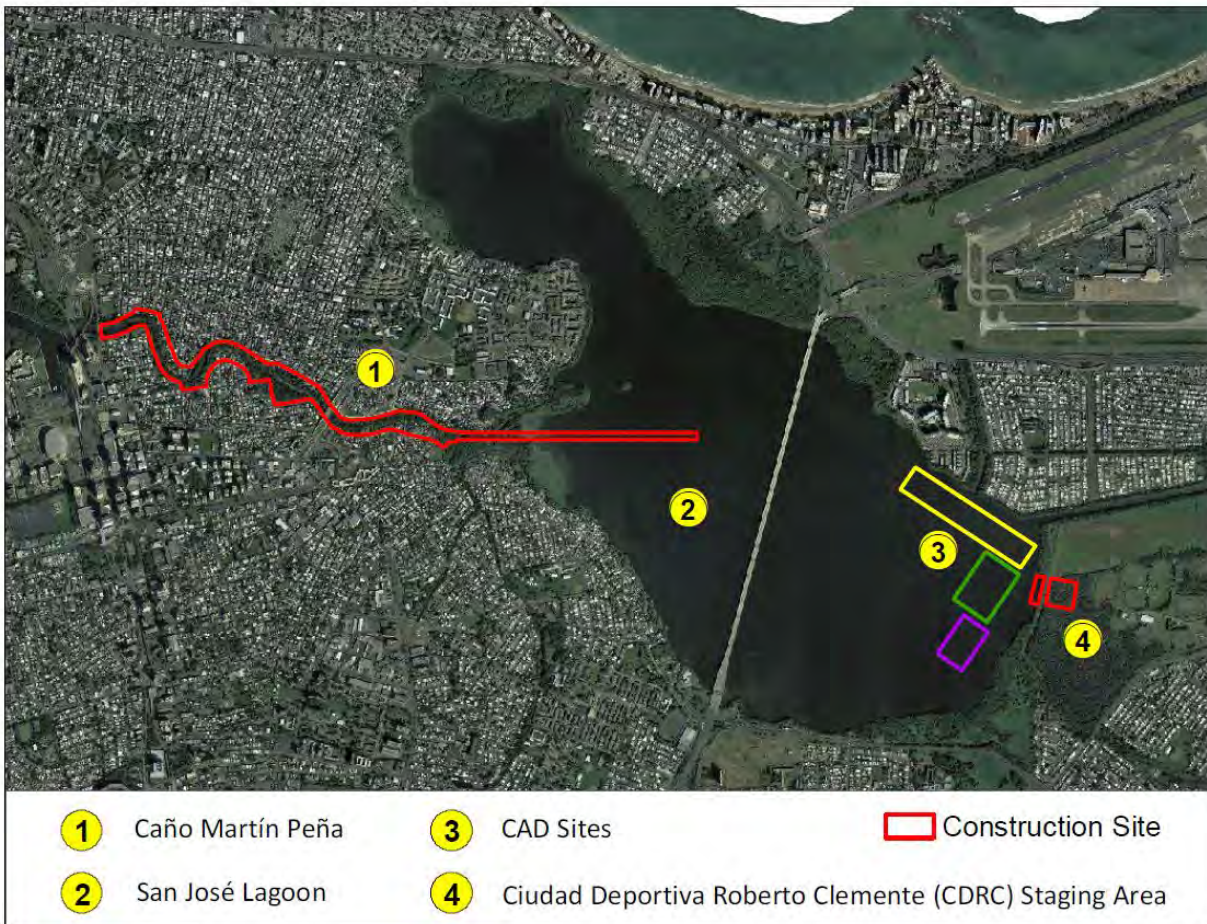
Figure 2-2. Project Area

The “Project Area” is where relocation, dredging, construction, and overall restoration activities would take place (Figure 2-2). It has been defined as the Project Channel, where dredging would take place; the adjacent delimitation of the public domain lands within the maritime terrestrial zone, where relocations are scheduled to occur; the San José Lagoon southeastern most artificial dredged pits, where dredged sediments would be disposed and turned into a CAD site; and the 6-acre Ciudad Deportiva Roberto Clemente (CDRC) dredged material staging area, where trash and debris would be transported to by barges in order to be handled and transferred by trucks for their final disposal at the Humacao Regional Landfill and were the temporary pier/dock would be built as a pontoon system for loading/unloading the dredged material.

Also included are the boating routes from the Project Channel to the CDRC, through the San José Lagoon. The Project Area is divided between the Municipality of San Juan, to the West, and the Municipality of Carolina, to the East.

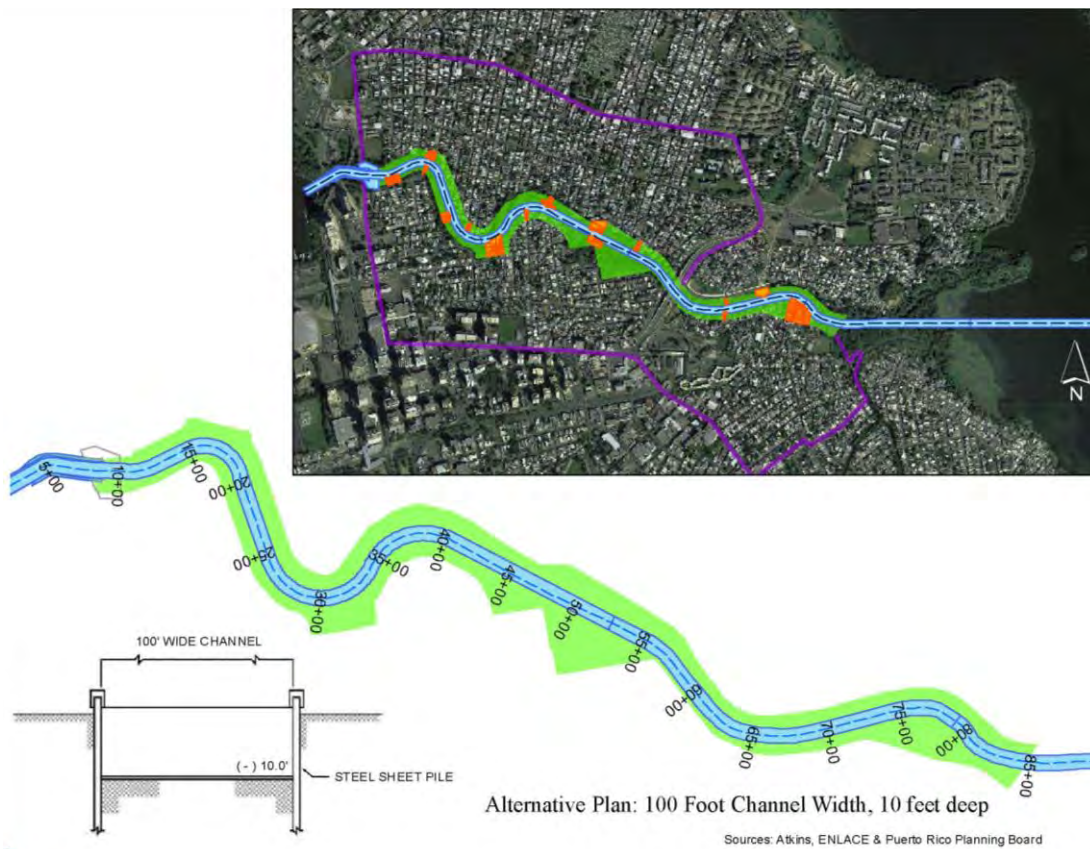
Figure 2-3. Proposed Channel

The walls of the channel would be constructed with vertical concrete-capped steel sheet piles with hydrologic connections to the surrounding lands. The sill depth of the window would be set at mean low water so tidal exchanges are facilitated to the mangrove beds.

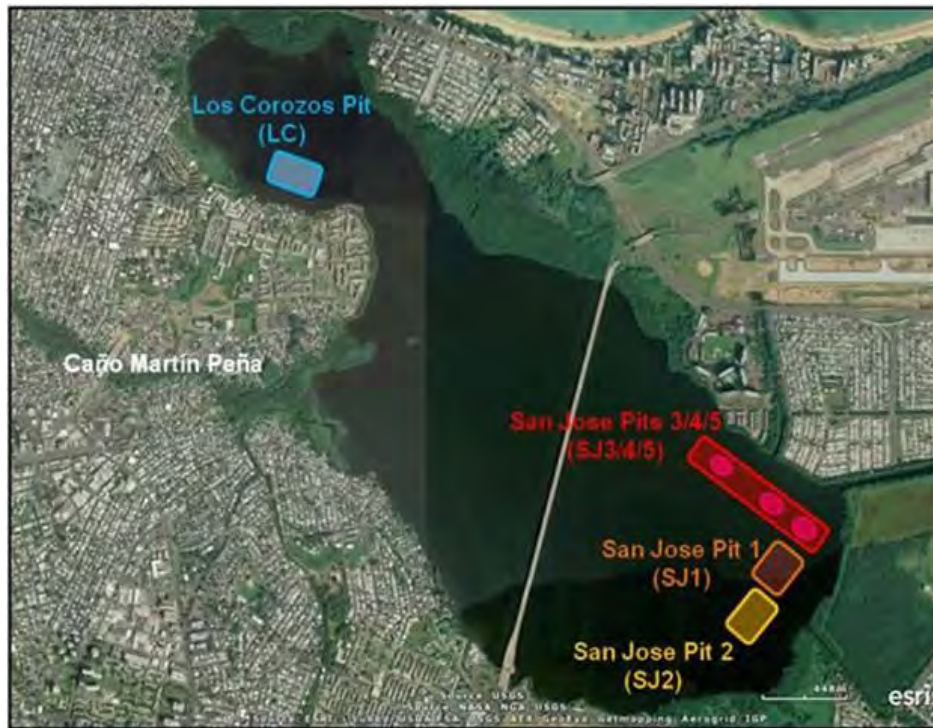
Figure 2-4. Artificial Pits at the San José Lagoon

As presented in the Bailey et al. (2002) report, the artificial depressions (pits) within the San José Lagoon were analyzed to potentially serve as CAD sites for the CMP dredged sediments.

Bailey et al. (2002) concluded that 2 feet of clean sand are necessary to maintain a physical barrier between contaminated dredged sediments to be disposed at the CAD pits and the benthic community above (USACE, 2002). This 2-foot sand cap would contribute in preventing the release of contaminants at concentrations above water quality standards. In addition, an analysis of the currents and water circulation occurring in the lagoon was performed and it was established that the energy within the lagoon and around the CAD sites is low, which means there is a very low risk of erosion of the cap within the CAD sites.

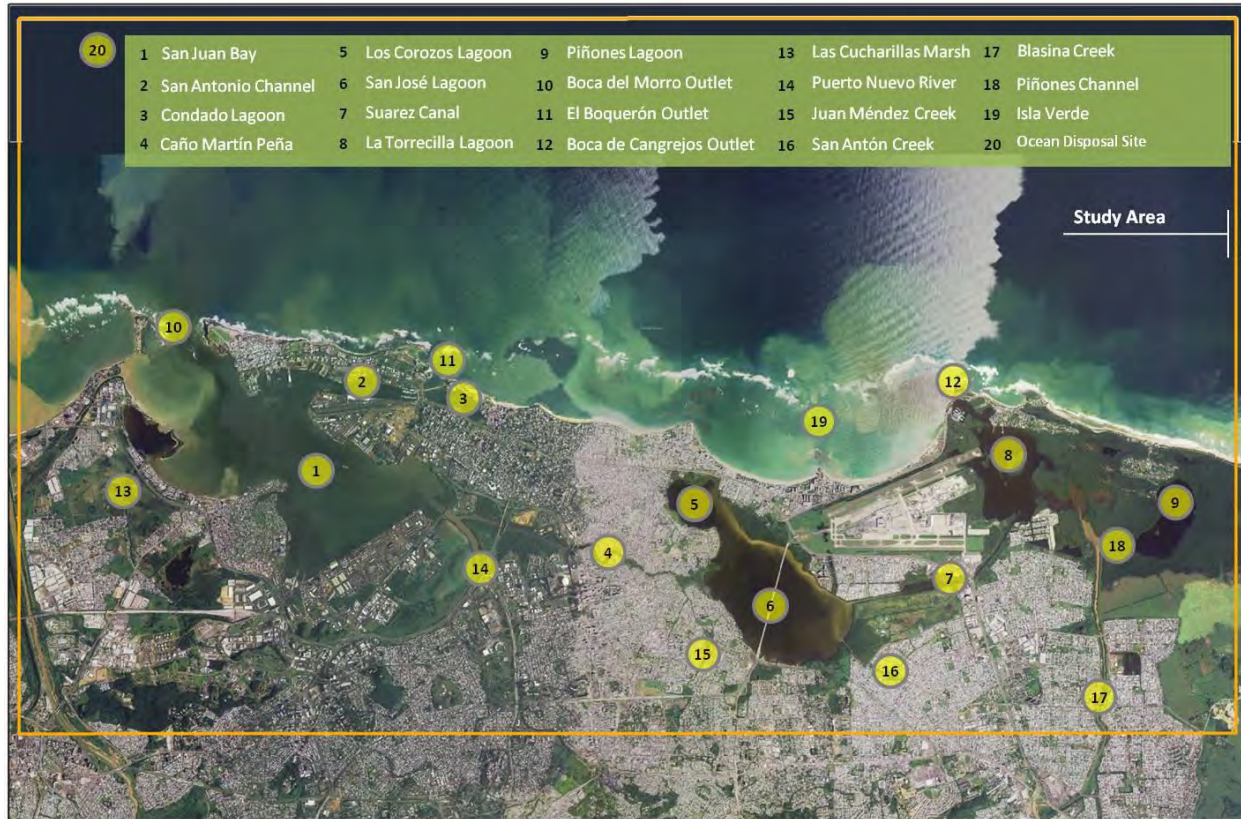
Figure 2-1. The San Juan Bay Estuary Study Area

The SJBE and its associated marine ecosystems are considered the Study Area (Figure 2-1). The SJBE's watershed covers an area of approximately 97 square miles (mi<sup>2</sup>). The SJBE is characterized by a network of lagoons, channels, man-made canals, a bay, and wetlands permanently and seasonally flooded with woody and herbaceous plants.

Associated marine ecosystems include those hard and soft substrates found north of the SJBE. These are influenced by the exchange of ocean waters and the discharges of waters exiting the estuarine system. Fresh water flows into the system from the creeks and rivers flowing mostly north from its watershed, which include the Puerto Nuevo River, Juan Méndez Creek, San Antón Creek, and Blasina Creek.

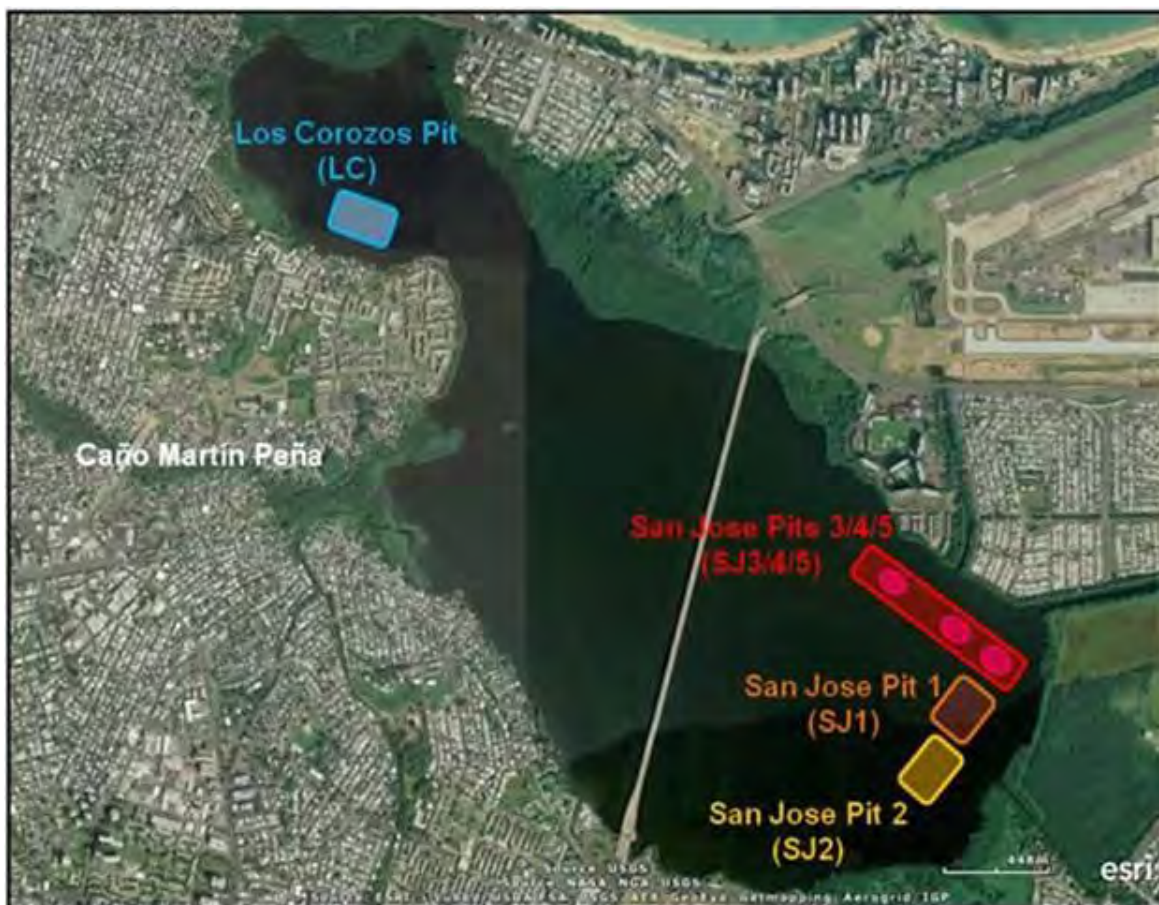
Figure 2-4. Artificial Pits at the San José Lagoon

A barge-mounted mechanical clamshell dredge would be used to widen and deepen the CMP, and would place the dredged material into dump scows. Of the 762,000 cubic yards (cy) of mixed materials, screens would separate solid waste debris (estimated at 76,200 cy) from sediments. It is estimated that the dredged solid waste debris would make up 10% of the total material to be dredged from the CMP, and the dredged sediments would bulk up to 126% of their in situ volume. Solid waste debris would also be transported by barge to a staging area for subsequent landfill disposal. Sediments would be transported by barge for disposal at the SJ1 and SJ2 CAD pits (Figure 2-4).

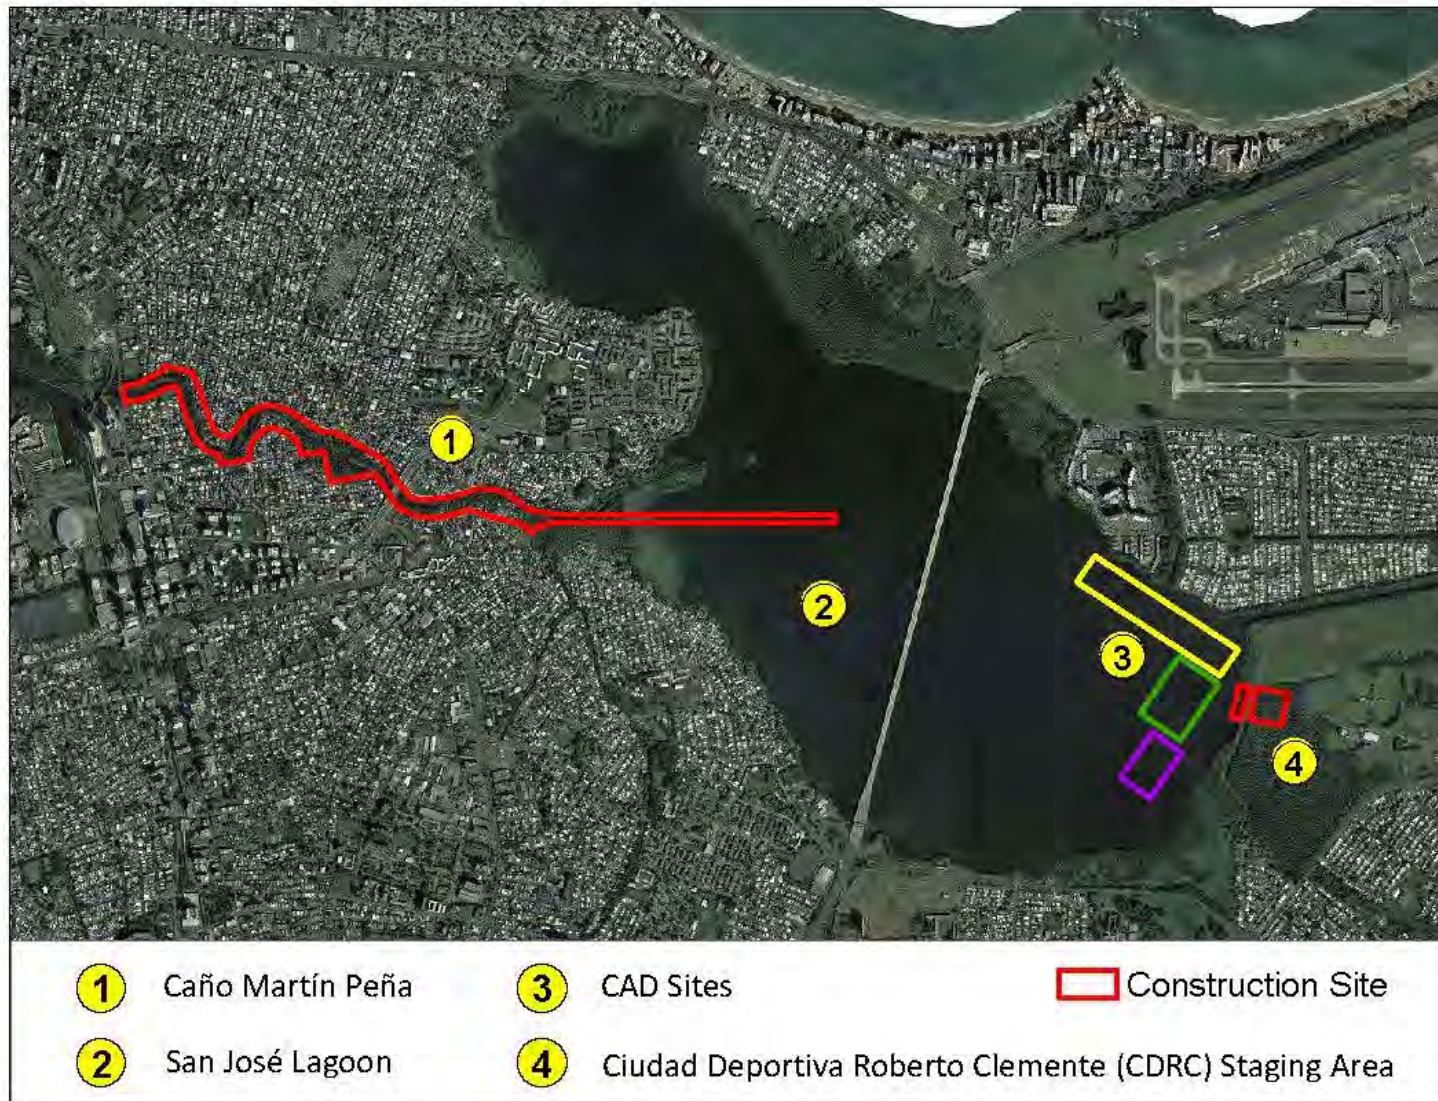
Figure 1. Caño Martín Peña Ecosystem Restoration Project Area Map

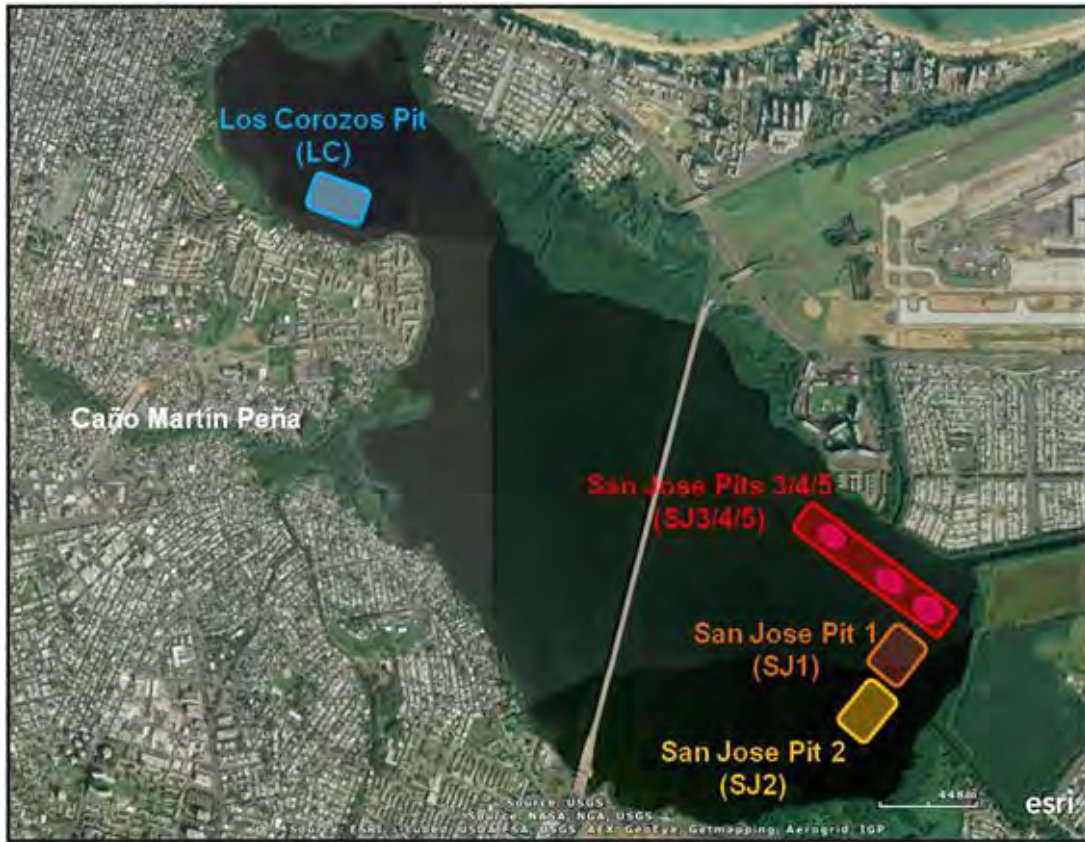
There are total of six artificial depressions (pits) located within San José Lagoon and Los Corozos Lagoon (Figure 2). Five of the six depressions (pits) reside within San José Lagoon and are identified as San José 1 (SJ1 Pit), San José 2 (SJ2 Pit), and San José 3/4/5 (SJ3/4/5 Pits). One artificial depression (pit) is located within Los Corozos Lagoon and is identified as LC Pit. Collectively the six artificial pits would need to have sufficient capacity to receive the full bulked volume (814,000 cy) of sediments to be generated by dredging the CMP, plus the volume of sand needed to cap the geocapsulated sediments within the artificial pits. The available existing capacities within each artificial pit to a controlled fill depth of -16 feet (for SJ1, SJ2, and SJ3/4/5 Pits) and -6 feet (for LC Pit) are shown in Table 1. For the San José Lagoon artificial pits, a -16-foot top-of-fill was selected to ensure uncontrolled dredged and cap sediments spill over into adjacent pits does not occur.

Figure 2. Artificial Pit Locations – San José & Los Corozos Lagoons

The total existing capacity (947,549 cy) for the six artificial pits is sufficient to receive nearly all the bulked dredged sediments volume (814,000 cy) from the Tentatively Selected Plan (TSP) CMP configuration. However, additional capacity of approximately 86,000 cy will be needed to allow for the preferred geocapsulated contaminated sediments to be capped with 2 feet of clean sediments.

This additional capacity can be achieved by modifying the depth and/or width of the artificial pits by excavating sediments from within the pits.

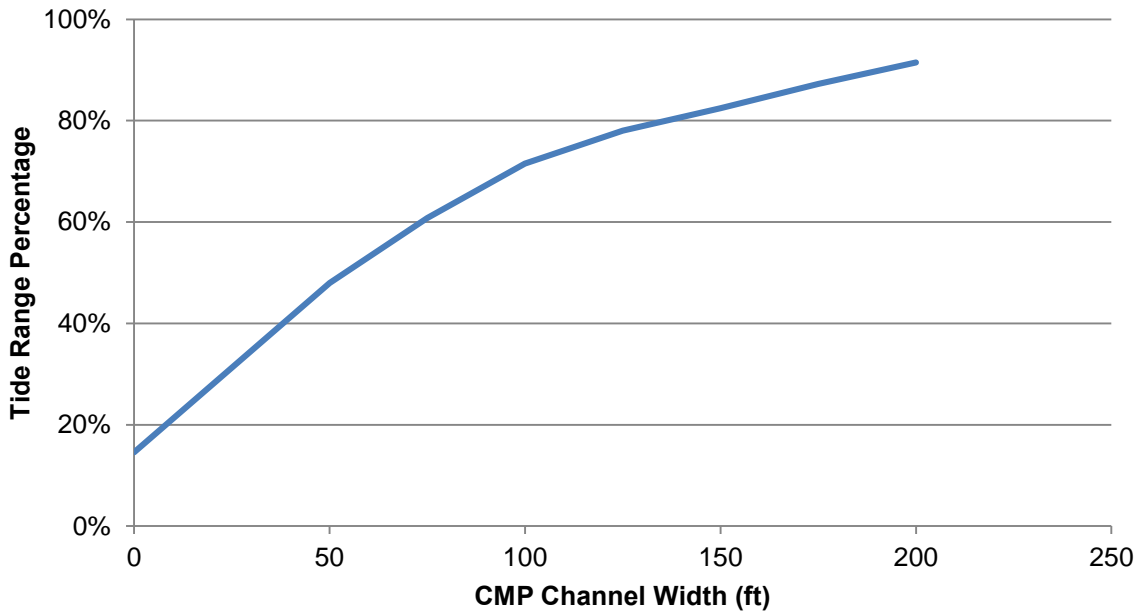
Figure 4. Spring tide range for July 12, 1995 (percentage of San Juan Bay tide range) as a function of channel width (feet) of the Caño Martín Peña (based on 9-foot channel depth).

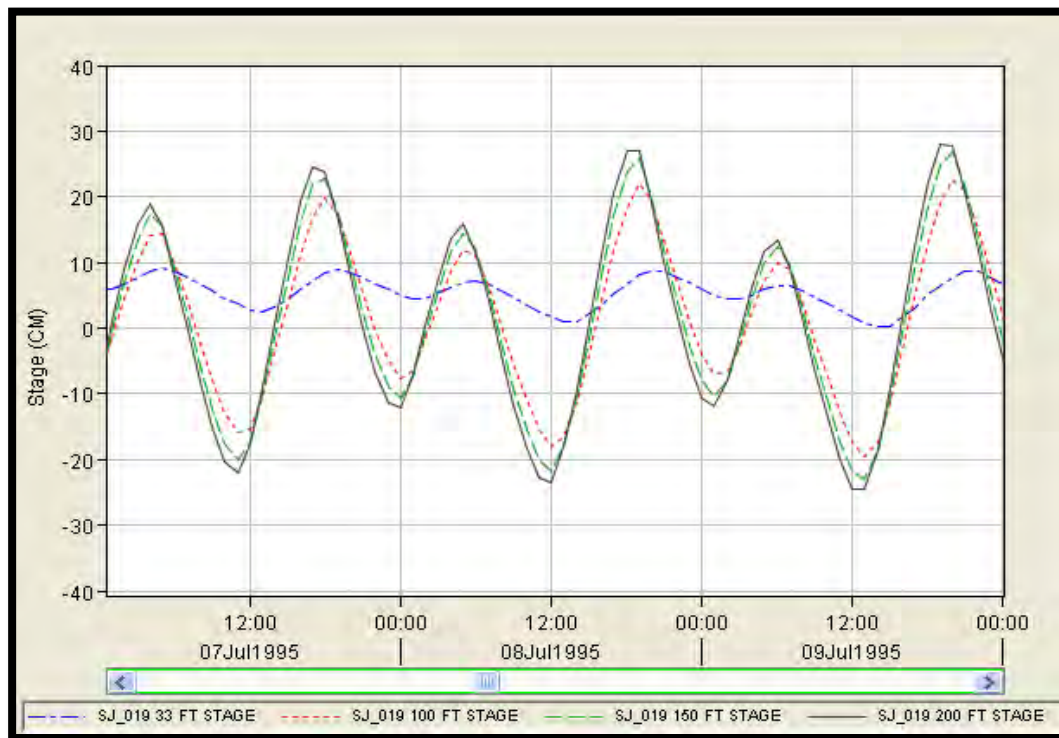
Figure 5. Tide signal in San José Lagoon for three days for existing conditions (blue dot-dash line), 100-x-9-foot channel (red dotted line), 150-x-9-foot channel (green dash line), and 200-x-9-foot channel (black solid line) (Atkins 2011a).

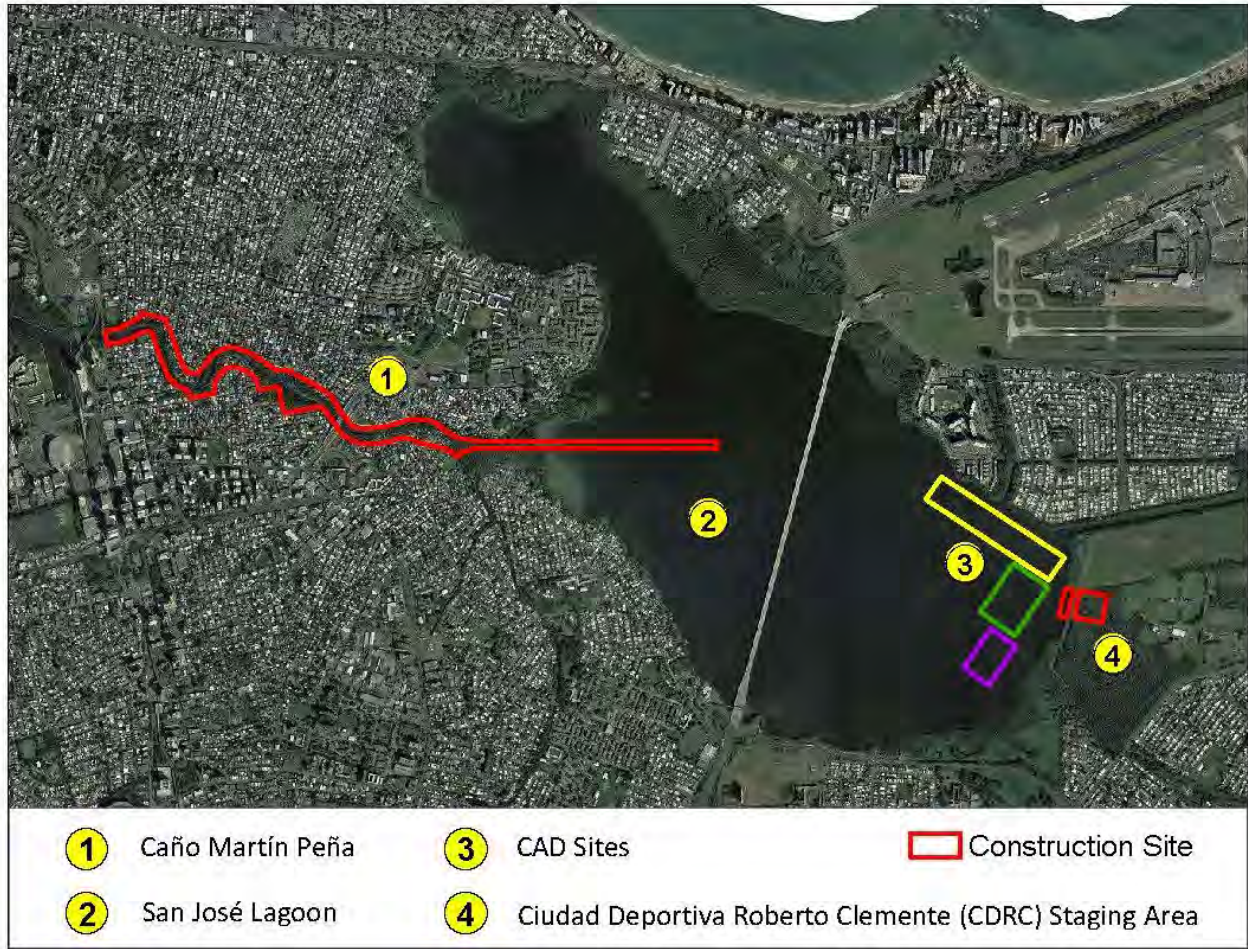
Figure 1. The Caño Martín Peña Ecosystem Restoration Project Area

ENLACE proposes the Caño Martín Peña (CMP) Ecosystem Restoration Project (CMP-ERP). The CMP is a tidal channel approximately 4 miles long, connecting the San Juan Bay and the San José Lagoon in metropolitan San Juan, Puerto Rico. CMP is part of the San Juan Bay Estuary (SJBE), the only tropical estuary that is part of the U.S. Environmental Agency (USEPA) National Estuary Program. The SJBE and its associated marine ecosystems are considered the “Study Area” because the proposed CMP-ERP is expected to have direct, indirect, and cumulative beneficial effects on this region as a whole. The “Project Area,” which mostly lays out the construction footprint, has been defined as the Project Channel, where dredging would take place, the adjacent delimitation of the public domain lands within the Maritime Terrestrial Zone (MTZ) of the CMP, where relocations are scheduled to occur. Also included in the Project Area is the 6-acre dredged material staging area within the 35-acre Ciudad Deportiva Roberto Clemente (CDRC) site, the boating routes from the eastern limit of the CMP to the CDRC, which includes the five pits in San José Lagoon (Figure 1).

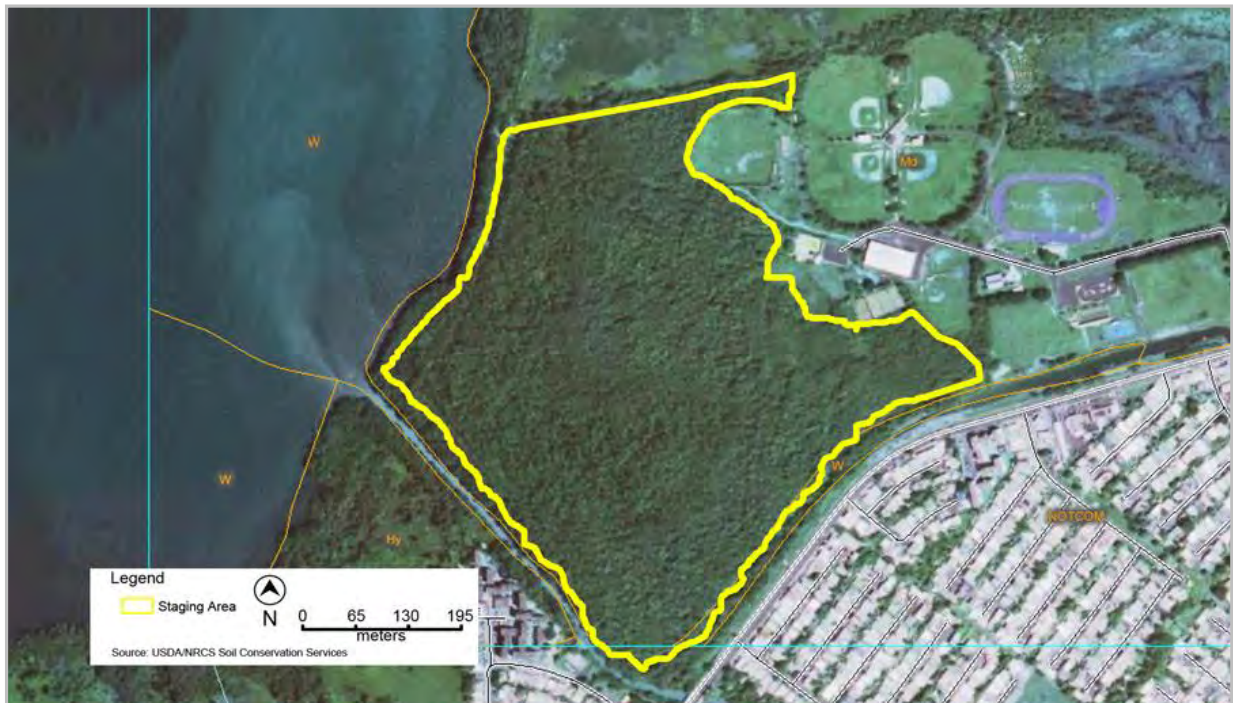
Figure 5. Soil Survey Map of the CDRC Staging Area

Figure 4 shows the Soil Survey Map of the Project Channel; Figure 5 shows the Soil Survey Map of the CDRC Staging Area.

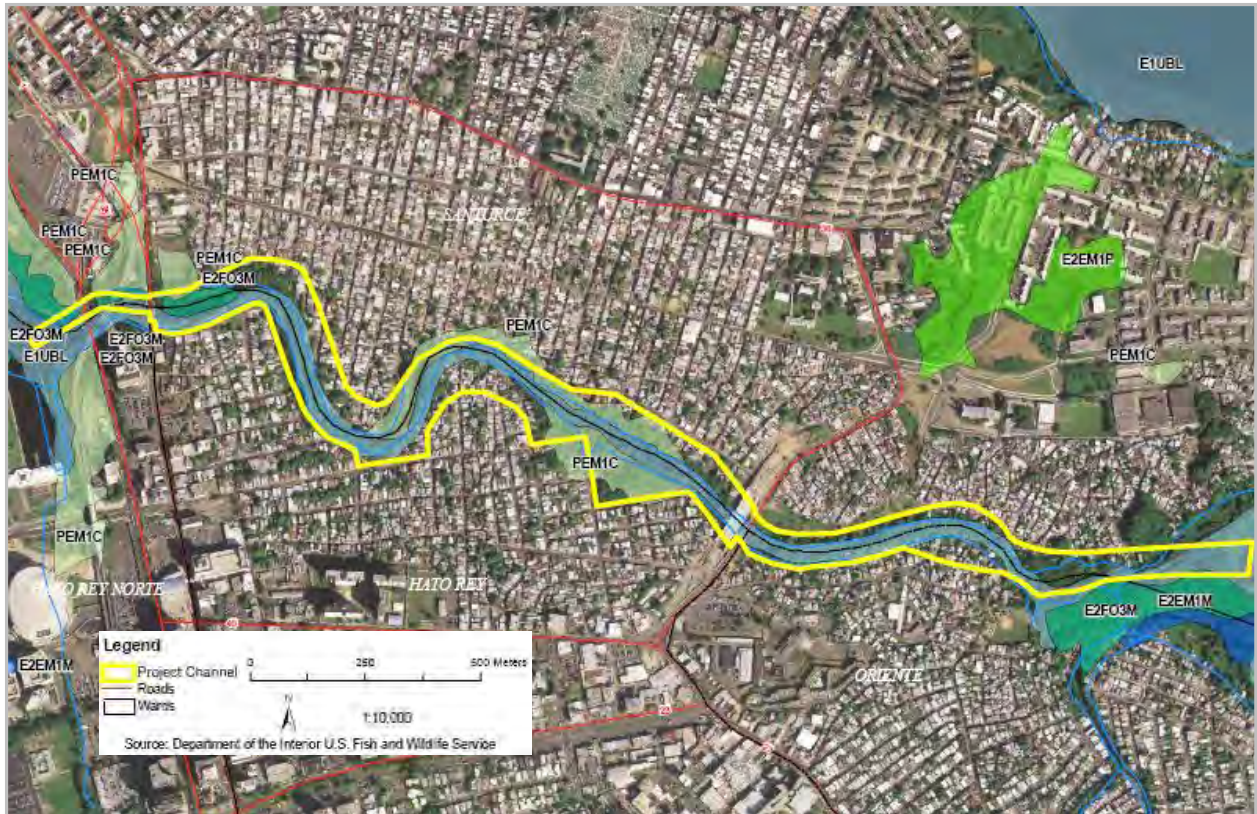
Figure 6. National Wetland Inventory Map of the Project Channel

- 8. National Wetland Inventory (NWI) Map:** The NWI Map from the U.S. Fish and Wildlife Service (USFWS) identifies most vegetative communities within the Project Channel as wetland. Based on the Cowardin classification (1979) of the NWI Map, the wetlands within the Project Channel are classified as: Palustrine, emergent, persistent, seasonally flooded (PEM1C); estuarine, intertidal, forested, broad-leaved evergreen, irregularly exposed (E2FO3M); and estuarine, subtidal, unconsolidated bottom, subtidal (E1UBL). Outside of the Project Channel, near the beginning and end, wetlands areas are classified as estuarine, intertidal, emergent, persistent, irregularly exposed (E2M1M). Wetlands within the CDRC staging area are classified as E2EM1/FO3M. Figure 6 shows the National Wetland Inventory Map of the Project Channel; Figure 7 shows the National Wetlands Inventory Map for the CDRC staging area.

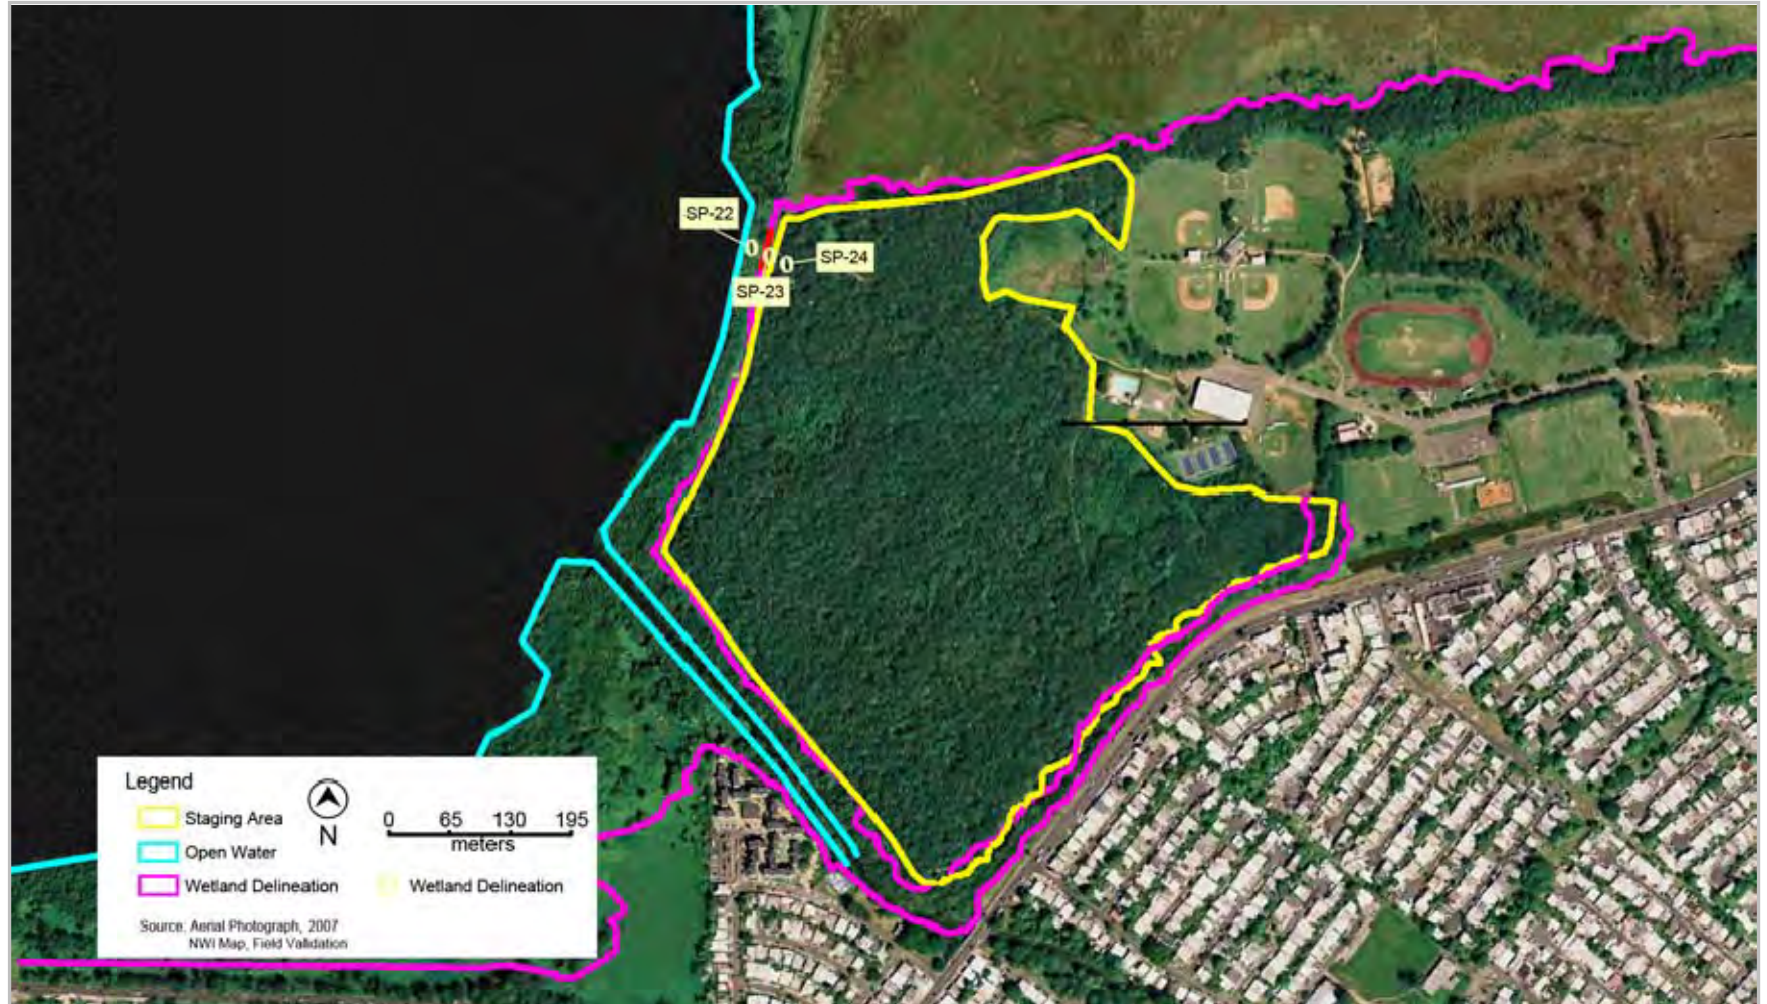
Figure 11. Wetland Jurisdictional Delineation Map of the Staging Area

During the site reconnaissance and jurisdictional wetland determination and delineation field visits, wetland areas were located and identified. Field reconnaissance and analysis revealed that, within the Project Area, wetlands present in the NWI Maps were mostly jurisdictional wetlands. Figure 10 and 11 illustrate the wetland delineation of the Project Area over aerial photographs.

Most sampling points within the Project Channel meet the 3 criteria of a jurisdictional wetland. Table 1 summarizes the Jurisdictional Wetland criteria that each one of the 24 sampling points met and the final decision on whether the area should be considered or not as a jurisdictional wetland. Sampling point locations are shown in Figures 10 and 11.

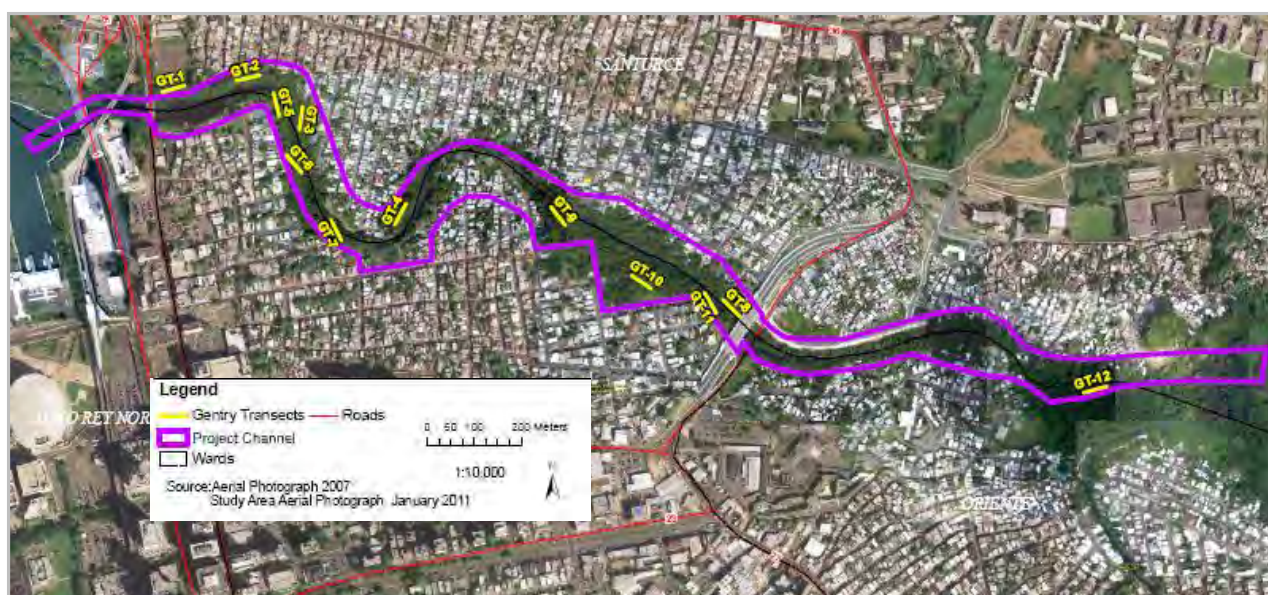
Figure 13. Gentry Transect Locations Within the Project Channel

transect. In addition, weather conditions were recorded at the beginning of each transect. Figure 13 includes the Gentry transect locations over the aerial photograph.

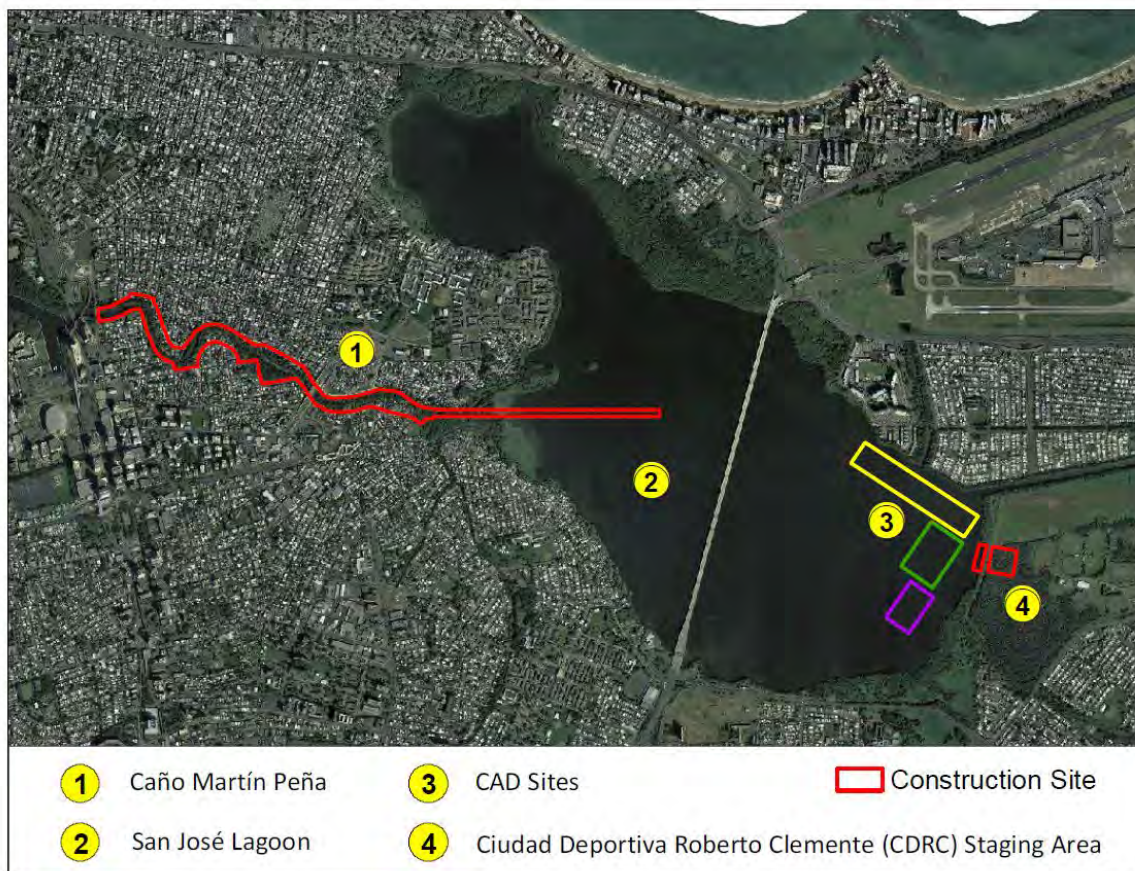
Figure 3. Project Area

The “Project Area” is where relocation, dredging, construction and overall restoration activities would take place (Figure 3). It has been defined as: the eastern CMP, where dredging would take place; the adjacent delimitation of the public domain lands within the maritime terrestrial zone of the CMP, where relocations are scheduled to occur; the SJL southeastern most artificial dredged pits, where dredged sediments would be disposed and turned into a Contained Aquatic Disposal (CAD) site, and the 6-acre Ciudad Deportiva Roberto Clemente (CDRC) dredged material staging area, where trash and debris would be transported to by barges in order to be handled and transferred by trucks for their final disposal at the Humacao Regional Landfill and were the temporary pier/dock would be built as a pontoon system for loading/unloading the dredged material.
