DRAFT  
FEASIBILITY REPORT  
DELIVERY PACKAGE

# Caño Martín Peña Ecosystem Restoration Project

SEPTEMBER 2015

DRAFT  
Feasibility Report  
& Environmental  
Impact Statement  
for the  
**Caño  
Martín  
Peña  
Ecosystem  
Restoration  
Project**

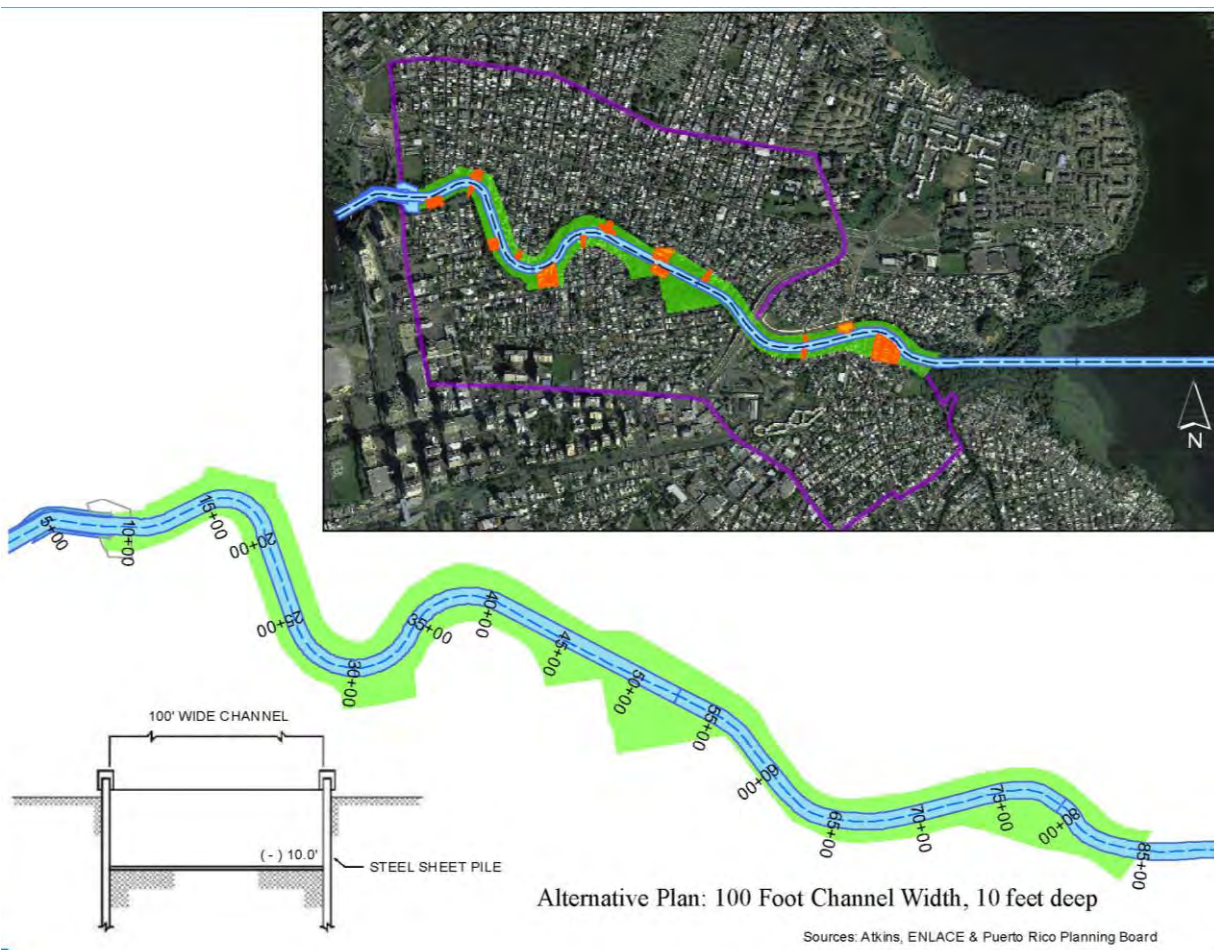
Figure 4. Proposed Channel

The walls of the channel would be constructed with vertical concrete-capped steel sheet piles with hydrologic connections to the surrounding lands. The sill depth of the window would be set at mean low water so tidal exchanges are facilitated to the mangrove beds.

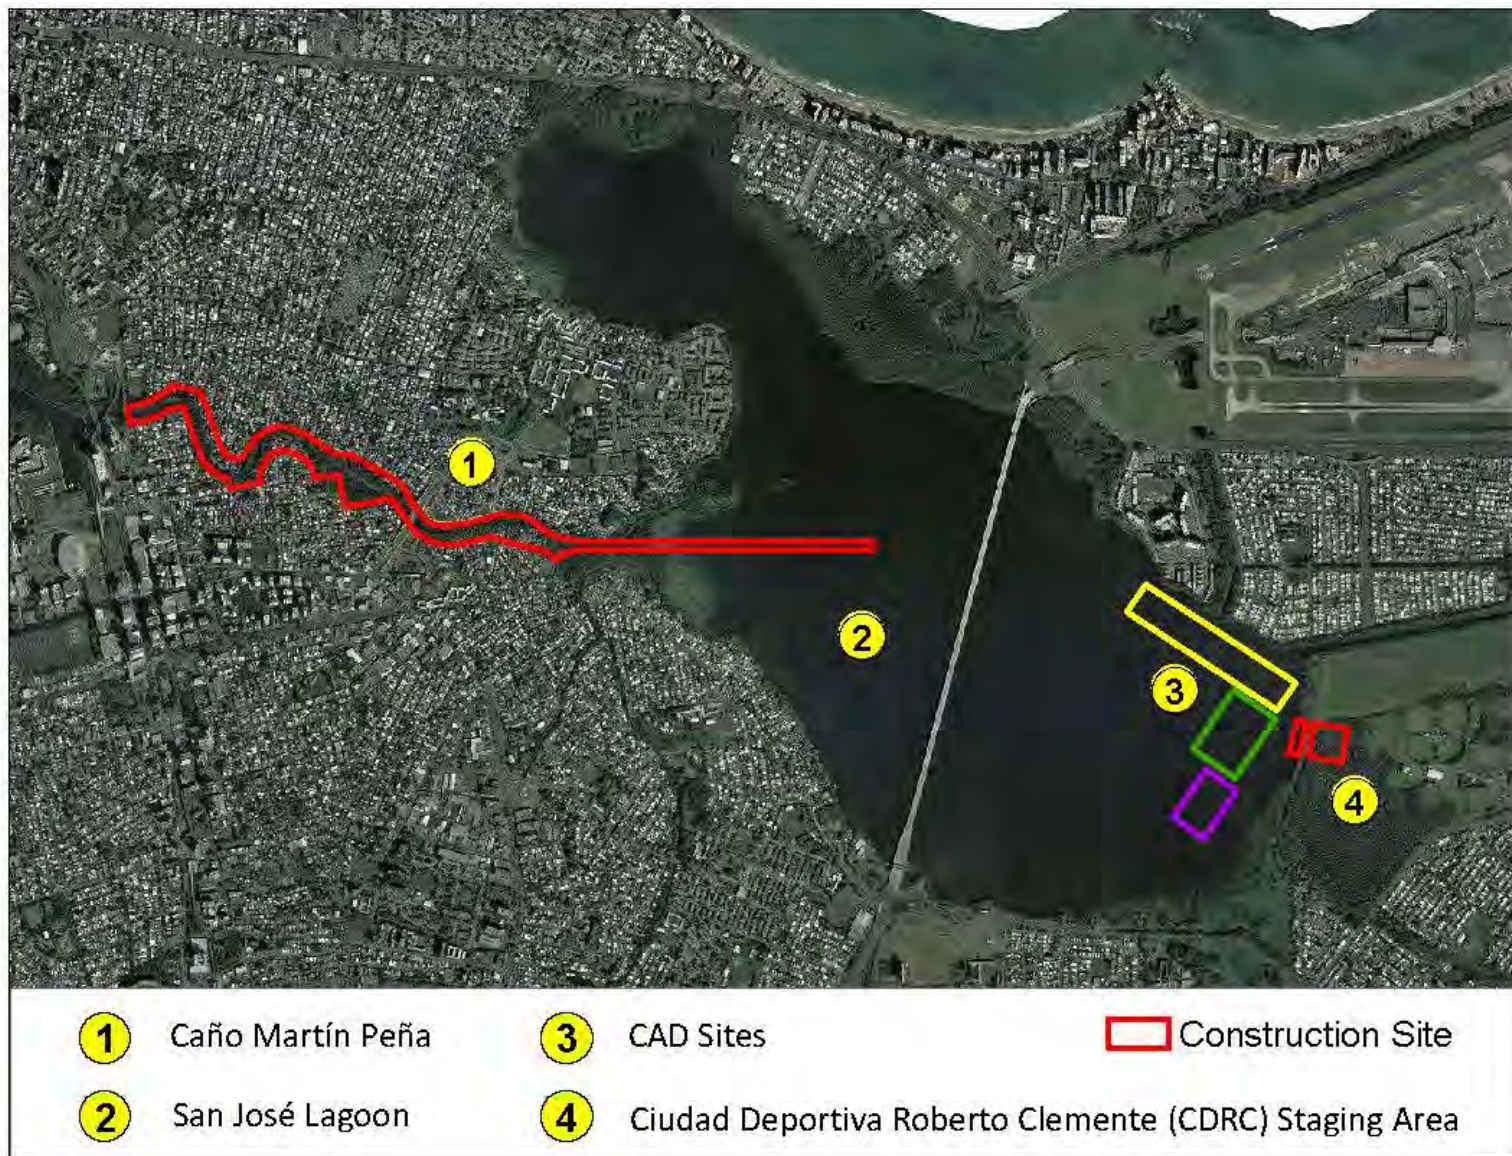
Figure 1. Project Area Map

This Hazardous, Toxic, and Radioactive Waste (HTRW) Initial Assessment (IA) report for the CMP Ecosystem Restoration Project (CMP-ERP), San Juan, Puerto Rico, was prepared for ENLACE. HTRWs are recognized as a potential social public health impact if exposed. The “Project Area,” which mostly lays out the construction footprint, has been defined as the Project Channel, where dredging would take place, and the adjacent delimitation of the public domain lands within the Maritime Terrestrial Zone (MTZ-CMP), where relocations are scheduled to occur. Also included in the Project Area is the 6-acre dredged material staging area within the 35-acre Ciudad Deportiva Roberto Clemente (CDRC) site, the boating routes from the eastern limit of the CMP to the CDRC and the nearby San José Lagoon pits, and the five pits in San José Lagoon (see Figure 1).
