# Application for Authorisation

Yarram Iron
-------------

# Mining Management Plan Exploration Activities

RUM JUNGLE PROJECT  
MINING MANAGEMENT PLAN AMENDMENT  
Assessment of land clearing  
impacts and risks

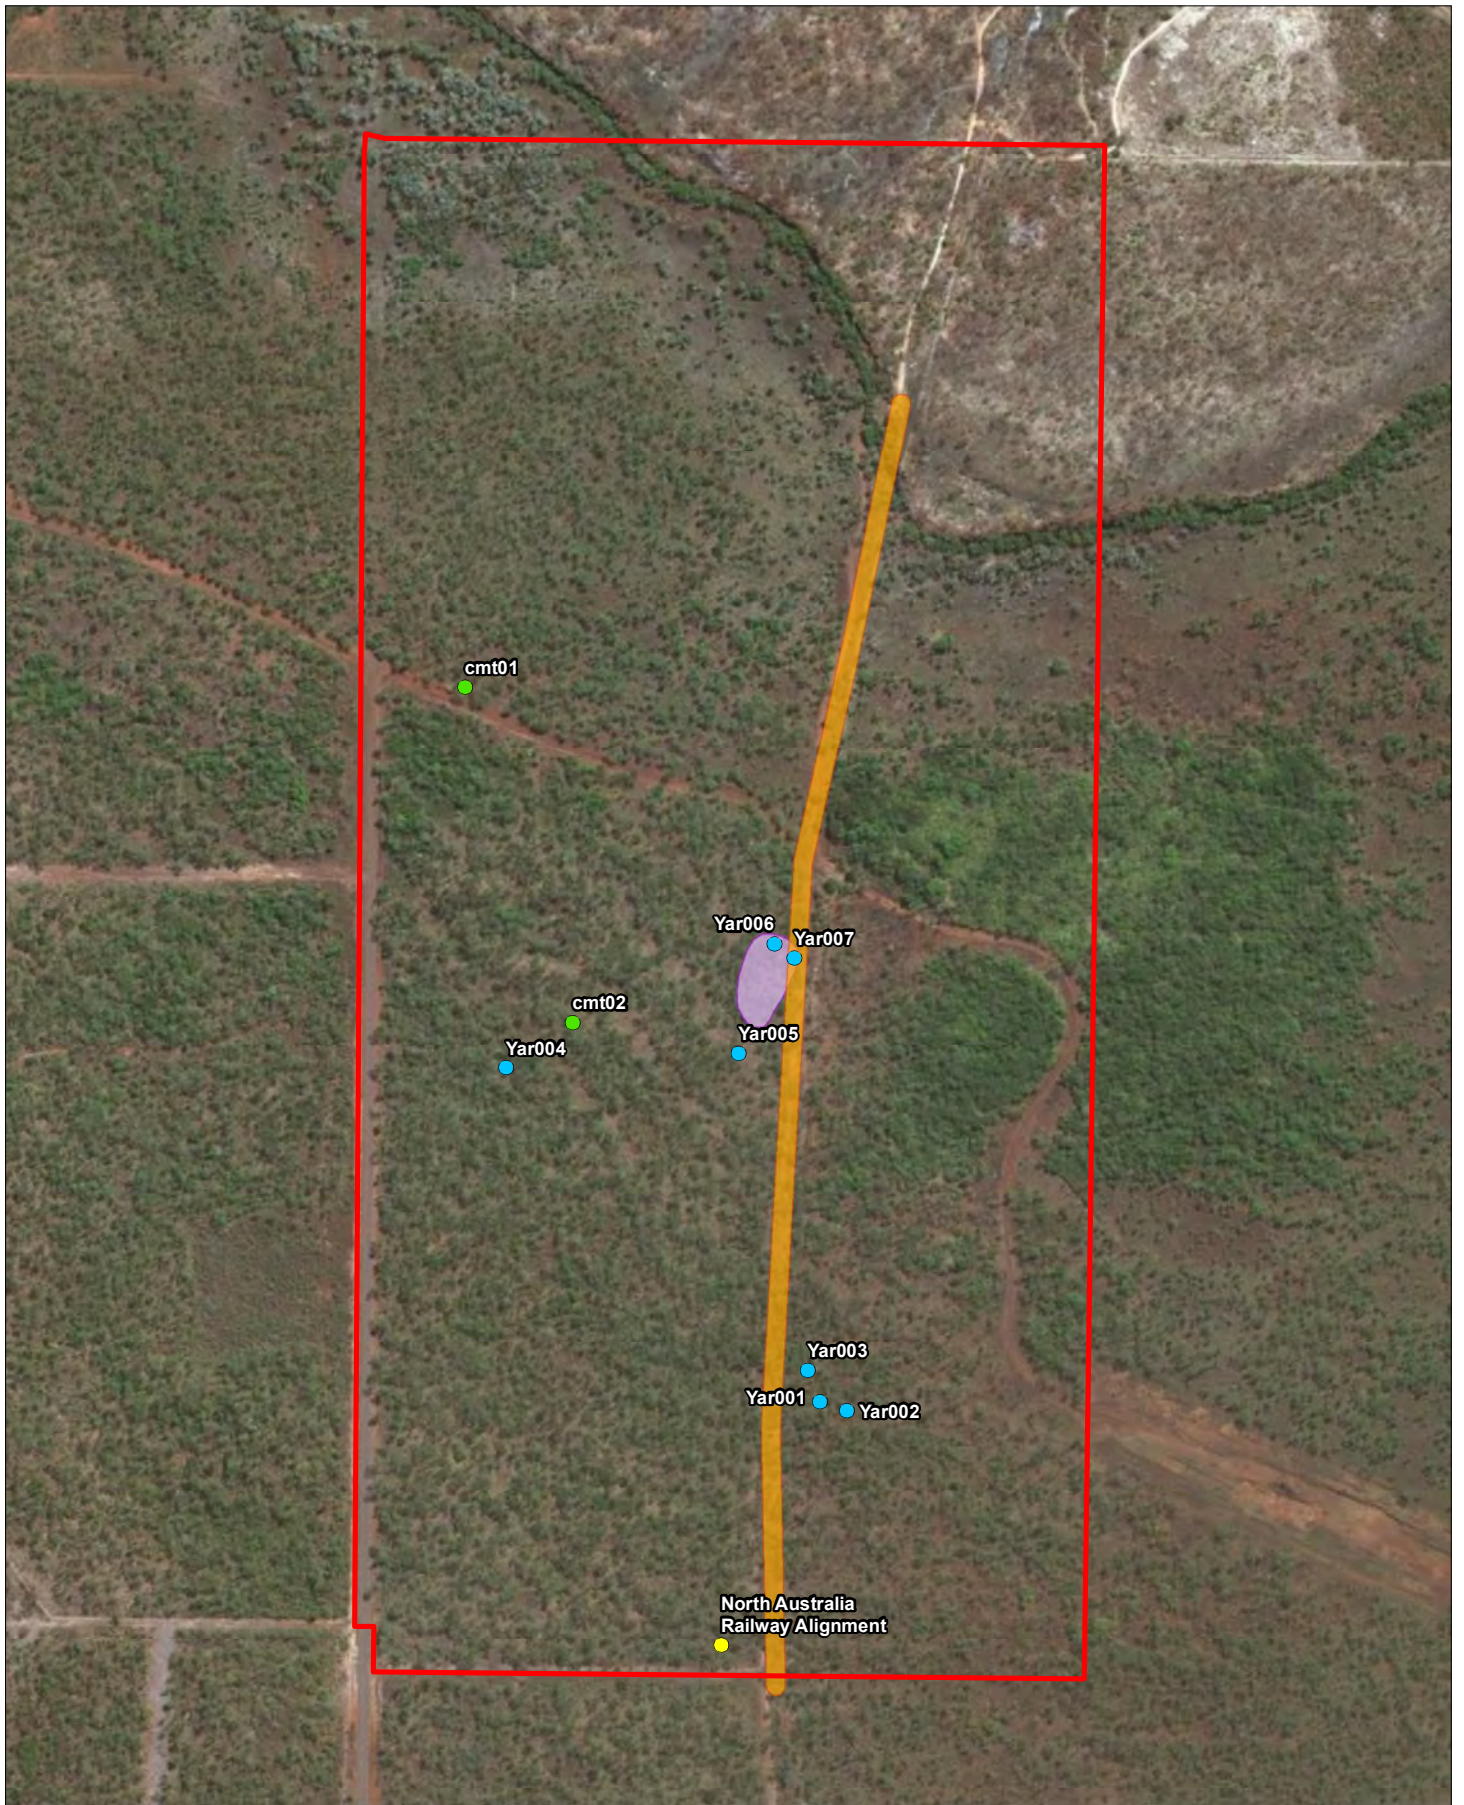
Current and Proposed Drill Holes and Tracks

Projection: GDA 1994 MGA Zone 52  
 Scale: 1:8,000  
 Project No.: 680.10606  
 Date: Thu 26-Sep-2019  
 Drawn by: JG  
 Sheet Size: A4

- Historical Site
- Isolated Artefacts
- Yarram Heritage Site
- MLN1163 Area
- Historical Site
- Yarram Heritage Site

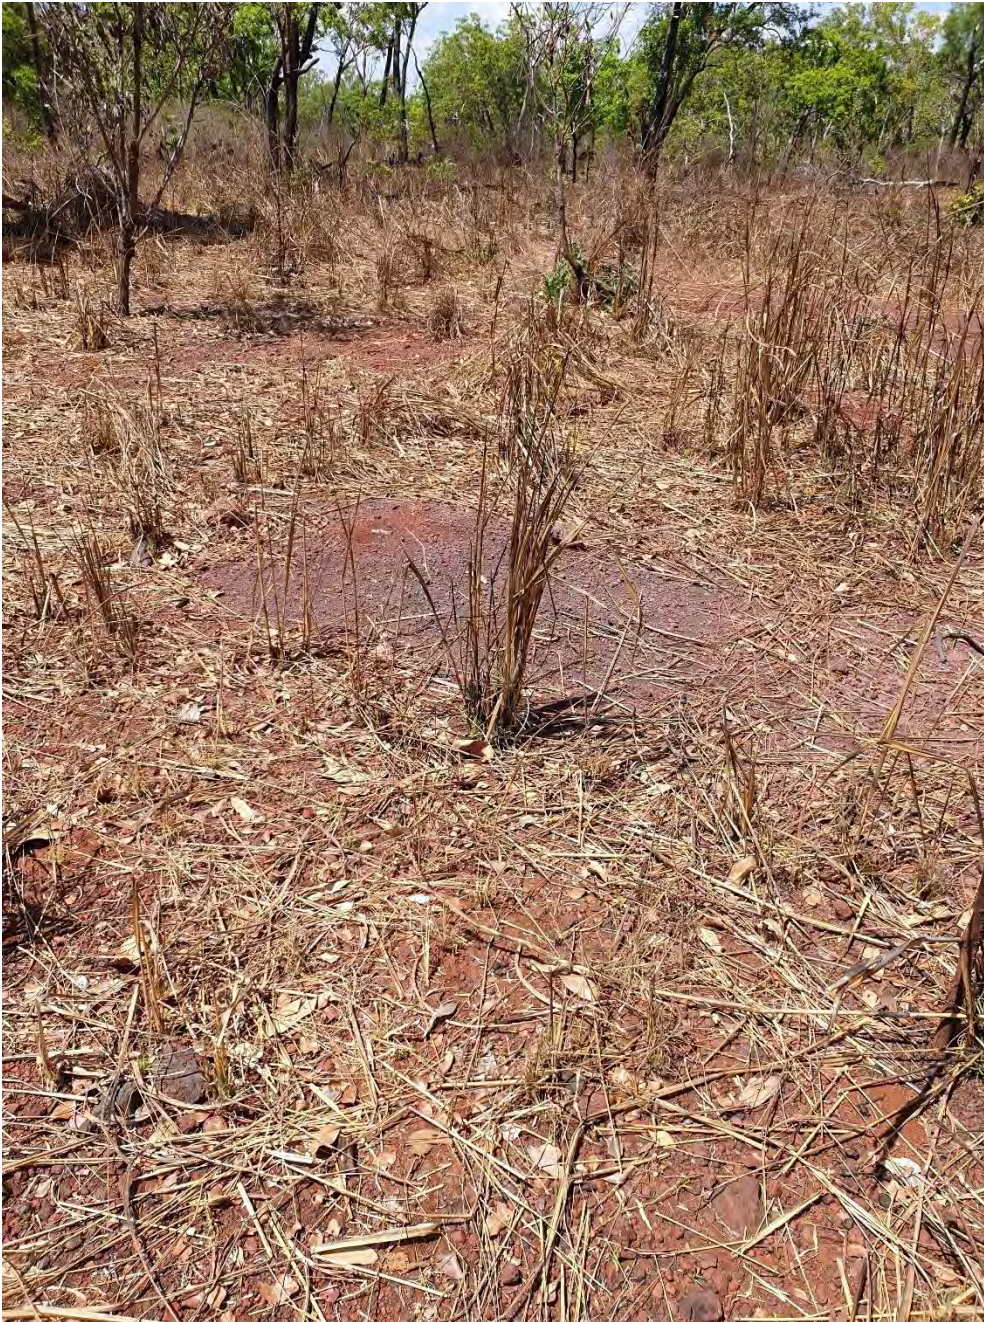
**Photo 6** Remnant drill spoil observed

During the recent joint SLR and DPIR site visit the site appeared in good condition with the only identified remnant exploration activities being a discarded wooden stake, a single pile of drill spoil used to cover a drill hole, one drill pad (approximately 25m x 25m) and a small volume of topsoil that has not been recontoured to match the existing landscape (**Table 1**). No further evidence of previous disturbance was noted. The proposed exploration activities proposed for October 2019, are situated within previous disturbed areas, including the 25m x 25m remnant drill pad, the security provided for these exploration activities will adequately cover the existing rehabilitation work required.

Action required	Evidence of completion or evidence that action is not required	Outcome
Drill holes plugged below ground level at a minimum depth of 0.4 metres and soil mounded to prevent subsidence.	No evidence of subsidence observed 5 years post rehabilitation. See <b>Appendix B Photo 1 - Photo 9</b>	Action not required
Drill samples/spoil returned down drill holes, buried in sumps, or removed from site.	A small area was observed where drill spoil remains. The drill spoil will be removed using hand tools and the area covered with topsoil during the next site visit. <b>Appendix B Photo 6</b> shows the remnant drill spoil.	Not completed, security to be retained
All drill hole and access markers including flagging tape, wooden markers and star pickets will be removed from site.	A single wooden stake was observed on site, this will be removed along with the drill spoil discussed above.	Not completed, security to be retained
