**INVESTIGATION OF *LANDOLPHIA BUCHANANII*
STEM AS A CONCRETE REINFORCEMENT
MATERIAL**

A thesis submitted to Pan African University, Institute for Basic Sciences Technology and Innovation in partial fulfillment of the requirement for the degree of M.Sc. of Science in Civil Engineering and Construction Management (Structural Option)

SEPTEMBER 2014

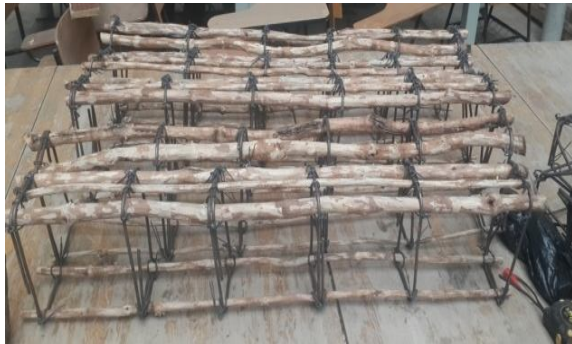
Plate 3.8: Fixed tensile reinforcements

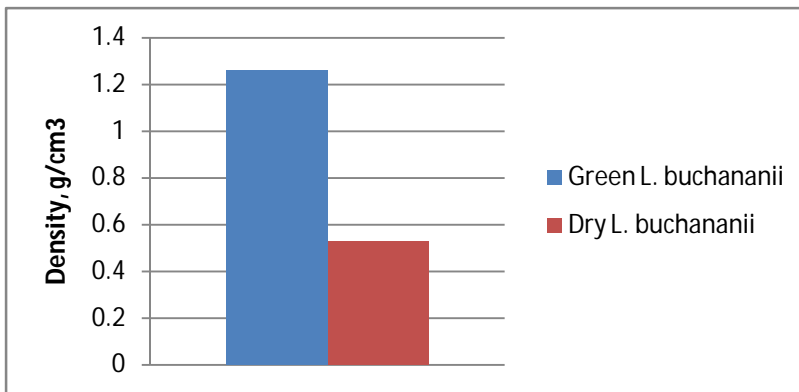
Figure 4.2: Comparison of density

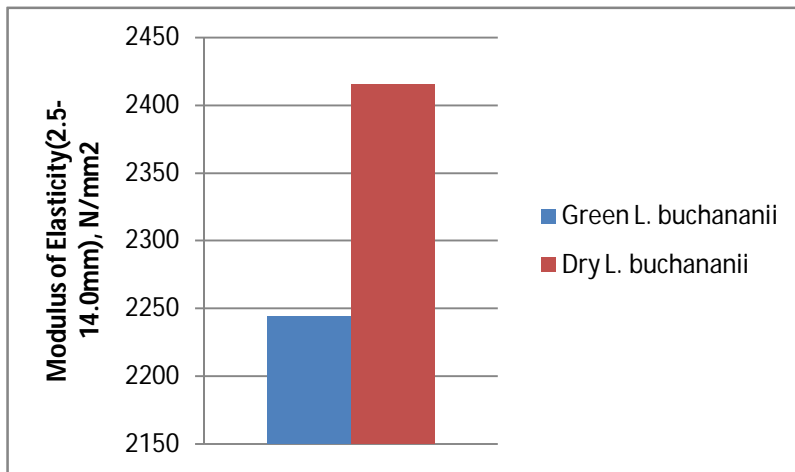
Figure 4.7: Comparison of Modulus of elasticity (2.5-14 mm deflection)

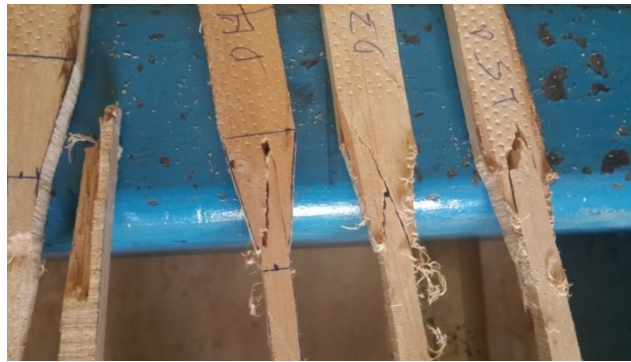
Plate 4.1: Tensile test samples mode of failure

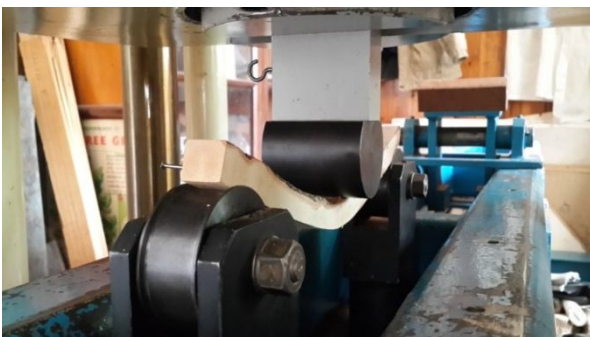
Plate 4.2: Beam test specimen under loading

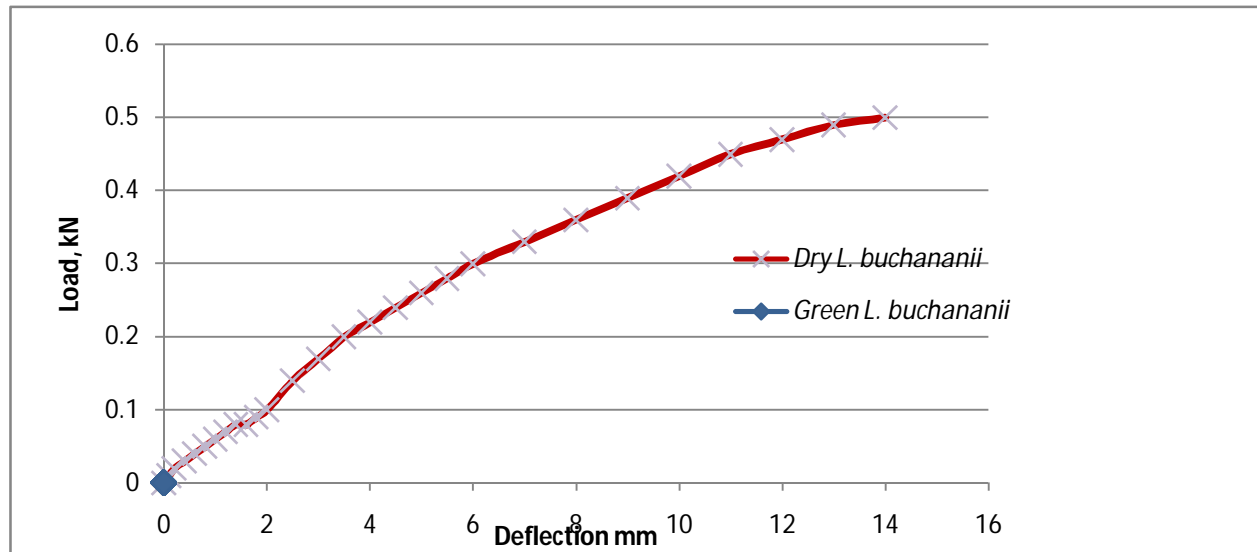
Figure 4.11: Load-deflection curve of typical samples of *L. buchananii* from bending test

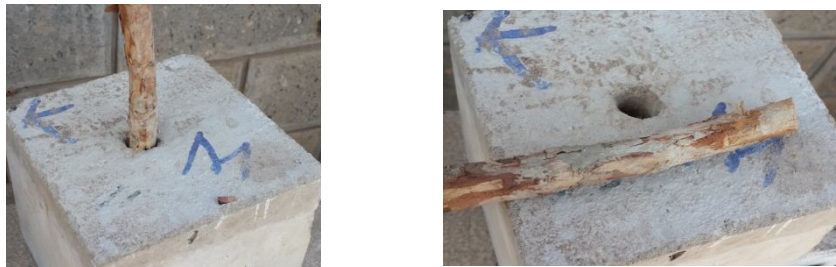
Plate 4.4: Mode of interfacial bond failure of *L. buchananii* in concrete

It was observed that the interfacial bond strength of steel was higher than that of *Landolphia buchananii* in concrete. This can be attributed to the fact that steel does not absorb water hence not swelling in wet concrete and again steel being twisted improves bonding in concrete. It can be seen however, in plate 4.5 that the interfacial bond strength of steel in concrete is high enough to pull out concrete hence creating a larger hole due to the steel reinforcement. On the other hand, *Landolphia buchananii* is round and untwisted and can absorb water and swell causing low bonding strength. It can be seen from plate 4.4 that the *Landolphia buchananii* did not pull out any concrete, the size of the hole fits the diameter of the reinforcement meaning that the low bonding strength can be attributed to swelling and the untwisted nature of the *Landolphia buchananii* stem.

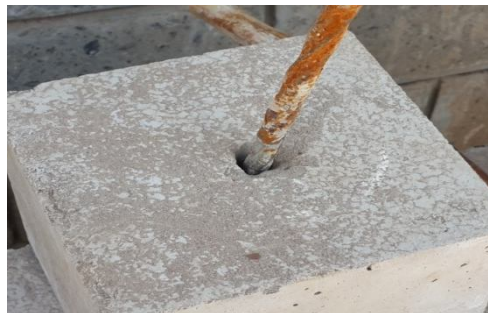
Plate 4.5: Mode of interfacial bond failure of steel in concrete

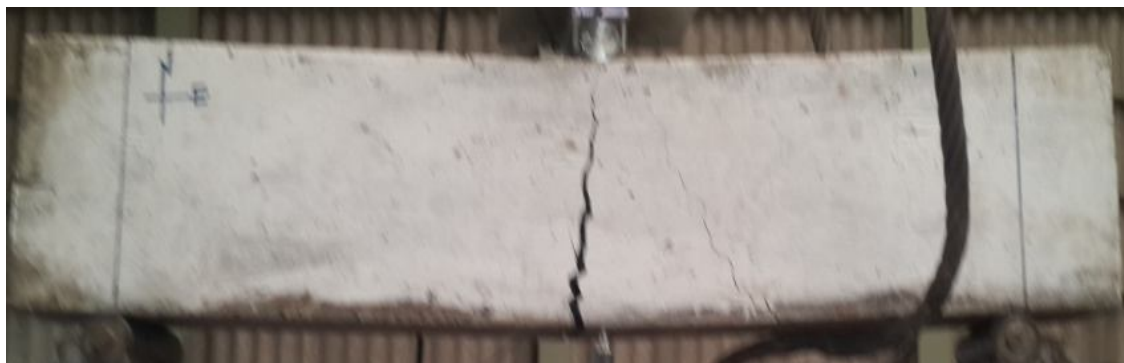
Plate 4.6: Failure pattern of L.B.805 beam

loading was increased. The second crack occurred just before the failure at around 200mm from the mid-span as shown in plate 4.6.

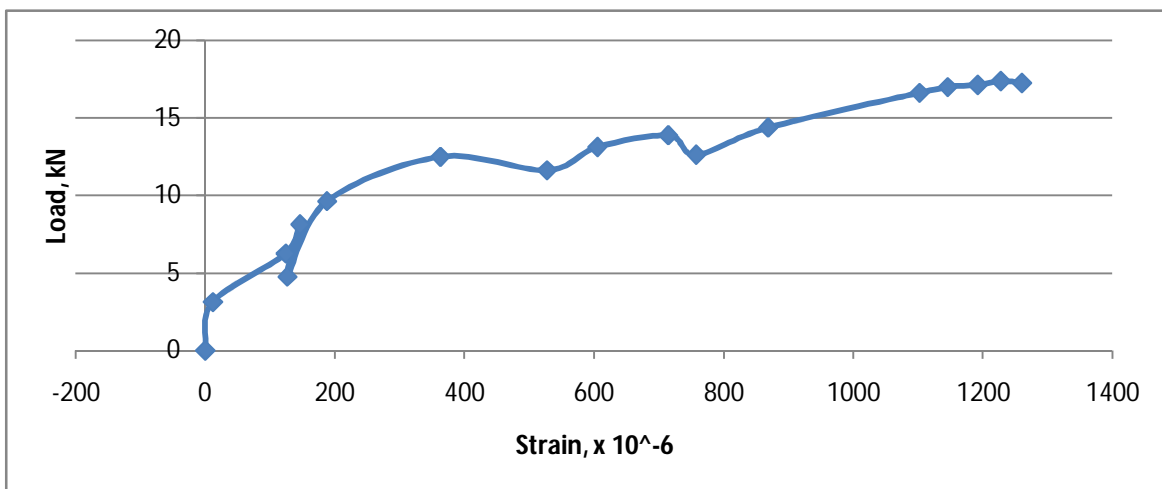
Figure 4.16: Concrete load-strain curve for L.B.787 beam

Consequently, in figure 4.16, it can be observed that the concrete strain kept increasing even after the first crack at a load of 8.15 kN. The negative gradient of the curve line corresponds to either crack occurrence or crack widening. The reinforcement strain gauge stopped recording because it peeled from the reinforcement. From figure 4.17, it can be observed that there was minimal deflection at initial stages up to when the load reached around 6.5 kN when it started increasing with increase in load till the ultimate load was reached at 17.38 kN. After the first crack occurrence, the crack widen progressively to the point when the ultimate load was reached at 17.38 kN. The first crack occurred at the bottom mid-span of the beam due to bending as shown in the plate 4.7.

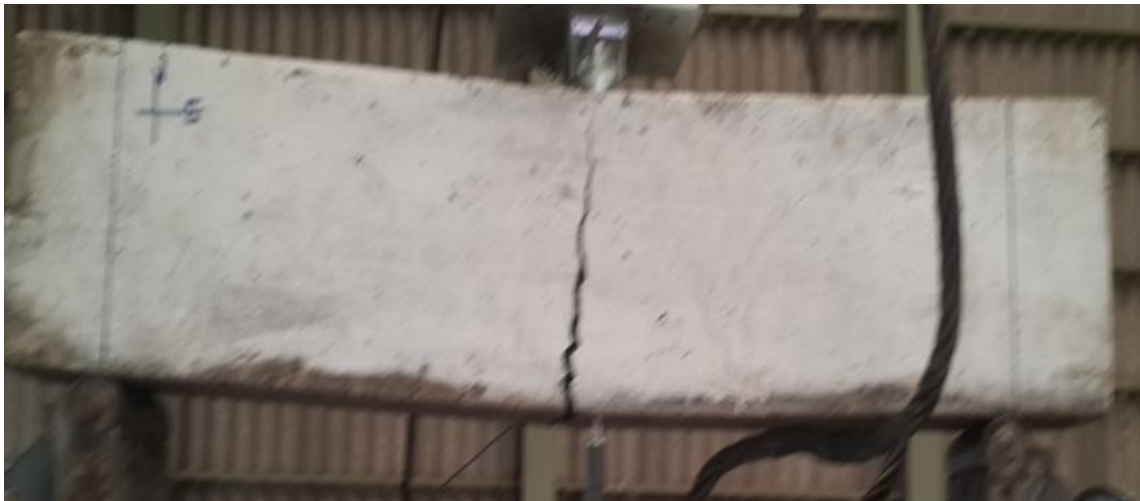
Plate 4.7: Failure pattern of L.B.787 beam

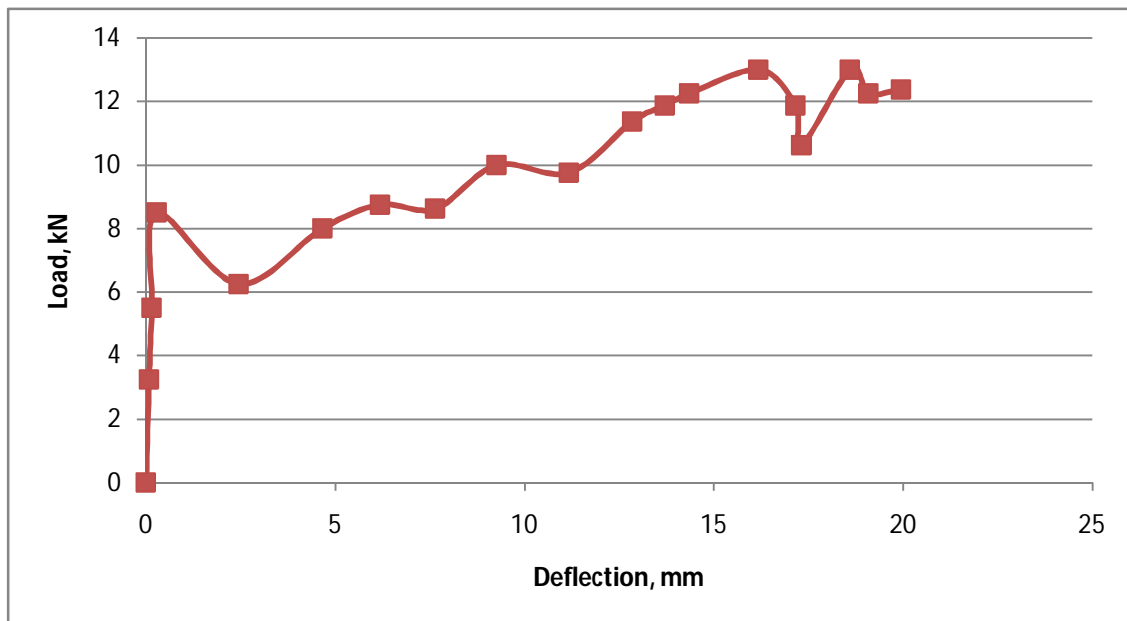
Figure 4.20: Load-deflection curve for L.B.7.87 beam.

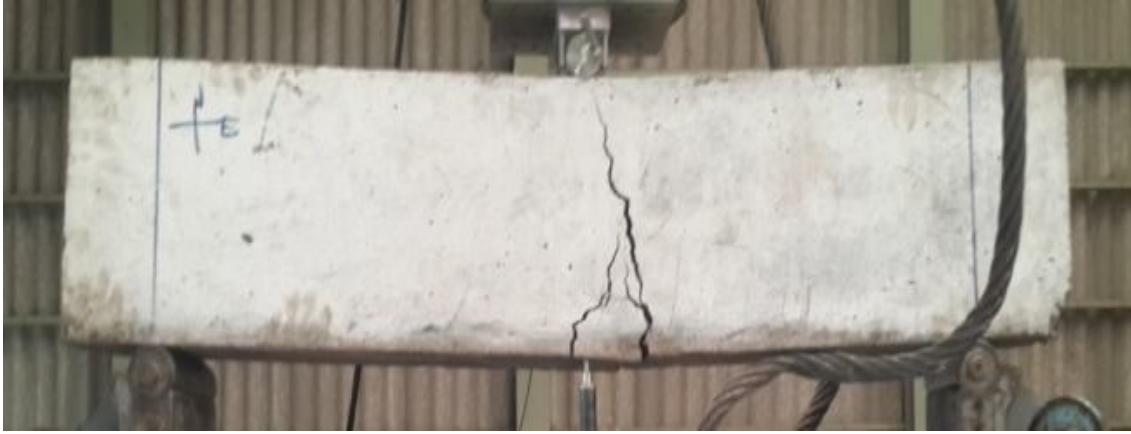
Plate 4.8: Failure pattern of L.B.741 beam

It is clear from the findings in figure 4.18 that there was minimal strain on both concrete and reinforcement up to the point when the load reached around 5.5 kN where the concrete strain started increasing rapidly until when the first crack occurred at a load of 8.5 kN. After the first crack the reinforcement strain increased rapidly even if there was decrease in load because there was failure in concrete thus transferred the resistance to the reinforcement. The reinforcement strain underwent relaxation strain gauge stopped recording by peeling off from the reinforcement. The concrete strain after the first crack underwent relaxation (figure 4.19) before it started increasing with increase in load up to when the load reached around 10 kN a point which the second crack occurred. After the 10 kN load, concrete strain relaxation occurred and continued till when the ultimate load was reached. Conversely, from figure 4.20, it can be seen that at there was minimal deflection at initial stages before the first crack occurred at a load of 8.5kN after which the deflection increased rapidly even when the load decreased. Thereafter deflection increased with increase in load up to when the second crack occurred at a load of 10 kN. At the point of second crack load, the deflection increased proportionally with decrease in load before it started increasing with increase in load up to the point when the ultimate load was attained. Concurrently, the first crack widen progressively until when the second crack on concrete occurred. However, the first crack occurred at the bottom mid-span of the beam due to bending while the second crack occurred just before the failure at around 100mm from the mid-span as shown in the plate 4.8.

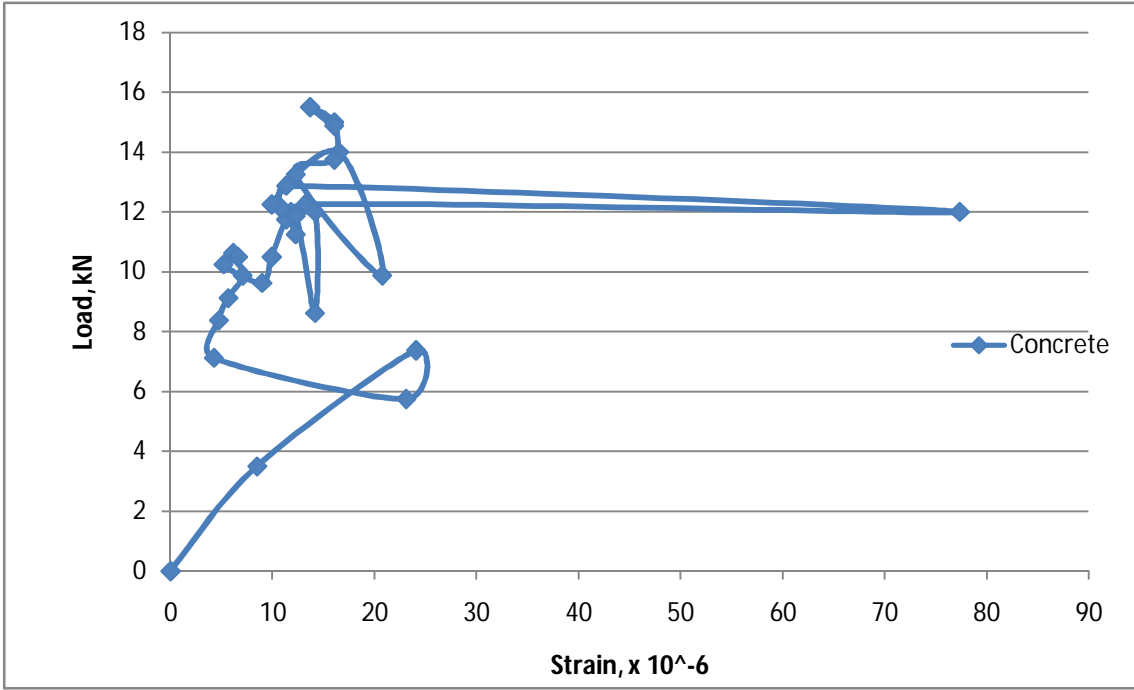
Figure 4.22: Concrete load-strain curve for L.B.710 beam

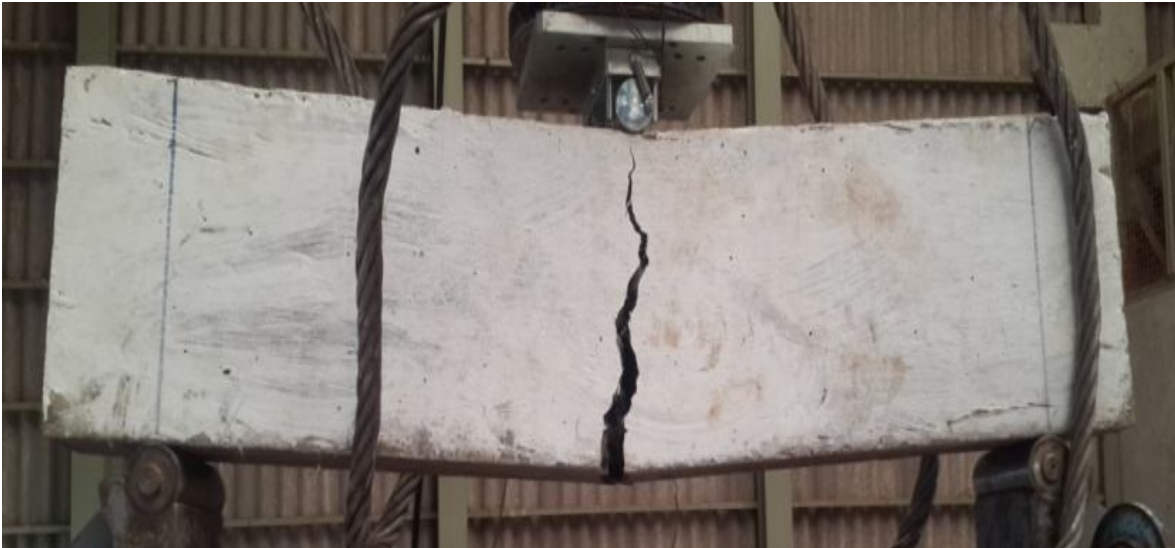
Plate 4.9: Failure pattern of L.B.740 beam

In this case, it was observed that there were minimal strains in both concrete and reinforcement until when the first crack occurred at a load of 7.3kN (see figure 4.21). After which the strain in reinforcement increased with decrease in load and is thus attributed to failure in concrete. The failed concrete perhaps transferred the load resistance to the strain in reinforcement causing it to increase. However, upon occurrence the first crack, the reinforcement strain increased with increase in load to the level when the strain gauge failed. It can be observed in figure 4.22, that there was relaxation of concrete strain after first crack load was reached. Thereafter the concrete strain increased and underwent relaxation till when the ultimate load was reached. On the other hand, the first crack widen gradually as the load was increased. Consequently, the first crack occurred at the bottom mid-span of the beam due to bending as shown in plate 4.9.

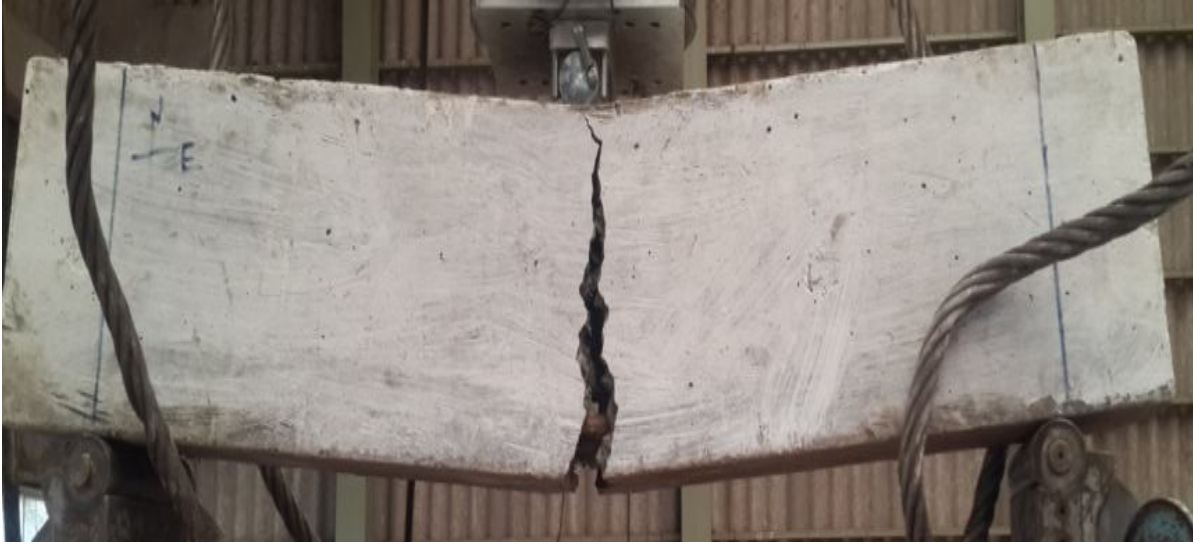
Plate 4.10: Failure pattern of L.B.419 beam

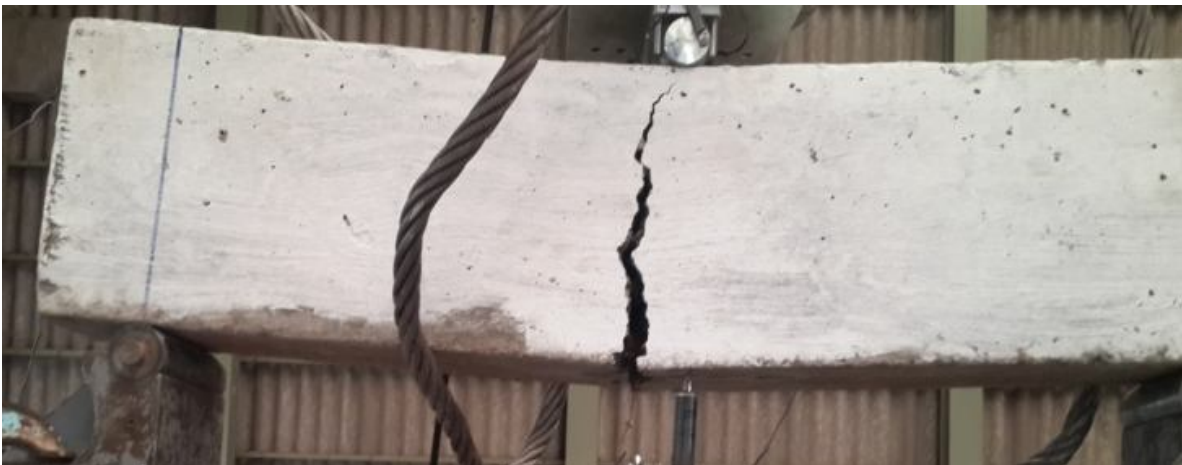
Plate 4.11: Failure pattern of L.B.399 beam

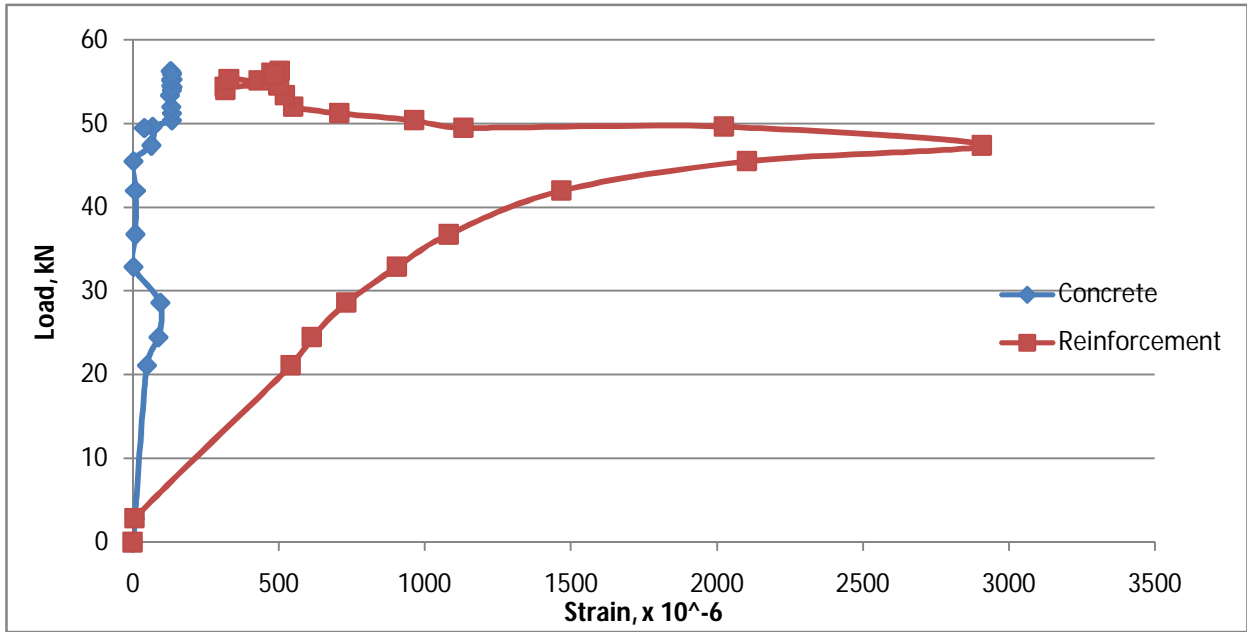
Figure 4.25: Load-strain curves for Steel 101 beam

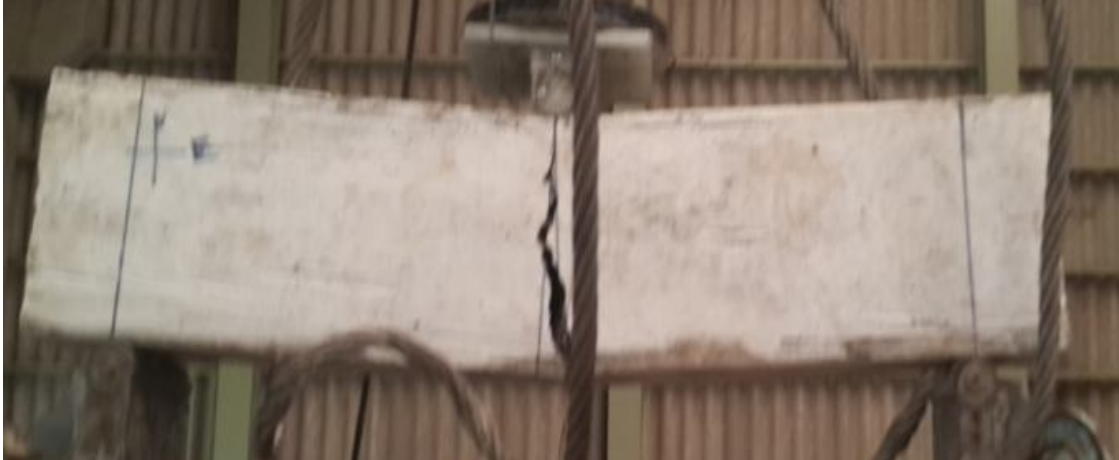
Plate 4.12: Failure pattern of Steel 101 beam

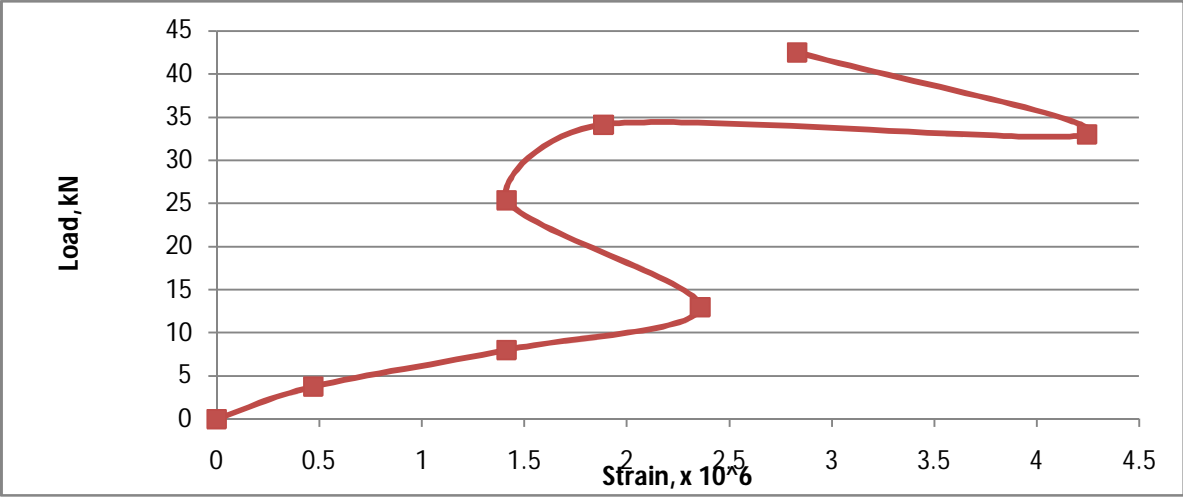
Figure 4.29: Reinforcement load-strain curve for L.B.1x6 beam

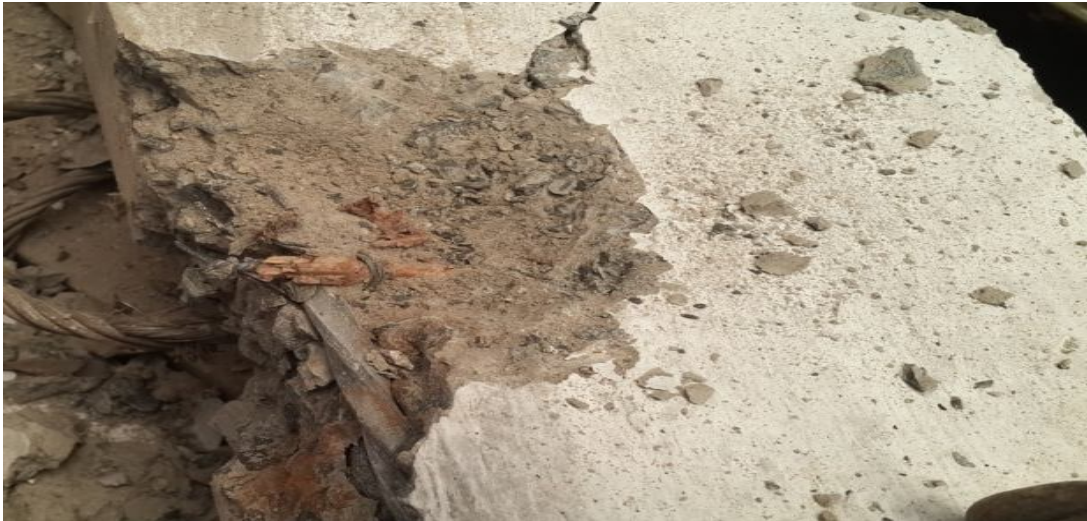
Plate 4.13: unbroken shear reinforcement for L.B.1x6 beam

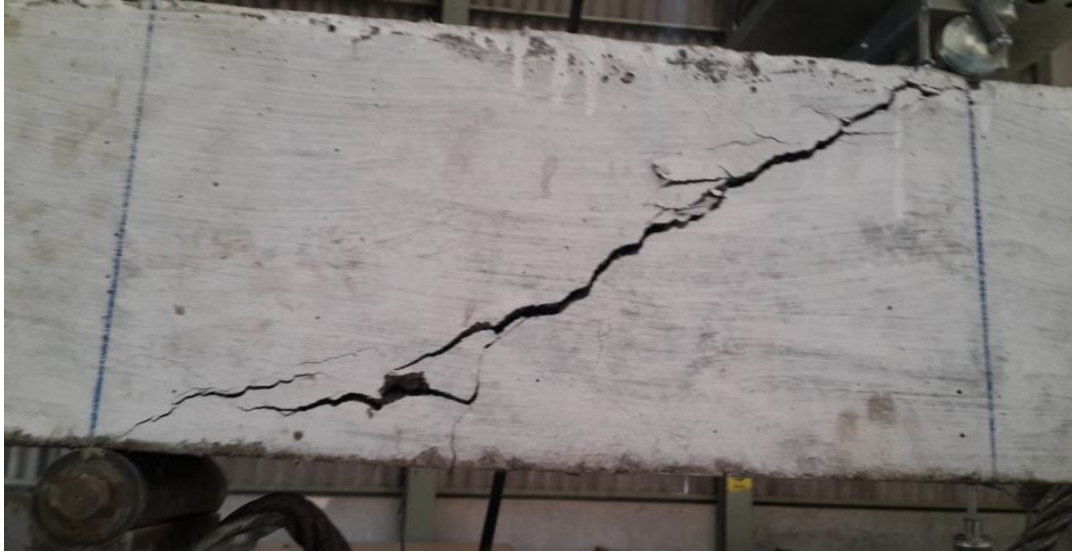
Plate 4.14: Failure pattern of L.B.1x6 beam

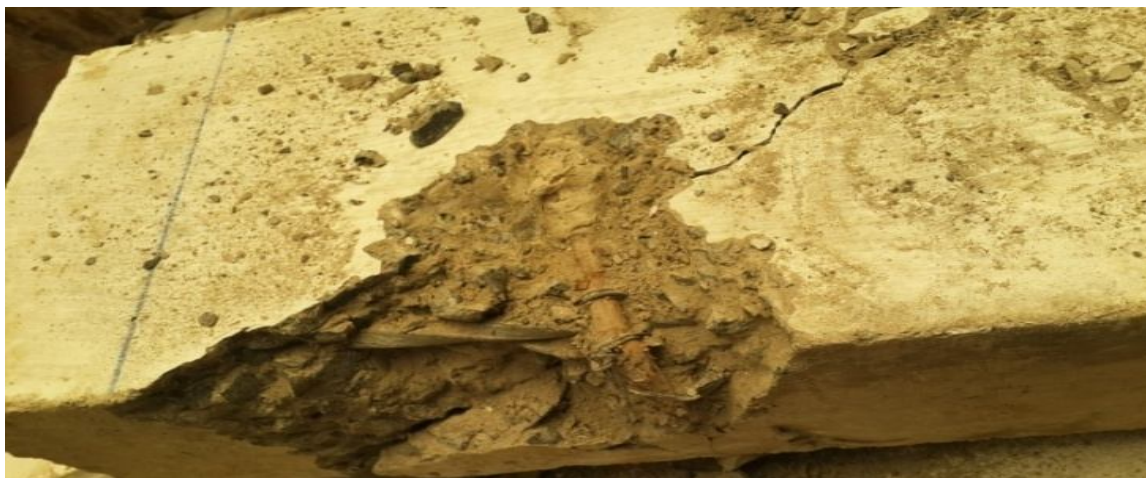
Plate 4.15: unbroken shear reinforcement for L.B.1x8 beam

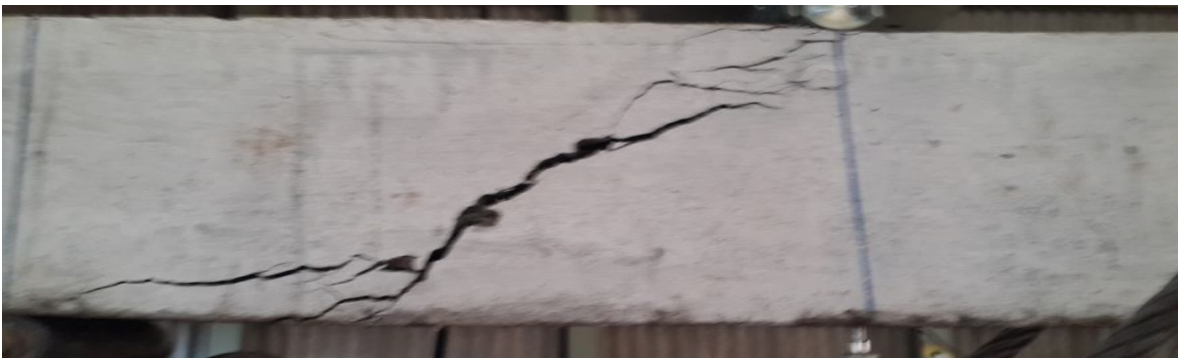
Plate 4.16: Failure pattern of L.B.1x8 beam

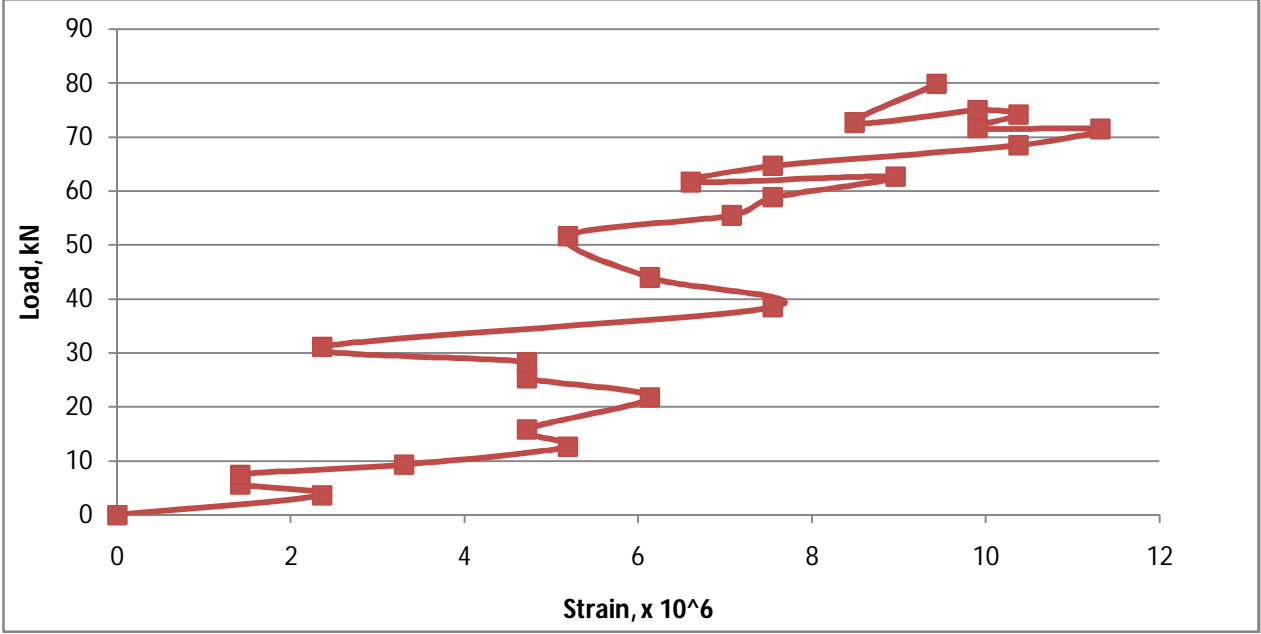
Figure 4.33: Reinforcement load-strain curve for L.B.2x10 beam

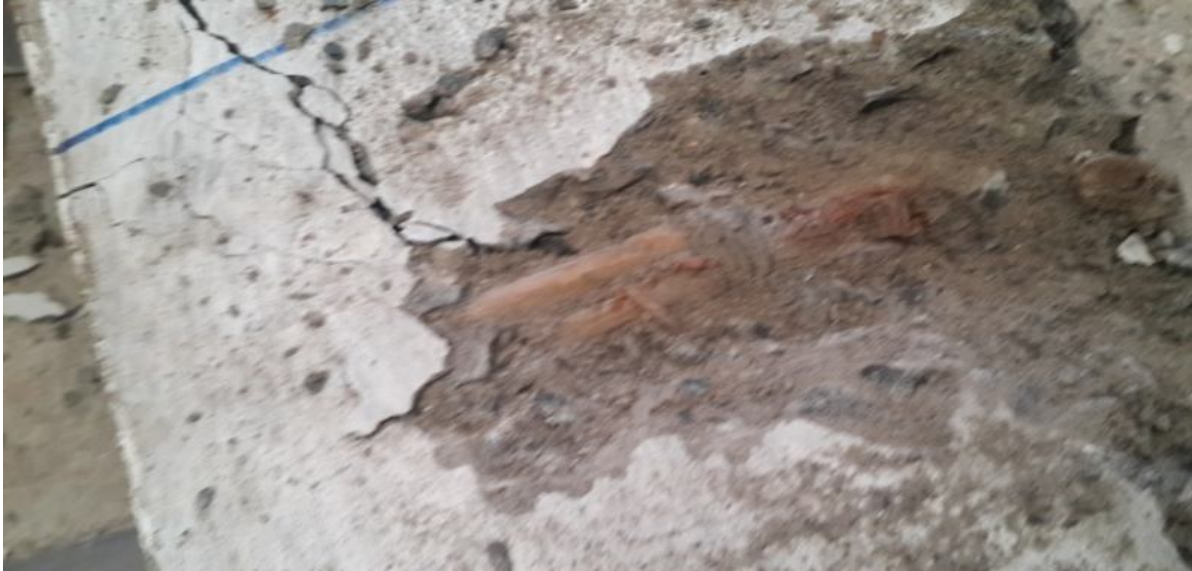
Plate 4.17: unbroken shear reinforcement for L.B.2x10 beam

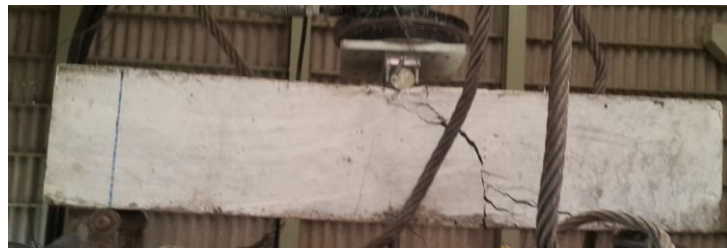
Plate 4.18: Failure pattern of L.B.2x10 beam

deflection curve is non-linear throughout the loading. The deflection increased with increase in load to the level in which failure load was reached at 79.8 kN. The first crack widen increasingly with load increase to failure. The first crack occurred at bottom of the beam around 20 cm after the mid-span which progressed as it widened to the point of loading. At around 44 kN load a second crack occurred at 10 cm before the mid-span at the bottom of the beam going up to the point of loading at the top of the beam as shown it plate 4.18.

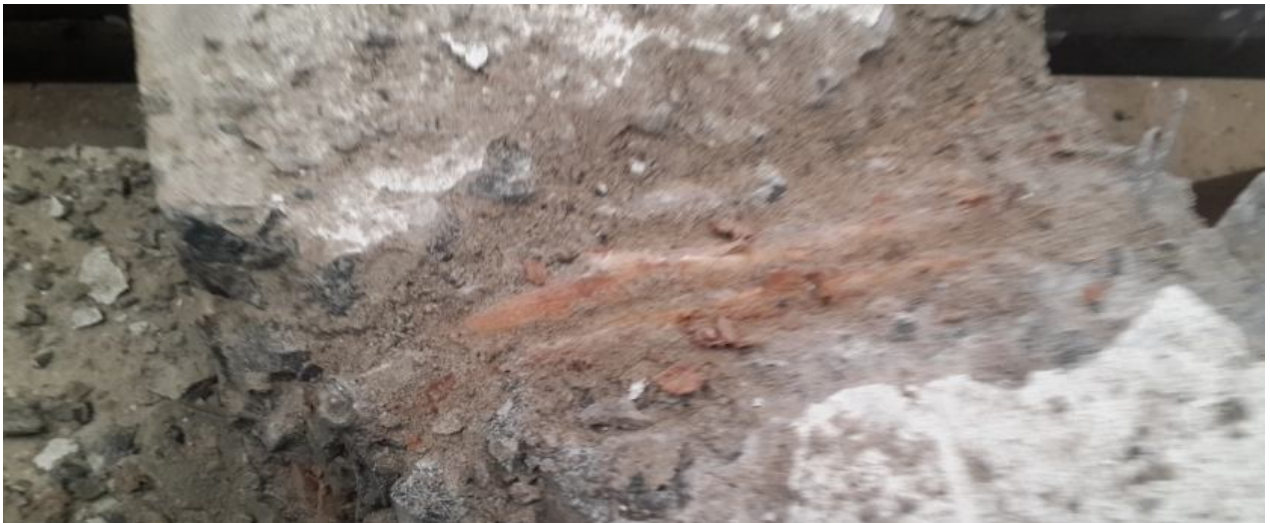
Plate 4.19: unbroken shear reinforcement for L.B.2x13 beam

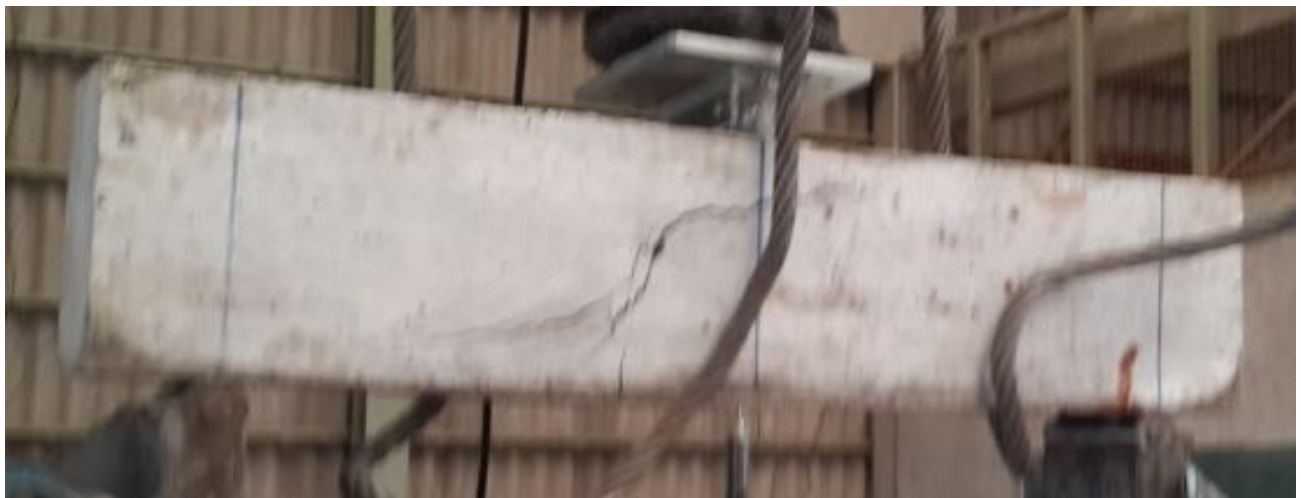
Plate 4.20: Failure pattern of L.B.2x13 beam

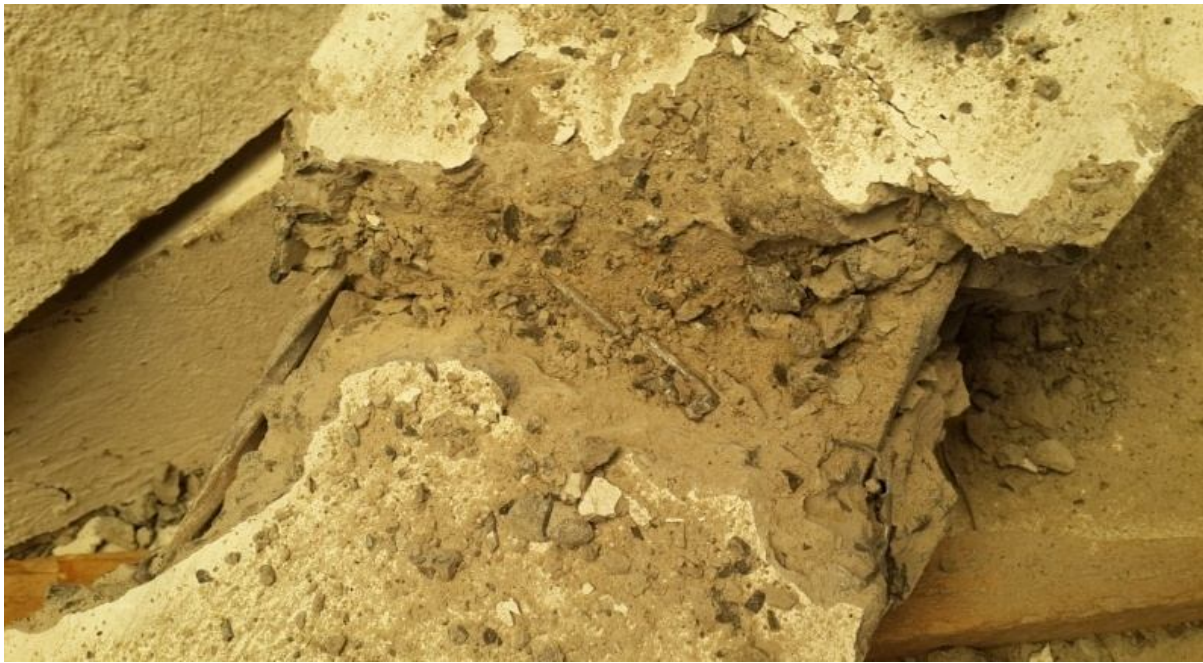
Plate 4.21: unbroken shear reinforcement for Steel 1x6 beam

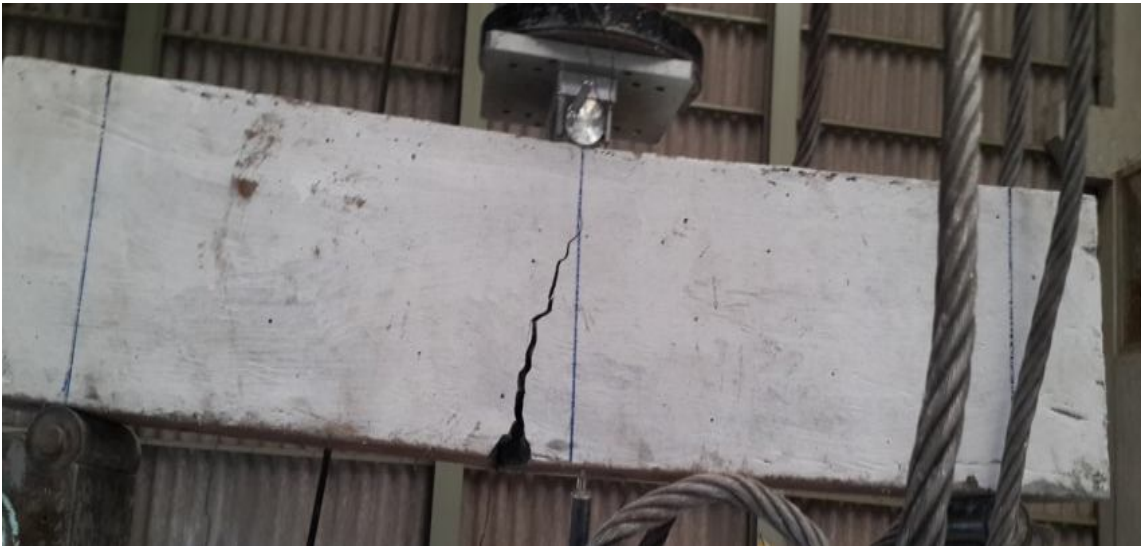
Plate 4.22: Failure pattern of Steel 1x6 beam

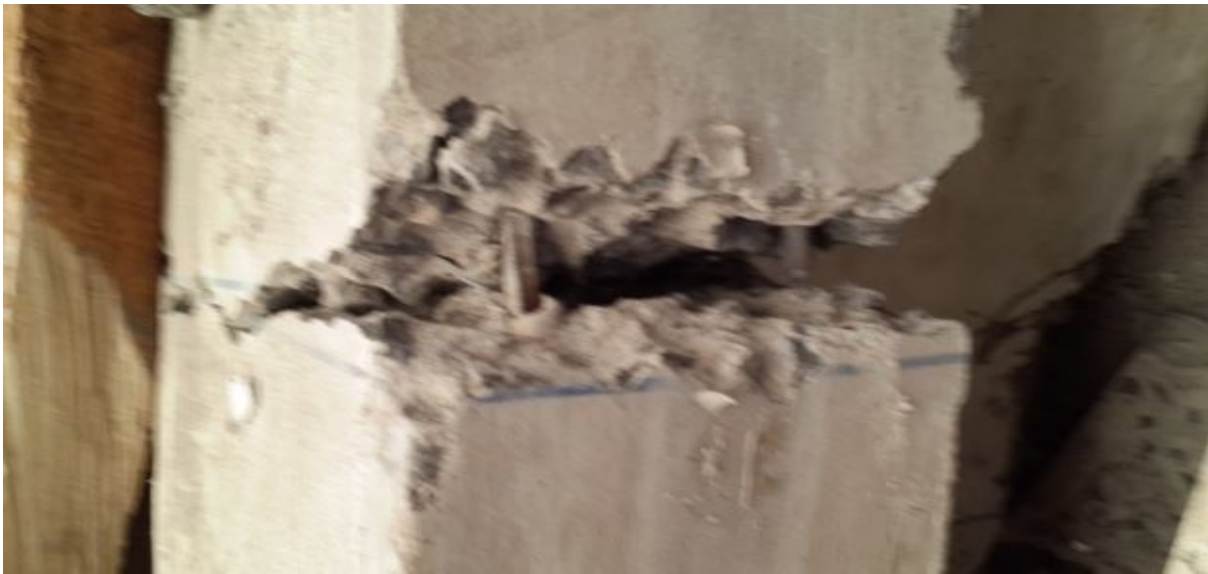
Plate 4.23: Snapped steel tensile reinforcement

Flexural failure is noted in all the beams with crack gradually starting at mid span and enlarges as the loading was increased. From the loading deflection curves (figure 4.39), failure pattern *L. buchananii* reinforced beams (plate 4.6, 4.7, 4.8, 4.9, 4.10 and 4.11) and failure in the reinforcements (Plate 4.24 and 4.25) as compared to that of the steel reinforced beam (plate 4.12 and 4.23). It can be noted that bonding failure could be the probable cause of the premature flexural failure in the *L. buchananii* reinforced beams. It can be seen that the tensile reinforcement was still intact but had slipped through the concrete while steel tensile reinforcement snapped as shown in figure 4.23. When the region of failure crack was examined in figure 4.26 the *L. buchananii* stem seem unbroken, suggesting that there was a poor bond between *L. buchananii* and concrete which led to beam failing in bonding.

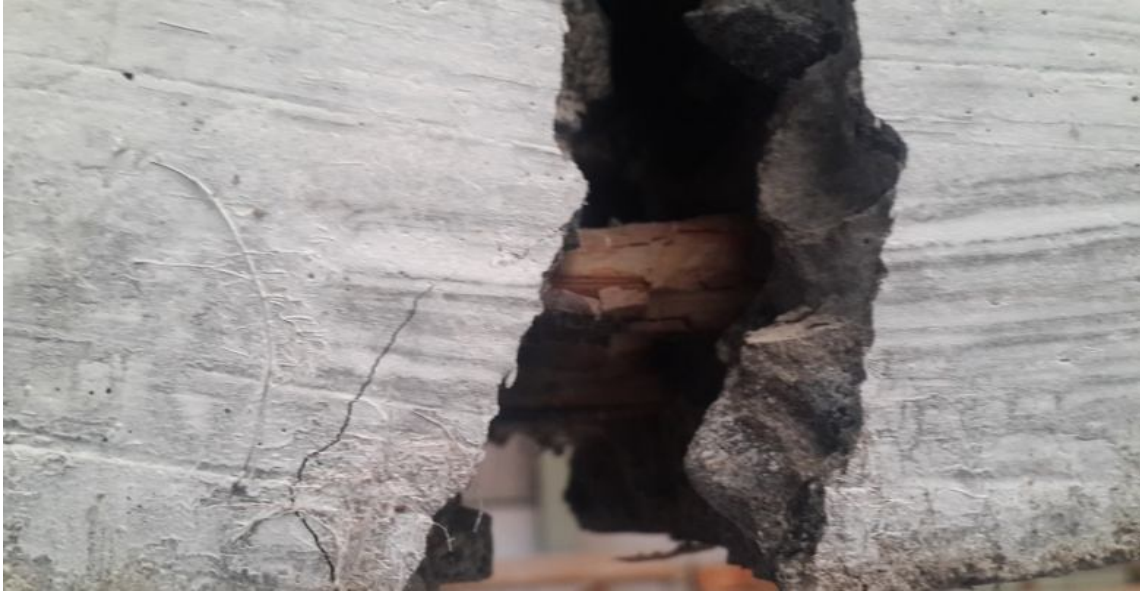
Plate 4.24: Slipped *L. buchananii* tensile reinforcement

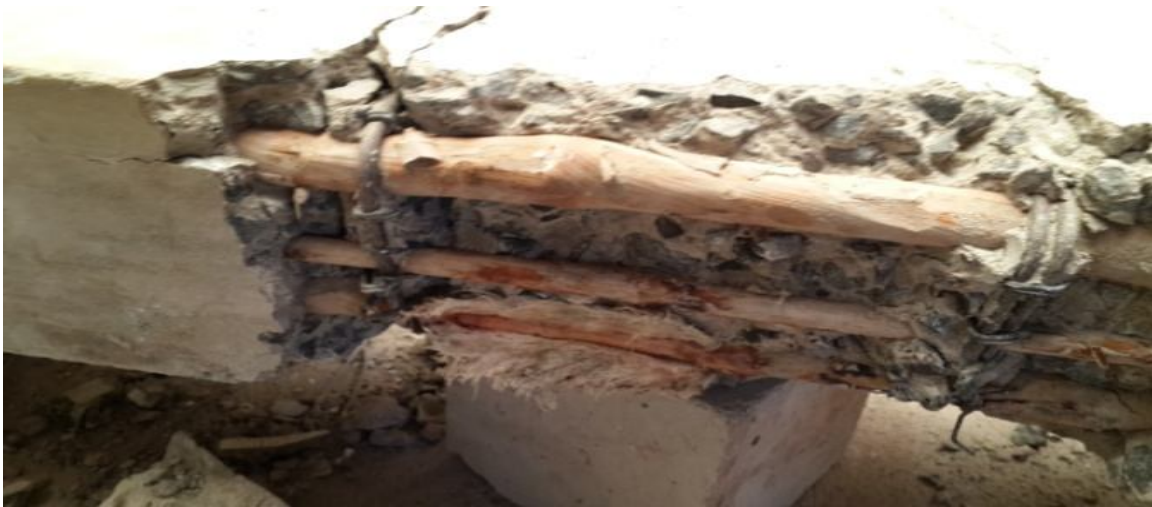
Plate 4.25: unsnapped *L. buchananii* tensile reinforcement
