DESK BASED ASSESSMENT ST JAMES THE GREAT CHURCH, EAST MALLING, KENT, ME19 6AH

Report reference: DAS017-21

St James the Great Church, East Malling Kent, ME19 6AH

Archaeological Desk Based Assessment

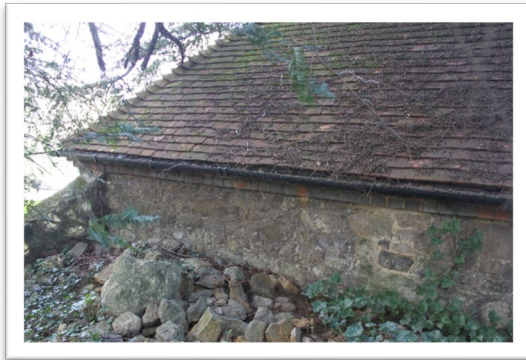
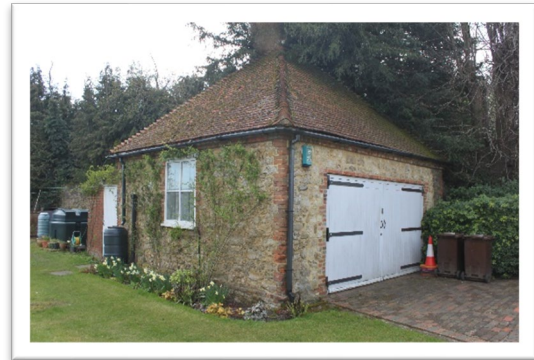
(Fig 6: garage looking north from churchyard) (Fig 7: garage looking south-east from Court Lodge)

- 3.1.9. A building adjacent to the made ground in the churchyard which is now a garage for the occupants of the neighbouring Court Lodge, appears to have been built in two phases. It is likely constructed onto the churchyard's original medieval south retaining wall and further raised by approximately 1.0m to create the building we see today. The building appears on the George Pink map of 1789, but, interestingly, a later phase of the churchyard retaining wall abuts the building's south-facing wall. This implies a later stage of wall construction around the churchyard to the north (after 1789), which, in turn, is discussed and has implications for the PDS (see Section 10).

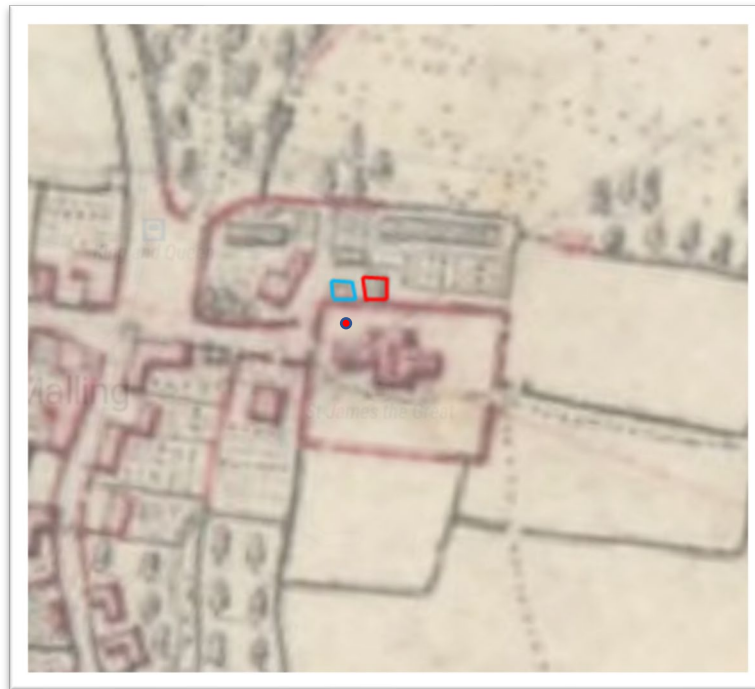
(Fig 8: Extract from George Pink Map of 1789 showing positions of garage [blue] and now demolished building [red], source: British Library)

- 3.1.10. A building, no longer evident, was adjacent to the made ground in the churchyard and east of the garage featured on the George Pink map of 1789. It is surmised that demolition rubble in the churchyard's made-up ground in the area of the PDS may have come from this building when demolished (see Section 10).

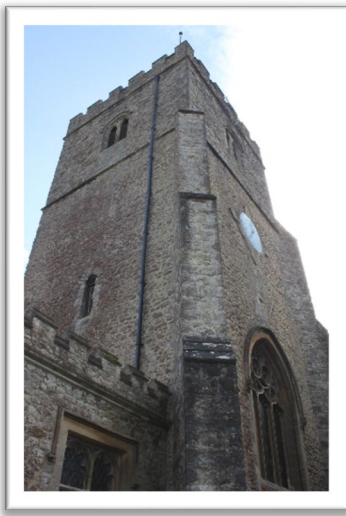
(Fig 12)

and chancel. Tower: 3 stages with angle buttresses, not original. Embattled with single pointed-arched belfry openings and string below belfry stage (Fig 12). The clock above the tall west window. Norman windows to north and south (blocked). Clerestory nave and chancel. Transeptal chapels originally lengthened into aisles, early C14 windows to north, the original chancel windows. C19/C20 chancel east window. INTERIOR: 3 bay aisle arcades, showing lengthening of transeptal chapels to become aisles in rhythm of east arches, then a short piece of wall followed by pair of west arches. Octagonal piers, double-chamfered arches. Fittings: Sanctuary panelling, early C17. Font area: Early C16, with doors. Tall, panelled base with a tall conical cap of pierced tracery. Pierced cresting to the base of birds attacking fruit. Octagonal stone font. Stained glass: same early C14 glass in the north aisle. Monuments: Thomas Selby, d. 1479. Brass. Richard Adams, d. 1522. Brass. Richard Mannyng, d. 1611. Alabaster hanging monument, with a figure with hand on skull. Thomas Twisden, d. 1683. Tablet. Jane Sympson, d. 1690. Baroque tablet with pediment and scrolls. Jane Twisden, d. 1779 (?). Tablet. Sir John Twisden, d. 1810. Monument with a figure of a woman leaning on urn by Thomas Assiter of Maidstone.

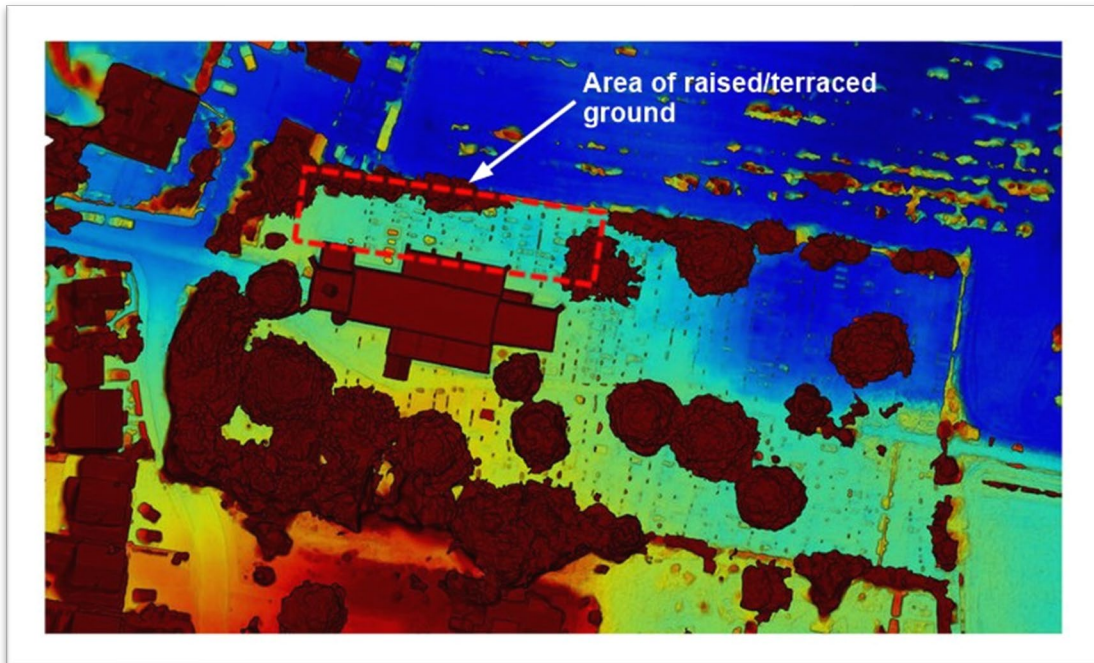
(Fig 27: Elevation Model of PDS showing area of raised/terraced ground)

- 10.6. An elevation model of the landscape was produced using drone video footage and mapping software (Figs 26, 27 & 28). The resulting image shows that the PDS sits within an area of raised or terraced ground compared with the surrounding landscape.

- 10.7. The higher ground to the south (red/yellow) gradually slopes to the north (green/blue) within the entire image. However, A terrace is evident on the north side of the church, employed as a burial ground and retained by a masonry wall headed east-west, corroborated by a local context LiDAR image (Fig 35).

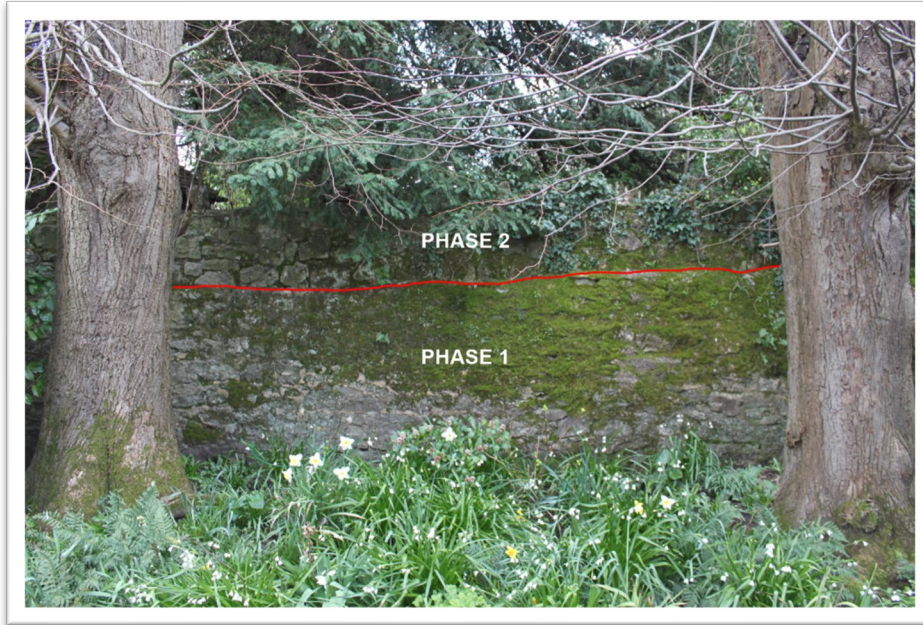
(Fig 29: Churchyard retaining and phasing wall looking east from Court Lodge)

- 10.8. Images of the masonry walls retaining the north and west sides of this raised area suggest two phases of activity associated with burial ground maintenance. Phase 1 likely represents earlier land management (c.1300-1400 AD) to accommodate burials: once this burial ground became too congested, phase 2 probably raised the area by approximately 0.5 metres (c.1800 AD) to accommodate additional burials.

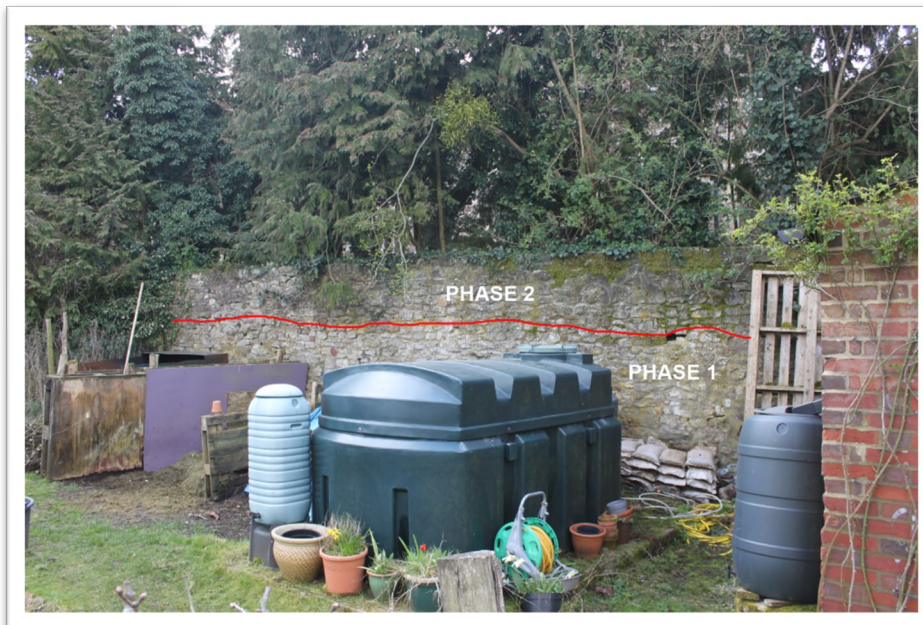
(Fig 30: Churchyard retaining wall and phasing looking south-east from Court Lodge)

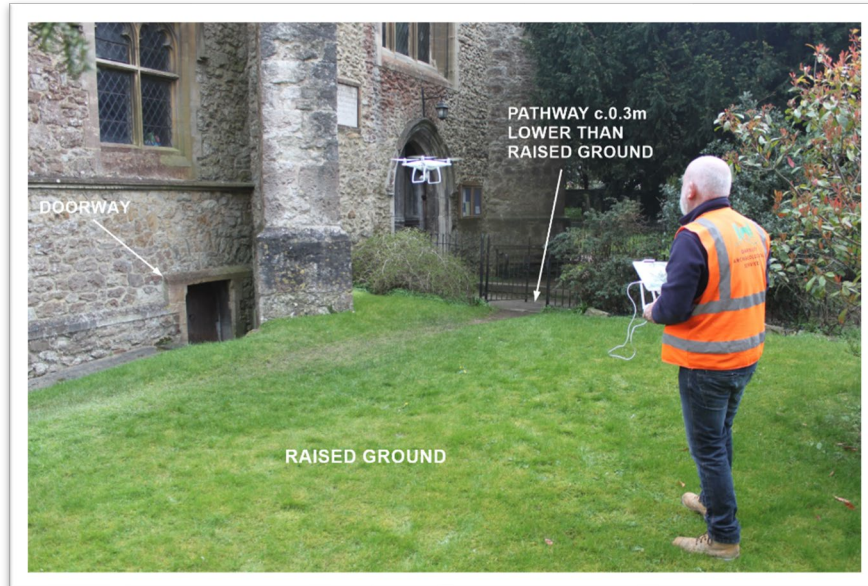
(Fig 31: Looking south-east from PDS across raised churchyard at West Tower and frontage)

- 10.9. Further evidence for the area of raised ground can be seen on the west side of the church near the main entrance: the grassed area is visibly higher than the pathway leading to the church entrance and obscures an earlier small doorway in the west wall to the north of the buttress.

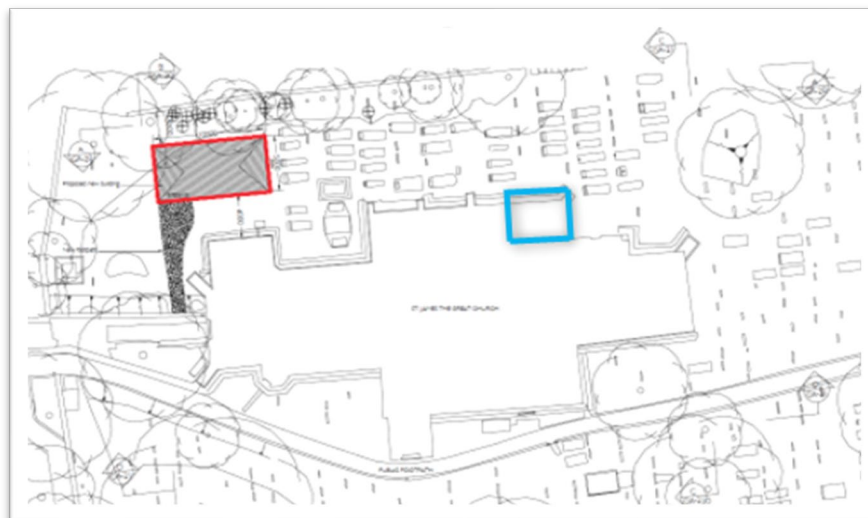
(Fig 32: location of the crypt (blue) & PDS (red))

- 10.10. Video camera analysis from June 2020 provided footage of a crypt, now sealed but believed to hold coffins belonging to the Twisden family. The crypt (Figs 32 & 33) appears as a single chamber with a vaulted ceiling. The crypt structure might be associated with an early phase of the church (i.e. Early Medieval), but this is difficult to substantiate without further investigation. It is unlikely that the crypt (or related subterranean structures) project as far west as the PDS.

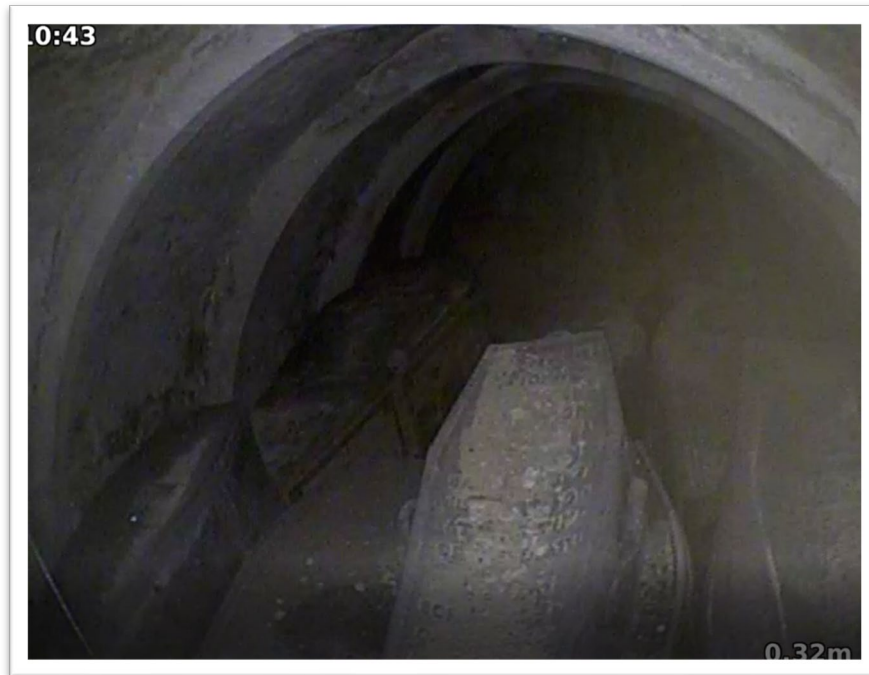
(Fig 33: Looking west through crypt air grate at coffins and vaulted ceiling, source: Mr Francois Gordon)

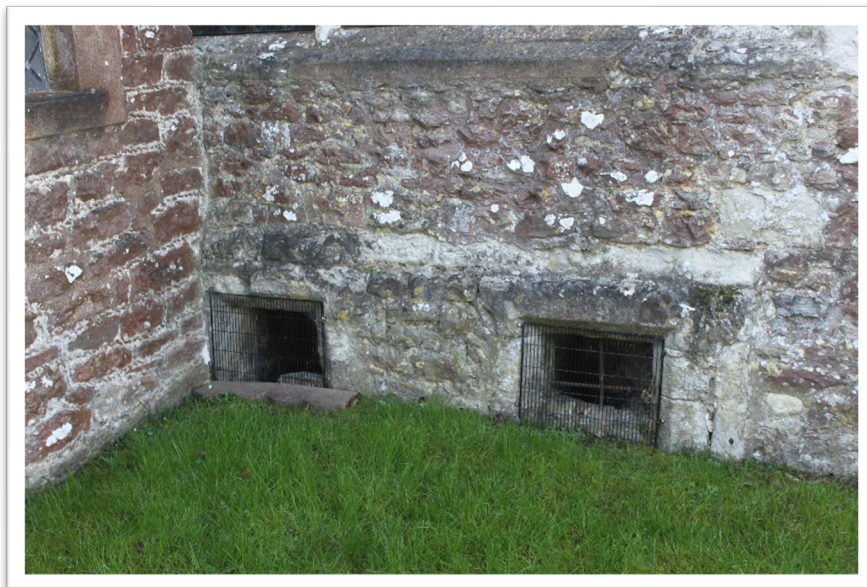
(Fig 34: East-facing north aisle wall which provided access for video cameras to film the crypt)

- 10.11. The exact location of the entrance to the crypt is not known. However, it is believed to have been internal with access via a slab in the north aisle. It is also possible that an external access point was on the north aisle's east-facing wall. Figure 34 shows metal grates covering holes incorporated within a ragstone wall, a different building phase than the later surrounding red sandstone.
