Point Fraser Monitoring and Evaluation Program

2010 Report

City of Perth

Report No. 2010-9

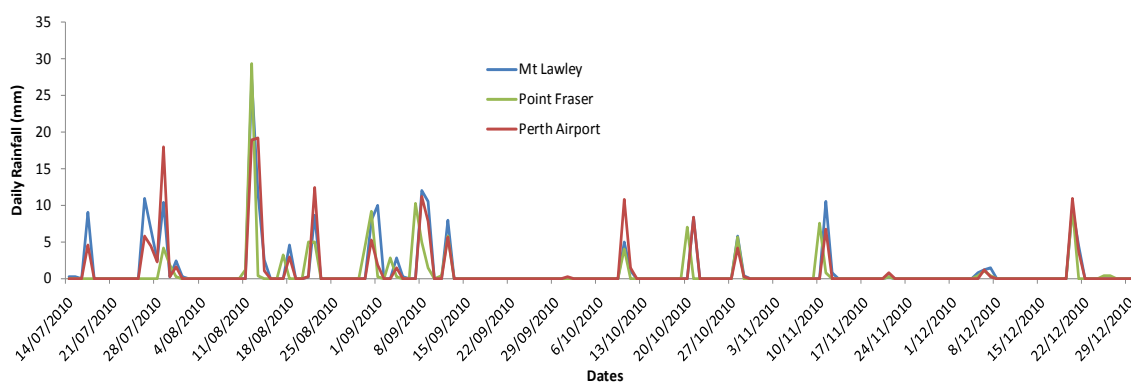
Perth had below average rainfall in 2010 only reaching 503.8 mm rather than the 850 mm long-term average (Bureau of Meteorology, Mt Lawley station). In Figure 5, daily rainfall measured at Point Fraser and by the Bureau of Meteorology (Mt Lawley and Perth Airport) are shown for comparison. These sites are all within a 10 km radius of each other, showing local variability in rainfall. Further, rainfall at Point Fraser was recorded each day from 12 am to 12 pm, while Bureau of Meteorology data are recorded at 9 am for each day and reflects the previous 24 h. This explains the Point Fraser data appearing out of sync by a day on some occasions.

Figure 5. Daily rainfall measured at Point Fraser, Mt Lawley and Perth Airport between 14/7/10 and 31/12/10. Mt Lawley and Perth Airport data from the Bureau of Meteorology and recorded 9 pm to 9 am, Point Fraser data recorded 12 am to 12 pm.

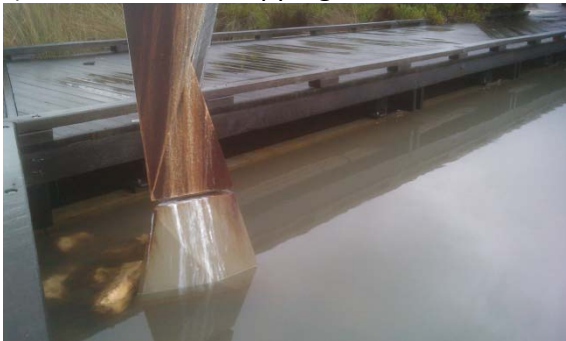
There were two intense rainfall events, one of 40.2 on the 23/3/10 and then on the 9/7/10 when 40.6 mm were recorded. The automated monitoring equipment was not operational until 14/7/10, missing both these events. During the July event water depth in Zone 1 exceeded the boardwalk wall allowing short cutting of flow into Zone 2 (Figure 6). No overtopping of the wall between Zone 2 and 3 was observed. No flows out of Zone 2 were observed; therefore it appears that all the inflows were captured by Zone 2, which would allow a measure of treatment prior to any subsequent release. High tides in the Swan River resulted in flooding of Zone 3 to a depth of approximately 200 mm at the boardwalk. These tides can be potentially destructive to armouring and poorly covered vegetated areas (see section on the Foreshore), and pose challenges to automated sampling equipment, which need protection from flooding). No evidence was seen of river water intrusion into Zone 2.

a) W1 – note overtopping of weir

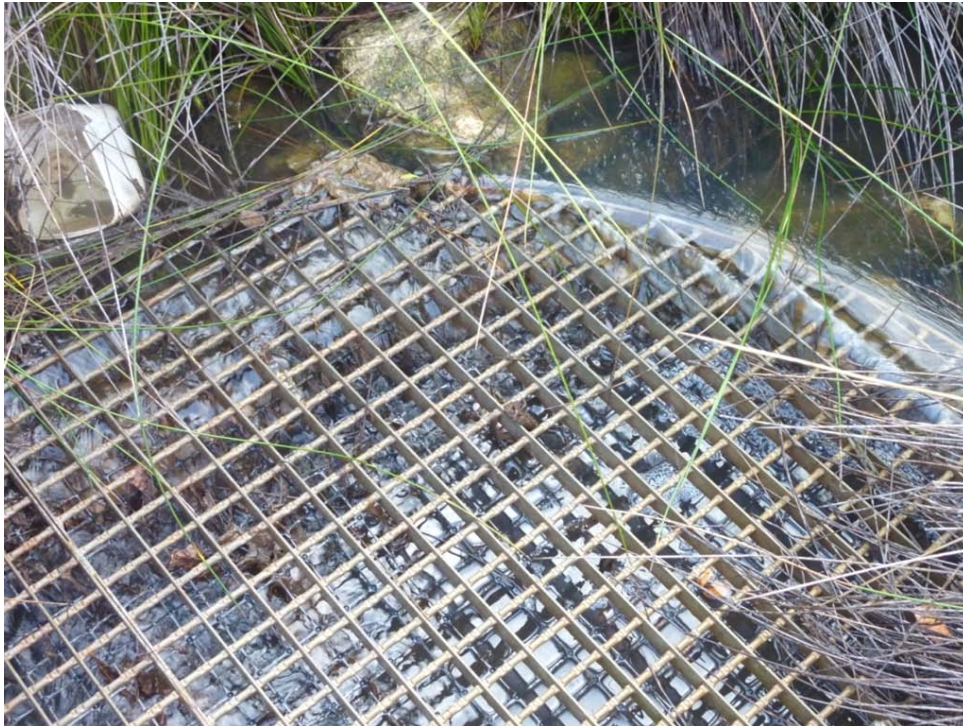
appear to be case currently, as the water level in the drain is continuously falling permitting backflow until the wetland is drained down to the level of the BUG. This water has not been observed draining into the Swan River via the highflow bypass pipe in the splitter box. When the water in Zone 1 is 30 mm (above the BUG and 10 mm below the weir) this equates to approximately 60 m³ of water draining back into the drain (Figure 8).

Figure 7. Water flowing from the wetland (W1) back into the drainage network via the bubble-up drain (taken 12/7/10).

It is recommended that the alternate exit/leak within the drainage network be identified and fixed. This is severely impacting on the function of the wetland, preventing it performing any useful function. Furthermore, loss of incoming water is resulting in increased need for pumping from Lake Vasto to maintain water levels.

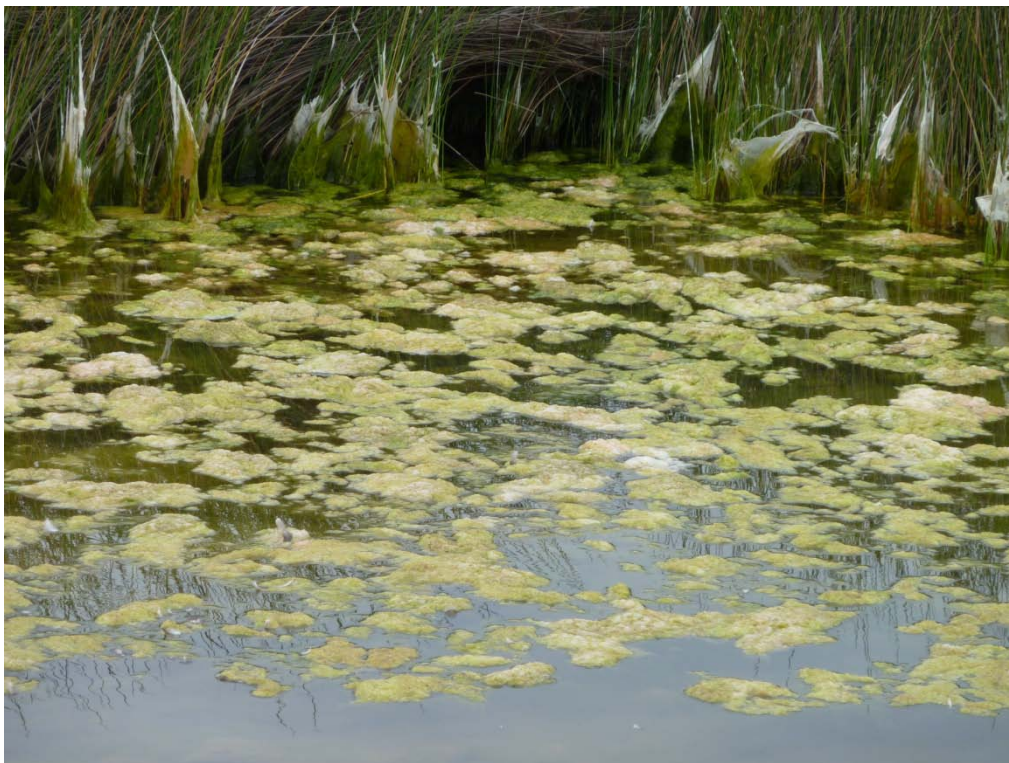
Dissolved oxygen concentrations were recorded in excess of 100% saturation, indicating excessive algal growth in the water (high rates of photosynthesis can temporarily raise % saturation above 100%), and coincided with high chlorophyll *a* (algal biomass) concentrations (Figure 13). Chlorophyll *a* concentrations were not high enough to cause aesthetic problems as the algae were mainly planktonic. However, W2 did suffer from a bloom of filamentous algae in September that did look unsightly (Figure 12). Filamentous algae can be easily controlled by harvesting by grounds staff.

Figure 12. Floating filamentous algae in W2 in September 2010.

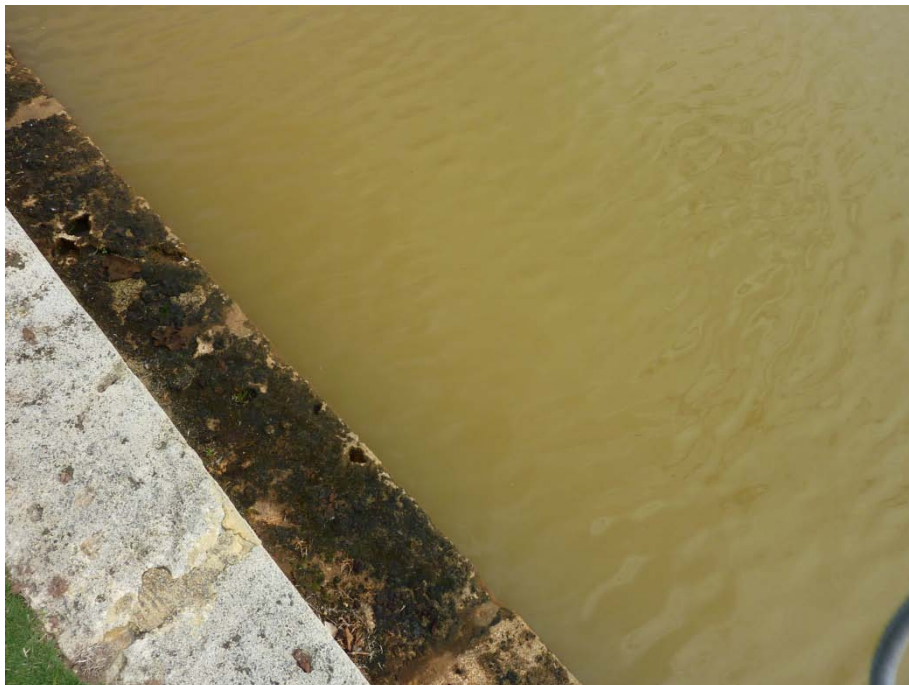
Figure 14. Photograph of Lake Vasto, highlighting the turbid waters

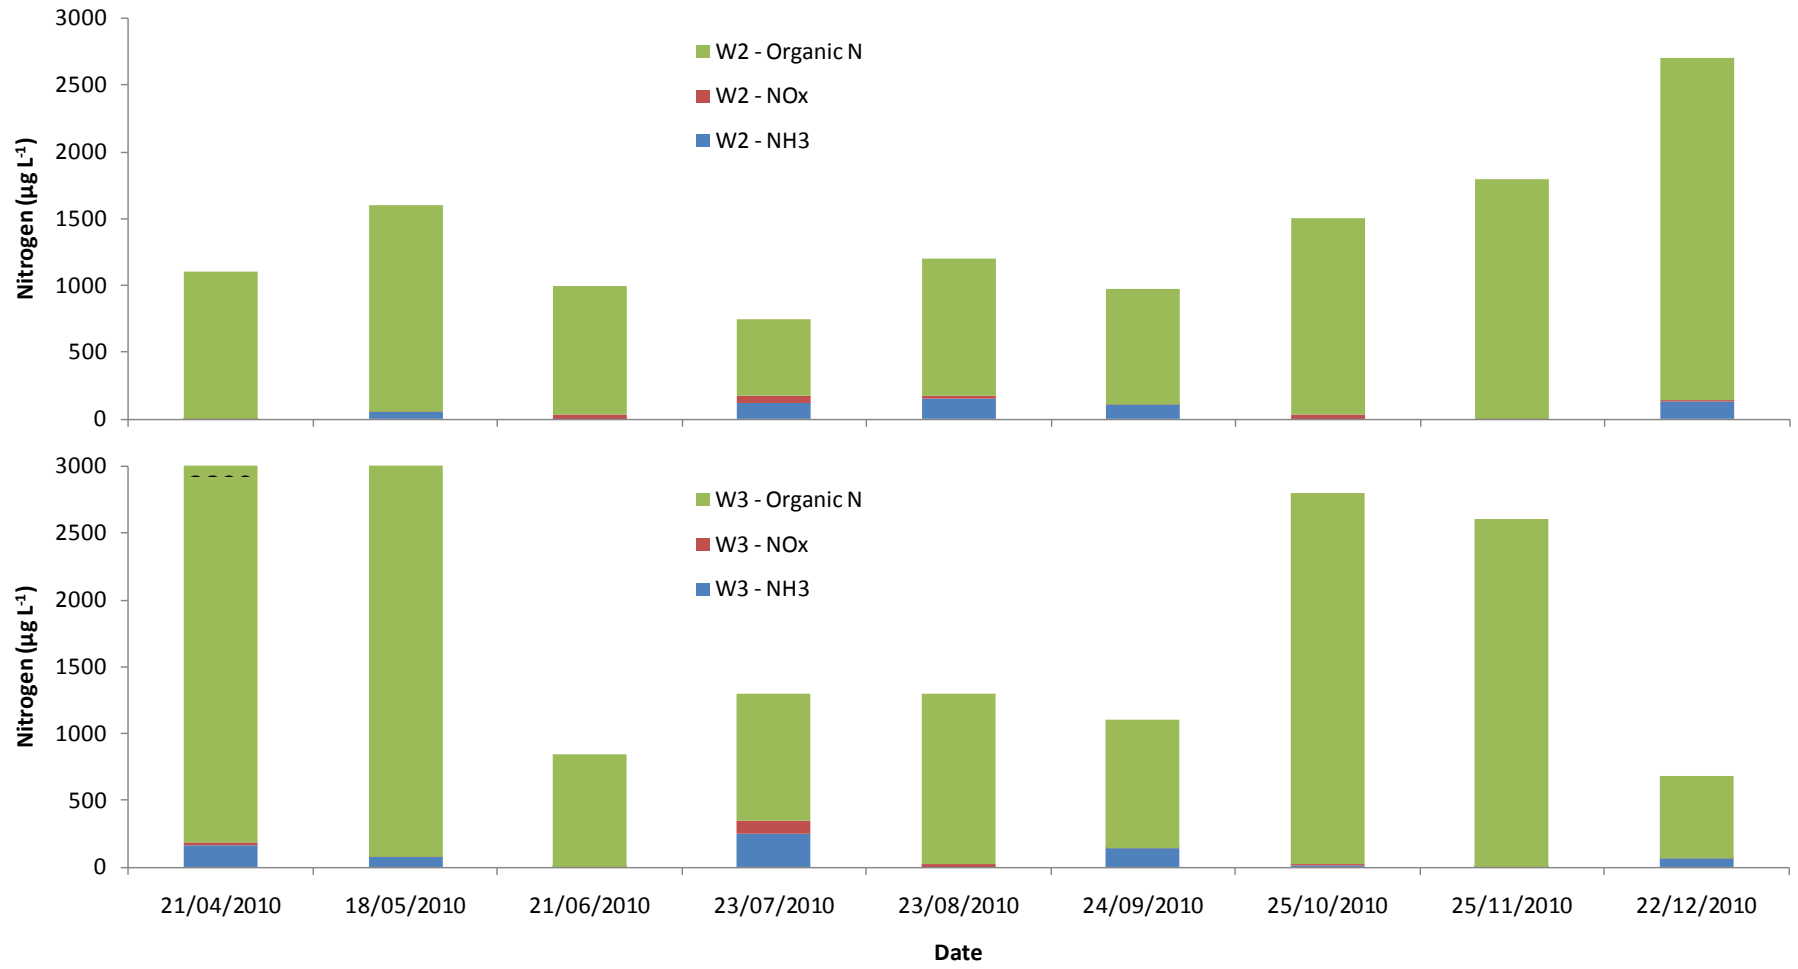
Lake Vasto contained relatively low Total N ($700 \mu\text{g L}^{-1}$) concentrations with NO_x and NH_3 being below detection ($<5 \mu\text{g L}^{-1}$). In all ponds, organic N (organic or particulate) accounted for the majority of the N present. In W1, which reflects any inflows, showed only high concentrations of NH_3 in August and September at 77 and 110 respectively, while $<60 \mu\text{g L}^{-1}$ (often below detection $<5 \mu\text{g L}^{-1}$) for the remainder of the months sampled. The Supersorb Activated Zeolite added to the sediment in Zone 1 is especially useful for removal of NH_3 from water (its main use is in the aquaculture industry). In W2, NH_3 concentrations generally remain unchanged or decrease from those reported for W1, however in July and August concentrations increase up to $150 \mu\text{g L}^{-1}$ (August). This suggests that the zeolite may be reducing NH_3 concentrations at low flows but in the most substantial inflows that occurred in July and August that it may have been less effective. NH_3 is also converted by nitrification to NO_x ; this appears to occur in July and August where NO_x concentrations increase in W2 and NH_3 concentrations are also high. In June, September to November NO_x concentrations ranged between 53 and $170 \mu\text{g L}^{-1}$ in W1. This contrasts with the lower concentrations in W2 which peaked in July at $52 \mu\text{g L}^{-1}$. NO_x is the preferred form of N for plant growth (although most other forms can also be used) and the drop in NO_x in W2 might be due to uptake (see Section 7.5.3 – high storage of N in plant biomass) or denitrification. Discharge from the wetland (if it occurred) comes from W4 and this pond showed low $<66 \mu\text{g L}^{-1}$ NH_3 and $<23 \mu\text{g L}^{-1}$ NO_x concentrations. W3 showed the highest NH_3 and NO_x concentrations at 250 and $100 \mu\text{g L}^{-1}$ respectively in July. Total N concentrations should aim to $<1000 \mu\text{g L}^{-1}$ to meet the Mounts Bay Water Quality improvement targets (Swan River Trust, 2009a), however in the Point Fraser higher concentrations were seen at all sites except W4. At W4, Total N concentrations exceeded the target on only one occasion (reaching $1100 \mu\text{g L}^{-1}$) suggesting that the wetland was successfully reducing Total N concentrations to the target level

Figure 16. Nitrogen (Total N = Organic N + NH₃ + NO_x) concentrations recorded at all sites in the wetland. Note on the 22/12/10 analytical error prevented Organic N being determined.

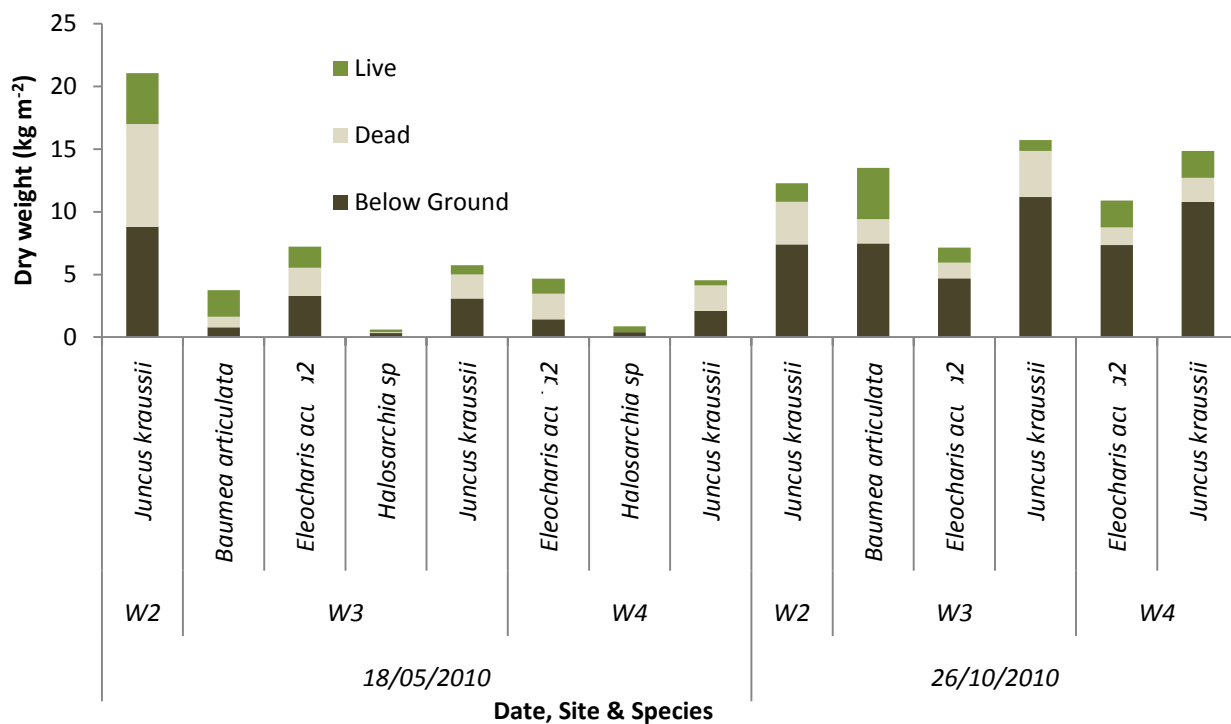
The stand of *J. kraussii* in W2 had a large quantity of dead material in May, however this had halved by October (Figure 26). None of the other *J. kraussii* stands showed a similar response, with similar quantities in both seasons. The reason for the large amounts of dead material in *J. kraussii* are unclear as it is unlikely that W2 would have low water levels or water quality issues that could account for it. With the exception of W2, where it appeared to decline for *J. kraussii* all other species generally increased slightly in live biomass between the seasons, reflecting the likely spring growth. The poor winter conditions (low rainfall) may have contributed to the small increase. Below ground biomass appeared to increase substantially in all species at all sites, except for little change for *J. kraussii* in W2. This growth in below ground biomass in a poor rainfall year (lowest on record; Bureau of Meteorology), shows that the plants are becoming established should respond well to a good growth season.

Figure 26 Mean dry weight (g) of live, dead and below material from collected species, from sites on two occasions.

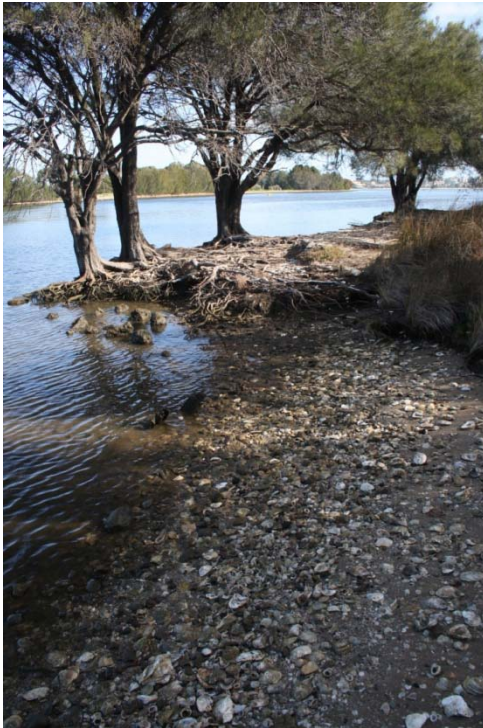
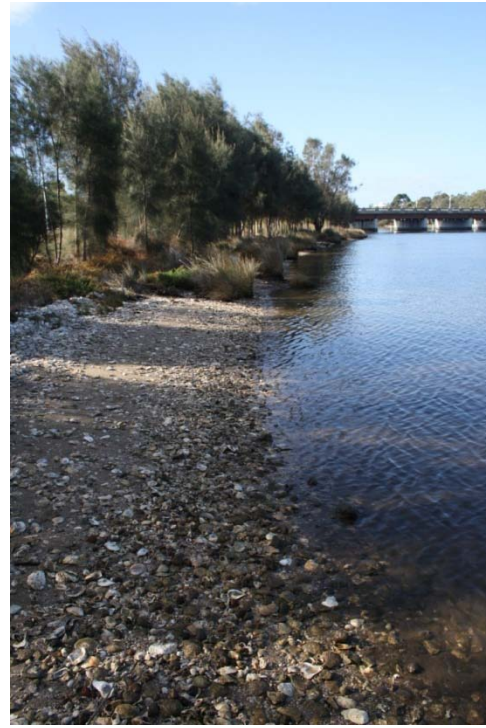
Foreshore Profiles of Site F1B

The condition of each foreshore monitoring site is shown in Table 13. Sites F1A and F1B had areas with sparse vegetation and this had resulted in some undesirable erosion and in F1B the rock armouring had ceased to be effective and needs management action to remedy.

Site F2B shows some human trampling. Armouring of areas around F1A and F1B needs to be repaired and replanted to prevent further damage to the foreshore.

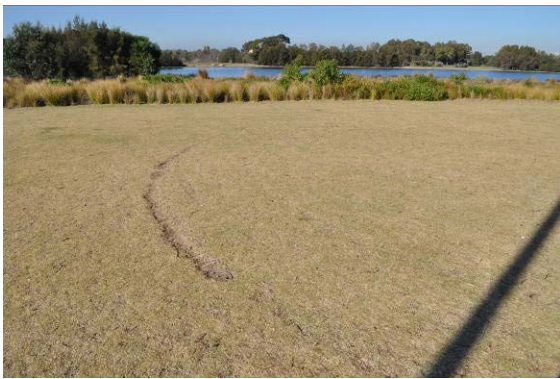
VANDALISM

Damaged lawn from vandals conducting donuts with cars

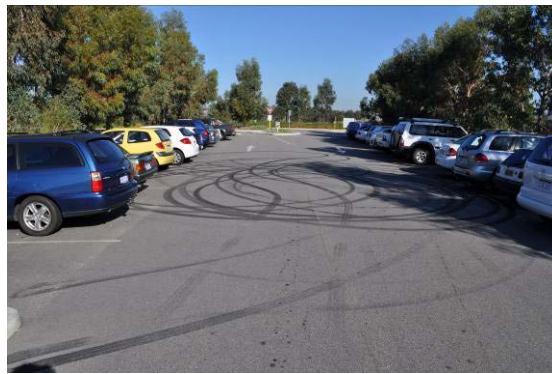
Tire marks in carpark from vandals conducting donuts and burnouts with cars
