National Park Service
Cultural Landscapes Inventory
2010

Bryce Canyon Lodge/Deluxe Cabins
Bryce Canyon National Park

Inventory Unit Summary & Site Plan

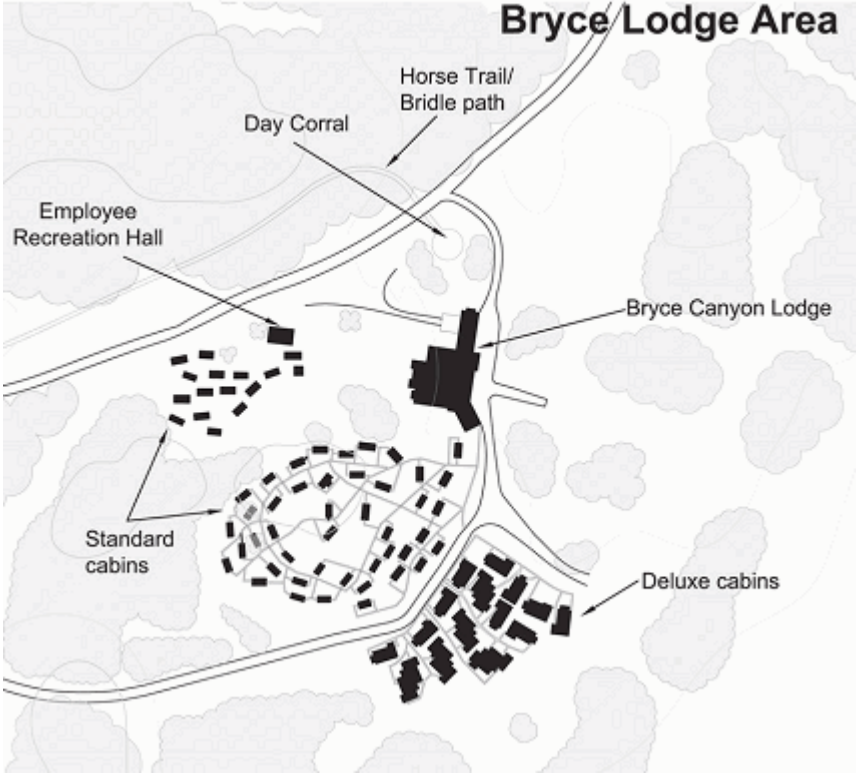
Plan of Bryce Canyon Lodge Area, 1929 (2009 CLR).

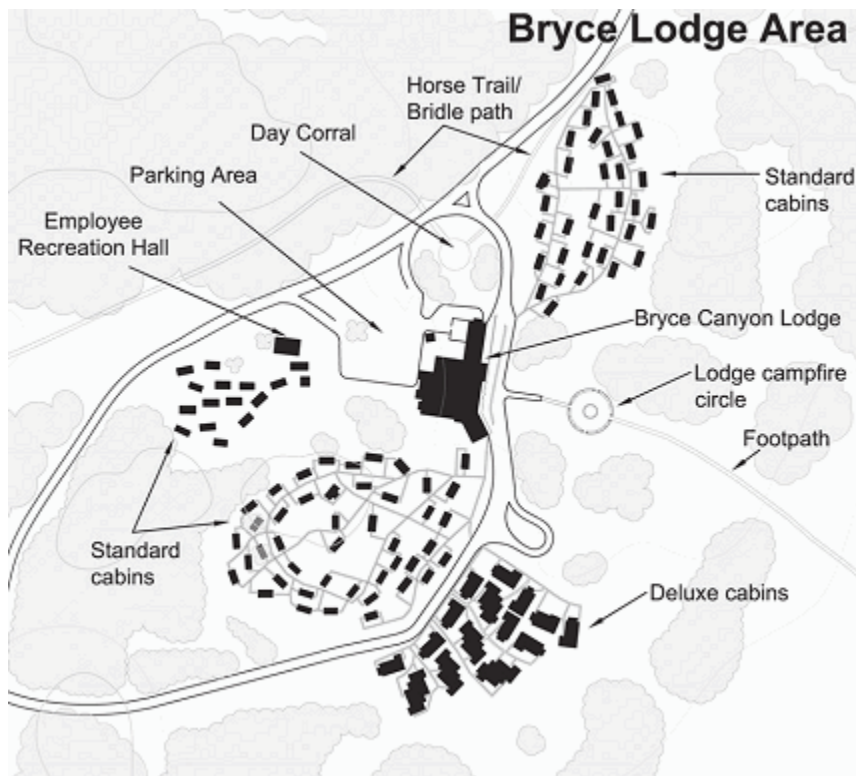
Plan of Bryce Canyon Lodge Area, 1932 (2009 CLR)

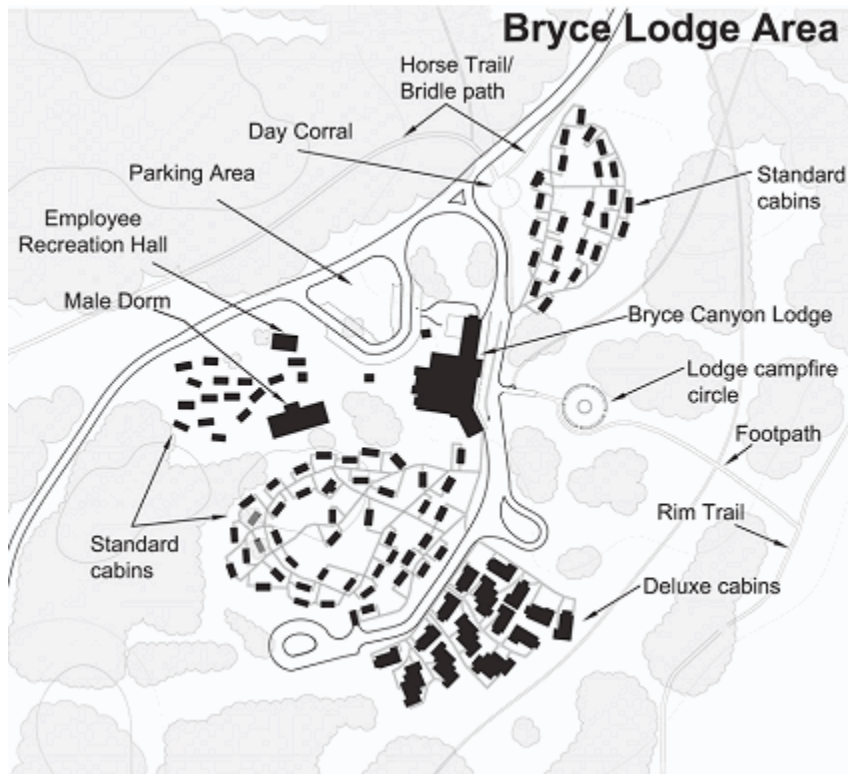
Plan of Bryce Canyon Lodge Area, 1955 (2009 CLR).

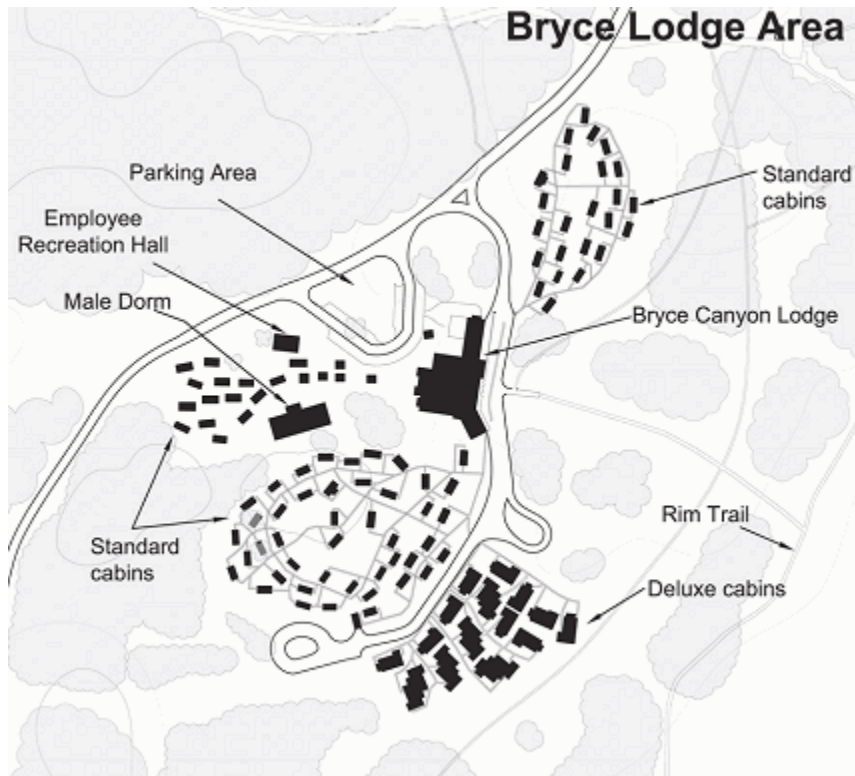
Plan of Bryce Canyon Lodge Area, 1966 (2009 CLR).

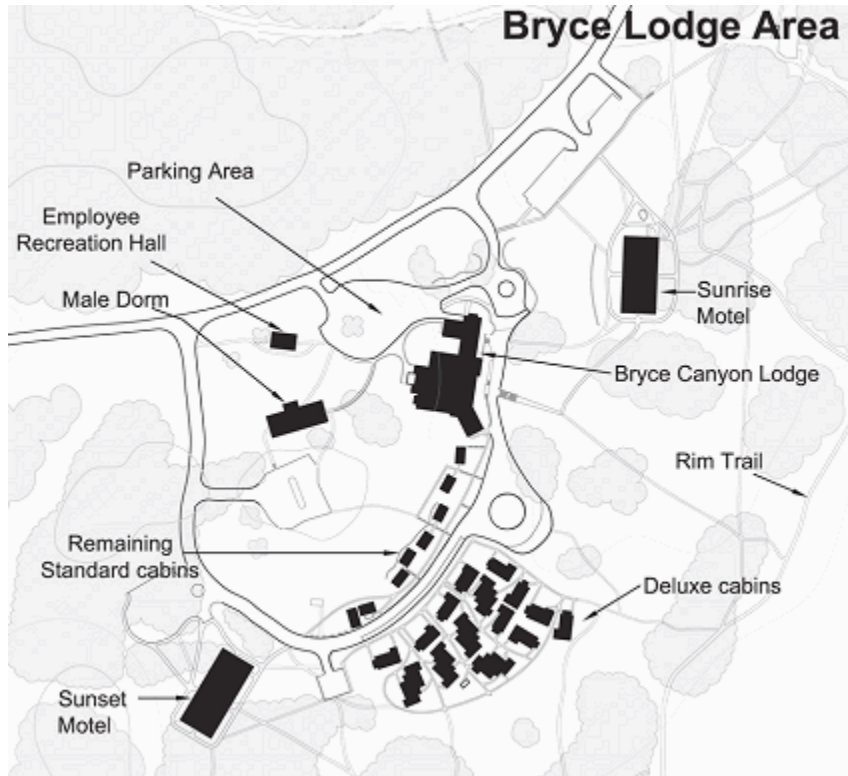
Plan of Bryce Canyon Lodge Area, 2006 (2009 CLR).

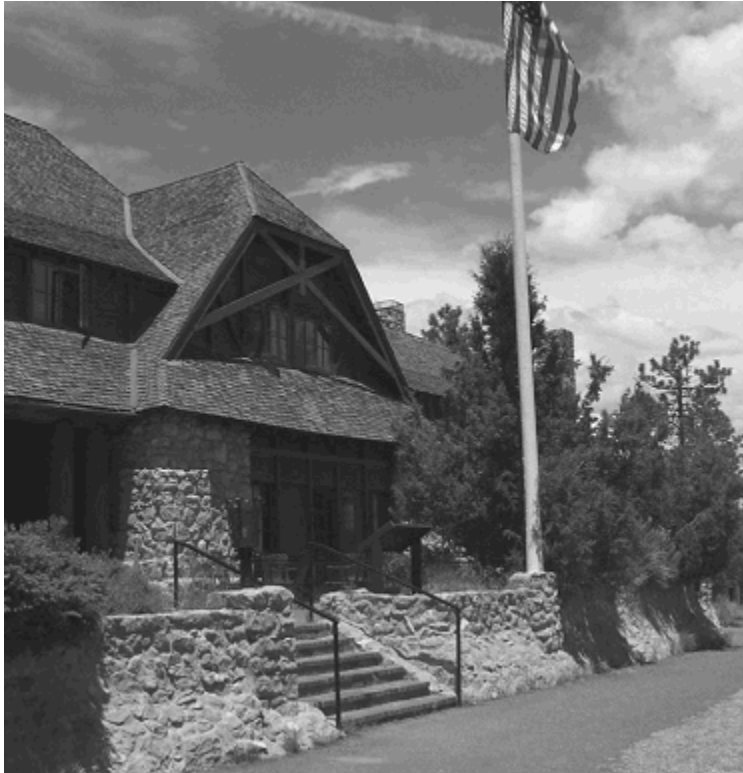
Front of the Lodge with flagpole, steps, and surrounding planting areas (2009 CLR).

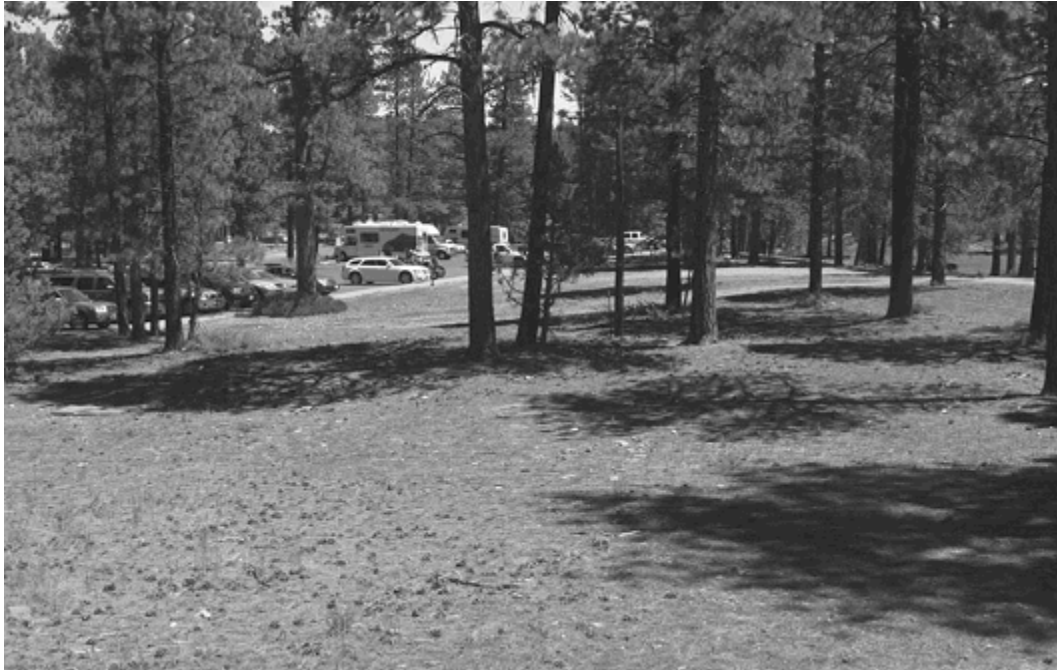
Former location of a cluster of Standard Cabin units now reverted to open space between the Lodge and the Sunrise Motel (2009 CLR).

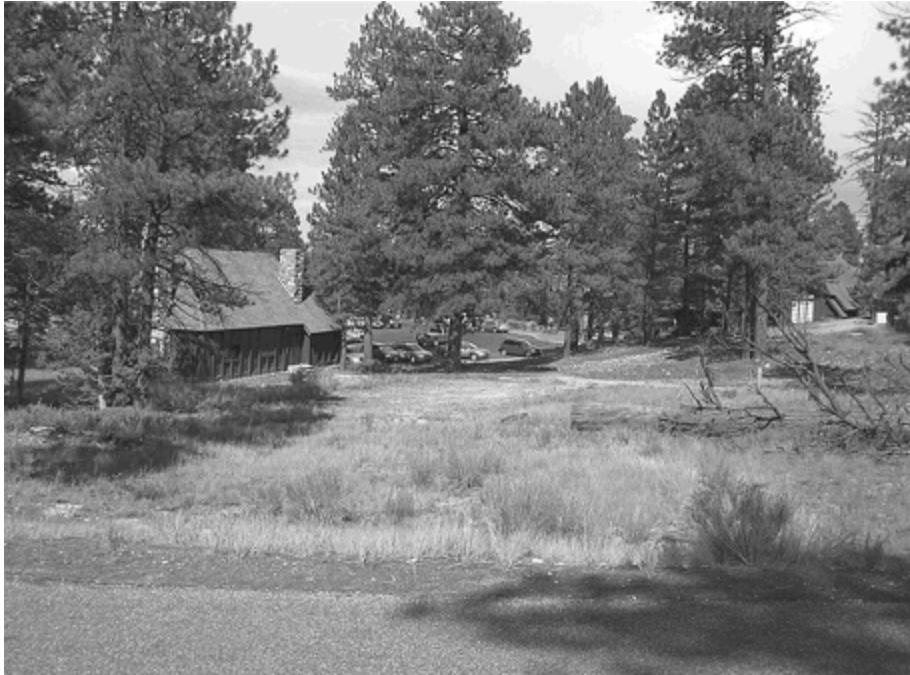
Slope between the rear of the Lodge and the dormitory buildings near the Administrative parking area (2009 CLR).

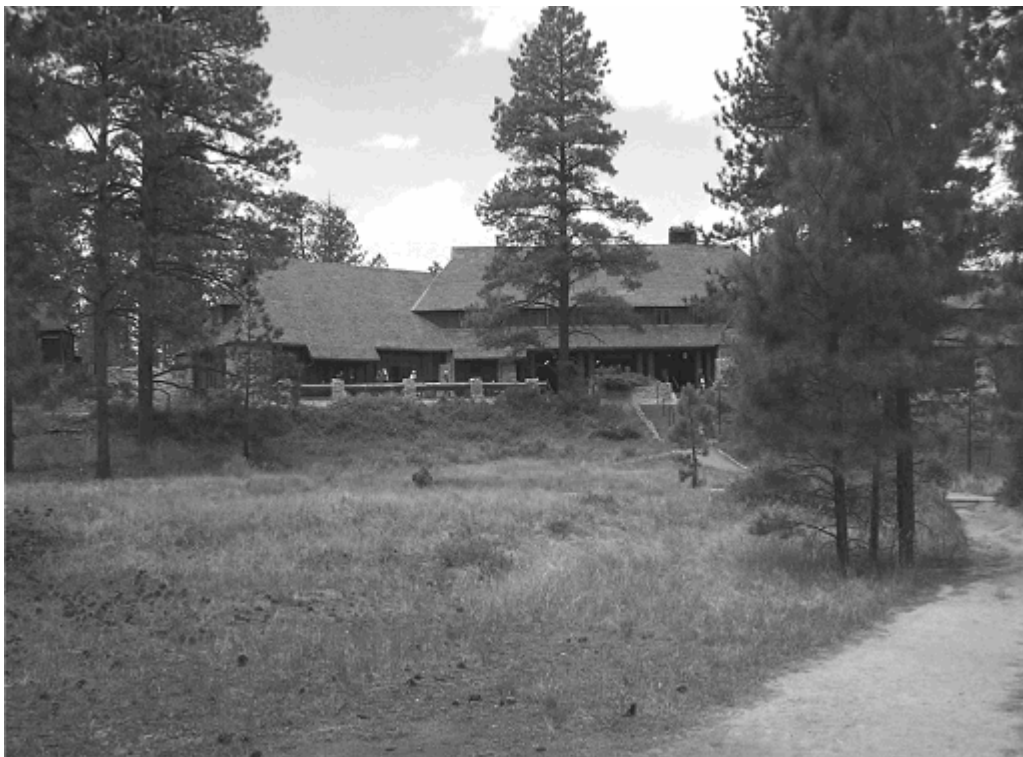
View from central trail looking toward Lodge showing surrounding topography. The clearing in the foreground was the site of a former corral and parking area (2009 CLR).
