Pacific Crest Well Pipeline Revegetation Project

2019 Annual Report

Scott E. Heisler, Carolyn S. Wyler, and Jennifer S. Hooke

April 2020

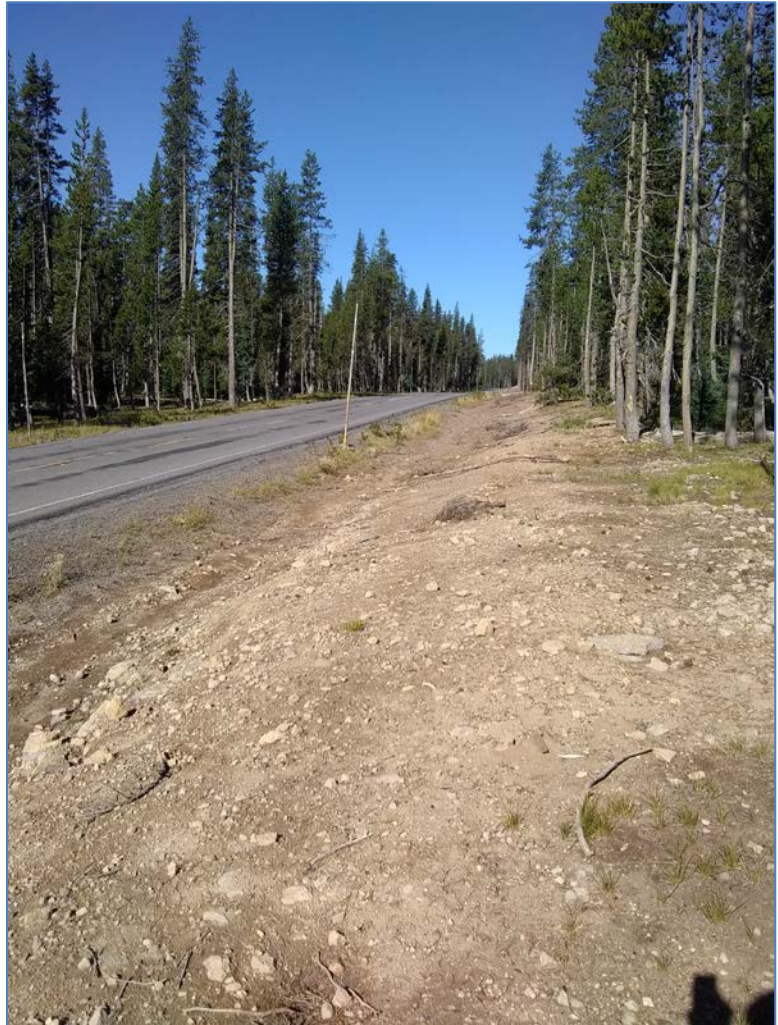
Figure 1. Disturbed areas along Highway 62 have been slowly revegetating since 2017. This area will be further impacted by installation of an underground electrical conduit. Photo by Scott Heisler.

Revegetation efforts targeted disturbed areas surrounding the wellhead and expanded Pacific Crest Trail parking lot, the length of pipeline/conduit trenching alongside Highway 62 (Figure 1), the area alongside the existing Mazama storage tanks access road, and the run of pipeline/conduit trenching from the Mazama storage tank access road to the Mazama booster pump under the Annie Creek bridge on Munson Valley Road. These areas notably exclude the run of pipeline/conduit trenching connecting the Mazama storage tank access road area to the Highway 62 roadside area, as this stretch follows an old highway grade that will be utilized as a service road. The project area is highlighted in Figure 2.

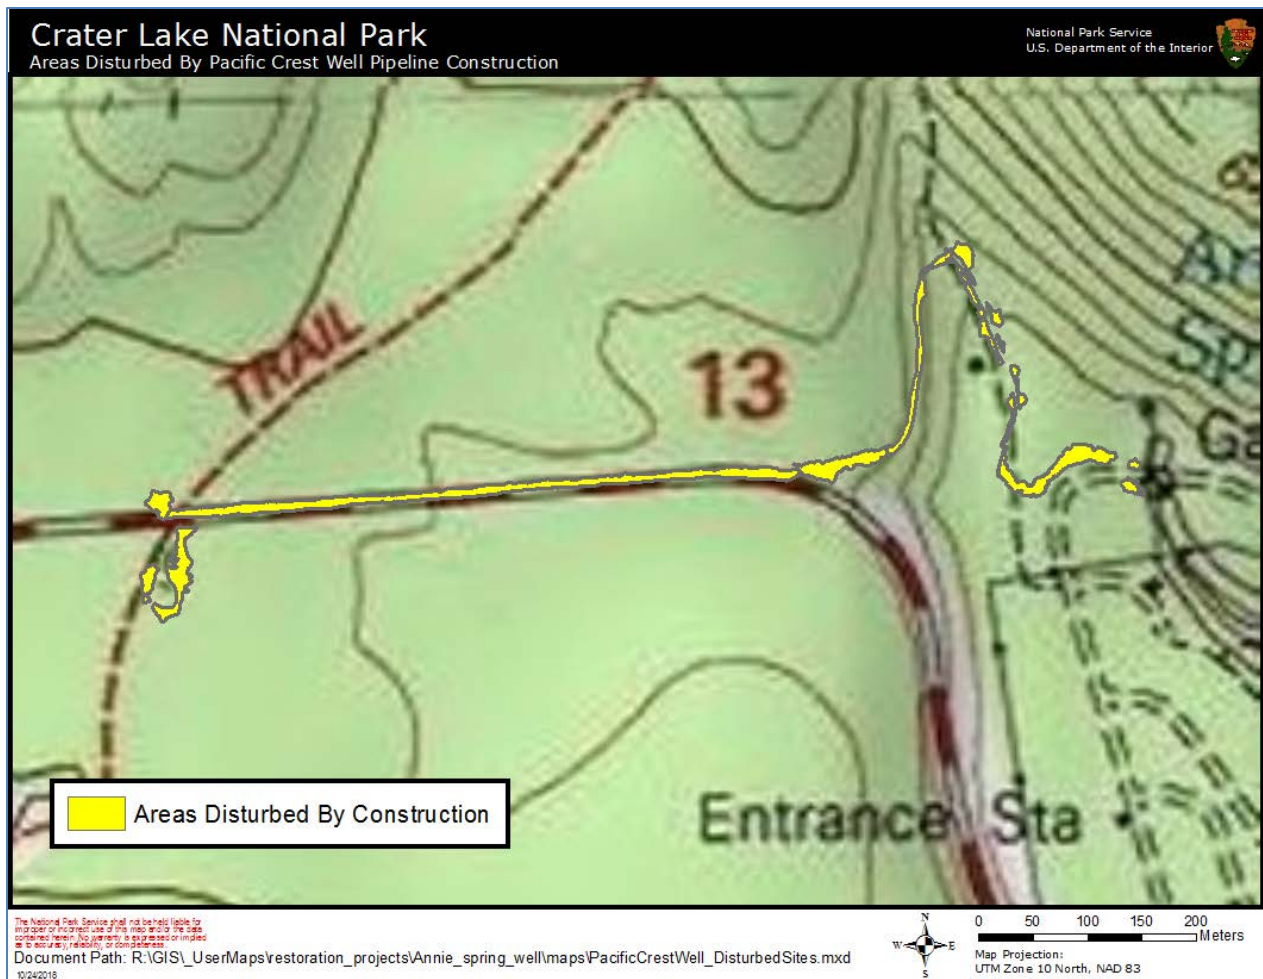
Figure 2. Areas disturbed by the PCT Well Pipeline are highlighted in yellow and total 2.3 acres. Map by Scott Heisler.

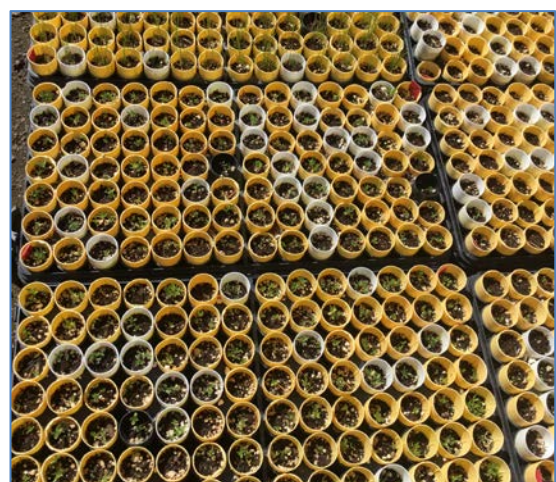
Figure 3. Plants growing for restoration at the Ball Diamond. Photo by Jen Hooke.

Two rounds of plant propagation (Figure 3) have been conducted to source containerized native plants for use in this project’s rehabilitation efforts: one in spring 2018, and another in fall 2018. The plants are housed at the Botany program’s nursery facility located at the Ball Diamond area, and were cared for throughout the 2019 growing season according to the program’s established native plant nursery protocols (on file on the Botany server). For overwintering, all of the pots were placed in a tight group, and mulch was packed around the perimeter to protect roots from exposure to severe cold and desiccation (Figure 4).

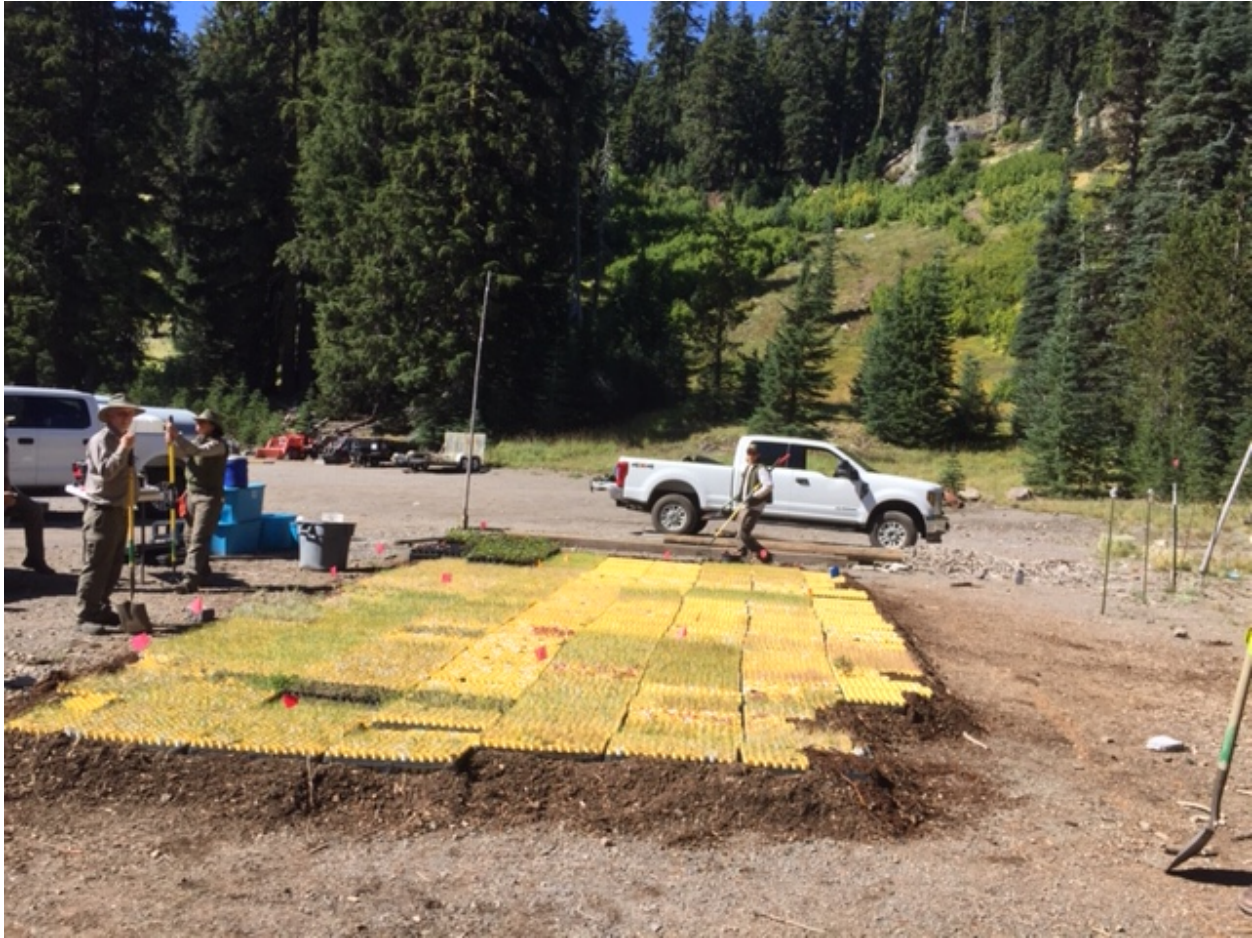
Figure 4. Preparing plants for overwintering by insulating the perimeter with mulch. Photo by Carrie Wyler.

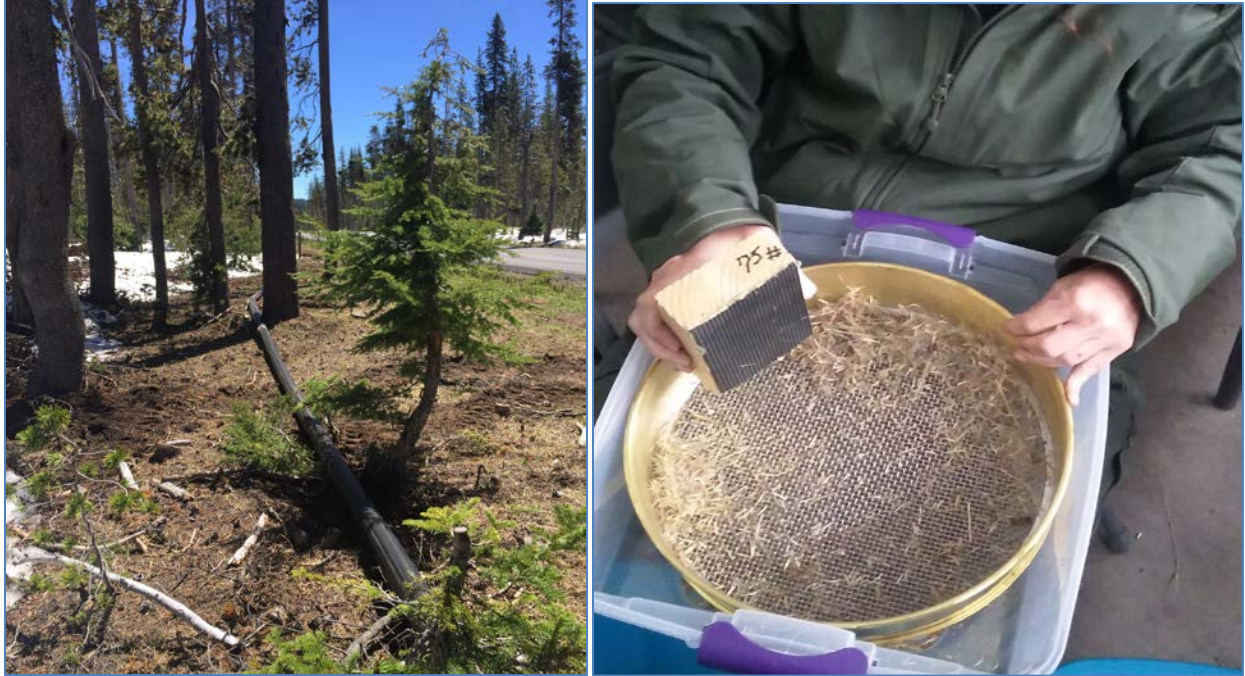
Figure 5. Depauperate understory area (left). Cleaning seed (right). Photos by Scott Heisler.

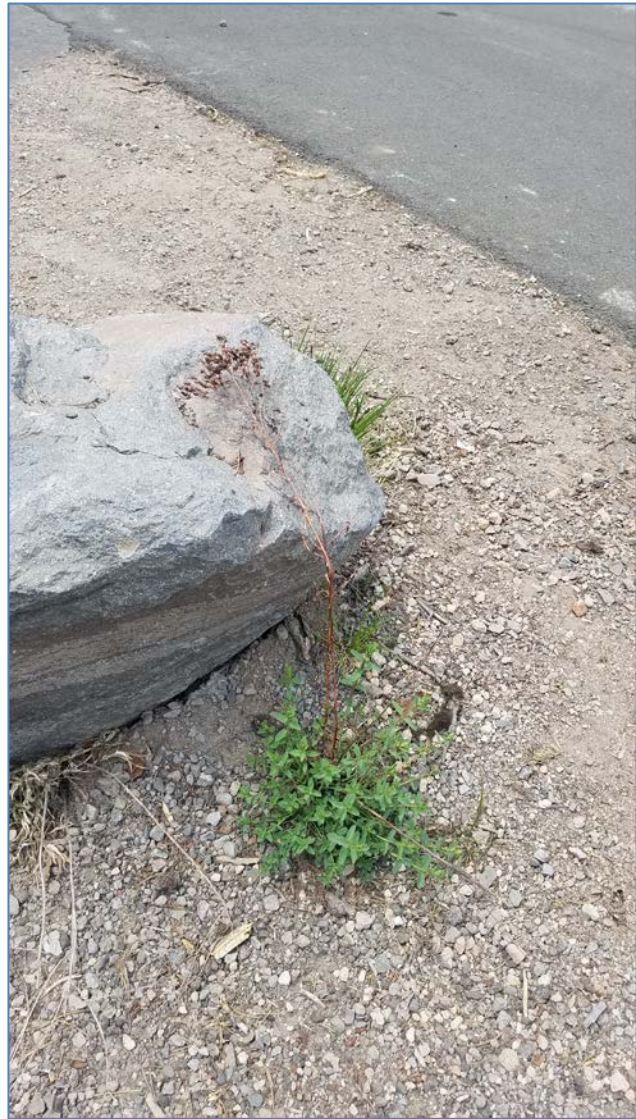
Figure 6. Roadside St. John's wort growing in the project area. Photo by Elena Olsen.

Given the project area location, IVM stands as a critical component of a successful revegetation effort (Figure 6). Highway 62 serves as both a portal into the Park, as well as a thoroughfare for vehicles crossing between the Rogue and Klamath basins. The PCT trailhead is a staging area for horses and pack-stock and the PCT is a popular trail through the Park. Mazama Village and Campground are located near the PCW pipeline corridor, and both areas have well-established populations of invasive plants. The heavy usage received by this area increases the risk for introduction of invasive plant seeds coming from outside the Park; combined with the high levels of disturbance found in the PCW pipeline corridor, establishment of new invasive plant populations is likely.

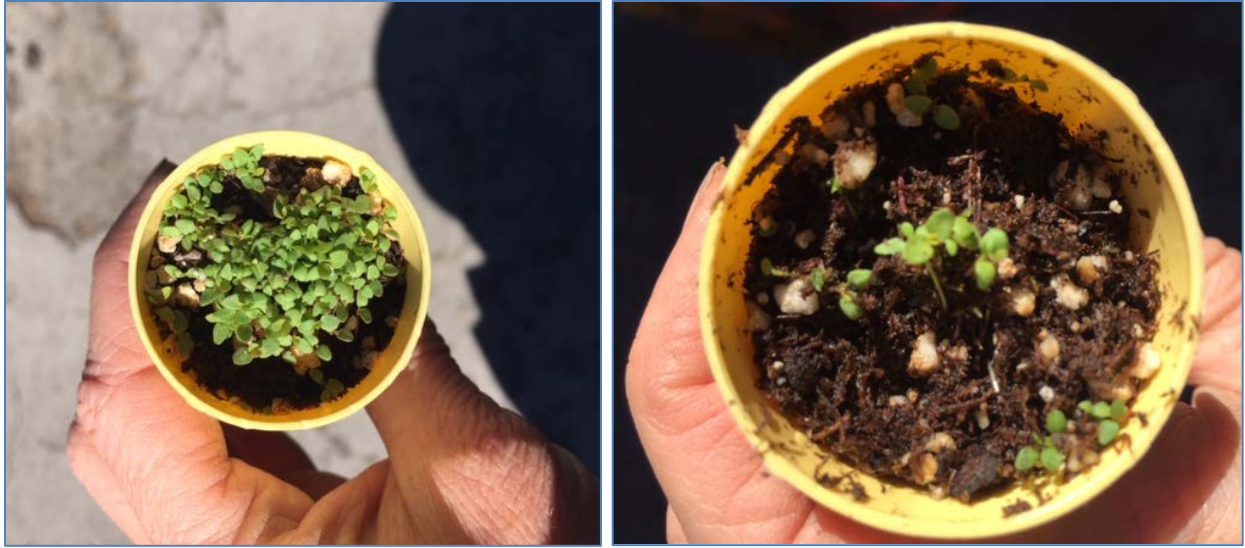
Figure 7. Thinning germinated seedlings to promote plant vigor and size. Photos by Carrie Wyler.

Revegetation efforts in 2019 were focused on care of previously propagated containerized plants awaiting outplanting (Figure 7), and continued collection of plant materials. All restoration sites were monitored in 2019; updated site monitoring documentation is included in Appendix A.

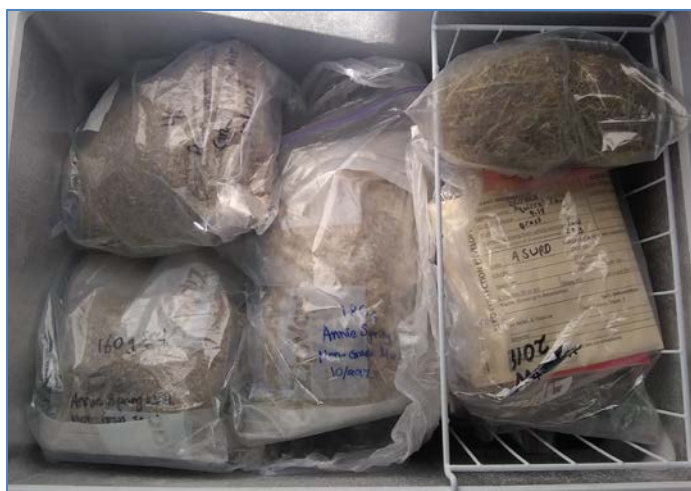
Figure 8. Seed in storage in the Botany freezer. Photo by Scott Heisler.

A total of 1,414 g of rough-cleaned native seed was collected during the 2019 field season, as outlined in Table 3. The total amount of seed in storage is also detailed in Table 3. This seed was dried and cleaned at the Park and is stored in the Botany program’s seed storage freezer (Figure 8). This will be available for broadcast seeding upon completion of construction. Additional seed collection efforts will not be made during the 2020 field season. After disturbed areas are planted and seeded in fall 2020, the area will be monitored for recovery and restoration success. Additional seed may be collected (summer 2021-22) to fill in poorly recovering sites as needed, although there are presently no funds to support this work.

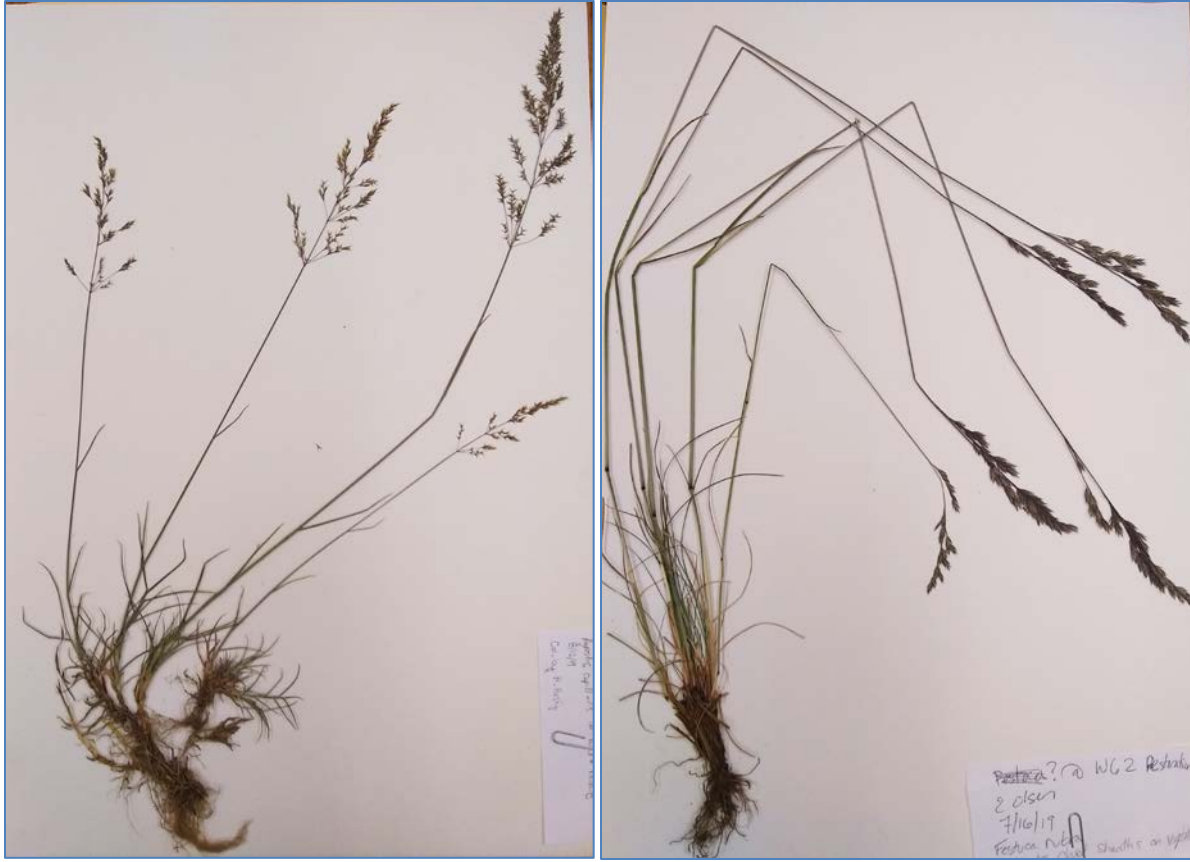
Figure 10. Two new-to-the-project-area invasive plant species encountered in 2019: colonial bentgrass (left) and red fescue (right). Photos by Scott Heisler.

The entire project area was surveyed for invasive plant species, including 150 historic populations. Twenty-seven populations of invasive plant species were encountered, mapped, and treated in 2019 (Figure 9). Populations of two invasive plant species new to the project area were discovered alongside the installed pipeline on Highway 62: red fescue (*Festuca rubra*), and colonial bentgrass (*Agrostis capillaris*) (Figure 10). The most commonly encountered invasive plant species in the project area were colonial bentgrass (219 plants); smooth brome (*Bromus inermis* – 123 plants); sheep sorrel (*Rumex acetosella* – 536 plants); and dandelion (*Taraxacum officinale* – 157 plants), with a total of 1,103 plants treated. Other invasive plant species encountered included bull thistle (*Cirsium vulgare*), red fescue (*Festuca rubra*), St. John’s wort (*Hypericum perforatum*), timothy (*Phleum pratense*), narrowleaf plantain (*Plantago lanceolata*), and red sandspurry (*Spergularia rubra*).

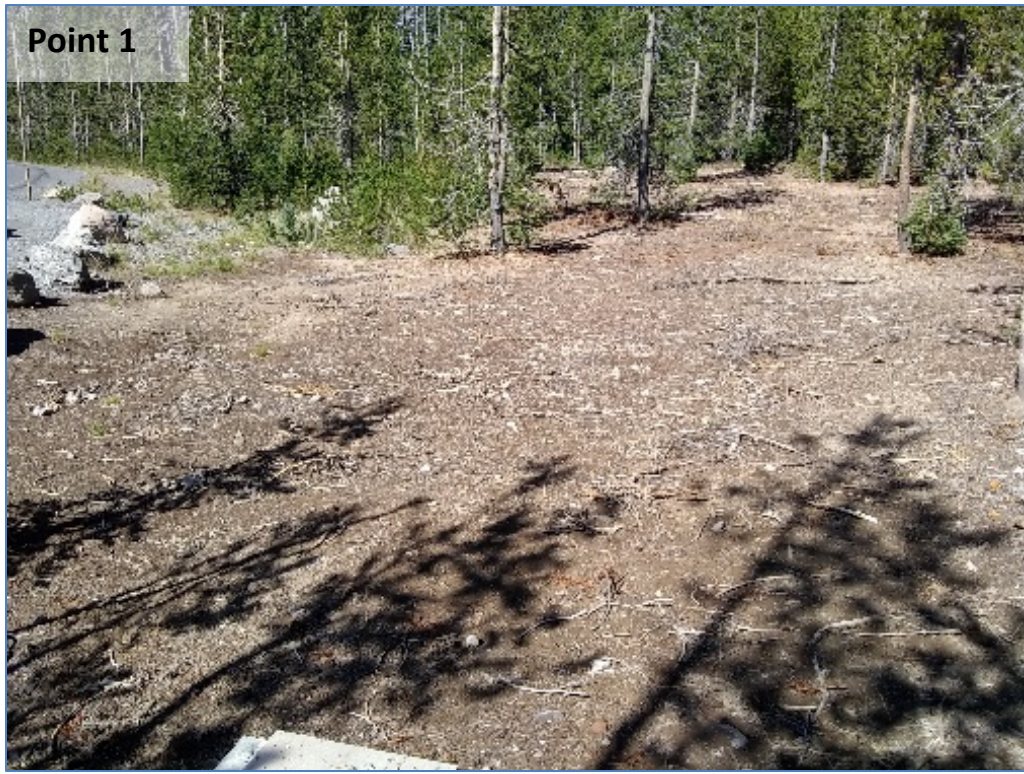
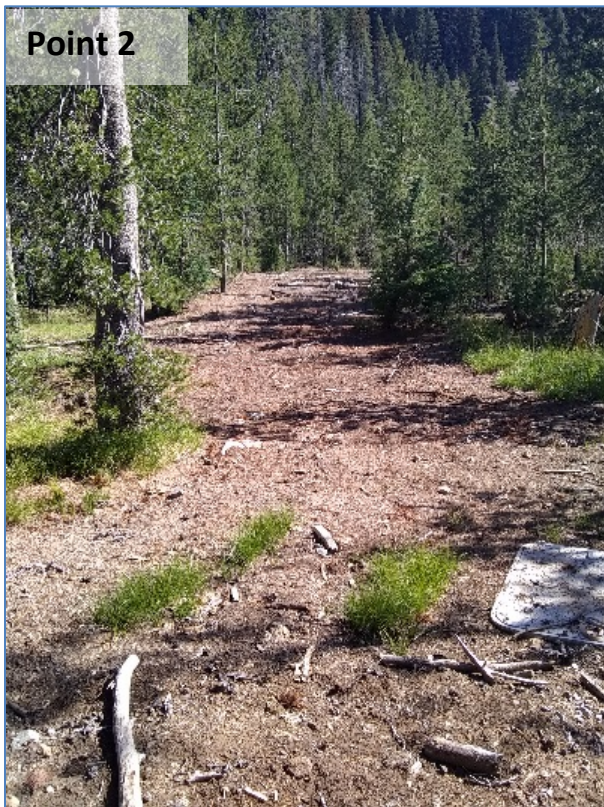
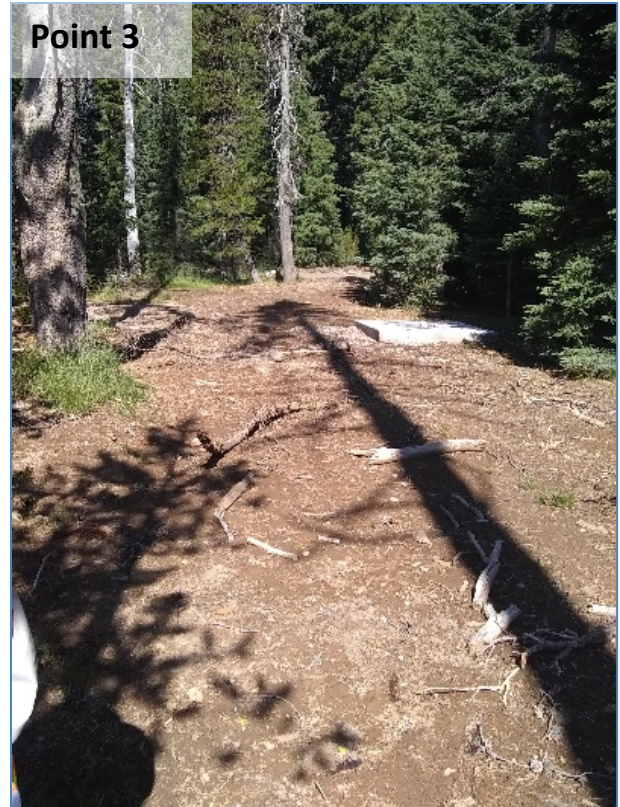
2019 Photos: Lower Section

Date: 8/12/19	Recorder(s): CW, SH	Time Since Restoration: 1 year*
Site ID/Name: PCT well lower, near south entrance station		
Survivorship from planting/seeding (High/Med/Low): Medium		
Repeat Photography Photopoints (UTM Zone 10, NAD83)		
1	UTME: 0567840	UTMN: 4746917
2 (facing North)	UTME: 0567768	UTMN: 4746882
3 (facing West)	UTME: 0567768	UTMN: 4746882
Regeneration Assessment		
Total Vegetation Cover: 5%		
Species Cover (As a percentage of the total vegetation):		
Species	Common Name	Relative % Cover
Grasses/Sedges/Rushes	Graminoids	78
<i>Lupinus lepidus</i> var. <i>lobbii</i> / <i>Lupinus andersonii</i>	Prostrate lupine/ Anderson's lupine	2
<i>Eriogonum marifolium</i> var. <i>marifolium</i>	Mountain buckwheat	1
Conifers (seedlings)	Seedling conifers	10
<i>Calyptridium umbellatum</i>	Pussypaws	7
<i>Gayophytum diffusum</i> ssp. <i>parviflorum</i>	Nuttall's groundsmoke	2
	TOTAL	100%
Site Notes: (note erosion, tire tracks, etc.)

Invasive Plant Assessment		
Invasive Plant Species	# Present at Restoration	# Present 2019
none	0	0
General Comments/ Additional Site Needs and Recommendations:		
<p>*Only salvaged plants were replanted and approximately 70 grams cleaned seed mix was distributed on the edges of the site. Area wasn't fully planted or seeded because a truck will need to be driven into the area to place cabling in the vaults.</p> <p>-Salvaged plants that were replanted are doing well, not many seedlings coming up.</p>

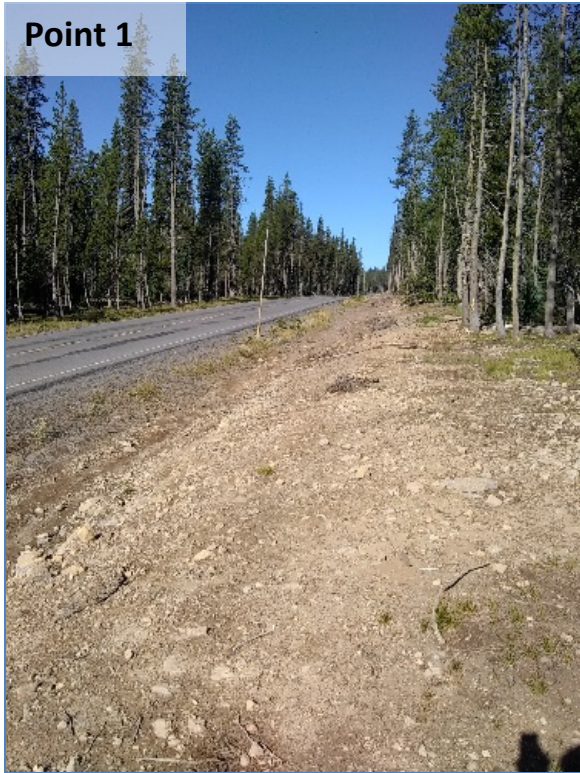
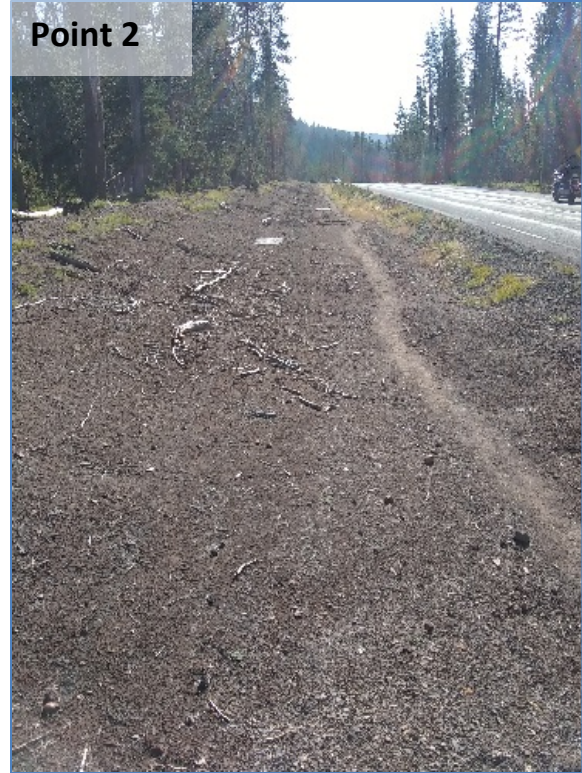
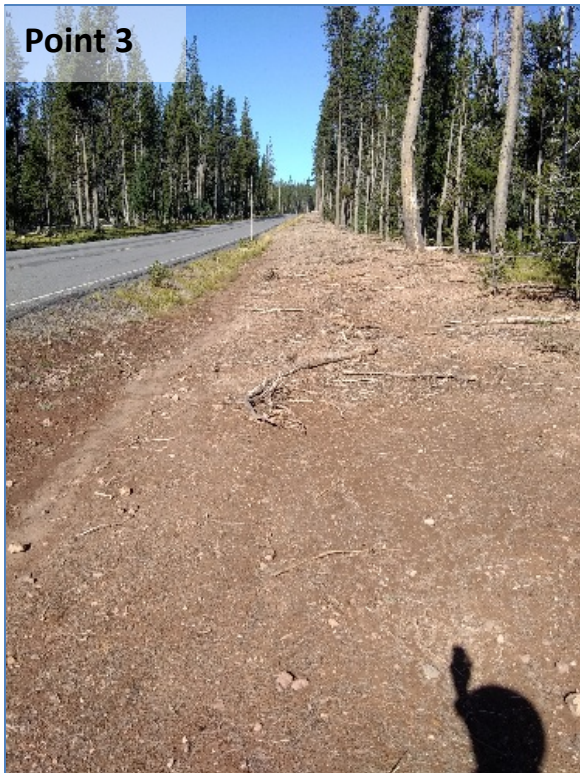
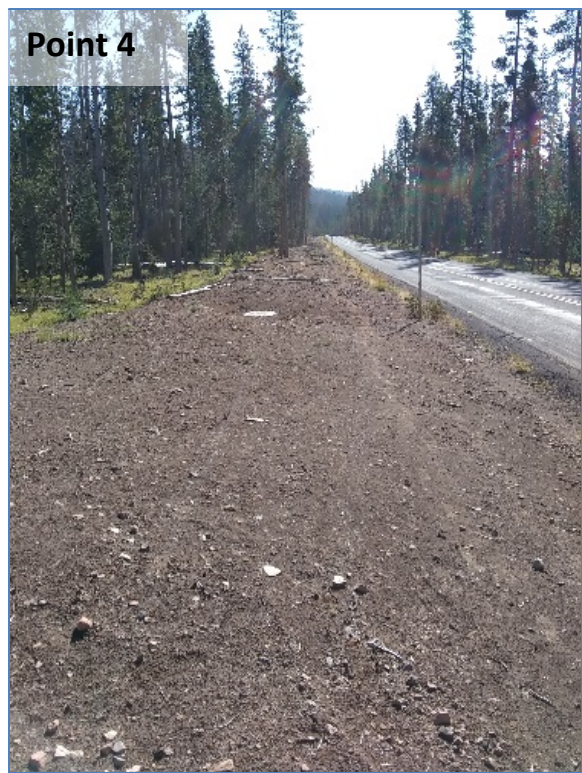
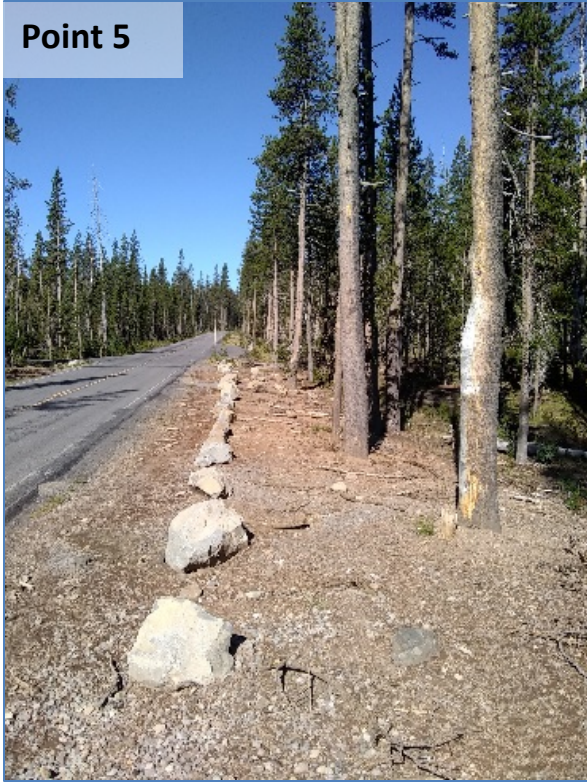
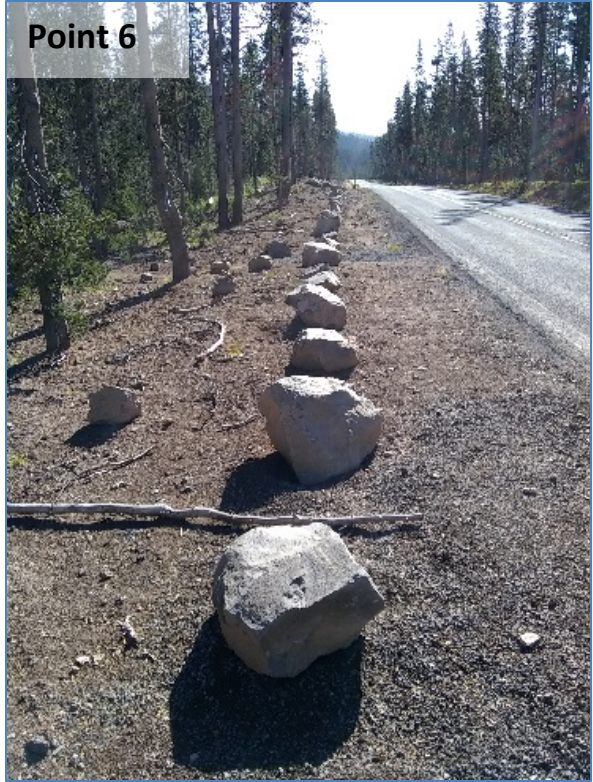
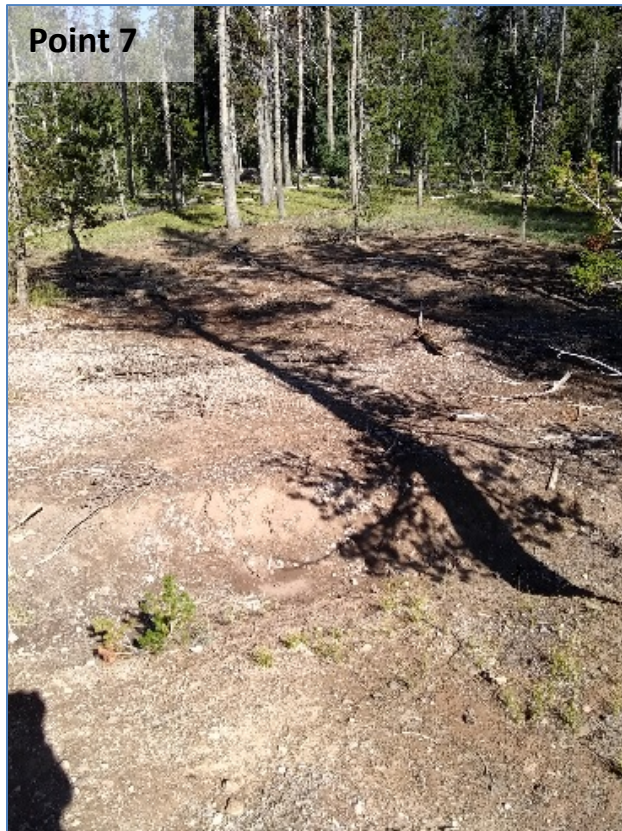
2019 Photos: Highway 62 Roadside

Date: 8/12/19	Recorder(s): CW, SH	Time Since Restoration: 1 year*
Site ID/Name: PCT well upper, Hwy 62 roadside		
Survivorship from planting/seeding (High/Med/Low): High		
Repeat Photography Photopoints (UTM Zone 10, NAD83)		
1 (end)	UTME: 0567494	UTMN: 4746900
2 (Facing East)(middle area)	UTME: 0567322	UTMN: 4746888
3 (Facing West)(middle area)	UTME: 0567322	UTMN: 4746888
4 (Facing East)	UTME: 0567049	UTMN: 4746873
5 (Facing West)	UTME: 0567036	UTMN: 4746867
6 (end)	UTME: 0566976	UTMN: 4746860
7 (area behind pullout)	UTME: 0566976	UTMN: 4746860
Regeneration Assessment		
Total Vegetation Cover: 5%		
Species Cover (As a percentage of the total vegetation):		
Species	Common Name	Relative % Cover
Grasses/Sedges/Rushes		35
<i>Lupinus lepidus</i> var. <i>lobbii</i> / <i>Lupinus andersonii</i>	Prostrate lupine/ Anderson's lupine	31
<i>Phacelia hastata</i> ssp. <i>compacta</i>	Compact phacelia	1
<i>Conifers</i> (seedlings)	Seedling conifers	5

<i>Gayophytum diffusum</i> ssp. <i>parviflorum</i>	Nuttall's groundsmoke	1
<i>Calyptidium umbellatum</i>	Pussypaws	20
<i>Anaphalis margaritacea</i>	Pearly everlasting	2
<i>Epliobium</i> species	Willowherb	5
	TOTAL	100%
Site Notes: (note erosion, tire tracks, etc.)		
Some tire tracks		
Invasive Plant Assessment		
Invasive Plant Species	# Present at Restoration	# Present 2019
<i>Bromus inermis</i>	Smooth brome	multiple
<i>Poa compressa</i>	Canada bluegrass	multiple
<i>Taraxacum officinale</i>	Common dandelion	multiple
<i>Plantago lanceolata</i>	English plantain	1
General Comments/ Additional Site Needs and Recommendations:		
<p>*Only salvaged plants were replanted and approximately 400 grams of rough-cleaned seed mix was distributed. Area wasn't fully planted or seeded because cable still needs to be pulled through the vaults in the ground in the future; therefore, large trucks will be driving on the area.</p>

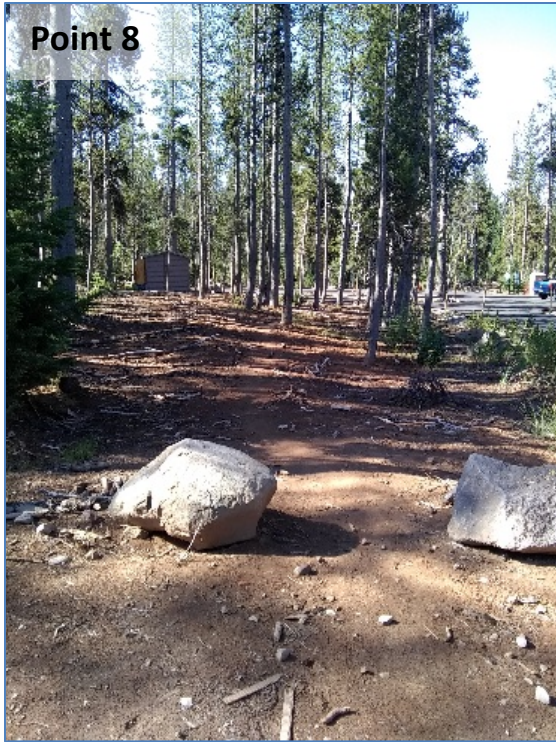
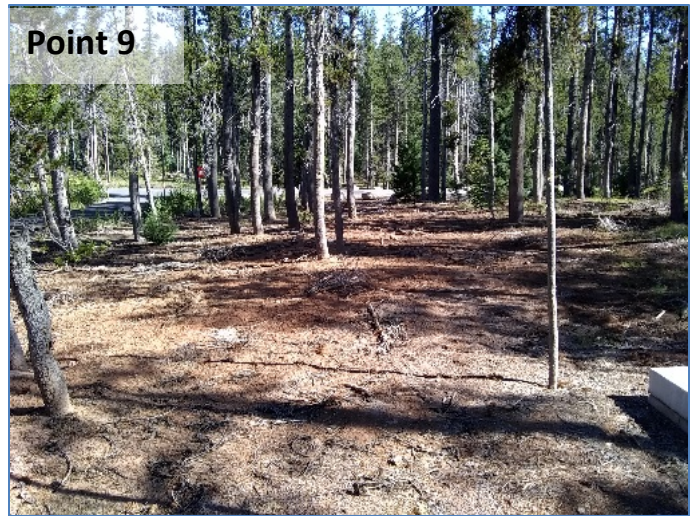
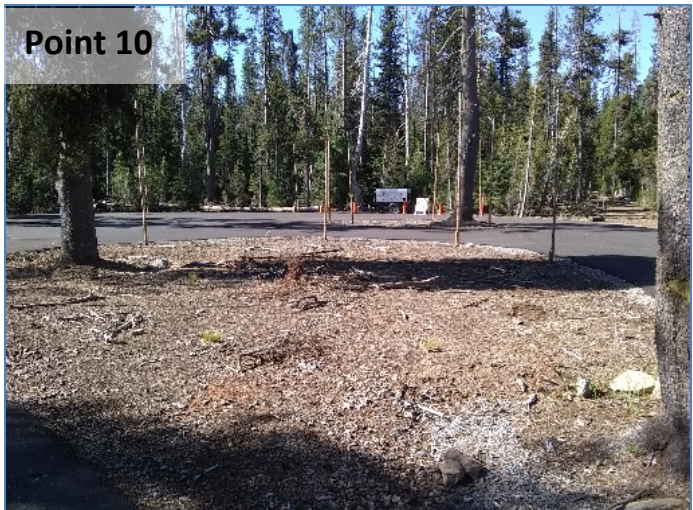
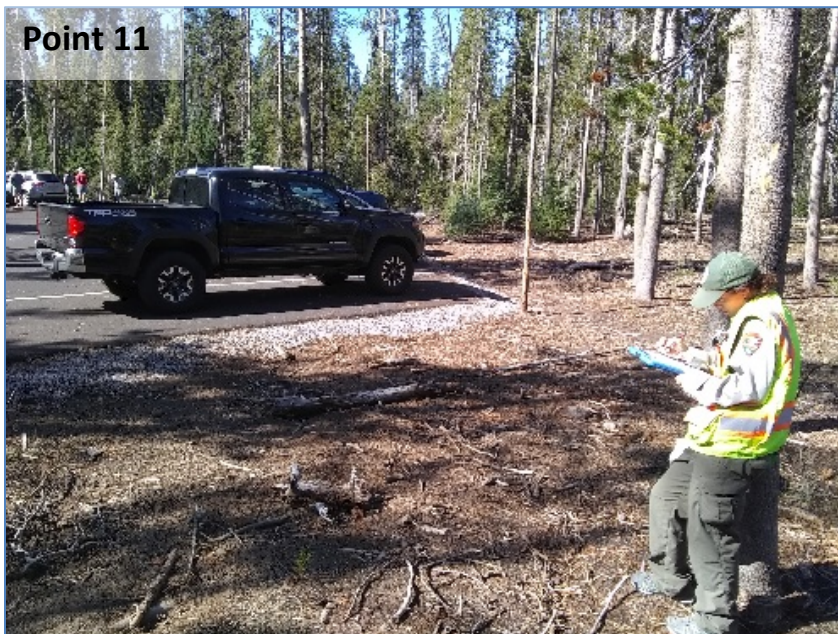
2019 Photos: Trailhead Parking

Date: 8/12/19	Recorder(s): CW, SH	Time Since Restoration: 1 year*
Site ID/Name: PCT well upper, trailhead parking		
Survivorship from planting/seeding (High/Med/Low): Medium		
Repeat Photography Photopoints (UTM Zone 10, NAD83)		
8	UTME: 0566984	UTMN: 4746845
9	UTME: 0566980	UTMN: 4746797
10 (island)	UTME: 0566963	UTMN: 4746805
11	UTME: 0566954	UTMN: 4746814
Regeneration Assessment		
Total Vegetation Cover: 10%		
Species Cover (As a percentage of the total vegetation):		
Species	Common Name	Relative % Cover
Grasses/Sedges/Rushes	Graminoids	50
<i>Lupinus lepidus</i> var. <i>lobbii</i> / <i>Lupinus andersonii</i>	Prostrate lupine/ Anderson's lupine	15
<i>Phacelia hastata</i> ssp. <i>compacta</i>	Compact phacelia	1
Conifers (seedlings)	Seedling conifers	30
<i>Calyptridium umbellatum</i>	Pussypaws	3
<i>Epliobium</i> species	Willowherb	1
	TOTAL	100%
Site Notes: (note erosion, tire tracks, etc.)		
Invasive Plant Assessment

Invasive Plant Species	# Present at Restoration	# Present 2019
none	0	0
General Comments/ Additional Site Needs and Recommendations:		
<p>*Only salvaged plants were replanted, and some rough cleaned seed mix was distributed. Area wasn't fully planted or seeded because we anticipated additional disturbance from electrical cabling project.</p>
