Rim Drive Rehabilitation Revegetation Project

2020 Annual Report

Carolyn S. Wyler, Scott E. Heisler, and Jennifer S. Hooke

April 2021

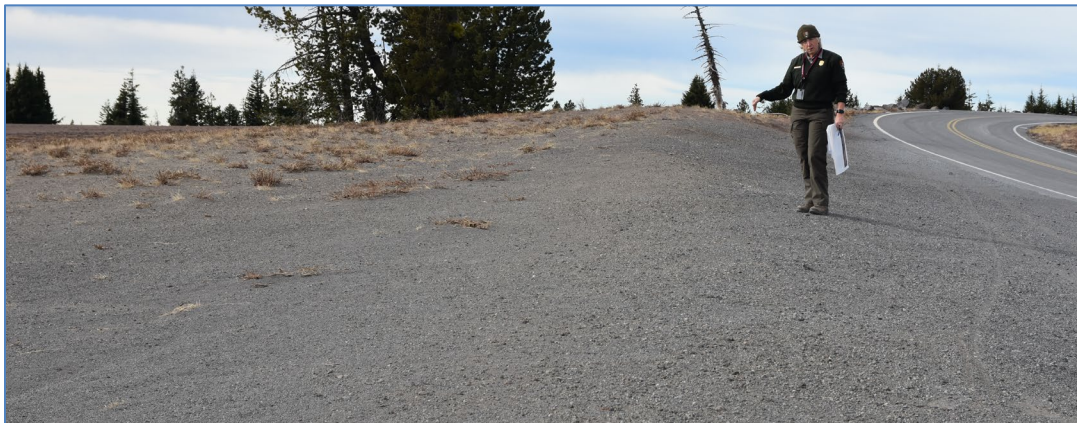
Figure 1. Example of an excessively wide parking area within the project area. Photo by Jen Hooke.

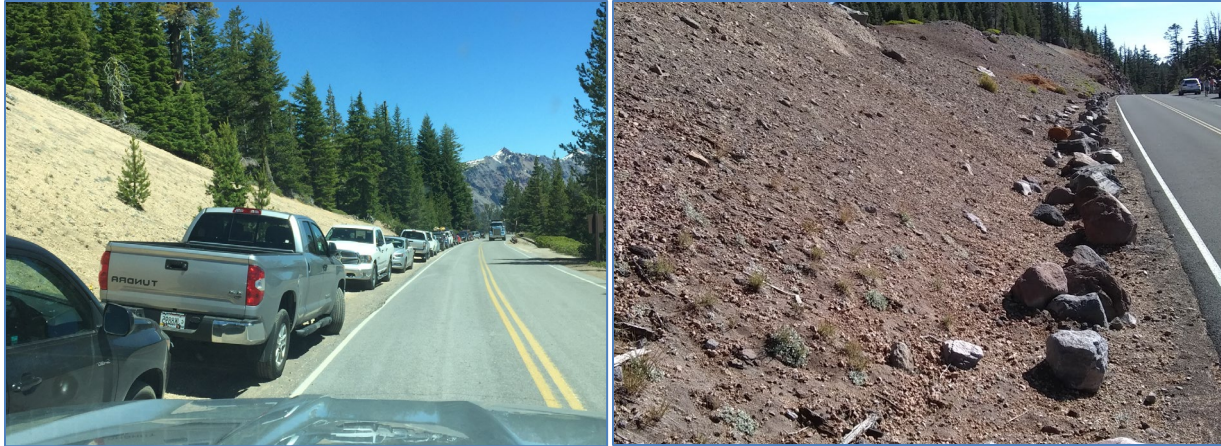
Figure 3. User-created pullouts before (left; photo by Carrie Wyler) and after (right; photo by Scott Heisler) obliteration as part of the Rim Drive Rehabilitation project.

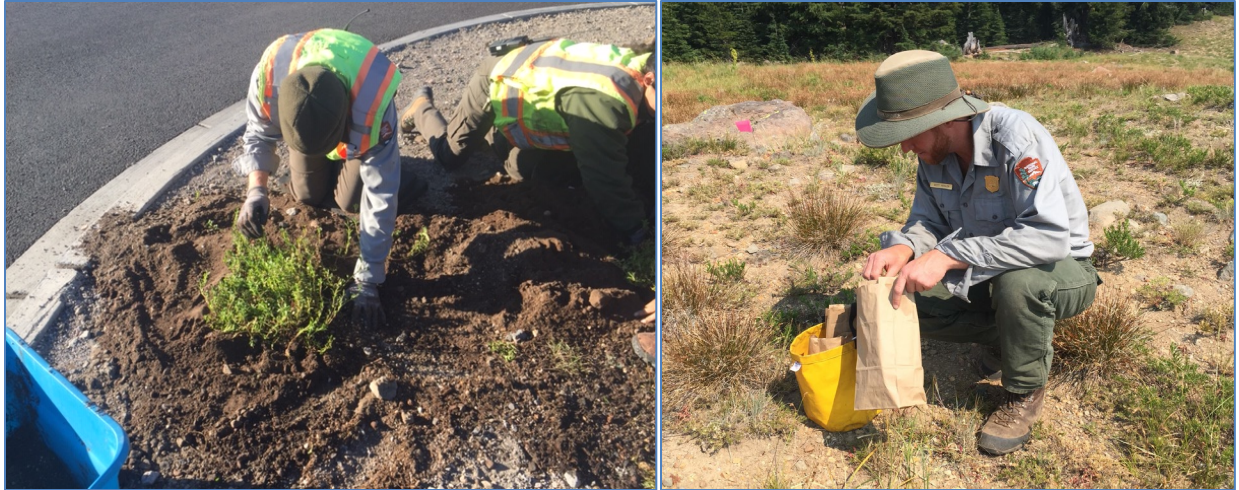
Figure 4. Conducting restoration outplantings (left) and collecting seed (right) for the Rim Drive Rehabilitation project. Photos by Carrie Wyler.

Restoration of areas disturbed by the Rim Drive Rehabilitation project (Figure 4) is necessary to jumpstart natural succession of vegetation communities, protect the rim environment from soil erosion, and prevent invasion by non-native plant species. Through using site-specific, native genotypes in revegetation efforts, the biodiversity and genetic integrity of the rim vegetation community is maintained. Additionally, as Rim Drive is a popular Park road, revegetation will yield aesthetic benefits to Park visitors by reducing the appearance of bare, disturbed ground throughout the project area.

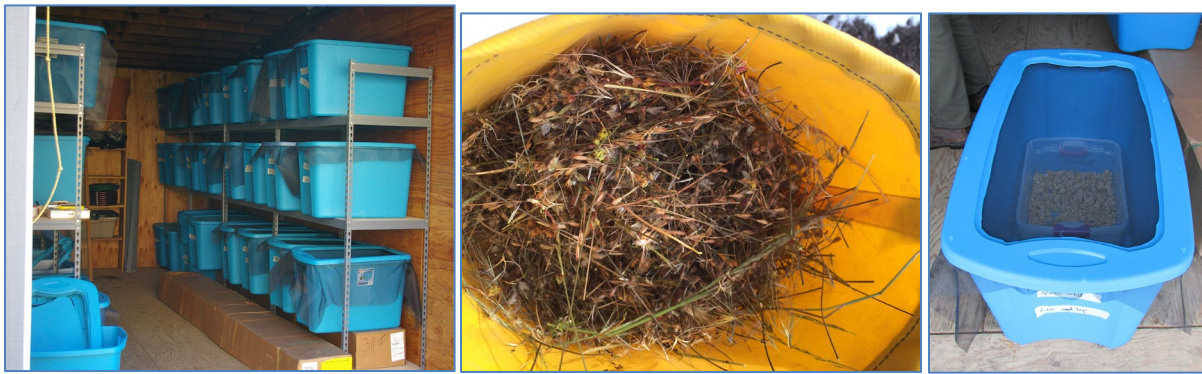
Figure 5. Seed drying and storage facility at Park headquarters (left). Collected seed before cleaning (middle). Seed drying in a container inside a drying bin with ventilated lid (right). Photos by Carrie Wyler.

dates, specific collection location, and seed zone. Seeds were then placed inside 30-gallon plastic storage totes secured with window screen at the top, allowing ventilation while reducing chances of predation. Plant species with very small seeds were first placed in smaller plastic bins before being stored within the larger 30-gallon tubs (Figure 5). The bins were labelled and organized on shelves by seed zone and species. Damp collections (especially lupines) were either shipped soon after collection (within a week) or set out in the sun during the day to speed the drying process.

Prior to shipping seed to the DGRC, all seeds from a single species within a discrete seed zone were combined into doubled paper bags; each bag was labeled with species code and seed zone and taped shut. Records were kept of boxes shipped and their contents. Shipping seeds throughout the growing season was crucial due to the shortage of seed storage space at the Park, and inadequate ventilation for effective drying of damp material.

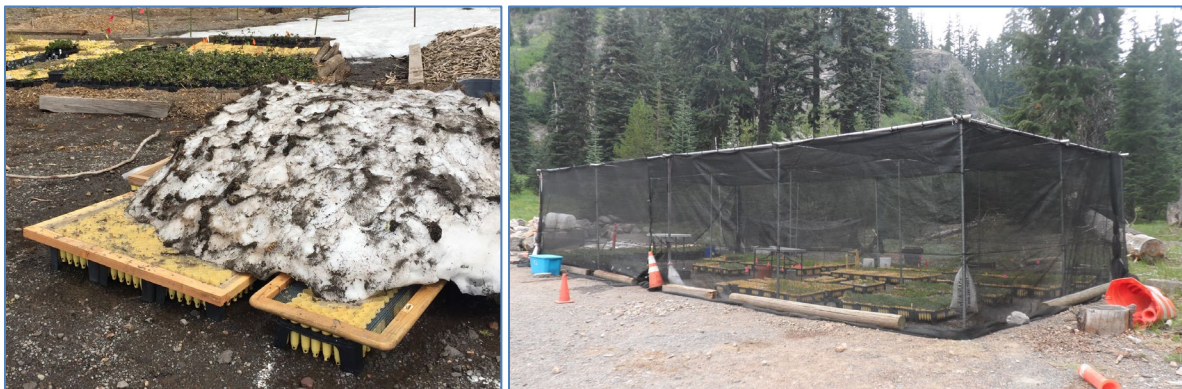
Figure 6. Overwintered plants emerging from the snow in the spring (left). Shadehouse at the Ball Diamond (right). Photos by Carrie Wyler.

Due to delays in the construction schedule, planting for Phase I was not completed in the fall of 2019 and several thousand plants needed to be overwintered at the Ball Diamond nursery at Park headquarters. These plants required care and maintenance throughout the 2020 field season. Once the snow melted in June, plants were covered with a shade house (40' x 20' x 10' – Figure 6).

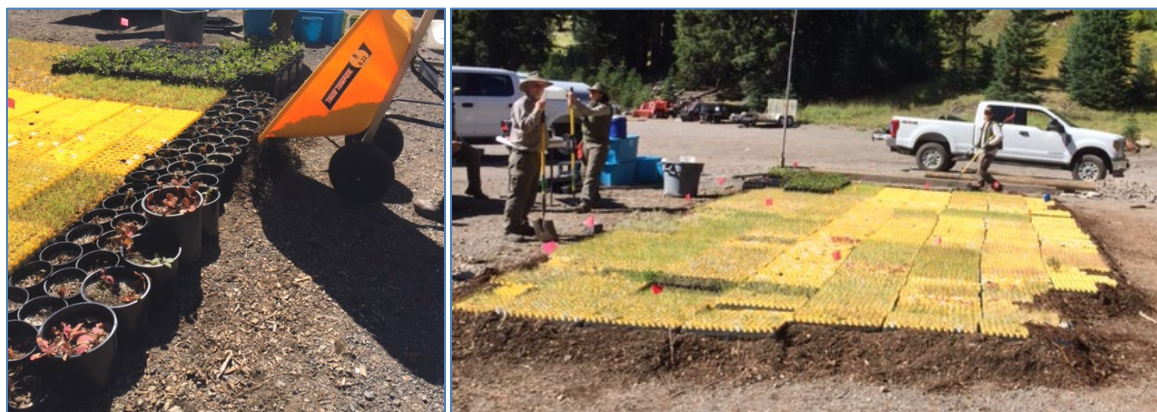
Figure 7. Distributing mulch around the edges of pots to insulate against frigid winter temperatures (left). Consolidated plants at the Park’s Ball Diamond prior to overwintering (right). Photos by Carrie Wyler.

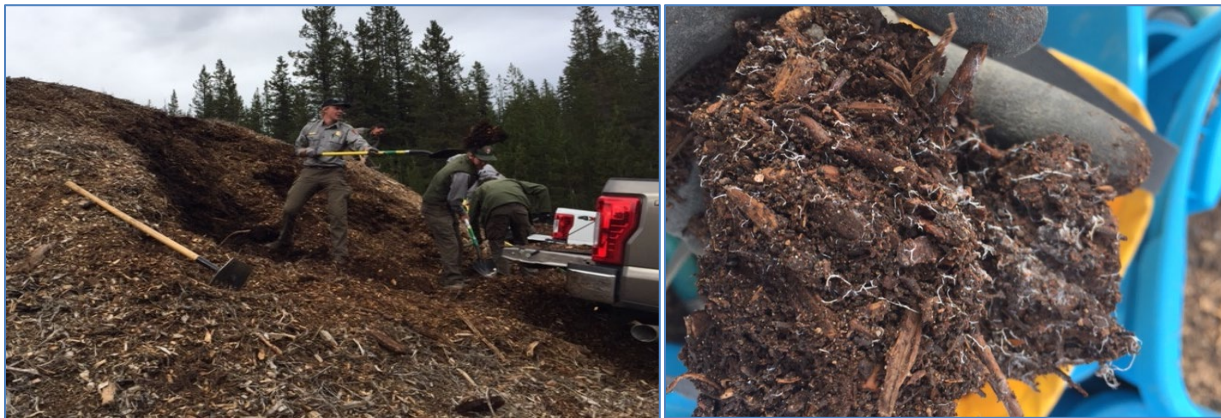
Figure 8. Compost being hauled from the Pole Bridge Quarry pile to the South Yard pile for use in restoration projects (left). Active biota in the Park-made compost (right). Photos by Carrie Wyler.

The Botany program creates compost from discarded vegetative materials resulting from Park maintenance activities; these compost piles are located in the Park's South Yard to capitalize on its lower elevation location. Compost temperature is monitored over the season to ensure the presence of active biota (Figure 8). Compost is used to provide a source of natural fertilizer and mulch for newly planted seedlings. Compost also helps create local microclimates, retain soil moisture, and provide microfauna to help promote soil development and aid the establishment and growth of young plants. Woody materials are also used to help stabilize recently disturbed and denuded sites from road construction while creating microclimates and seed pockets to further encourage the natural recovery of disturbed areas. Larger woody debris (branches, logs, etc.) is obtained from the surrounding forest at disturbed sites and added to restoration sites as appropriate to assist with erosion control and site amelioration.

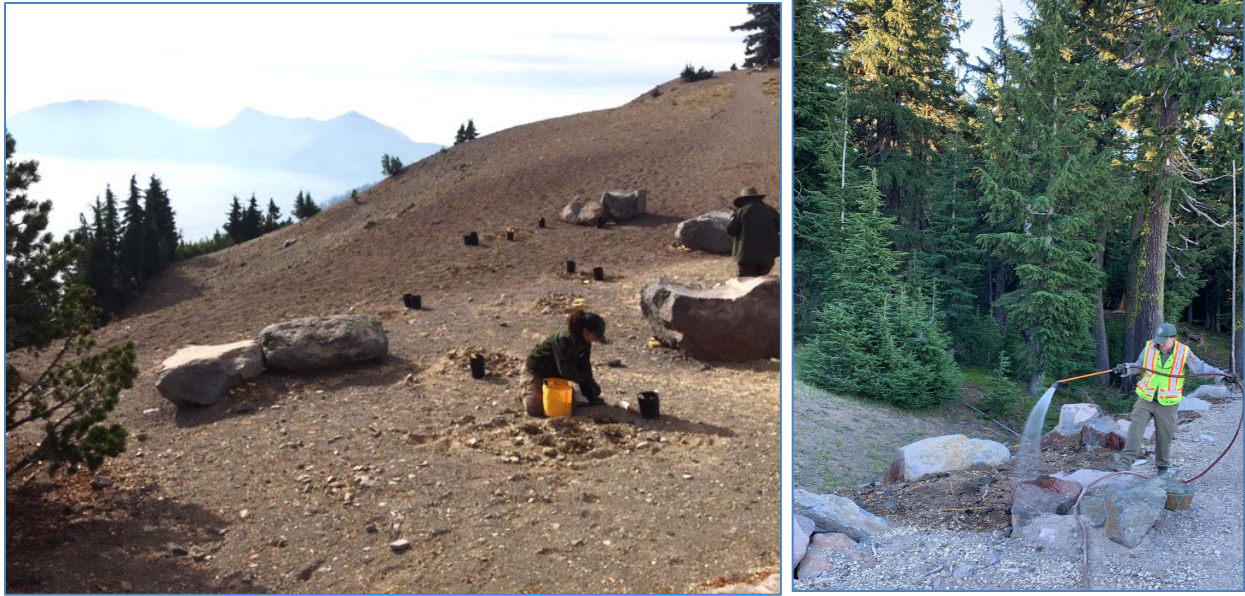
Figure 9. Planting in disturbed sites along West Rim Drive (left). Watering plants after restoration planting (right). Photos by Scott Heisler.

A mix of plant species was planted in the Phase I disturbance areas in accordance with revegetation prescriptions and availability of plant materials. After planting, compost was added, and plants were watered (Figure 9). Site-specific seed mixes were prepared and hand-broadcast over planted areas, and across areas with slopes that were too steep to plant. After broadcasting seeds, the sites were scarified with hand rakes and compost was broadcast over the scarified areas.

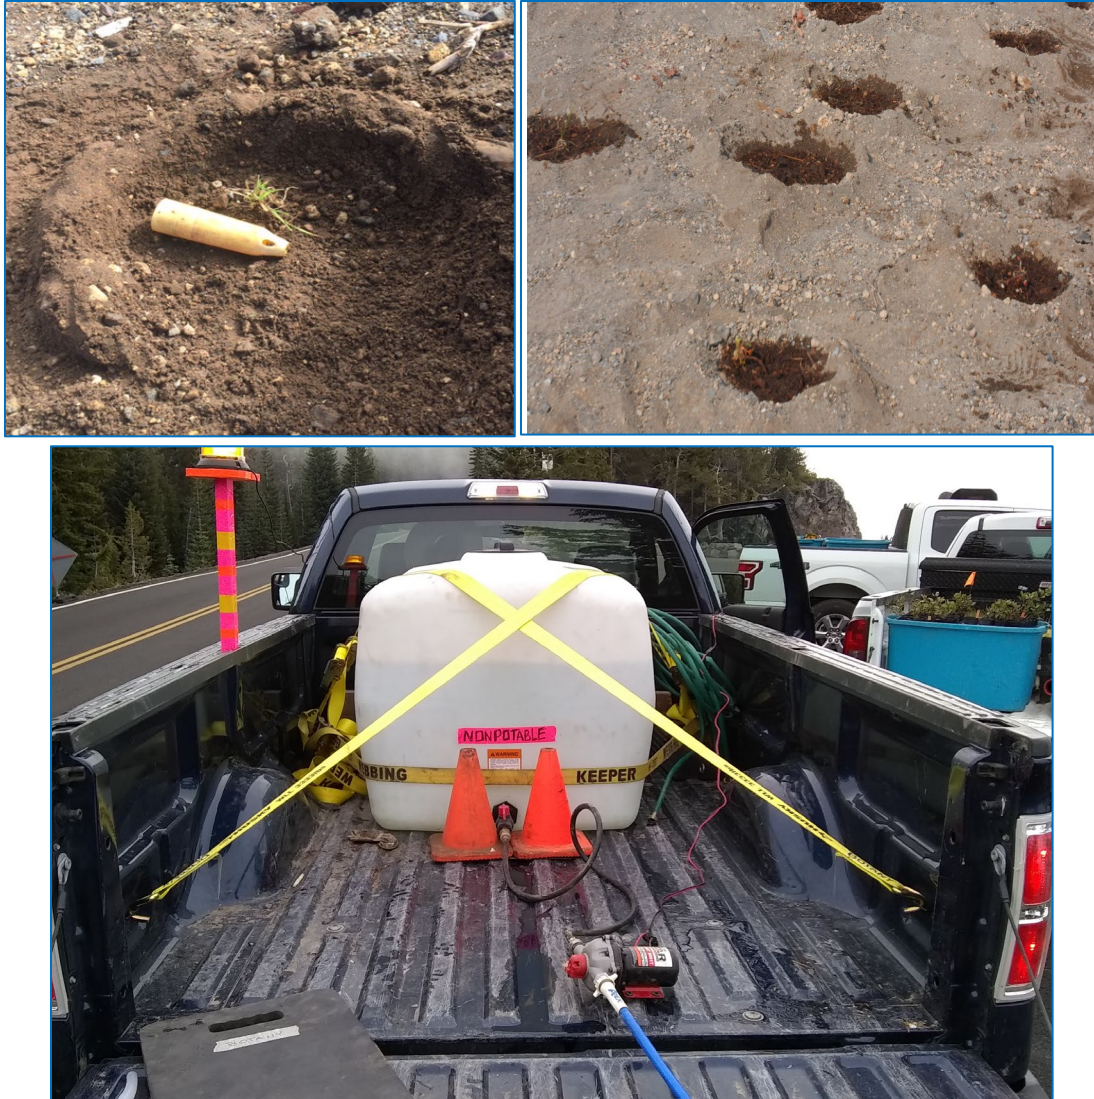
Figure 10. Building a berm for a plant (upper left). Recently installed plants with compost and soil berms to contain water (upper right). The 200-gallon truck-mounted water tank (bottom). Photos by Carrie Wyler.

At restoration sites, holes were dug to a depth equal to or greater than the length of the planting tubes. Plants were carefully removed from the tubes by pressing on the sides of the tubes or tapping the rim of the tubes while they were inverted over the planting holes. After the plants had been removed, the roots were inspected for any signs of being root bound, having roots growing upward in the tube (“J”-rooting), or root girdling. If any of these were found, the roots were either trimmed or gently teased apart to encourage root growth and plant establishment. The plants were then placed in planting holes to ensure they were upright perpendicular to the pull of gravity (not relative to the local topography). Soil was then pushed back into the planting holes and tamped down gently to remove any air pockets in the soil. Plantings were installed so that the root collars of the plants were just at or slightly below the surface of the soil. Remaining soil or additional soil from the surrounding area was used to create a berm wall around the plants to facilitate water retention and help stabilize and protect plants. One or two handfuls of compost were then placed in the center of the rings around plants (Figure 10). After mulching, the plants were watered at least once. A 200-gallon water tank was mounted in the bed of a truck and used in conjunction with an electric pump to facilitate watering of newly planted plugs (Figure 10).

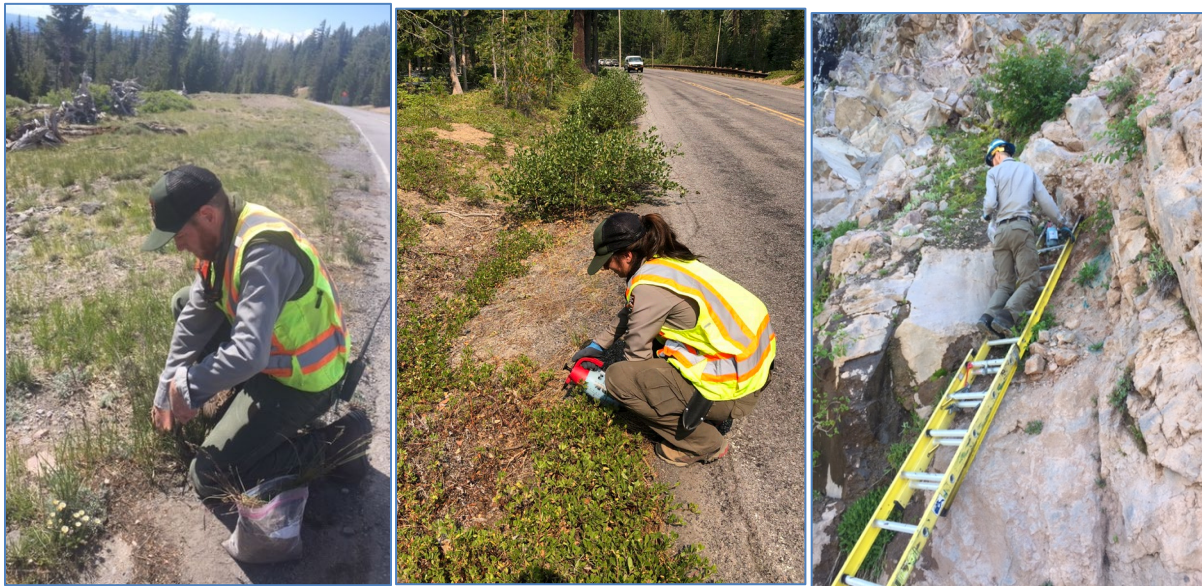
Figure 13. Manually controlling an invasive grass near Skell Head overlook (left). Chemically controlling St. John's wort (*Hypericum perforatum*) on East Rim Drive (middle). Chemically treating common dandelion (*Taraxacum officinale*) on a cliffside along East Rim Drive (right). Photos by Carrie Wyler.

When invasive plants are encountered, data are recorded including scientific name, UTM coordinates (Zone 10, NAD83 datum), total number of plants present, area occupied by invasive plants, and treatment applied to population. Invasive plants are controlled via manual or chemical methods (Figure 13) as per the Park's Invasive Vegetation Management Plan (DOI NPS 2017). All plant parts capable of reproduction are bagged and disposed of in the trash compactor at Park headquarters. Vegetative parts incapable of reproduction are left to desiccate on site unless they present logistical or aesthetic problems for Park visitors, employees, and partners.

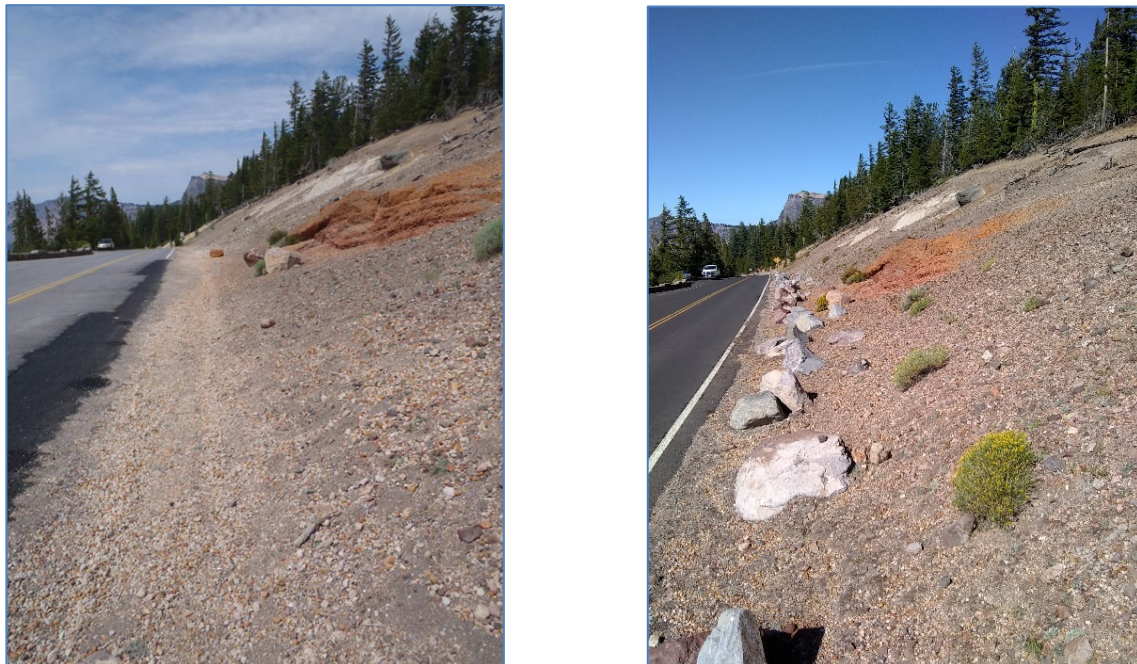
Figure 14. Restoration site NEERD4 before (left) and after (right) rehabilitation and revegetation efforts. Photos by Carrie Wyler.

As of November 2020, 62 restoration sites have been defined for Phase I and 21 for Phase II of the RDRR project, each with a unique revegetation prescription based on pre-disturbance conditions (Table 4). Identification of the Phase II restoration sites was guided by the 70% construction plan sets and did not include sites disturbed by Roundtop Quarry rehabilitation, deep patch, or edge stabilization treatments. It is likely the number of sites will increase as impacts from those treatments become more apparent. When Phase I of the Rim Drive Rehabilitation project was completed, the actual area disturbed was found to be greater than three times what was planned (Table 3). The planned area of disturbance for Phase II of this project is anticipated to affect 21.2 acres. Full details of each site’s prescription and planned versus actual disturbance areas can be found on the Botany file server. Similar documentation will be made for Phase II of the project to track disturbed areas (Figure 14).

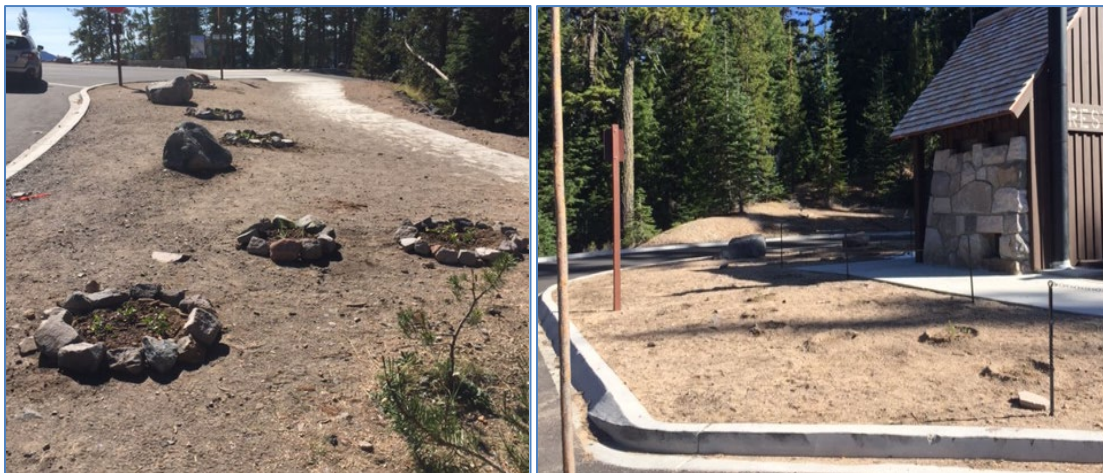
Restoration work has begun at site NEERD3, which is the Cleetwood Cove parking lot. Construction work at the comfort stations and ticket booth sites was not completed until the fall of 2019. Landscaping islands and beds in the parking lot have been revegetated, but these areas are heavily trampled by visitors which presents challenges to restoration. These areas will need to be assessed yearly for traffic patterns and trampling and filled in with plants as problem areas arise. Additional barriers (fencing) may be needed to protect the newly established vegetation. Installation of fencing was not possible in the front of the parking lot due to a buried gas line's unknown location. To protect young vegetation until it is large enough to be visible by parking lot users, plants were placed in groups and circled with large rocks to form a barrier (Figure 15). Each year additional plants will be added, and the rock circles expanded. Once the plants have established, and are more obvious to visitors, then the rock circles will be removed. The back of the parking lot will be worked on during Phase II of the RDRR project. The area presently is not big enough for large recreational vehicles pass through and their back wheels often jump the curb and damage a revegetation site. This area has been sparsely planted in areas that would not be impacted by vehicle traffic (Figure 15). Site NEERD 3.1 is the east embankment of the Cleetwood Cove parking lot and will need to be addressed in future years. It has a steep slope of pumice soil that is continuously eroding and hindering restoration efforts.

Figure 15. Plantings in groups with rock borders to mitigate trampling in heavily trafficked Cleetwood Cove parking lot areas (left). The area at the back of the Cleetwood Cove parking lot will be adjusted to allow for RVs to drive around the comfort station (right). Photos by Carrie Wyler.

The east embankment at the Cleetwood Cove parking lot will continue to need slope stabilization and erosion control for revegetation efforts to be successful. This embankment was disturbed by contractors stacking cut logs on it when they were clearing trees to expand the parking lot. The embankment is steep and consists of loose pumice soil, which collapses when walked on. The site does not hold seed or water well, and it has been difficult to restore and revegetate. In 2019 large logs and rocks were put into place and areas were vertically mulched with little success. This area needs to be reassessed in 2021 to develop a new plan of action. Creating and burying waddles stuffed with native seed and planting behind them is a method to be considered in 2021. Every revegetation attempt creates more soil disturbance and erosion, so this need to be considered. Hall's sedge (*Carex halliana*) is presently being propagated for this area; its fibrous and extensive roots system may aid in soil stabilization.

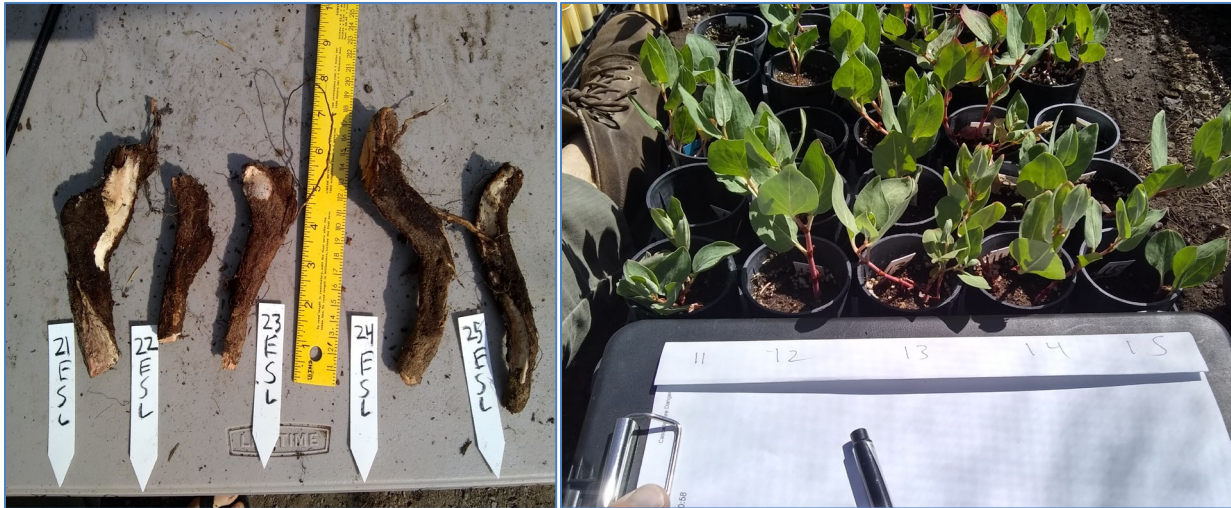
Figure 16. Root division cuttings of Davis’ knotweed (left); pots of Davis’ knotweed emerging from root cuttings (right). Photos by Scott Heisler.

easy to collect, and thus made up the bulk of the 2020 seed collection. Species that were collected in lower quantities include lupine (*Lupinus* sp.), pussypaws (*Calyptridium umbellatum*), and Greene’s goldenbush (*Ericameria greenei*) as predation from unknown insects and mammals significantly reduced the quantity and quality of available seed. However, these species do extremely well at establishing in disturbed areas from seed, and therefore are worth the extra effort to collect. Davis’ knotweed (*Aconogonon davisiae* var. *davisiae*) continued to pose a challenge for seed collection and plant propagation efforts by seed. Fertilization appears to be very patchy in the field, and while fruit development can be detected for the first few months after fertilization, many developing seeds appear to be aborted weeks before any viable seed can be acquired. Previous attempts at propagating Davis’ knotweed suggest root division/cuttings are viable means of propagation (Trindle and Flessner 2003). During the 2018 field season, several successful trials of propagating fleecflower from root divisions/cuttings were conducted by the Botany program. The success of these trials establishes this method as a viable option for producing this species for future revegetation needs at CRLA (Figure 16). Salvage of these plants from active construction zones before they are destroyed and propagating them from root divisions will be employed during Phase II revegetation efforts.

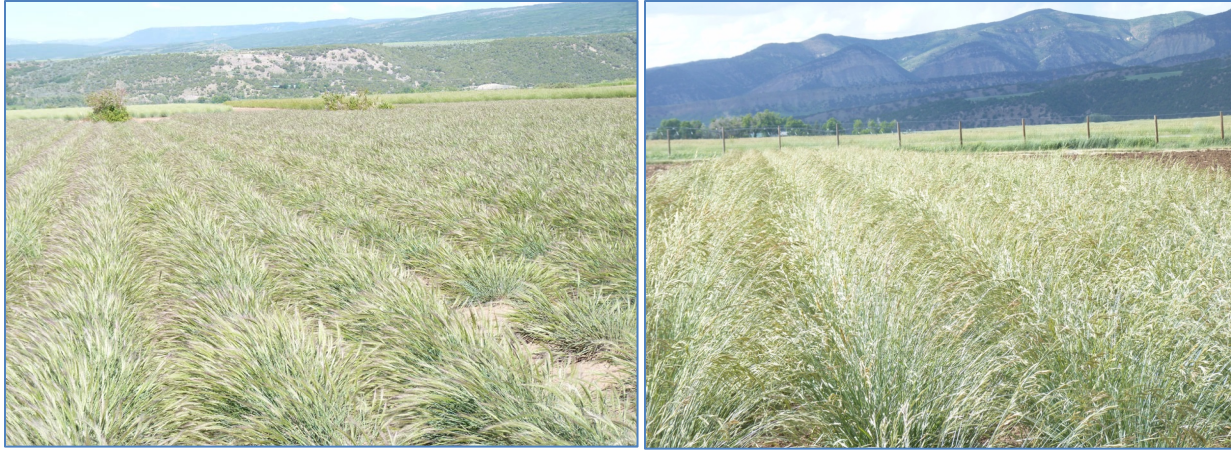
Figure 17. Common squirreltail seed increase field (left) and California brome seed increase field (right) at the Meeker PMC. Photos by Steve Parr.

To augment the amount of plant materials available for revegetation in both Phase I & II of this project, the seed increase services of the Meeker PMC were utilized. The Meeker PMC installed two seed increase fields for California brome (*Bromus sitchensis* var. *carinatus*) and common squirreltail (*Elymus elymoides* ssp. *elymoides*) sown from CRLA seed (Figure 17).

To maximize seed yield, it was agreed to combine common squirreltail seed from all Phase I RDRR seed zones for seed increase purposes. California brome seeds were combined from the three West Rim Drive seed zones, and from the two East Rim Drive seed zones. Additional California brome and common squirreltail seed from Phase II areas was planted in the seed increase fields in 2018. Production totals are displayed in Table 7. The Meeker PMC experienced a very dry and windy 2020 growing season, which reduced seed production for all species. Seed production will continue into the 2021 season, which will be the final season of seed increase for this project.

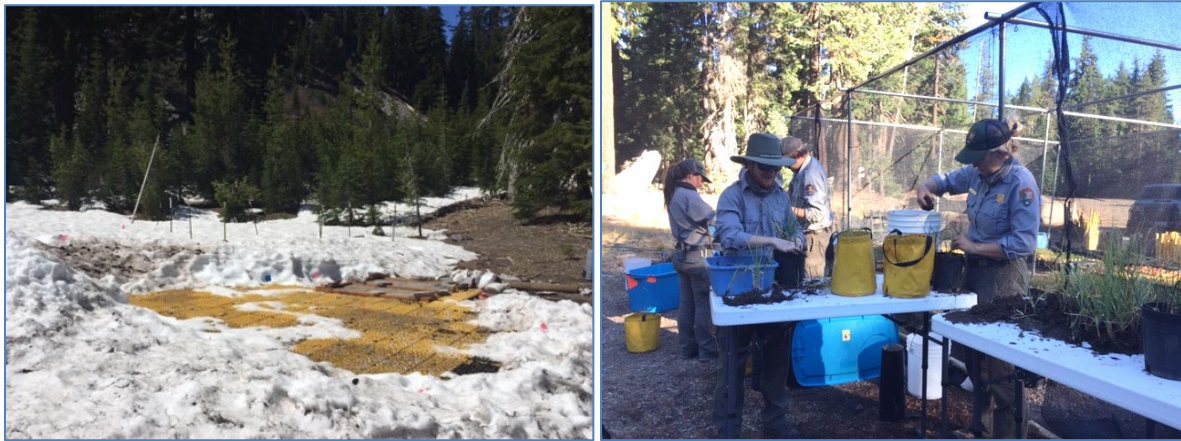
Figure 18. Overwintered plants emerging from the snow in June 2020 (left). Plant care at the Park’s nursery (right). Photos by Carrie Wyler.

goldenbush experiencing high mortality. Plants with well-developed roots were transplanted into larger containers while others with detritus, moss, liverwort, or volunteer plants were cleaned (Figure 18). Most of the grass species became infected with a rust in the fall of 2020. The infected areas were trimmed and treated with a baking soda, soap, oil, and water mixture. This helped reduce the rust infestation but not eliminate it. Plants will be assessed in 2021 and if still contaminated will be treated with a chemical fungicide; a Pesticide Use Permitting System proposal has been submitted to facilitate this treatment. Detailed reports of daily nursery activities are on file in the Botany office in the Nursery Activities binder. Over the fall and winter of 2020/2021 1,134 plants are being propagated by CRLA and the DGRC (Table 8). These plants need multiple years of growth in order to become large enough to be planted in heavily disturbed areas.

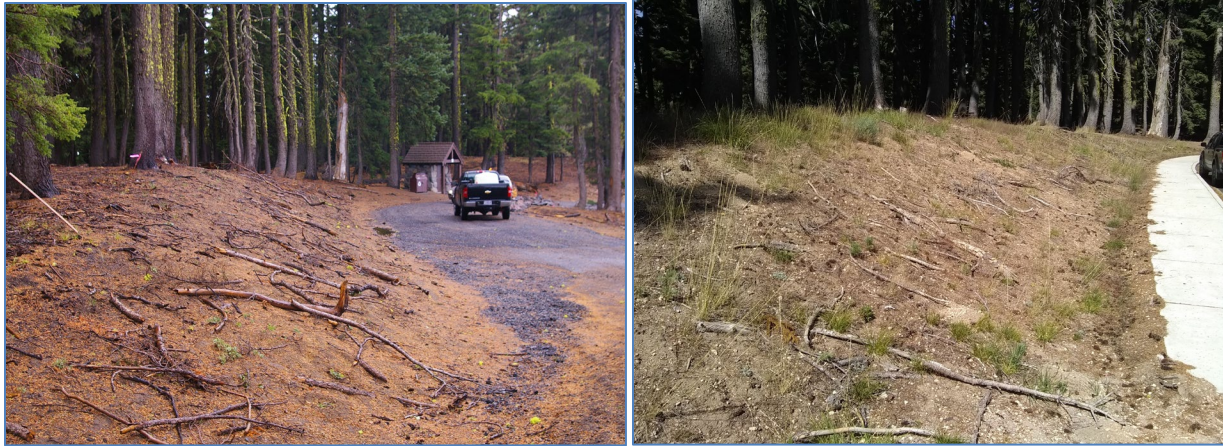
Figure 19. Site NEERD0.1 in 2016 (left) and in 2019 (right). Photos by Carrie Wyler.

Yearly site documentation and monitoring is completed for all sites that were restored. For these sites, one- two- and three-year post-restoration photo points were taken, and monitoring forms were completed as a means of assessing the success of revegetation efforts and determining additional site needs (Figure 19). Due to the Covid-19 pandemic, there was insufficient staff to conduct formal monitoring. An informal assessment directed the 2020 outplanting and seeding work.

Monitoring results showed a clear pattern: restored sites that were protected from further impacts (e.g., vehicle damage, trampling) did markedly better than those that experienced additional and/or ongoing impacts. Forty-eight of the 62 restored sites are doing well, and vegetative recovery is progressing with no further action needed. The other 14 sites were either damaged by vehicle traffic, trampled by Park visitors, or have challenging site conditions (e.g., steep slopes, erosion, unstable soils) that make revegetation difficult. Supplemental planting and seeding in the future will continue to assist the recovery of restoration sites that are struggling, and some sites may need fencing and/or signage to protect them from further damage especially at the Watchman Overlook and Cleetwood Cove parking lot.

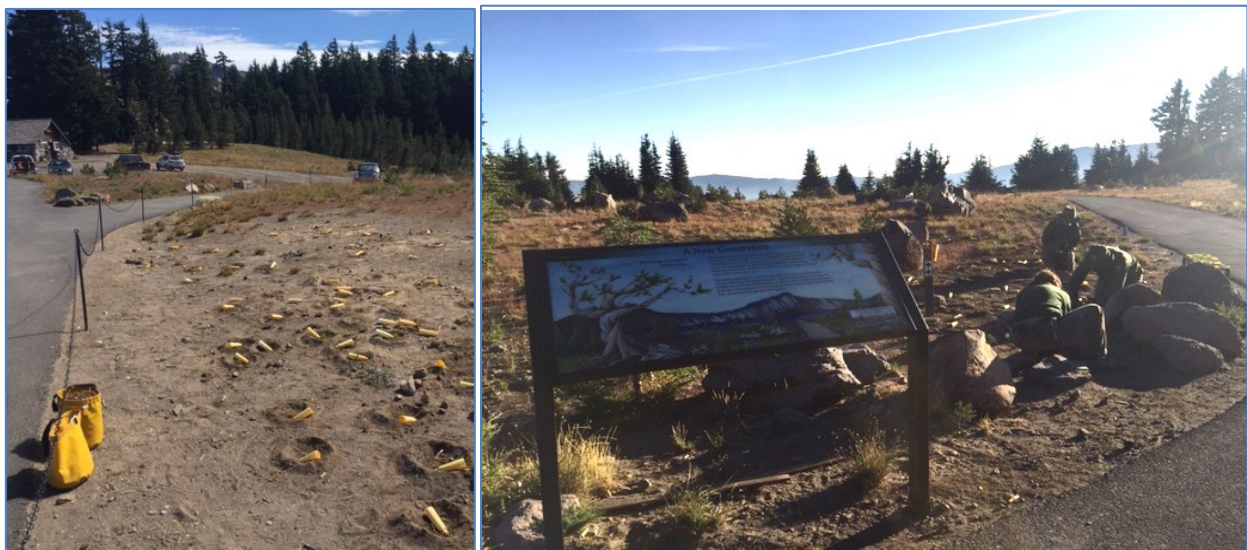
Figure 25. Potted plants laid out for planting in treated areas at Rim Village (left). The Botany crew planting in red sand-spurrey treatment areas behind the Rim Café (right). Photos by Carrie Wyler.

Buckhorn plantain (*Plantago lanceolata*), pineapple weed (*Matricaria discoidea*), and common St. John's wort (*Hypericum perforatum*) populations were treated in their entirety with all observed individuals removed. However, large invasive plant populations of bitter winter cress (*Barbarea vulgaris*), sheep sorrel (*Rumex acetosella*), and red sand-spurrey (*Spergularia rubra*) at Rim Village were treated as time allowed. The large population of sheep sorrel by the Crater Lake Lodge has been subject to a large control effort annually since 2013, often using volunteer groups. This site was first treated with herbicide in the fall of 2017 and was treated again in June-July 2018, 2019, and 2020. Sheep sorrel abundance was greatly reduced in 2018 and 2019, which may be attributable to the effectiveness of chemical treatment. In 2020 two new population areas were discovered which led to an increase in numbers from 2019. Common knotweed (*Polygonum aviculare* ssp. *depressum*) was another species that continues to increase greatly in number for unknown reasons, especially around the Lodge. This is another difficult species to treat by manual means due to its deep root systems. Red sand-spurrey (*Spergularia rubra*) has become an increasingly abundant invasive plant species, forming mats in some disturbed areas and outcompeting native plants. In 2019, Botany staff manually removed red sand-spurrey from the landscape islands around the Rim Village Café and Gifts building and chemically treated it in 2020. This treatment was followed up in the fall of 2020 by planting 2,642 native plants and dispersing and raking in 3,238 g of native seed (gathered from Rim Village) in hopes of outcompeting any new invasive plant species (Figure 25). These areas will need to be monitored in the future and treated with herbicide before flowering in early spring, and again in late summer to control the plant during its multiple flowering periods.
