A Restoration and Monitoring Plan for *Puccinellia howellii*, Whiskeytown National Recreation Area, California

David J. Cooper, Ph.D. & Evan C. Wolf, M.S.

Department of Forest, Rangeland and Watershed Stewardship

2007

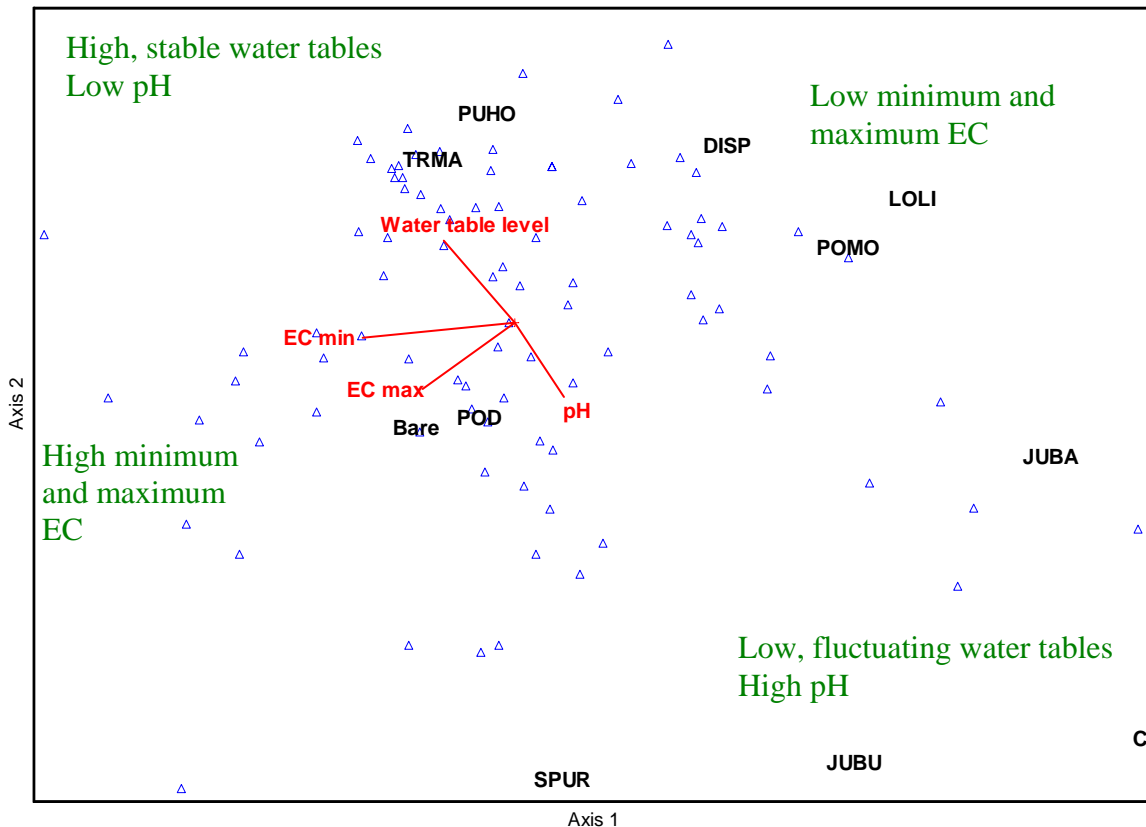
Figure 1. Direct gradient analysis showing the distribution of plots (blue triangles) and species centroids in relation to significant gradients in environmental parameters (radiating red lines). The environmental parameters increase in value along the red lines in the direction of their label, and decrease in the opposite direction. PUHO = *Puccinellia howellii*, TRMA = *Triglochin maritima*, DISP = *Distichlis spicata*, Bare = bare ground, POD = Plaque of Death, LOLI = *Lolium multiflorum*, POMO = *Polypogon monspeliensis*, JUBA = *Juncus balticus*, SPUR = *Spergularia marina*, JUBU = *Juncus bufonis*, C = *Cirsium vulgare*. EC = electrical conductivity (Cooper and Wolf 2005).

The initial study of the habitat affinities of *Puccinellia howellii* (Fulgham et al. 1997) and a more recent study (Cooper and Wolf 2005) both concluded that *Puccinellia* and *Distichlis* occupy distinct sites with different environmental characteristics. Fulgham et al. found that only 4.9% of vegetation plots supported both *Puccinellia* and *Distichlis* at >5% cover. By this same criterion, only 2.2% of our 2005 vegetation plots had both *Puccinellia* and *Distichlis*. Through ordination analysis of the vegetation and environmental parameters, Fulgham et al. (1997) found that *Puccinellia* was associated with sites that have high winter salinity, low Mg, and were commonly inundated. Sites with *Distichlis* were typified by high Mg, low winter salinity, high P and N, and were rarely inundated. Our 2005 vegetation analysis also identified different habitats for *Puccinellia* and *Distichlis*. The primary distinction was the tendency of *Distichlis* to occupy lower salinity sites, with a secondary inclination towards sites with deeper water tables and higher pH values (Figure 1). Both reports also found that *Triglochin maritima*, another native halophyte, shares a nearly identical habitat with *Puccinellia* and they commonly co-occur. *Puccinellia* is most abundant in habitats with high summer water tables, prefers the most acid (low pH) sites, and occupies the middle ground of the winter salinity (EC) gradient. Winter salinity is key because that is the rainy season, and the time when freshwater can most influence sites. Our ordination is presented in Figure 1.

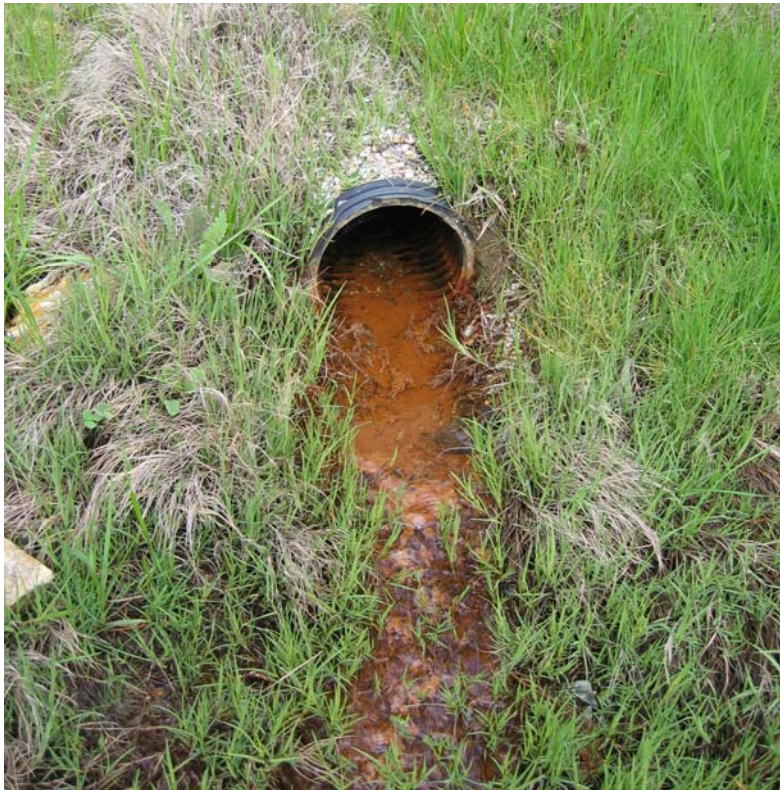
Figure 7. One of two 8-inch plastic culverts that discharge fresh water from the road fill onto Spring 3. The grass in the foreground is *Distichlis spicata*.

Fresh water is a pollutant in this salt spring complex and has had dramatic effects on limiting the distribution of *Puccinellia*. To address this issue three separate projects are suggested, one for spring 3 and two for spring 2. The discharge of drainage from road fill directly onto Spring 3 is the easiest impact to address. Fresh water drains onto the site through two 8-inch black plastic pipes (Figure 7). The pipe lengths should be increased so that water discharges directly into Willow Creek. New ground water monitoring wells and vegetation plots should be added to monitor the effects of the proposed restoration activities (removing fresh water from spring 3 on water chemistry, ground water levels and vegetation). It likely won't be necessary to plant *Puccinellia*, but it might be necessary to remove *Distichlis* patches using hand shovels to expose bare soil for *Puccinellia* to establish.

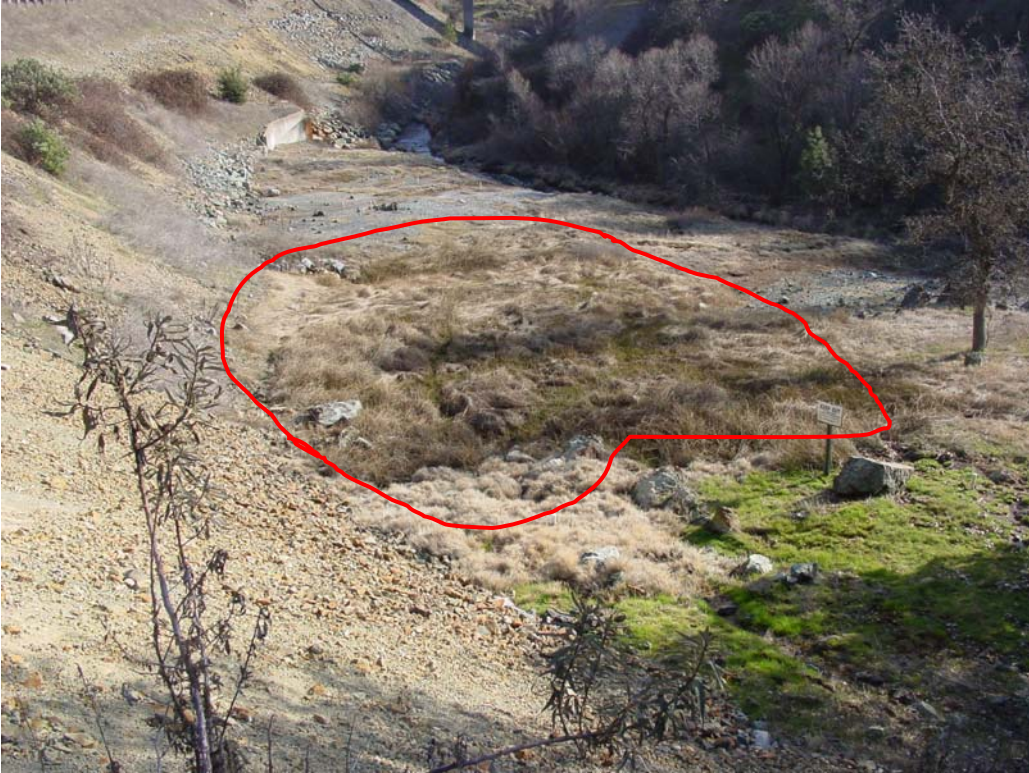
Figure 8. Looking east from the highway into Spring 2. The *Juncus balticus* (dark colored plant) fan and fresh water area is bounded by the red line.

At spring 2, two large projects are proposed. First, surface water runoff from the highway must be rerouted. Presently rainwater flows from the highway into the northwestern corner of spring 2, creating and supporting a large freshwater marsh dominated by *Juncus balticus* (Figure 8). This water must be captured at the highway and diverted into the culvert located beneath the highway. This could be done by installing a perforated pipe near the junction of the highway and the *Juncus* stand to capture flow into this area. This pipe would then feed the stream that discharges from the culvert.

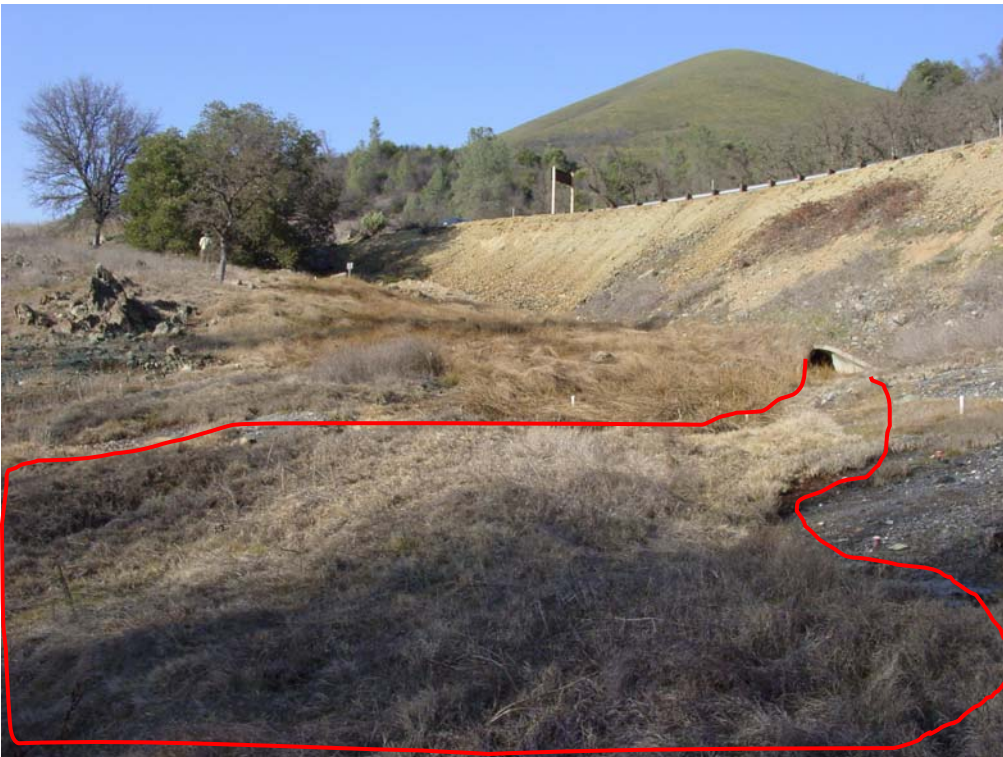
Figure 9. Looking north toward the highway in Spring 2. The alluvial fan and fresh water plume formed by the culvert stream is bounded by the red line.

The second project is the redesign of the channel that formed by stream discharge from the culvert located beneath the highway. This stream has deposited a large mineral sediment alluvial fan, which is irrigated with fresh water (Figure 9). The sediment must be removed and a stable channel constructed to guide culvert water to Willow Creek. This project should be designed by Caltrans with assistance from NPS WRD staff. Although the fresh water in this channel is from a natural drainage system above the highway, it also receives augmented flow and sediment loads from dirt roads and the highway. In conjunction with the removal of the alluvial fan, a plan to prevent further sedimentation must be developed and implemented. One possible solution is to construct a settling pond upstream of the highway which would be dredged periodically to remove accumulated sediment. Another solution may be to extend the culvert through Spring 2 to Willow Creek.

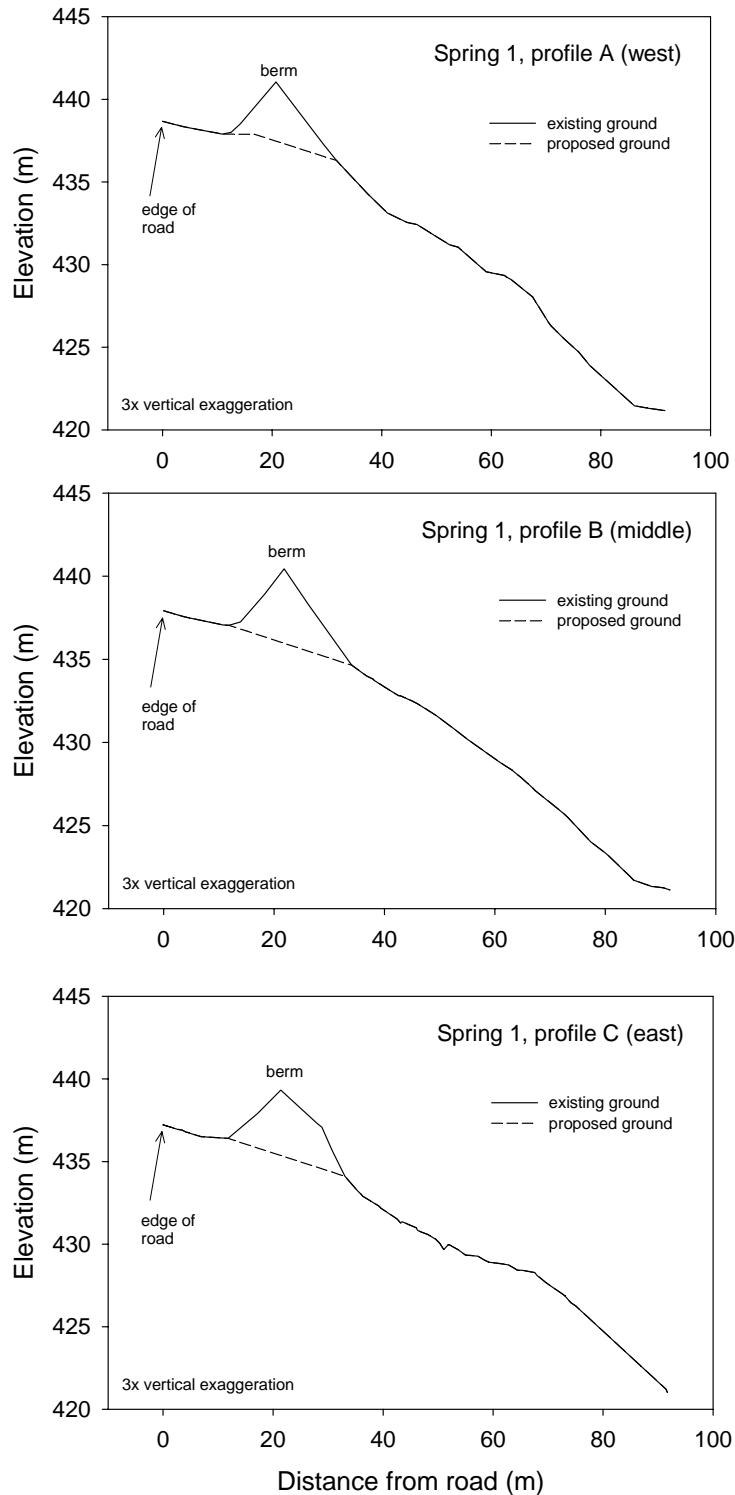
Figure 10. Profiles A, B, C of proposed fill removal. For profile locations see Fig. 11b.

the project. Existing contours, showing the berm, as well as proposed contours and thickness of fill to be removed, are shown in Figures 10 and 11 a, b, c. A channel likely is not necessary to effect this flow change.

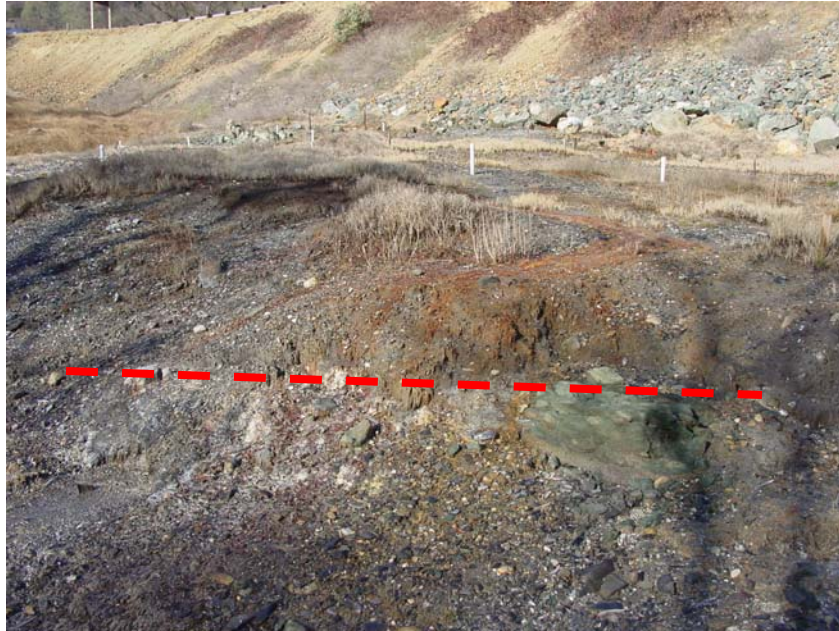
Figure 13 Fill thickness in Spring 2. Sediment above the dotted red line is fill.

Areas in spring 2 and possibly spring 3 have significant mineral sediment deposits that should be removed to expose the natural mineral springs/bedrock surface. The largest area of fill is in Spring 2 (Figure 13). A portion of this fill was removed years ago during a CalTrans mitigation project (Bacca 1990). However, insufficient sediment was removed to create the appropriate irrigated gravel environment that is suitable habitat for *Puccinellia*. Additional sediment should be removed (471 m^3 , or 616 yd^3) so that a maximum 20 cm of decomposed bedrock exists above the consolidated bedrock, which would closely match baseline conditions in the best remaining habitats in springs 1 and 2. Existing topographic contours for spring 2 are shown in Figure 15a, and our proposed ground surface is shown in Figure 15b. Figures 15c and the profiles in Figures 16 a-g, show the thickness of fill that should be removed. The fill removal should be done with

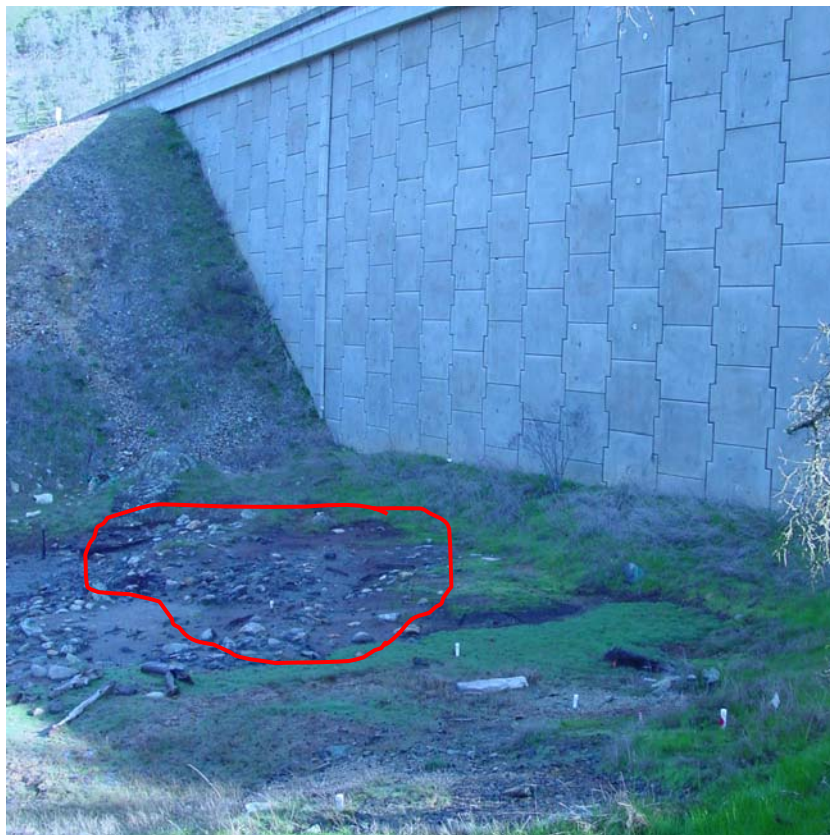
Figure 14 Potential fill removal area in Spring 3.

A small area of potential fill exists just beneath the wall at spring 3 (Figure 14). This area is unvegetated, and we are uncertain of the thickness of fill that exists and should be removed. We will do additional borings during the winter of 2007-2008 in this area, but it may be necessary to bring a small excavator into the site to accurately determine the volume of fill in place. Once fill is removed, these areas should have *Puccinellia* seed broadcast. If sufficient fine-textured sediment exists in the gravel matrix, a high pressure hose may be needed to flush the gravel free of fines.

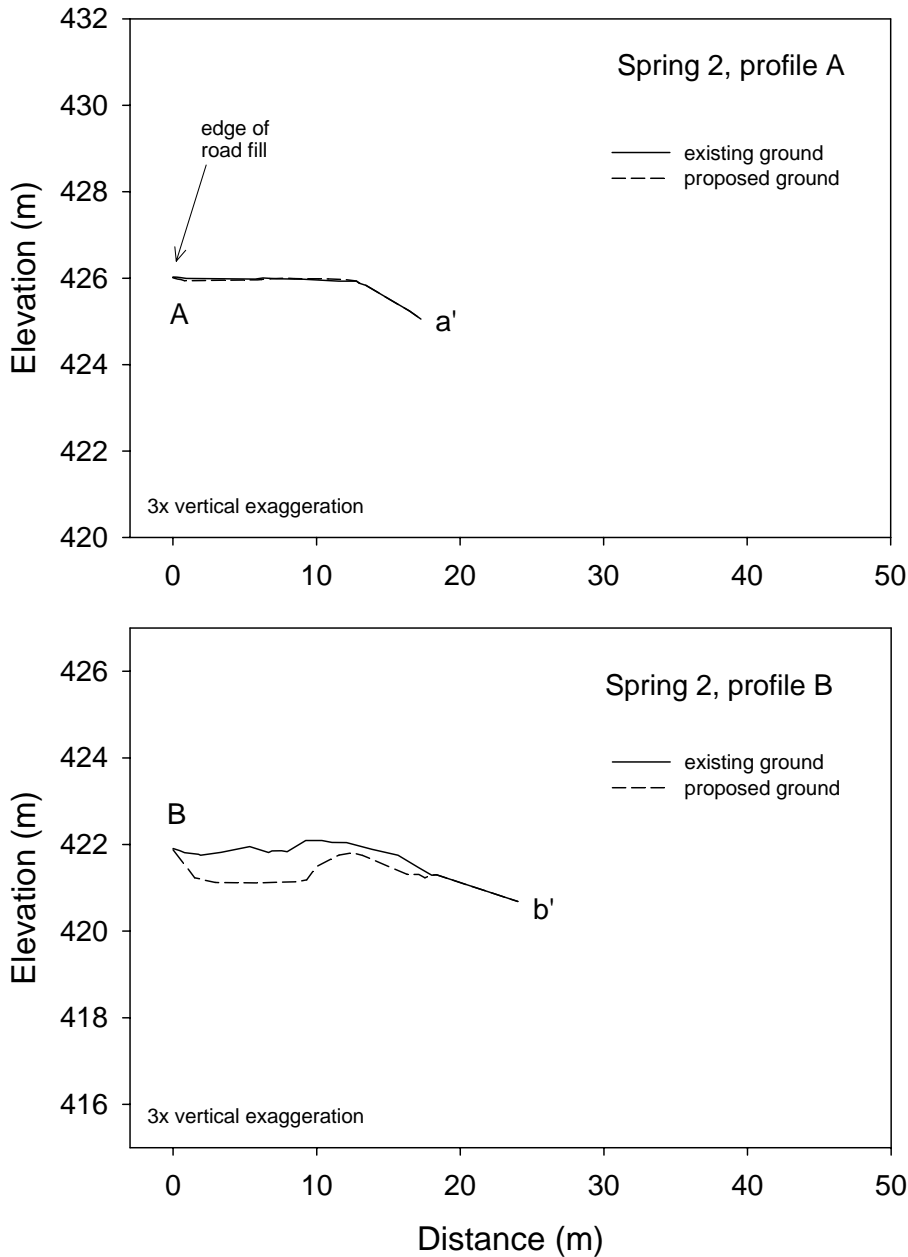
Figures 16a-c. Profiles of existing and proposed ground for spring 2. Profile locations are shown in Figure 15c.
