REPORT

2015

# Wetland restoration

Study tour in the Czech Republic 06.10.14 – 11.10.14

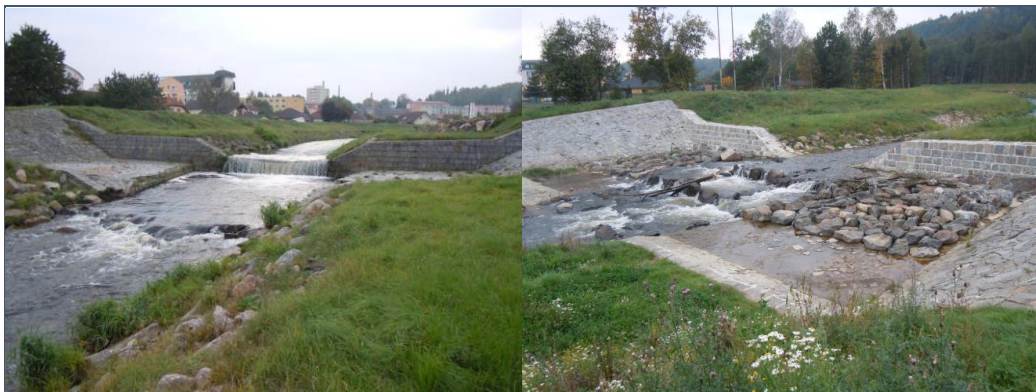
**Figure 4** Two of the dams built in the 80'ies. The dam to the right has been successfully restored for migrations of fish during the latest years

In the Ohře river several dams have been built in the 1980'ies, to enhance sedimentation of silt, reduce erosion and to slow down the current. The dams represent obstacles for fish to move upstream. This has made some spawning grounds inaccessible for parts of the brown trout population, and also limits reproduction for other fish species.

The old alternation due to silt sedimentation and soil erosion was improved by adding large rocks and establishing fish ladders.

The fish ladder is effective. Only one ladder is so far completed, so the fish are trapped further upstream. We did see some fish succeed to jump where no improvements were made, but we also observed several that did not make it.

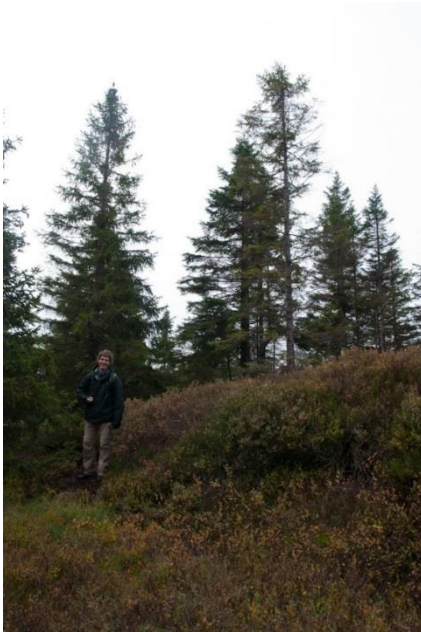
**Figure 7** The gap between the area with former peat extraction (to the left) and the natural peat lands (to the right). The difference in level is negative for the water level in the remaining peatlands. The person in the photo is Kjell Carm. Photo: Mia Husdal

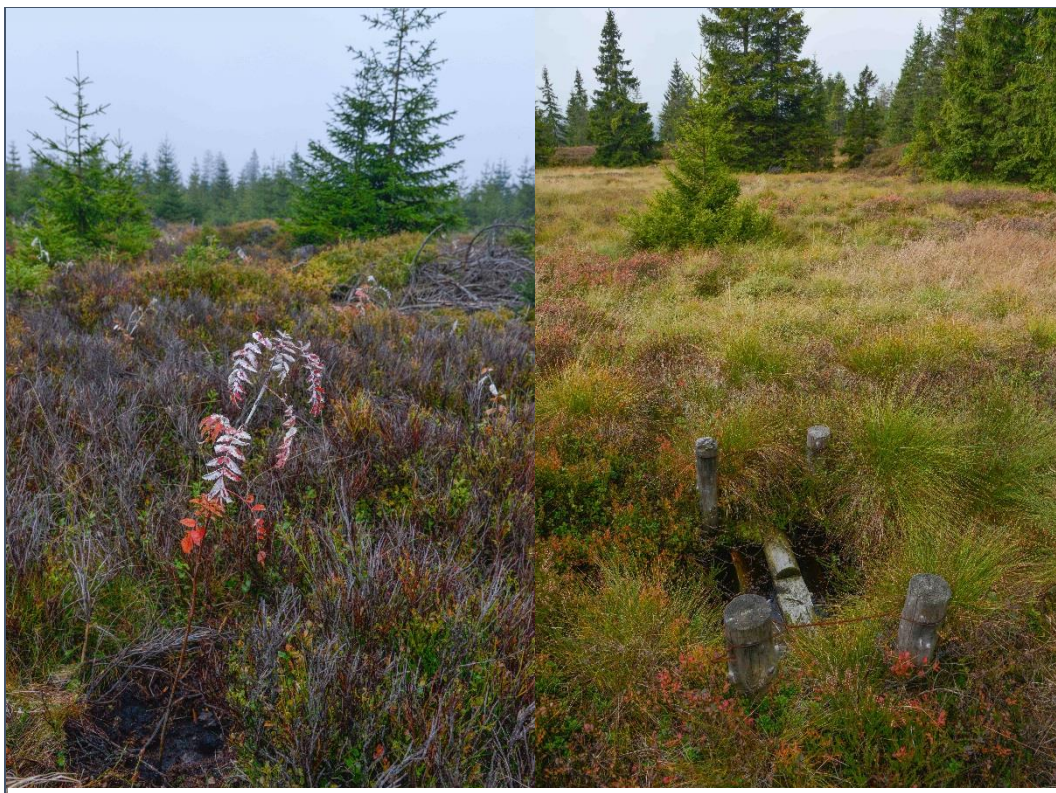
**Figure 8** Different measures were made to enhance growth of deciduous trees; singel-tree fences, group-tree fences and white-anti-deer-painting (painting every year for 15 years). Wooden dams made to increase the water table. Notice the metal string on each end of the wooden structure. It prevents the deer from crossing the dam and thereby destroying the structure. Picture at right shows the “anti-deer” painting on *Sorbus aucuparia* Photo: Magnus Johan Steinsvåg.

To enhance deciduous forest, both newly planted and already existing trees were fenced in to keep the deer from eating.

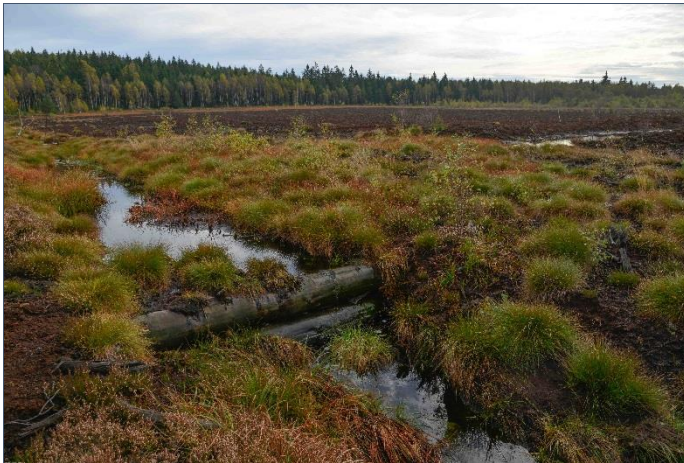
*Figure 10* Wooden dam in old ditch in the Protected Landscape Area Slavkovsky les. The area was earlier an important era for peat extraction. The water level was still too low to prevent drainage of the peatlands.

Wooden dams were built in the existing drainage ditches, to prevent the water leaving the ditch and to raise the water table. Some places the ditches partly were filled with branches and peat. This is the most used restoration method in drainage ditches in the Czech Republic.

2200 wooden dams of five different types were made between years 2010-2012. Some were simple wooden constructions and others were more advanced; including geotextiles and also filled with branches and stems from trees.

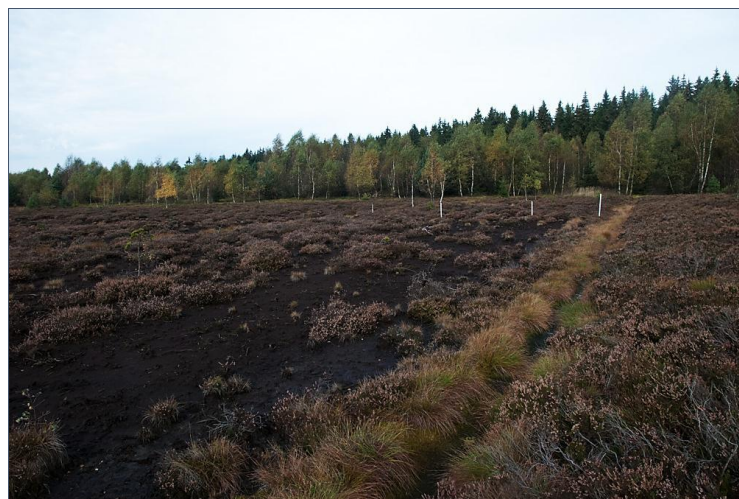
*Figure 11* Revegetation of the remaining peatlands has proved difficult. This is partly due to surface temperature during summer up to about 60°C. The peat surface does not absorb water, but develops a hard and sustainable surface

There are some difficult challenges to the restoration, because the peat is now only 0,5-2 m deep. The peat depth was about 7 m before the exploitation. A huge area is almost without vegetation and in the summer, the surface becomes very dry, hard and warm. It can reach about 60°C on the surface. The peat surface does not absorb water, but develops a hard and sustainable surface.

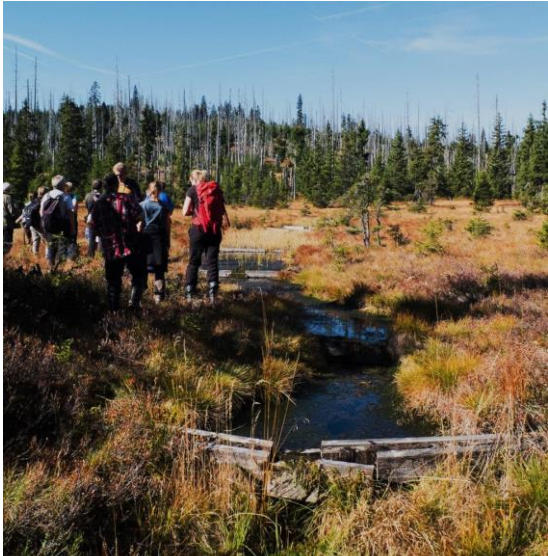
*Figure 14* Dam and old ditch in a raised bog in Breznik peatlands

There were built several dams to block drainage ditches in 2006. The work was done manually. The material for the dams were carried from the nearest road and the holes were dug by hand.

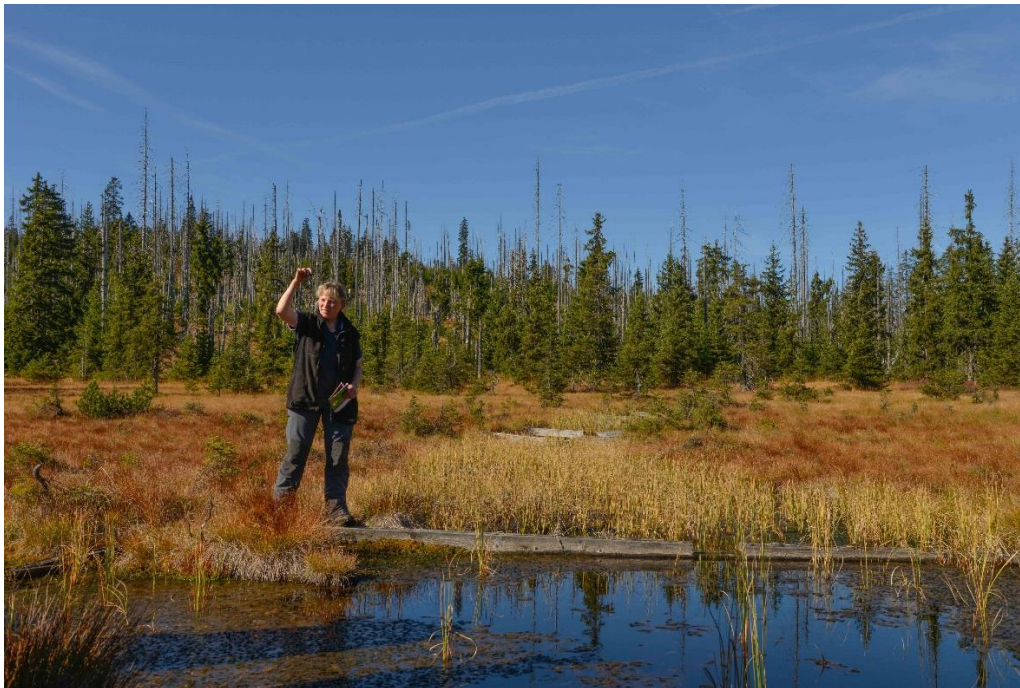
*Figure 15* The guide Ivana Bufková shows examples of species living in the raised bogs. The photo shows one of the longest dams that was particularly difficult to construct.

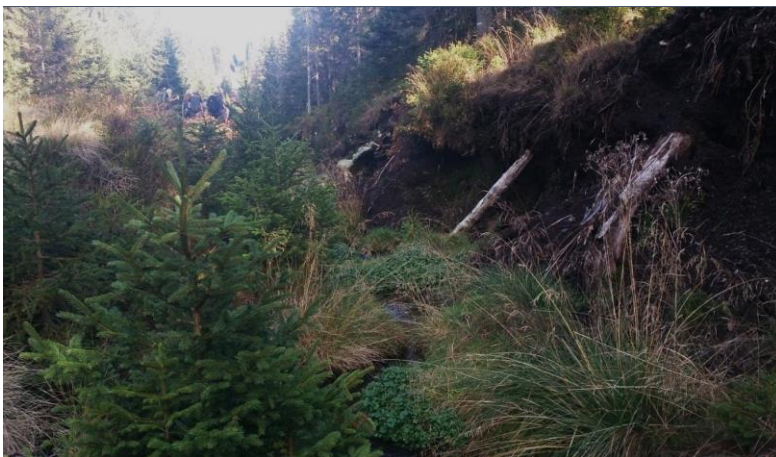
Figure 15 Ditch eroded 3-4 m deep and 6-7 m wide.

In the 1950s the line of the Iron Curtain was cut through the area in a completely straight line, regardless of nature qualities or other obstacles. All vegetation was removed from the route of the Iron Curtain, and on both sides it was dug a wide and deep drainage ditch. This drained the wetland on both sides of the Iron Curtain, and cut off the natural network of springs and small capillar streams, and caused massive vertical erosion on slopes.

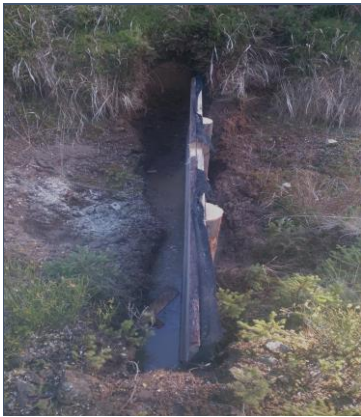
**Figure 16** The dam is built with a double wall with a membrane in the middle to make it waterproof.

The drainage ditches have been blocked by a network of wooden dams. To enhance the terrestrialisation of the ditches they have been filled with masses of natural material and clusters of four

different species of *Sphagnum* able to grow floating on water.

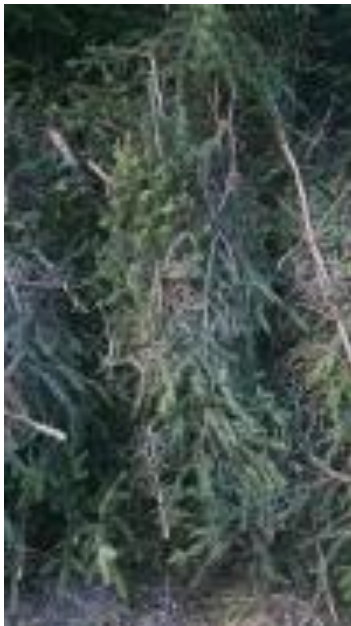
**Figure 17** Also bundles of branches are made to be used in the ditches on the slope, to make fine sediments accumulate.

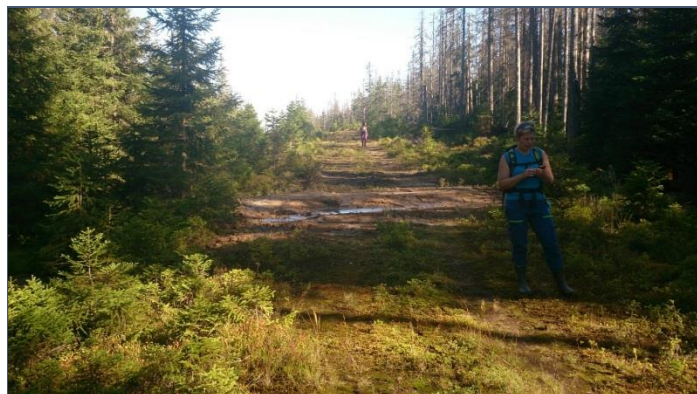
**Figure 18** Restored stream crossing the Iron Curtain.

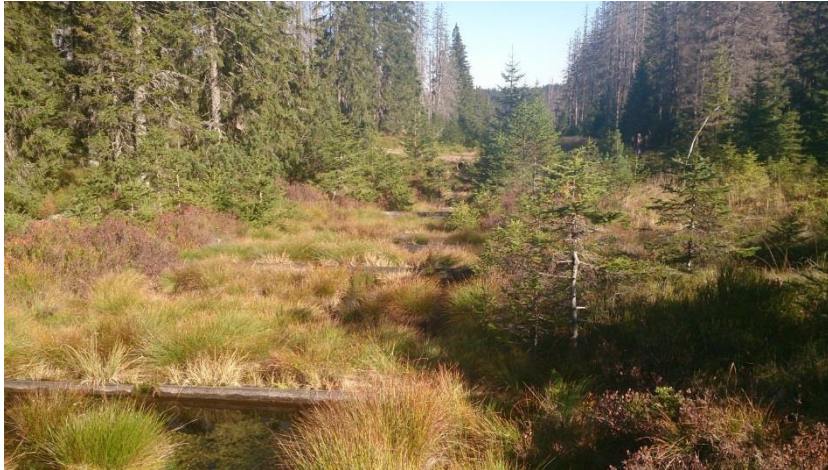
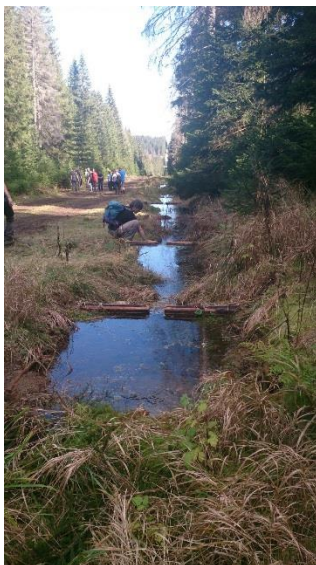
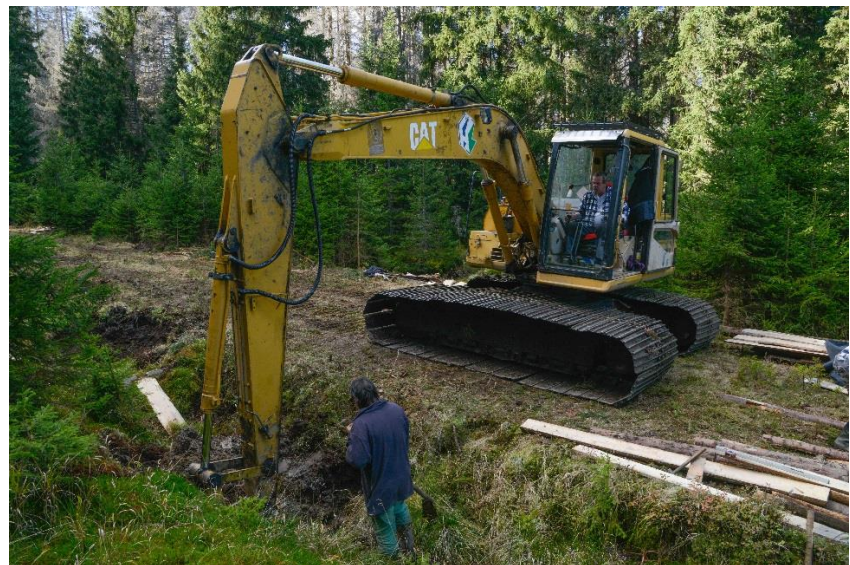
**Figure 19** (left) Ditch dammed in 2006 with almost no open water surface due to terrestrialisation

**Figure 21** (under right) Contractors building dams along the Iron Curtain.

On the top of the hill where the gradient is quite flat one can clearly see that there is terrestrialisation of the ditches in progress.

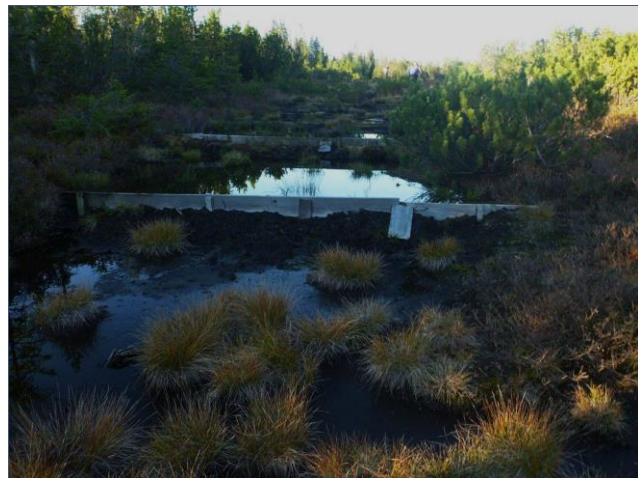
**Figure 23** Dams built to re-establish water level.

No peat or other masses were added to the ditch. As can be seen from the picture above the regeneration might take some time, but in some of the small pools the terrestrialisation has started.

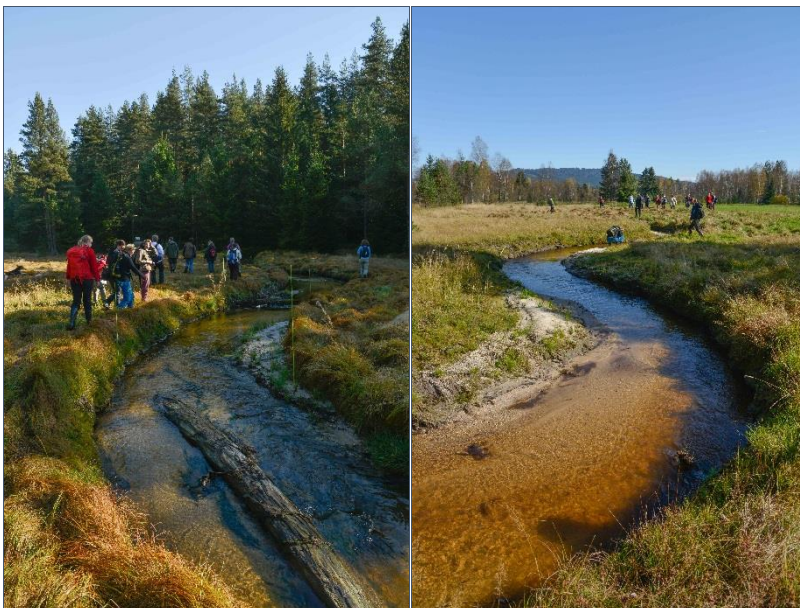
**Figure 26** A section of the restored river in alluvial meadows in Hučina river system. Notice the woody debris in the photo to the left. They will enhance habitat diversity  
Photos: Magnus Steinsvåg

The river has responded extremely well to restoration and only a year after there is few signs left to tell that the river had been constructed.

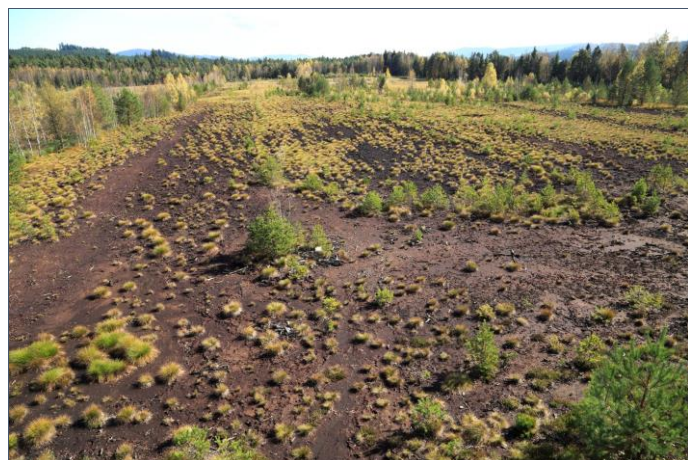
*Figure 28* View from the observation tower in Soumarsky Most peatland. The bare peat is slowly being colonized by plants, especially *Eriophorum* tussocks

temperature fluctuations and evaporation from the peat surface. This also enhanced colonization in to bare peat because of seeds of sedges and spores of sphagnum from the mulch. Sphagnum mosses were reintroduced into shallow basins. In addition tufts of *Eriophorum angustifolium* and *Carex rostrata* were planted in the peat to increase plant cover and recolonization. It took 10 years to raise enough money to start stage two of the restoration process.

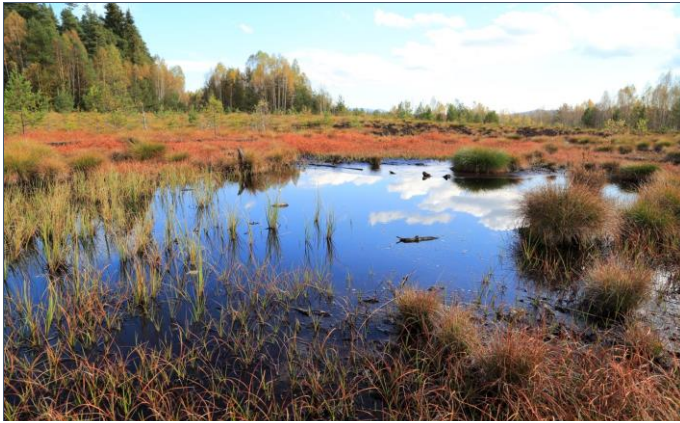
**Figure 29** A small pool in Soumarsky most peatland is a results of the increased water table caused by blocking drainage ditches. These pools are important habitats for several groups of insects including dragonflies.
