**THEMBALETHU UPGRADED INFORMAL SETTLEMENT PROJECT (UISP):
BULK SERVICES TERRESTRIAL FAUNA & FLORA SPECIALIST STUDY FOR BASIC ASSESSMENT
DEA&DP Ref No: 16/3/1/1/D2/50/0060/12**

**PRODUCED FOR CAPE EAPRAC
ON BEHALF OF GEORGE MUNICIPALITY**

September 2013

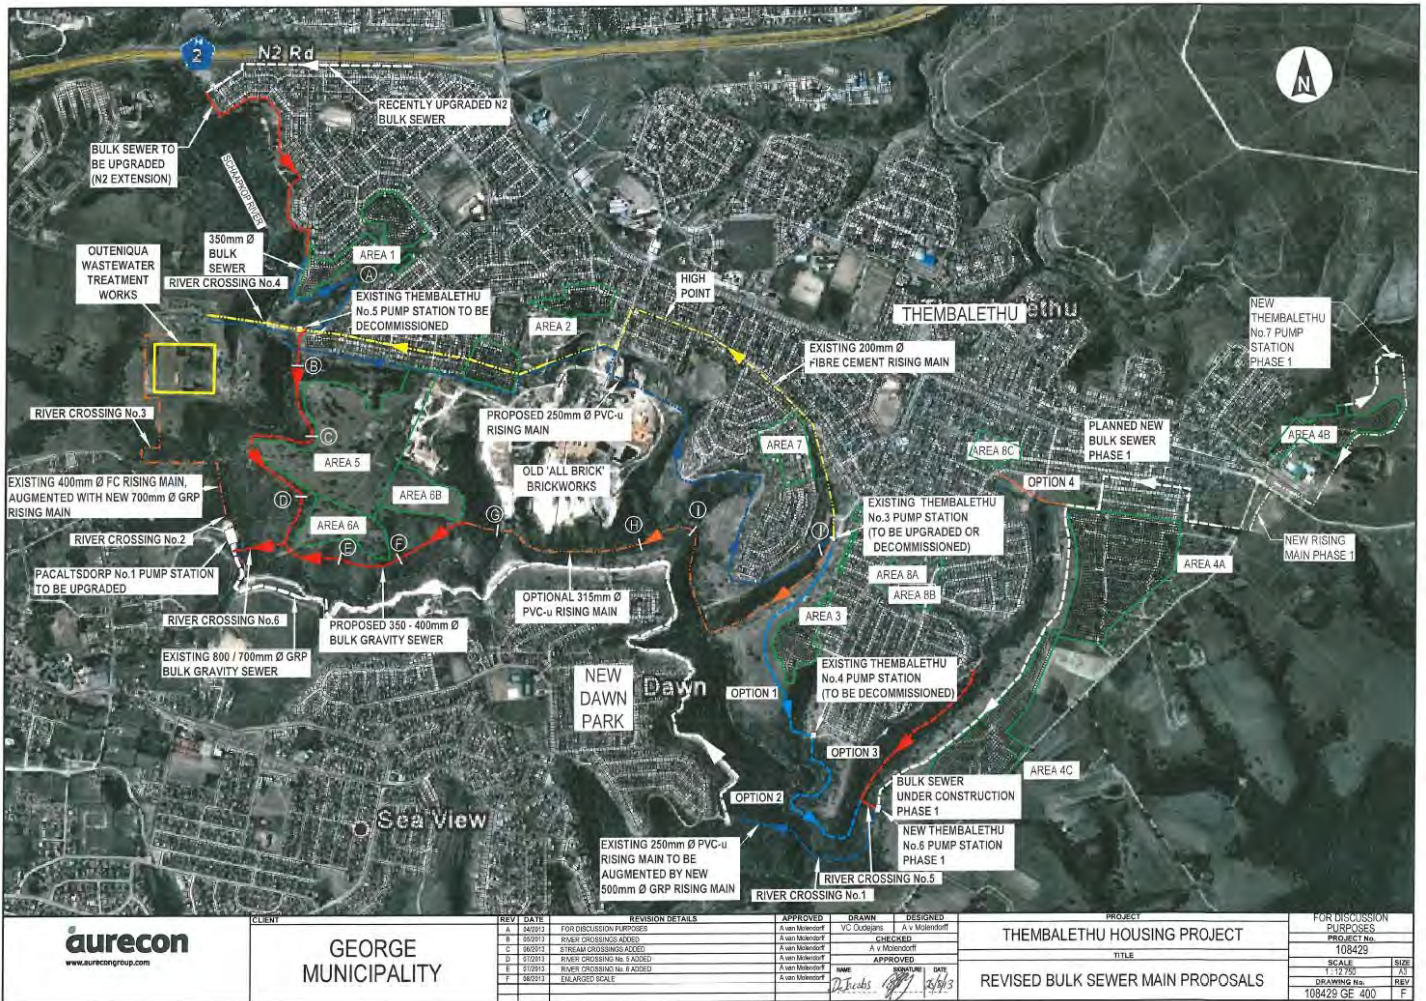
Figure 1. Layout of the Thembaletu UISP as provided by Aurecon, the project engineers. The bulk sewers and river crossings along the Schaapkop River are illustrated. Please note that the white and yellow lines on the above diagram indicate the existing sewer lines (not part of this

assessment), while the red, orange and blue lines indicate the proposed sewer gravity lines and rising mains.

- A number of pipe bridges are required to traverse the Schaapkop River, as well as the tributaries.
 - A 60m long concrete pipe bridge is proposed over the tributary of the Schaapkop River, near the Thembaletu No. 6 Pump Station, noted as Crossing 5 in the layout diagram below (No. 108429 GE 400 Rev.F).

- Shorter concrete bridges are required at crossings labelled 2 and 3 below.
 - A 30m post-tensioned concrete pipe bridge, adjacent to Pacaltsdorp No.1 Pump station, noted as Crossing 6 in the layout diagram.

- River Crossing 1 across the existing steel-bridge structure from Pump station 6.
 - A 50m concrete pipe bridge, from Thembaletu No.5 Pump station to the WWTW, noted as Crossing 4 in the layout diagram.

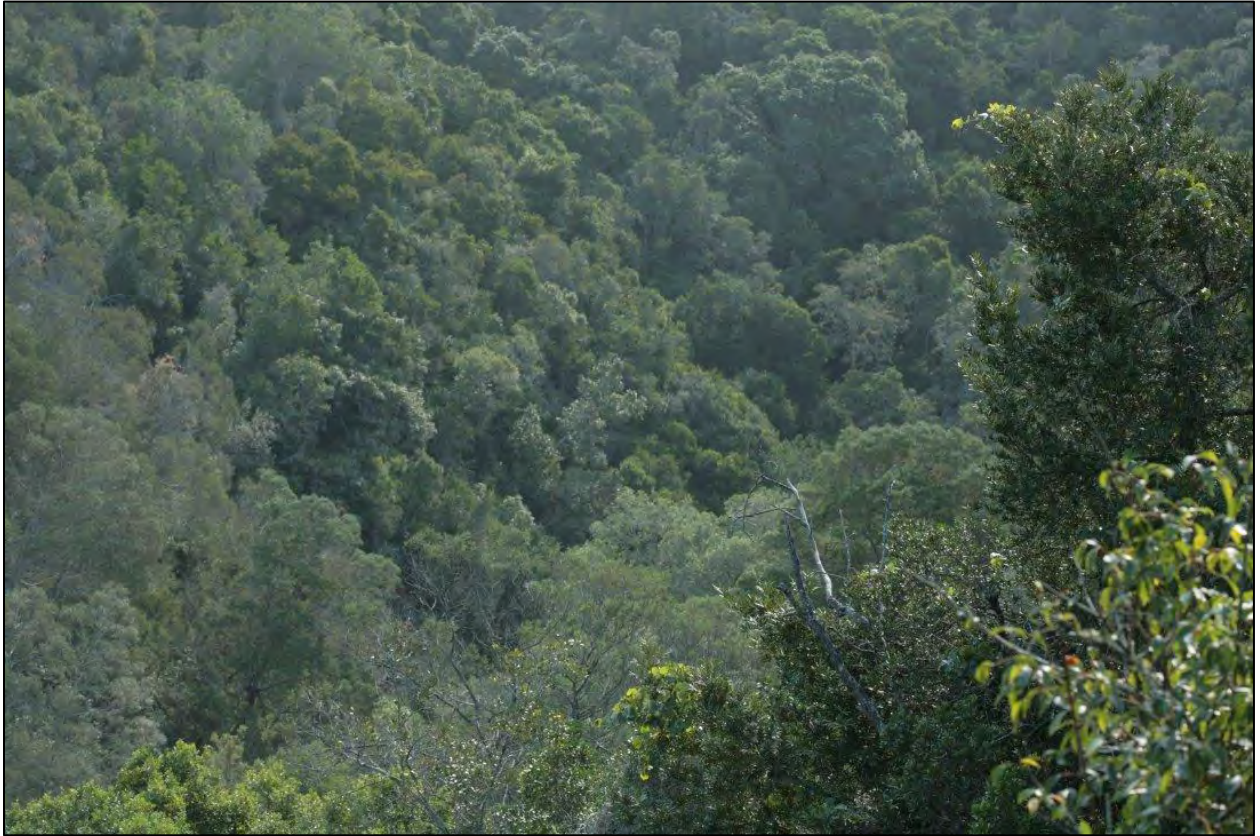
The steeper and more sheltered slopes within the Schaapkop River valley consist of Afrotemperate Forest. Although these are degraded and invaded by Black Wattle in some areas, there are also some dense forests that have resisted invasion and are comprised of species such as *Curtisia dentata*, *Cassine peragua*, *Podocarpus falcatus* and *Trimeria grandifolia* subsp. *grandifolia*, with an understorey of ferns, geophytes and lianas.

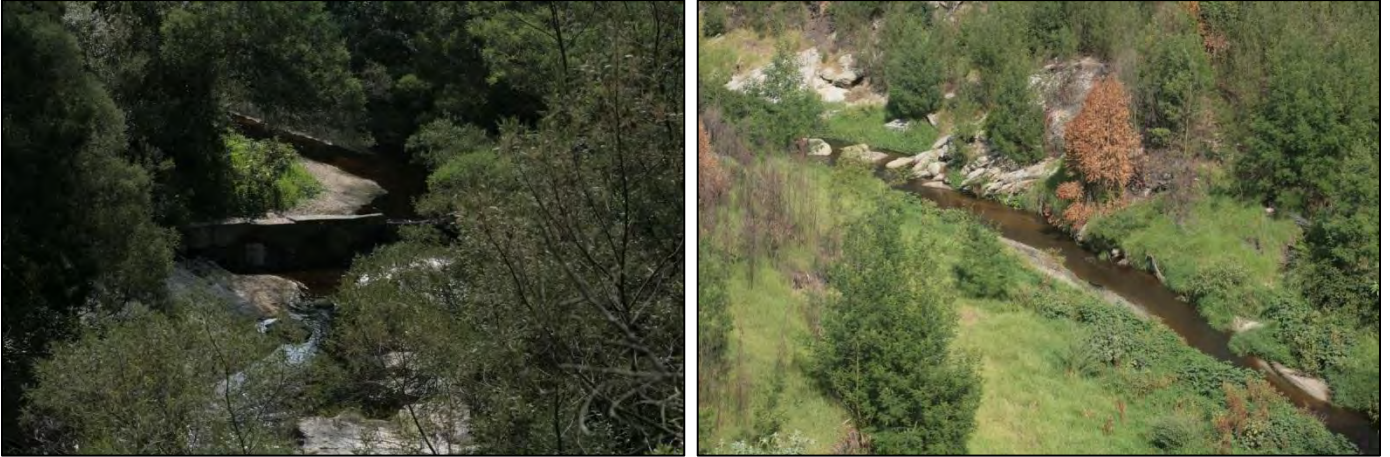
The Schaapkop River is badly degraded, firstly as a result of sewerage effluent entering the stream on a regular basis, and secondly as a result of extensive alien invasion. As can be seen in the images above, the stream banks do not have indigenous riparian vegetation but rather alien species such as kikuyu, wattle and *Xanthium strumarium*.

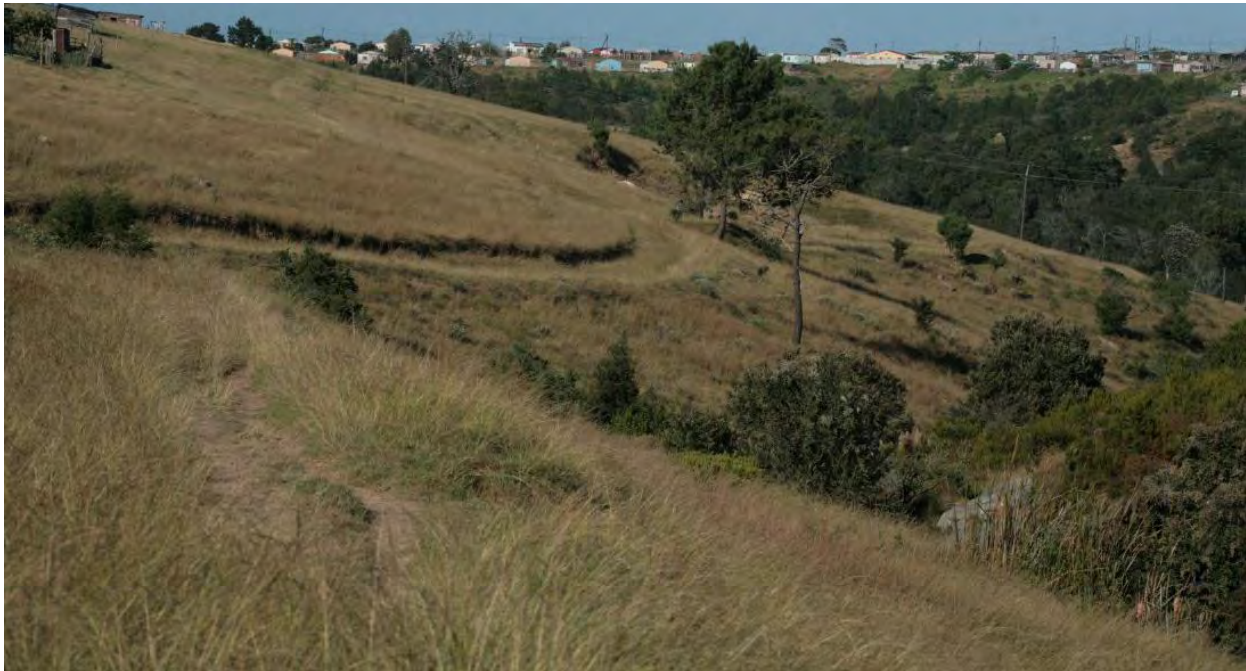
The flatter crests of the hills flanking the Schaapkop River are mostly anthropogenic grasslands resulting from past cultivation and dominated by species such as *Eragrostis curvula*. These areas are also often invaded by wattle or pines. Some of the lower slopes may have small remnant fragments of fynbos present.

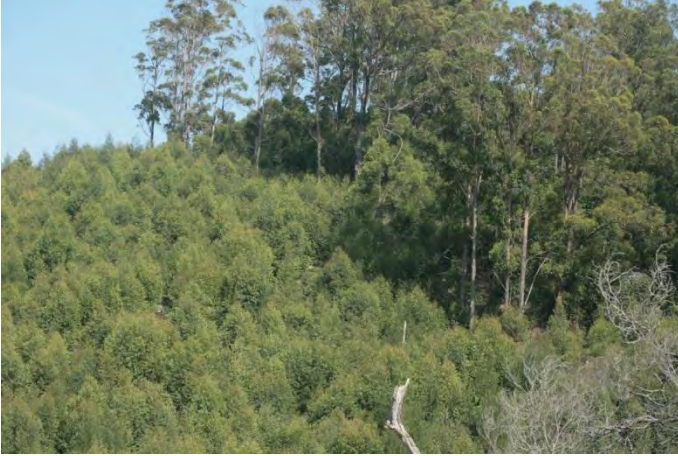
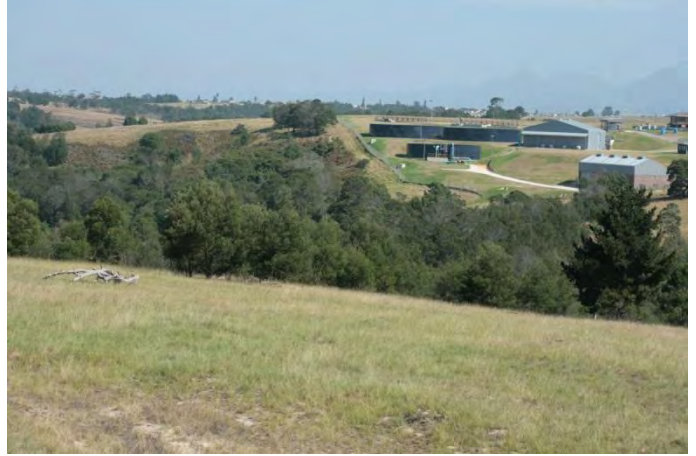
Other examples of transformed habitats at the site include Eucalyptus plantations near the old brickworks, as well as the Outeniqua waste water treatment works and surrounding environment. The trees in the drainage valley in the foreground all black wattle with occasional pines.

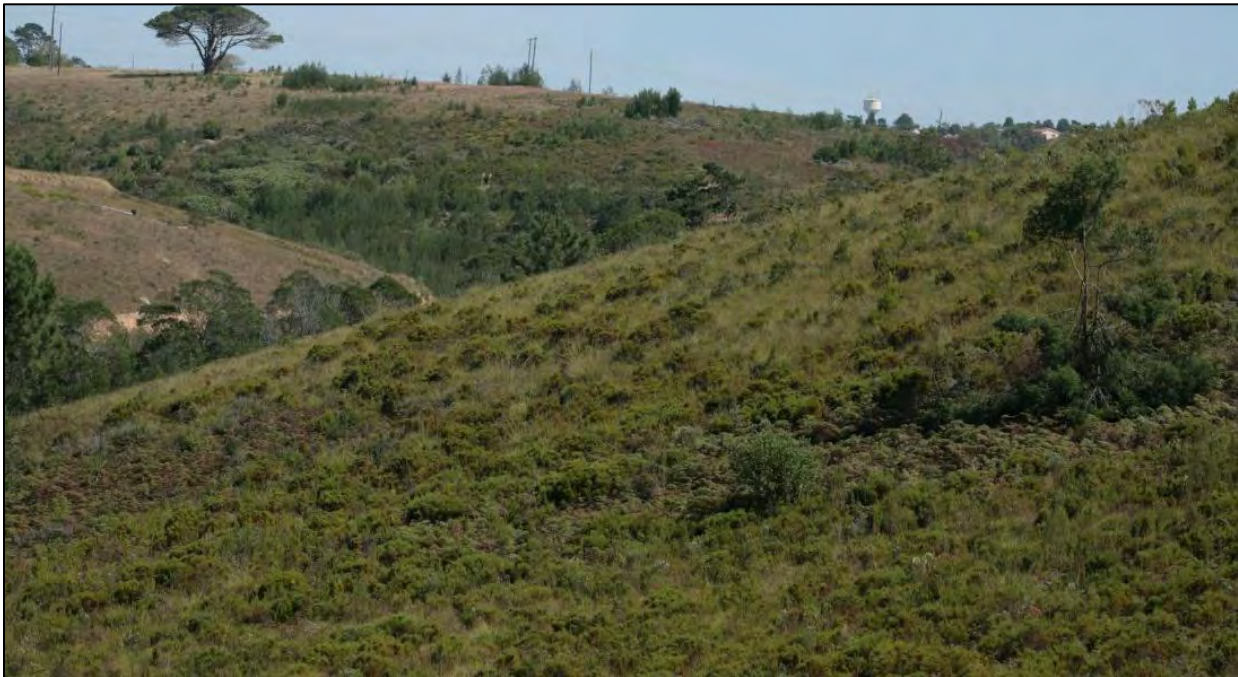
Example of intact fynbos southwest of the old brickworks. The vegetation is dense and dominated by dense stands of *Berzelia intermedia*. Although the diversity of this area is currently fairly low, it may be significantly higher following fire when it is open and more geophytes and forbs are present.

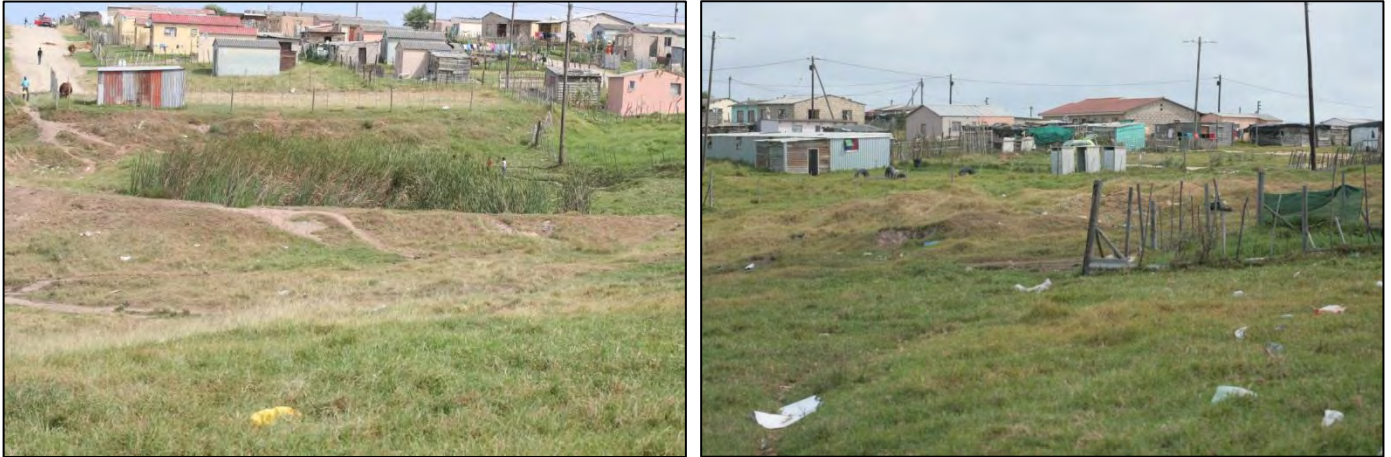
Area 8 A & B consists of an open area within the township dominated by kikuyu, with some informal houses towards the edges and a small broken earth dam towards the corner. Although the dam has some *Typha capensis* growing in it, it is not likely that the dam is very important for fauna due to the surrounding urbanisation. From an ecological standpoint it would be acceptable to fill the dam as it is not likely to be significantly used by fauna.
