# HULL RIVER CROSSING

November 2014.  
DRAFT BASIC ASSESSMENT

Basic Environmental Assessment  
for the Replacement of a  
Causeway Crossing of the Klaserie  
River, Klaserie Game Reserve

EMROSS Consulting  
P.O. Box 507  
White River  
1240  
Phone: 013 750 2782  
Cell: 082 3399 627  
Fax: 086 675 4320  
Email: [andrew@emross.co.za](mailto:andrew@emross.co.za)

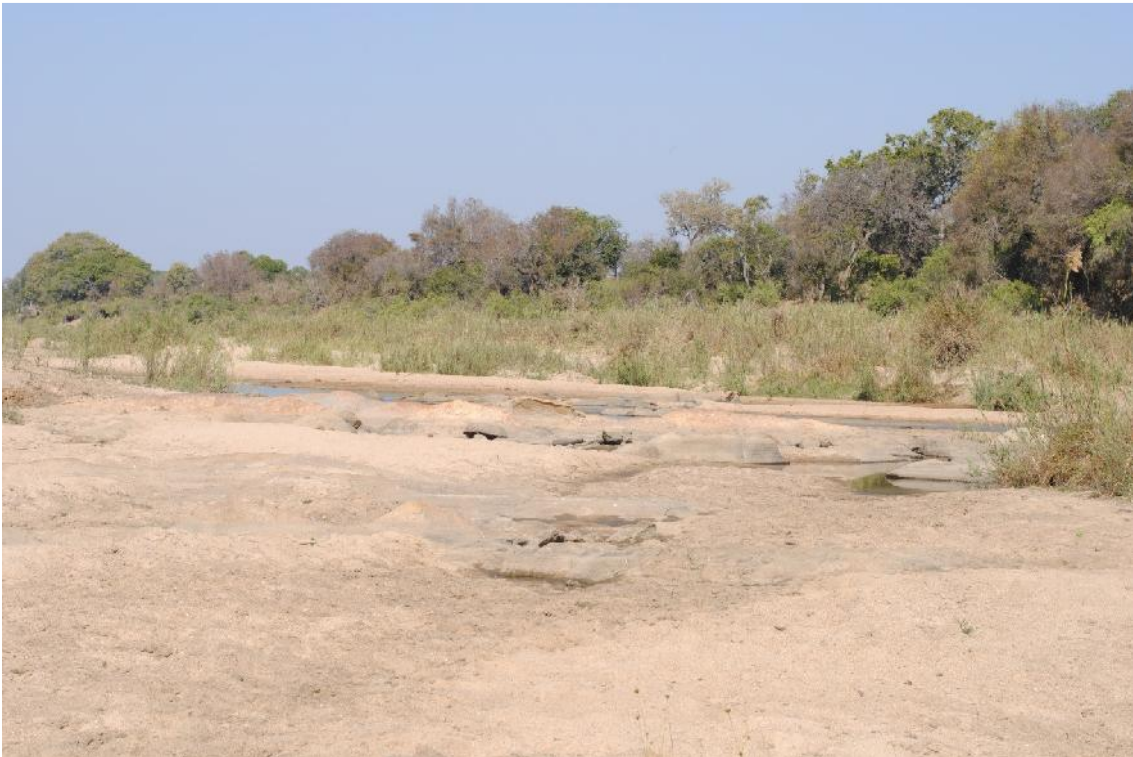
**Figure 1. The preferred site (KCP) for the causeway over the Klaserie River, facing upstream.**

The client, Emross Consulting (Pty) Ltd, requires that an Aquatic Assessment be undertaken in the Klaserie River System (KRS) at 24°16.634'S and 31°08.067'E (site KCP) (Figure 1), given that the construction of a low water causeway is planned for the locality.

The site KCP is the preferred one for the construction. Three alternatives under consideration include (1) a site 180m downstream of KCP, designated A1 (24°16.549'S, 31°08.038'E), (2) a site 370m downstream of KCP and close to the northern infrastructure of the property along the Left bank (LB), designated A2 (24°16.451'S, 31°08.031'E) and (3) the present access across the river 2.41km downstream of KCP, designated A3 (24°15.561'S, 31°08.198'E).

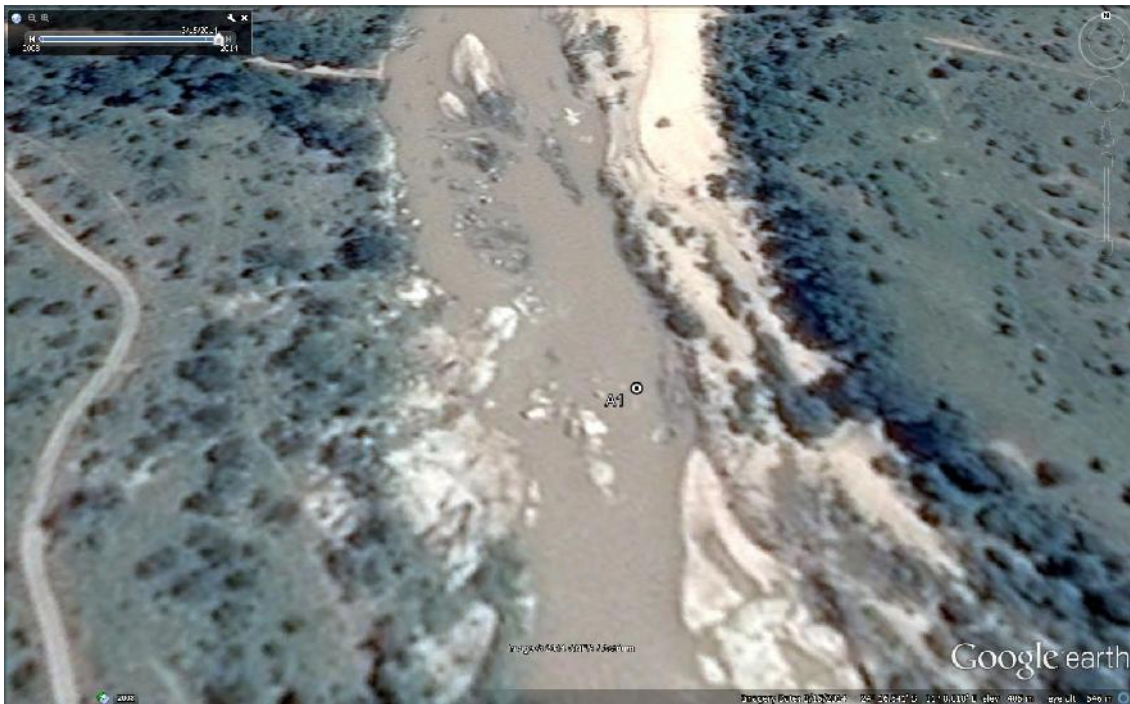
**Figure 5. The Klaserie River at alternative site A1 (Google Earth™, 2014).**

of the channel and leads to a more gradual and broader non-marginal zone along the right bank (RB). A tributary enters the river approximately 130m downstream of the site. *In terms of the reference and present extent of the riparian zone (2008 to 2014)*, a comparison of the images for 2013 and 2014 with that for January 2008 clearly shows that the river channel has been significantly scoured, broadening the channel and resulting in a reduction in cover of marginal non-woody vegetation from approximately 40 to 10%. There has also been a decrease in woody vegetation along the non-marginal zone, especially along the LB. In terms of *the biotopes for macro-invertebrates and flow-depth habitat classes for fish*, site A1 appears to have a high diversity of habitats, including SIC, SOOC, MVEG and GSM macro-invertebrate biotopes and deep and slow, shallow and slow, deep and fast and deep and slow water environments for fish species. In terms of *anthropogenic activity*, there is a well-defined gravel road parallel to the river approximately 70m to the west of the LB. There are no gravel roads immediately to the east of the RB. There is no direct, existing gravel road access to the river channel from either the LB or RB.

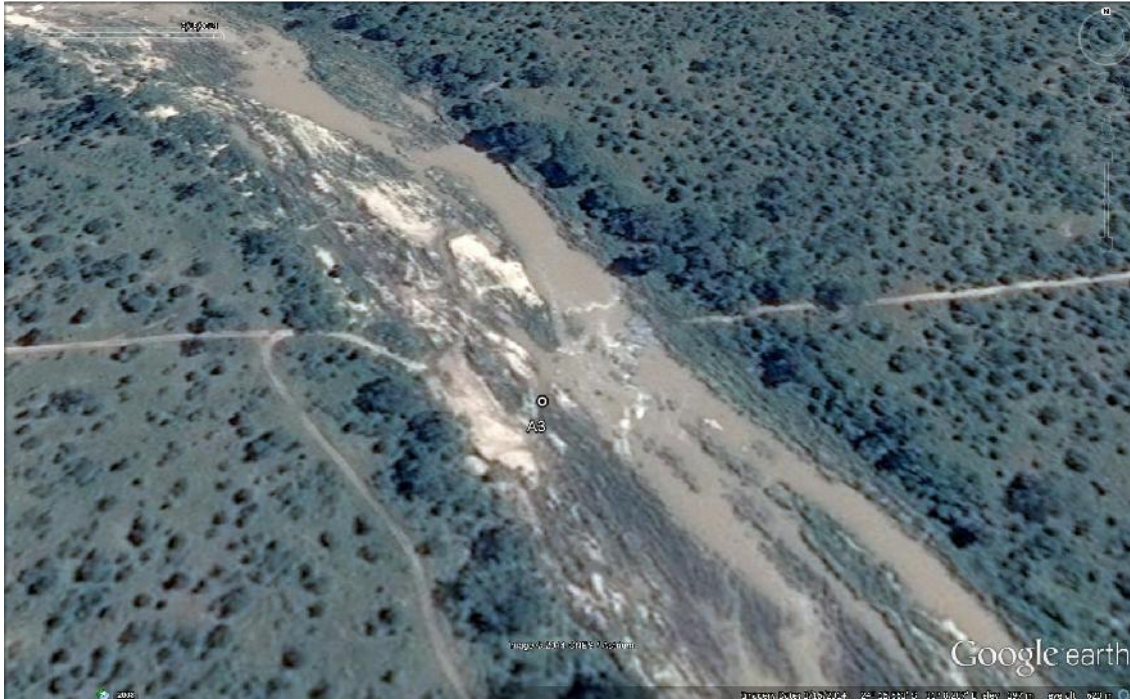
**Figure 7. The Klaserie River at alternative site A3 (Google Earth™, 2014).**

In terms of *river reach, channel and morphological units*, alternative site A3 is characterized by a well-defined channel (15/3/2014) approximately 110m in width (Figure 7). The examination of an image from November 2013 indicated that the base-flow is in the form of a braided to anastomosing channel, well represented by riffle-pool sequences for a distance of 500m upstream and a distance of nearly 1.0km downstream of the site. The non-marginal zone along both the LB and RB is gradual. A comparison of the images for 2013 and 2014 with that for January 2008 clearly shows that the river channel has changed from a single straight channel to a more diverse one, with base flow changing from mid-channel to a position along the base of the RB. In terms of *the reference and present extent of the riparian zone (2008 to 2014)*, there has been a change in non-woody cover in the marginal zone from approximately 90% to 60 to 80%. There appears to have been a slight increase in woody cover along both the LB and RB. In terms of *the biotopes for macro-invertebrates and flow-depth habitat classes for fish*, site A3 appears to have a very high diversity of habitats, including SIC, SOOC, MVEG and GSM macro-invertebrate biotopes and deep and slow, shallow and slow, deep and fast and deep and slow water environments for fish species, both immediately upstream and downstream of the crossing. In terms of *anthropogenic activity*, alternative site A3 is the presently existing river crossing along a major gravel road (“cutline”) that separates adjoining properties and serves as an access and servitude across the KPNR in a west-east direction. There is also a well-defined gravel road parallel to and 35m from the LB, upstream of the crossing.

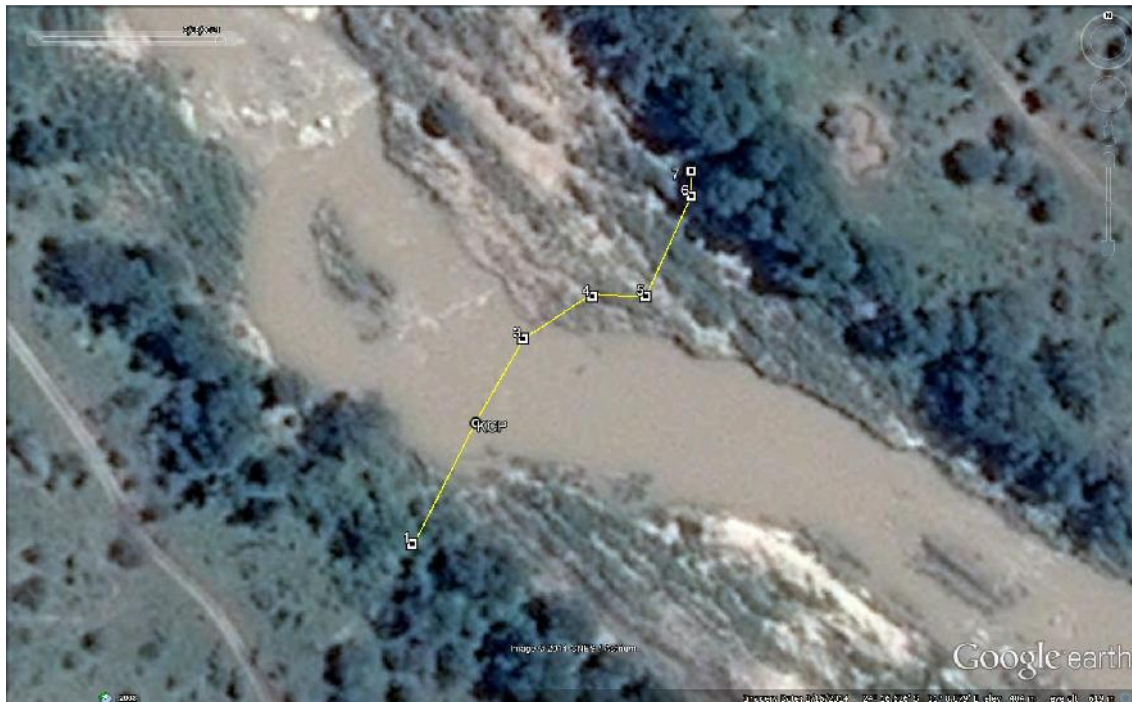
**Figure 8. The transect across the Klaserie River along which the VEGRAI assessment was conducted** (Image, 2014; Google Earth™, 2014).

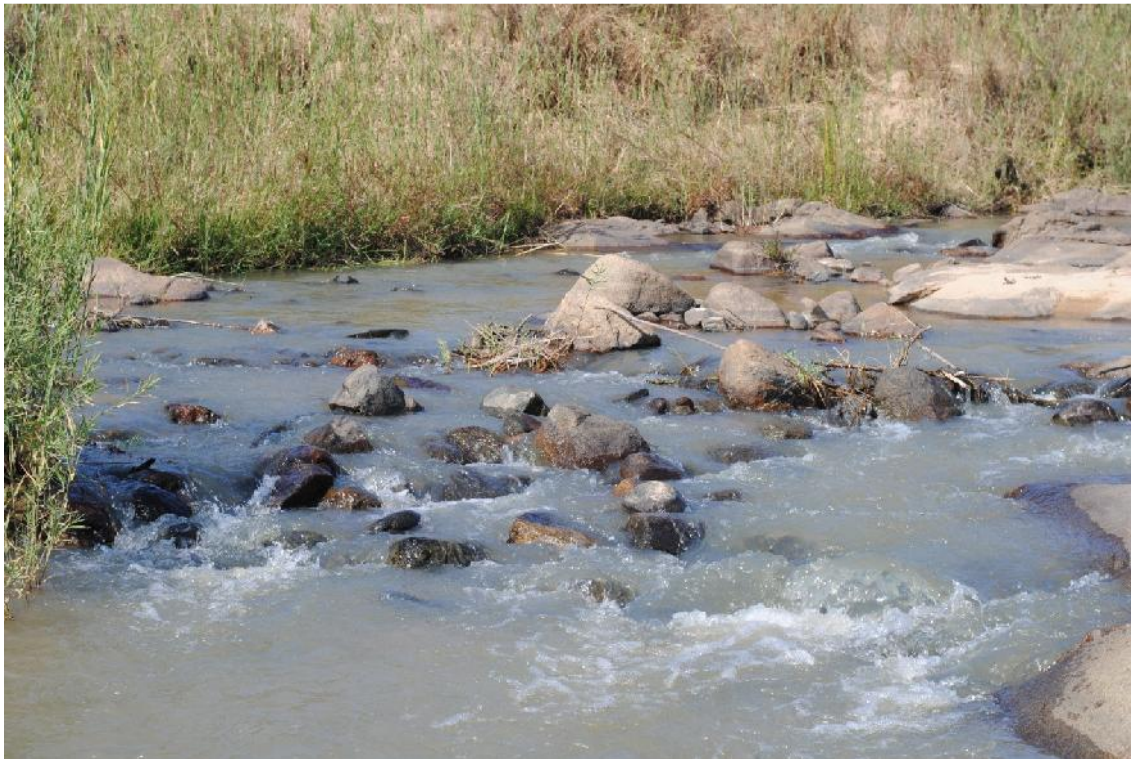
**Figure 10. The stones-in-current biotope at the SASS5 sampling site.**

**The SASS5 score at the KCP<sub>m</sub> site was calculated to be 153 with an ASPT score of 5.5. The Ecological Category (Table 5), using the Biological bands for the Lower Lowveld (Figure 4) was found to be a B, which may be described as unmodified, natural.**

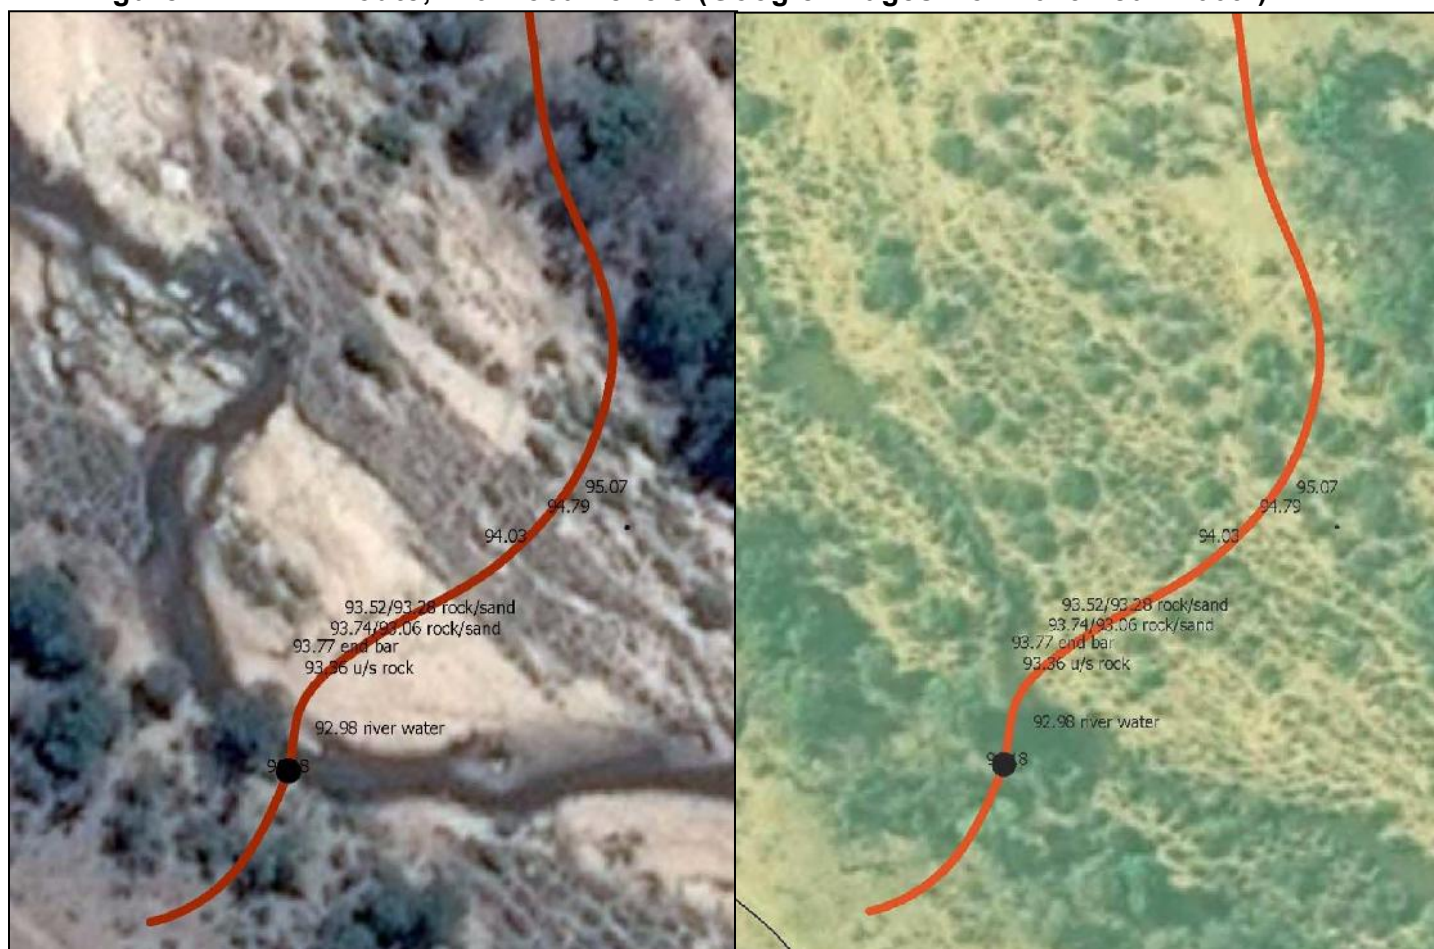
**Figure 2-2 : KCP route, with local levels (Google images Nov 2013 / Jan 2009 )**

The site has an exposed low level gneissic rock sill in the middle of the river, with a dolerite dyke intrusion, which forms a natural low weir. This extends to about 13m from the left bank and is covered by sand on the right central and bank area.

There had been considerable scour and re-deposition of sand between dates of images, with a significant loss of larger flora and a marked change in the riverbed except at the preferred site. The animal track is also very similar !

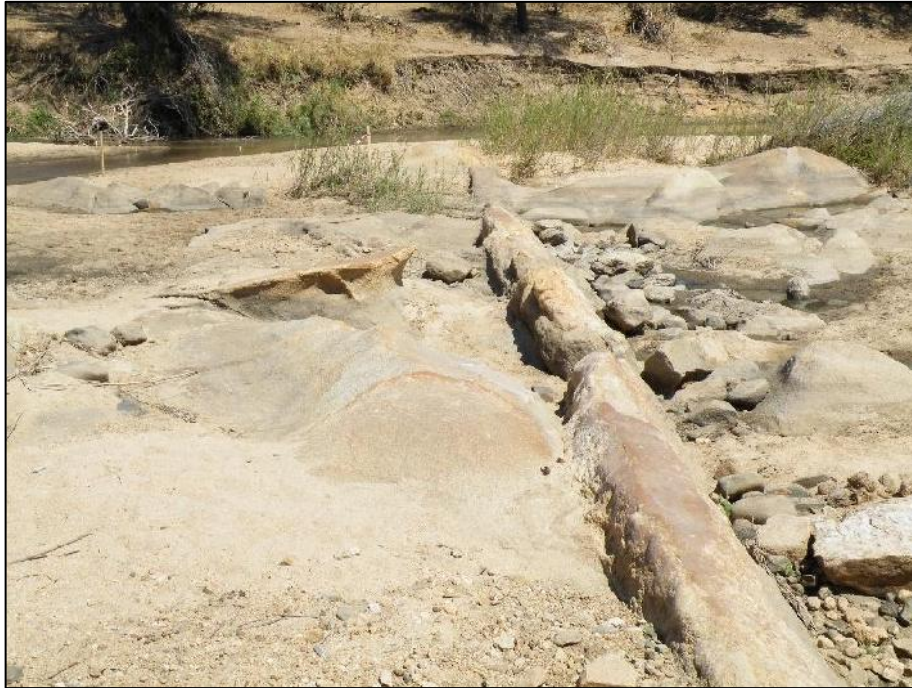
**Figure 2-3 : KCP Central rock sill with dolerite dyke – looking at left bank**

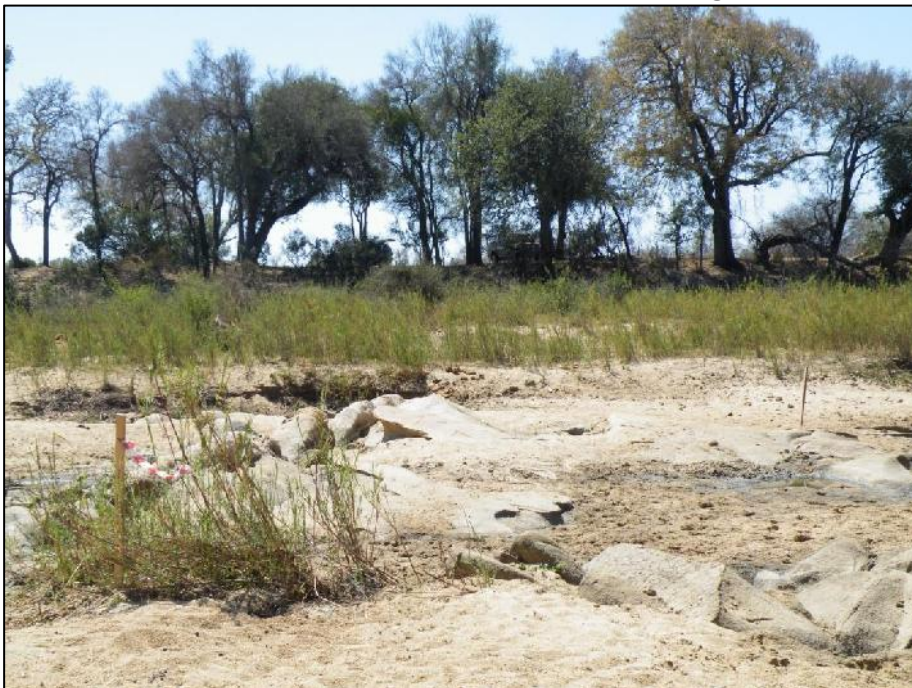
**Figure 2-4 : KCP View from left bank end of rock sill to right bank.**

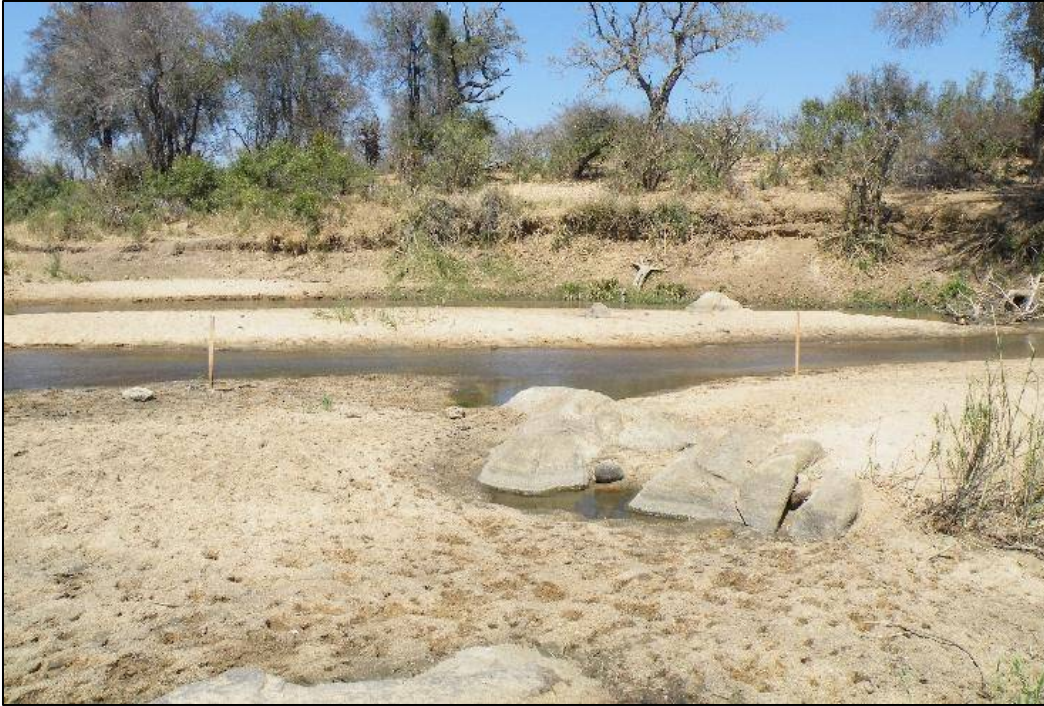
**Figure 2-5 : KCP left bank at the access route**

Approach roads would be in clayey sandy soils, which would allow moderate shaping, but require hardened side drainage to prevent erosion. The left bank approach would be in a minor cutting, which would require armoring against erosion by flood water. The right bank approach road would be oblique to the river bank and would not need armoring, more than the road fill retaining blocks.

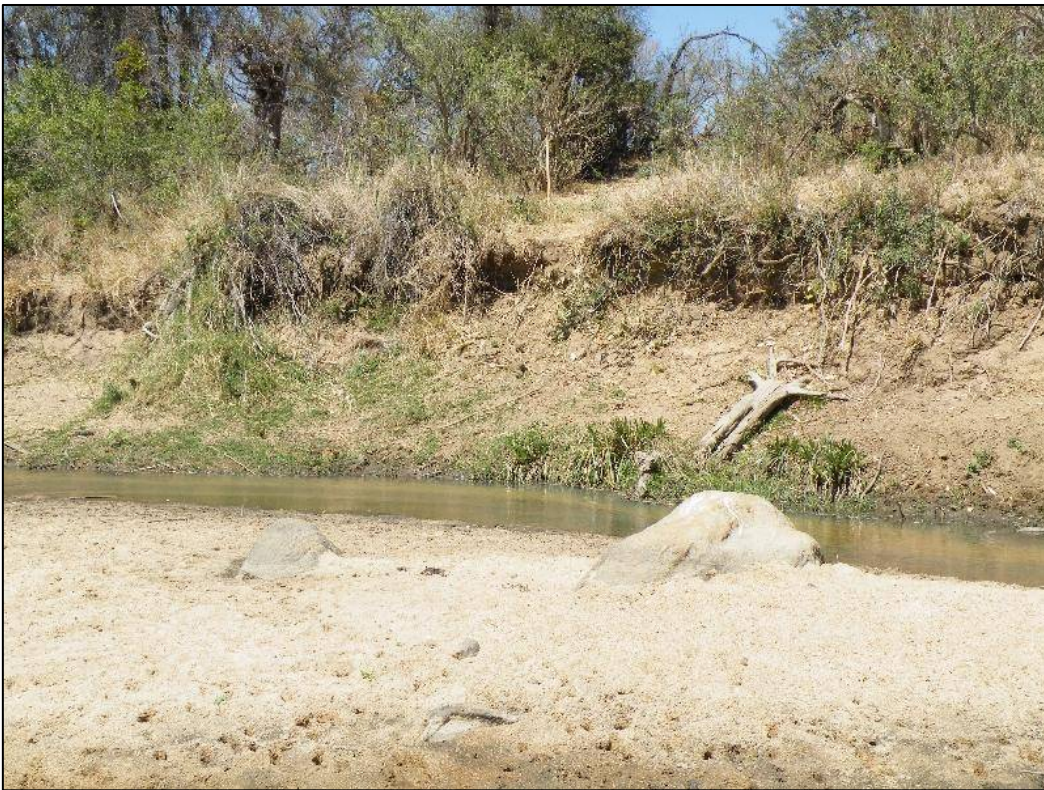
**Figure 2-6 L KCP left bank characteristic**

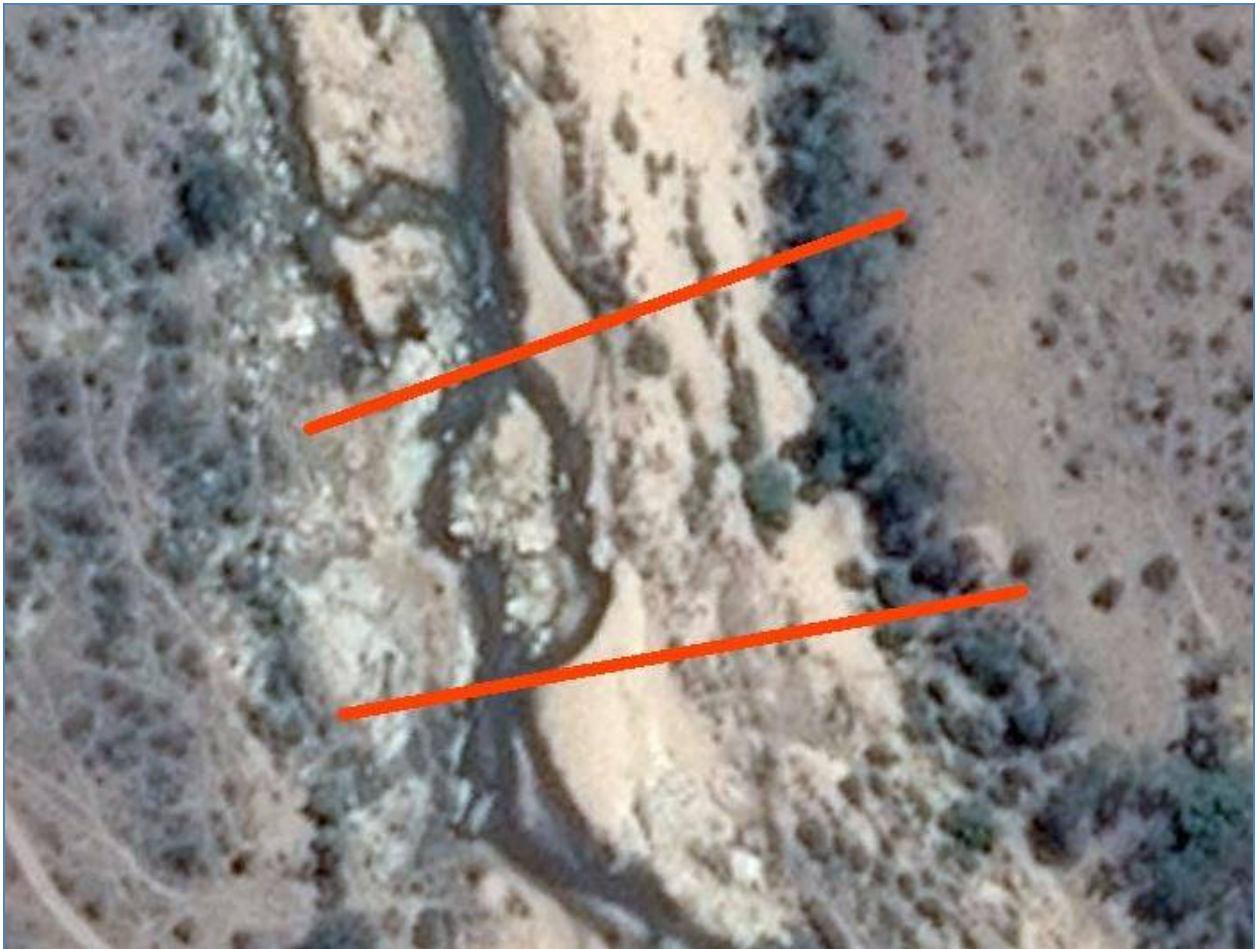
**Figure 2-7 : Options on Alternative 1**

The site is over a short reach of river, which is characterized by steep left (western) bank approach in outcropping rock to incised braided channels with whaleback rock outcrop in between channels (Figure 2-10 and Figure 2-11). The right bank is deep sand, which was not probed for foundation because it was evidently more than 1.80m down, which was the limit of the hand probe.

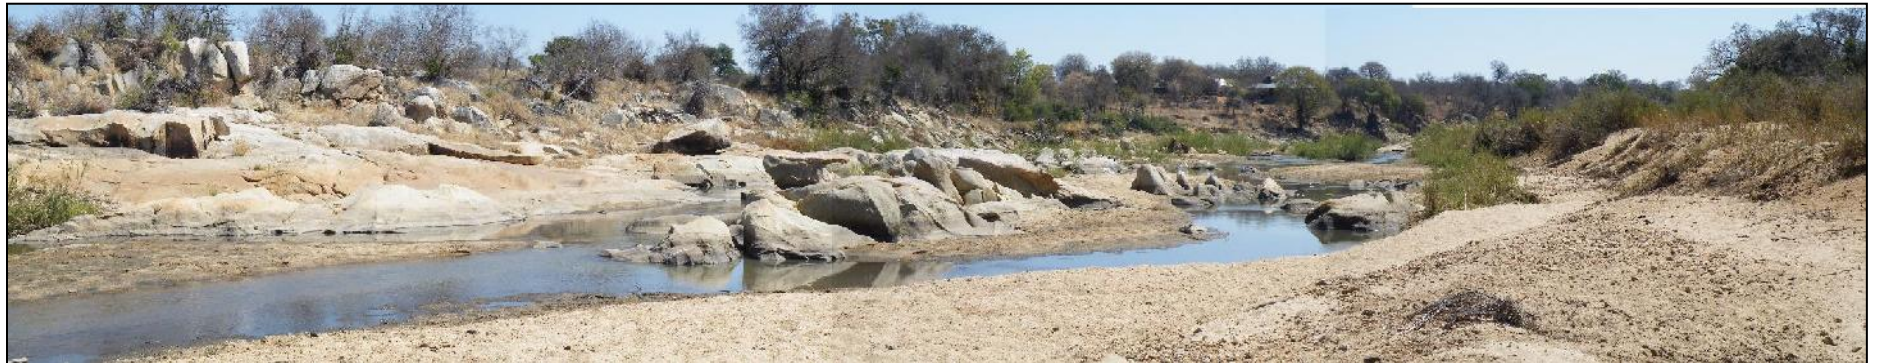
**Figure 2-11 : KCA1 – approximate line of northern crossing.**

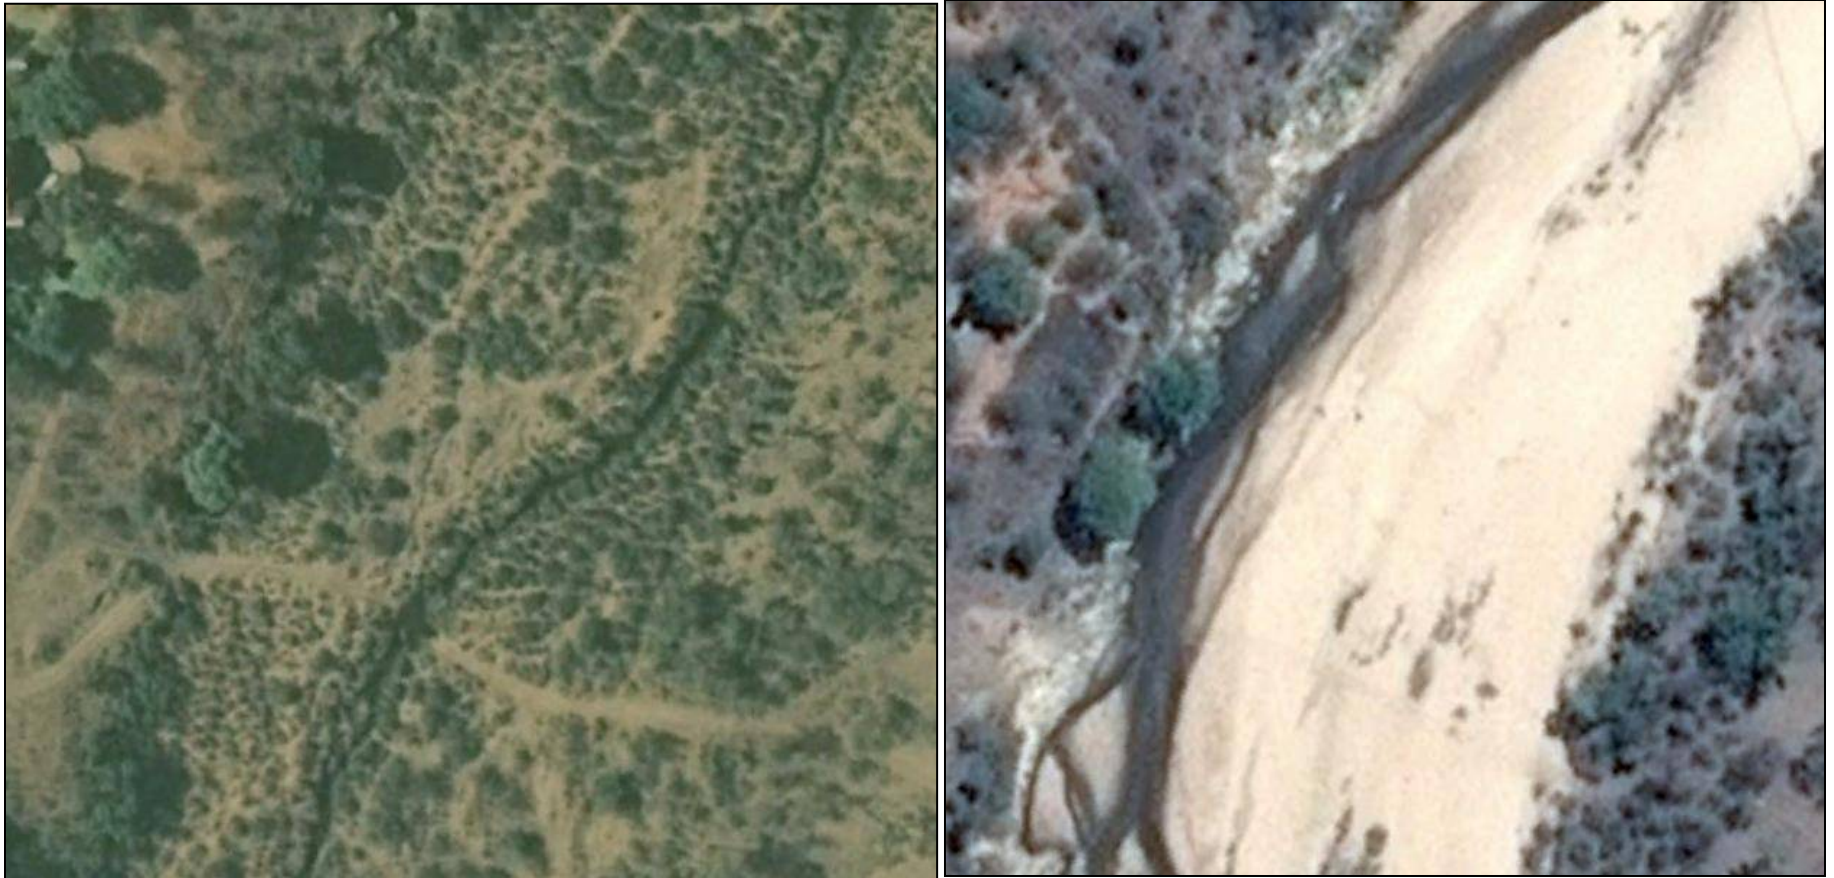
**Figure 2-14 : KCA2 – Comparison of Google images January 2008 and November 2013 – no visible rock foundation for cross channel causeway.**

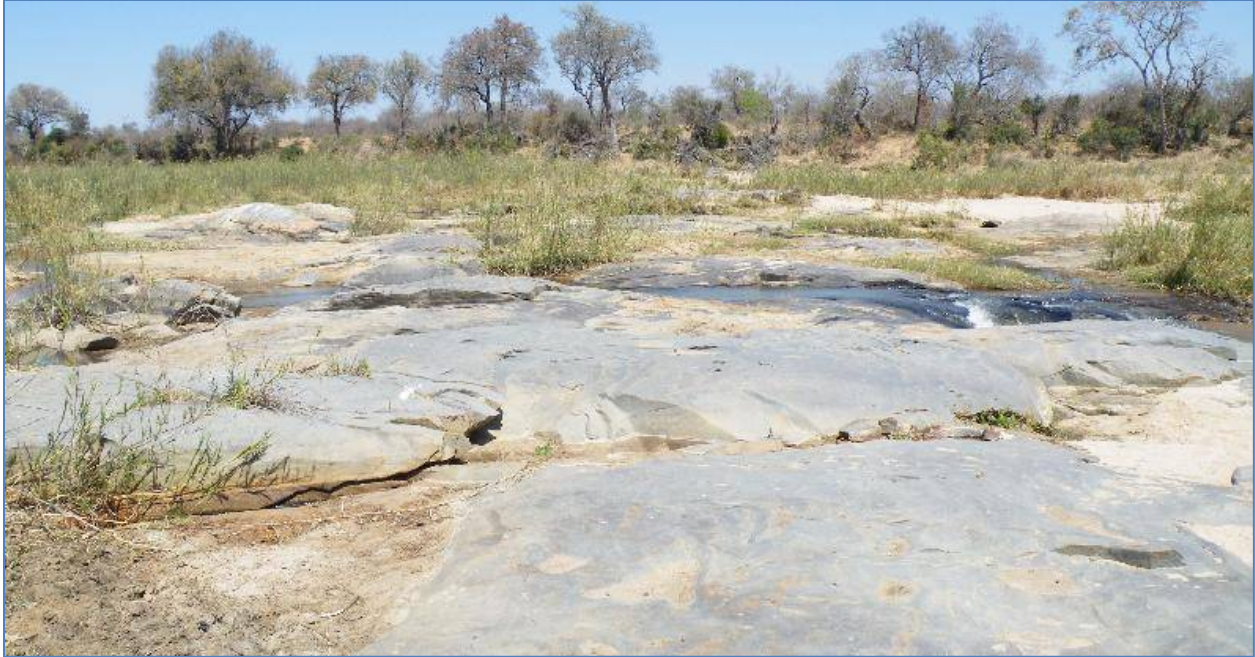
**Figure 2-15 : KCA3 – Rock outcrop – possible route for permanent causeway**

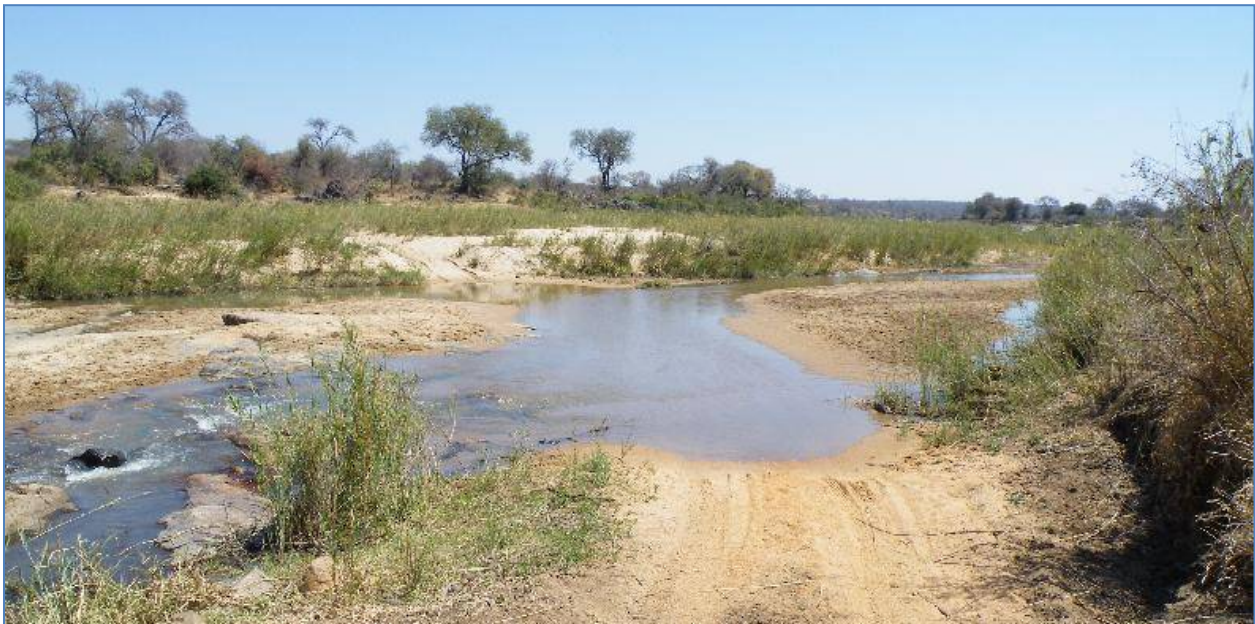
**Figure 2-16 : KCA3 – Current route for crossing through reed beds and sand banks.**

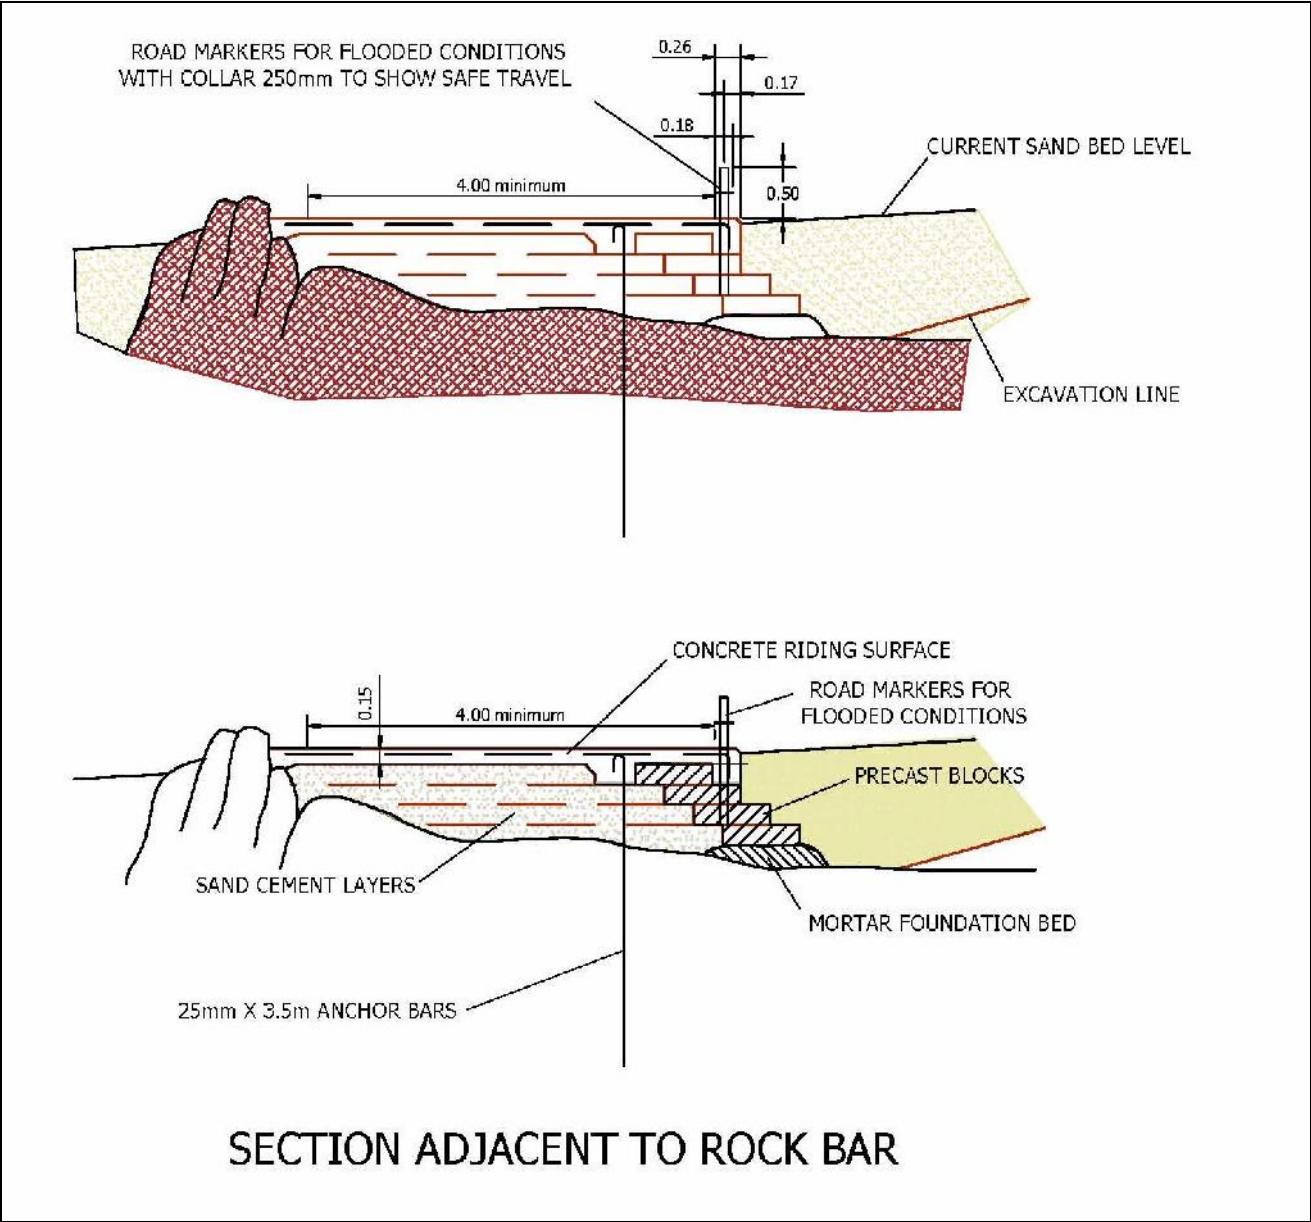
**KCP – Causeway adjacent to rock bar (flow from right to left)**
