**Environmental Impact Assessment on the proposed  
330kV Power Line from Zambezi Substation to Wanela/Sesheke  
Border:**

**Impact on the Vegetation**

Ben Strohbach  
October 2013

for:  
Enviro Dynamics cc and NamPower  
Windhoek

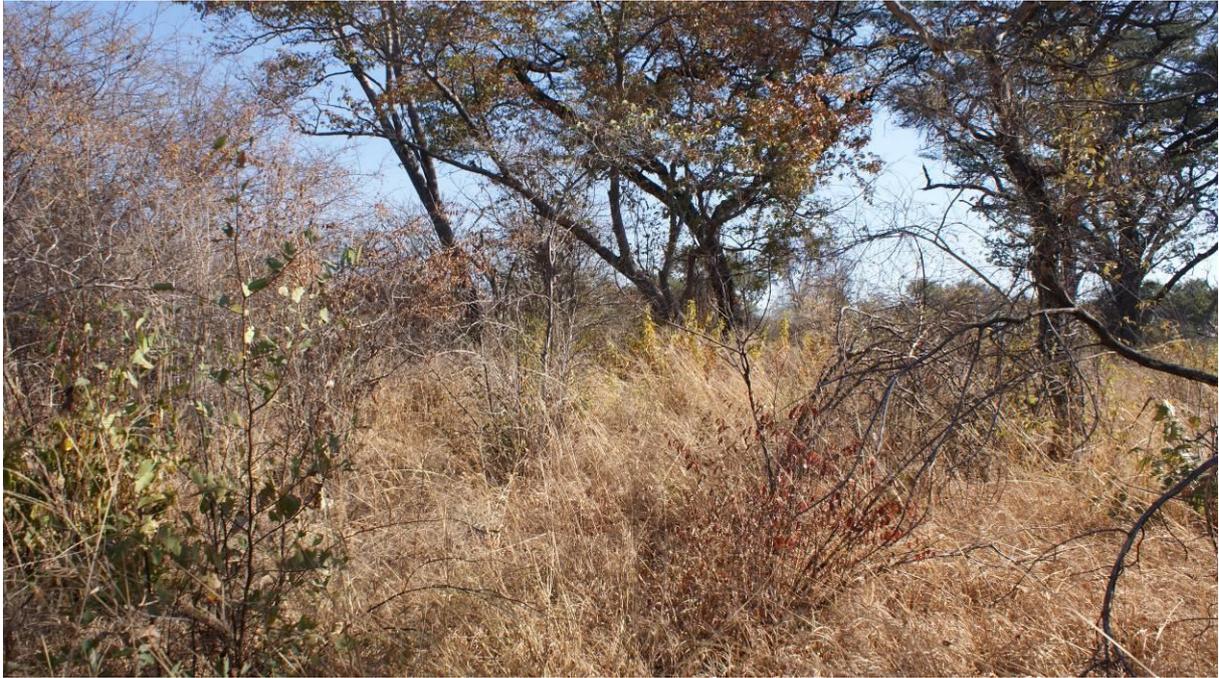
Figure 2: *Baikiaea plurijuga* – *Pterocarpus angolensis* bushlands as seen along the existing powerline towards Zambia.

These bushlands occur on the deep sandy soils. Here a large number of timber tree species occur, including *Pterocarpus angolensis*, *Guibourtia coleosperma*, *Baikiaea plurijuga* and *Burkea africana* (Figure 2). Compare to observations done in 2011, however, the vegetation was far less diverse, with many of the prominent timber species lacking (e.g. no *Pterocarpus angolensis* or, *Guibourtia coleosperma*), and

looked more disturbed, with a very dense shrub layer typical of frequent fires. This reduced the sensitivity rating of this particular vegetation type drastically to being only moderately sensitive, compared to the high sensitivity rating given to the same vegetation type in 2011 (Table 1). The fact that the powerline affects only 3.6 km of Namibian vegetation also considerably reduces the impact it has on our vegetation.

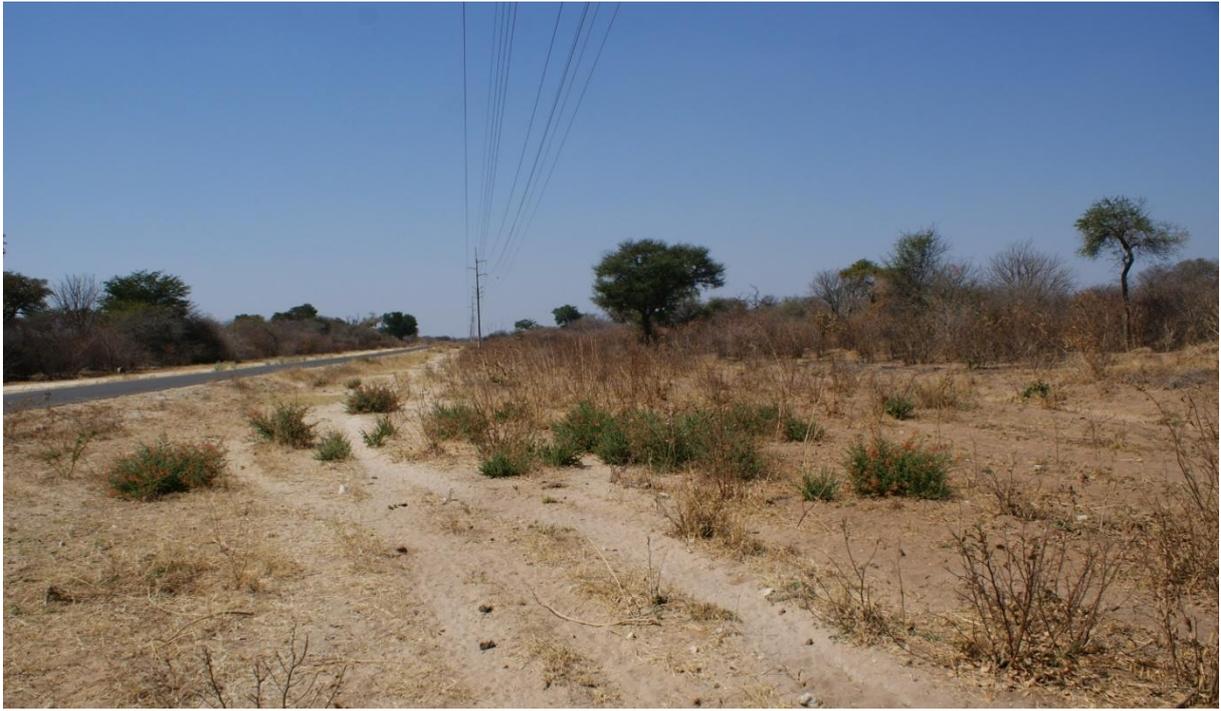
Figure 3: *Baikiaea plurijuga* – *Pterocarpus angolensis* bushlands after being cleared, under the powerline towards Katima Mulilo. Note the relative low regrowth of shrubs.

Clearing of these *Baikiaea plurijuga* – *Pterocarpus angolensis* bushlands will result in extensive bare patches, which will be recolonized only slowly with annual grasses like *Aristida stipitata*, as well as the low shrub *Rothea uncinata*. Depending on the clearing technique, extensive coppicing of *Combretum collinum* and *Bauhinia petersiana* can be expected. These cleared patches will be encroached by *Dichrostachys cinerea* shrubs as well (Figure 3). *Rothea uncinata* is a weedy species, typically encroaching disturbed areas, and can be expected to encroach into all cleared areas along the powerline route (Figure 4).

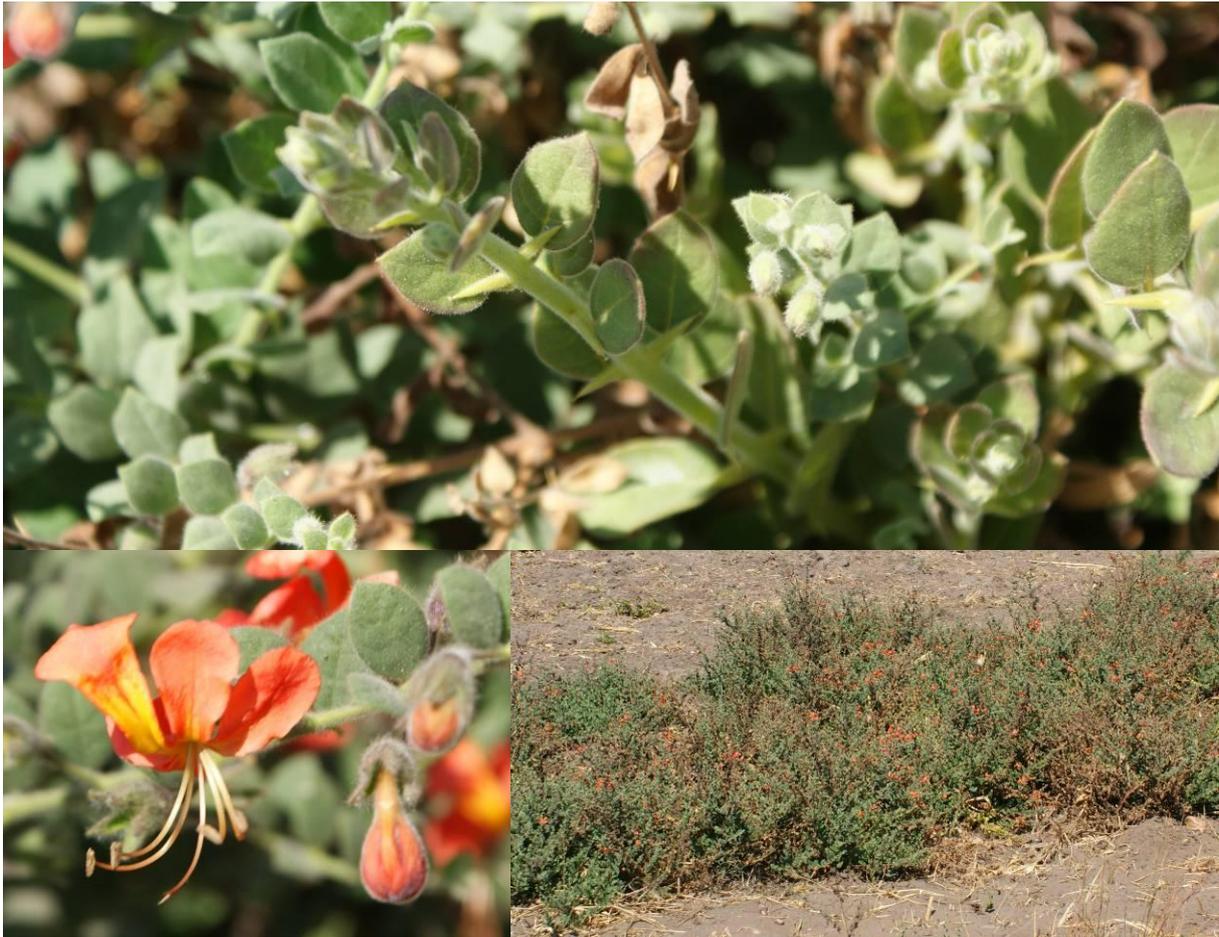
Figure 4: *Rotheca uncinata*, a weedy, thorny dwarfshrub, can be expected to encroach all cleared areas under the powerline.

Several species in the area are known to coppice strongly. Especially *Dichrostachys cinerea* and *Combretum collinum* are known for their coppicing ability (Strohbach, 1998, 2000). *Dichrostachys cinerea* is also known as the most aggressive encroaching species in Namibia, encroaching especially in disturbed areas (Bester, 1998; De Klerk, 2004). *Rotheca uncinata* is less well-known as encroacher (mainly because of its relative low growth, and often not persisting shoots), but has been observed to encroach extensively in disturbed areas like road verges and old fields (own observations, Figure 4).
