# CULTURAL HERITAGE 11

11.1 This Environmental Impact Statement (EIS) is prepared on behalf of Roadstone Ltd. and has been undertaken to assess the significant effects, if any, on local cultural heritage, archaeology and architecture which may arise on account of the proposed development of an inert soil recovery facility on lands at Killough Upper, Kilmacanogue, Co. Wicklow. A wide variety of paper, cartographic, photographic and archival sources was consulted for the purpose of this study and all lands within the application area were visually inspected.

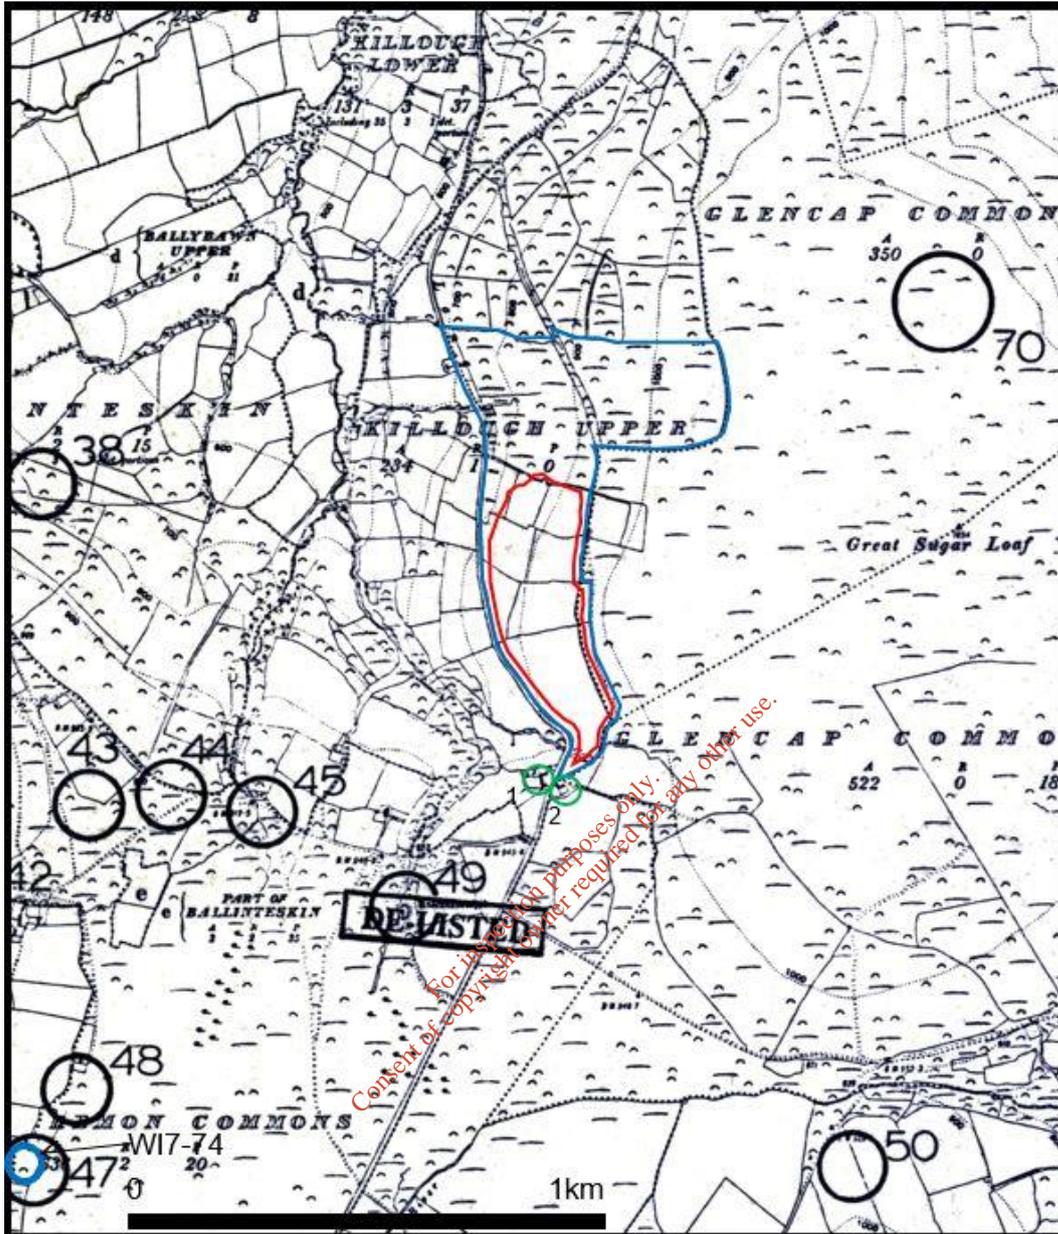
**Figure 11-1**  
**Record of Monuments and Places at Application Site**

The application area is outline in red and the landholding is outlined in blue. Recorded Monuments are indicated with black circles. Monuments in the Archaeological Survey database are indicated with blue circles and structures on the 1912 edition of the six inch Ordnance Survey map within 100m of the application area are indicated with green circles.

- 11.21 Examination of the Record of Monuments and Places indicated that there are no Recorded Monuments located within the application area (see Figure 11.1 and Appendix 11-A).
- 11.22 The closest Recorded Monument to the application is an enclosure in Ballyremon Commons townland (WI007-045, see Appendix 11-A). This monument is situated 0.6km south-west of the application area and is too far distant to be directly or indirectly impacted by the proposed development.
- 11.23 The remaining Recorded Monuments in the study area are more distant from the application area than WI007-045 and are considered to be too far distant to be directly or indirectly impacted by the proposed development.

- a farmhouse and a cottage, both located in Killough Upper, both of which are located immediately south of the Roadstone property holding, on opposite sides of the R755 Regional Road, at locations indicated on Figure 11-1 and

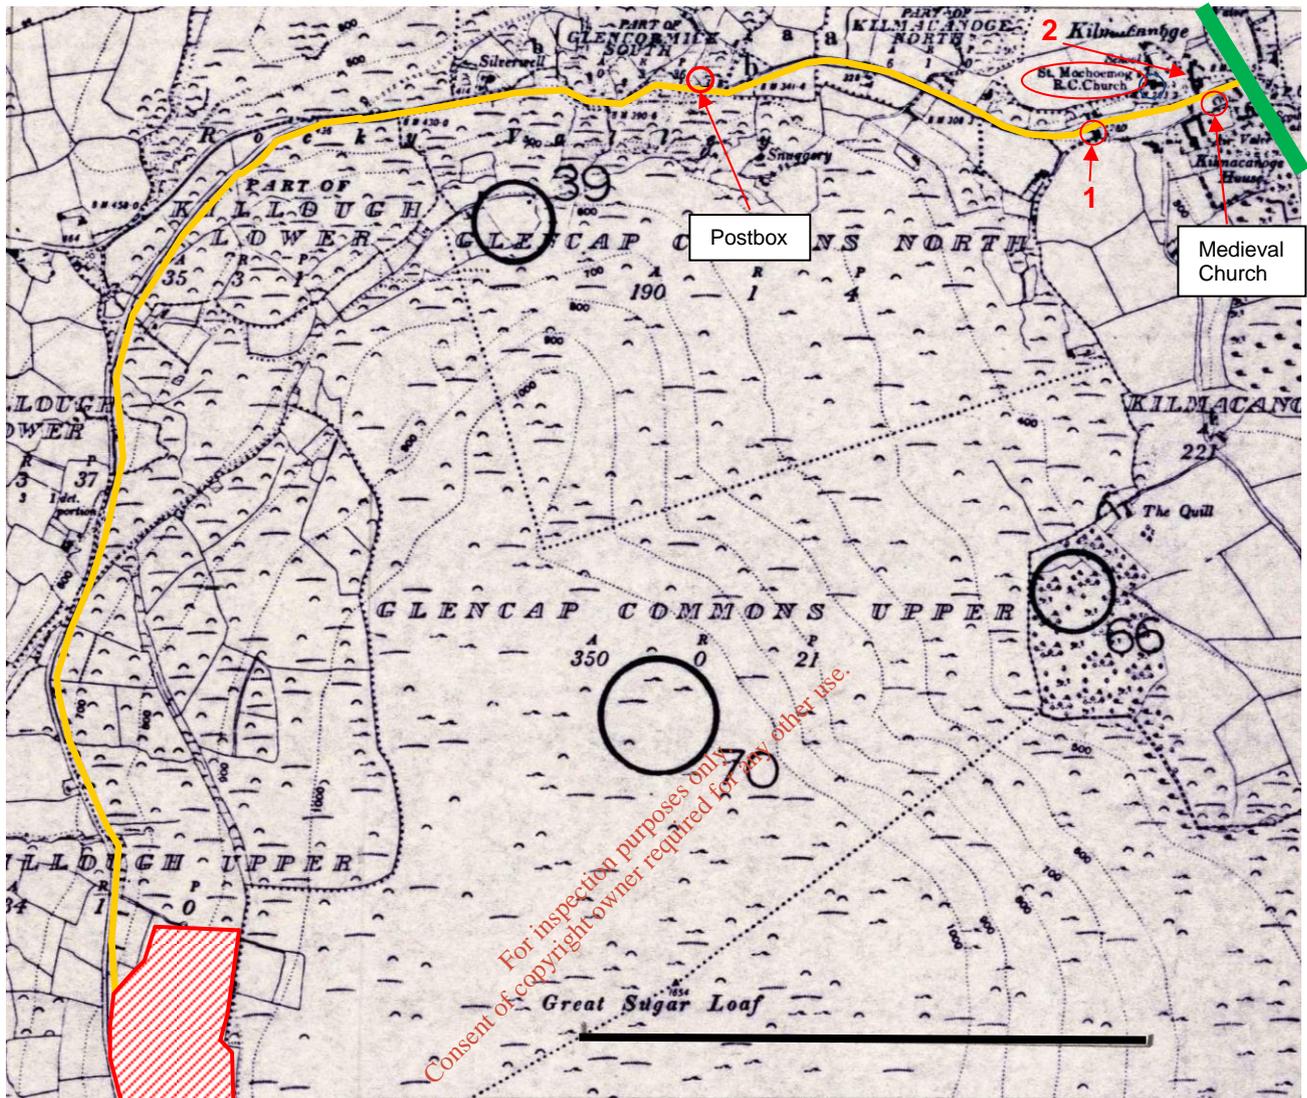
**Figure 11-2**  
**Buildings of Heritage Interest along R755**

Buildings of heritage interest along the R755 Regional Road are annotated on an extract from the RMP map for Co. Wicklow (itself based on the 1912 Edition Ordnance Survey map). The proposed quarry extension is outlined in red. The proposed haul route is indicated in orange and the N11 National Primary Road / Dual Carriageway is in green.

- 11.36 Volume 2 of the current Wicklow County Development Plan 2010-16 identifies a number of structures along the R755 Regional Road in the Record of Protected Structures, at locations indicated in Figure 11-2. These comprise

- Reighmore House and Glencormac Inn, both of which are located in Kilmacanogue village, at locations indicated on Figure 11-2 (and numbered 1 and 2 respectively).

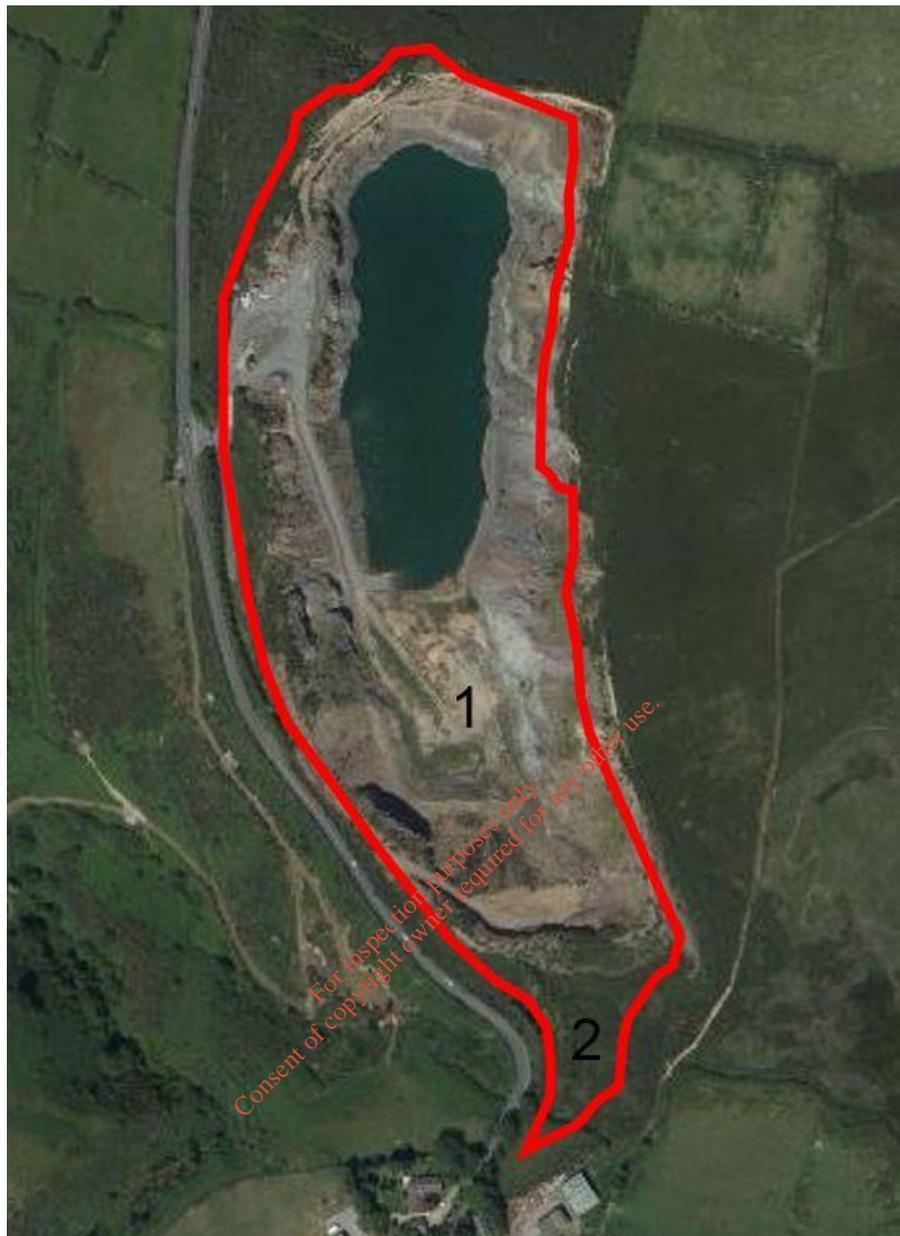
**Plate 11-1**  
**Aerial View of the Application Site (within the red line)**  
(from Bing maps with the fieldwork areas numbered).

11.32 A field inspection was carried out on the 24th of February 2015. This involved an inspection of all the lands in application areas (see Figure 11-1). The fieldwork areas are numbered on Plate 11-1.

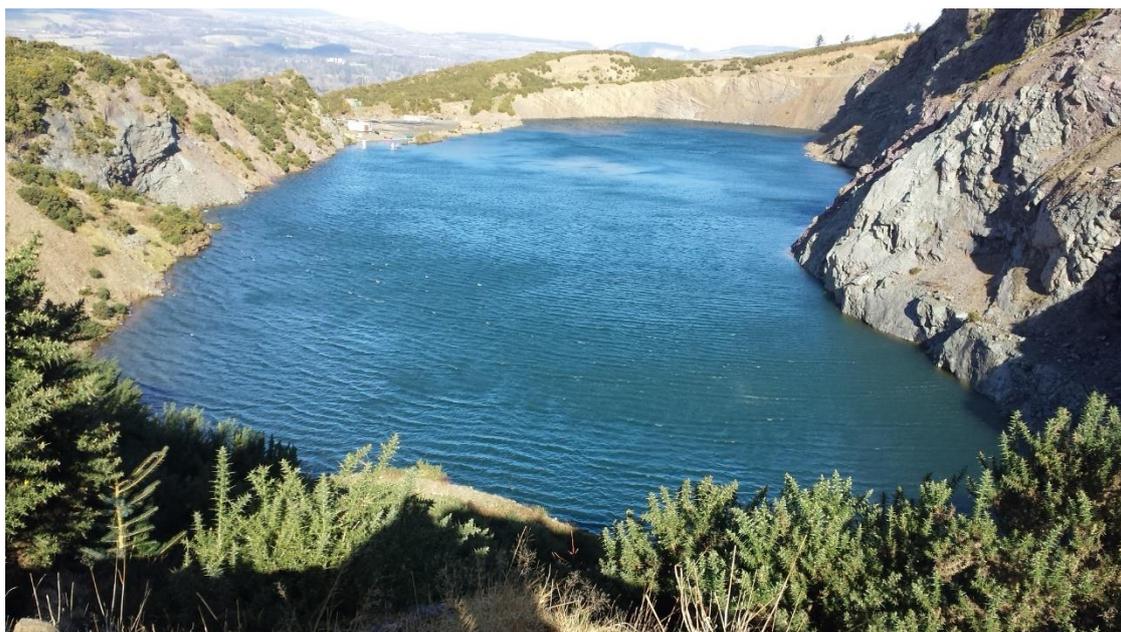
**Plate 11-2**  
**View of Area 1, the Main Quarry Area, Looking North**

11.33 Area 1 is the area of extraction from which all the topsoil has been removed and quarrying has continued down into geological strata. There was no visible indication of any cultural heritage material (Plate 11-2).

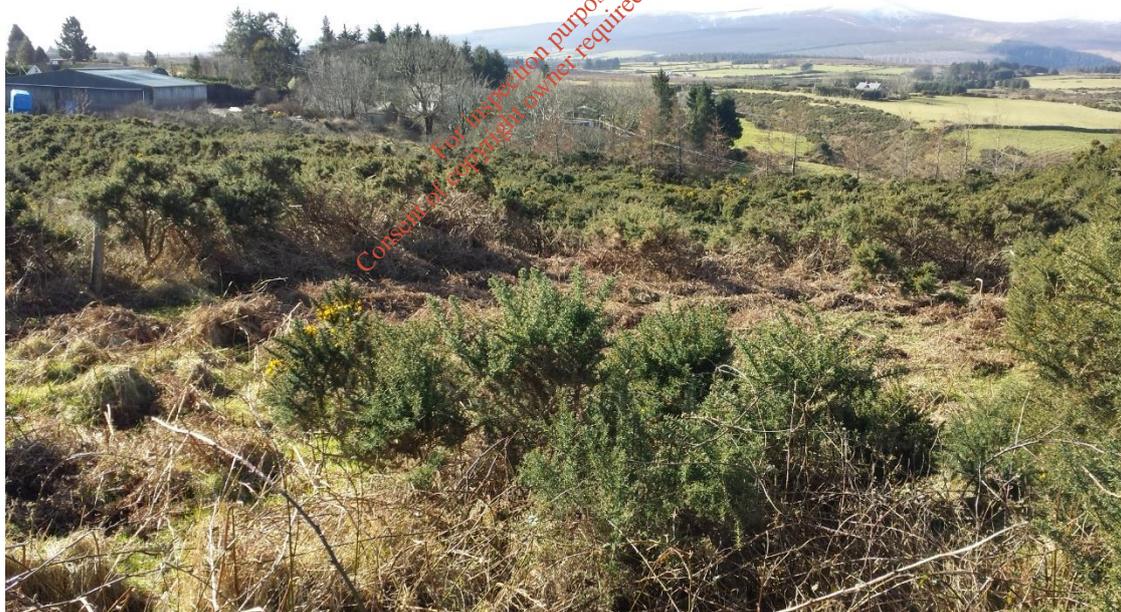
**Plate 11-3**  
**View of Area 2, Looking South**

11.34 Area 2 is a roughly triangular-shaped area of rough south-sloping ground to the south of the site screening berm. The area is heavily overgrown with gorse and there was no visible indication of any cultural heritage material (Plate 11-3).

11.62 Due to the possibility of the survival of previously unknown sub-surface archaeological deposits or finds within Area 2, at the southern end of the application area, all soil-stripping in this area should be archaeologically monitored.

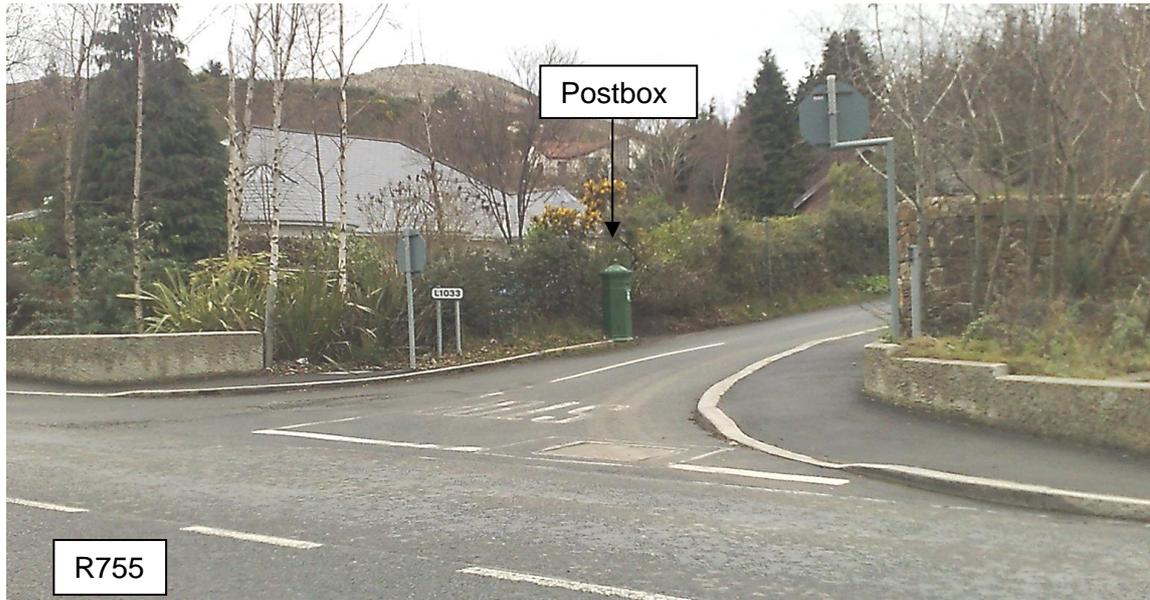
**Plate 11-4**  
**Location of Carrigoona Commons Post Box**

- (i) a hexagonal postbox in Rocky Valley, in Glencormick South townland (RPS Ref. No. 07-03). It is one of the very few postboxes in Ireland with the monogram 'VR'. The post-box is situated on the L1033 local road and is set back a distance from the junction with the R755 Regional Road, as shown in Plate 11-4.

- (i) Carrigona Commons East Post Box (NIAH Ref. No. 16400710) and
  - (ii) Saint Mochoemog's Catholic Church (NIAH Ref. No. 16400708).
- 11.39 The post box in Carrigona Commons East is a freestanding octagonal cast-iron letter box, erected c.1870. It is known as the 'New Standard Letter Box', was designed by J.W. Penfold and built by Cochrane in Birmingham in 1866. Sited by the road side, it is understood that this letter box is still in use.

11.54 The post-box is situated on the L1033 local road is set back a distance from the junction with the R755 Regional Road. As traffic to and from the application site will not use the L1033 (except for a possible, very occasional consignment of inert soil for recovery from development works nearby), the post box will not be impacted by traffic from the proposed development.

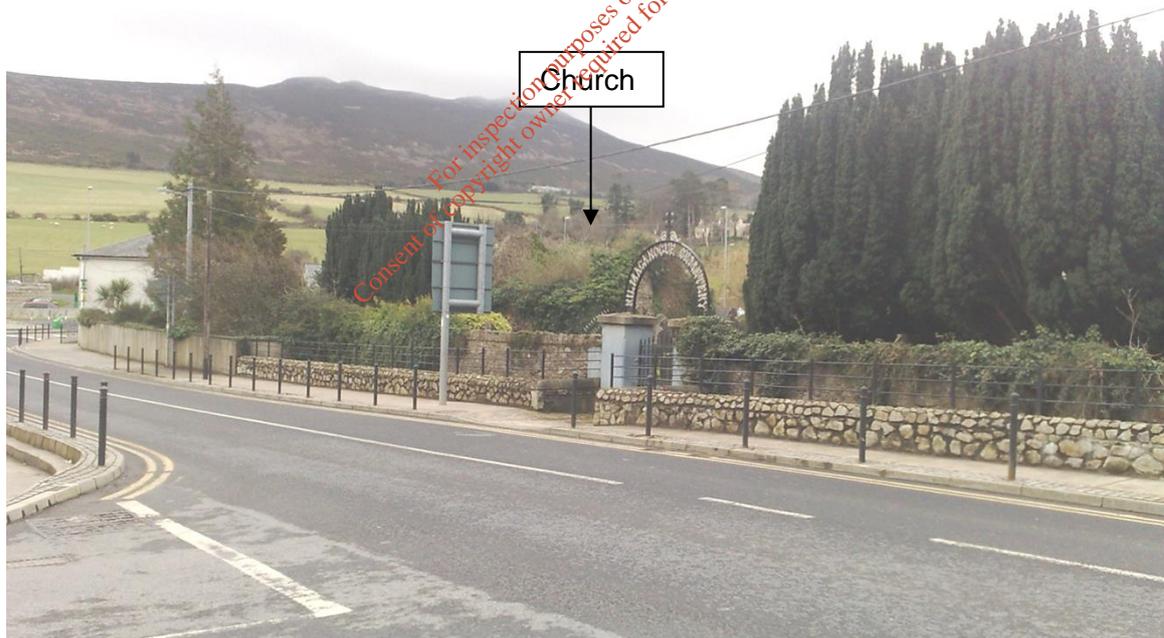
**Plate 11-5**  
**Kilmacanogue Old Church**

- (ii) ruin of a small medieval church, known as Kilmacanogue Old Church, located in Kilmacanogue village (RPS Ref. No. 07-08). This Medieval church is situated within a walled graveyard, to the south of the R755 road, as shown on Plate 11-5.

11.55 Kilmacanogue Old Church is located approximately 3.7km from the application site along the R755 and is set well back from the road. The road surface has recently been upgraded, is smooth and is in very good condition. There will therefore not be any perceptible structural vibration generated by passing

haulage traffic. The church will not be impacted by HGV traffic travelling to and from the proposed development.

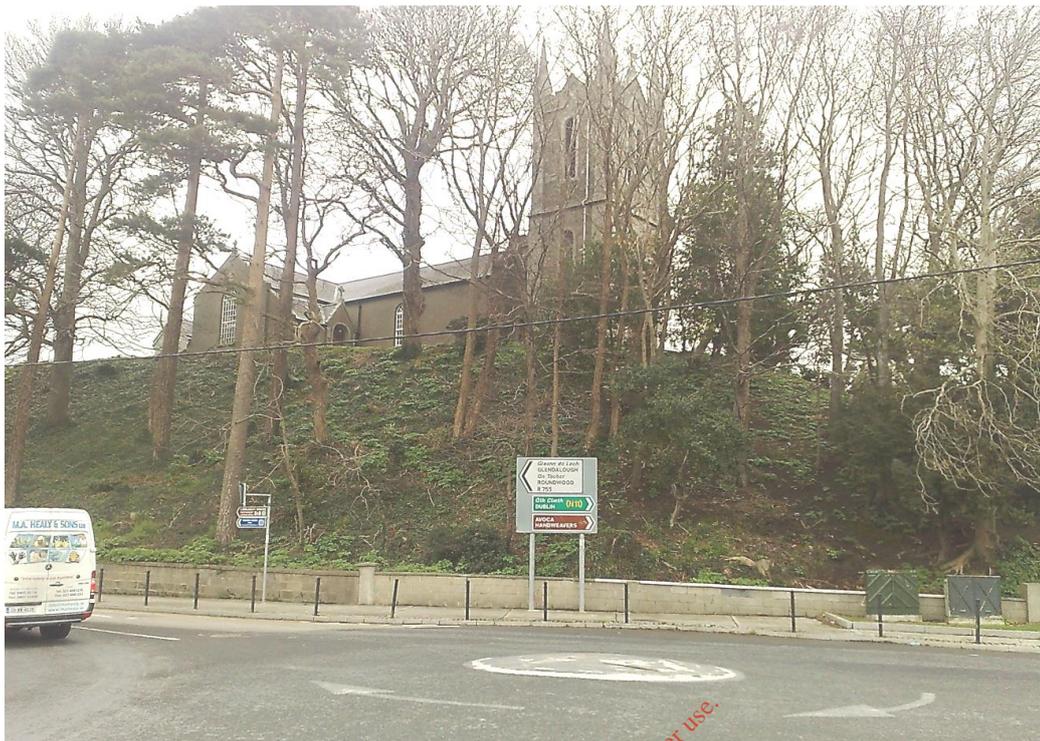
**Plate 11-6**  
**St. Mochoemog's Catholic Church**

- (iii) St Mochoemog's Catholic Church in Kilmacanogue village (RPS Ref. No. 07-09). It is described as T-plan, possibly dating from c.1800, with rendered walls and large round-headed windows. A two stage tower of coursed-rubble granite with simple crenellations and pinnacles was added in the early 19<sup>th</sup> century). The church lies on elevated ground to the north of the R755. It is set back from the road and is screened by mature trees, as shown on Plate 11-6.

- 11.40 Saint Mochoemog's Catholic Church in Kilmacanogue is described as a detached three-bay single-storey Roman Catholic church. It was built c.1850. and is T-plan with a square two-stage tower to the east side. It has a castellated parapet and tall pinnacles. To the rear west side, there are a number of later gabled single-storey additions. The building is finished in render, while the tower is in granite rubble with raised ashlar granite quoins. The doors are set within semi-circular arched openings. Window openings are generally semi-circular arch headed with either decorative leaded glass or multiple pane timber frames. The pitched roof is finished with slate and cast-iron rainwater goods. Internally the church was re-ordered following the Second Vatican Council but is otherwise in original condition. At either side of the transepts there are galleries with panelled guard rails. The original altar and altar rails have been retained along with the original pews and stations of the cross. The building sits on a slight rise.

11.56 St. Mochoemog's Catholic Church is located in Kilmacanogue, set back and on elevated ground to the north of the L755 road, on a site that is screened by mature trees. The church is approximately 3.7km from the quarry. It will not be impacted by traffic from the proposed development.

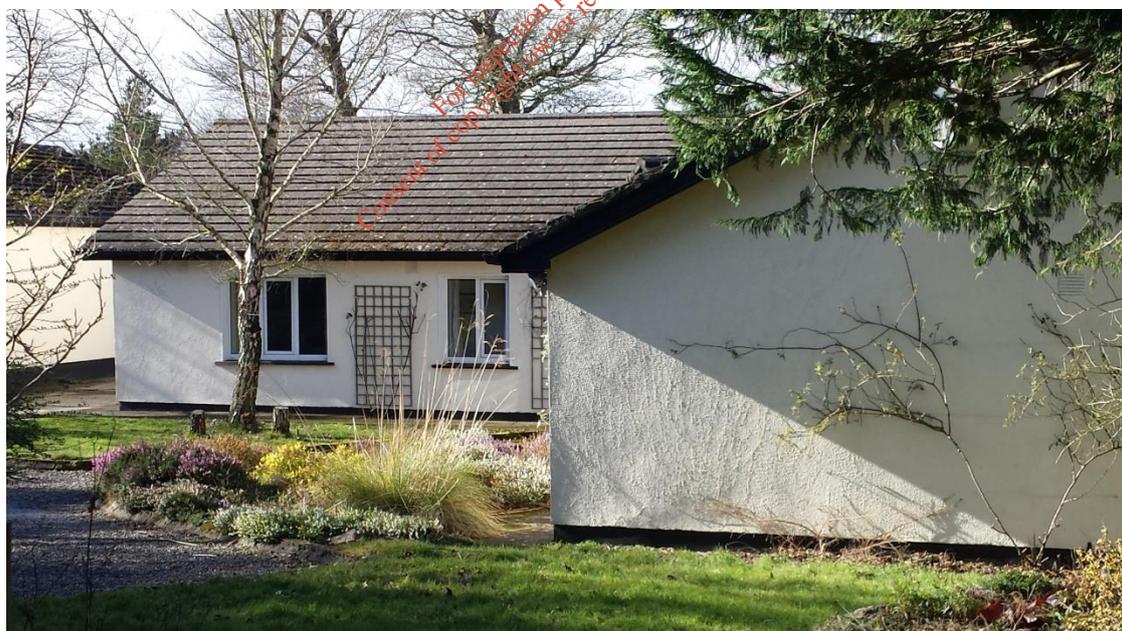
**Plate 11-7**  
**Farmhouse in Killough Upper Looking West**

- 11.45 The 1912 Edition of the Ordnance Survey (OS) map identifies a farmhouse to the south of the application site on the western side of the R755, shown in Plate 11-7. This structure is an L-shaped single storey 5 bay house with concrete roof tiles and uPVC replacement windows. The perceived significance of this farmhouse, from a cultural heritage perspective, is negligible.

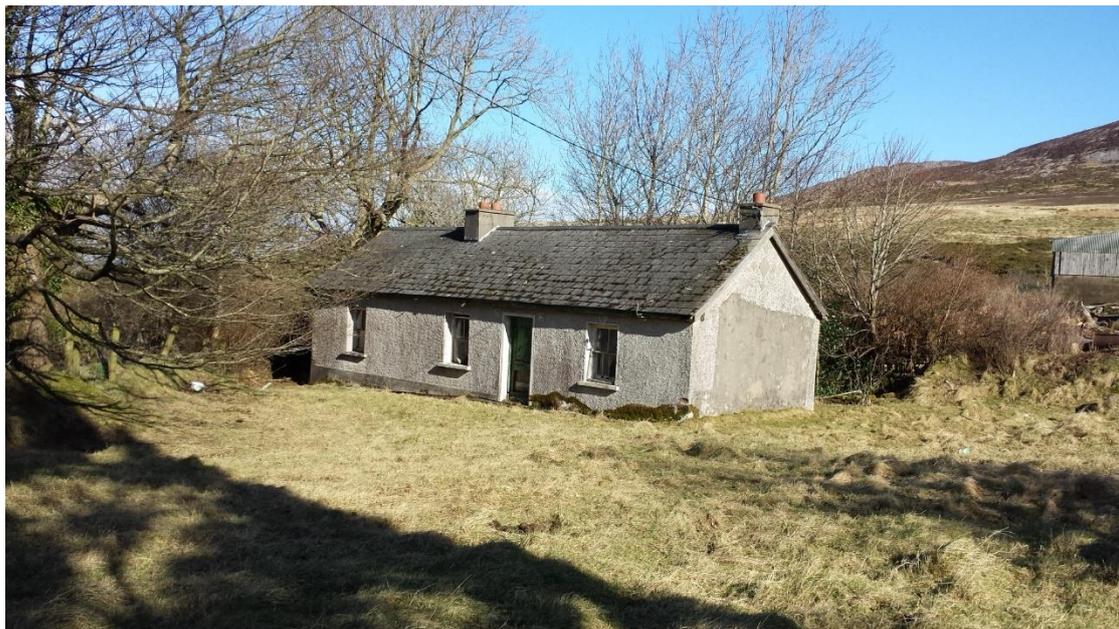
**Plate 11-8**  
**Cottage in Killough Upper Looking North-East**

- 11.46 The 1912 OS map also identifies a farmhouse to the south of the application site on the eastern side of the R755, shown in Plate 11-8. This structure is a single storey 3 bay cottage with slate roof and two chimneys. The perceived significance of this cottage, from a cultural heritage perspective, is minor.

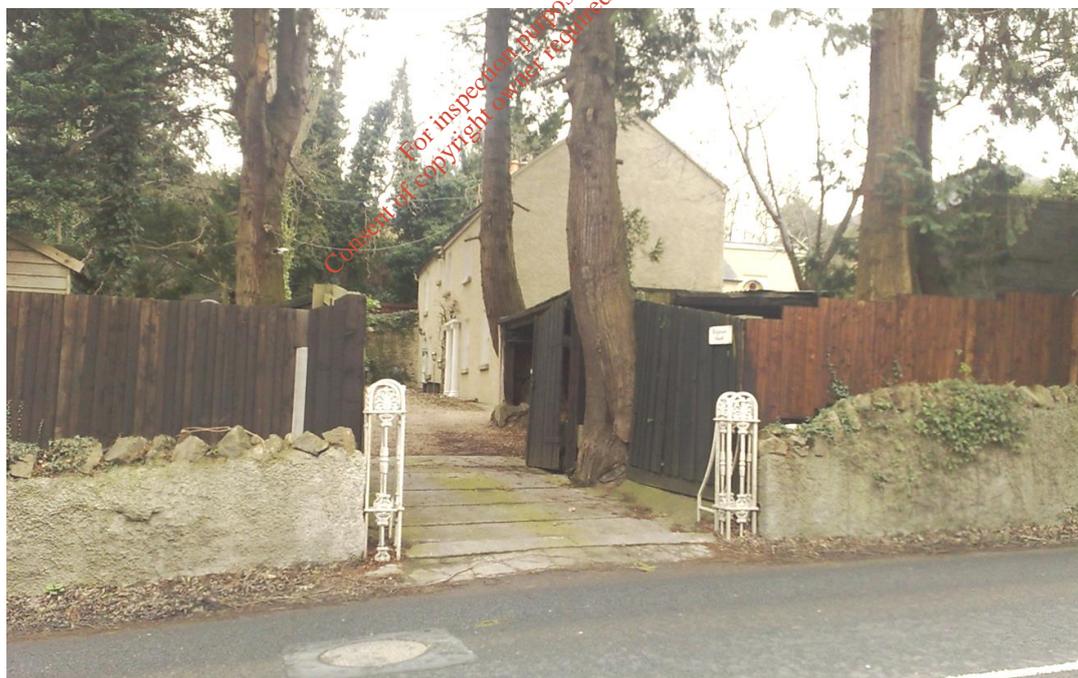
**Plate 11-9**  
**Reighmore House**

- 11.47 Reighmore House is a two storey six-bay nineteenth century farm house set gable end to the road and is shown in Plate 11-9. The building is set back approximately 15m from the road.

11.57 The road surface at Reighmore House is smooth and has few defects and building is not subject to perceptible structural vibration by passing haulage vehicles. The road surface is smooth and has few defects and the building is set far enough back from the road that it will not be impacted by traffic from the proposed development.

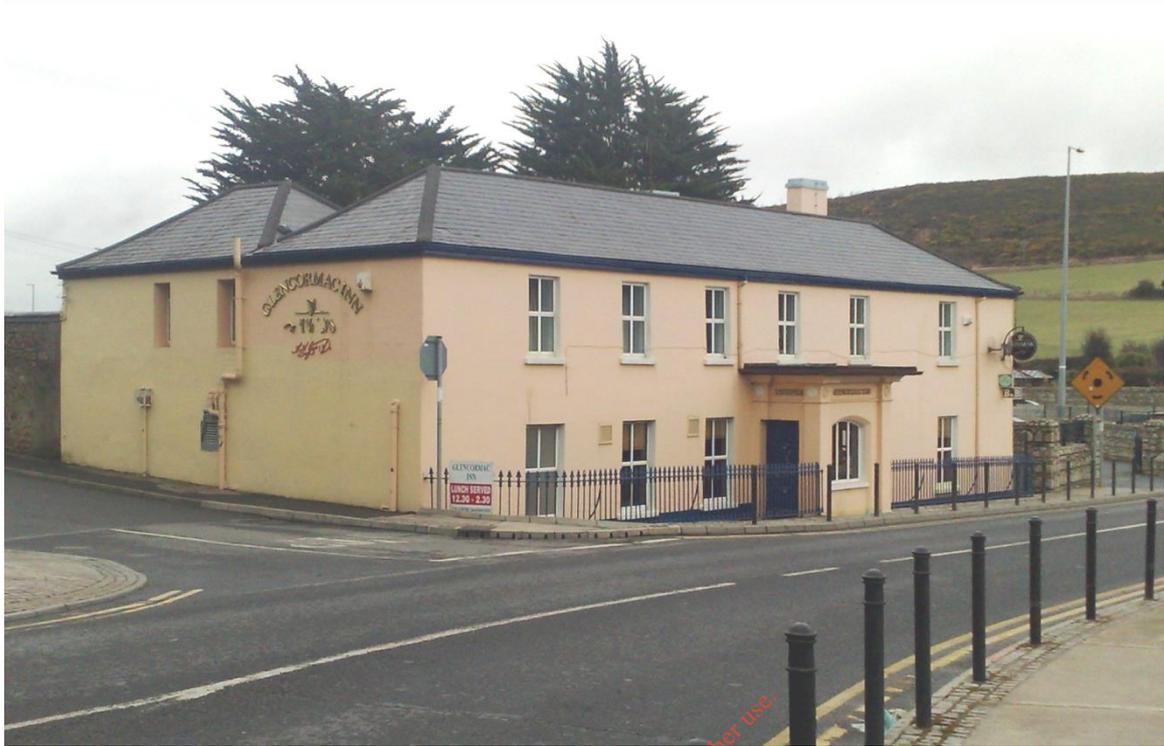
**Plate 11-10.**  
**View of Glencormac Inn Looking North-East**

- 11.48 The Glencormac Inn is situated in Kilmacanogue on the north side of the R755 just before (west of) the N11 junction and is shown in Plate 11-10. The structure appears to have been built c. 1822. Although the building fronts onto the R755, it is well protected by a raised curb with closely spaced iron bollards on the roadside, a footpath and continuous iron railings close to the building.

11.58 The Glencormac Inn is well protected by a raised curb with closely spaced iron bollards on the roadside, a footpath and continuous iron railings close to the building. The road surface has no defects and the building is not subject to perceptible structural vibration by passing haulage vehicles. The structure will not be impacted by traffic from the proposed development.
