# **The Estero Americano Watershed Management Plan**

**A Project of the Gold Ridge Resource Conservation District  
with funding from the State Water Resources Control Board**

**Version 1, February 2007**

**Prepared by:  
The Gold Ridge Resource Conservation District**

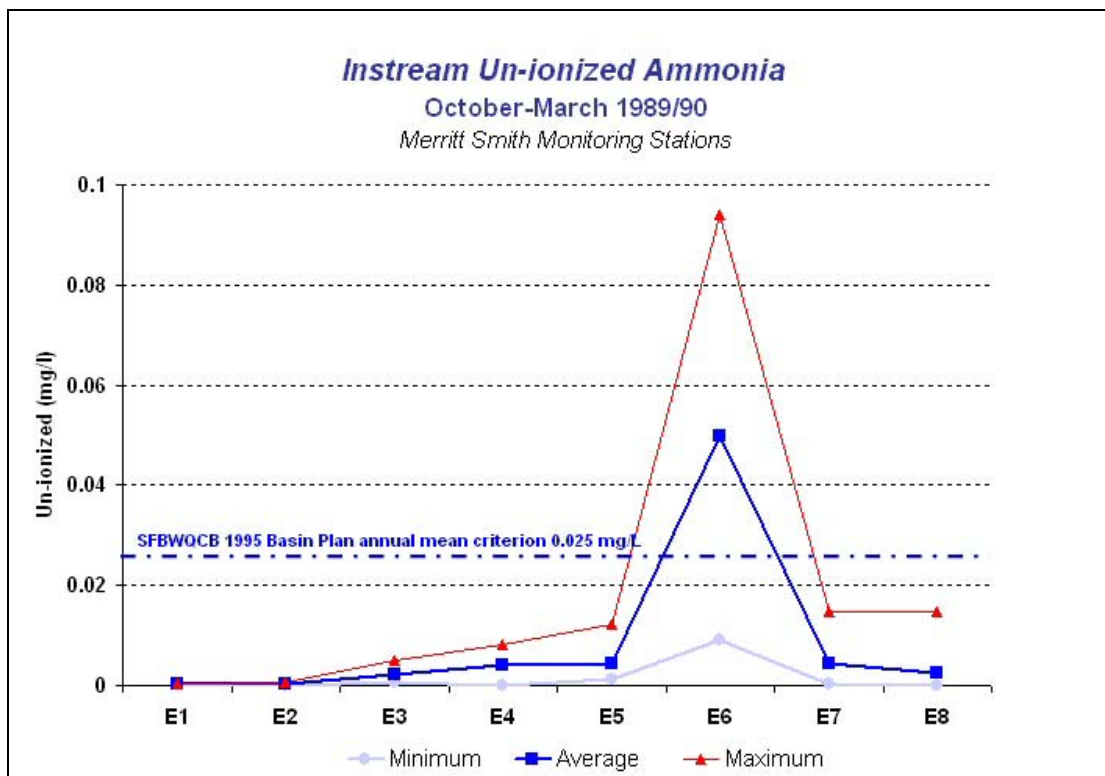
**Figure 3-2. Un-ionized ammonia levels at sampling stations in the watershed during the 1989/1990 winter.**

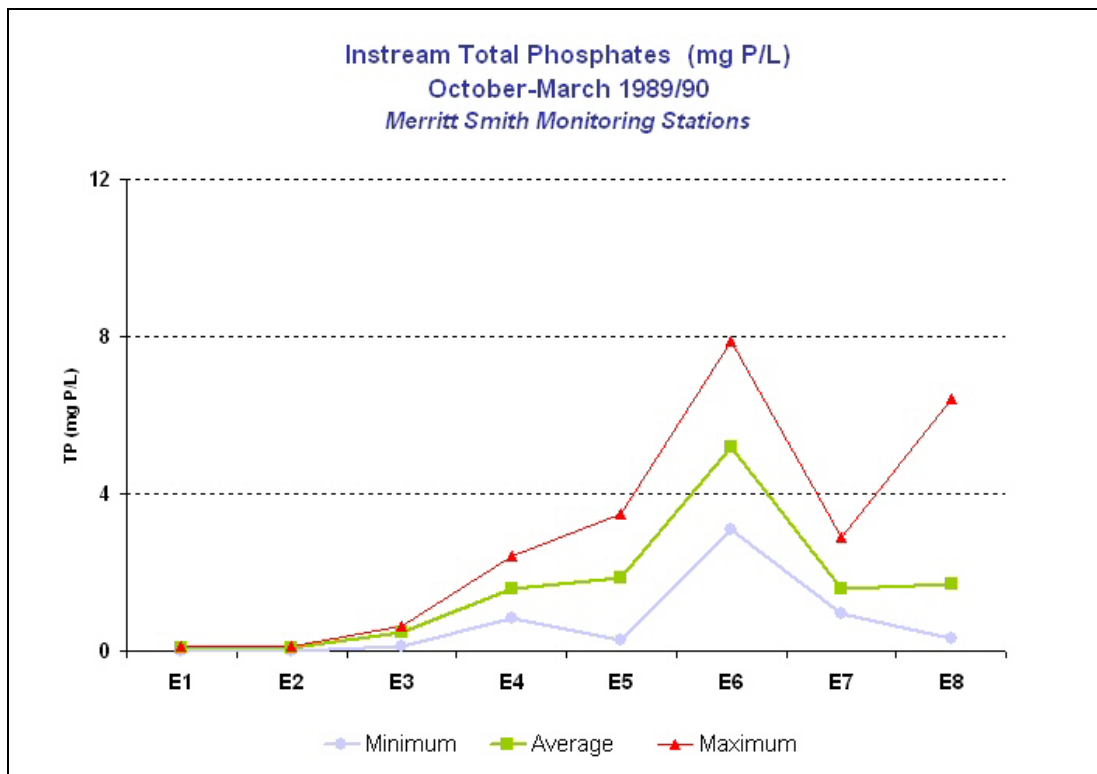
**Figure 3-3. Total phosphates levels in the watershed during the 1989/1990 winter.**

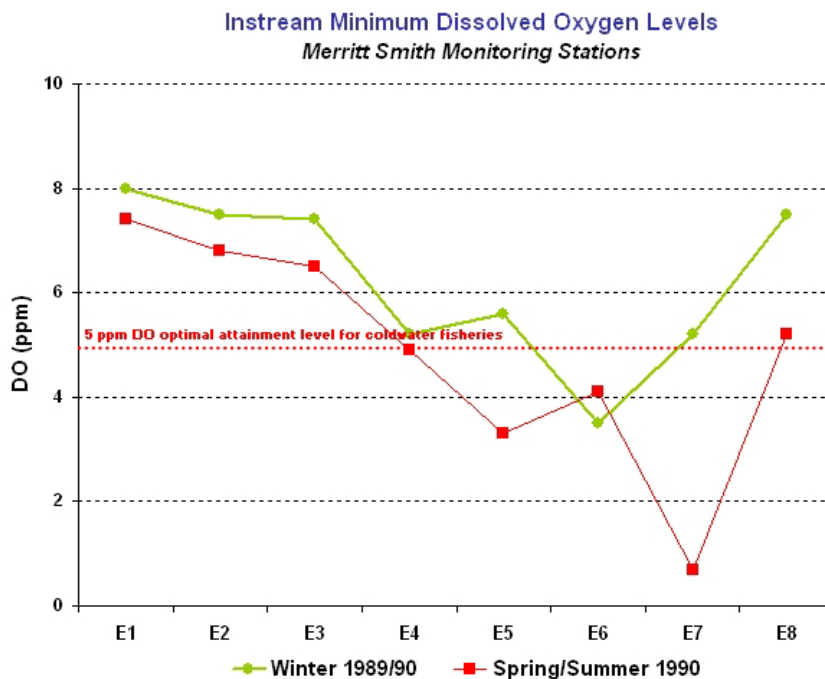
**Figure 3-4. Average minimum Dissolved Oxygen levels at sampling stations throughout the watershed during the 1989/1990 sampling season.**

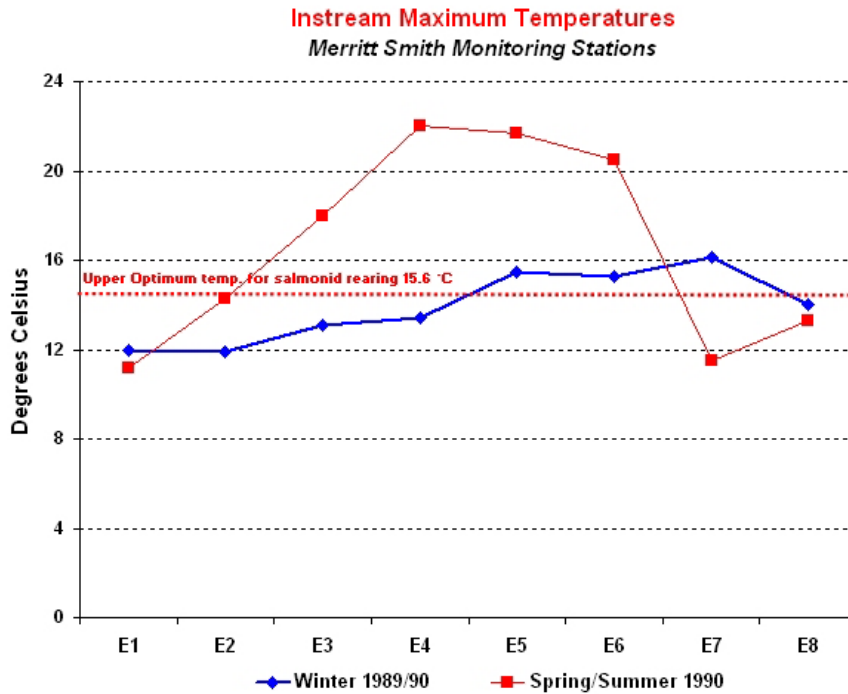
**Figure 3-5. Maximum water temperatures throughout the watershed during the 1989/1990 sampling period.**

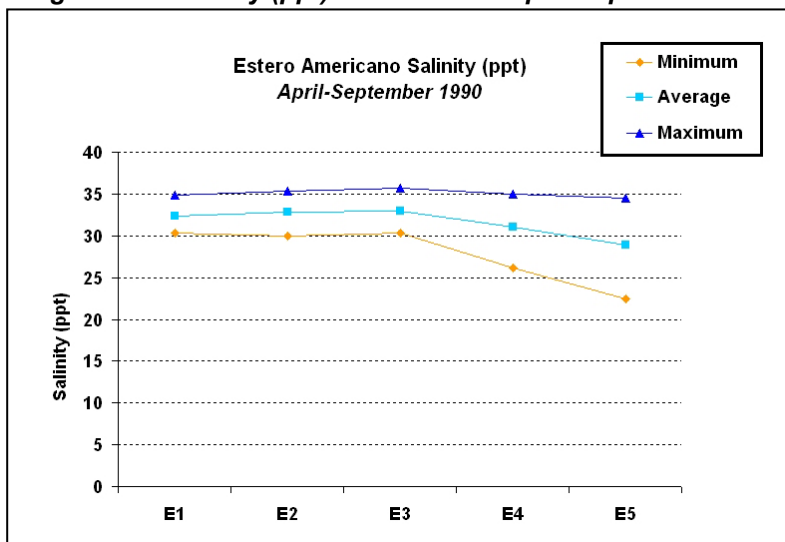
**Figure 3-6. Salinity (ppt) in the Estero April-September 1990.**

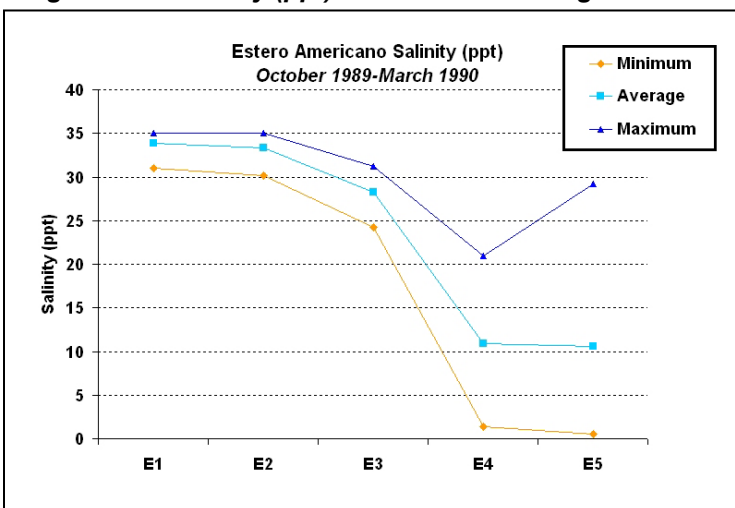
**Figure 3-7. Salinity (ppt) in the Estero during the winter of 1989/1990**

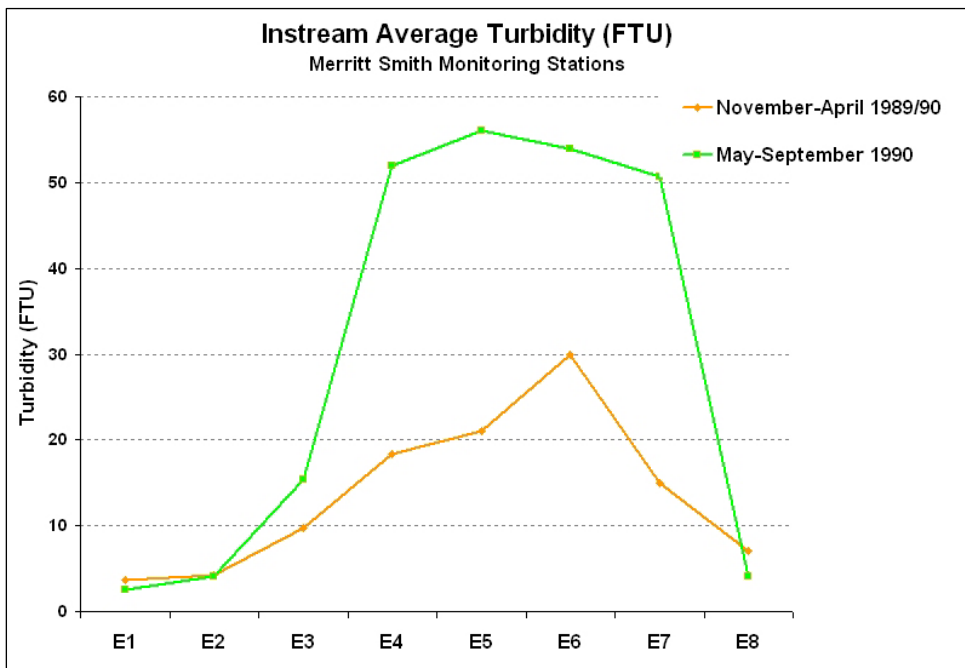
**Figure 3-8. Average seasonal turbidity at sampling stations throughout the watershed.**

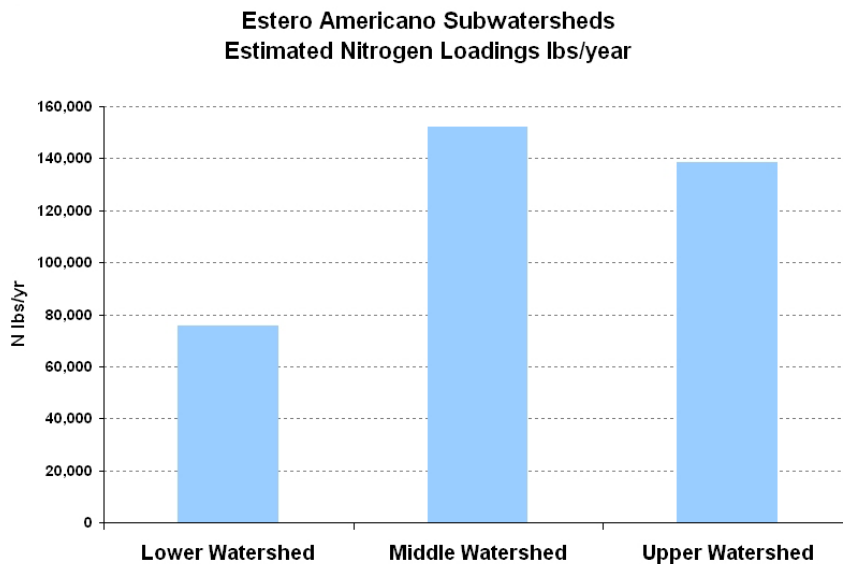
**Figure 3-10. Annual Nitrogen loading in the three Subwatersheds.**

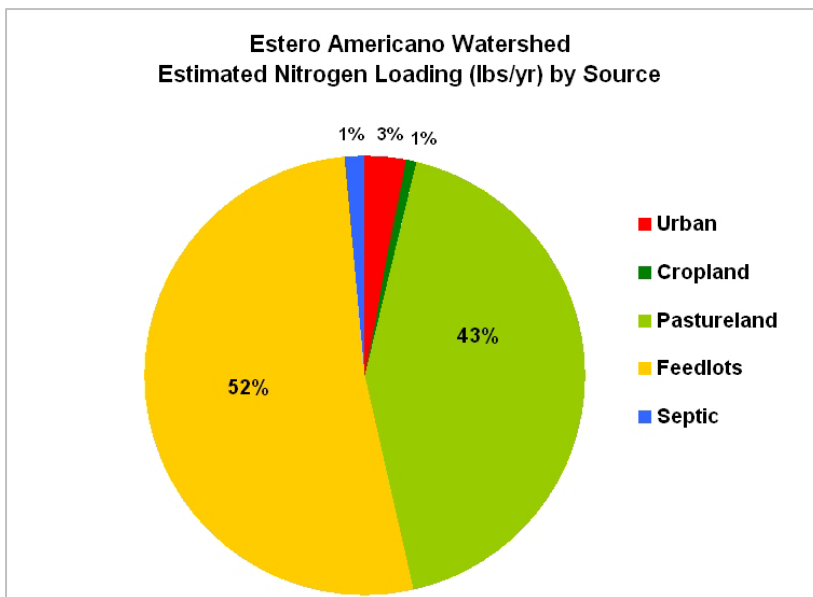
**Chart 3-1. N Loading (lbs/yr) by Source**

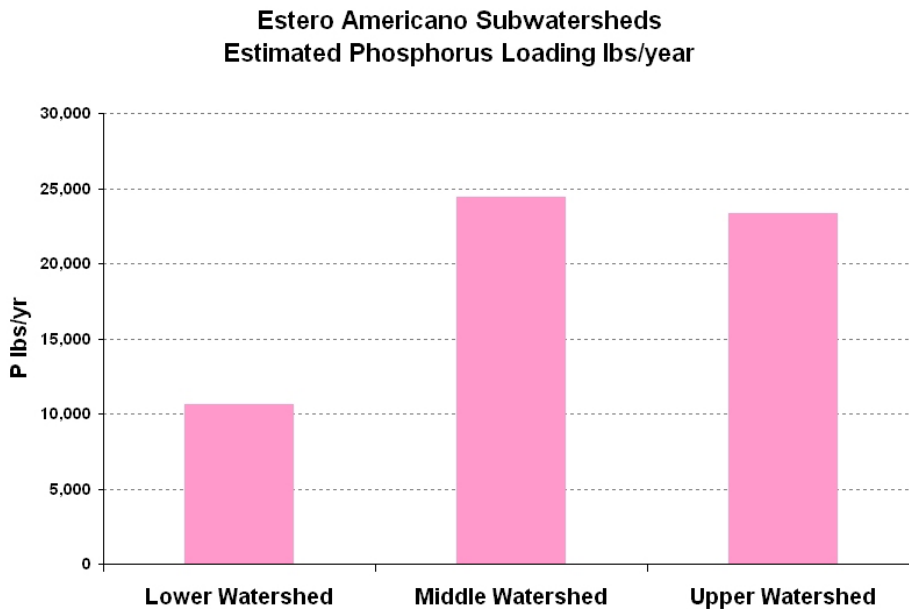
**Figure 3-11. Annual Phosphorus loading by subwatershed.**

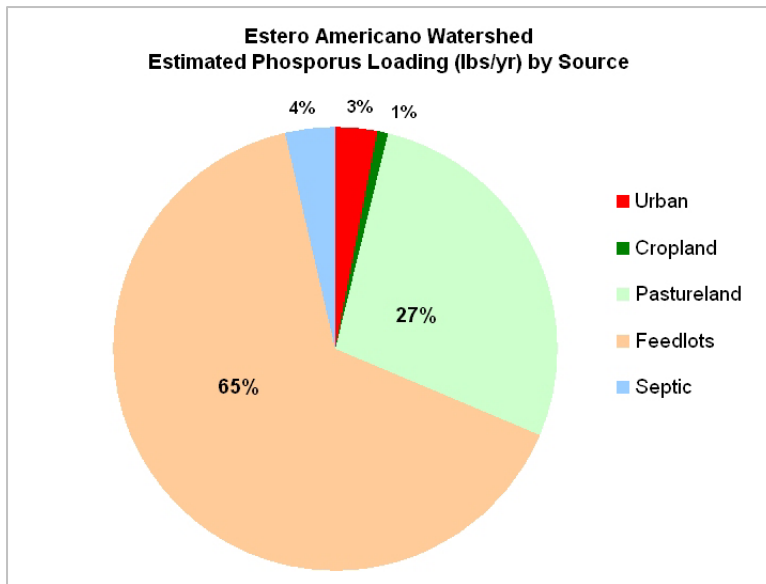
**Chart 3-2. P Loading (lbs/yr) by Source**

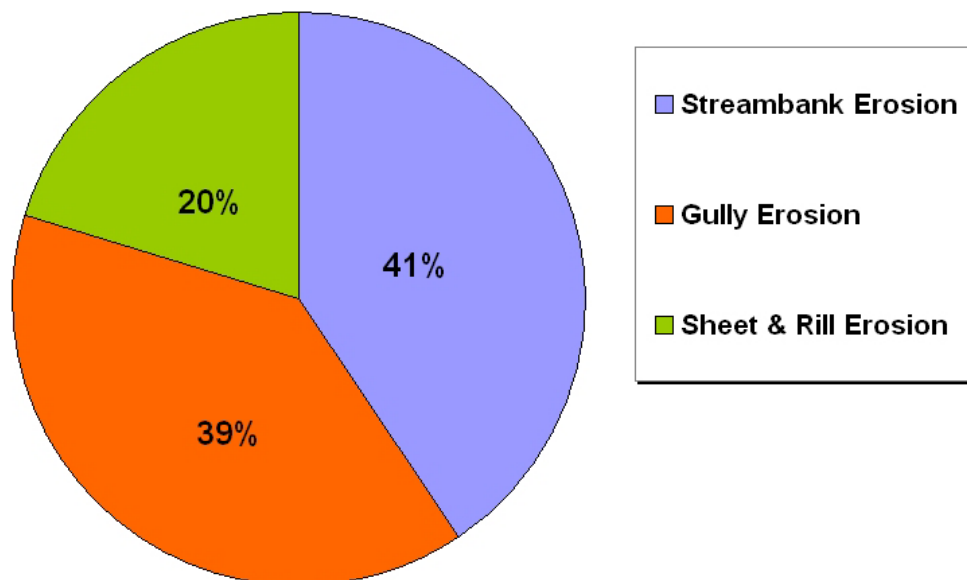
**Estero Americano Watershed  
Estimated Sediment Loadings from Various Sources**

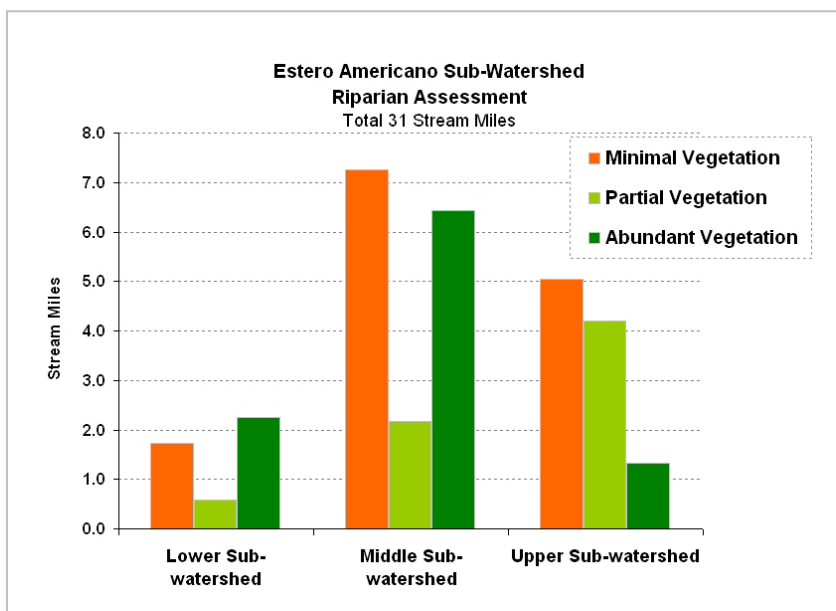
**Chart 4-2. Riparian Assessment by Sub-watershed**

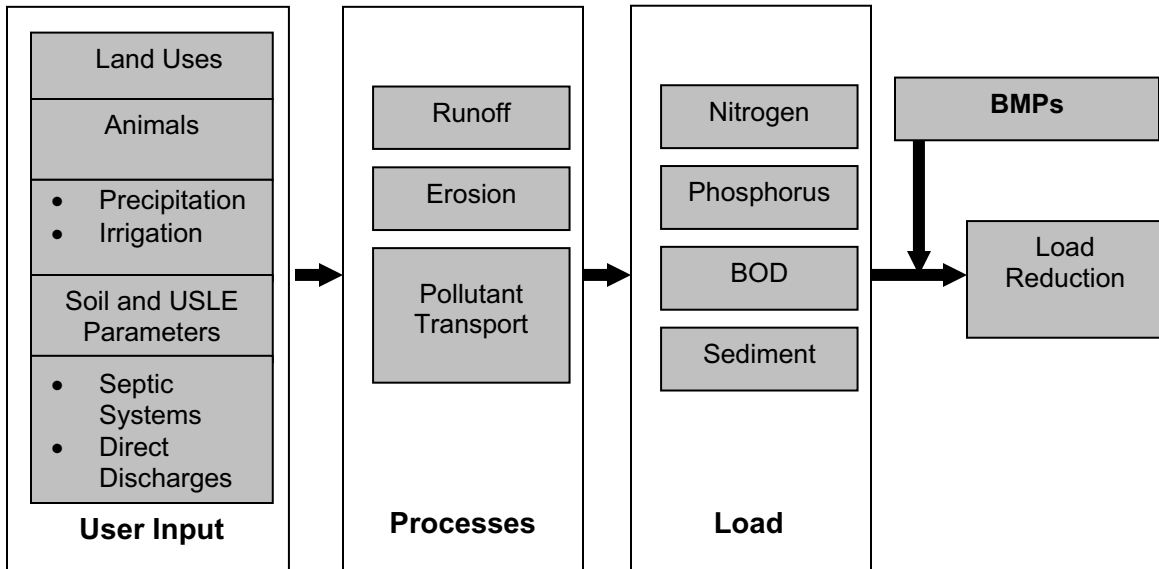
Figure 1. Spreadsheet structure.

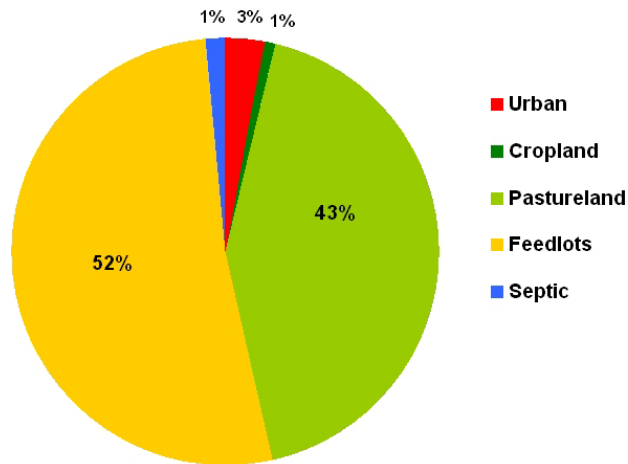
**Figure 2. N Loading (lbs/yr) by Source**

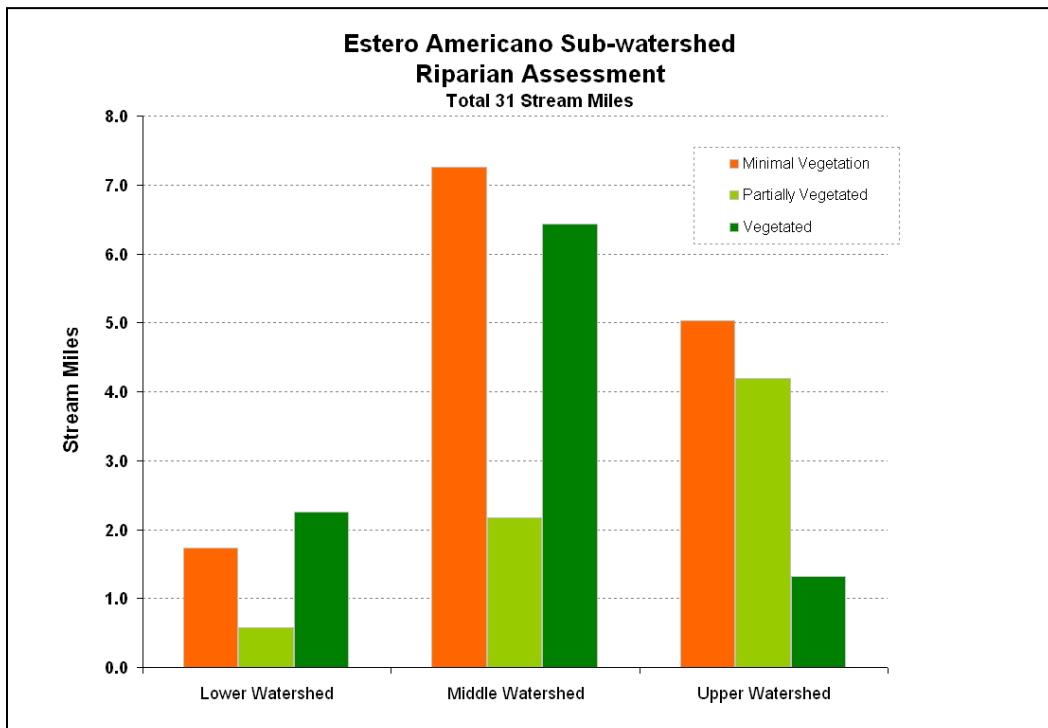
**Figure 1-1. Riparian Conditions by Sub-watershed for USGS blue-line streams.**
