**PRELIMINARY ECOLOGICAL HABITAT  
ASSESSMENT & MANAGEMENT  
RECOMMENDATIONS FOR THE  
PROPOSED UPGRADING OF THE N11;  
MOKOPANE; LIMPOPO PROVINCE**

**SUBMITTED: 30<sup>th</sup> SEPTEMBER 2011**

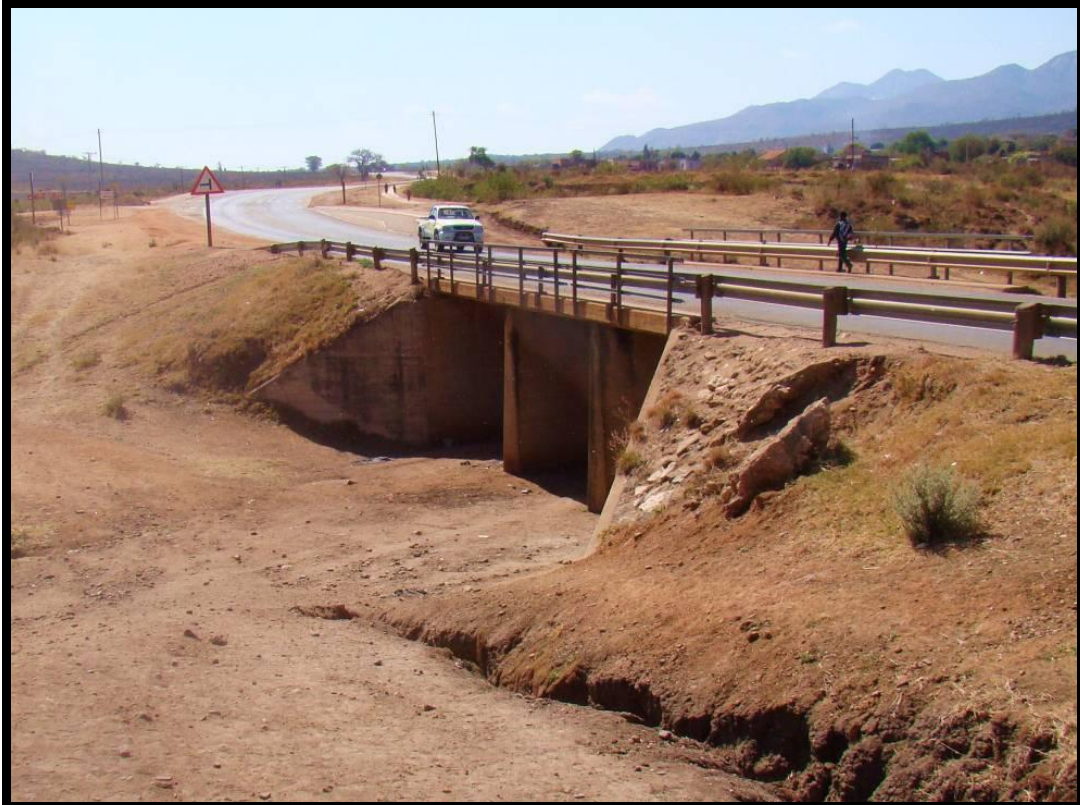
**Figure1.** The majority of habitat immediately adjacent to the N11 as well as within the present road reserve consists of transformed bushveld vegetation. The vegetation has been heavily impacted on by surrounding rural communities including extensive vegetation clearance, wood harvesting, collecting of traditional medicinal plants as well as alien vegetation invasion

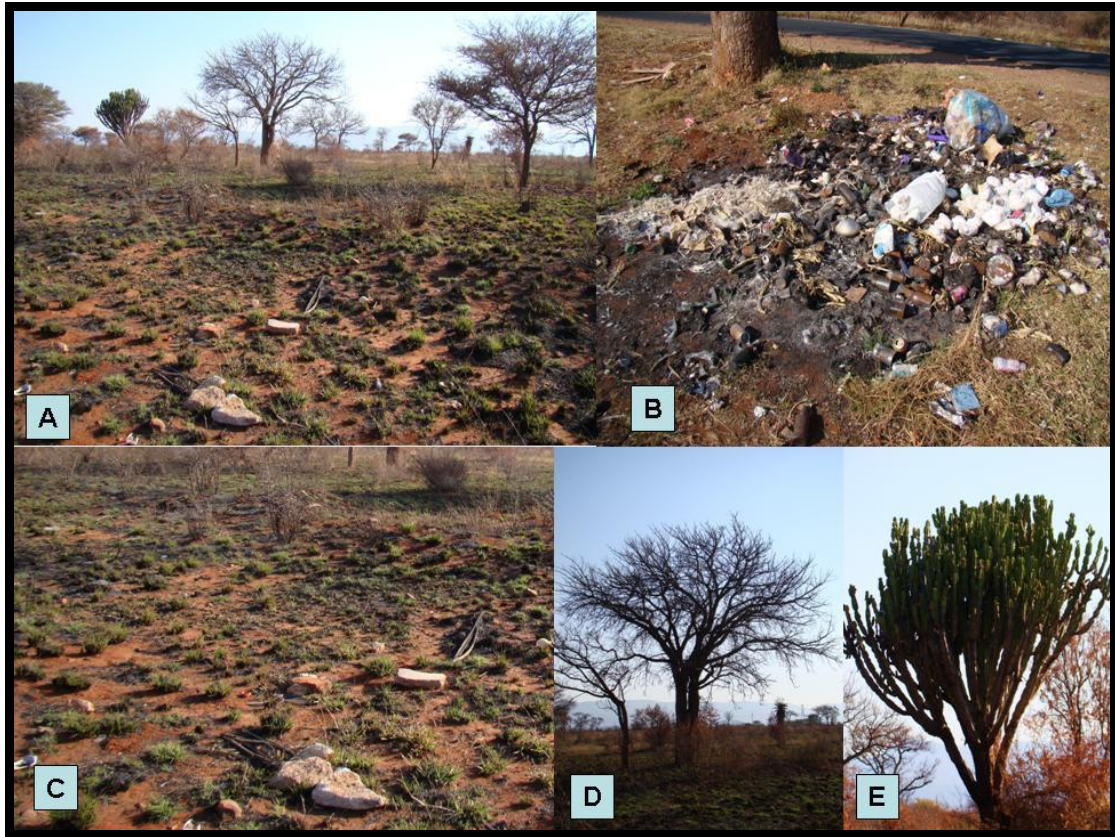
### Borrow Pit 1: New Borrow Pit

**Figure 4.** A conglomerate of photographs displaying the prevailing environmental conditions around the proposed borrow pit 1. **A:** The area around the proposed borrow pit is degraded bushveld and presently utilised for cattle grazing activities; **B:** Extensive littering occurs adjacent to the borrow pit area. **C:** Evidence of previous vegetation clearance with removal of the majority of tree and shrub species; **D:** Scattered large indigenous tree species were observed around the borrow pit area including *Sclerocarya birrea* as well as (**E**) *Euphorbia ingens*. Ideally no large indigenous tree (>4m) should be destroyed and the borrow pit should be positioned around remaining large tree species.

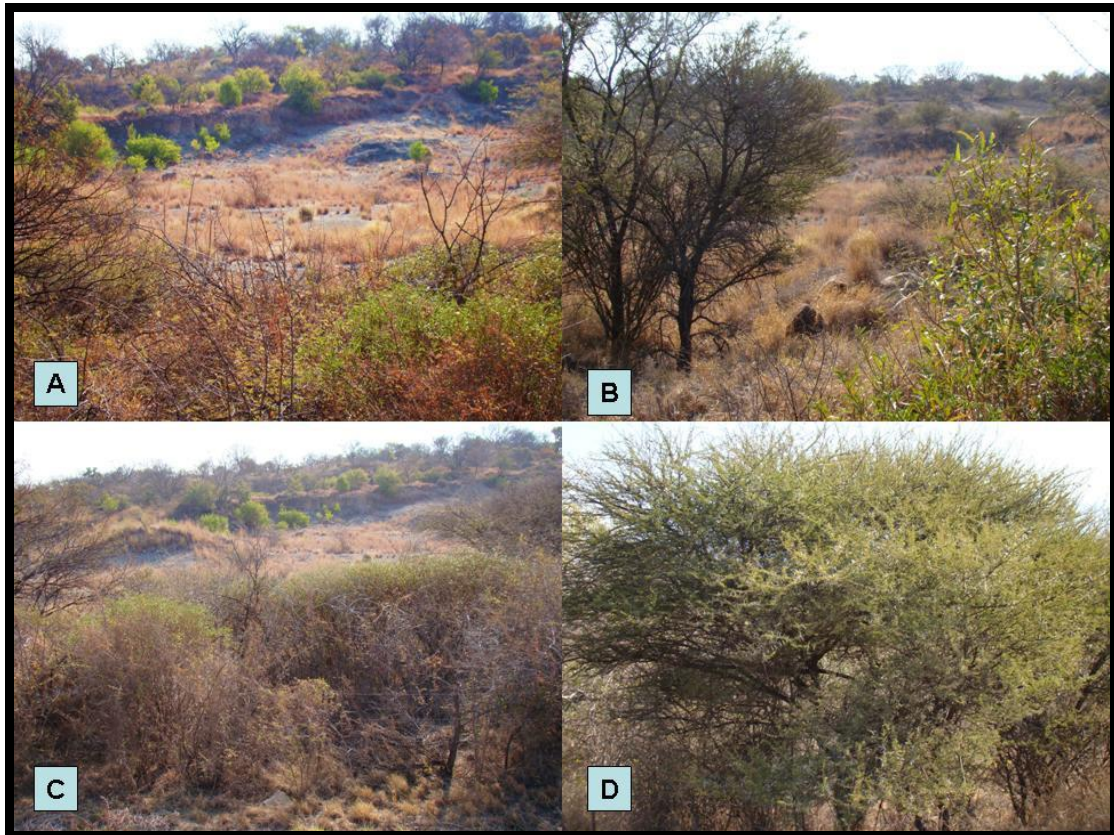
**Borrow Pit 2: Existing Borrow Pit**  
GPS Locality: 24°06' 50.8" S 29° 02' 09.8" E

**Figure 5.** A conglomerate of photographs displaying the prevailing environmental conditions around borrow pit 2. **A:** The area around the existing borrow pit is degraded bushveld with secondary succession vegetation and presently utilised for cattle grazing activities; **B:** The southern and eastern portions of the existing borrow pit has been re-colonised mainly by smaller *Acacia* species; **C:** Extensive bush encroachment adjacent to the fence by *Dichrostachys cinerea* **D:** Larger indigenous tree species occur such as and *Acacia karroo* and *Combretum apiculatum* occur around the periphery of the borrow pit and should not be destroyed as they provide important habitat for remaining arboreal faunal species as well as stabilizing the soils

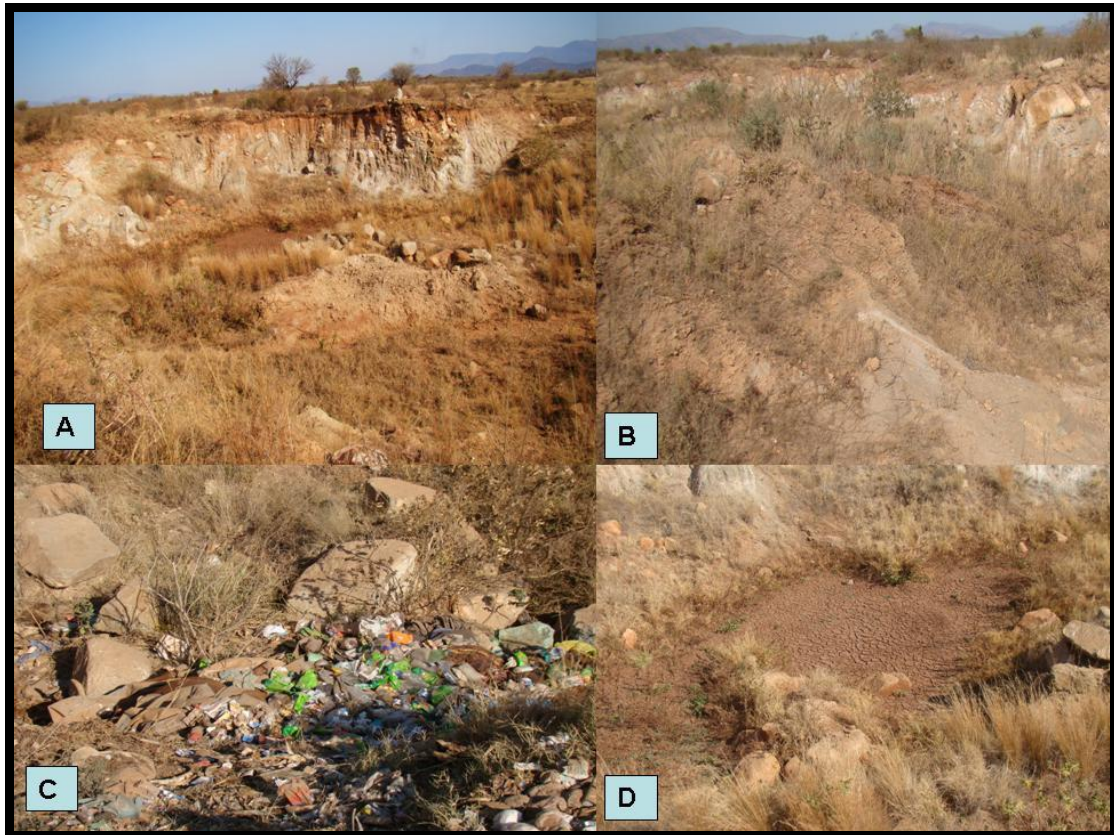
**Borrow Pit 3A: Existing Borrow Pit**  
**GPS Locality: 24°05' 56.5" S 28° 59' 25.6" E**

**Figure 6.** A conglomerate of photographs displaying the prevailing environmental conditions around borrow pit 3A. **A:** The area around the existing borrow pit is degraded bushveld with extremely limited secondary succession vegetation; **B:** The steep embankments of the borrow pit are poorly vegetated and result in extensive soil erosion; **C:** The borrow pit is currently utilised for illegal dumping activities. Extensive litter as well as a decomposing cow were observed during the site visit; **D:** Surface water collects in a small seasonally inundated pool at the bottom of the borrow pit. The seasonal pool could provide suitable breeding habitat for certain amphibian species such as Guttural Toads (*Amietophrynus gutturalis*) and Sand Frogs (*Tomopterna spp.*).

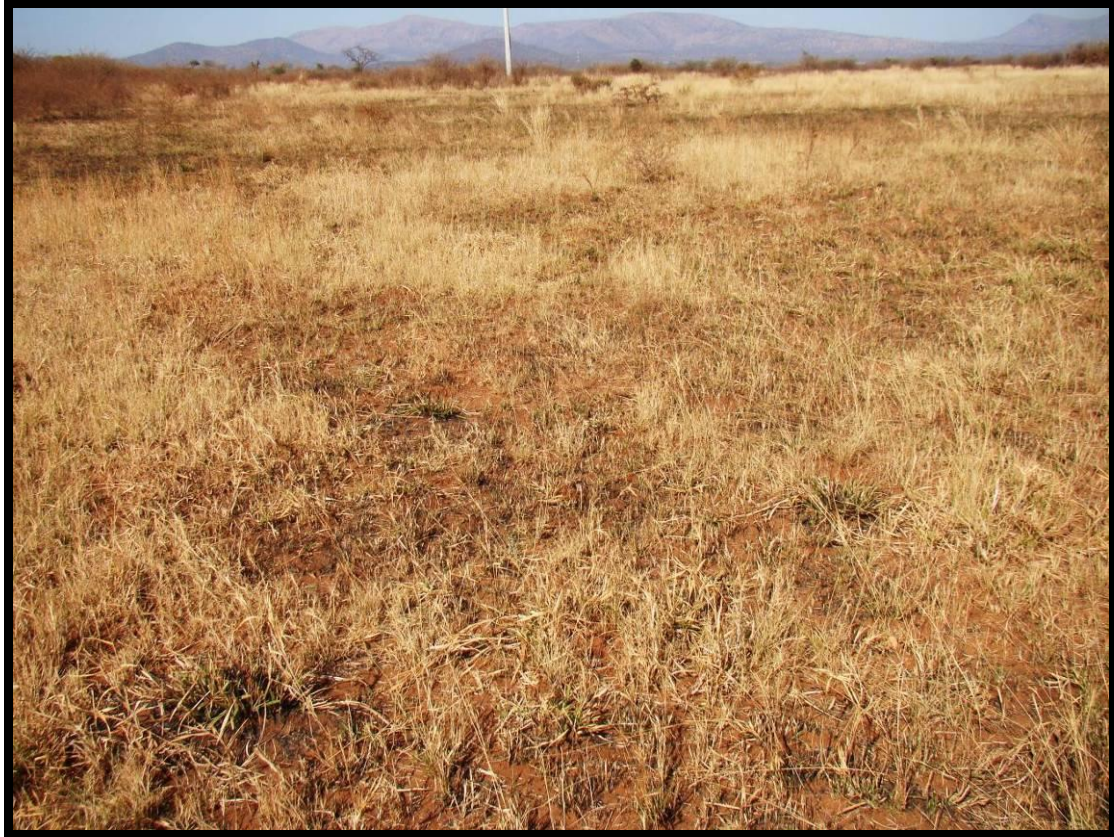
**Borrow Pit 3B: New Borrow Pit**  
**GPS Locality: 24°06' 03.2" S 28° 59' 48.8" E**

**Figure7.** A photograph displaying the prevailing environmental conditions around the proposed borrow pit 3B. The area around the proposed borrow pit consists of transformed or fallow agricultural lands dominated by secondary succession grasses. Extensive bush encroachment by *Dichrostachys cinerea* occurs adjacent to the secondary access road adjacent to the proposed borrow pit site.

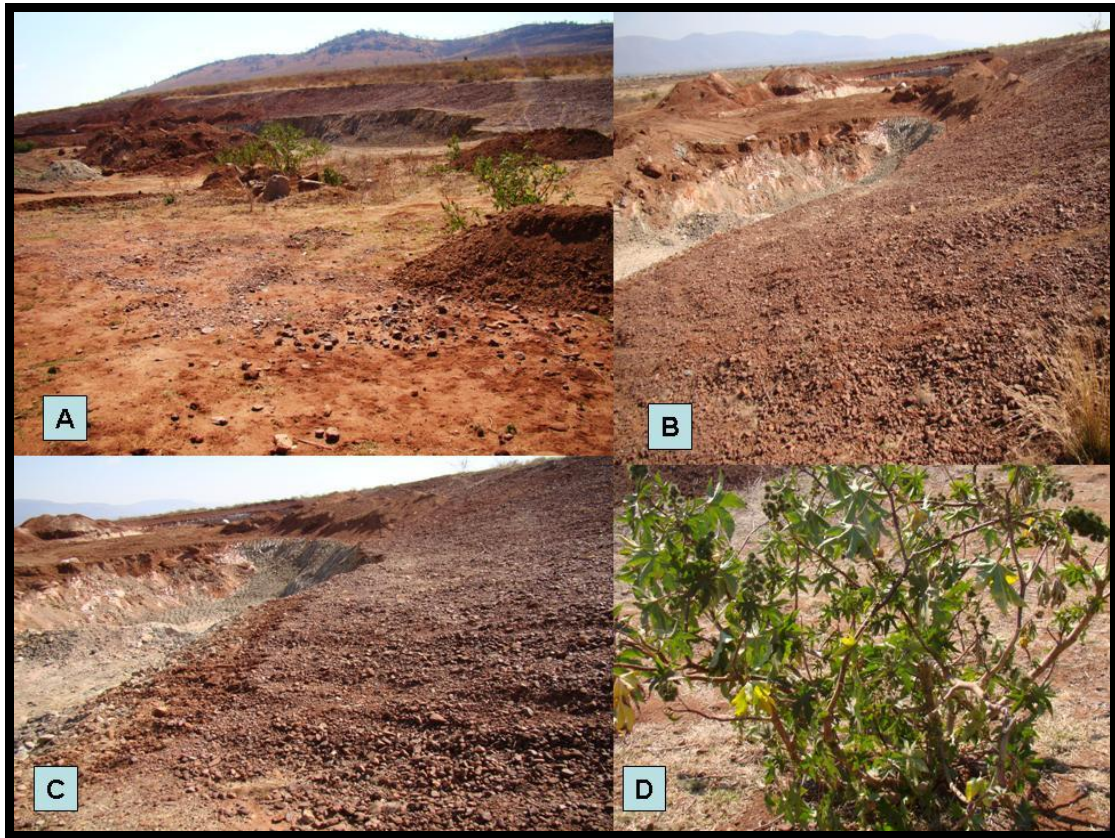
**Borrow Pit 4: Existing Borrow Pit**  
GPS Locality: 24°03' 32.7" S 28° 58' 24.8" E

**Figure8.** A conglomerate of photographs displaying the prevailing environmental conditions around borrow pit 4. **A:** The area around the existing borrow pit is degraded bushveld with extremely limited secondary succession vegetation; **B & C:** The borrow pit is presently operational with little or no vegetation present within the actively mined areas; **D:** A few scattered Category 1 alien invasive Castor-Oil Plants (*Ricinus communis*) were observed within the borrow pit

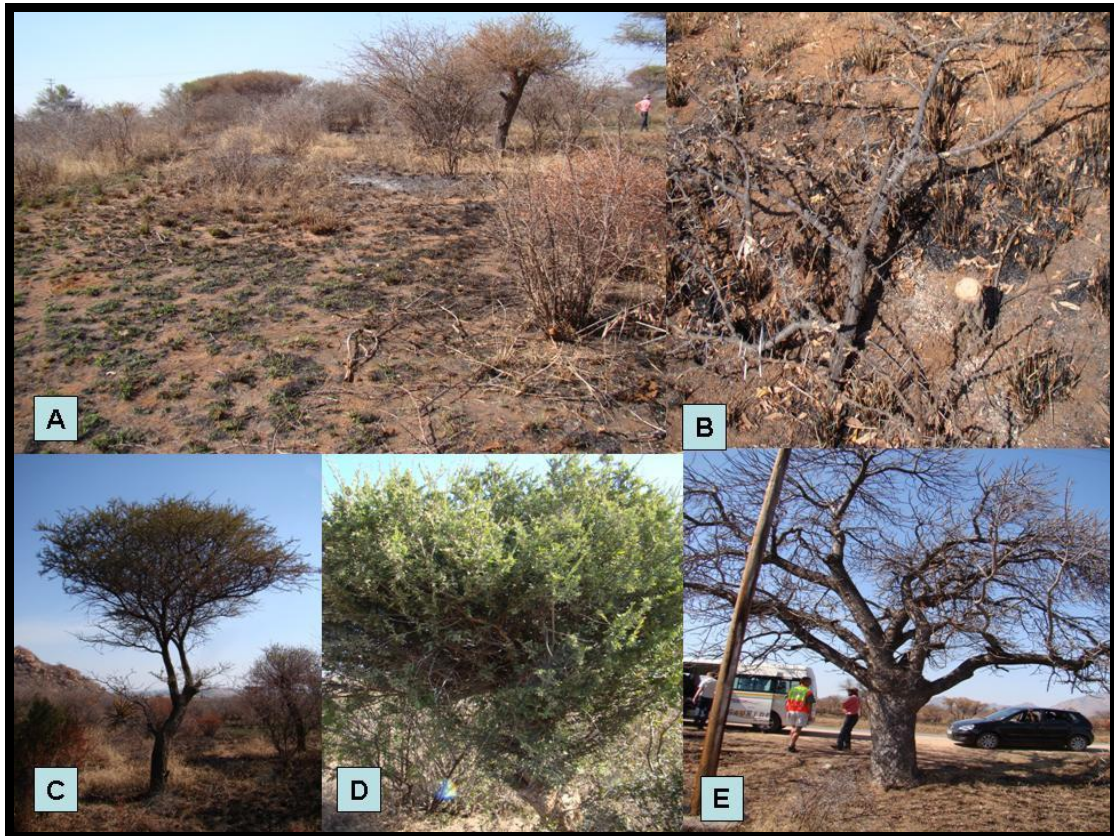
### Borrow Pit 5: New Borrow Pit

**Figure 9.** A conglomerate of photographs displaying the prevailing environmental conditions around borrow pit 5. **A:** The area around the proposed borrow pit is degraded bushveld with extensive wood harvesting activities **B.** Several large indigenous tree species occur around the proposed site including *Acacia tortilis* subsp. *heteracantha* (**C**) as well as (**D**) Shepherd's Tree *Boscia albitrunca* and (**E**) Marula *Sclerocarya birrea* subsp. *caffra*. Several emerging Marula trees were observed within the proposed borrow pit area. These two tree species are protected according National Forests Act, 1998 (Act no. 84 of 1998). Permits will be required if these trees are to be removed during the mining operations. Ideally the borrow pit area should be positioned around all remaining large indigenous tree species.

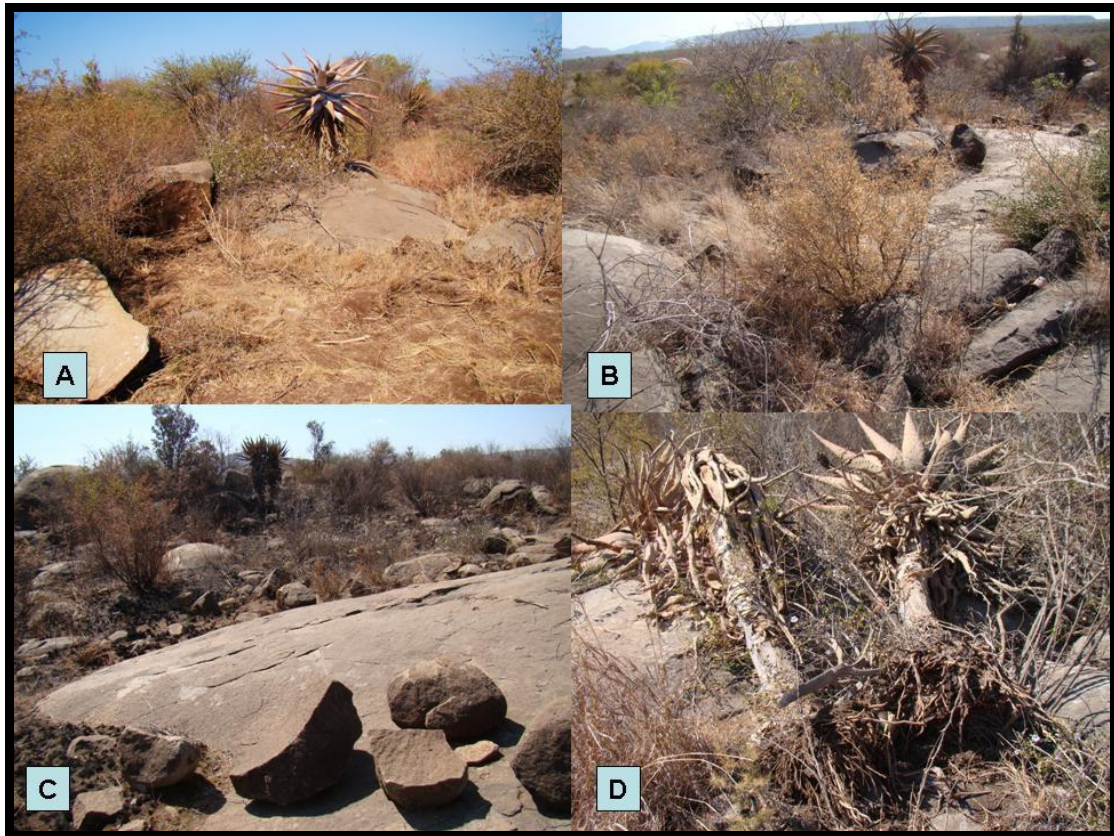
## Proposed Quarry Site

**Figure10.** A conglomerate of photographs displaying the prevailing environmental conditions around the proposed quarry site. **A:** The area around the proposed quarry site consists mainly of degraded bushveld with extensive wood harvesting activities **B.** The proposed quarry site is situated within an isolated patch of low-lying mostly embedded rocky outcrop. **C:** The rock sheets and boulders provide important habitat for rupicolous faunal species especially reptiles. **D:** The needless flattening of large Mountain Aloes *Aloe marlothii* subsp. *marlothii* for access to the quarry site is highly condemned by the consultant. Remaining large aloes should be carefully excavated and replanted adjacent to the quarry site or kept in a suitable "on-site" nursery and used for rehabilitation of the quarry after the cessation of mining activities. The proposed quarry will have a high negative impact on remaining plant and animal species occurring within the proposed mining area. Limited alternative habitat remains in the immediate area. It is imperative that the area is appropriately rehabilitated after the cessation of mining activities. This will require a site specific environmental rehabilitation plan/report compiled by a suitably qualified ecologist.

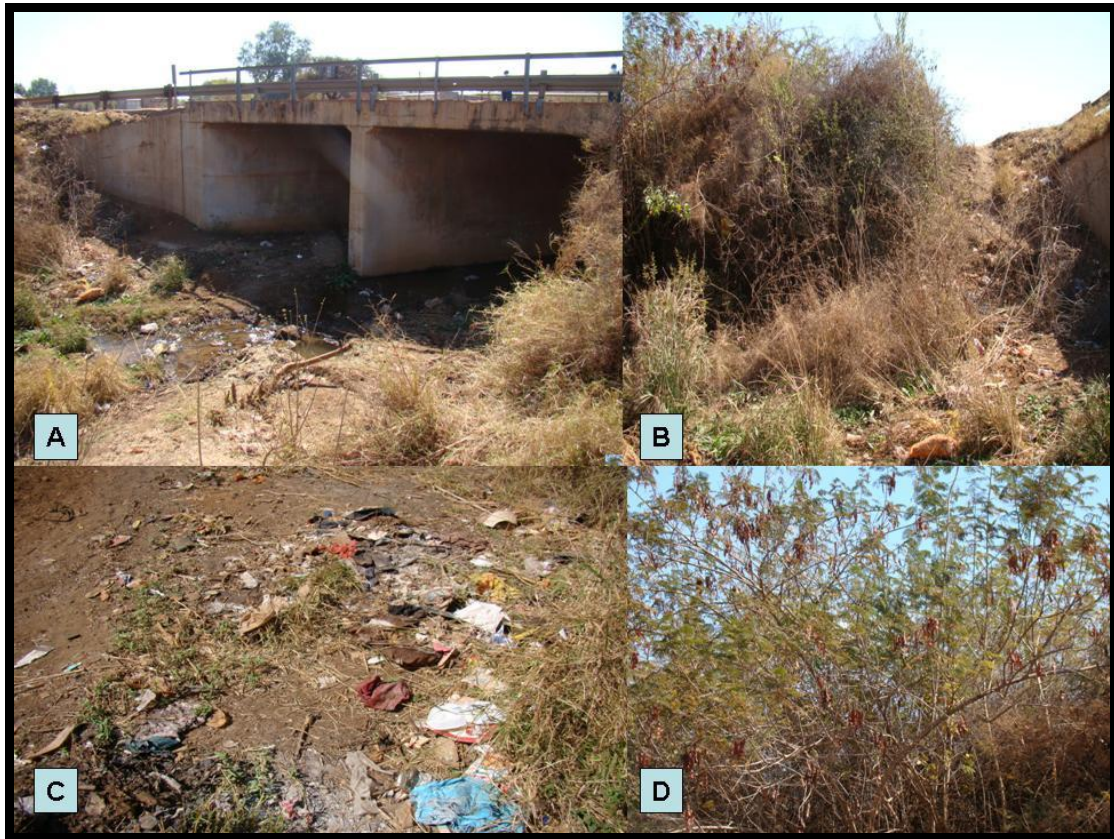
### Bridge Crossing 1: Dorps River

**Figure11.** A conglomerate of photographs displaying the current impacts observed at the Dorps River bridge crossing: **(A)**: The area around the current bridge is heavily degraded due to high levels of human disturbances within the Dorps River as well as adjacent riparian zone has resulted in habitat destruction and degradation as well as deterioration of water quality; **(B)**: Evidence of vegetation clearance and wood harvesting within the riparian zone as well as erosion channels from surface water from the road entering through eroded channels directly into the stream **(C)**: Extensive littering and illegal dumping activities within the active channel as well as macro-channel banks; **(D)**: Bush encroachment and thicket formation by *Acacia ataxacantha* within the remnant patches of riparian vegetation.

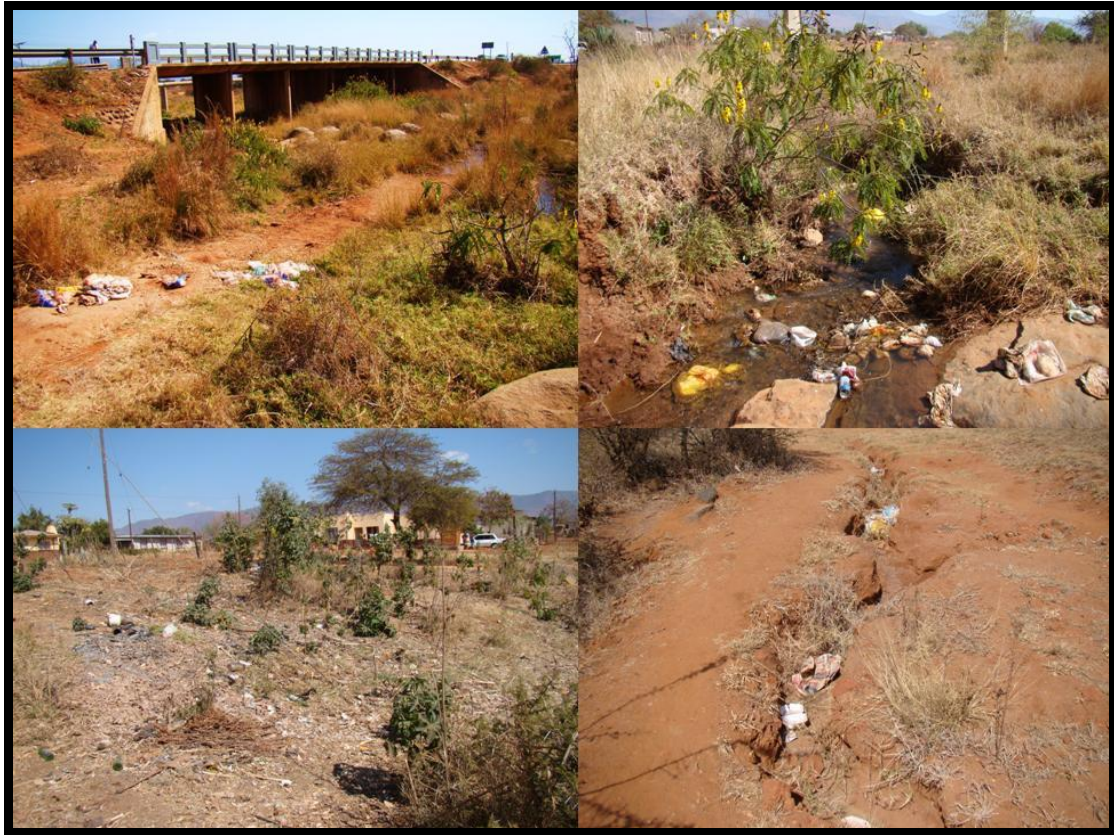
**Bridge Crossing 2: Rooisloot**  
**GPS Locality: 24°08' 11.9" S 28° 59'11.6" E**

**Figure12.** A conglomerate of photographs displaying the current impacts observed at the Rooisloot bridge crossing; **(A)**: The area around the current bridge is heavily degraded due to high levels of human disturbances within the active channel as well as macro-channel banks of the Rooisloot as well as adjacent riparian zone has resulted in habitat destruction and degradation as well as deterioration of water quality; **(B & C)**: Evidence of vegetation clearance and wood harvesting within the riparian zone as well as alien vegetation invasion, extensive littering and illegal dumping activities within the active channel as well as macro-channel banks; **(D)**: Erosion channels from surface runoff from the road entering through eroded channels directly into the Rooisloot; resulting in increased levels of siltation and sedimentation within the river.

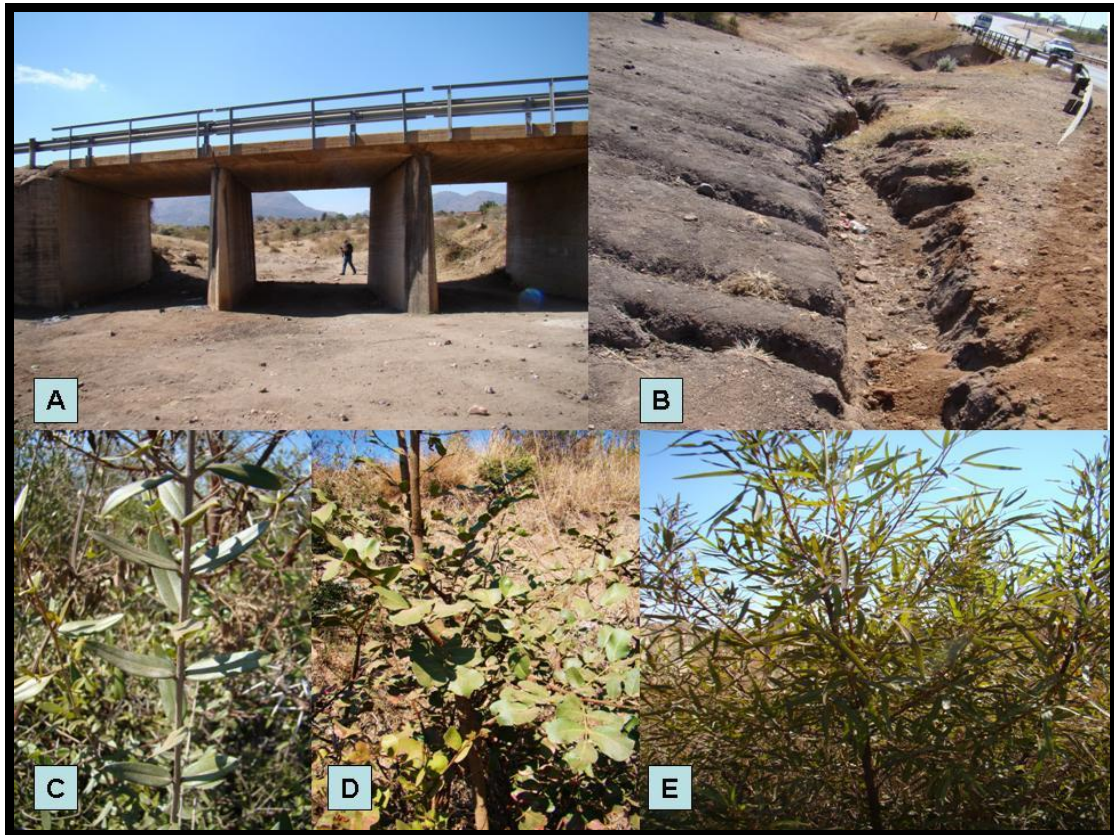
**Bridge Crossing 3: Unnamed non-perennial drainage line**

**Figure13.** A conglomerate of photographs displaying the current impacts observed at the non-perennial or intermittent river crossing: **(A)**: The area around the current bridge is heavily degraded due to high levels of human disturbances within the active channel as well as macro-channel banks of the stream as well as adjacent riparian zone has resulted in habitat destruction and degradation as well as deterioration of water quality; **(B)** Erosion channels from surface water from the road entering through eroded channels directly into the stream resulting in increased levels of siltation and sedimentation. **(C)**: Remnant patches of indigenous riparian vegetation was observed approximately 50m downstream from the bridge. Coppicing stumps of Wild Olive (*Olea europaea* subsp. *africana*); **(D)**: Weeping Boer Bean (*Schotia brachypetala*) and **(E)**: Karree (*Searsia lancea*).

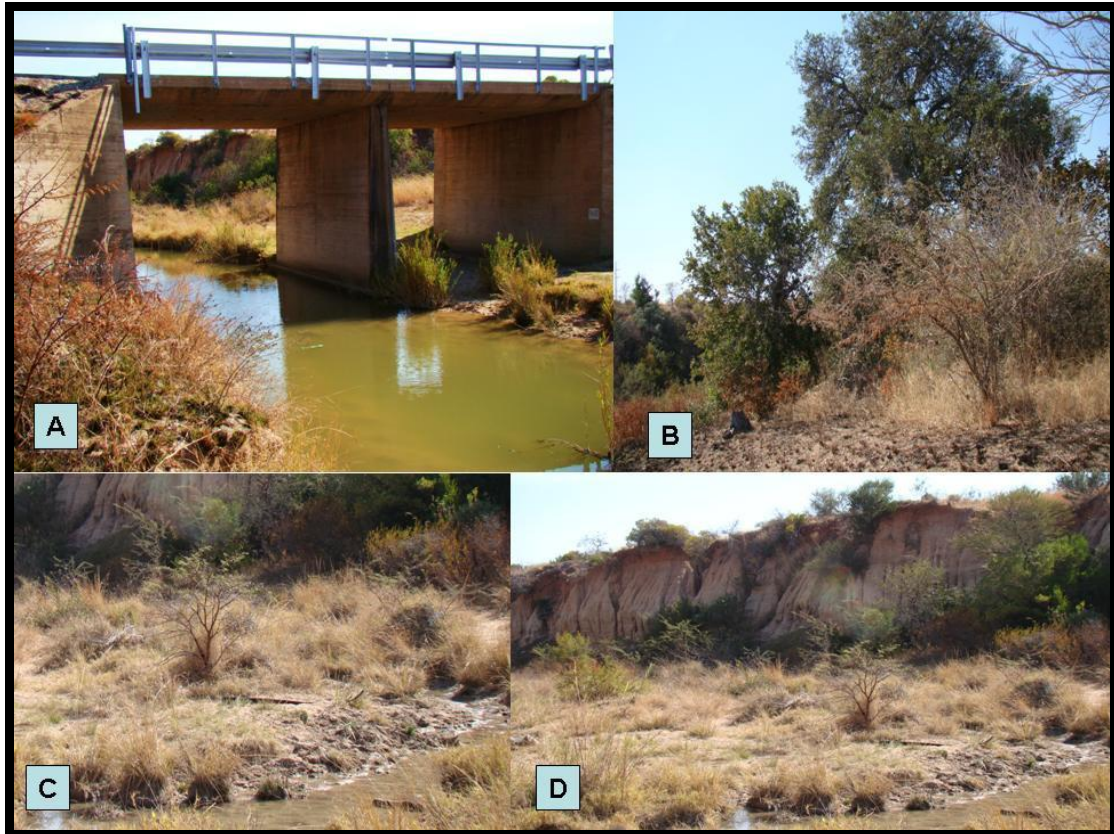
**Bridge Crossing 4: Groot Sandsloot**  
**GPS Locality: 23°59' 36.0" S 28° 57' 34.9" E**

**Figure14.** A conglomerate of photographs displaying the current impacts observed at the Groot Sandsloot River crossing: **(A)**: The area around the current bridge is heavily degraded due to high levels of human disturbances within the active channel as well as macro-channel banks of the river as well as adjacent riparian zone has resulted in habitat destruction and degradation as well as deterioration of water quality; **(B)**: Remnant patches of indigenous riparian vegetation was observed approximately 10m upstream (east) of the bridge. Species observed included *Ziziphus mucronata*, *Dombeya rotundifolia*, *Gymnosporia buxifolia*, *Searsia lancea*, *Sclerocarya birrea* subsp. *caffra* and *Schotia brachypetala*. It is imperative that the bridge expansion does not destroy any remaining natural riparian vegetation and construction activities are restricted downstream from the bridge (to the west); **(C)**: The riparian vegetation downstream from the bridge is heavily degraded with a few emerging *Acacia karroo* and *Acacia gerrardii*; **(D)**: Extensive bank erosion both upstream and downstream from the bridge crossing. Erosion preventative measures such as gabions or gabion mattresses should be installed adjacent to the bridge to prevent further bank erosion as well as the planting of indigenous (to the area) tree species within the riparian zone for bank stabilization.

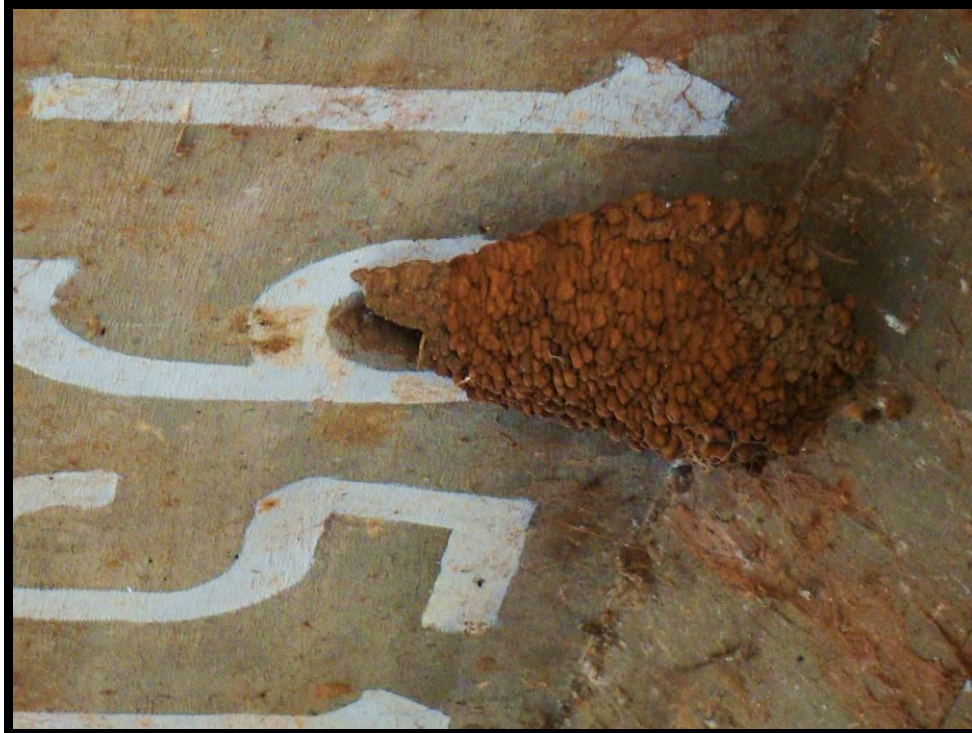
**Figure15.** Several old swallow nests were observed under the current Rooisloot bridge. Construction activities should ideally be undertaken during the winter months after the swallows have completed their nesting/breeding activities. Nests should not be unnecessarily damaged or disturbed as the nests may be re-used by some species of swallows.

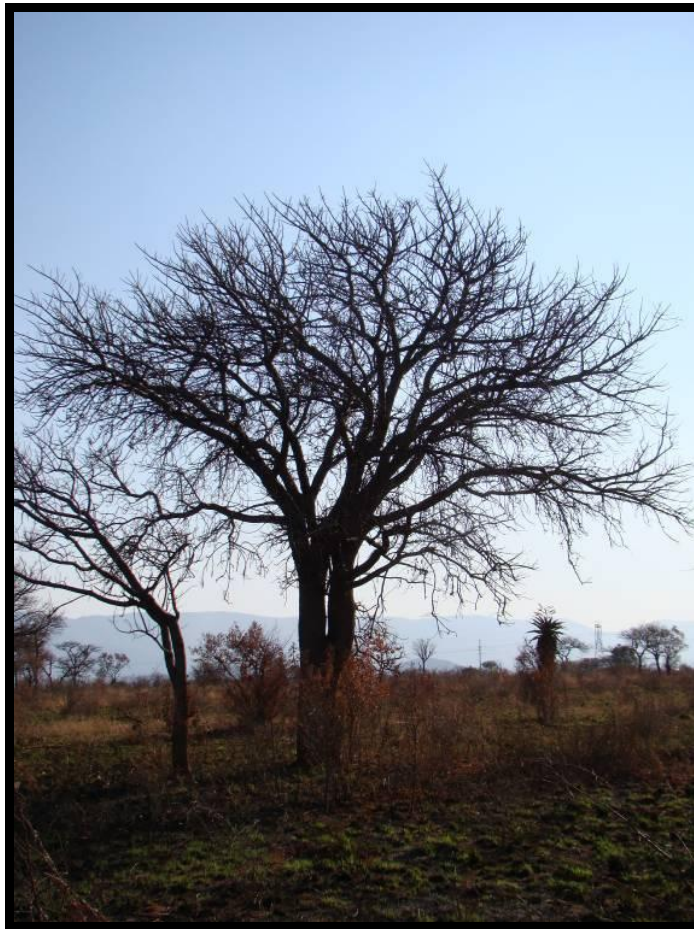
All remaining large indigenous tree species (>4m) and shrubs (>2m) should be retained wherever possible and included in the proposed borrow pit areas. Trees form vital habitats for numerous faunal species adapted to their arboreal habitat as well as playing a vital role in erosion stabilisation. Impacts on the sloping areas such as the macro-channel banks of the Groot Sandsloot must be strictly regulated preventing possible further deterioration of the environment. The soils of the site are highly erodable; extensive erosion could result without a protective vegetative layer. Habitats such as the rock outcrops, trees, stumps, termitaria and leaf litter are all vital habitats for numerous animal species.

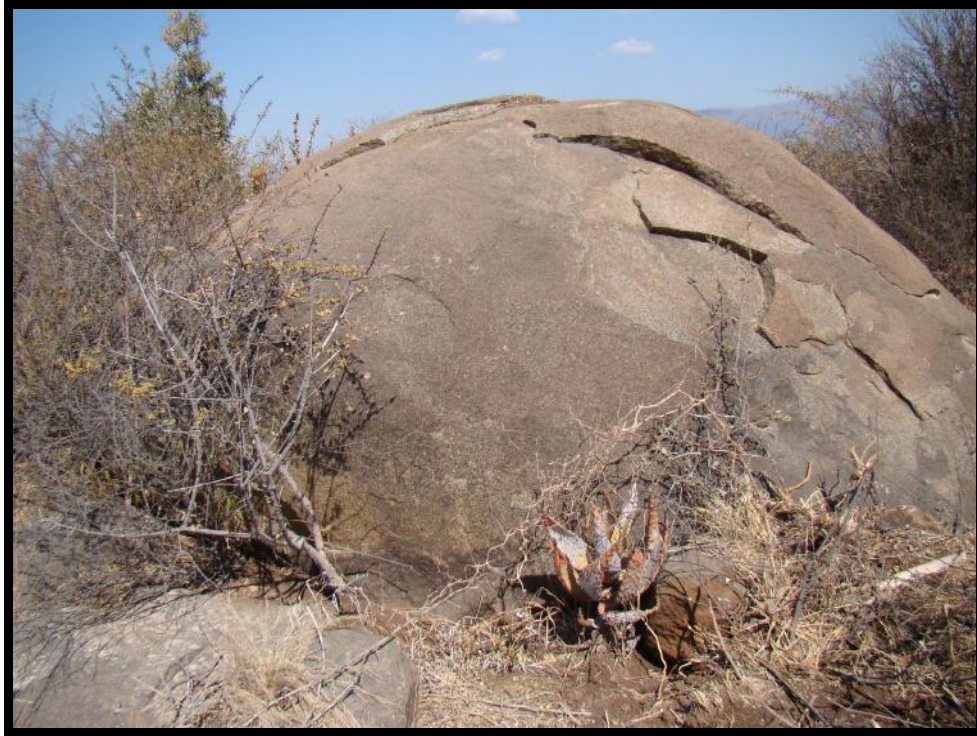
The low-lying granite outcrops and sheets occur around the proposed quarry site provide favourable refuges for certain rupicolous snake and lizard species. Reptile species recorded from under loosely embedded rocks on the low-lying rocky areas included Yellow-Throated Plated Lizard (*Gerrhosaurus flavigularis*), Montane Speckled Skink (*Trachylepis (Mabuya) punctatissima*), Variable Skink (*Trachylepis (Mabuya) varia*) Ground Agama (*Agama aculeata*) and Transvaal Thick-toed Gecko (*Pachydactylus affinis*). Scattered rocky outcrops are important habitats for numerous rupicolous animal species including scorpions, arachnids, geckos, skinks, snakes and smaller mammals.

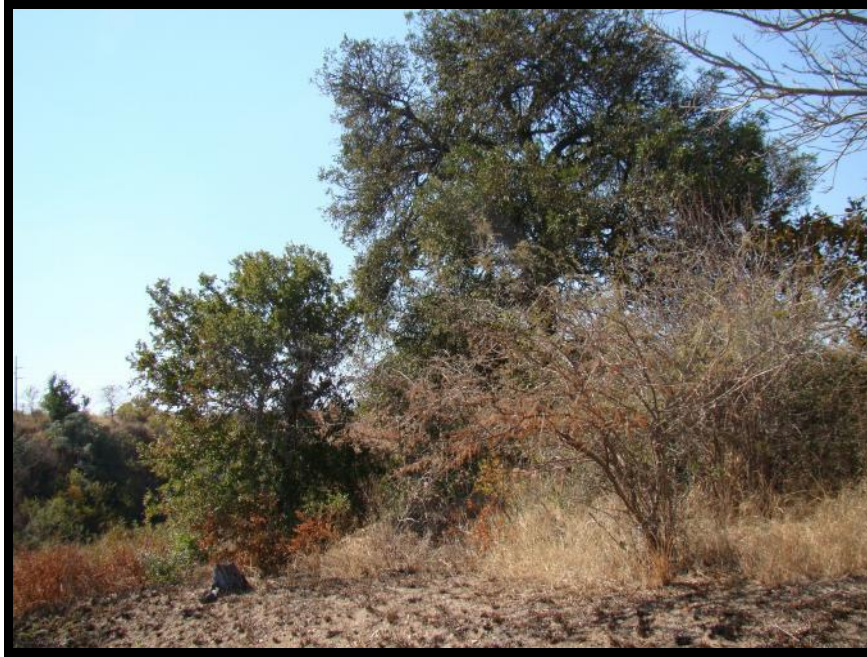
The riparian zone comprises plant communities contiguous to and affected by surface and subsurface hydrological features of perennial or intermittent water bodies (rivers and streams). Riparian areas have one or both of the following characteristics: 1) distinctly different vegetative species than adjacent areas, and 2) species similar to adjacent areas but exhibiting more rigorous or robust growth form. The vegetation is dependant on the river for a number of functions including growth, temperature control, seed dispersal and germination and nutrient enrichment (Kemper, 2000). The vegetation comprises a distinct composition of species, often different from that of the surrounding terrestrial vegetation. Tree species are positioned according to their dependence or affinity for water, with the more water loving (mesic species) being located closest to the river channel, often with their roots in the water, and the less water loving terrestrial species further away from the river (Kemper, 2000).

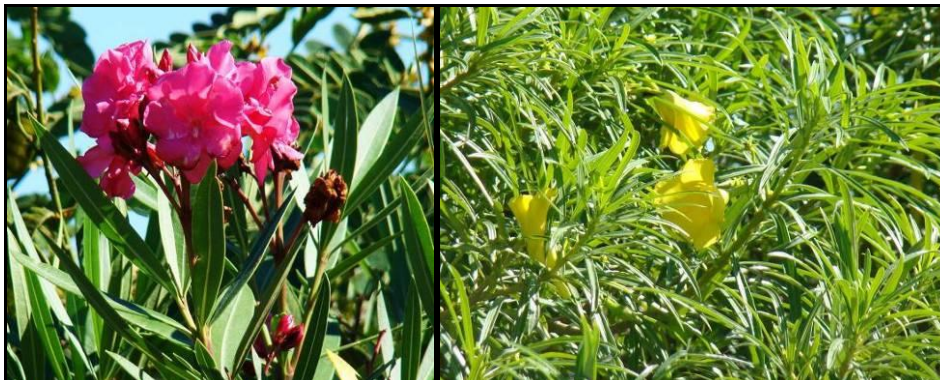
**Figure16.** The Oleander (*Nerium oleander*) and the Yellow Oleander (*Thevetia peruviana*) are both poisonous plants and are potentially lethal to livestock as well as humans. They are common within the rural homesteads situated along the N11 road reserve. Two leaves and around 4 seeds of the Yellow Oleander can be fatal to a child.
