# Sub – Chorionic Fibrin Deposition of the Placenta

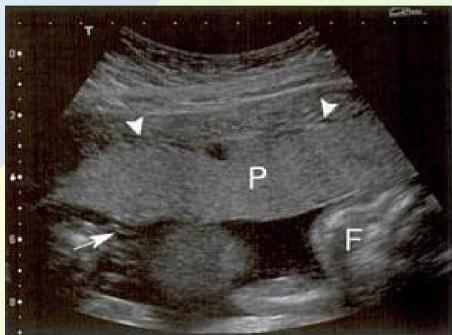
Normal Homogenous appearance of the Placenta on Ultra Sound

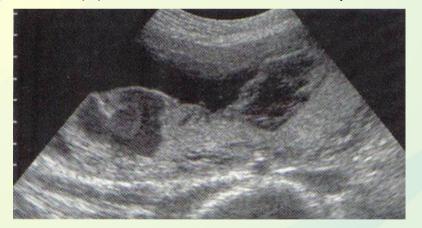
Areas of lobulated, hypo – echoic / cystic echo texture (S) in the Sub – Chorionic space

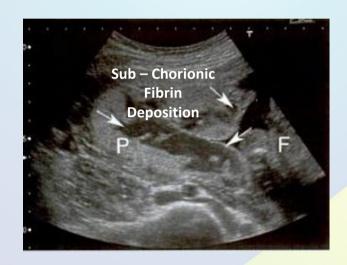
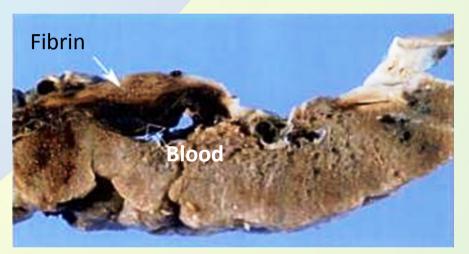
Colour flow imaging shows no detectable flow, owing to low sinus flow and fibrin deposition

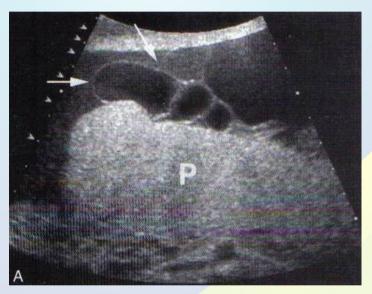
Sub-Chorionic cyst: Curvilinear Echogenecities which form an arc with the chorionic surface

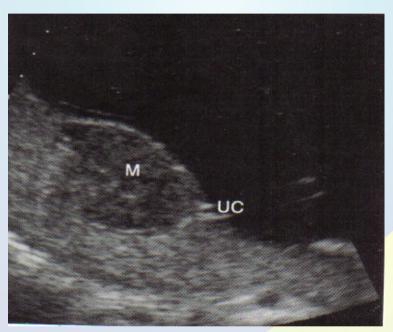
Hypoechoic mass (M) rises from the placental surface near the umbilical cord insertion (UC)

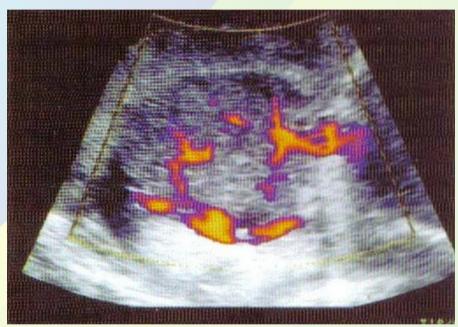
Colour flow imaging shows prominent vascularity in the mass

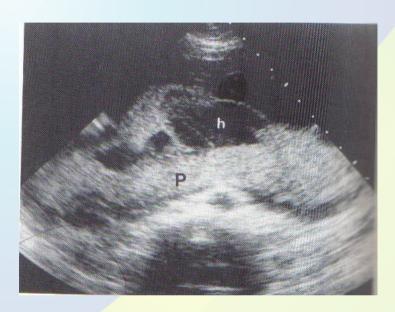
Sub – Chorionic Haematoma (h): These usually distort the chorionic surface

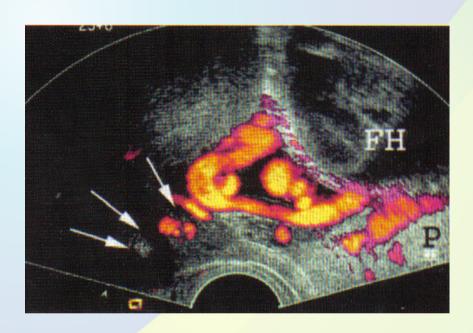
Vasa praevia -1 -may occur when the umbilical vessels course over the cervix in Velamentous insertion of the umbilical cord into the placental membranes

Succenturiate lobe- 2

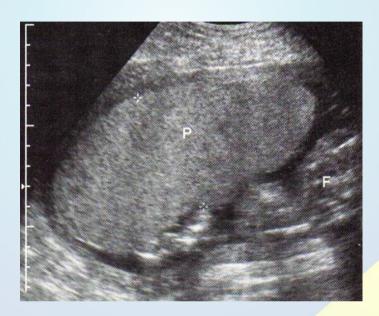
Placentomegaly: abnormally thickened Placenta (P) in early pregnancy appears to carry a higher risk of IUGR and placental insufficiency
