NWC TP 6343

Hydrogen Embrittlement in 17-4PH Stainless Steel

by
Kenneth R. Hayes
Engineering Department

**NAVAL WEAPONS CENTER
CHINA LAKE, CALIFORNIA 93555**

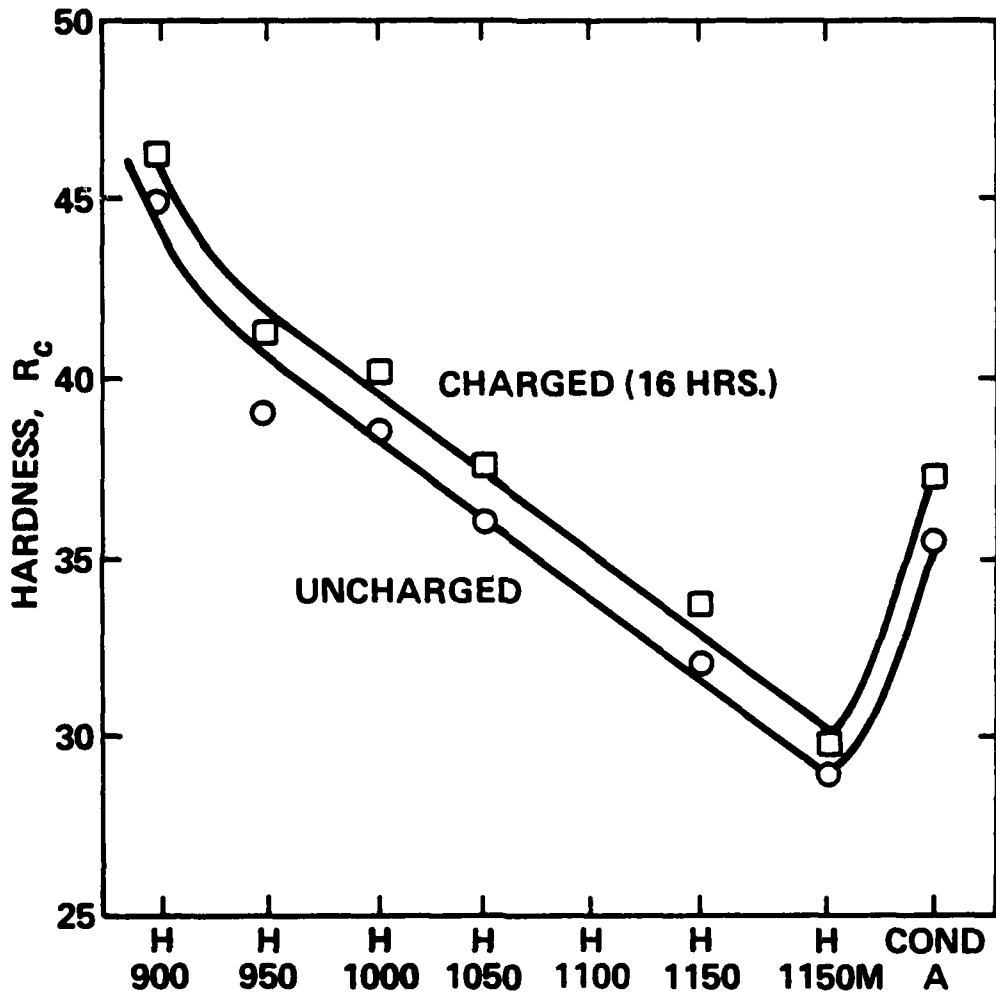
FIGURE 2. The Influence of Hydrogen Charging on the Hardness of 17-4PH in Various Aged Conditions.

The hardness data (Figure 2) showed that hydrogen charged specimens exhibited a consistent increase in hardness of from one to three Rockwell C points when compared to the values for uncharged specimens. Although the effect was small, it appears real in that it was observed for all aging conditions. Each data point represents an average of at least three independent hardness measurements.

The results of this investigation show a small but consistent increase in hardness in all heat-treated conditions after hydrogen charging. This behavior implies some kind of hydrogen atom-dislocation interaction taking place, probably causing dislocation pinning to occur. This investigation also presents data indicating that at intermediate strain rates,

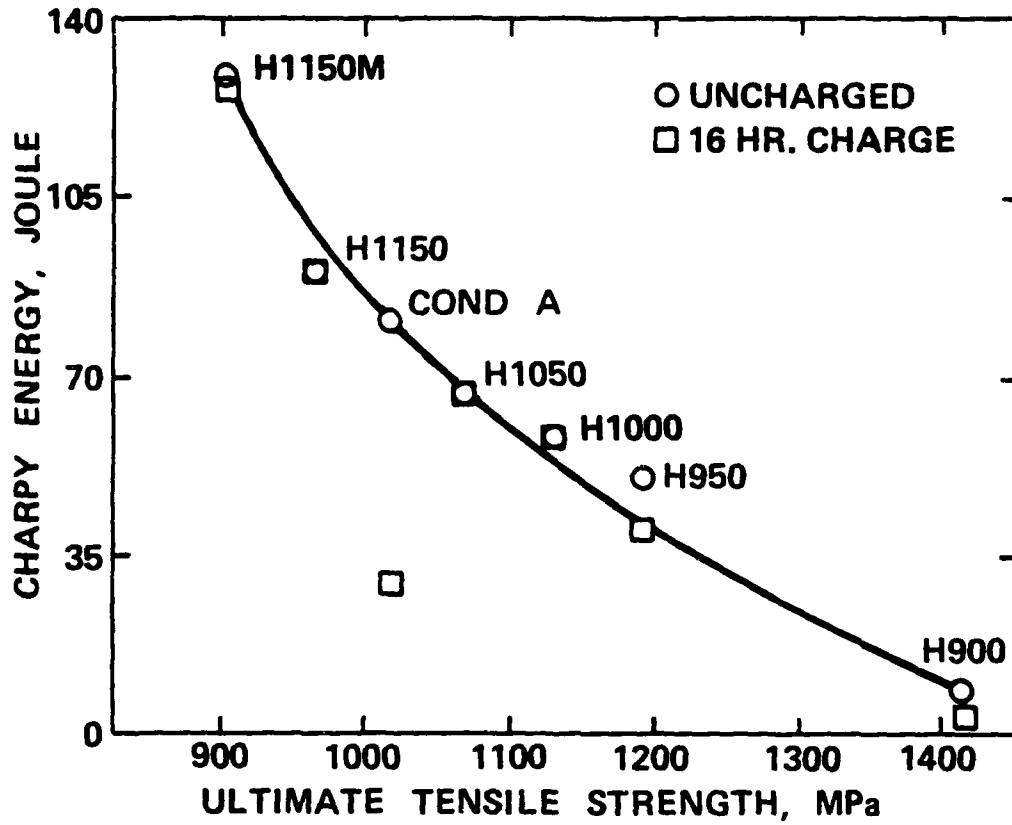
FIGURE 3. Charpy Impact Energy of Hydrogen Charged and Uncharged Specimens of Varying Ultimate Tensile Strength.

Charpy impact tests were performed and it was found that in general, hydrogen charged specimens had comparable impact properties to uncharged specimens. The one exception was that in the solution treated condition which showed a significant loss of impact energy when charged. This is not surprising since it is generally agreed that untempered martensite is the most susceptible microstructure to HE (Reference 9). Figure 3 is a plot of charpy energy versus ultimate tensile strength of 17-4PH, and shows the decrease in impact energy associated with the strength increase, as well as the charged versus uncharged impact energy results.

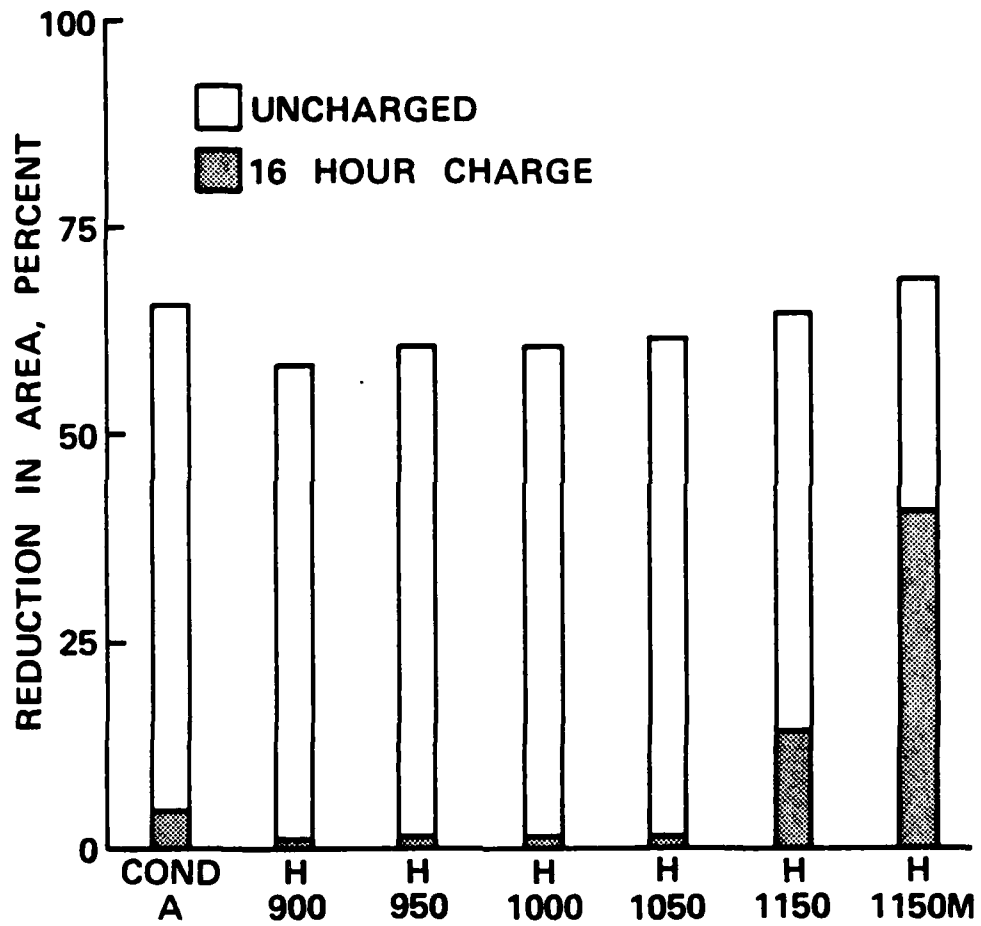
FIGURE 4. Influence of Hydrogen Charging % RA of 17-4PH in Various Aged Conditions.

It was observed that ductility as measured by % RA was affected in all aging treatments of the 17-4PH stainless steel when charged with hydrogen. Figure 4 illustrates that the heat-treated condition of the specimen had some influence on the degree to which specimens were embrittled. For example, the H900 specimen decreased in ductility from 57.9% RA to 0.4% RA upon charging while the double overaged H1150M tensile bar only decreased from 68.4% RA to 40% RA.

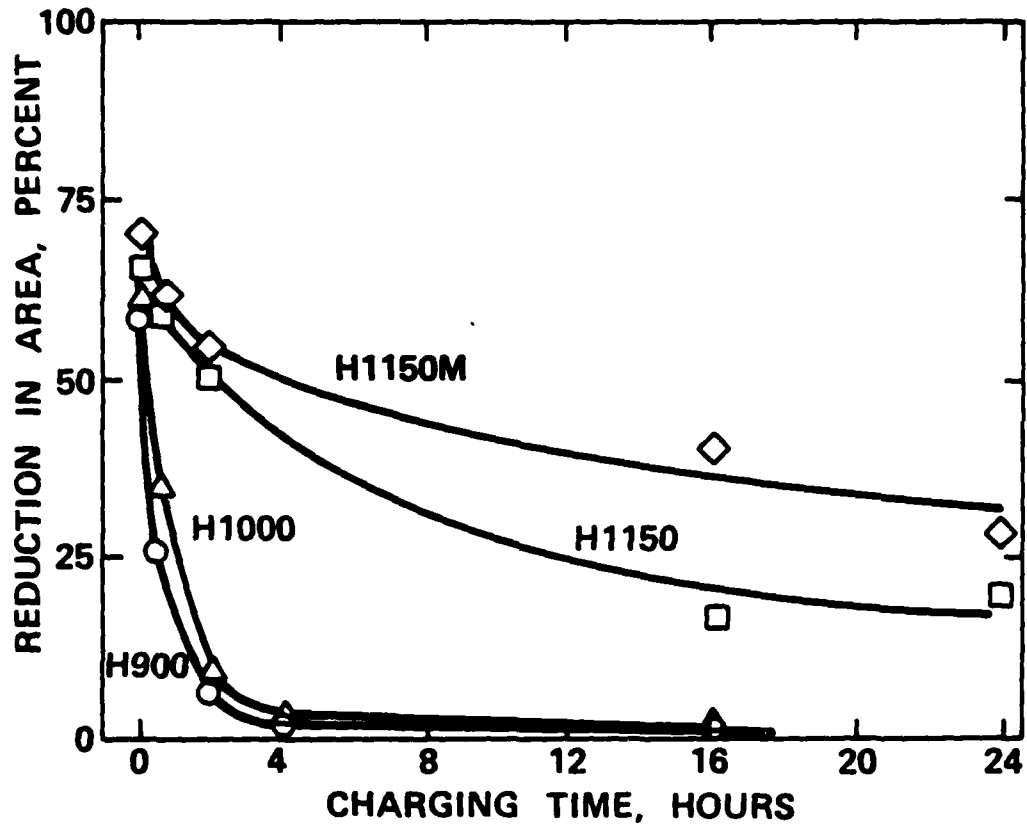
FIGURE 5. The Effect of Hydrogen Charging Time on % RA of Heat-Treated 17-4PH.

The effect of hydrogen charging time on HE was studied by varying this time from 0.5 hour to 24 hours. The results of the four aging treatments investigated are plotted in Figure 5 as % RA versus charging time. It is apparent that higher aging temperatures lead to less severe HE. In 0.5 hour of charging, the H900 and H1000 specimens lost approximately 50% of their ductility. The lower strength H1150 and H1150M specimens required approximately 16 hours of charging to incur an equivalent loss.

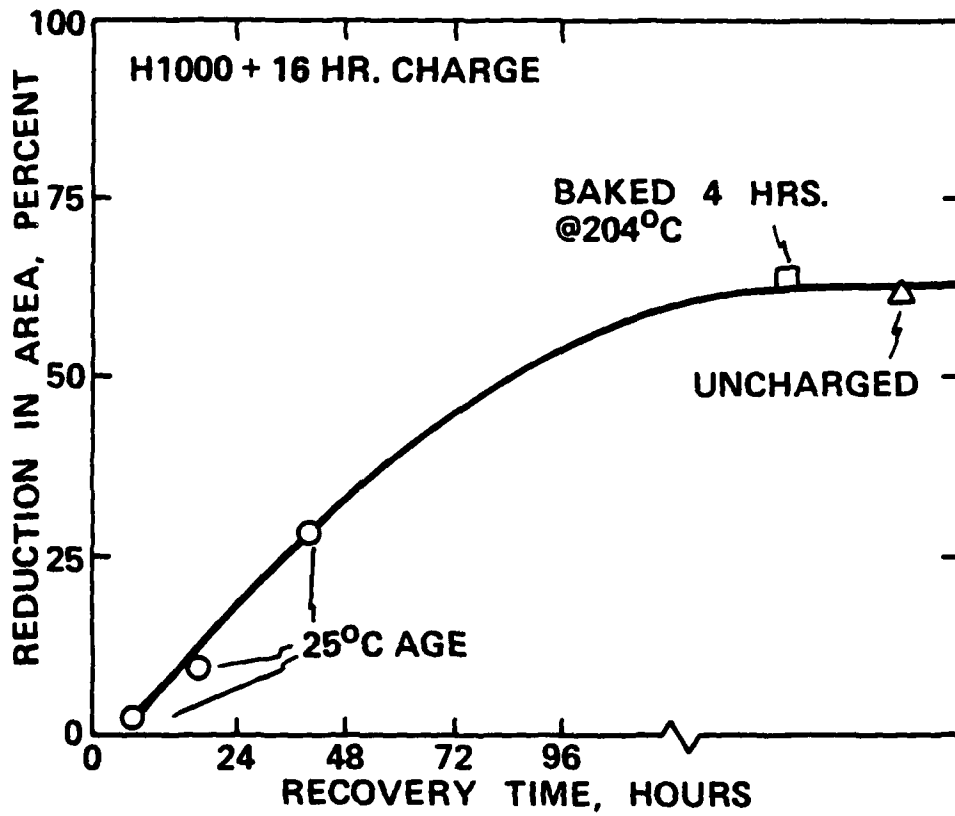
FIGURE 6. Recovery of % RA in Hydrogen Charged 17-4PH in Condition H1000.

Three specimens in condition H1000 were charged for 16 hours. Two of the specimens were allowed to stand at room temperature for 16 hours and 40 hours respectively. The third specimen was baked at 204°C for 4 hours. At the end of the recovery treatment, tensile test data indicated that significant ductility was recovered, going from 0.4% RA for a 16-hour charge with no recovery to 29.4% RA for a 16-hour charge followed by a 40-hour recovery. The baked specimen completely regained its ductility, showing 63.4% RA compared to 61.2% RA for an uncharged specimen (Figure 6).

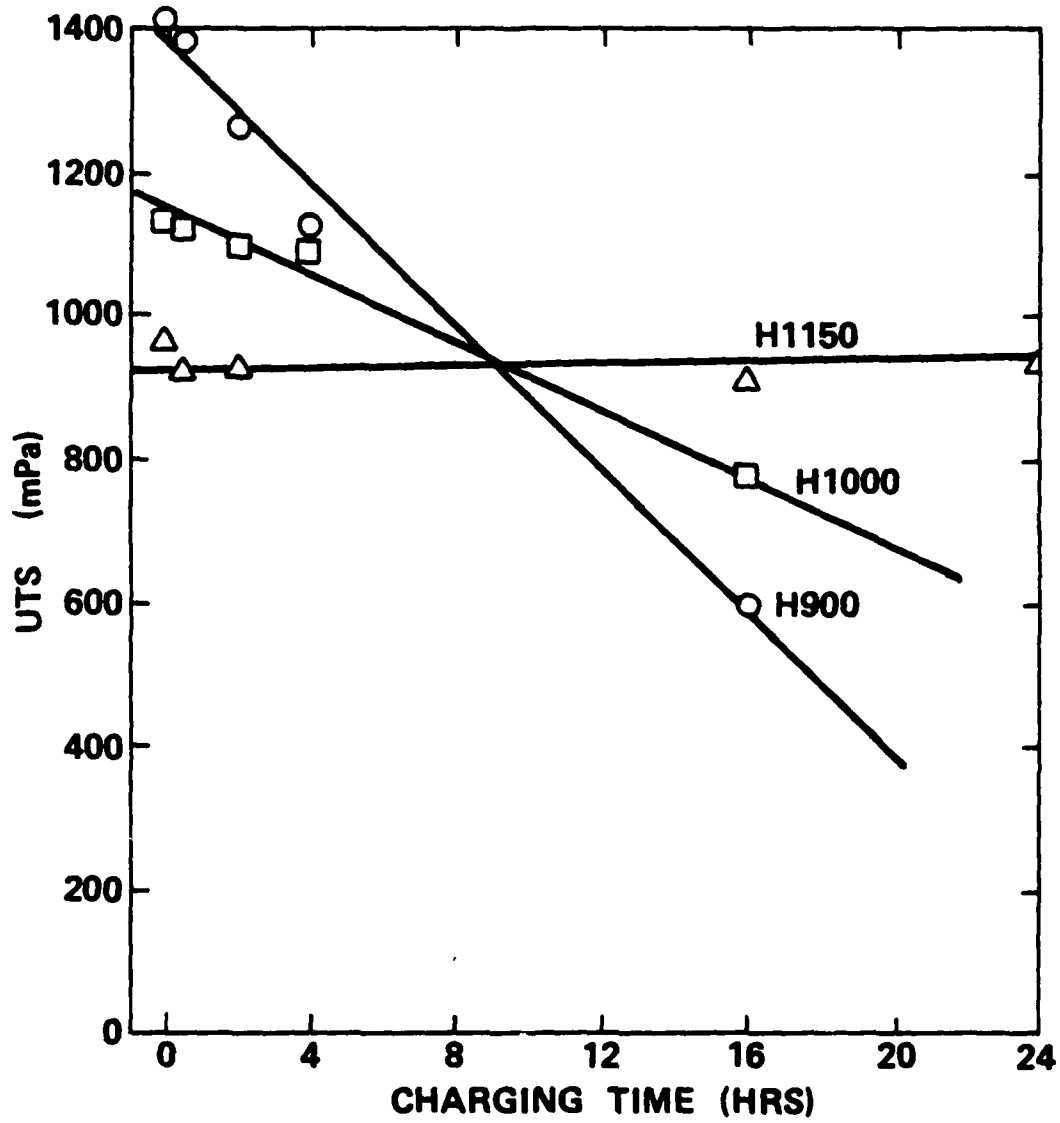
FIGURE 7. Variation in Ultimate Tensile Strength with Hydrogen Charging Time for 17-4PH in Various Aged Conditions.

The effect that charging time had on the ultimate tensile strength (UTS) can be seen in Figure 7. It is apparent that the high strength H900 condition lost considerable UTS with increasing charging time while the more ductile, low strength H1150 condition was not significantly affected. This is consistent with the results of other investigations (References 10, 11) which explain that hydrogen decreases ductility, leading to less workhardening, thus decreasing the UTS. However, in the case of 17-4PH very little workhardening occurs. Consequently the reason for the decrease in UTS of high strength 17-4PH after hydrogen charging may be related to relative resistance to crack propagation. In the high strength, low fracture toughness condition, hydrogen assisted crack propagation is not readily arrested and failure occurs at lower UTS than in the uncharged condition. In the lower strength conditions, hydrogen assisted crack propagation is more readily arrested by the tougher material, and UTS is affected to a lesser degree.

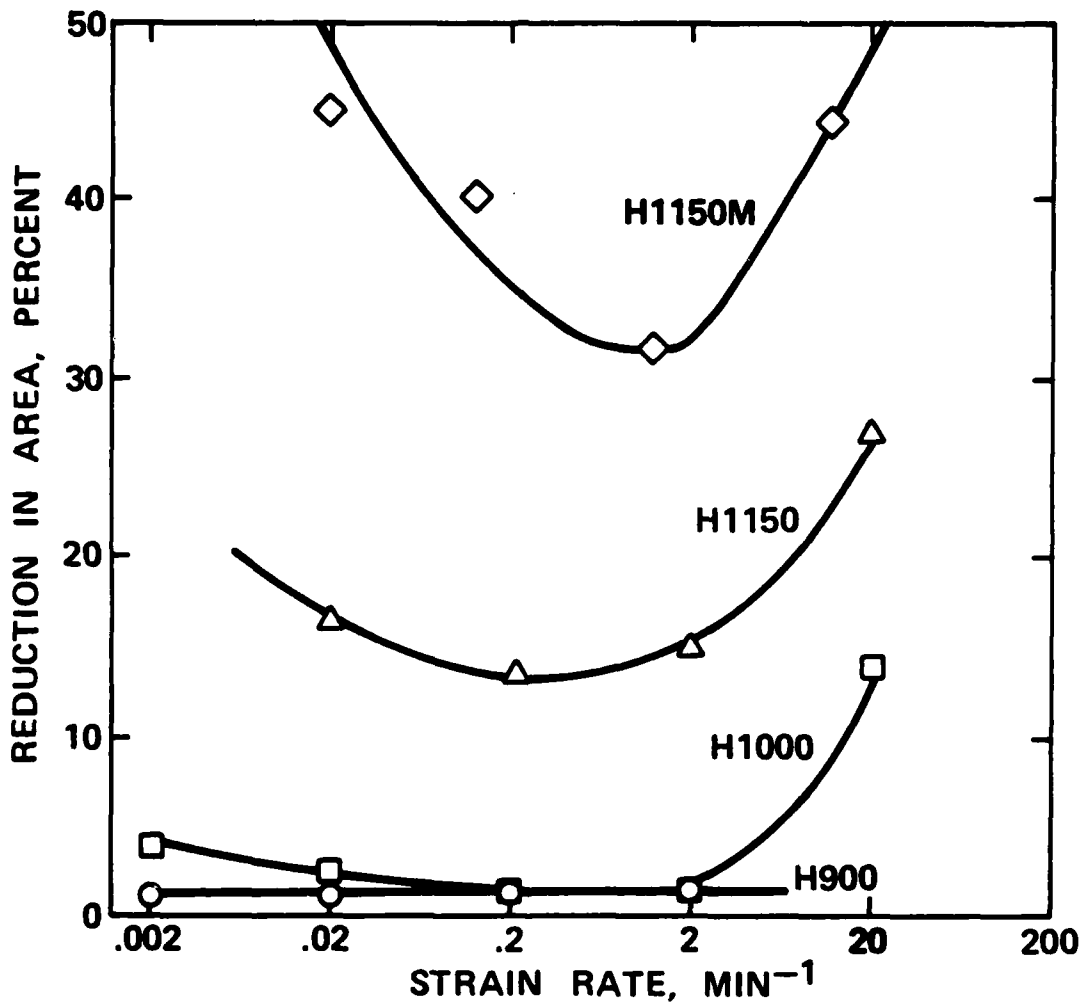
FIGURE 8. The Influence of Strain Rate on % RA of Hydrogen Charged 17-4PH in Various Aged Conditions.

The final variable investigated in this study was that of strain rate. As described earlier, a series of tensile specimens that were charged 16 hours were tested with strain rates varying from 0.002 min⁻¹ to 20.0 min⁻¹. This was performed for each of the following heat treatments: H900, H1000, H1150, and H1150M. Percent RA plotted versus strain rate for the four treatments is presented in Figure 8. While the H900 condition seemed unaffected by loading rate, the other three treatments showed varying degrees of sensitivity to the strain rate. All three exhibited minimum values of % RA for strain rates in the vicinity of 0.2 min⁻¹ to 2.0 min⁻¹. At the same time, some loss of % RA was observed no matter what strain rate was employed. Typical of the three treatments was that for condition H1150. At a strain rate of 0.02 min⁻¹ the RA was measured to be 16.4%. This decreased to a minimum value of 13.7% RA at 0.2 min⁻¹. At a strain rate of 20 min⁻¹ the RA increased to 27.0%.

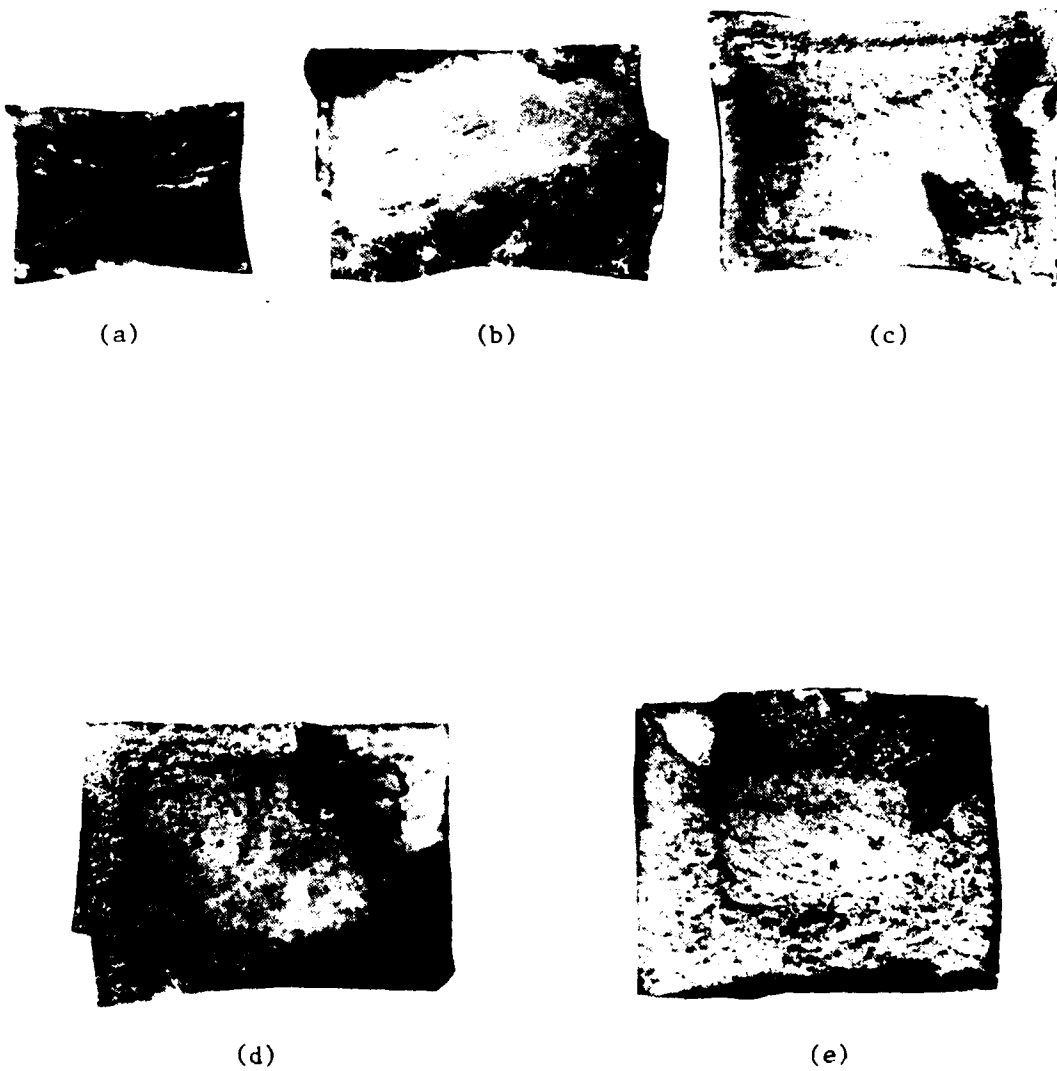
FIGURE 9. Fracture Surfaces of 17-4PH Tensile Specimens Aged to Condition H1000, Then Hydrogen Charged for (a) 0 hour, (b) 0.5 hour, (c) 2.0 hours, (d) 4.0 hours, and (e) 16 hours.

In most cases, visual examination of the fracture surfaces showed a distinct shell near the exterior of the hydrogen charged specimens. Figure 9 is a series of fractographs of specimens aged to condition H1000 and hydrogen charged for varying times. It can be seen that as the charging time increases, the shell thickness also increases. The thickness of the shell plotted against the hydrogen charging time is shown in Figure 10.

It should be noted that the aging treatment had a pronounced effect on the shell thickness. This shell was later determined to be a zone of transgranular and intergranular fracture, while the interior structure was that of dimpled rupture. In the case of both the H900 and H1000 conditions, the shell thickness increased with charging time until it extended across the complete cross section of the tensile bars.

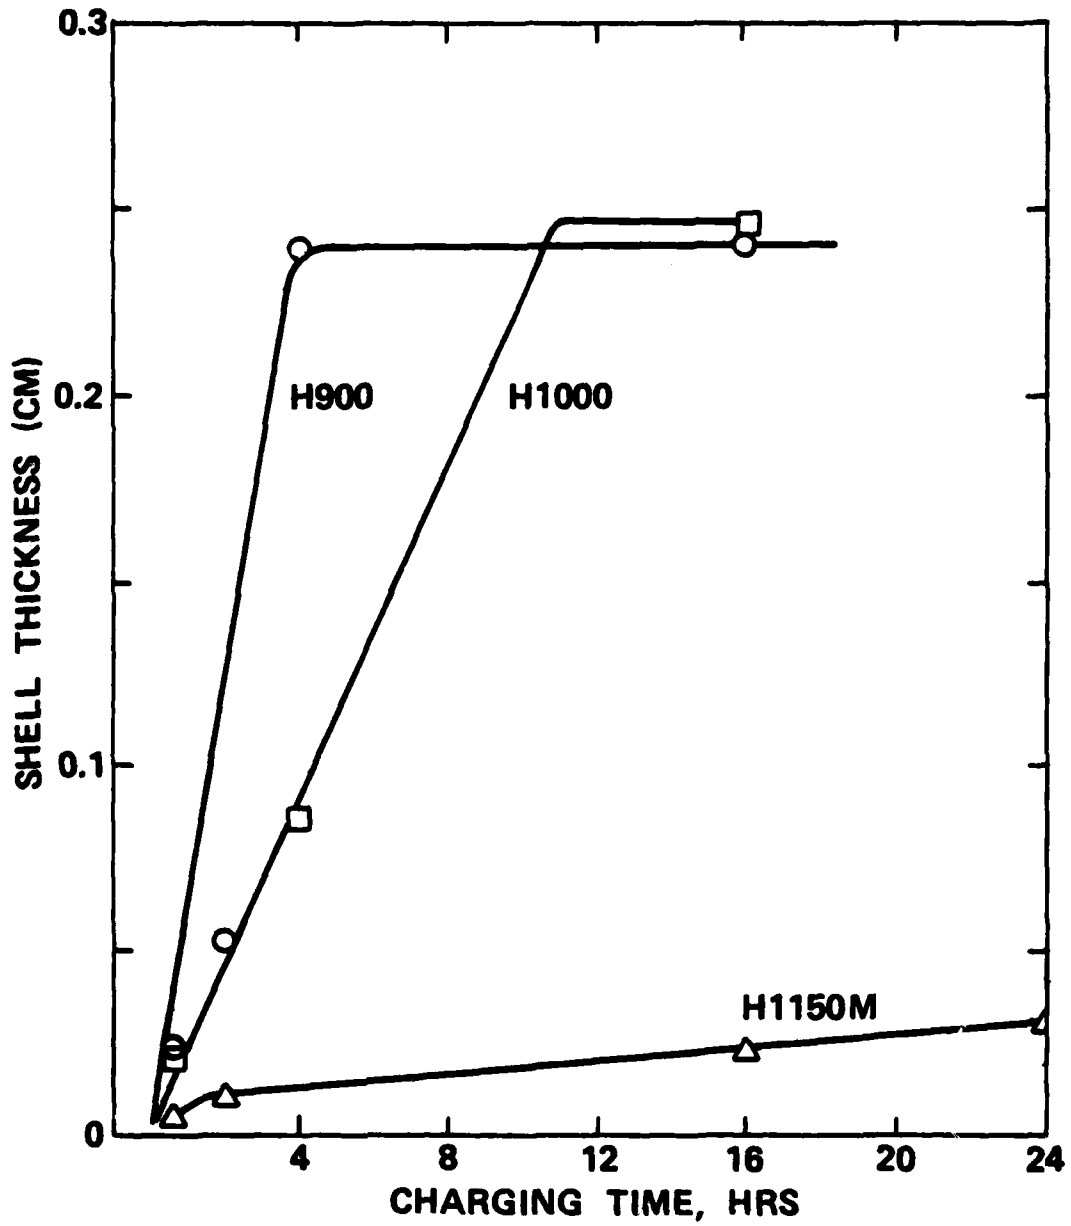
FIGURE 10. Relationship Between Shell Thickness and Hydrogen Charging Time for 17-4PH in Various Aged Conditions.

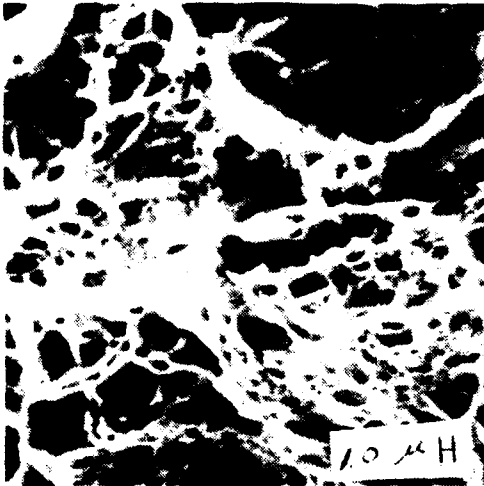
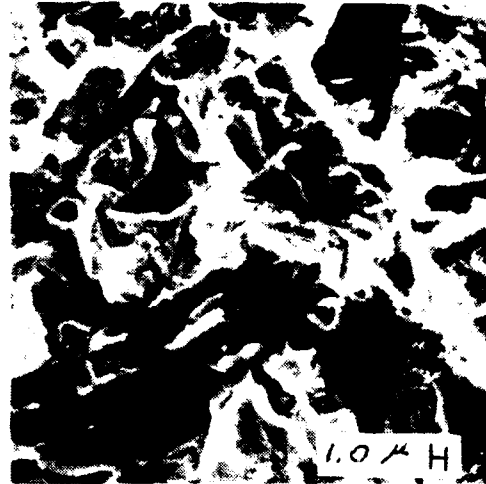
FIGURE 11. SEM Fractography of 17-4PH in Condition H900 Hydrogen Charged for 2 hours, (a) Central Region Showing Mixture at Dimpled Rupture and Quasi-Cleavage, and (b) Shell Region Near Edge Exhibiting Quasi-Cleavage.

SEM fractography was employed to characterize the fracture behavior of the embrittled material. The specimens observed were in the H900, H1000, H1150, and H1150M conditions with a common charging time of 2 hours. In each specimen (Figures 11-14) it can be observed that the structure ranges from dimpled rupture in the center to a type of brittle fracture at the edge. In the H900 (Figure 11) and the H1000 conditions (Figure 12), the central region is a mixture of dimpled rupture and quasi-cleavage, while the edge is almost exclusively quasi-cleavage. In the H1150 (Figure 13) and the H1150M conditions (Figure 14), the central region is composed almost completely of dimpled rupture, while the structure at the edge is observed to exhibit microplastic tearing mixed with some quasi-cleavage. When exposed to longer hydrogen charging times, specimens in the higher strength conditions exhibited instances of intergranular fracture like that observed in Figure 15 (H1000 condition, 16-hour charge).

The changes in fracture mode seen in this investigation are commonly observed in hydrogen embrittled alloys. The fracture mode of the specimens whose treatments yielded high strength behavior (H900, H1000 conditions) changed from primarily dimpled rupture to quasi-cleavage after hydrogen charging. The high temperature aging treatments (H1050, H1150) caused the structure to change from pure dimpled rupture to a combination of quasi-cleavage and what Thompson and Chesnutt (Reference 15) termed "tearing topography surface" (TTS).

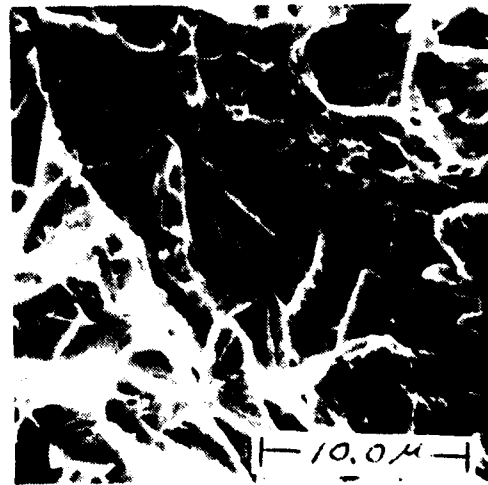
FIGURE 12. SEM Fractography of 17-4PH in Condition H1000 Hydrogen Charged for 2 hours, (a) Central Region Showing Mixture at Dimpled Rupture and Quasi-Cleavage, and (b) Shell Region Near Edge Exhibiting Quasi-Cleavage.

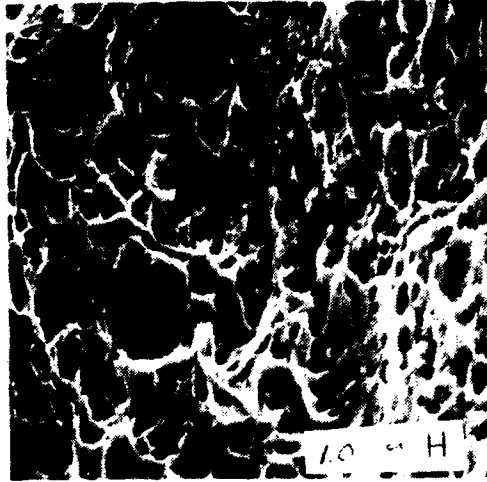
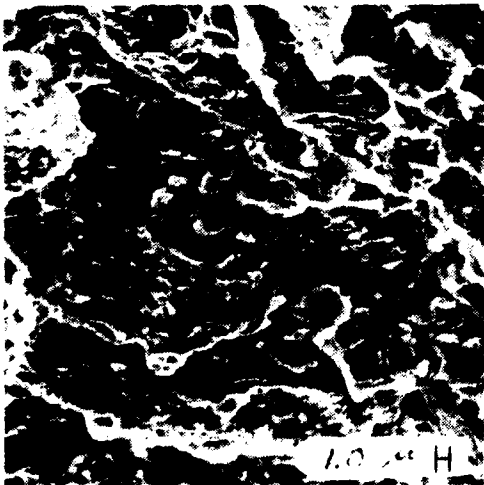
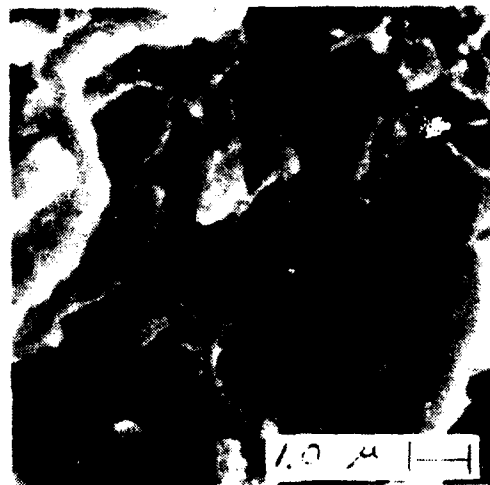
FIGURE 13. SEM Fractography of 17-4PH in Condition H1150 Hydrogen Charged for 2 Hours, (a) Central Region Illustrating Dimpled Rupture, (b) and (c) Shell Region Near Edge Exhibiting Microplastic Tearing.

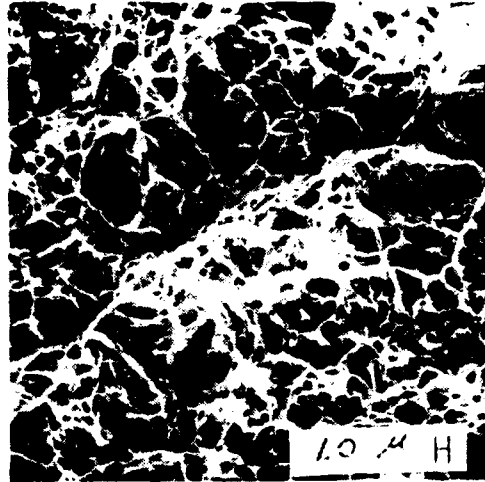
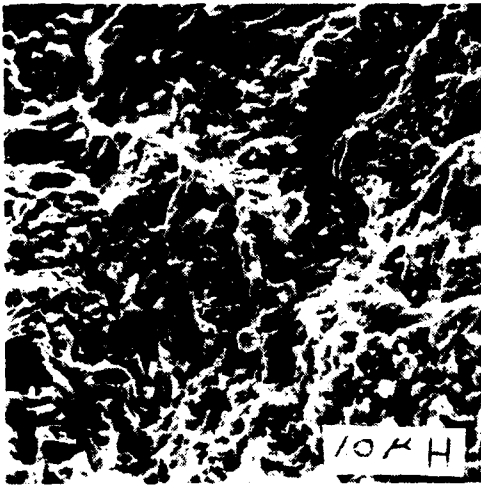
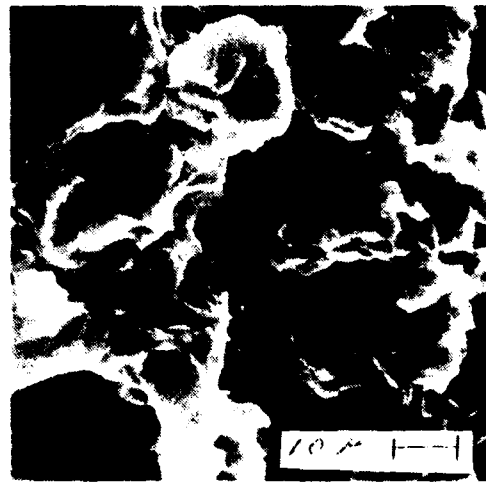
FIGURE 14. SEM Fractography of 17-4PH in Condition H1150M Hydrogen Charged for 2 Hours, (a) Central Region Illustrating Dimpled Rupture, (b) and (c) Shell Region Near Edge Exhibiting Microplastic Tearing.
