TECHNICAL REPORT CERC-88-7

BEACH FILL AND SEDIMENT TRAP AT CAROLINA BEACH, NORTH CAROLINA

Final Report

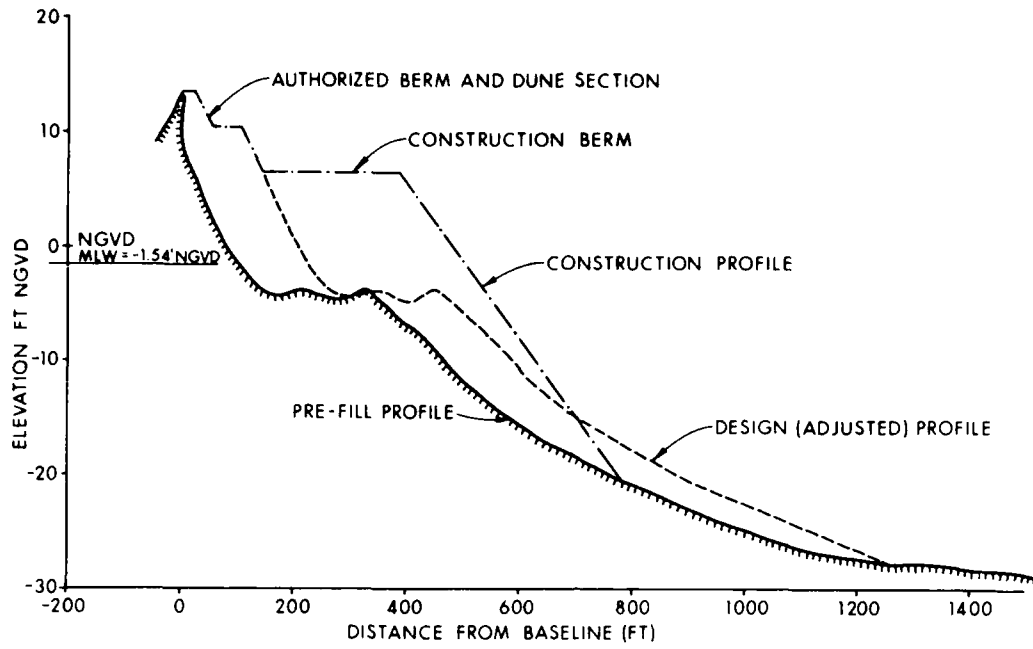
Figure 5. Design and construction profiles, berm and dune beach-fill section

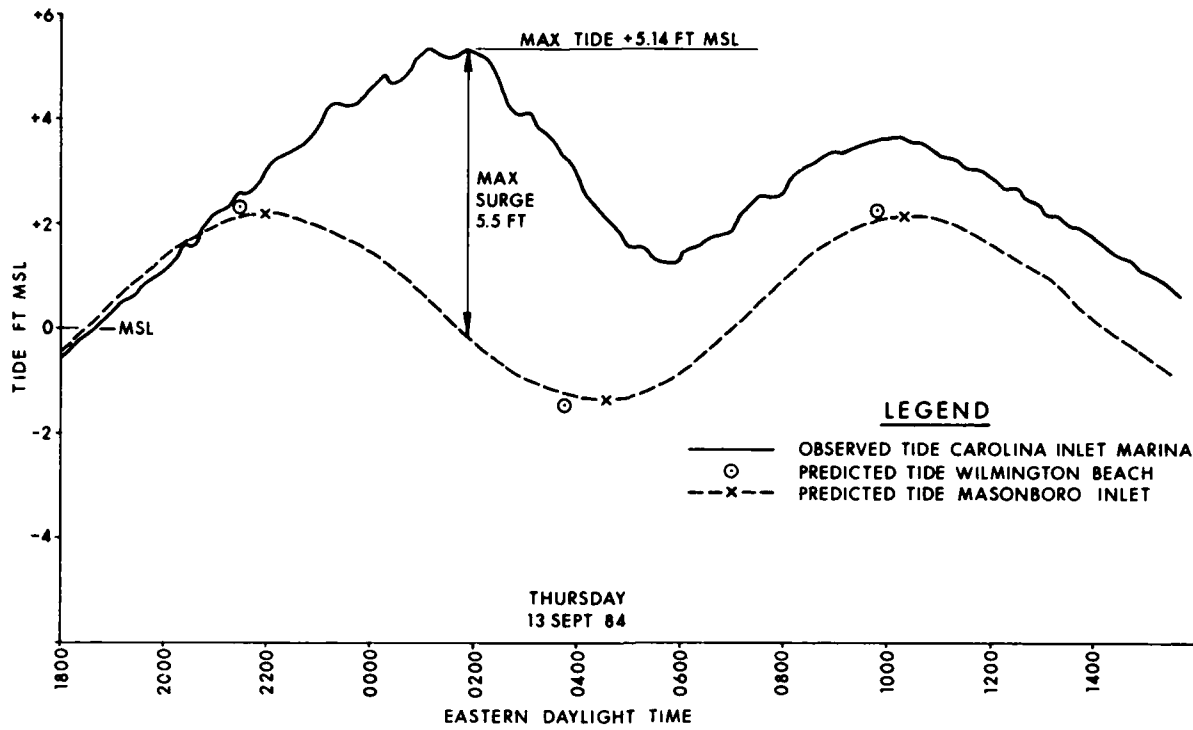
Figure 11. Observed versus predicted tides during Hurricane Diana landfall

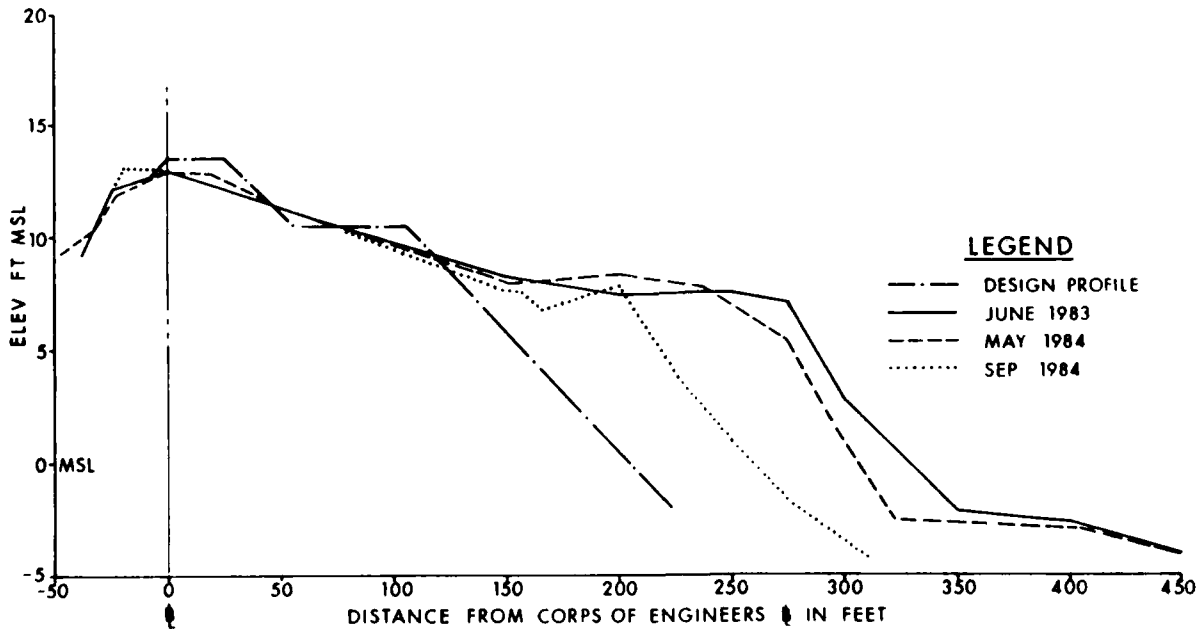
Figure 12. Profile comparison, sta 40+00 Carolina Beach

51. Following the passage of Hurricane Diana, beach profile surveys of Carolina Beach were made to determine the changes in the shoreline caused by the storm. These surveys were made between 24 and 28 September and covered the profile lying above the -4 ft plane. The prestorm survey for Carolina Beach was made 4 months earlier in May; therefore, the effects of Diana had to be estimated by subtracting the changes that normally would have occurred during the 4-month interval from the changes that were actually measured. Normal changes during the 4-month period were based on the average monthly rate of change measured between June 1983 and May 1984. A typical example of the profile surveys for June 1983, May 1984, and September 1984 measured at sta 40+00 is given in Figure 12.

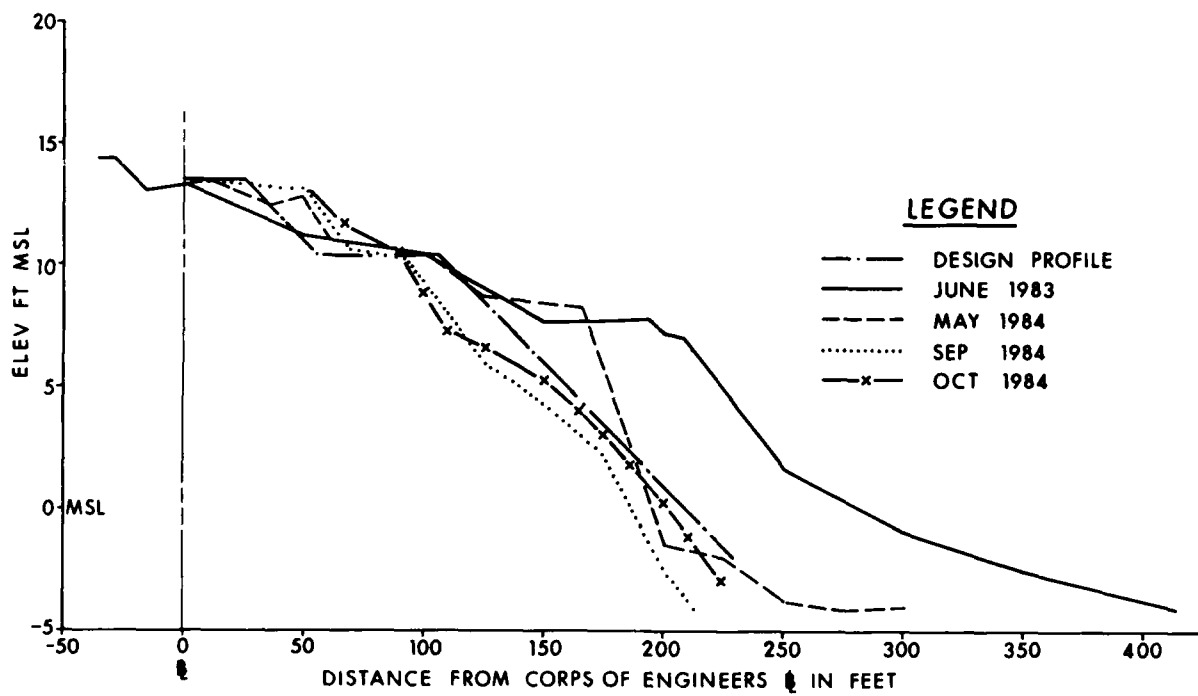
Figure 13. Profile comparison, sta 100+00 Carolina Beach
