# HISTORIC FARMING ON THE HOGWALLOW PRAIRIES

## ETHNOARCHAEOLOGICAL INVESTIGATIONS OF THE MOUNTAIN CREEK AREA, NORTH CENTRAL TEXAS

Joe Pool Lake Archaeological Project, Volume II

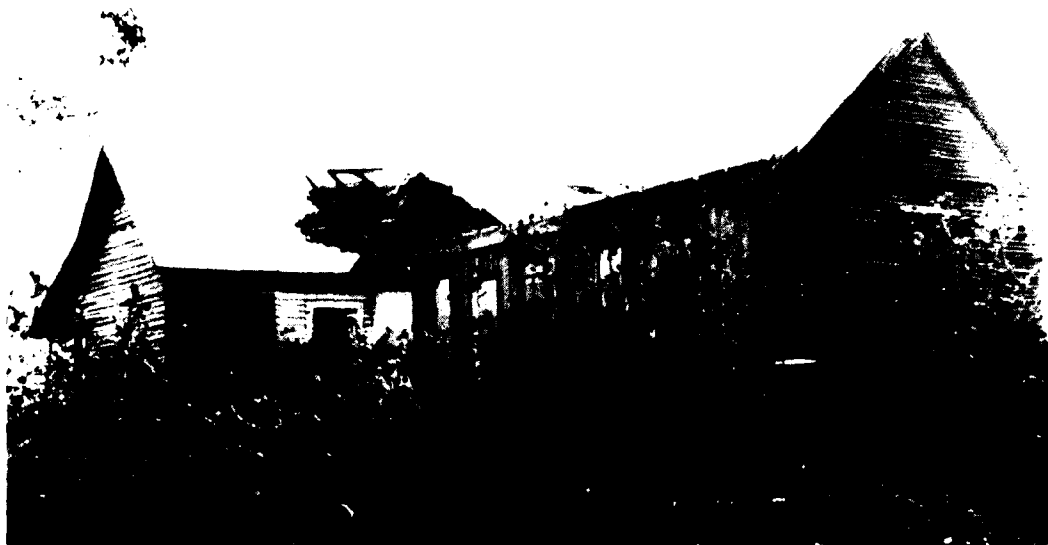
Figure 4-3. Photograph of the dwelling at 41DL181, viewing the rear addition which had the roof removed.

The original floorplan was changed in 1915 by a T-shaped addition to the western end of the dwelling. The new rooms included a dining room with a kitchen at the end of the T. The old porch on this side of the house was enclosed to form a hallway and a small additional room. A new porch was built which connected the remaining portion of the original front (west) porch, and ran parallel to the T addition. Wire nails were used throughout the new section, and shiplap siding was used instead of clapboard. The 1915 addition was later altered when a rear porch was added off the kitchen door, and the area between this porch and the original dwelling was enclosed, forming two small rooms, including a bathroom. The third addition involved converting the original back porch on the east side of the house into a laundry room. Interior remodeling included linoleum floors or carpeting, linoleum wainscoting in the kitchen, and sheetrock on several interior walls. Indoor

plumbing and electricity had been added, and the original chimneys had been removed, and space heaters were in use when the house was documented during the 1979-1980 testing season (Ferring and Reese 1982: 156).

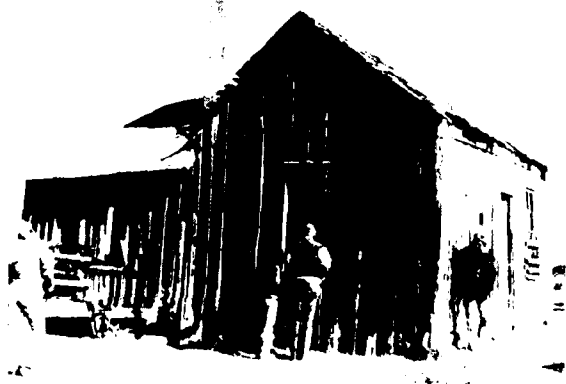
Figure 5-3. Photograph of the Holveck House (41DL183) taken in 1976 during initial survey.

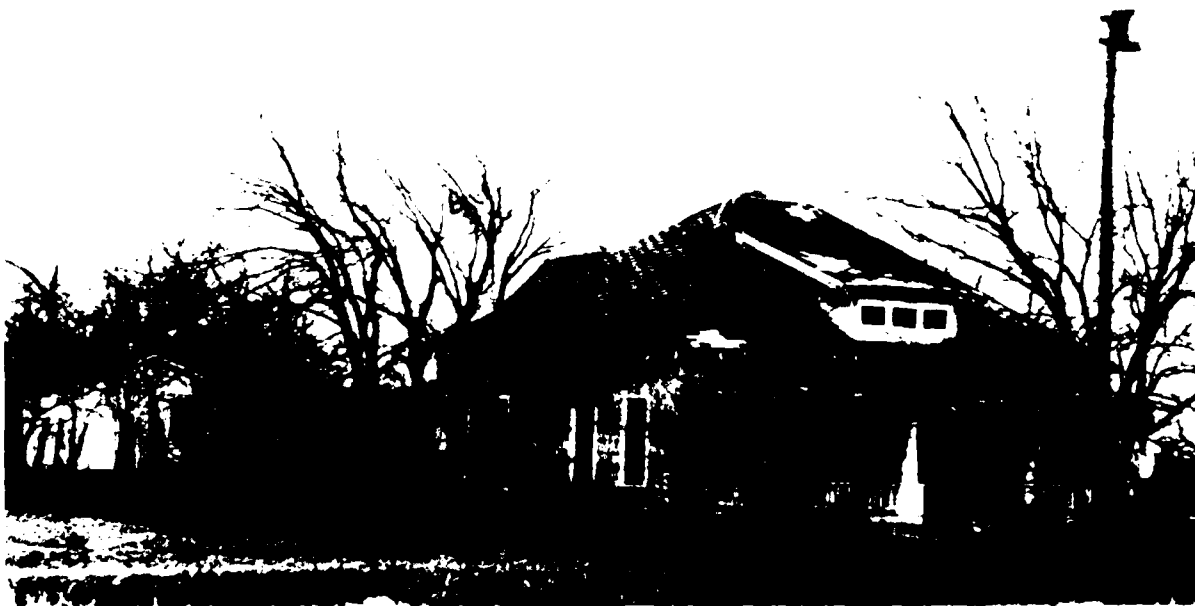
Figure 7-3. Photograph of the dwelling at 41DL191, showing outbuildings and windmill in the rear.

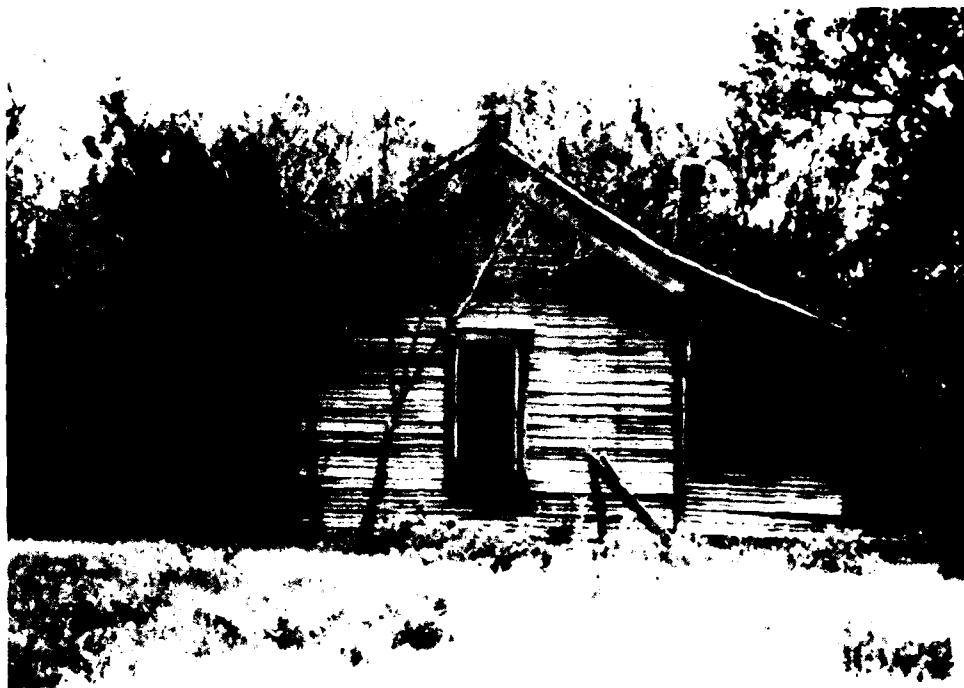
Figure 8-16a. Photograph of the east side of the original Penn house built in 1859.

The original portion of this building was a single pen with front and rear porches (Figure 8-16a - d) or rooms. It was built from fully hewn red cedar beams with mortise and tenon joinery. It was probably built after John Wesley Penn had established his farm, sometime around 1859. The siding was imported (East Texas) pine clapboard and was placed on both exterior and interior walls of the central room. Half hewn red cedar logs were used as ceiling and floor joists, and the roofing consisted of cedar poles. All red cedars were juvenile trees, which once grew under disturbed circumstances. The craftsmanship indicates that this was designed to be a simple yet appealing dwelling, which fitted into the ranching practices of John W. Penn at that time.

The house was enlarged to a central hall in 1911 (Figures 8-16c - d), based on a grafitto on a concrete pier. These concrete piers were also placed under the

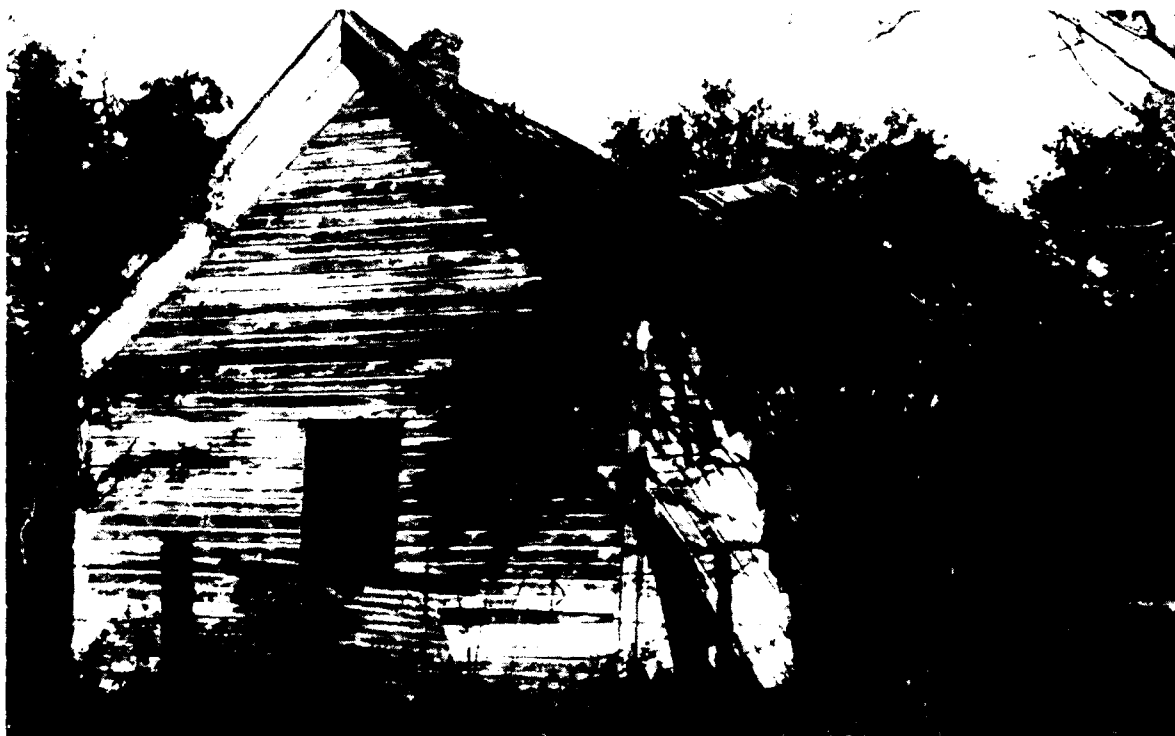
Figure 9-1. Photograph of the Hintze Tenant dwelling.

Detailed architectural drawings and notes were made during the testing phase in 1979 - 1980 and indicated that no additions were made to the dwelling at 41DL196. The house was a Cumberland built around 1901, three years after the dwelling at 41DL181. It was constructed following the same basic floorplan at 41DL181, and had two main rooms on a north - south alignment, as well as a porch on the east side (Figure 9-4). Each room had

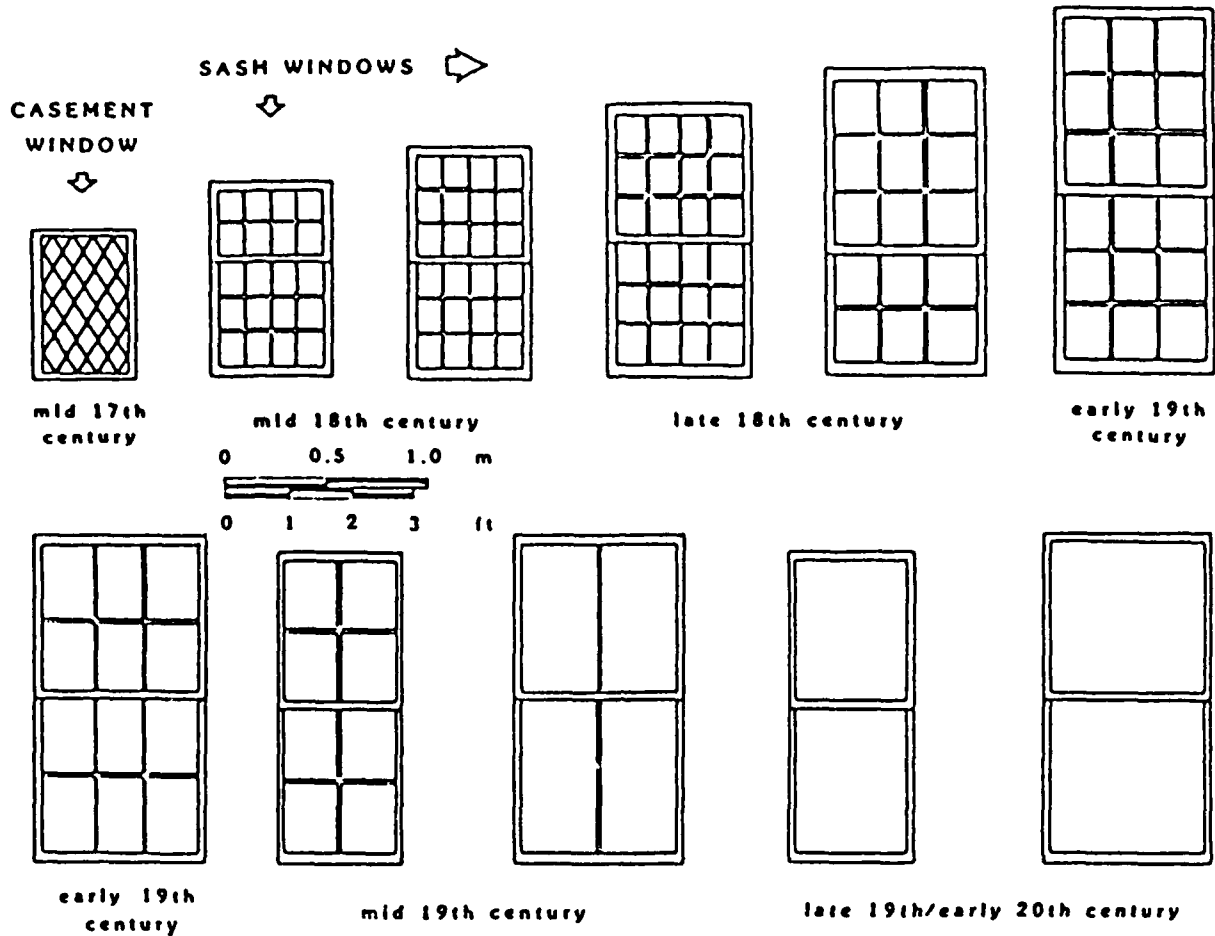
Figure 21-1. Generalized scheme of window pane development for non-upper class rural dwellings. As illustrated, both window panes and frames increased in area until the early nineteenth century, and thereafter only panes increased while the sizes of frames fluctuated in either direction.

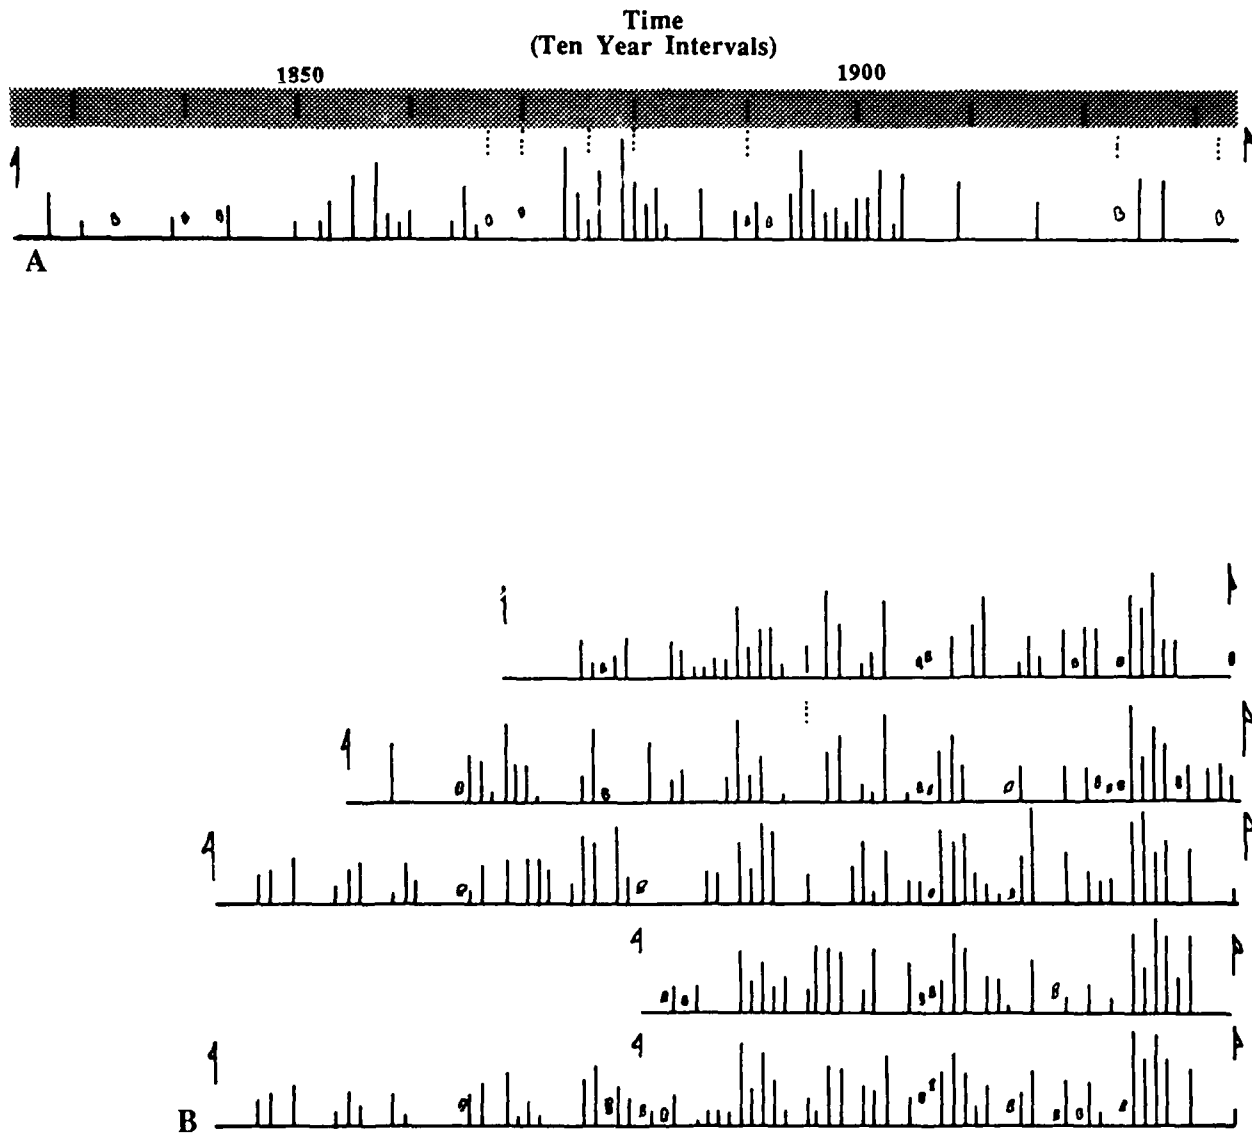
Figure 28-3. Skeleton plot (a) of the dated oak specimen from 41TR45, showing the wide and narrow ring sequences and frost rings. The lower group of skeleton plots are from the red cedar floating chronology, derived from the double crib barn and recycled mortise and tenon beams (b) of the Penn Farm (41DL192).
