ERDC/GSL TR-21-41

Rapid Airfield Damage Recovery Program

Evaluation of Geocell-Reinforced Backfill for Airfield Pavement Repair

December 2021

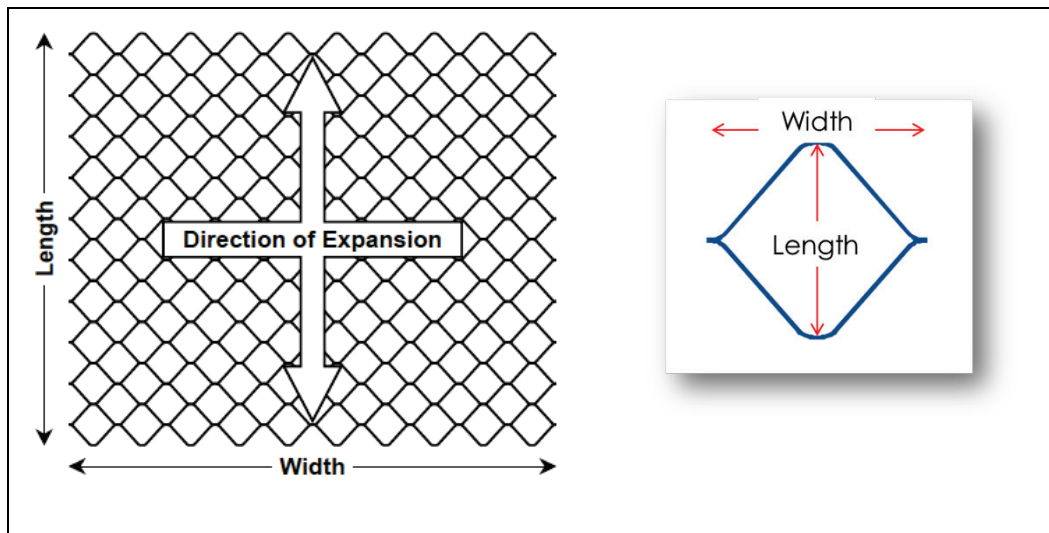
Figure 2-1. Geocell length and width defined.

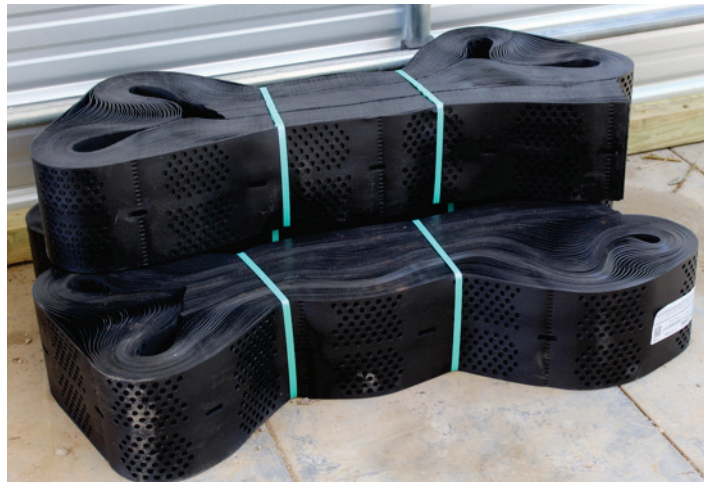
Figure 3-1. Collapsed and banded Geoweb geocell section.

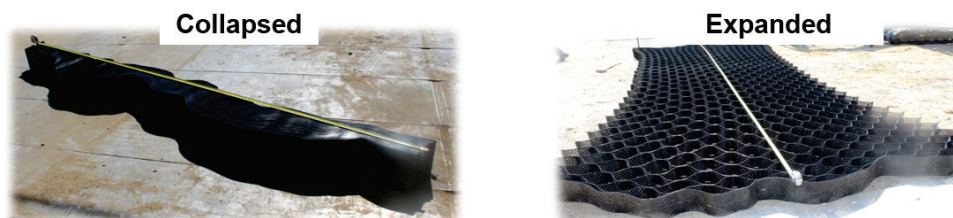
Figure 3-2. Collapsed and expanded Geoweb geocell section.

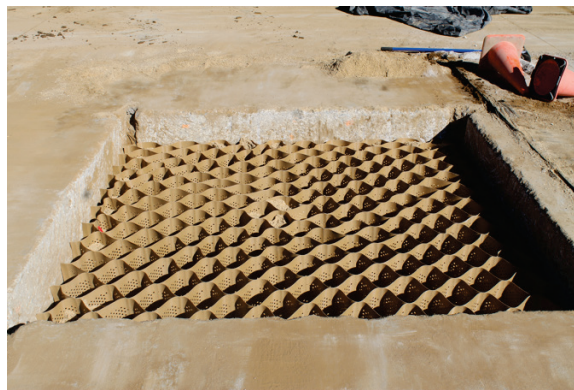
Figure 3-3. Neoweb geocell.

One of the newest geocell products available on the market is a product manufactured by PRS Geo-technologies called Neoweb. The geocell material is a nano-polymeric alloy (NPA), also called Neoloy[®], which is a composite alloy of polyester/polymaride nano-fibers dispersed in a polyethylene matrix. The Neoweb geocell line is offered in categories, i.e., A-D, according to the application profile, where Category A is offered for erosion control on slopes and Category D is offered for load support in airports, railways, and railroads. For this test program, Category D Neoweb was chosen; these were textured and perforated. Individual strips were ultrasonically welded at intervals to form the cellular confinement system. PRS Geo-technologies offered several more options for geocell geometry and color than other vendors. The tan color was chosen for testing (Figure 3-3). The sections were delivered collapsed and measured about the same dimensions as the Geoweb collapsed section. Neoweb geocells were ordered directly from the manufacturer, which is located in Israel. Currently, there are no distributors in the United States. Cost varied depending on the length of a section and the height of the geocell. A section of PRS-356-150-D (6-in. height) that expanded to about 24 ft costs \$186, while a section of PRS-356-200-D (8-in. height) costs \$256, as of 2016.

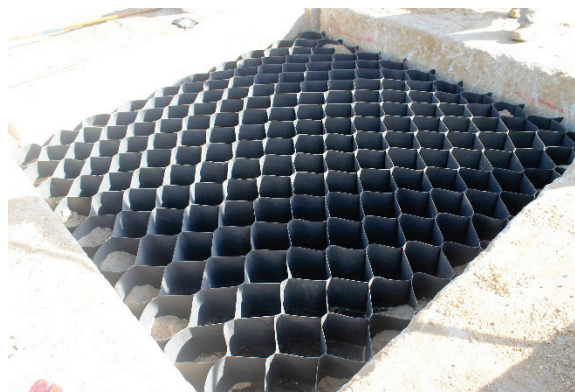
Figure 3-4. Typar geocell.

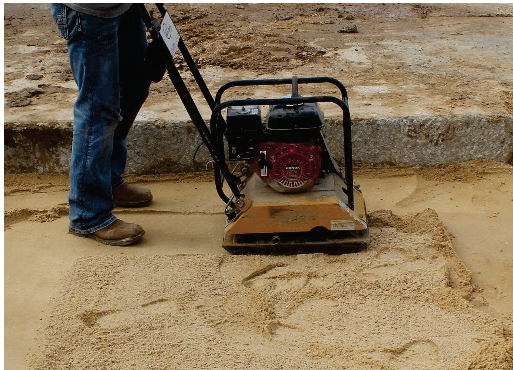
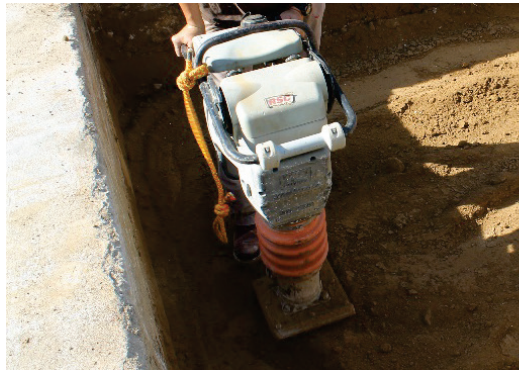
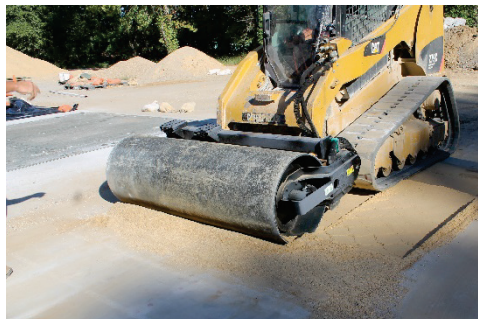
Figure 4-3. Photographs of compaction equipment.

JPC-80 vibratory plate compactor.

Multiquip Mikasa MTX-70 rammer.

CAT CV18B vibratory drum compactor attachment.

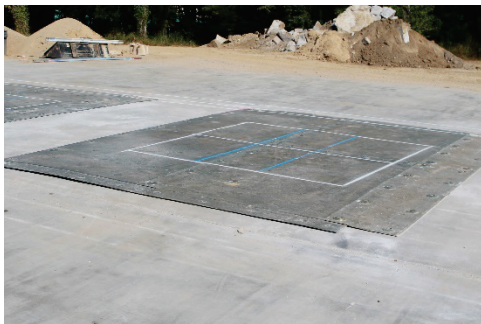
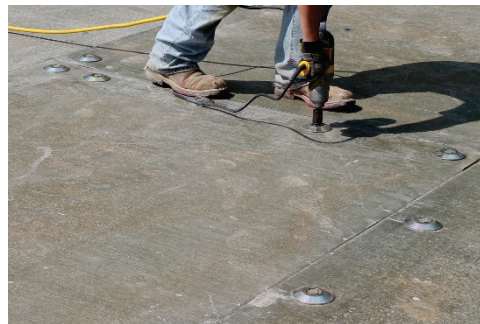
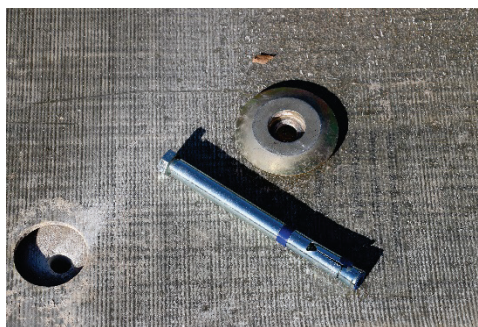
Figure 4-4. FRP FOD cover system.

FRP panels assembled.

Connector bushings.

Anchor bushing and concrete expansion anchor.

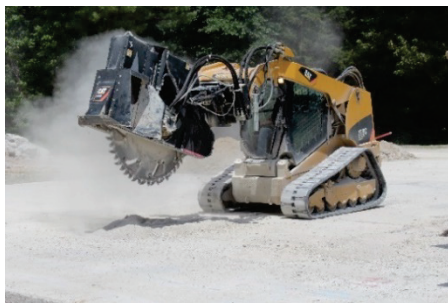
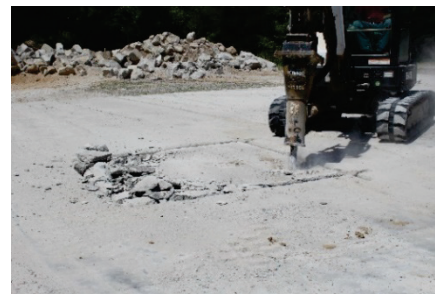
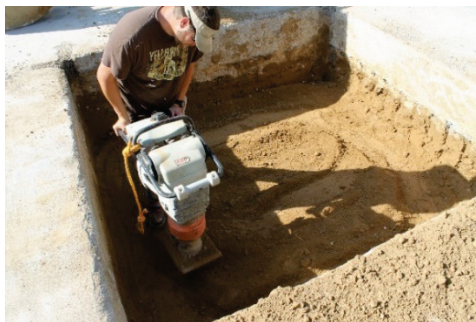
Figure 5-1. Preparation of simulated crater.

(a) Cutting with SW60 attachment.

(b) Breaking withmoil-tipped hammer attachment on the mini-excavator.

(c) Compaction of the CL layer with the rammer.

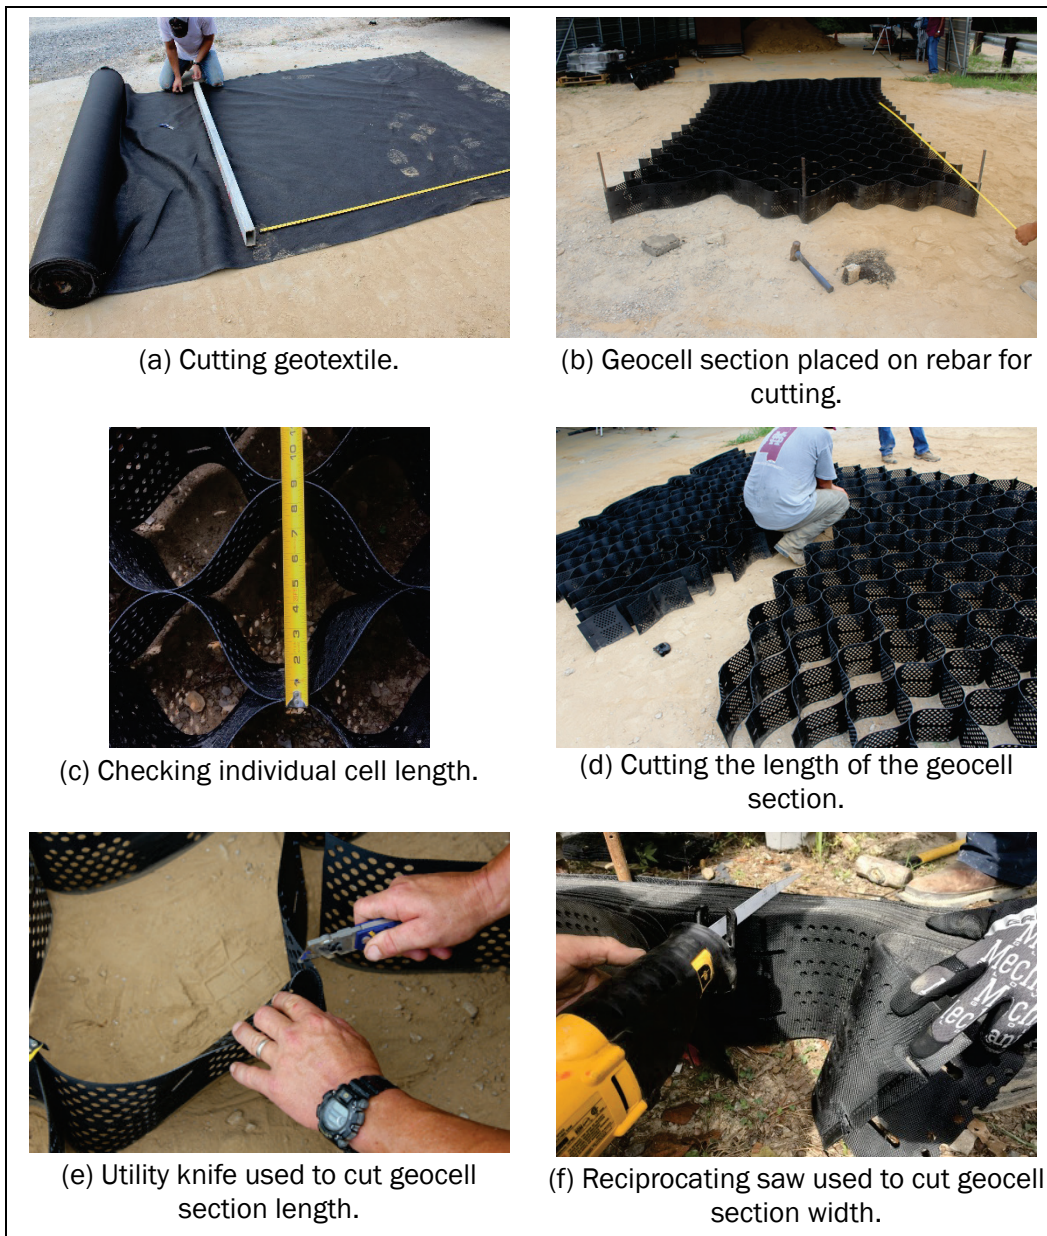
Figure 5-2. Cutting geotextile and geocell.

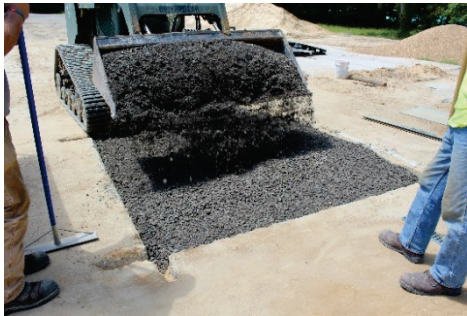
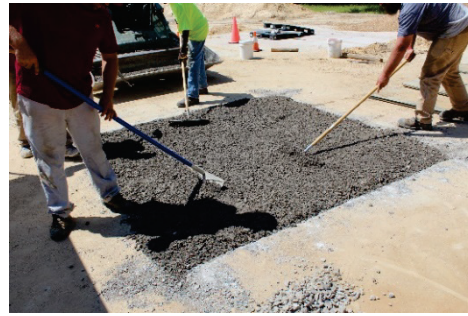
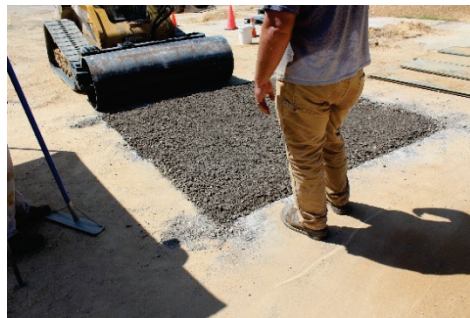
Figure 5-8. Construction of GP-GM repair cap.

Placing GP-GM in repair.

Raking GP-GM.

Compacting GP-GM with CV18B.

The capping material used in Phase 1 was 4 in. (compacted) of GP-GM. The material was placed in one lift with a bucket attachment on a CTL and hand-raked until it was approximately 1 in. to 2 in. above the original PCC surface. Around 2 gal of water was added to assist with compaction. Two coverages were applied with a rammer and then compacted with a CV18B vibratory roller attachment (as defined in Figure 5-6). Photographs of capping material construction are shown in Figure 5-8.

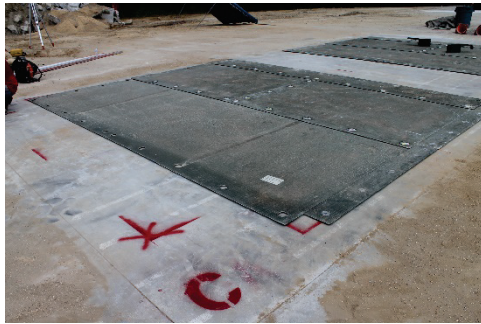
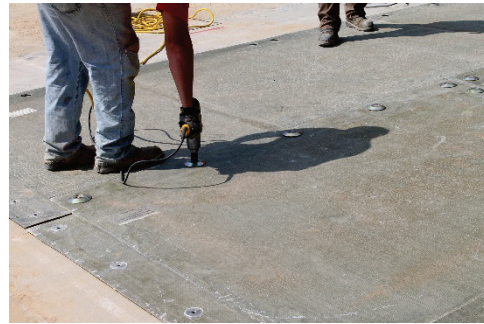
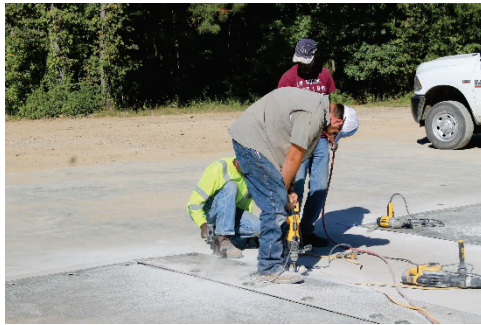
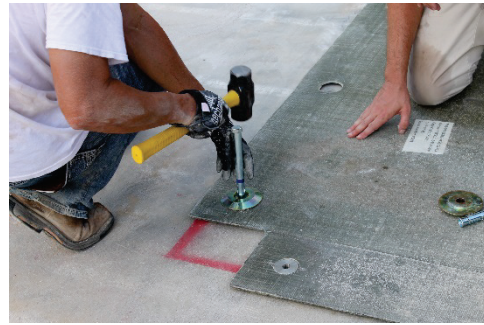
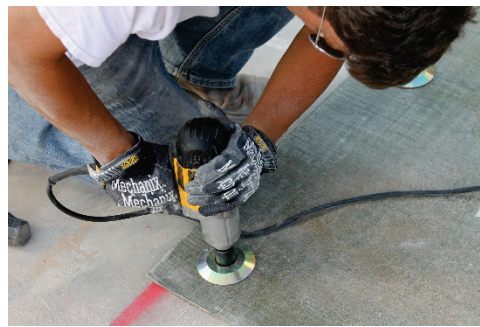
Figure 5-10. Installation of FRP FOD cover.

(a) Assembled panels.

(b) Applying torque to connector bushing bolt.

(c) Drilling through PCC.

(d) Placing concrete anchor.

(e) Applying torque to concrete anchor bolt.

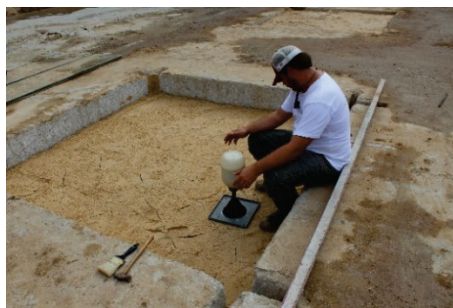
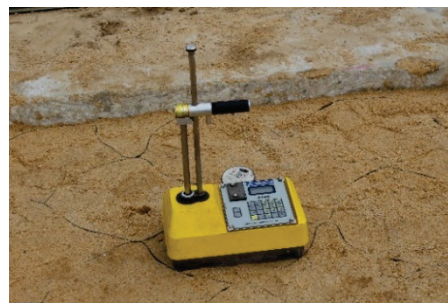
Figure 5-11. In-situ soil testing.

(a) Sand cone test.

(b) Nuclear moisture and density gauge test.

(c) DCP test.

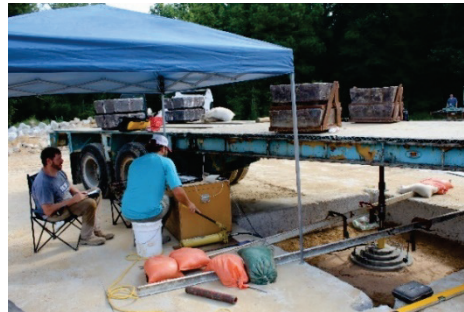
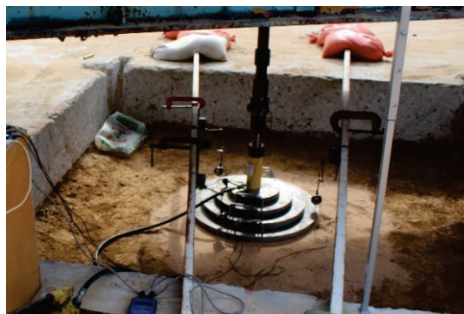
Figure 5-12 Plate bearing test.

(a) Overall view of plate bearing test.

(b) Closeup view of plate bearing test.

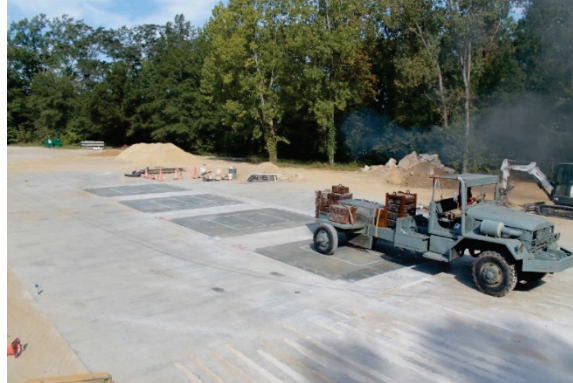
Figure 5-13. Trafficking with the single-wheel C-17 load cart on the finished repairs.

(a) Single-wheel C-17 load cart.

(b) Traffic pattern.

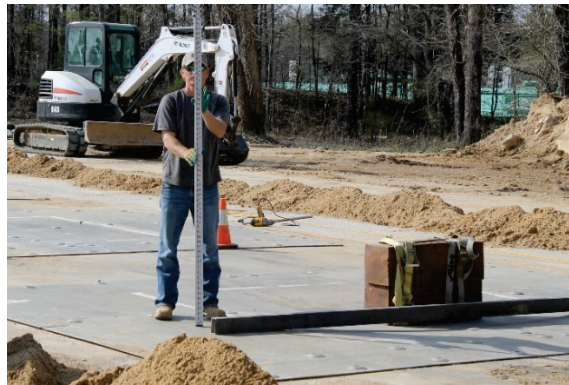
Figure 5-14. Data collection on the surface of the FRP FOD cover.

(a) Data collection locations on the GP-GM and FRP FOD caps.

(b) Loaded cross-section measurements on the FRP FOD cover.

Data collection efforts included rod and level measurements at 1-ft intervals along the centerline and at two cross sections that were offset 3 ft from the edges of the repair (Figure 5-14a). Rod and level measurements along the cross section were taken on the GP-GM cap or on the loaded FRP FOD cover surface, where two (2) 1-kip blocks (much less weight than the load cart) were placed next to the cross section (Figure 15-14b). This was an attempt to measure the permanent deformation of the backfill throughout trafficking without having to disassemble the panels, since the FRP FOD cover tended to bridge over any deformation on the underlying reinforced backfill. All measurements were taken prior to trafficking, at select pass levels throughout trafficking, and after completion of trafficking. The results reported in Chapter 6 included upheaval measured on each side of the rut. Measurements were also taken during construction and after completion of trafficking at each construction layer to measure the deformation at different depths.

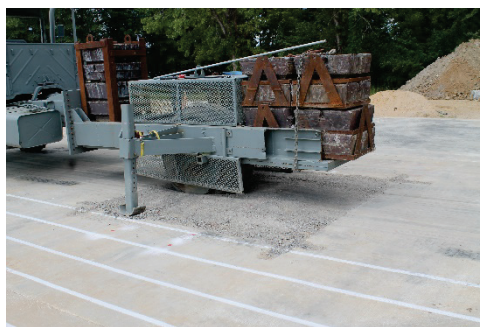
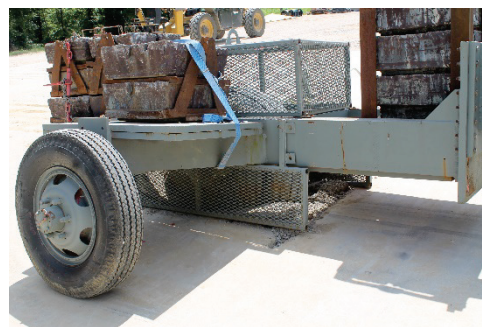
Figure 6-1. Damage after a few passes of trafficking the Phase 1 repairs.

(a) Repair 1-A after 13 passes.

(B) Control repair after 1 pass.

Although the repairs in Phase 1 sustained a limited number of passes, the results showed that repairs with geocell reinforcement performed better and that performance was improved with smaller geocell diameters. The results also showed that a thin GP-GM was not a suitable cap for contingency repairs and further proved that the performance of a pavement structure heavily relies on the subgrade strength (refer to Table 5-2). Since Repair 1-A

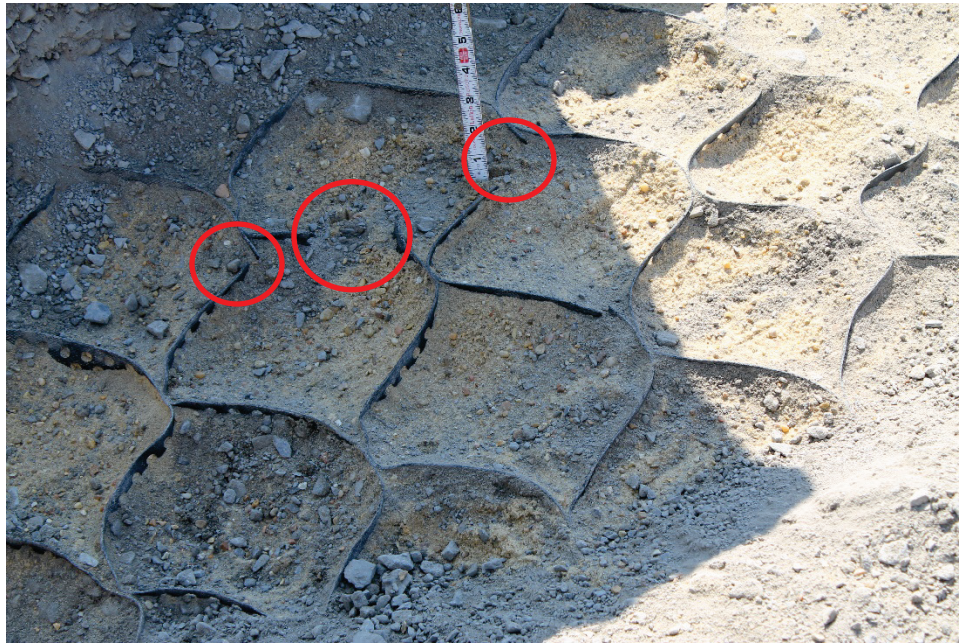
Figure 6-2. Damage to the 8-in.-height geocells in Repair 1-A after 13 passes.

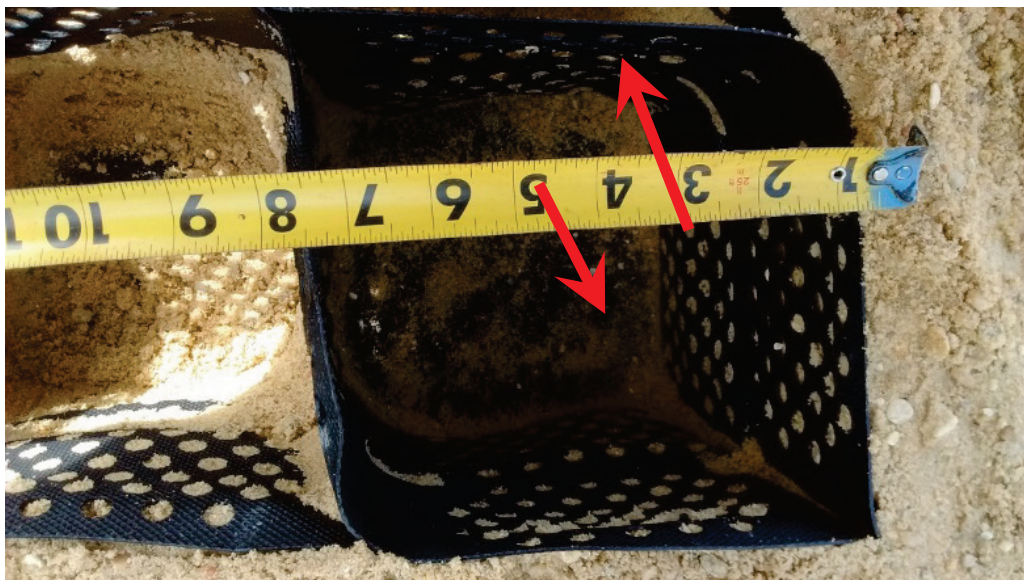
Figure 6-4. Buckling of the cell wall of the 8-in.-thick geocells after completion of Phase 2 trafficking.

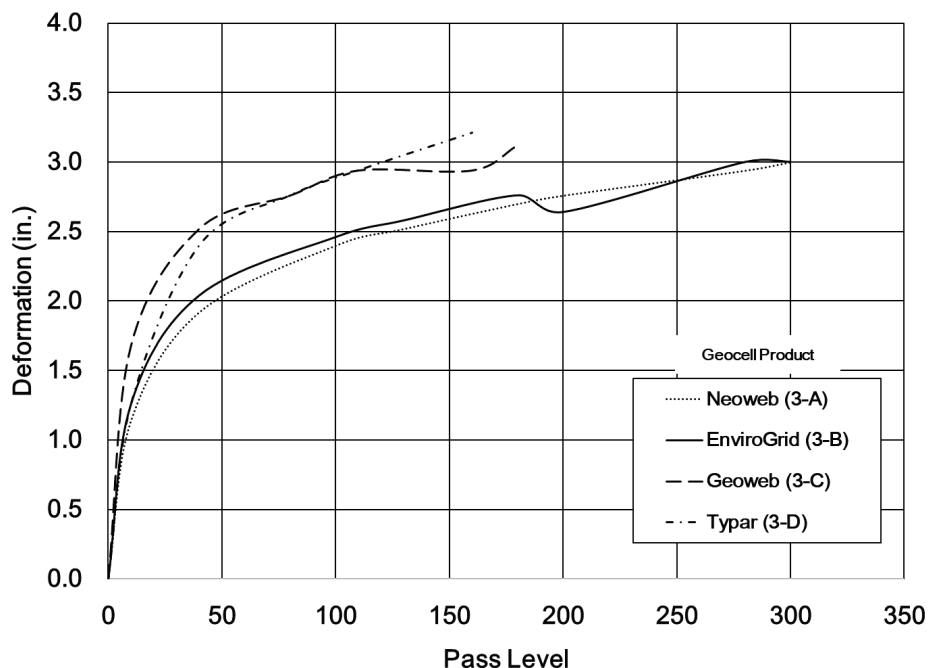
Figure 6-5. Deformation of Phase 3 repairs at different pass levels.

A summary of the deformation measured throughout trafficking of the Phase 3 repairs is shown in Figure 6-5. Repair 3-D failed by rutting greater than 3 in. first and was followed by Repair 3-C. Repairs 3-A and 3-B were trafficked until 300 passes were completed, and both repairs reached 3 in. of rutting at that point. The rate of deformation was higher for Repairs 3-D and 3-C, although Repair 3-C, reinforced with Geoweb, was able to sustain at least 40 more passes before failure. The rate of deformation was similar for Repairs 3-A and 3-B, which were reinforced with Neoweb and EnviroGrid, respectively.

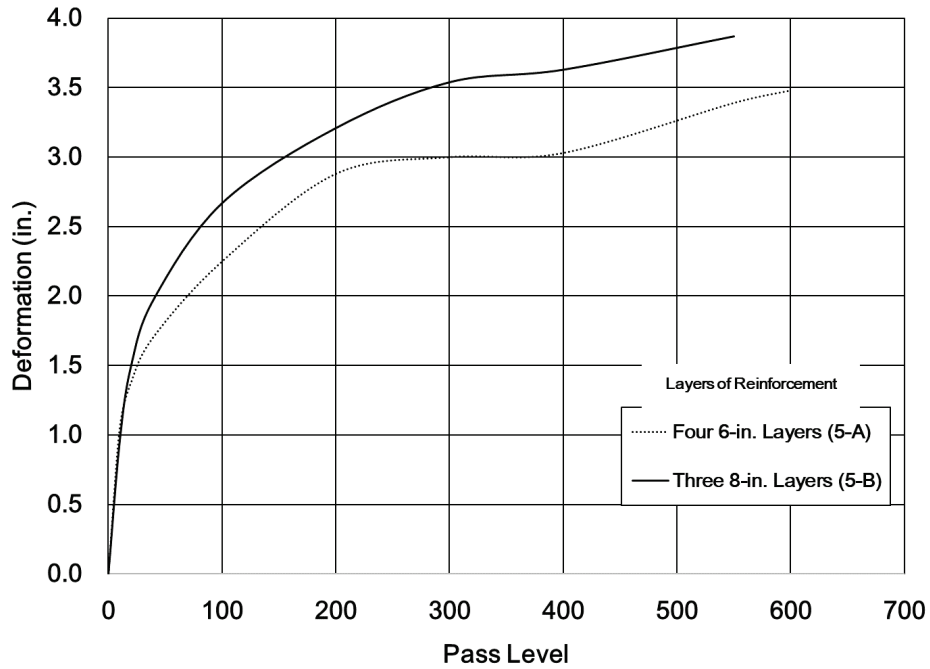
Figure 6-7. Deformation of Phase 5 repairs at different pass levels.

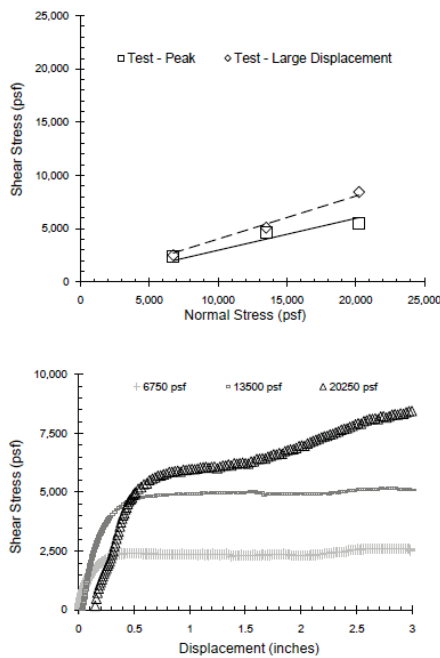
Ottawa Sand, 20-30 vs.
Geocell - HDPE-A-8 Presto HDPE
