# Coastal Bluffs and Sea Cliffs on Puget Sound, Washington

By Hugh Shipman

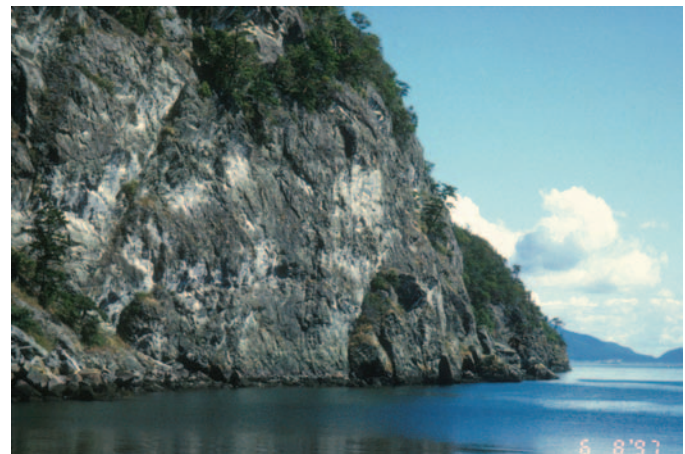
**Figure 2.** Basalt sea cliff in the San Juan Islands of northern Puget Sound. The base of the cliff is marked by a narrow erosional ramp. Erosion rates here are negligible, with the exception of rare block falls.

Rocky shorelines are common in many portions of the northern sound where bedrock is exposed at the coast. Steep cliffs are not unusual, but these features are rarely actively eroding sea cliffs (fig. 2). Rather, they represent glacially scoured knobs and hills of moderate relief that have experienced little marine erosion due to their resistant lithologies and the modest wave energy of the sound. Marine erosion may have removed a veneer of glacial sediment, but the resis-

tant bedrock has undergone little change, except possibly the formation of a narrow ramp on higher energy shorelines or in more erodible lithologies.

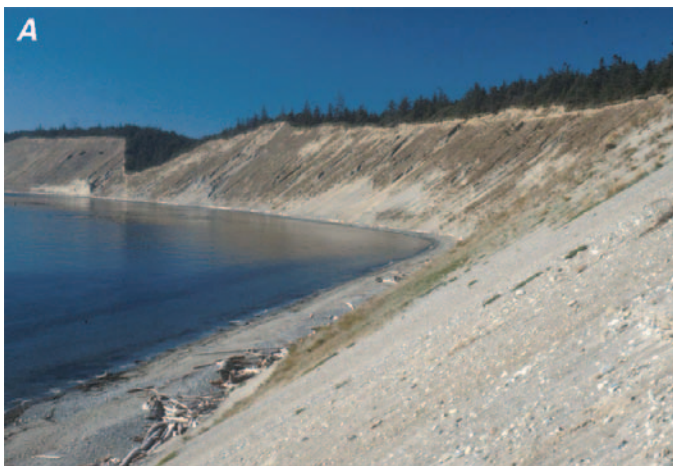
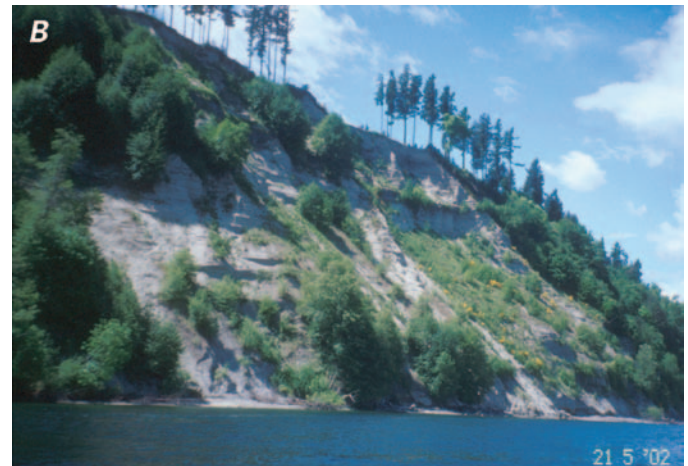
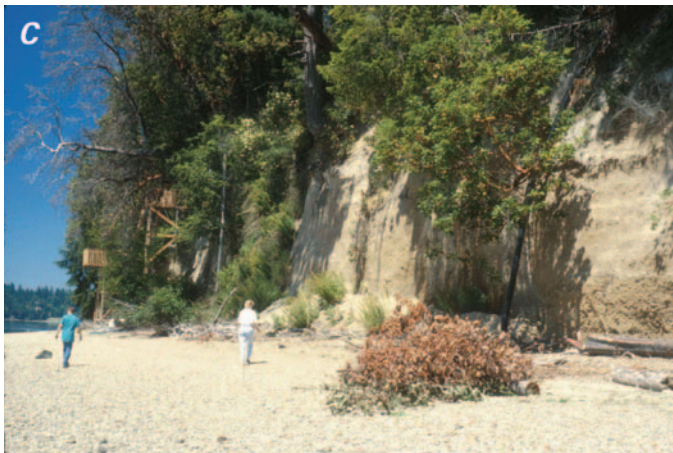
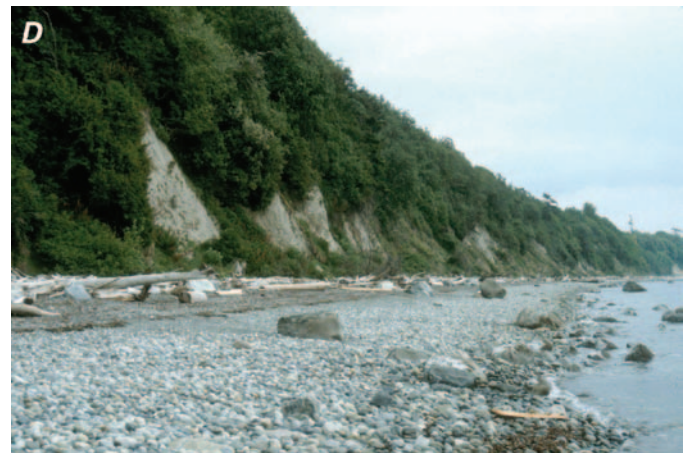
**Figure 3.** Examples of coastal bluffs from different parts of Puget Sound. *A*, High bluffs composed entirely of poorly consolidated recessional outwash gravels. *B*, 100-m high bluff in Tacoma consisting primarily of advance glacial outwash. Vegetation establishes rapidly after periodic failures. *C*, 15-m bluff in southern Puget Sound. Compact glacial sediments form near-vertical face; vegetation occurs along top of bluff and on colluvial material at toe of slope. *D*, Upper portion of these 40-m bluffs in northern Puget Sound are gradually sloped and heavily vegetated, whereas lower slopes are steeper and more exposed.

Bluff profiles reflect a complex combination of lithology, toe erosion, and upslope mass-wasting. The simplest bluffs are those dominated by a single lithology and a single erosional process. High bluffs of glacial outwash gravel on the west side of Whidbey Island and at Cattle Point on San Juan Island form remarkably uniform slopes at the angle of repose of the unconsolidated material (fig. 3A). In contrast, bluffs consisting solely of glacial till or marine drift may form near-vertical banks (fig. 3C).

*Raveling.*—Poorly consolidated deposits of glacial outwash sands and gravels may erode primarily through raveling of the bluff face (fig. 3A). Failures tend to be progressive, beginning with undercutting at the toe by wave action, then gradually expanding upslope. Raveling tends to occur in areas where loose sediments are eroding rapidly enough so that vegetation cannot become established or in areas that for other

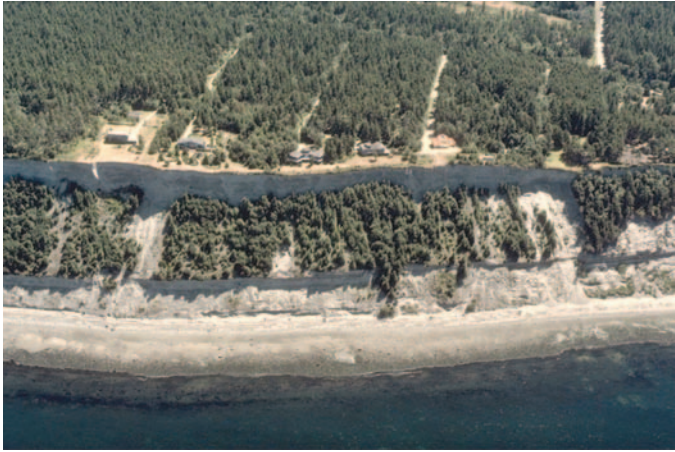
**Figure 4.** High bluffs near Port Townsend illustrate role of distinct stratigraphic units in defining bluff profile. Upper unit of glacial till fails in vertical slabs and does not support vegetation. Central sandier outwash unit is at angle of repose, with substantial revegetation between erosional events. Lower glacial unit is subject to wave action when storms and high tides coincide and when beach volume is reduced.

Most bluffs, however, are cut through a sequence of sedimentary units, each with distinct slope-forming properties. This can lead to complex bluff profiles containing both steep and gradual segments (fig. 4), depending on the lithologic, hydrologic, and mechanical properties of individual units. Poorly consolidated sands and gravels become slope-forming units, whereas glacial till and lacustrine silts and clays are often cliff-forming.

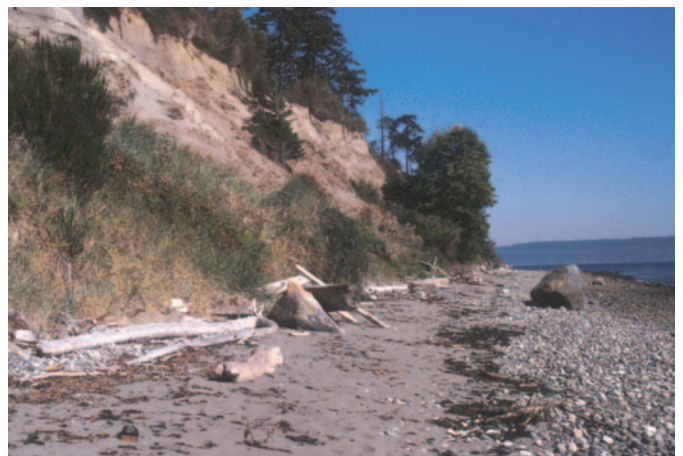
**Figure 6.** Typical mixed sand and gravel beach at base of high coastal bluff on Puget Sound. Berm, which consists of sandy material overlying a coarse gravel core, protects slope toe from wave action except when storm waves coincide with unusually high tides.

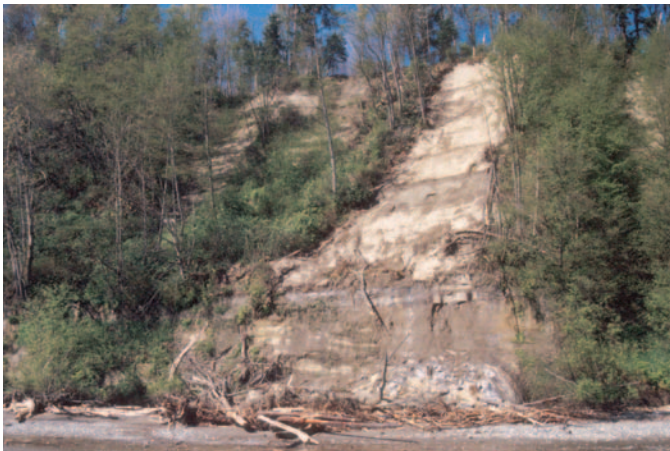
**Figure 7.** Shallow landslide extending entire height of bluff on Puget Sound. Landslide was likely triggered by saturated conditions at contact between lakebed clays and overlying outwash sand (note dark band above bottom portion of bluff).

Most landslides that occur on Puget Sound's bluffs consist of shallow landslides and debris avalanches (fig. 7). Shallow landsliding is pervasive along many shoreline reaches, although any one site may slide only once every 30 or 40 years. These landslides typically involve only a thin layer (<1-2 m) of soil and associated vegetation. Some extend the entire height of the bluff, but others only affect a portion of the slope. Shallow failures may occur as small slumps, debris avalanches, or as topples of overlying glacial till. Single slides may occur by several mechanisms — for example, a block failure of glacial till high on a bluff may develop into a debris avalanche as it moves downslope.

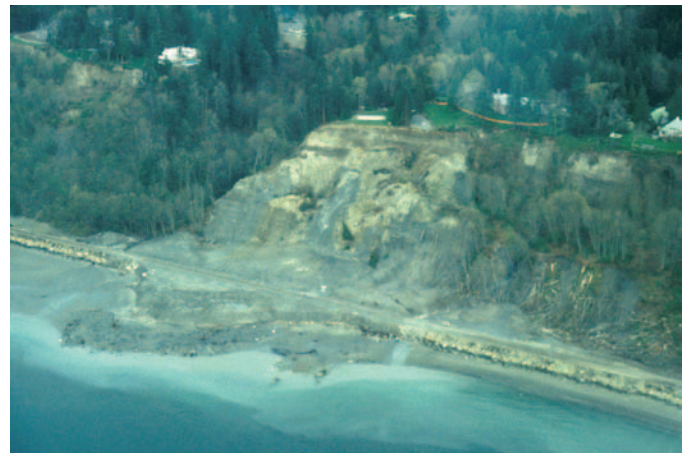
**Figure 8.** Large landslide north of Seattle that occurred in January 1997, following heavy rains. Note distinct mid-slope bench to the right of the landslide, marking the contact at the base of the glacial outwash. The landslide, which pushed a train into the Sound, involved a deeper failure in the underlying clay units. The toe of slope had been protected by the railroad grade at beach level for approximately 100 years and was not involved in the slide.

Puget Sound is subject to occasional, much larger, landslides that may involve many tens of thousands of cubic feet of material (fig. 8). These slides are much less common than

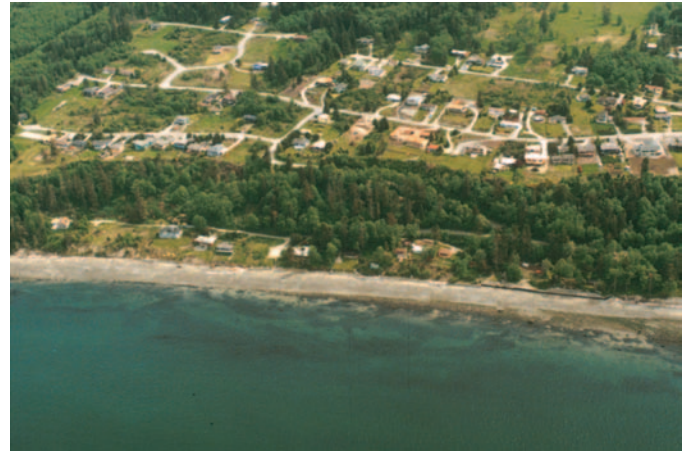
**Figure 9.** Large, prehistoric landslide on Whidbey Island. Portions of this slide periodically reactivate during wet weather. The toe of this landslide occurs slightly below beach level in this area. The landslide extends almost 2 km along the shoreline.

a complex of individual slide blocks, may reach several hundred meters inland and extend more than a kilometer along the shoreline (fig. 9). Movement is often less than a few meters during any particular event and may only affect a small area of the larger slide complex, though in some cases deep-seated movement can trigger additional, shallow slides. Reactivation is related to regional ground-water levels and appears to require extended periods of wet weather, possibly extending over years (Shipman, 2001).

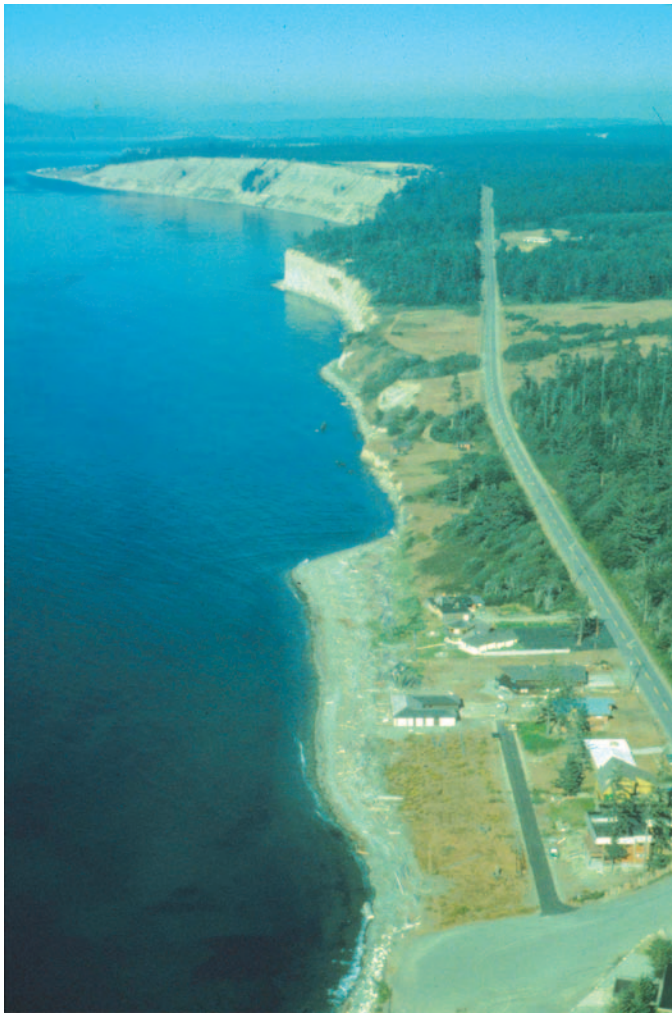
**Figure 10.** Irregular shoreline along western shore of Whidbey Island. Wave exposure is relatively uniform along this reach, and shape of shoreline is related to lithology and longshore redistribution of sediment by littoral processes. Beach in foreground is a barrier. Sharp point in mid-distance occurs where a resistant glacial till unit emerges at the toe of the bluff. (Photo by Gerald Thorsen).

Some geologic materials resist the erosive action of waves better than others. Erosion rates on rocky shorelines are at least an order of magnitude less (Keuler, 1979; Shipman, 1995) than on shorelines consisting of poorly consolidated Pleistocene sediments. More resistant lithologies, such as crystalline rocks, well-cemented gravels, and highly indurated diamicton (pre-Vashon tills, in particular), often form distinct protuberances along the shoreline. Lateral changes in the lithology exposed at the toe of the bluff can result in irregularities in shoreline shape (fig. 10).

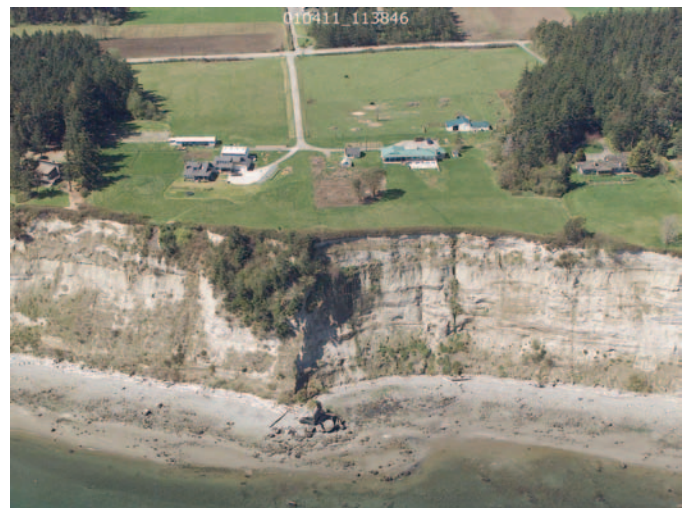
**Figure 11.** Offset in bluffs resulting from the presence of large glacial erratic in the nearshore. Wave action and longshore drift are from left to right. The boulder acts as a groin—on the left side the beach is relative stable, but erosion has been exacerbated on its downdrift side.

Where beaches are broad, due to a recent influx of sediment or proximity to a groin or other drift obstruction, bluff erosion may be locally reduced (fig. 11). Conversely, where beaches are starved of sediment due to either natural or artificial circumstances, the erosion rate of associated bluffs may accelerate. Jacobsen and Schwartz (1981) noted that bluff morphology systematically changes through individual littoral cells — that beaches generally widen and bluff erosion rates decrease in a downdrift direction. In general, on the sound, rapid erosion rates are most common on bluffs at the origin of littoral cells where beaches are minimal and eroded sediment is readily carried away by longshore transport.

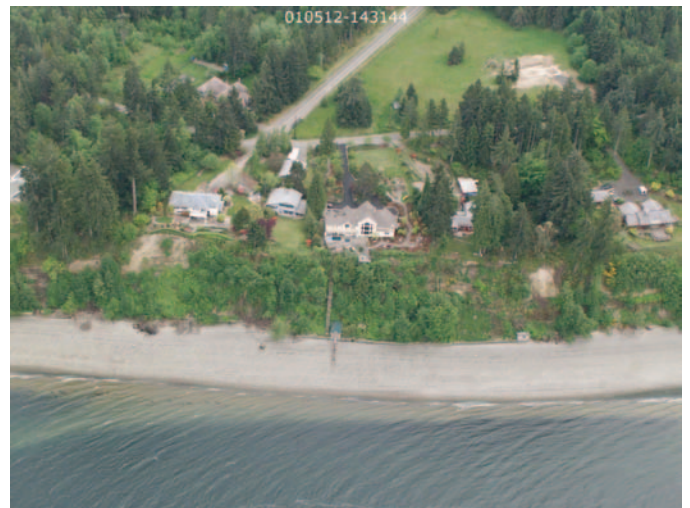
**Figure 12.** Homes built along the top edge of a bluff in southern Puget Sound. Setback requirements vary among jurisdictions. The desire for views typically leads property owners to build as close to the bluff as regulations allow.

Development along bluffs most commonly occurs at the top of the bluff (fig. 12). The distance a building is set back from the bluff edge depends on local regulations, the history and age of the structure, the topography of the site, lot lines, and the original property owner's concept of risk and their desire for views. Property owners often build as close to the

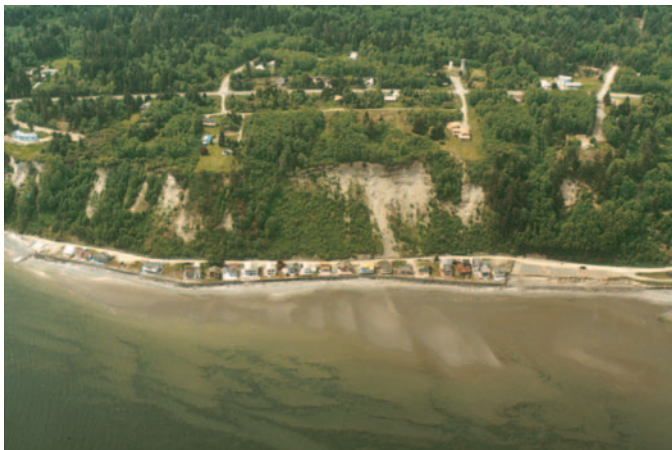
**Figure 13.** Residential development on artificial fill below high bluffs on eastern Whidbey Island.

In several locations around the sound, development has occurred at the base of steep coastal bluffs. In some cases, homes are built on spits, stream deltas, or related depositional landforms that have accreted waterward of the bluff toe. In other cases, development occurs on artificial fill placed across the backshore or beach. On Whidbey and Camano Islands, in central Puget Sound, numerous residential developments were created in the 1950s and 1960s by constructing bulkheads on the beach below a high bluff and then using hydraulic methods to wash bluff material in as landfill. The legacy of such development is rows of homes at water level, constructed on unengineered hydraulic fill, and located at the base of unstable bluffs 40-70 m high (fig. 13).

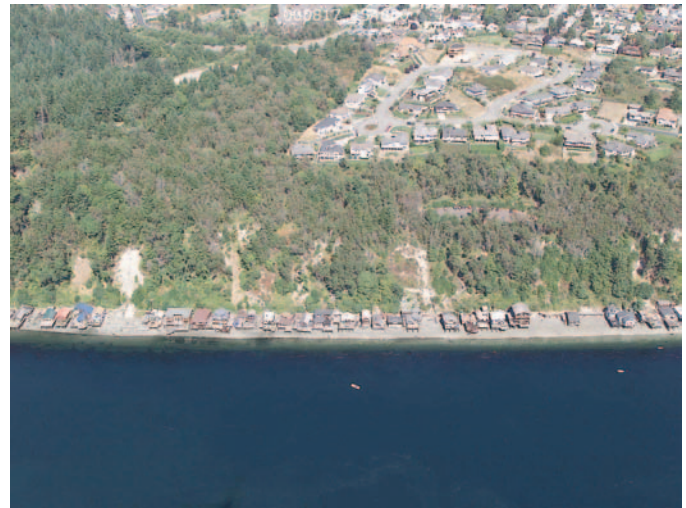
**Figure 14.** Salmon Beach community in Tacoma. Homes built over beach on piles at base of high bluff are periodically damaged or destroyed by landslides.

In some locations, homes (and in the case of Tacoma's Salmon Beach, an entire community) were constructed on piles over the beach at the base of high bluffs (fig. 14). Such development would not be allowed today for many safety and environmental reasons, but where it already exists, we observe regular conversion of small cabins into large homes and periodic slide damage to homes.

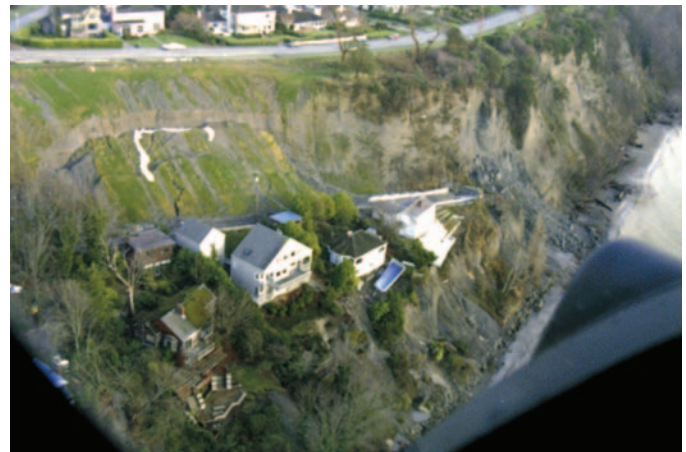
**Figure 15.** Homes destroyed by landsliding along Magnolia Bluff in Seattle during the winter of 1996-97. Homes had been built on a mid-slope bench formed by past erosion and landsliding.
