**GUAM COASTAL MANAGEMENT PROGRAM
FEDERAL CONSISTENCY FORM APPLICATION:
HONG KONG-GUAM CABLE LANDING
PITI, GUAM**

Subject: CZMA Federal Consistency Certification for Hong Kong-Guam Submarine Cable Landing, Tepungan, Piti, Guam.

Benthic cover and ESA coral surveys for the proposed Hong Kong-Guam, Japan-Guam-Australia North, and Japan-Guam-Australia South cable systems landings in Piti, Guam

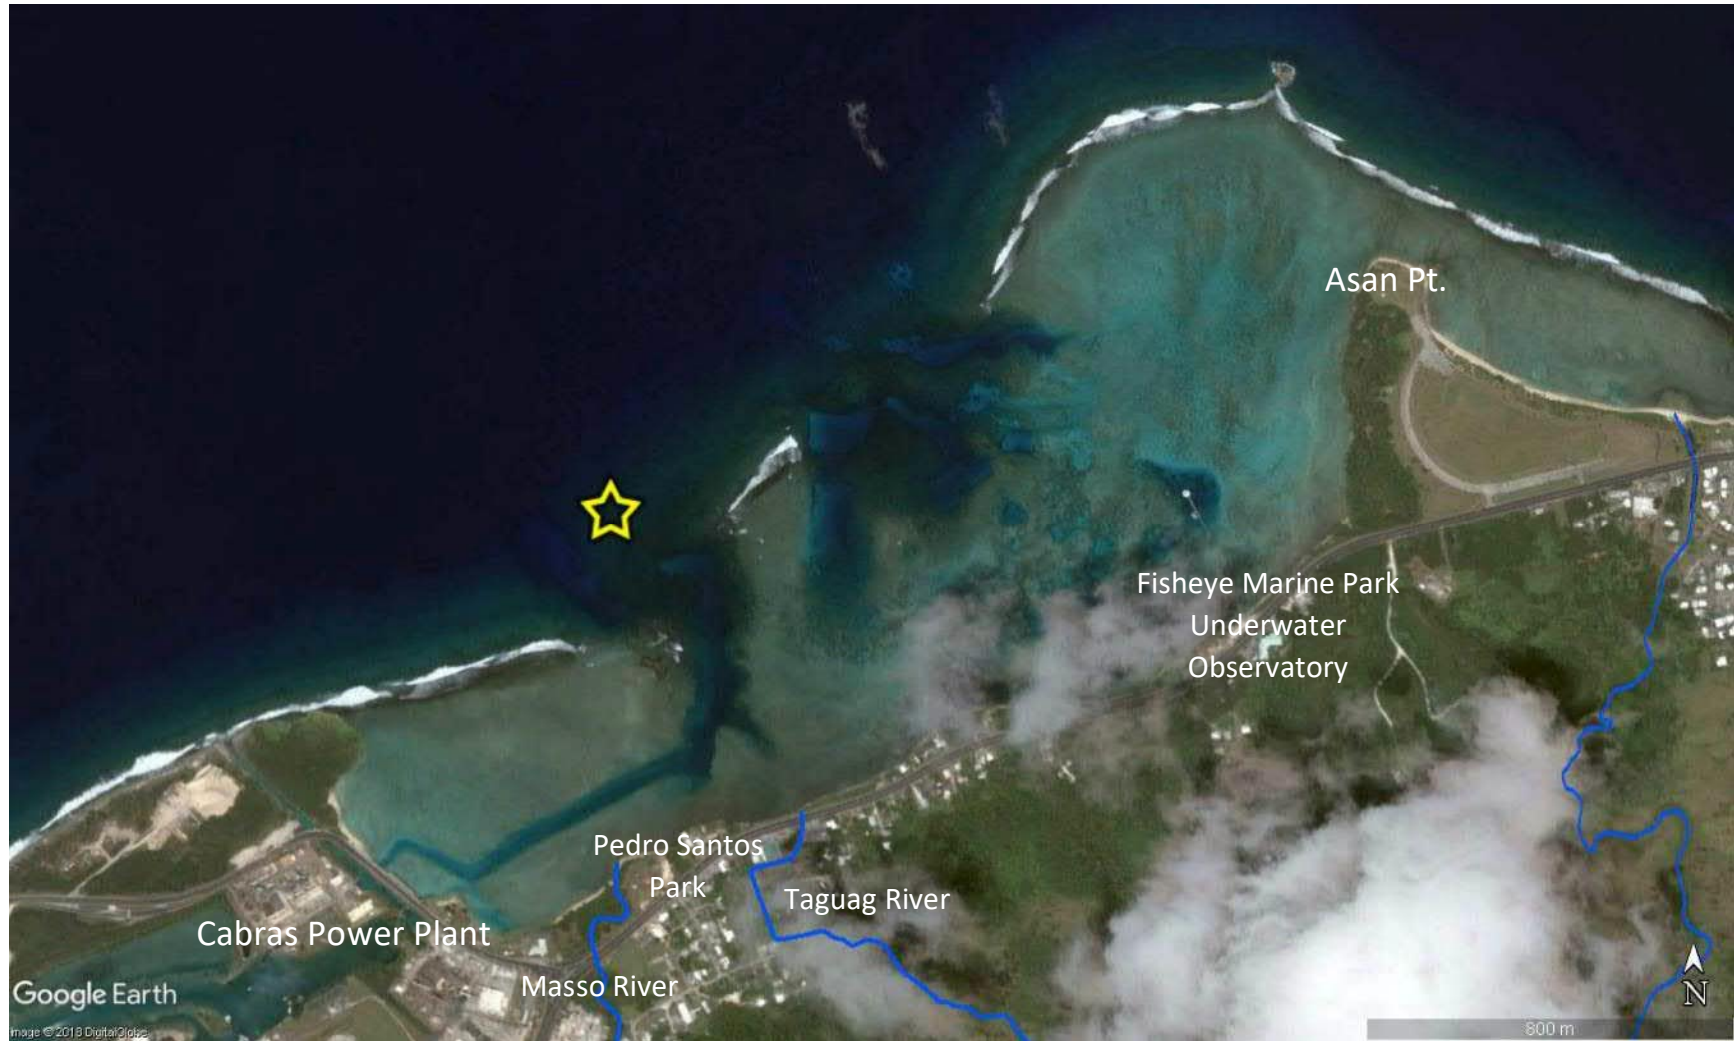
Figure 2. Map depicting the general location of the survey areas in Piti Bay.

Piti Bay is northwest-facing embayment on the central-western coast of Guam that extends approximately 2.5 km between Cabras Island on its western boundary and Asan Point on its eastern boundary (Figures 1 & 2). The western portion of the bay is intersected by the Tepungan Channel, which extends approximately 400 m from the reef margin shoreward, and then turns westward and runs parallel to shore towards the Cabras Power Plant. The western, shoreward portion of the channel that runs parallel to shore was dredged in the early 1930s to facilitate the shipment of coal from Cabras Island to the Hagåtña power plant (Moore and Amesbury, 2009).

The Masso and Taguag rivers, as well as an unnamed ephemeral stream, discharge onto the reef flat adjacent to Tepungan Channel (Figure 2). Deposits of terrestrial-derived sediments can be observed on the reef flat near the river mouths, and within the portion of Tepungan Channel where the natural channel intersects with the dredged portion that extends westward to the power plant. The heavy deposition of terrestrial-derived sediment appears to be limited to areas not directly affected by near constant water movement within the channel; bioclastic, primarily calcium carbonate sediments dominate the channel floor across the majority of the channel. The dredged portion of the channel hosts a significant number of small *Acropora cf. pulchra* thickets, ranging in size from less than one square meter to more than five square meters. These thickets appear to be particularly robust to thermal/irradiative stress, as they have exhibited little or no signs of bleaching in during known periods of moderate-to-severe coral bleaching-associated mortality. The relatively deep (compared to staghorn corals on the shallow reef flat) location of these thickets, and the sometimes-turbid water that is in near-constant water movement in the channel, may mitigate the effects of the thermal/irradiative stress events. Also located within the channel are three 25 m² plots designated as coral mitigation sites for impacts associated with the landing of the SEA-US and ATISA cables. Two GTA coral relocation sites are located on the reef flat adjacent to the channel, and coral relocation sites associated with the SEA-US and ATISA cable landing projects are located on the seaward slope near the mouth of the channel (Figure 3)

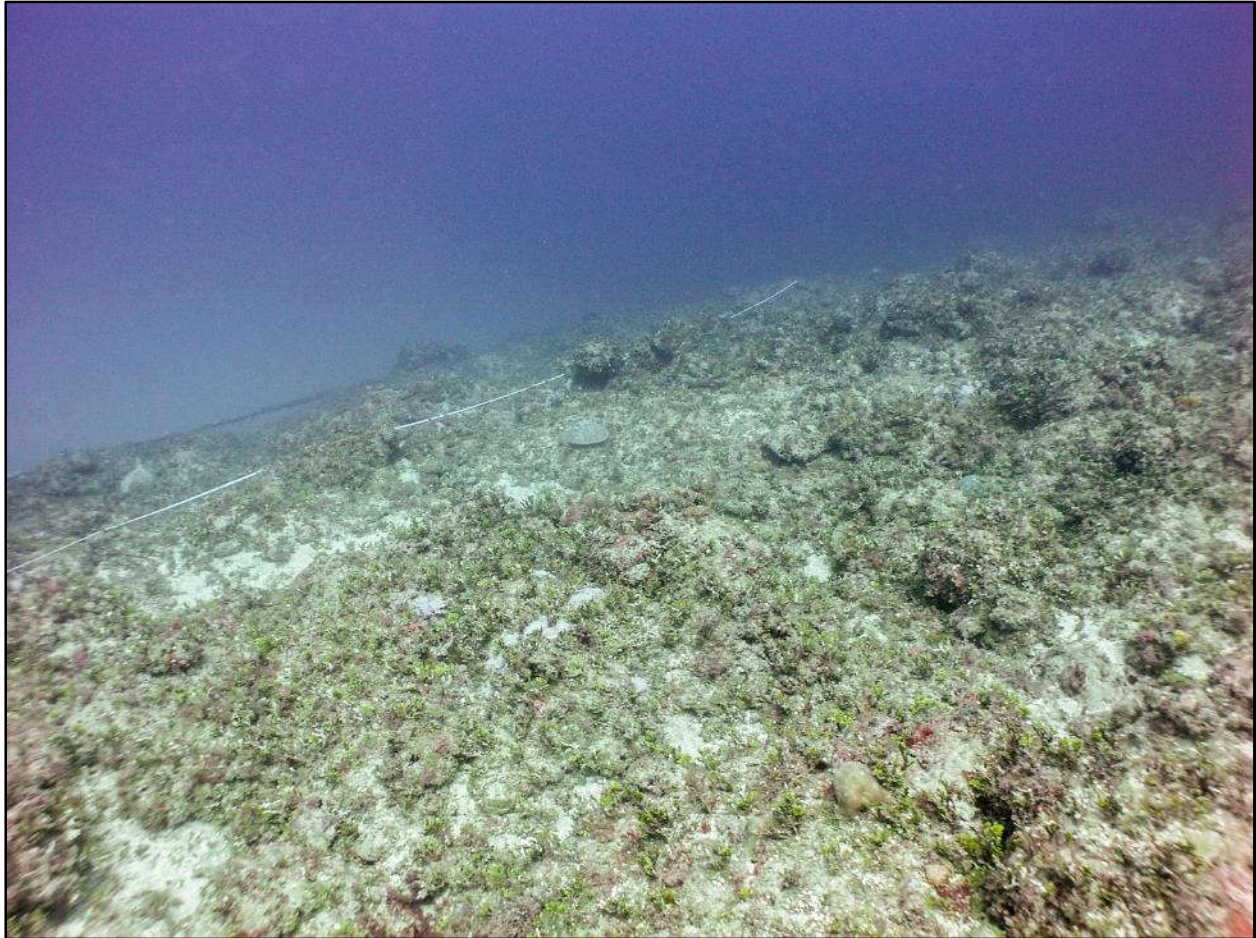
Figure 5. A low-relief, low coral cover, high algal cover benthic community representative of that observed at Site A between depths of approximately 30.5 m (100 ft) and 18 m (60 ft). The Tata cable (without articulated pipe) can be seen in the upper-left quadrant of the image, beyond the white transect tape.

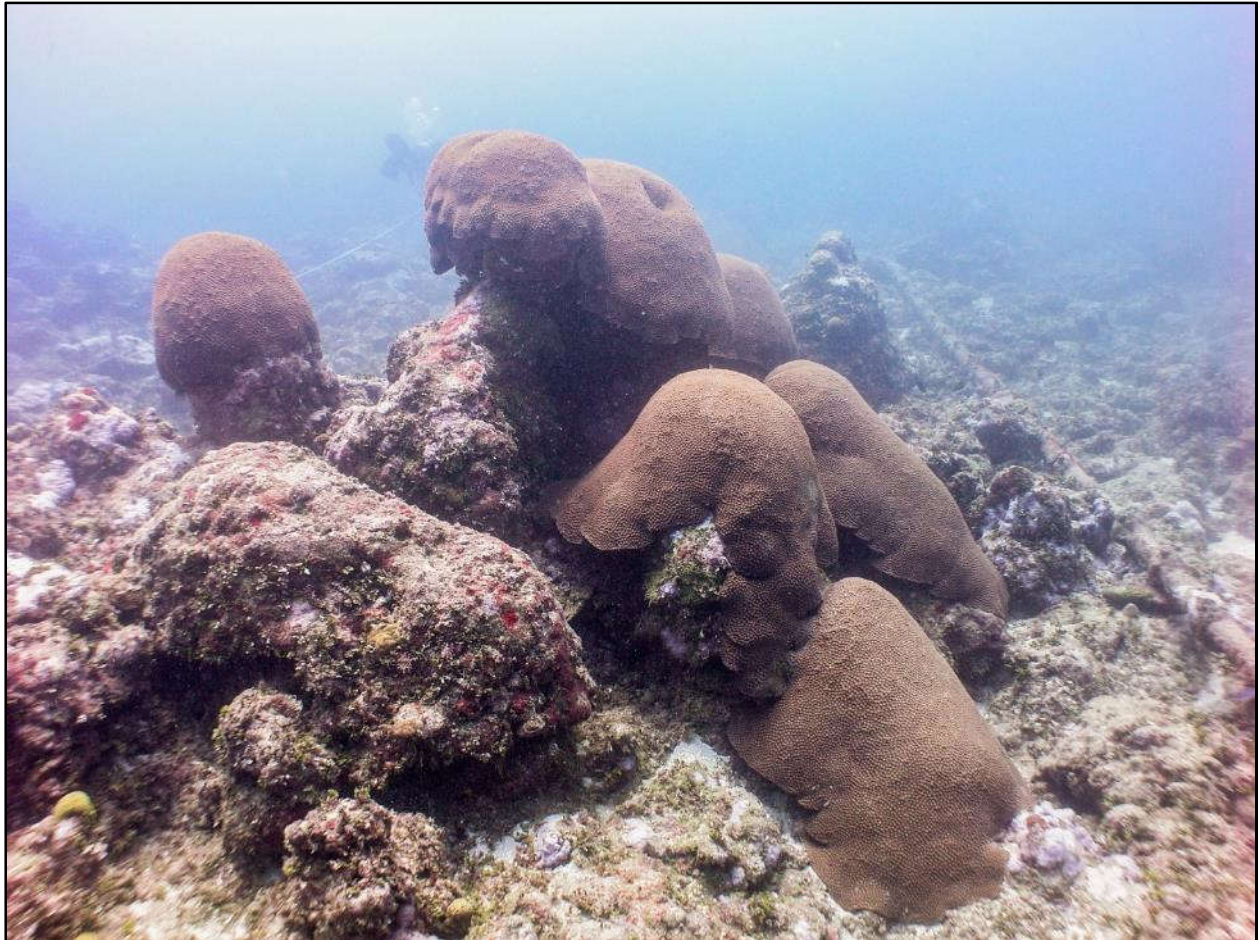
Figure 6. Large colonies of the coral, *Diploastrea heliopora*, within the deeper portion of Site A. While coral cover along the deeper half of Site A was generally low, several large *D. heliopora* colonies were observed in this area, including the aggregation of colonies pictured here. The above colonies occur within the center of Site A (Transect 2). The Tata cable with articulated pipe can be observed immediately to the right (southwest) of the colonies.

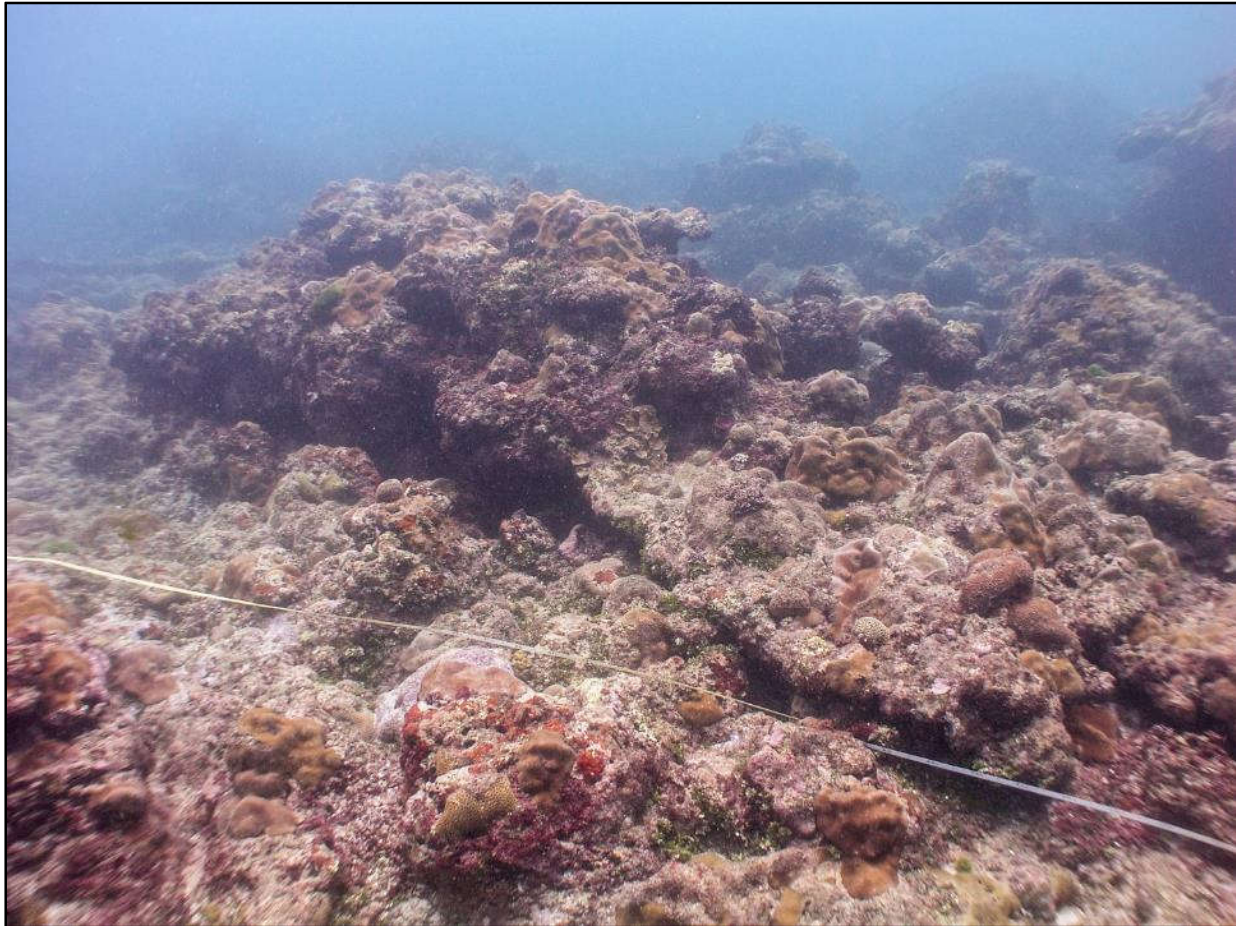
Figure 7. A relatively high-relief benthic community representative of that observed in the shallower (< 18 m depth) half of Site A. This benthic community exhibits higher coral cover and lower macroalgal cover than the deeper portion of Site A.

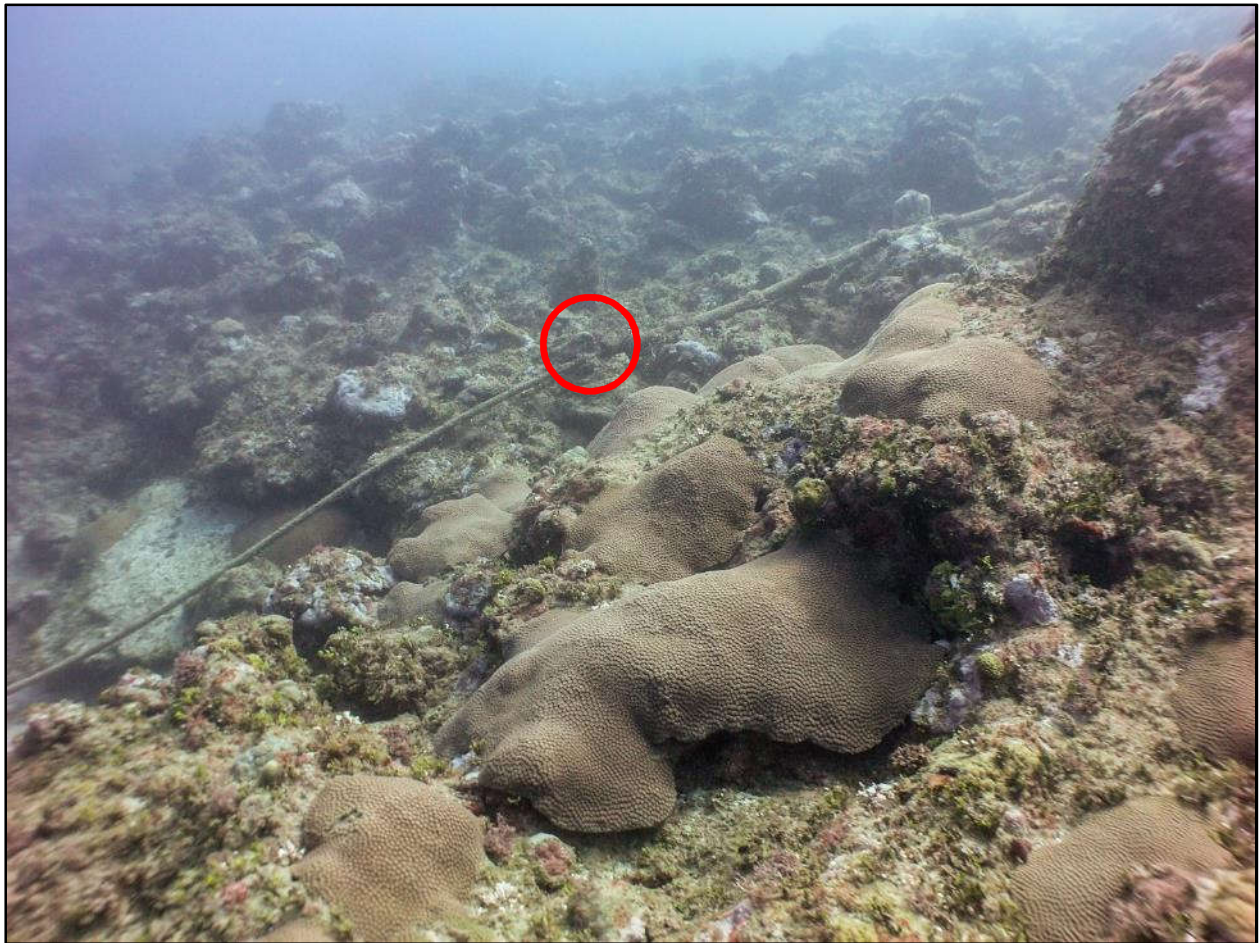
Figure 8. *Diploastrea heliopora* colonies within the deeper portion of Site B. Similar to the pattern observed at Site A, coral cover was lower in the deeper portion of Site B compared to the shallower portion. However, also similar to what was observed at Site A, several large *D. heliopora* colonies (pictured above) occurred within the deeper portion of Site B. The red circle marks the shoreward-leading transition on the Tata cable (at 28.7 m depth) from bare cable to articulated pipe.

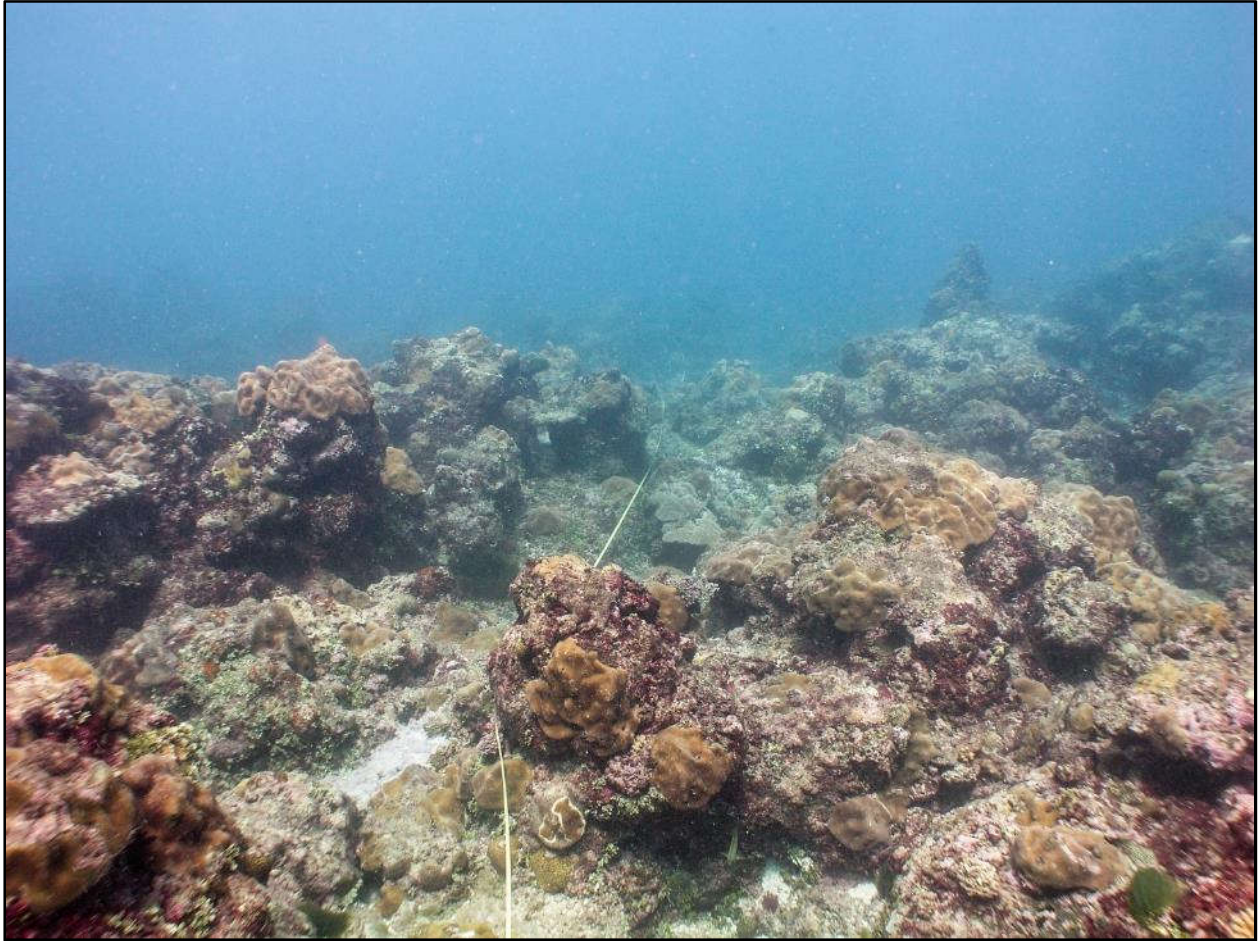
Figure 10. A moderate-to-high-relief benthic community comprised predominately by the brain coral, *Leptoria phrygia*, in the shallower portion of Site B.

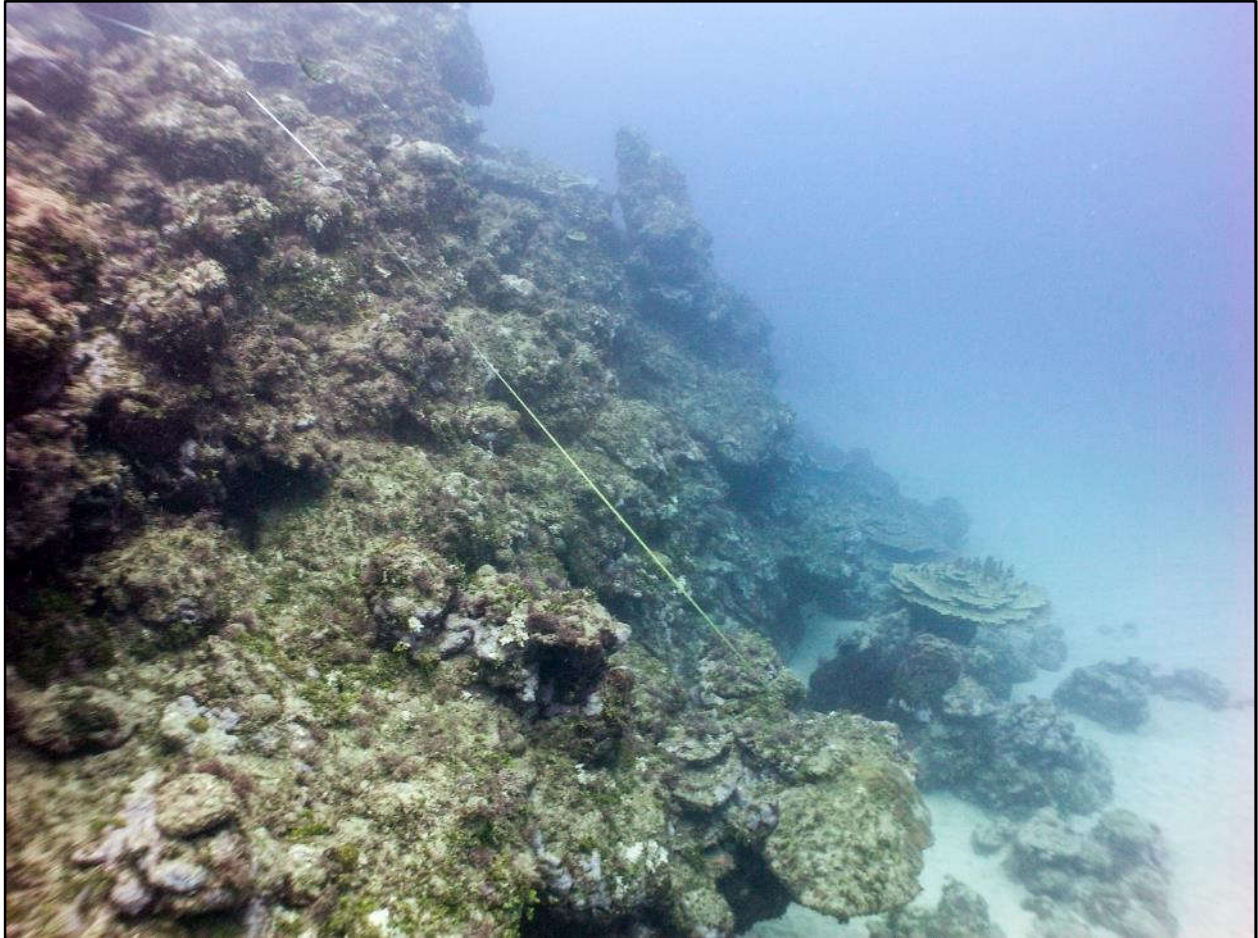
Figure 11. A steep slope at deep end of Site C. The steep hardbottom slope rises from a sand flat at a depth of approximately 22 m (72 ft) to a depth of approximately 15 m (50 ft).

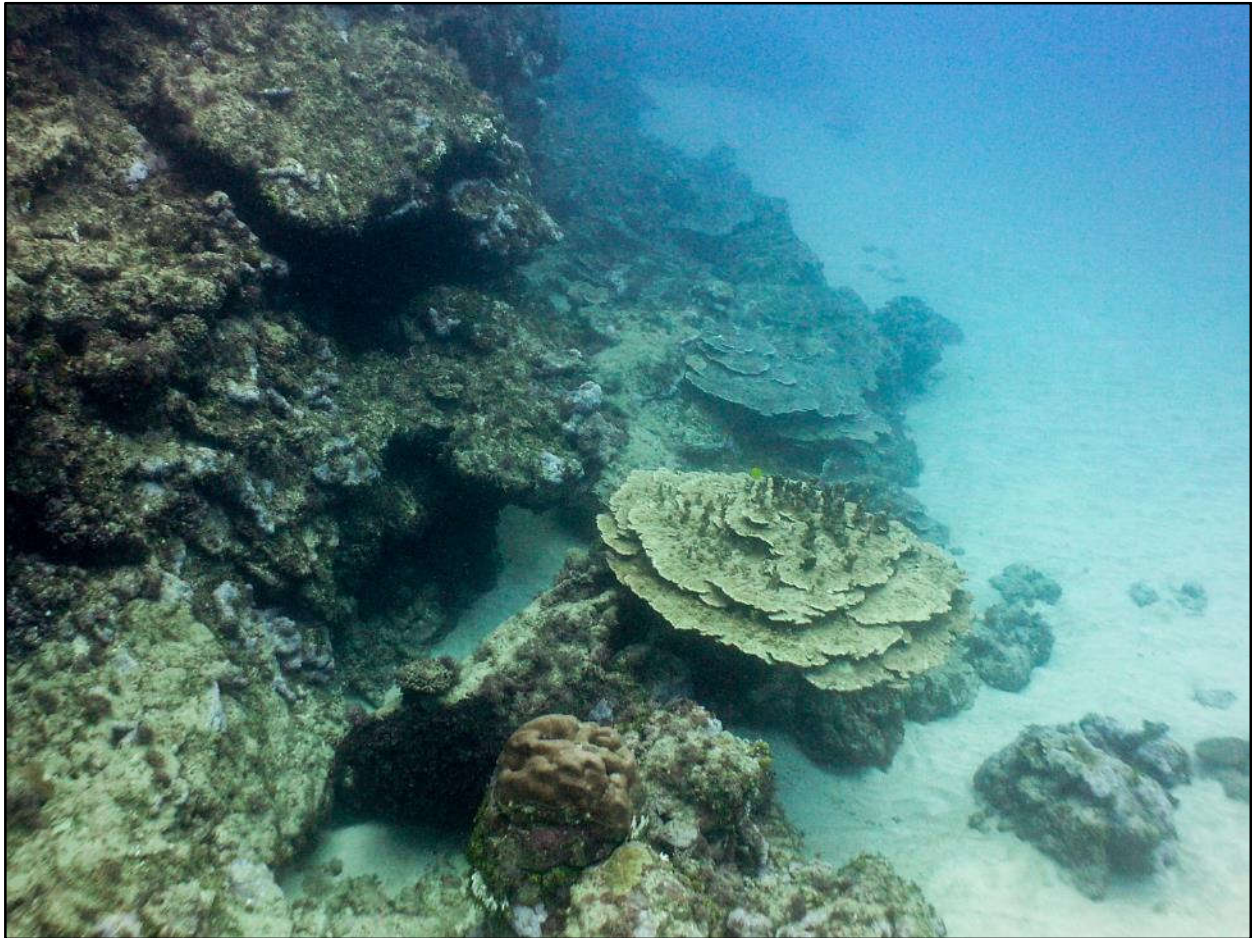
Figure 12. A plate-and-pillar coral, *Porites rus*, along the base of the steep slope of Site C pictured in Figure 11. While coral cover is relatively low along the steep slope of Site C some notable coral colonies, such as the *P. rus* colony pictured above, are present along the slope. Colonies such as this one are relatively fragile and would be highly susceptible to physical damage if care is not taken to avoid them.

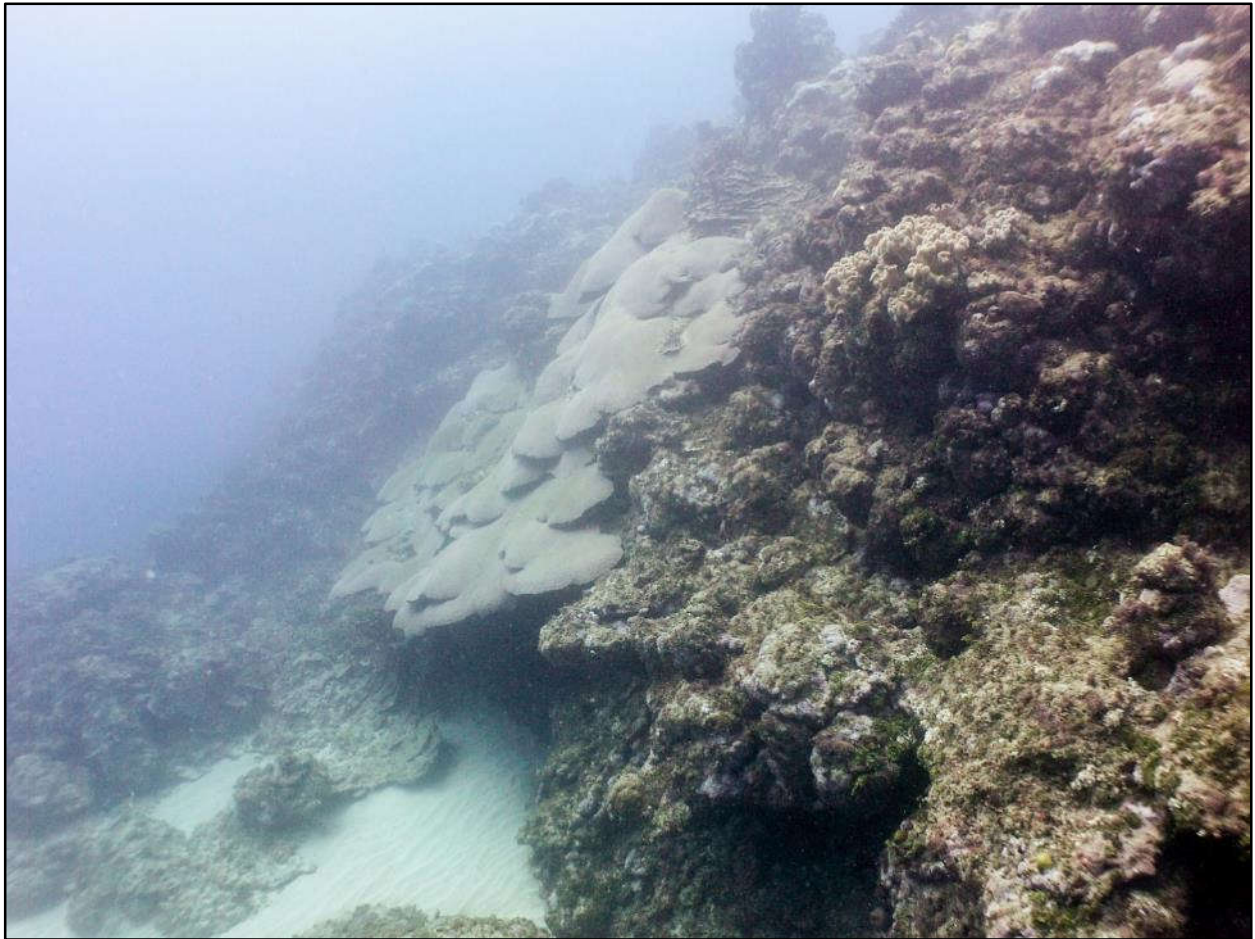
Figure 13. An exceptionally large *Diploastrea heliopora* colony in the vicinity of the section of steep slope across which Site C extends. This colony would not be impacted if the cable is laid within the boundaries of Site C as proposed, but its close proximity to Site C should be noted and care taken to avoid it. While colonies of this species seem relatively robust to physical damage, this partially plating form is less robust than the massive (i.e., boulder-shaped) colonies and could break or sustain significant tissue damage if a cable is placed across it.

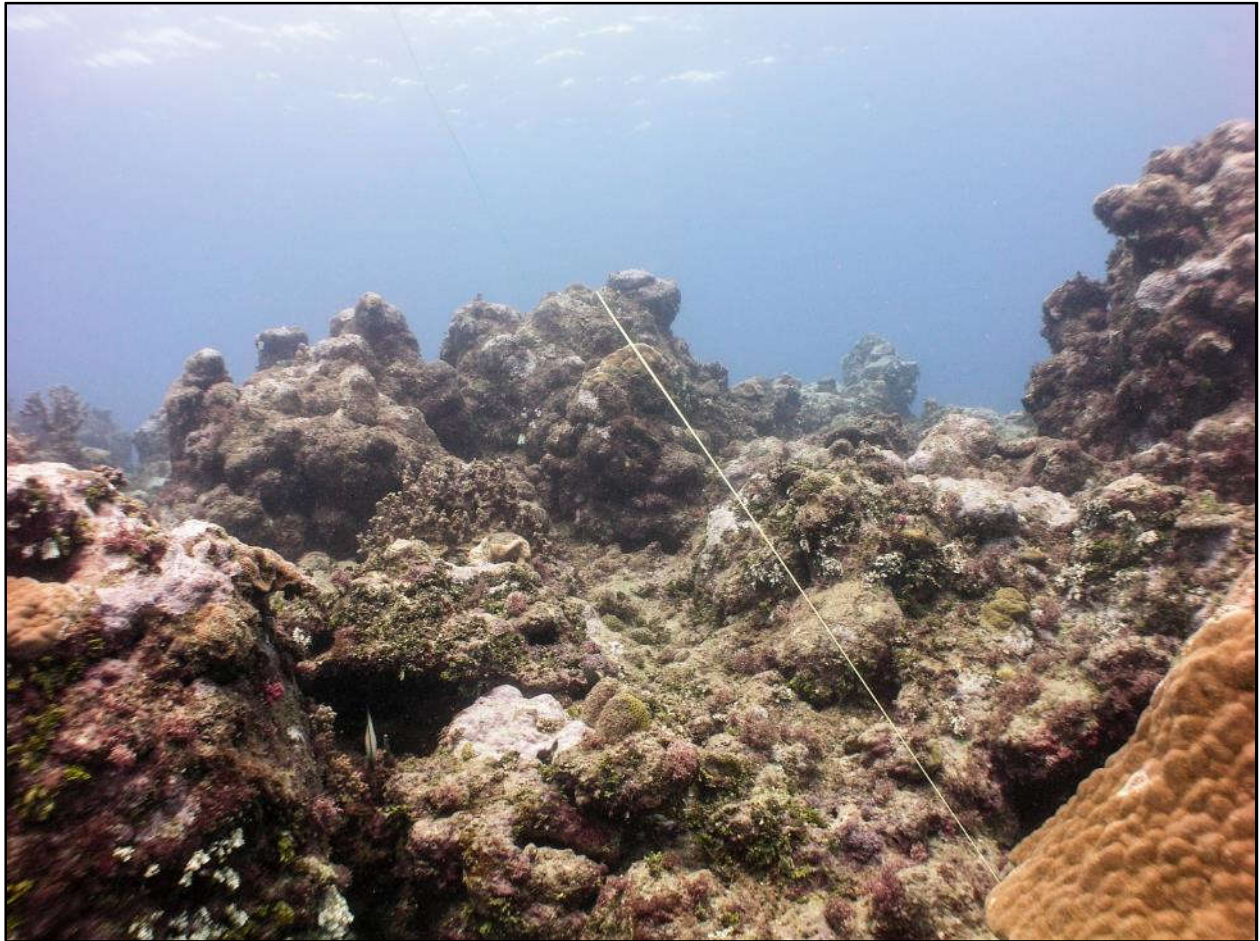
Figure 14. A moderate-to-high relief, relatively low coral cover benthic community primarily dominated by massive *Porites* spp. in Site C. The community depicted here is representative of the portion of Site C between the steep slope pictured in Figs 11–13 and the shallower, shoreward portion of the site pictured in Figure 15.

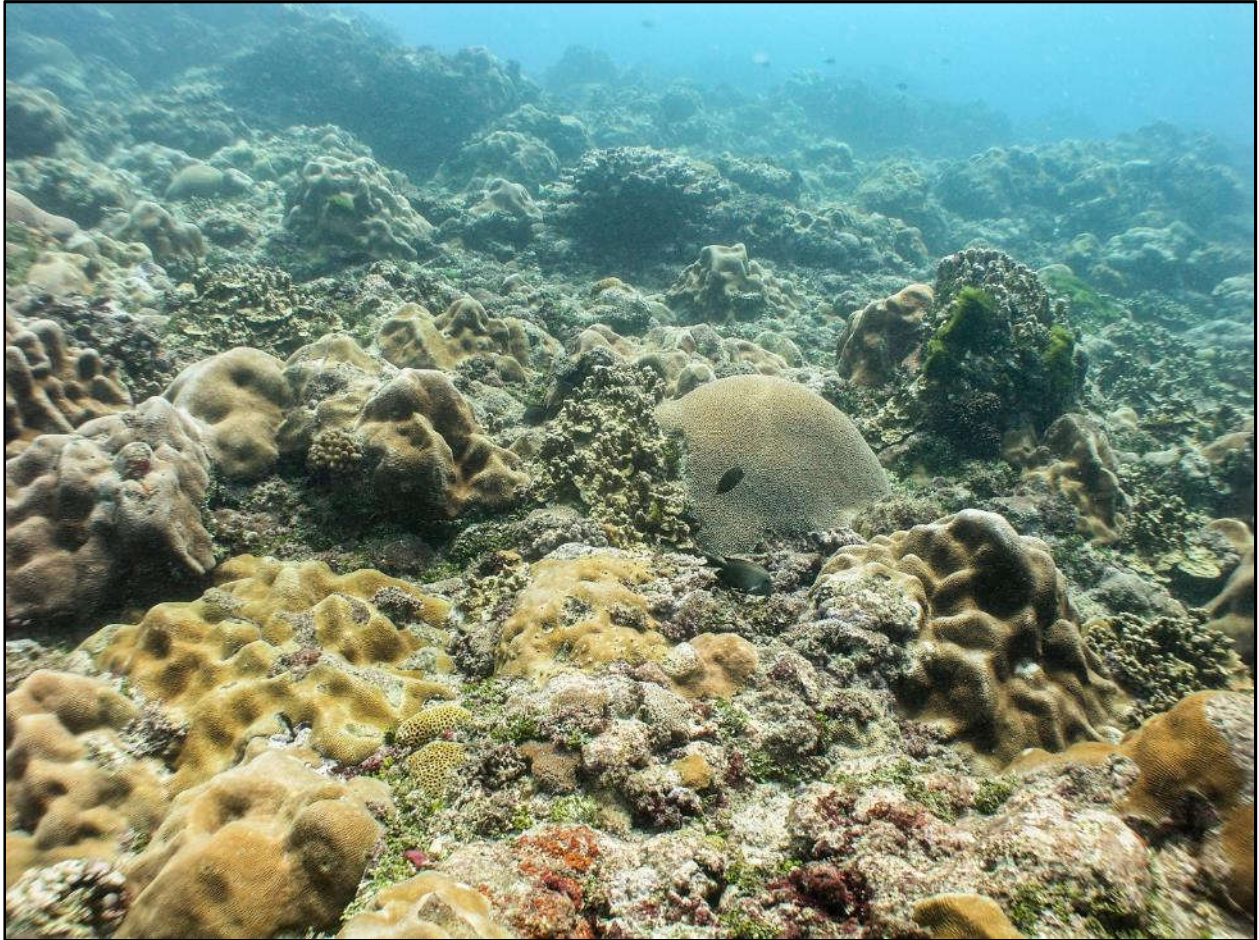
Figure 15. A moderate relief, relatively high coral cover benthic community dominated by the brain coral, *Leptoria phrygia*. This benthic community is representative of the shallower, shoreward-most portion of Site C.

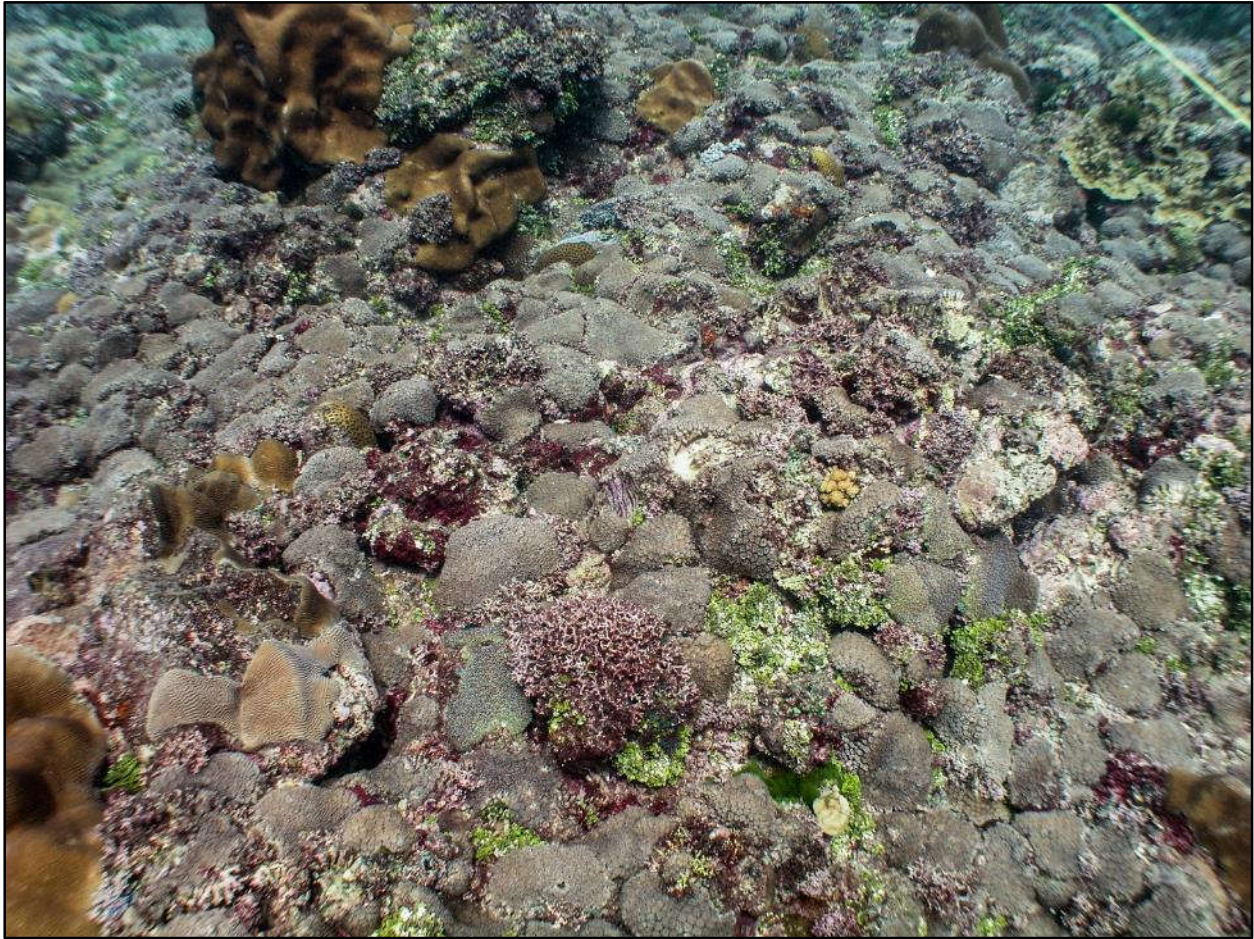
Figure 16. Unusually dense and extensive cover of *Galaxea fascicularis* colonies in the shallower portion of Site C. While these encrusting colonies do not form branches, they have delicate skeletal features that are highly susceptible to physical damage.

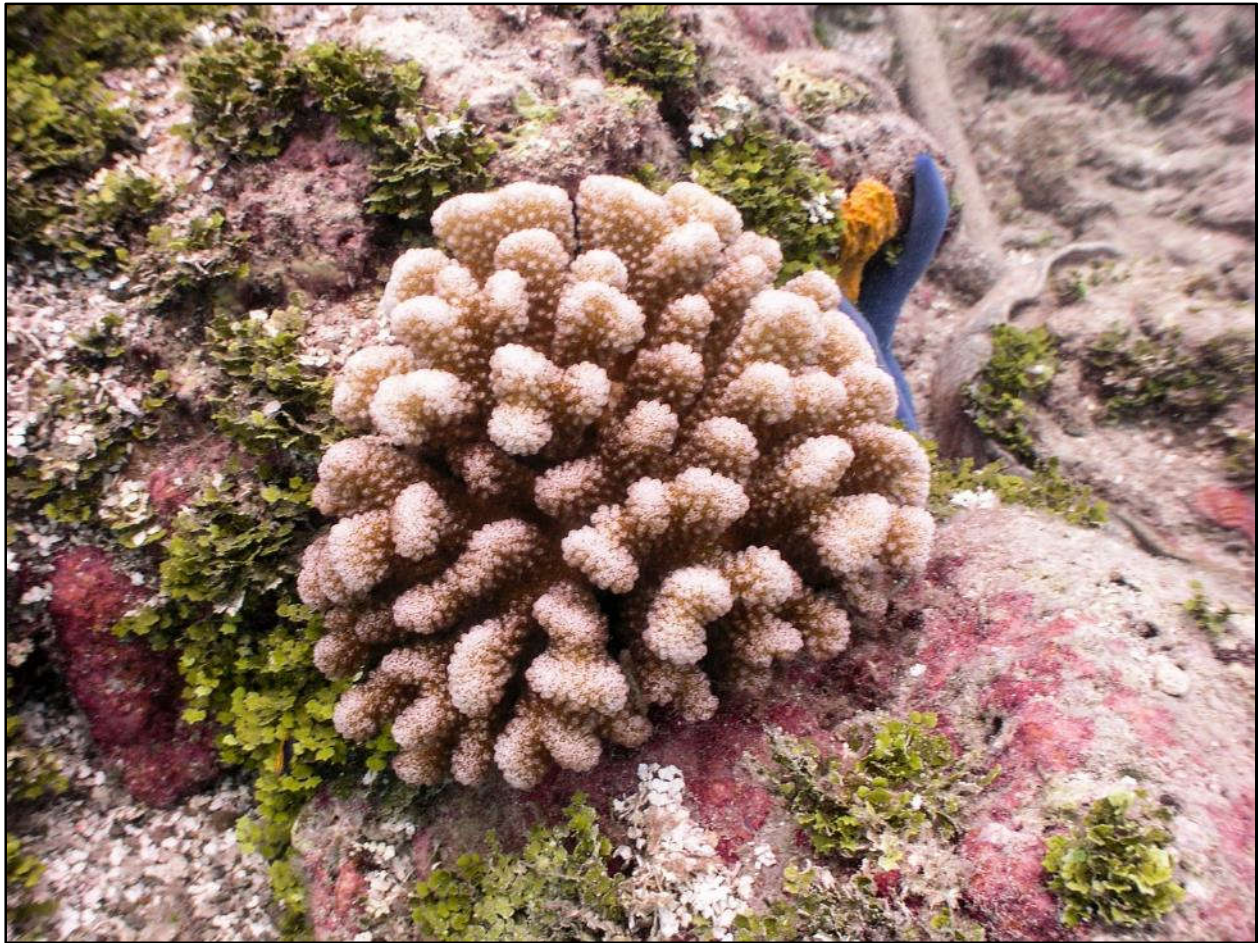
Figure 19. A colony of the branching coral, *Pocillopora meandrina*, observed within Site D. While coral cover was very low at Site D, a few notable coral colonies, such as this *P. meandrina* colony, were observed within the site. Care should be taken to avoid physical damage to these fragile branching colonies.

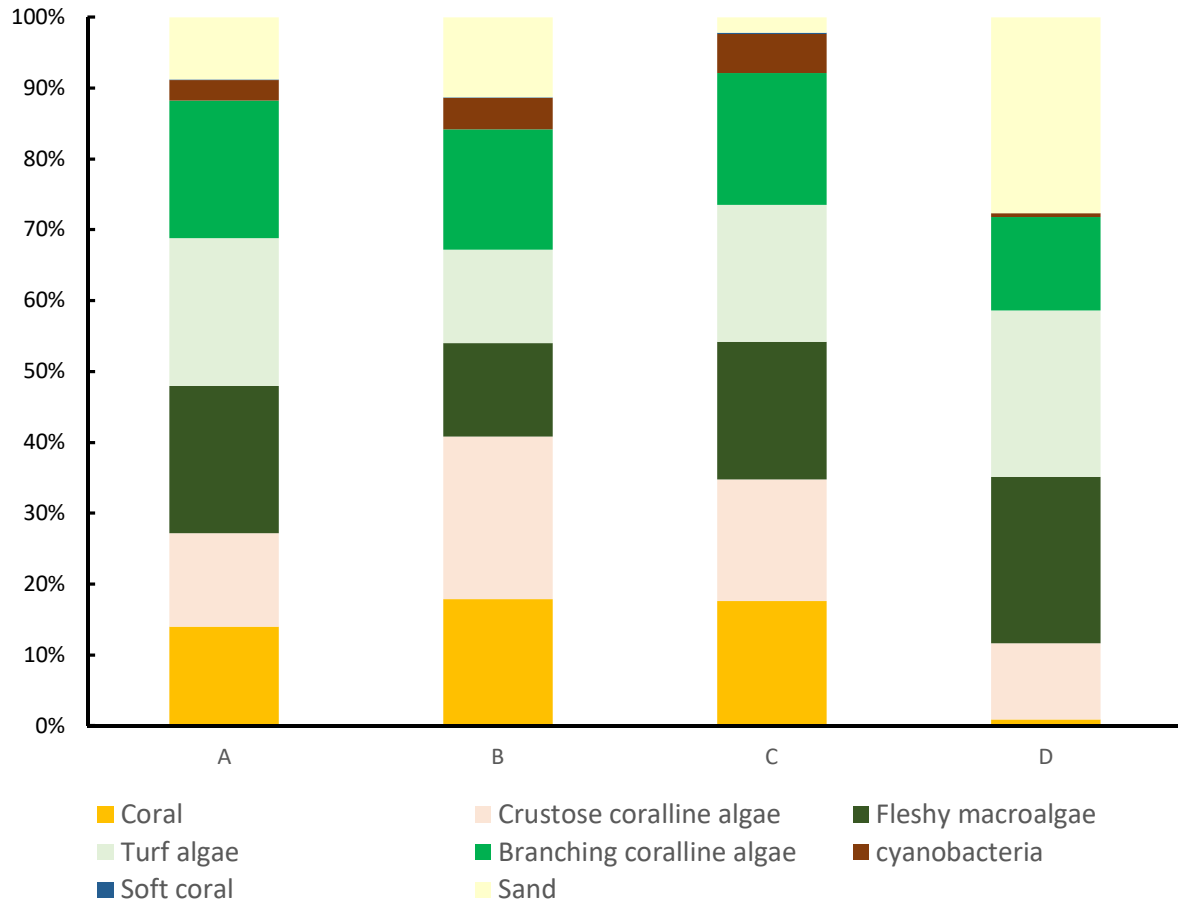
Figure 20. Mean percent cover for major benthic cover types at Sites A–D.

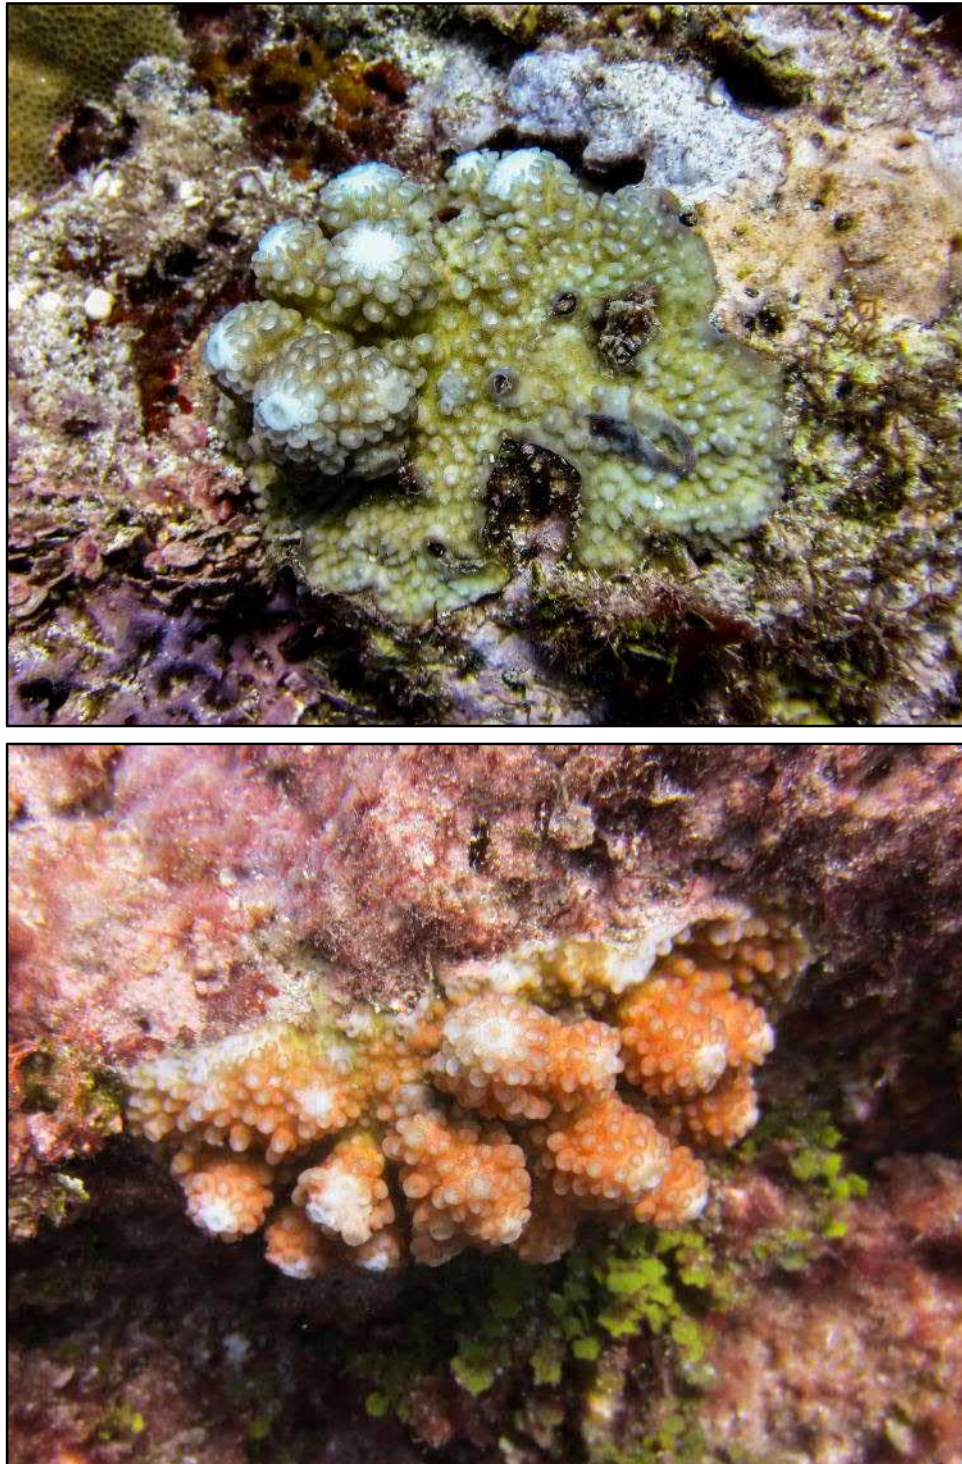
Figure 31. Colonies A1 (top) and A2 (bottom) tentatively identified as the ESA-listed coral species, *Acropora globiceps*, that were observed in Site A. Young colonies such as these are difficult to discern from the very similar *Acropora* cf. *humilis*.

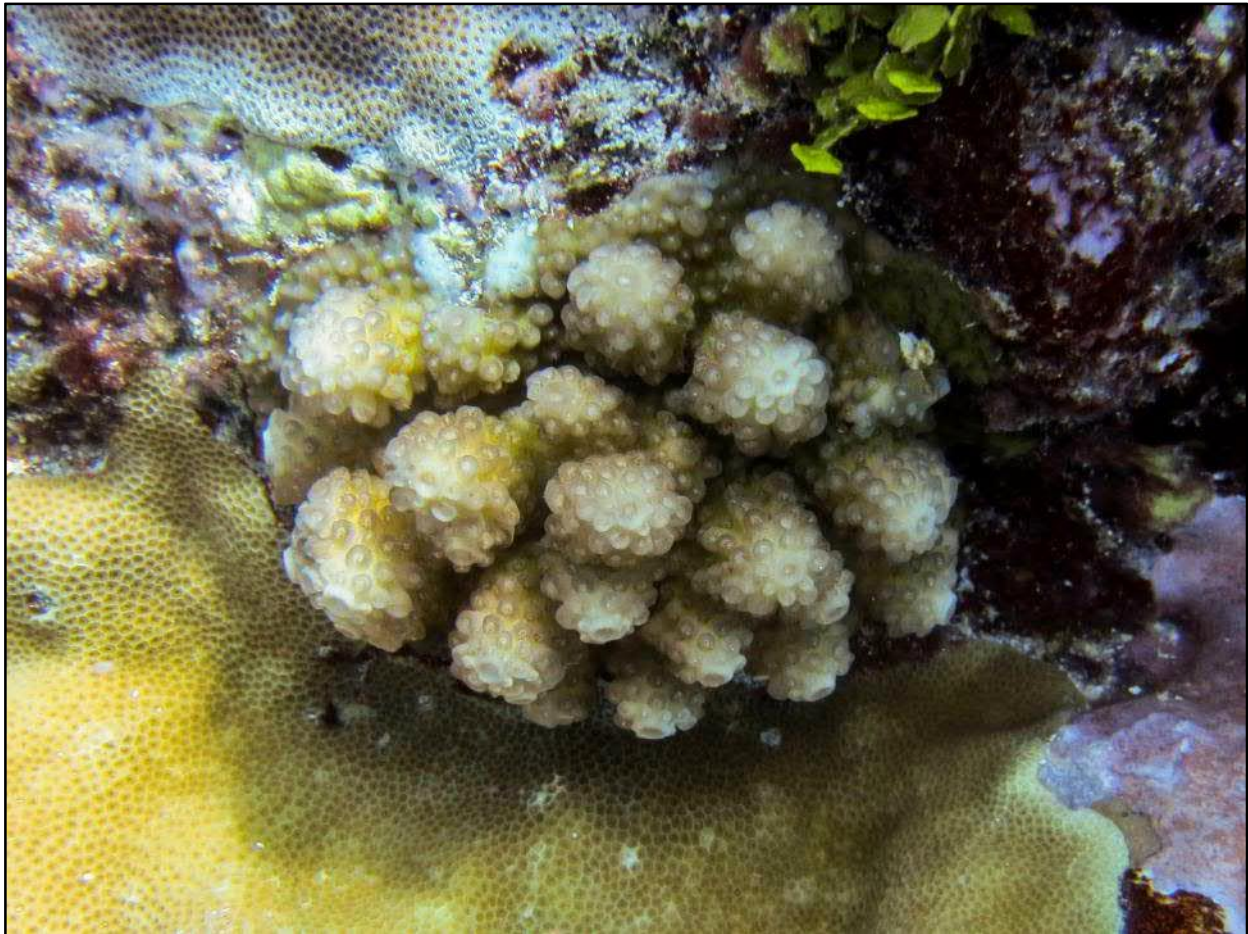
Figure 32. Colony A3 in Site A, tentatively identified as the ESA-listed coral species, *Acropora globiceps*. This colony is slightly larger and possesses more branches than the colonies pictured in Figure 31, and thus characters that distinguish *Acropora globiceps* from *A. cf. humilis*, such as the terete branches with even lengths, are more readily visible. Still, the high degree of similarity between small colonies of *A. globiceps* and *A. cf. humilis*, and the general lack of understanding of the relationship between these two species, make even this identification tentative.
