**GUAM COASTAL MANAGEMENT PROGRAM
FEDERAL CONSISTENCY FORM APPLICATION:
HONG KONG-GUAM CABLE LANDING
PITI, GUAM**

Subject: CZMA Federal Consistency Certification for Hong Kong-Guam Submarine Cable Landing, Tepungan, Piti, Guam.

Benthic cover and ESA coral surveys for the proposed Hong Kong-Guam, Japan-Guam-Australia North, and Japan-Guam-Australia South cable systems landings in Piti, Guam

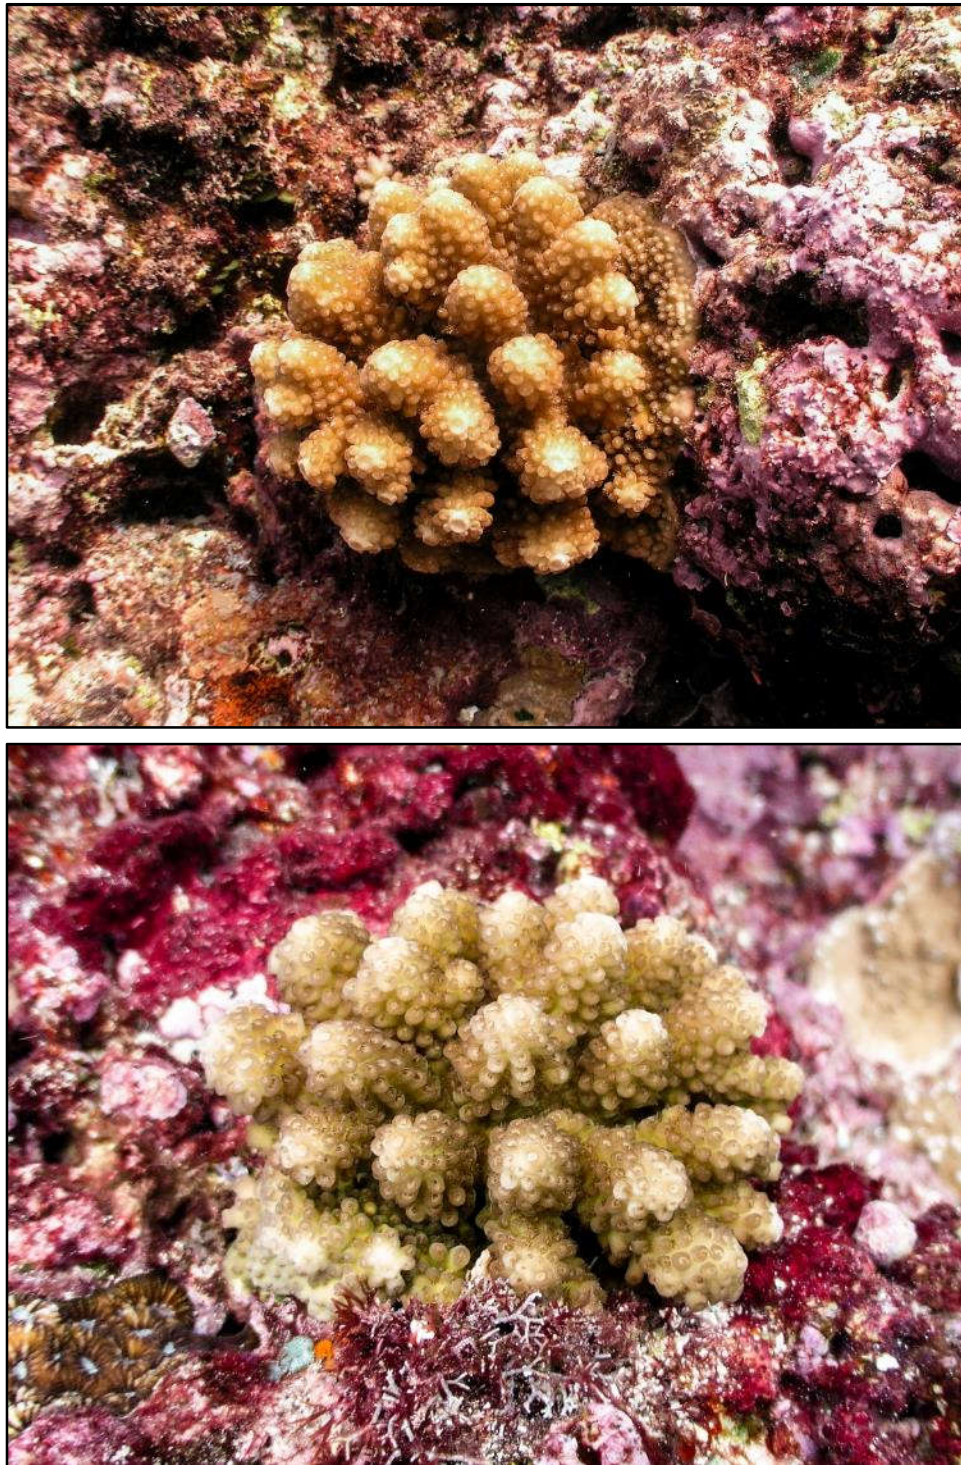
Figure 33. Colonies B1 (top) and B2 (bottom) in Site B, tentatively identified as the ESA-listed coral species, *Acropora globiceps*. Young colonies such as these are difficult to discern from the very similar *Acropora* cf. *humilis*, but the terete branches of relatively even length suggest that these colonies may be *A. globiceps*.

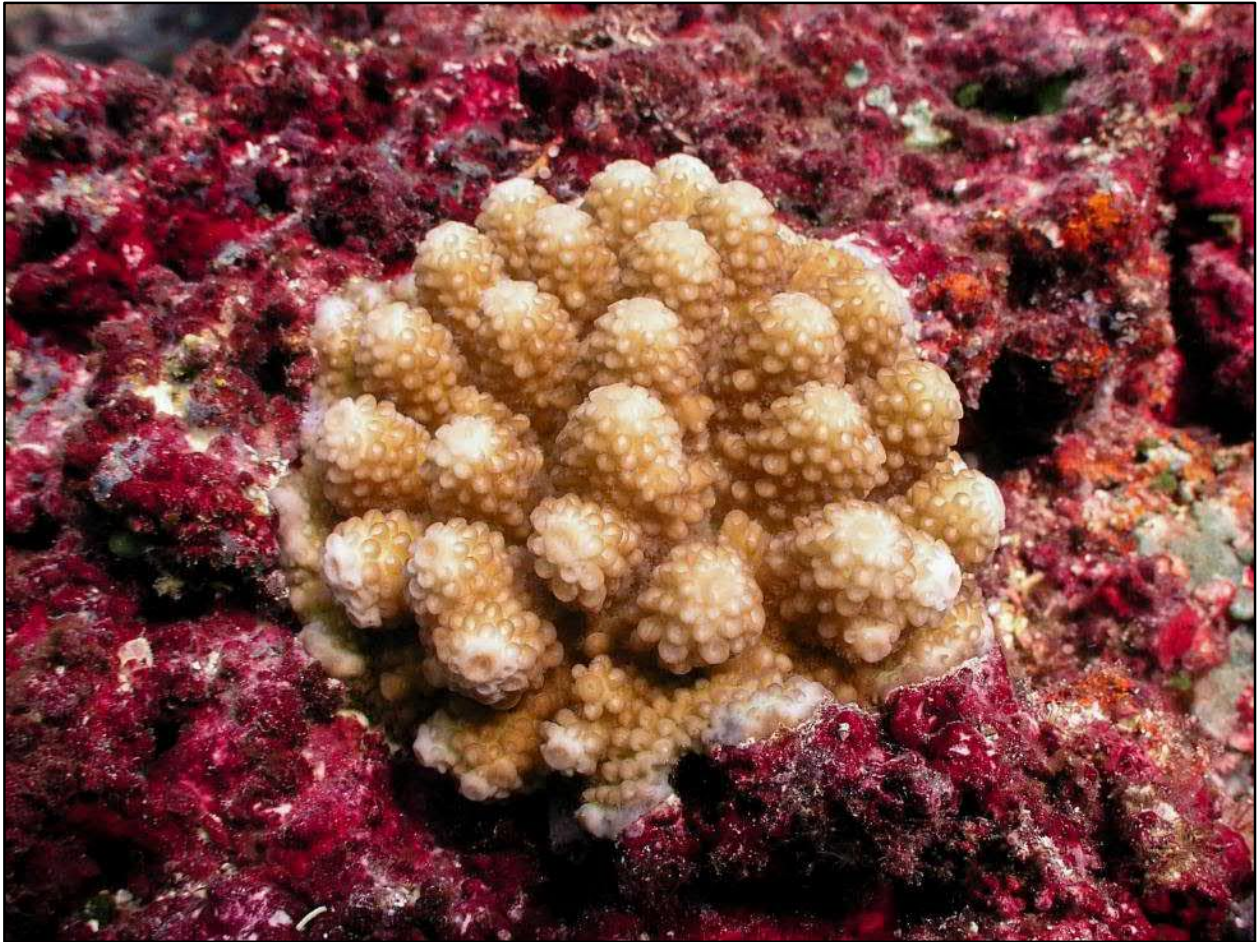
Figure 34. Colony B3 in Site B, tentatively identified as the ESA-listed coral species, *Acropora globiceps*. Young colonies such as these are difficult to discern from the very similar *Acropora* cf. *humilis*, but the terete branches of relatively even length suggest that these colonies may be *A. globiceps*.

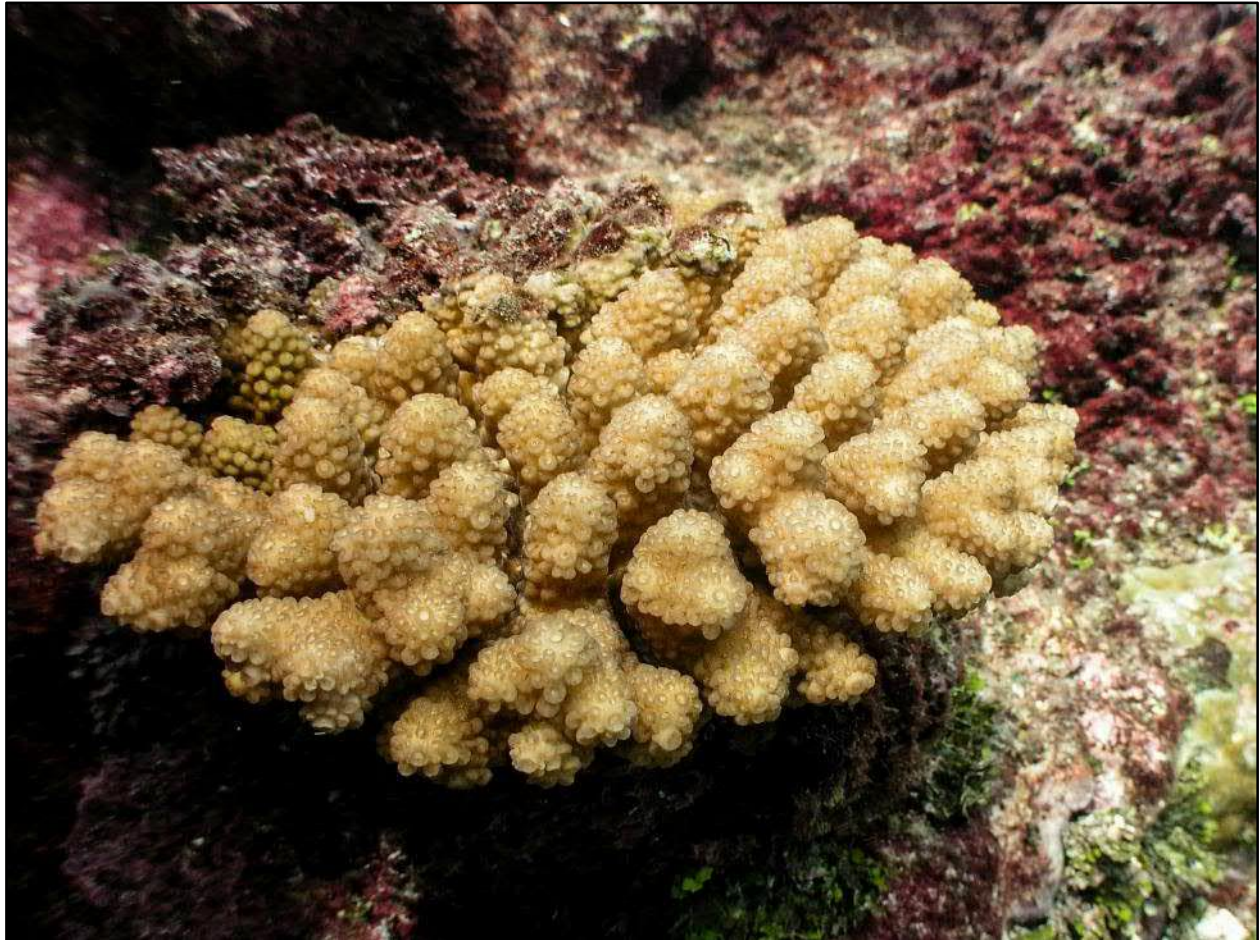
Figure 37. Colony C5 in Site C, tentatively identified as the ESA-listed coral species, *Acropora globiceps*. This relatively large, well-developed colony exhibits the short, terete branches of even length that are characteristic of what is currently considered the Marianas form of *A. globiceps*. Also visible in this colony are the branch clusters typical of this species.

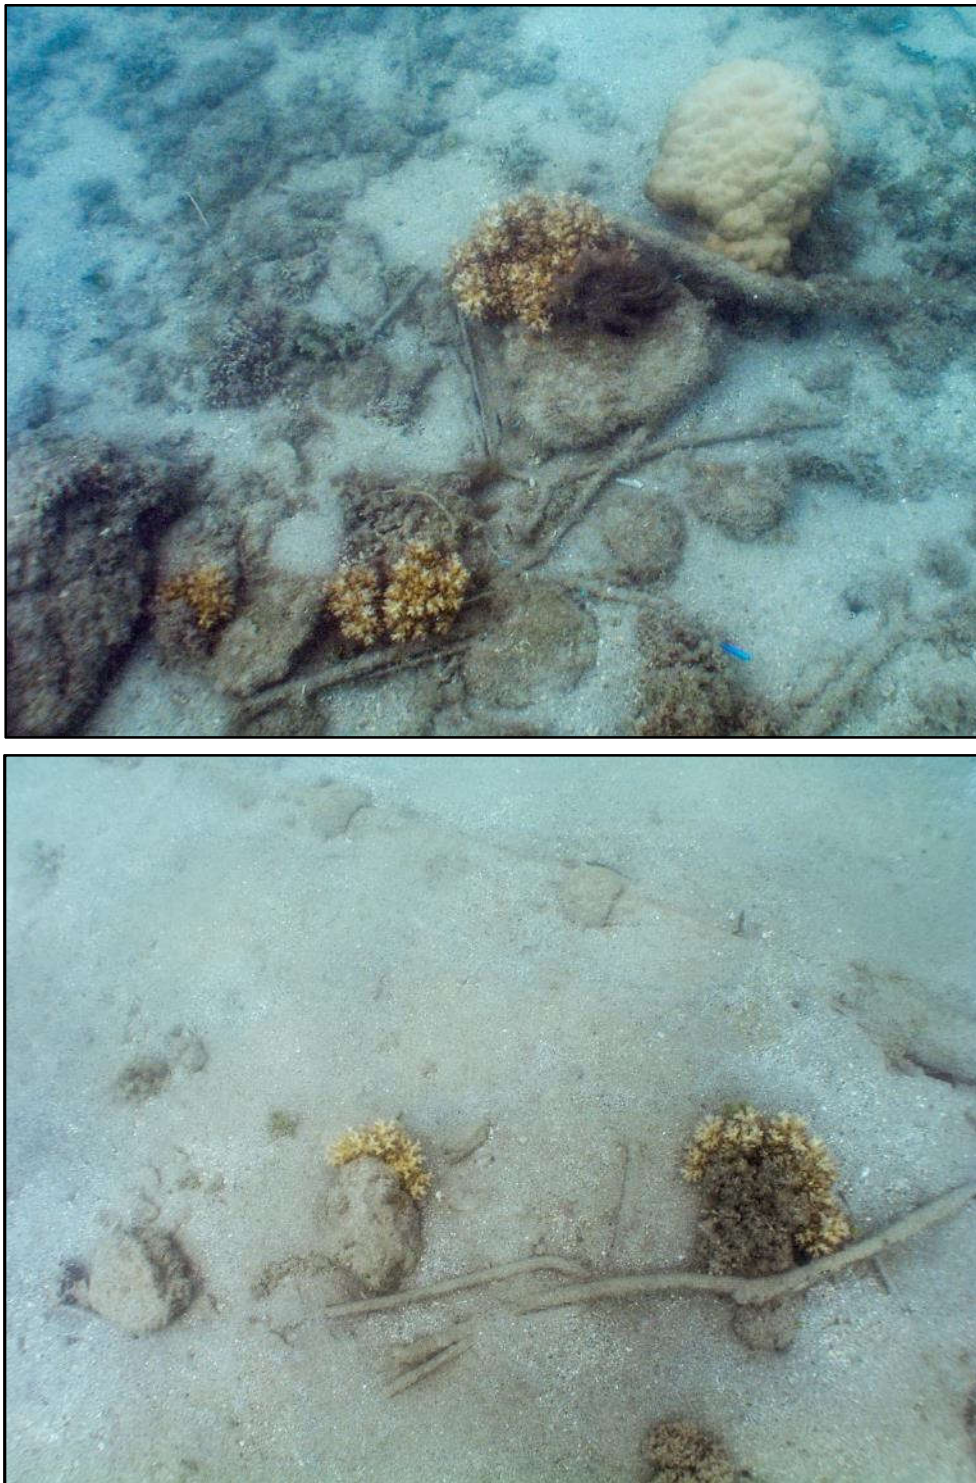
Figure 39. A *Porites* colony and a group of *Pocillopora damicornis* colonies (top) located approximately 10 m seaward from the bulkhead at Site E. Two additional *P. damicornis* colonies (bottom) within the path of the proposed cables. The colonies in both of these images could be moved to nearby softbottom substrate to avoid damage during the placement of the cables. The silty/sandy substrate with scattered rock and rubble pictured here is prevalent in the vicinity of the bulkhead.

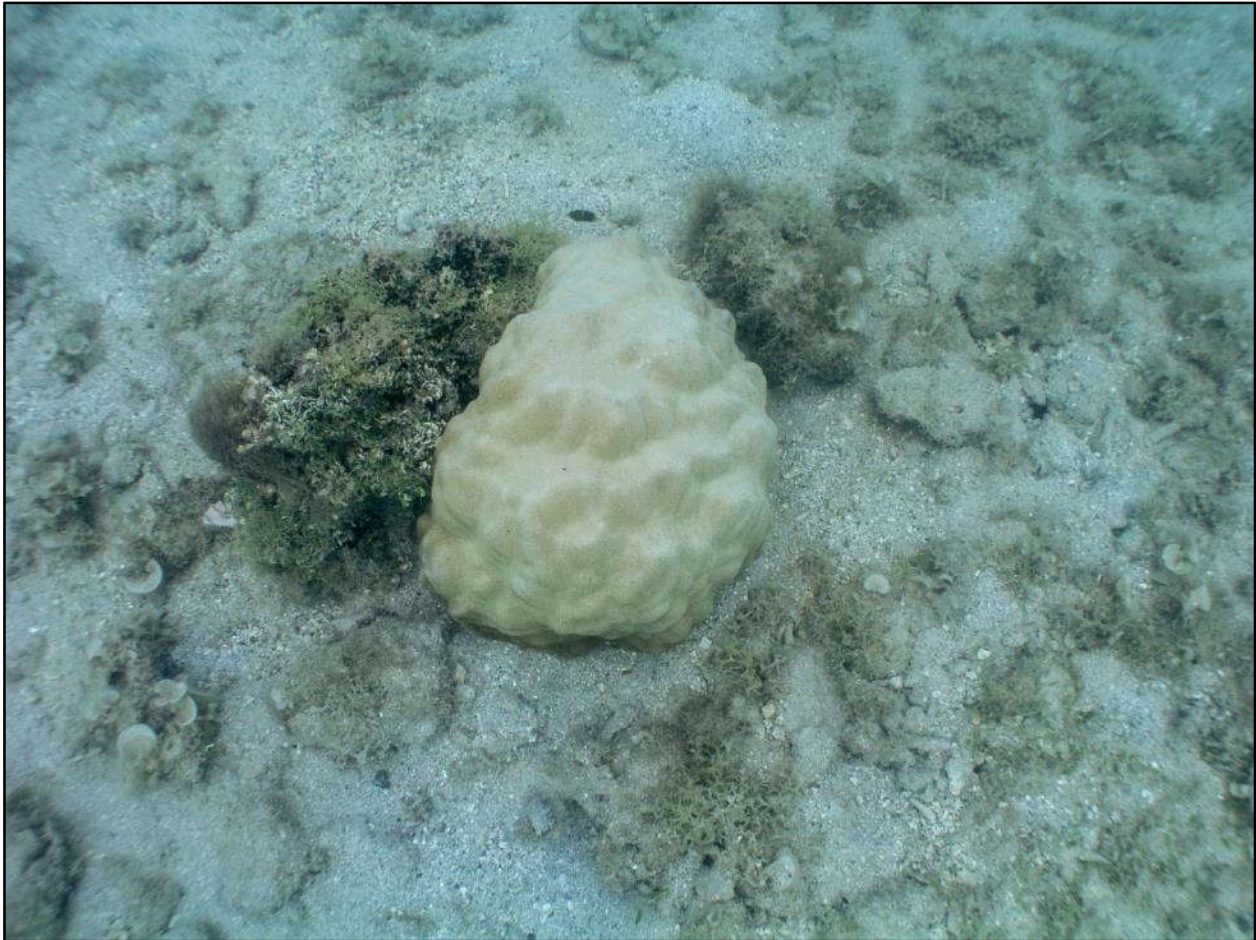
Figure 40. A third massive *Porites* colony located approximately 20 m seaward of the bulkhead, also resting on the unconsolidated substrate in Site E.

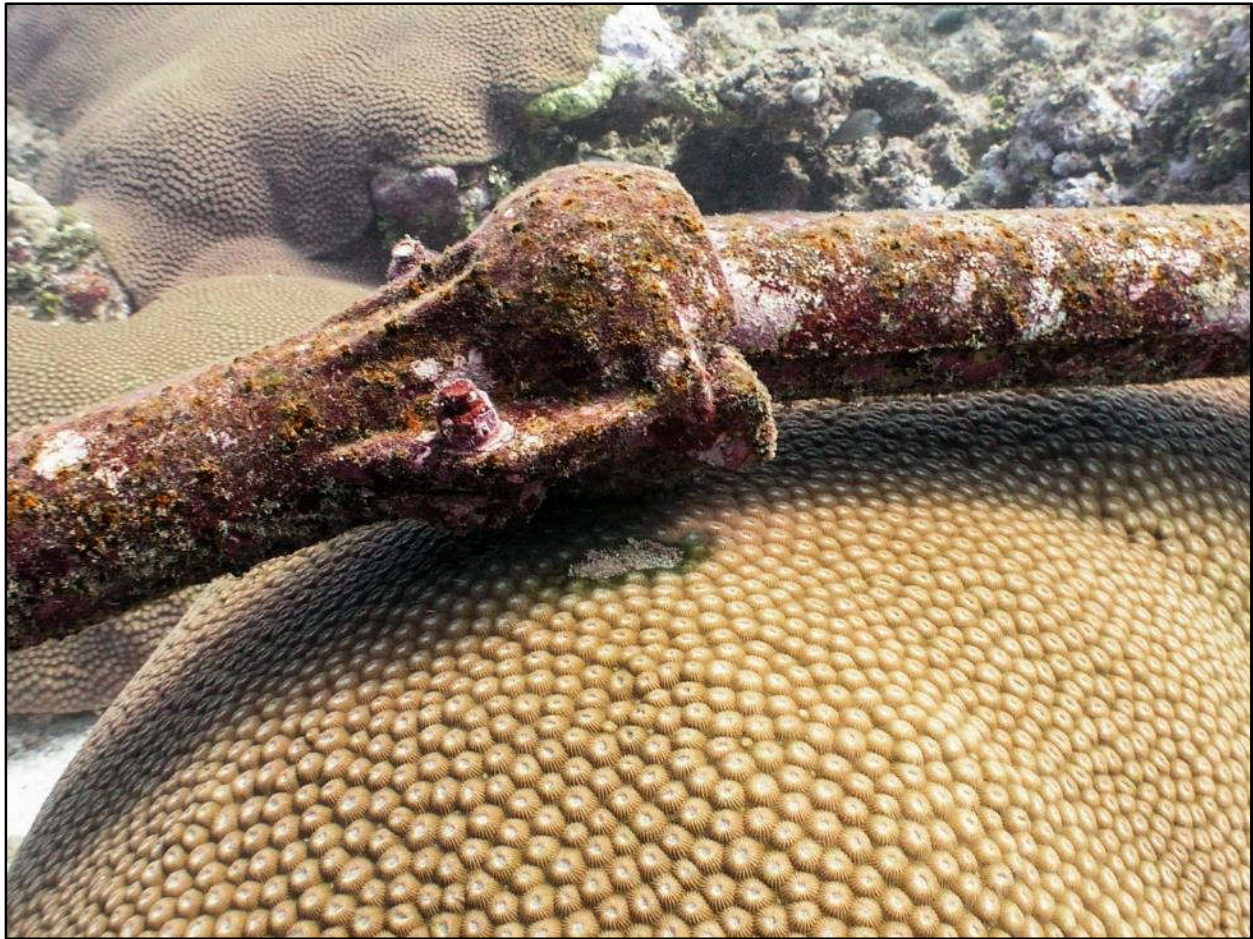
Figure 41. The ATISA Cable resting on the surface of a large *Diploastrea heliopora* colony. The small area of dead tissue may be an area of the colony where the cable had previously rested.

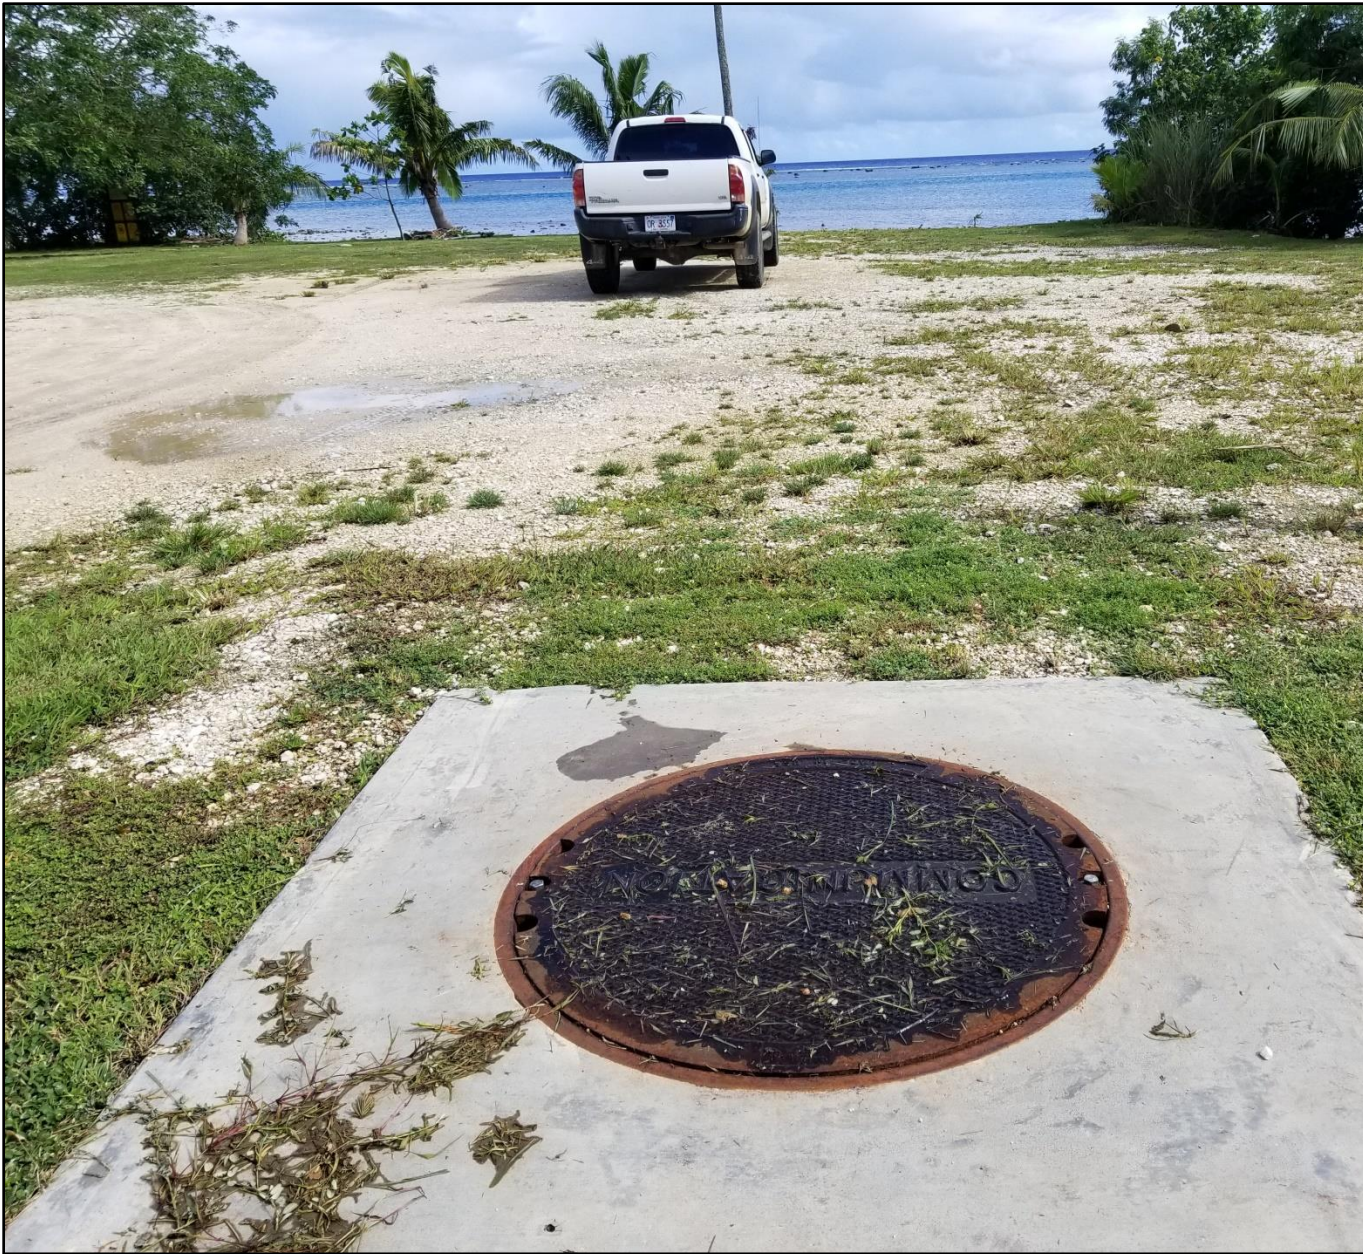
Photo 2. GTA Beach Manhole installed in 2017 located within Santos Park, facing north.

The project will land a single cable through one of the conduits in the GTA raceway, and pull the cable to shore where it will be spliced to land cables at a beach manhole located above the high tide line. The excavator to pull the cable to shore will be equipped with on-board spill response equipment for work near marine environments. These include absorbent pads and booms to be deployed in case of accidental oil leaks. No heavy equipment will be operated in marine waters. Similarly, the cable ship will have on-board spill response equipment to deploy in accordance with the vessel's spill response plan. The Environmental Protection Plan (EPP) developed for the project describes the EPP measures that would be implemented to control discharges and manage spills from heavy equipment operating at the site. Construction would be performed in accordance with specified best management practices (BMPs) to control erosion and minimize sedimentation.

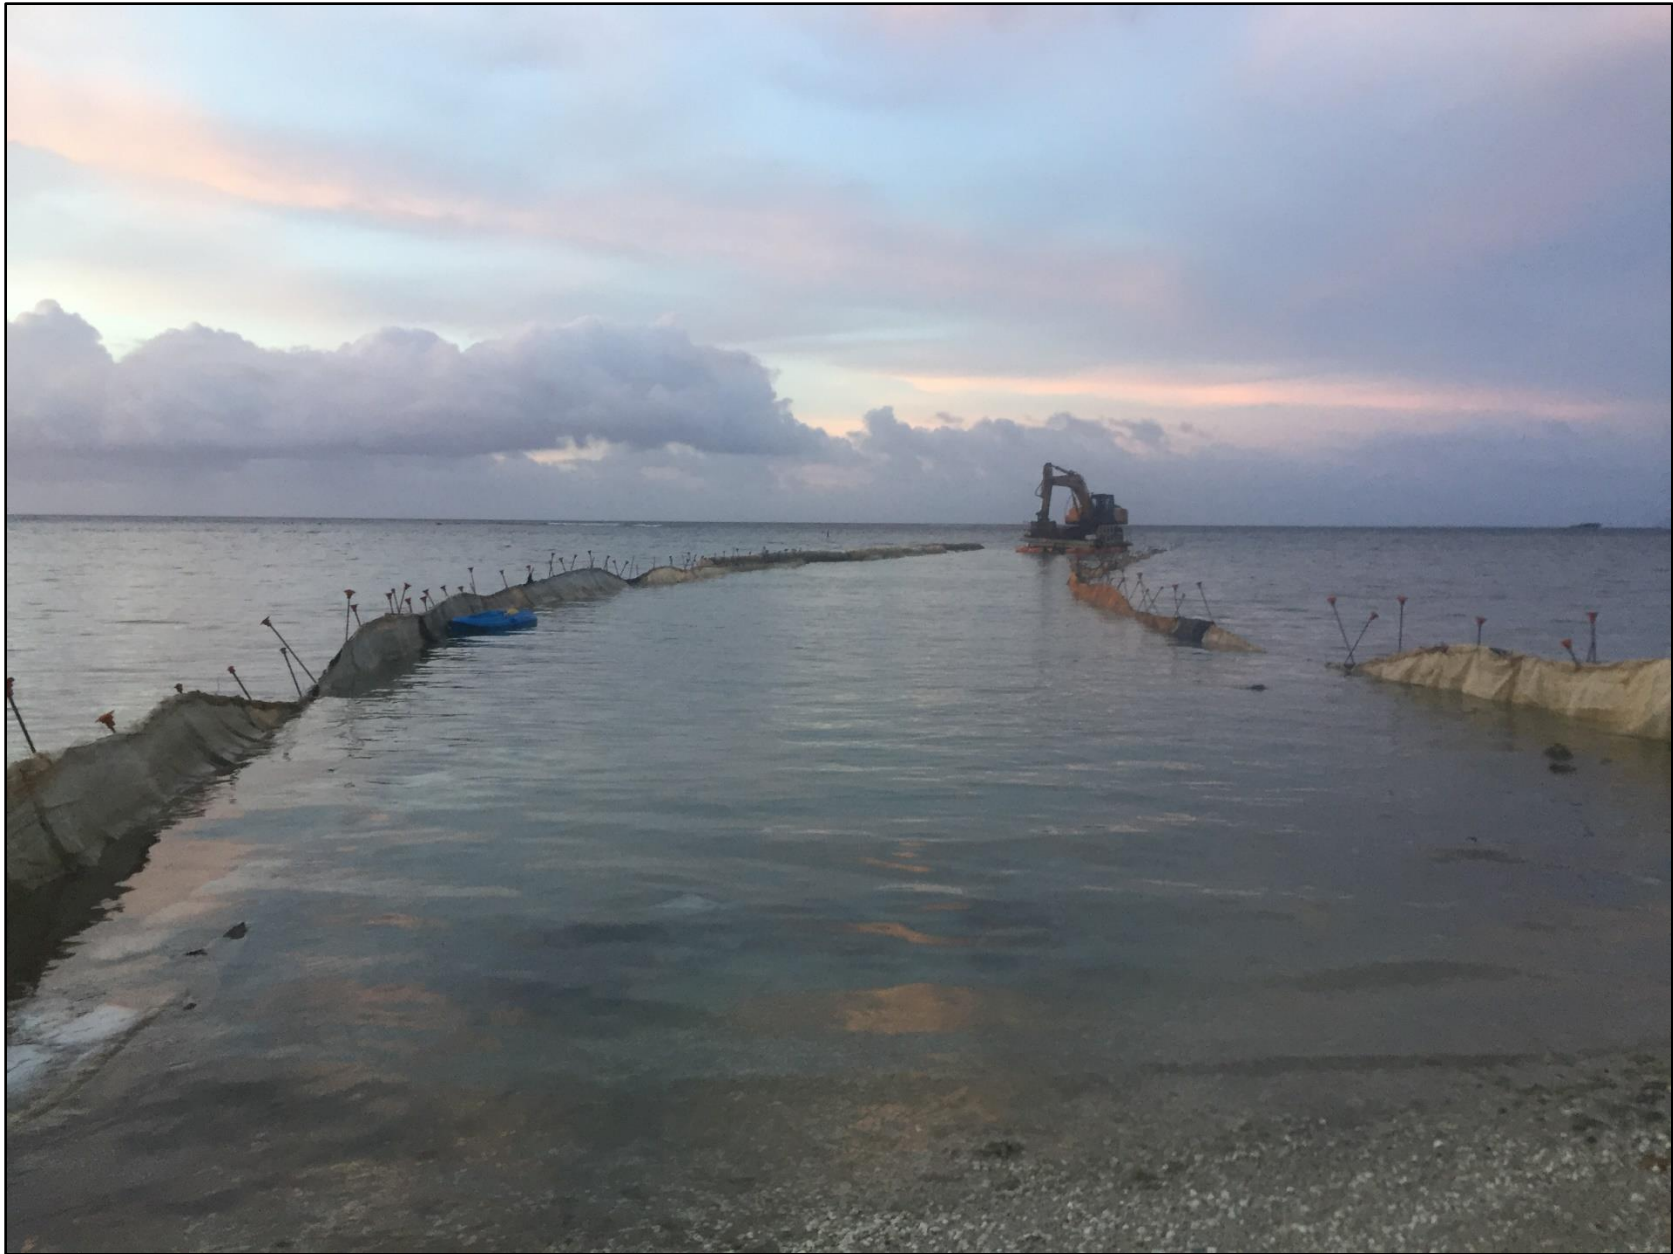
Photo 3. GTA conduit raceway construction corridor. The entrance corridor to allow for small support vessels and pedestrian access would be located entirely within this corridor and would have a smaller area.

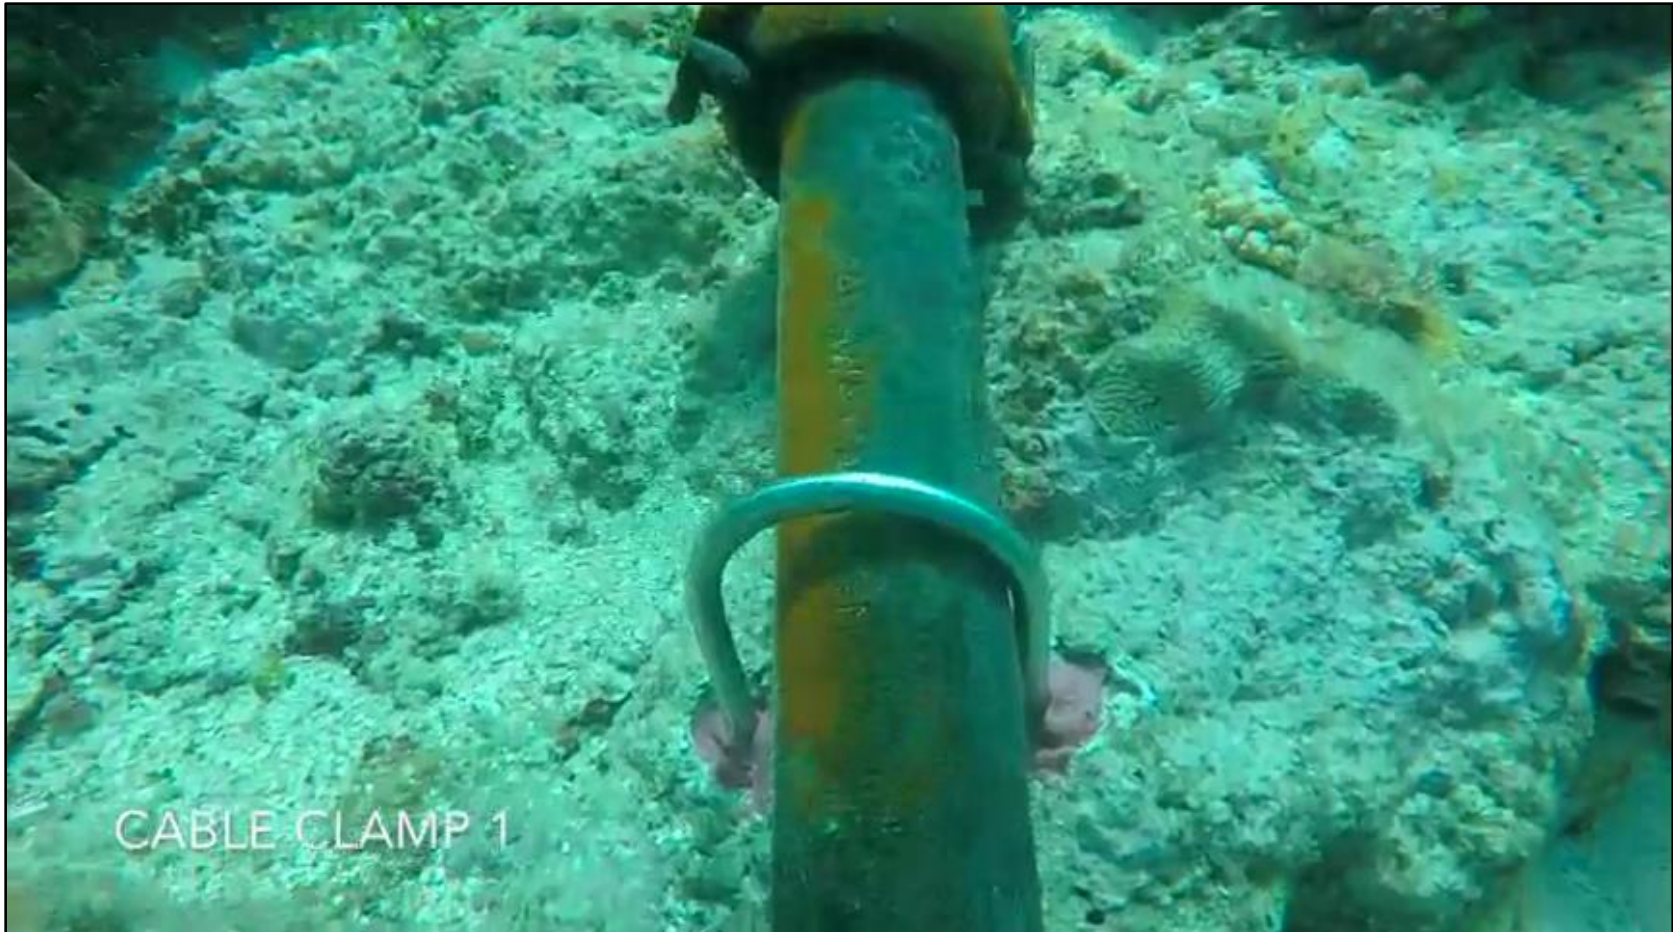
Photo 4. Cable pin installed on the ATISA Cable in 2017. The same hardware and methods would be used for the HK-G Cable pin installation.

- 9) Offshore, the portion of cable encased in articulated pipe will be selectively pinned to the substrate with U-bolts at locations where no live corals are present. The cable will be pinned in the channel and at the channel mouth to prevent lateral movement. The U-bolts will be stainless steel with typical dimensions of 14 in. long, 5 in. wide, and 0.5 in. diameter (38 cm long, 12.7 cm wide, and 1.2 cm diameter). After the U-bolts are positioned over the cable, two 1 in. (3 cm) diameter holes for each bolt will be drilled down to approximately 12 in. (30 cm) with a marine-grade hydraulic drill, and the bolts will be inserted and secured in place with a non-toxic marine epoxy. Pins will be installed in approximately 33 ft. (10 m) intervals along the cable's path over the reef crest. Approximately 20 pins will be installed.

the channel mouth to prevent lateral movement of the cable. The U-bolts will be stainless steel with typical dimensions of 14 in. long, 5 in. wide, and 0.5 in. diameter (38 cm long, 12.7 cm wide, and 1.2 cm diameter). After the U-bolts are positioned over the cable, two 1 in. (3 cm) diameter holes for each bolt will be drilled down to approximately 12 in. (30 cm) with a marine-grade hydraulic drill, and the bolts will be inserted and secured in place with a non-toxic marine epoxy. Pins will be installed at approximately 33 ft. (10 m) intervals along the cable's path over the reef crest. A total of 20 pins will be installed.

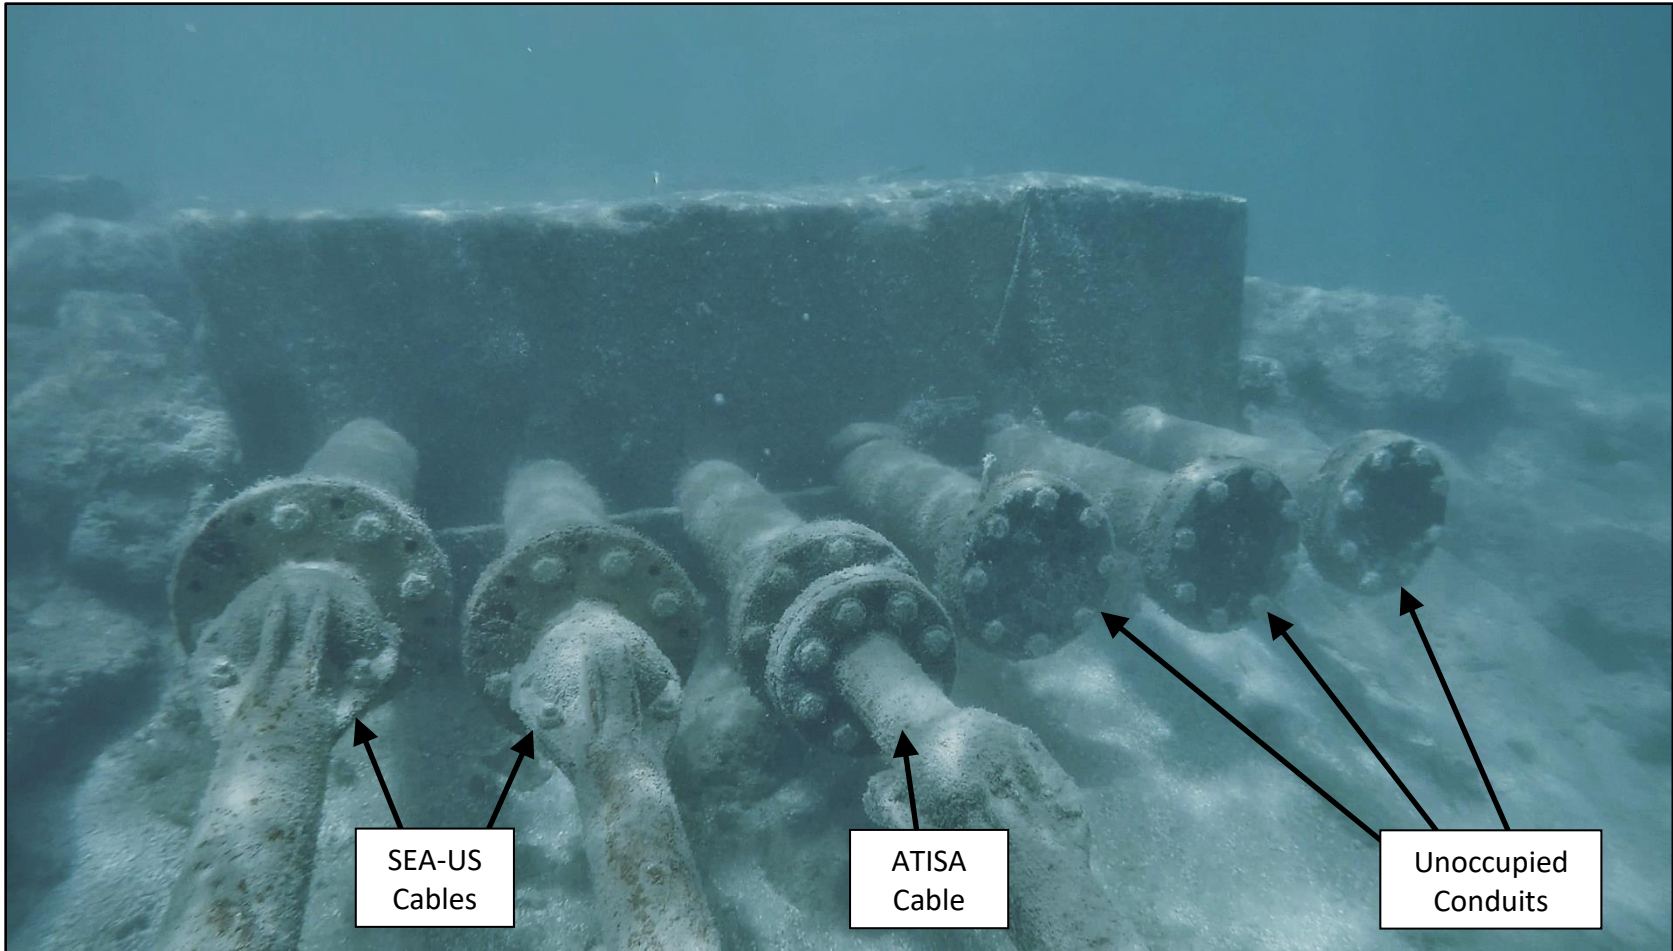
Photo 6. Bulkhead with two SEA-US Cables, ATISA cable, and three unused conduits, facing south.
