**Aquatic Specialist Impact Assessment for the Section 24G
and Water Use License Applications required for the
proposed Village Ridge housing development on Erven
21028 and 21029, George**

Prepared by Dr. Jackie Dabrowski of Confluent Environmental (Pty) Ltd

February 2022

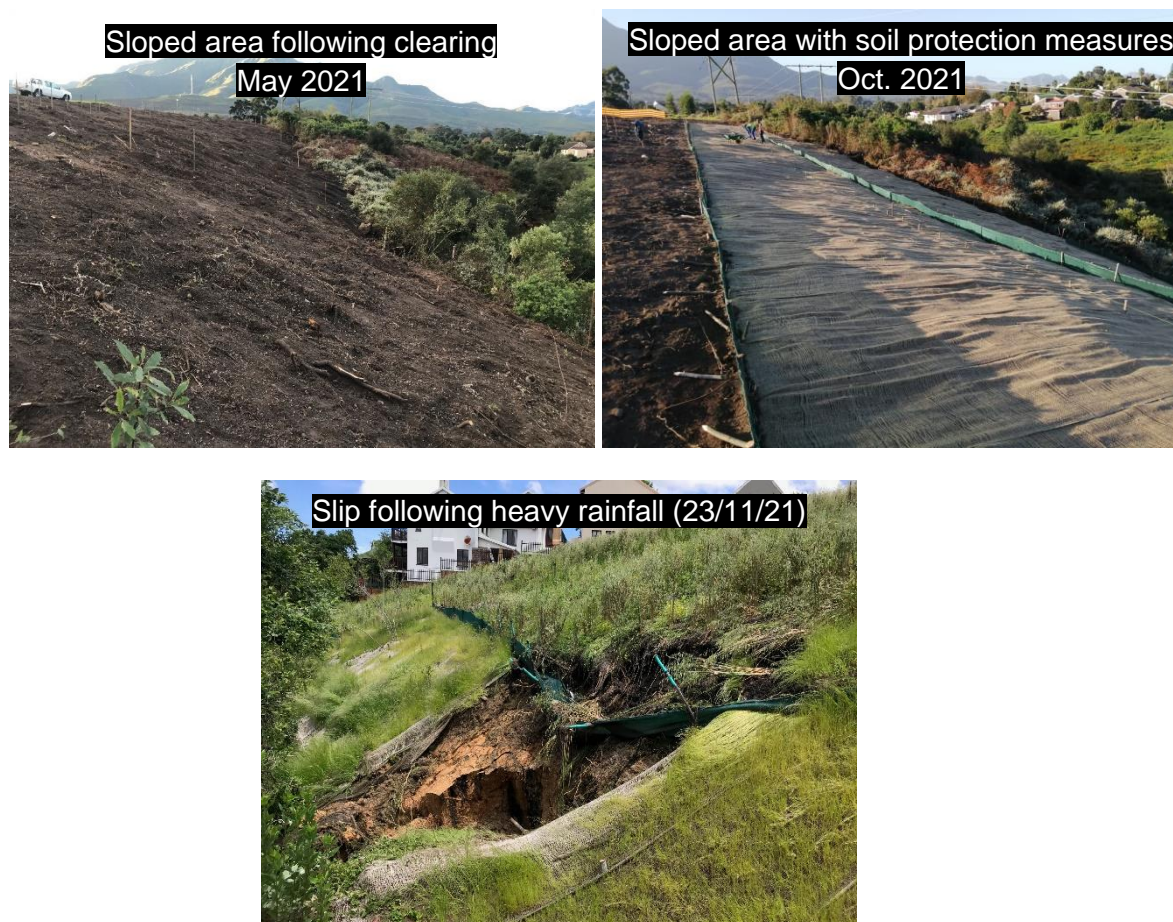
An area of riparian vegetation measuring 1 928 m² was cleared down a steep slope towards the Camphersdrift Wetland on Erf 21029. The potential for soil erosion was immediately mitigated through the installation of soil protection measures including seeding with Oats, laying of soil mats, and installation of silt fences (Erosion control on slope in Figure 1; Confluent Environmental, Immediate Mitigation V3; Figure 2). Unfortunately, heavy rainfall on 22 November 2021 resulted in a soil slippage at the base of the slope which will need to be reinforced and rehabilitated.

Figure 2. Photo of the area where riparian vegetation was cleared (left) subsequently stabilised with soil erosion control measures (right), and where a slip occurred following heavy rainfall on 22 November 2021 (below).

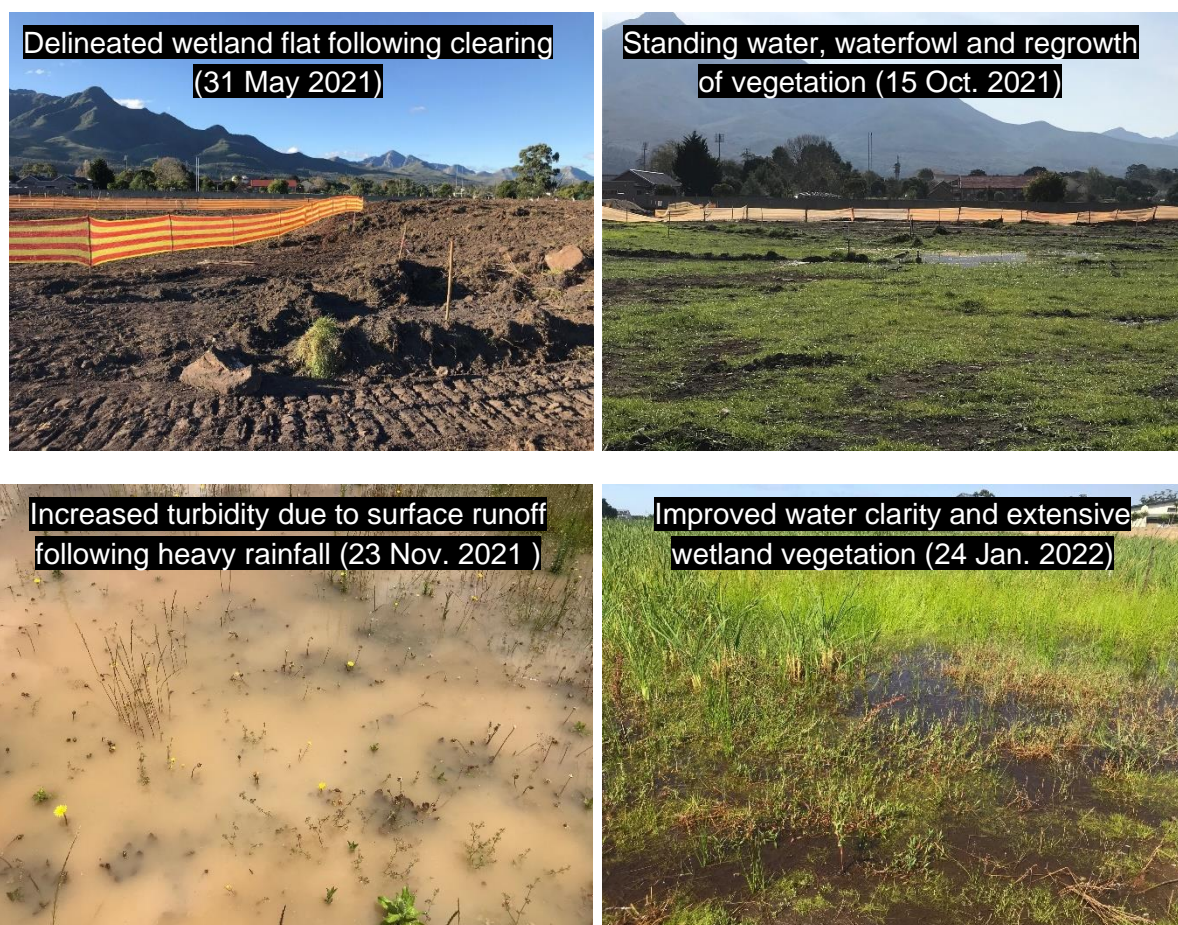
The wetland flat area on Erf 21028 was cleared of vegetation and excavated, and a large quantity of soil was placed over approximately one third of the area. Following the initial delineation and demarcation of the No Go area, most of the fill was removed. Over the course of 6-8 months of good rainfall, wetland vegetation started to regenerate, and there is frequently standing water on the surface which attracts waterfowl such as Egyptian Geese and Yellow-billed Ducks (Figure 3).

Good water quality with high clarity is an important requirement for *A. knysnae*. Events such as increased turbidity following heavy rainfall on 22 November therefore need to be considered and mitigated in future construction and operational phase activities (Figure 3). The

Figure 3. Photo of the wetland flat immediately after it was excavated, partially infilled and delineated (top left), approximately 3 months following removal of the infill material and cessation of work in the area (top right), water quality following heavy rainfall on 22/11/21 (bottom left), and following extensive regrowth of vegetation and good rains (bottom right).

Immediately following the excavation and infilling of the wetland flat, the PES would have been significantly worse than the current PES determined (Refer to photo sequence in Figure 3). The DEA&DP directive to cease work in the wetland and delineate it as a no-go area, along with recommendations to remove the infill partially covering the wetland (Confluent Environmental, 2021) have resulted in prevention of further damage and a remarkable recovery of the wetland over an 8-month period (May 2021 to January 2022).

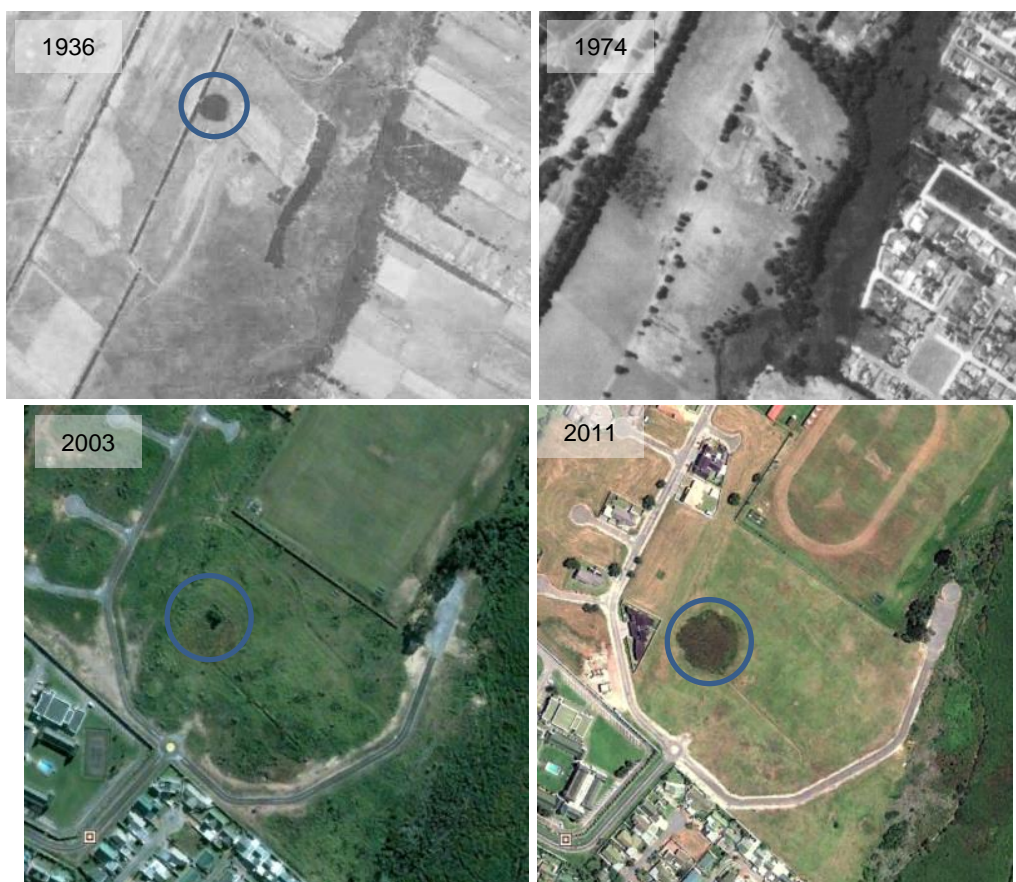
Most of the development area has been disturbed for many decades. The earliest aerial photo of the site is from 1939, where both the circular wetland flat is clearly visible as distinct vegetation, as well as the Camphersdrift Wetland. At this time the development area was used as agricultural land. Possibly grazing for livestock. In a few subsequent aerial photos, such as 1974, the wetland flat is not discernable, and may have been partially drained or mowed during a dry phase. Dense fringing vegetation, possibly alien, is visible along the Camphersdrift Wetland. From 2000 onwards the site was further disturbed with construction of Loch Lormondry Road. The road was built up with soil and fill material within its footprint, and there is still infill material such as broken bricks evident on the slope above the Camphersdrift Wetland (observed during site visits).

Figure 8. Historical aerial and satellite images showing the development site including the wetland flat area when it is visible (blue circle).

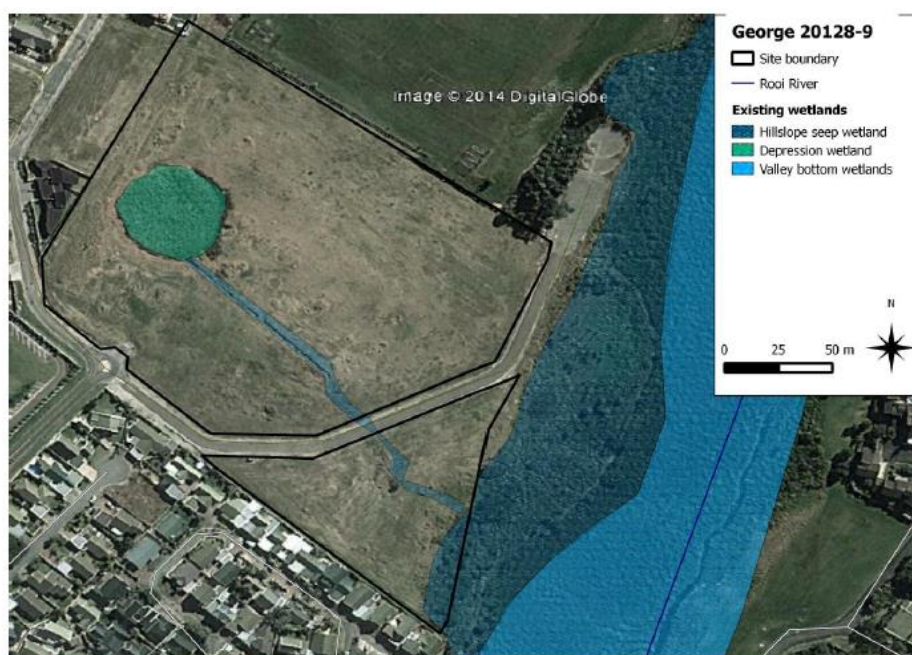
Sensitive vegetation and wetlands on Erven 21028 and 21029 have been previously assessed. Ractliffe (2014) and Vlok (2014) provided specialist inputs on aquatic and botanical aspects of the site respectively. Ractliffe (2014) identified the wetland flat (depression wetland), a connecting channel, and hillslope seep adjacent to the Camphersdrift wetland. Buffers were recommended for these areas as indicated in Figure 11. Wetland buffers were 30 m and the interconnecting channel was 25 m.

Figure 11. Wetlands identified on Erven 21028 and 21029 (above) and buffer recommendations (below) from Ractliffe (2014).

Through discussion with Ractliffe (*pers. comm.* 21/06/2021) the following issues pertaining to the buffers identified in Figure 11 were identified:

1. The Ractliffe assessment was meant as a scan of sensitive aquatic habitat on the site, and not a complete and thorough assessment.
2. The recommended buffers were based on commonly applied distances at the time, and were not established using the subsequently developed tool for determining buffers for wetlands and rivers (Macfarlane & Bredin, 2017).
3. Both wetland areas were not delineated in detail using methods developed for this purpose (DWAF, 2005). Soil augering was conducted in the middle of each wetland to confirm wetland conditions only.
4. The linear channel leading from the wetland flat (depression) visible in various historical images is entirely artificial and had no features of a watercourse. It appears to have been dug at some point in an unsuccessful attempt to drain water from the wetland.

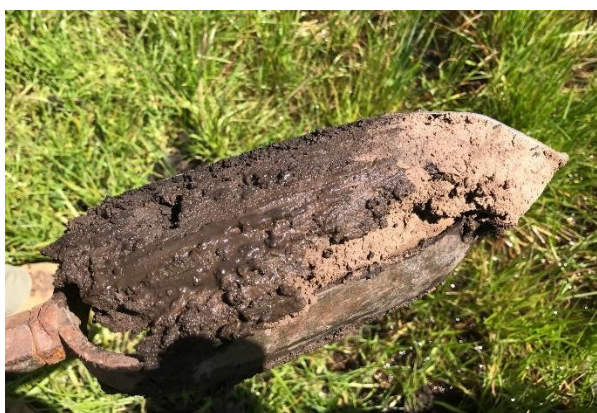
This is a Tukulu soil form. Plinthic soils have characteristic accumulations of iron and manganese oxides and hydroxides that form localised high-chroma (coloured) mottles and concretions. These features develop in zones of periodic water saturation at the limits of a fluctuating water table. The soft plinthic layer is underlain by hard plinthite which is also known as laterite. The gleyed layer shown in soil auger samples from the wetland flat indicate a layer of permanent saturation at approximately 40 cm depth at this location (Figure 12). These soil features indicate that groundwater inflow from a fluctuating water table interacts with rainfall which accumulates above the clay later. Soil features were also confirmed on site with Professor Josua Louw, a lecturer in soil science at the Nelson Mandela University.

Figure 12. Soil auger sample from the wetland flat showing gleyed (grey) material >40 cm depth.

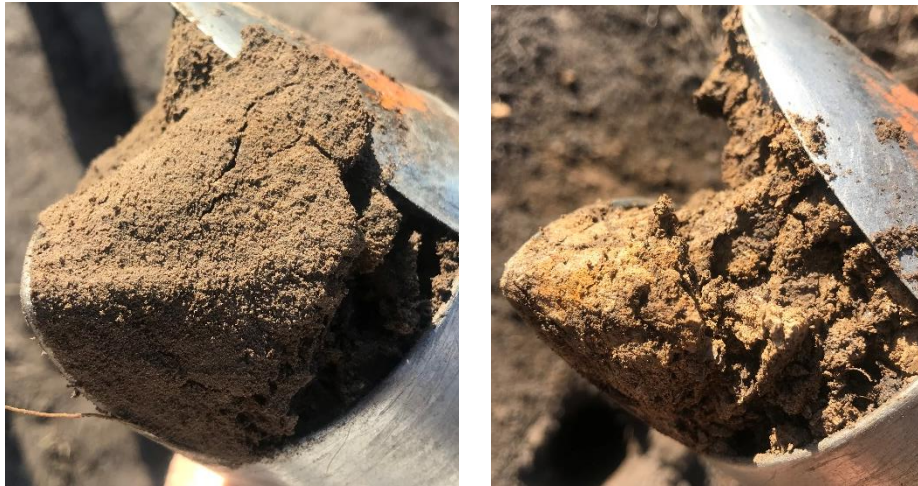
As vegetation was recently cleared on the slope above the Camphersdrift wetland, soil indicators were used to delineate the wetland in this area. A series of four transects perpendicular to the Camphersdrift wetland were augered up the slope where vegetation was cleared. Augering was conducted approximately every 2 – 3 m along the transect. Soils were augered to a depth of 50 cm to search for evidence of permanent, seasonal or temporary wetness. The delineated edge of the wetland was determined as the line between auger points indicating temporary wetness and no wetness (Figure 13). Delineated wetland areas in the vicinity of the two erven to be developed are presented along with the revised buffer recommendation in Figure 14.

Figure 13. Example of augered soil down the slope towards Camphersdrift wetland showing soil with no wetland indicators (left) compared to soils with indicators of temporary wetness (right).

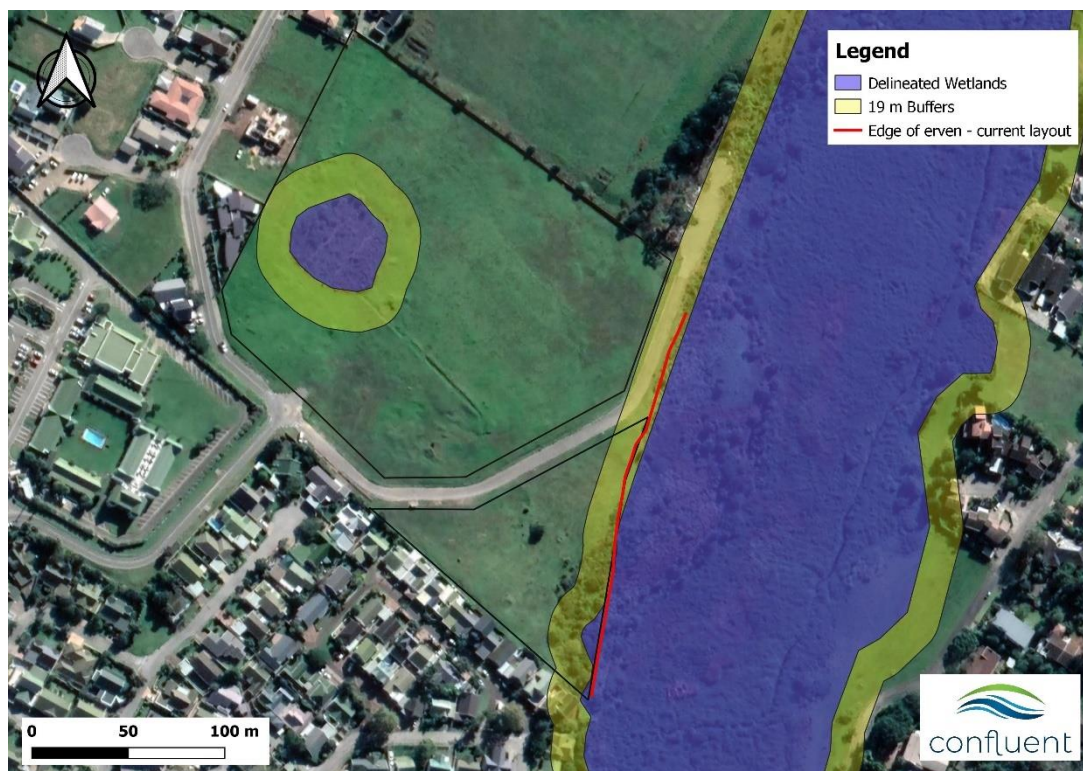
Figure 14. Delineated wetland areas and recommended buffers for Erven 21028 and 21029. Red line indicates the edge of erven in the Approved Development Plan.

The revised aquatic buffers of 19 m have been considered by the amphibian specialist (F. de Lange) and were determined as adequate for the purpose of protecting *A. knysnae* in the wetland flat. The 19 m buffers were therefore incorporated into the Preferred Development Plan and development of housing removed from these areas.

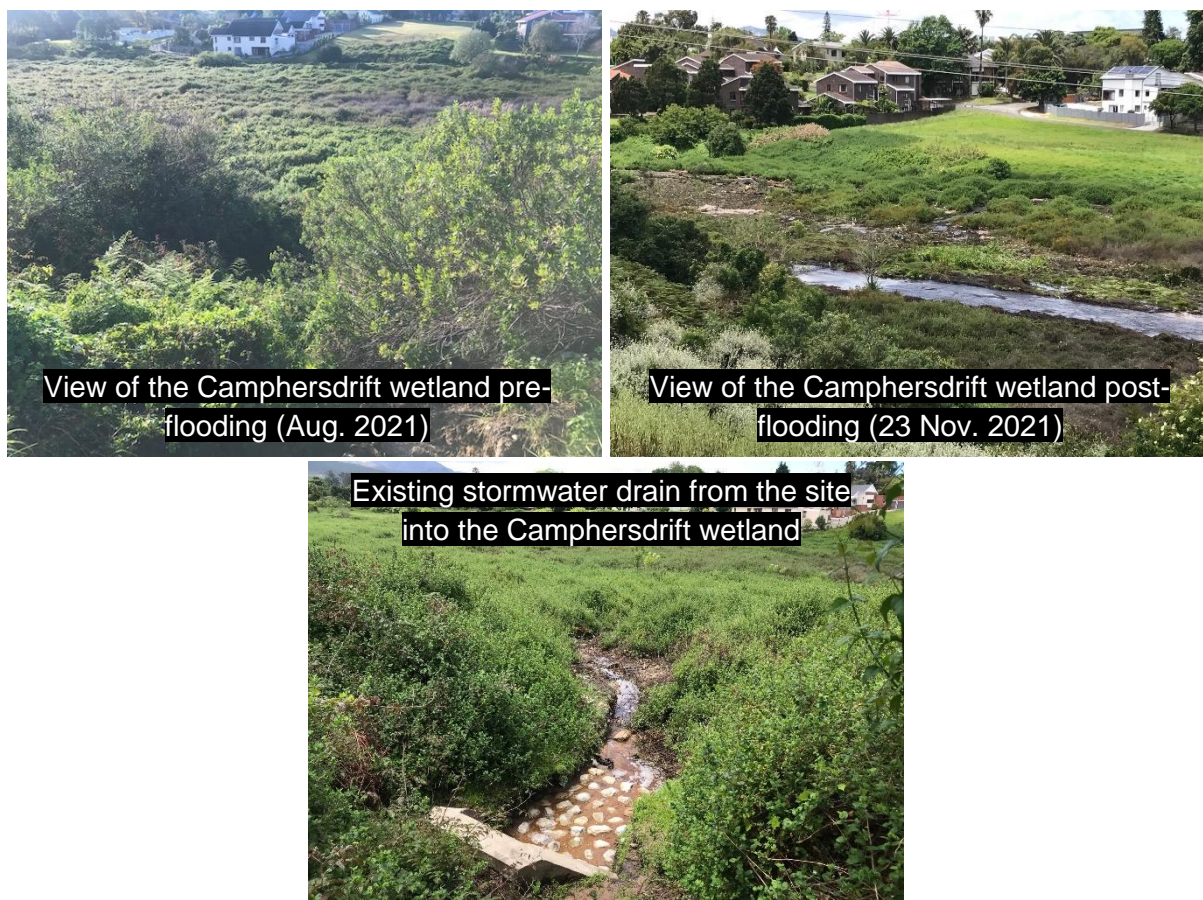
Present Ecological State
HYDROLOGY
Major increase in flood peaks due to hardened surfaces and stormwater discharge into the wetland
Minor increase in inputs due to discharge from various urban sources
Reduced surface roughness in catchment areas
Hydrology PES Category: C, Moderately Modified
GEOMORPHOLOGY
Infilling associated with the bulk municipal sewer line and historical road construction on Erf 21029
Increased runoff resulting in more extensive channelling of the wetland and channel incision
Downcutting / erosion of the channel occurring due to stormwater flows
Geomorphology PES Category: B, Largely Natural
VEGETATION
Infilling / infrastructure has replaced / disturbed natural vegetation in areas (e.g. sewer line)
Isolated dense patches of aliens, especially Lantana, are present
Lawn / parkland has replaced wetland vegetation on the opposite bank
Downcutting of the wetland channel has removed extensive wetland vegetation exposing the wetland to increased risk of alien encroachment.

Figure 15. Camphersdrift wetland showing various impacts considered in the PES assessment.

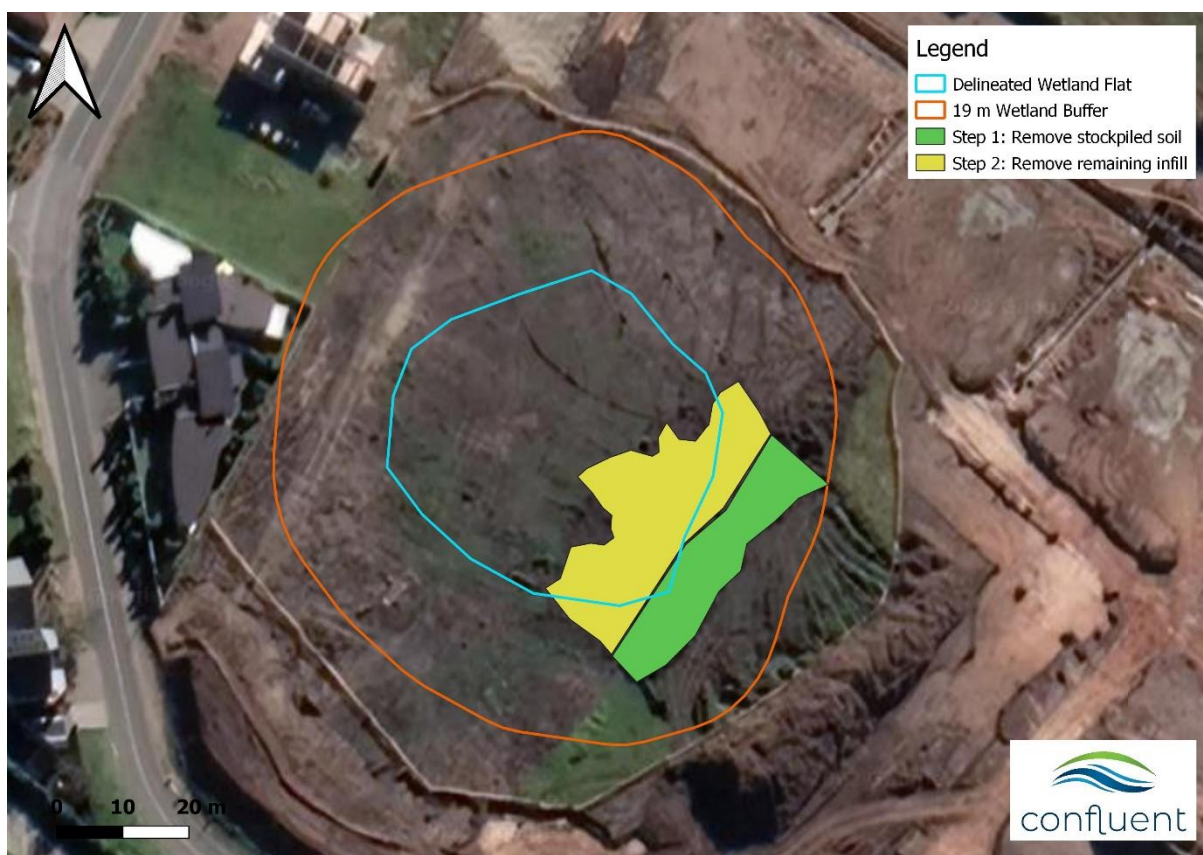
Figure 16. Map showing Step 1 and Step 2 soil to be removed from the Wetland Flat and buffer area.

- Use topsoil from the site to build a continuous, gently sloping soil berm approximately 60 cm high which runs along the inside edge of the 19 m buffer. This is in line with recommendations from the amphibian specialist study and aims to ensure stormwater runoff doesn't enter the Wetland Flat during both the construction and operational phases.

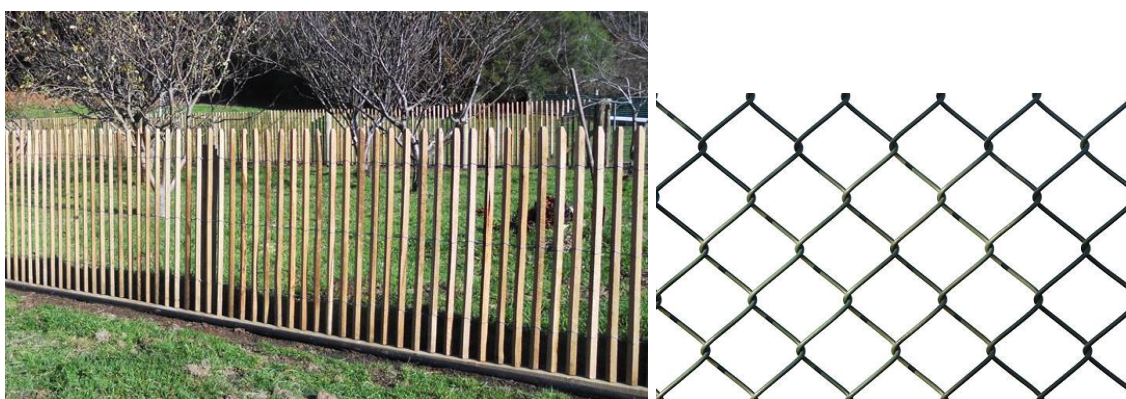
Figure 17. Suggested fencing showing wood latte for aesthetic appeal, approximate spacing so the wetland is visible, and diamond mesh which must be on the inside of wooden latte.

- Single pedestrian entry gate that can be locked
 - Suggested construction should be similar to that indicated in Figure 17. The wetland should be clearly visible beyond the fence, and diamond mesh is recommended on the inside.

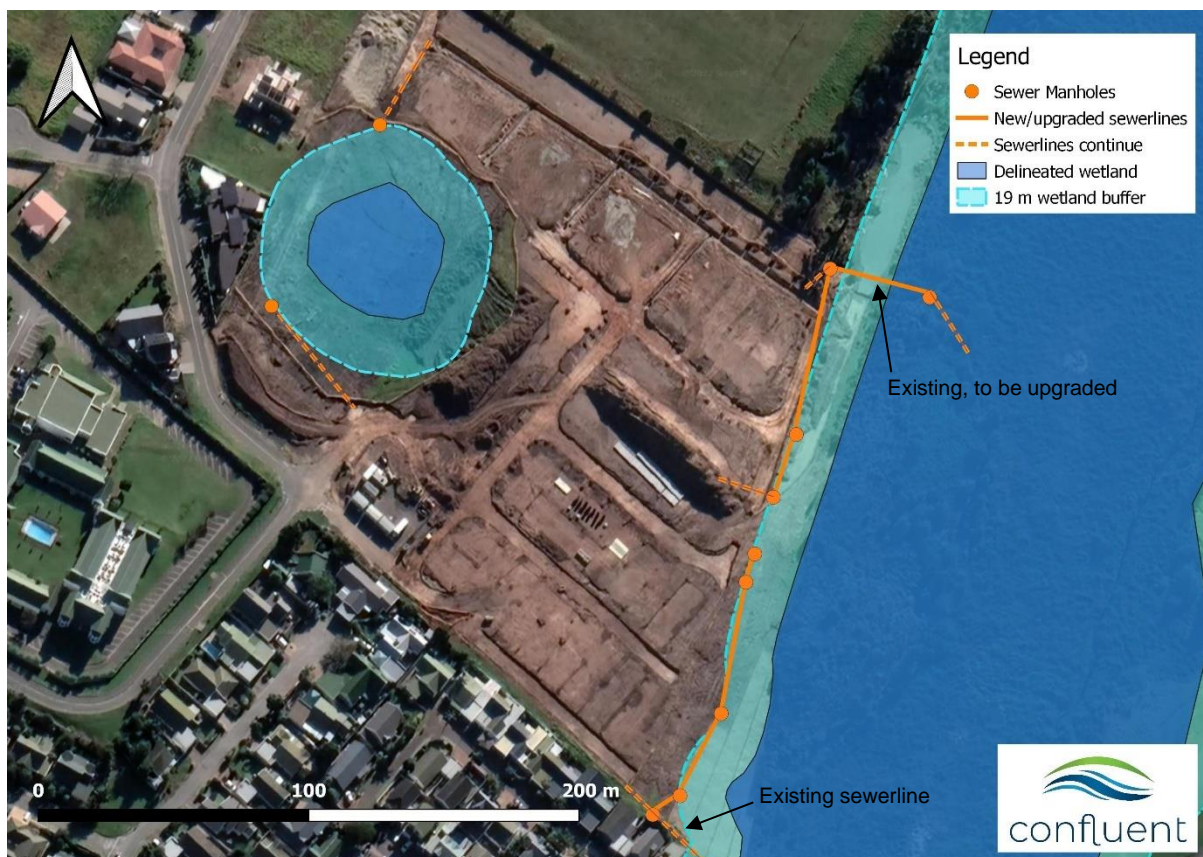
Along with standard expected methods for installing sewer pipelines and manholes, a method statement provided by Power Construction for the upgrade of the northern sewer line was used as the basis for the impact assessment and is provided in Appendix 7. Mitigation measures provided in Table 15 are applicable to the installation of sewer lines in proximity to wetland areas or buffers as indicated in Figure 18.

Figure 18. Mapped sewerlines and manholes for the Preferred Layout in direct proximity to wetland and buffer areas (Refer to Zutari Engineering Services report, 2022).

The feasibility of reducing the depth and resulting disturbance footprint for the sewer line connection to be upgraded may only be determined during construction, as the contractors were not able to locate the actual position of the manhole prior to receiving the directive to cease work on the site. However, assuming all mitigation measures can be implemented, the impacts are considered **Negligible** (Table 15).
