**TERRIEN-LANATA STUDY**  
of an  
**Eversource Right-Of-Way**

**2042 & 2060 NEW LONDON TURNPIKE  
GLASTONBURY, CONNECTICUT**

**April 2020**

### **THERRIEN - LANATA STUDY OF AN EVERSOURCE RIGHT-OF-WAY SEGMENT**

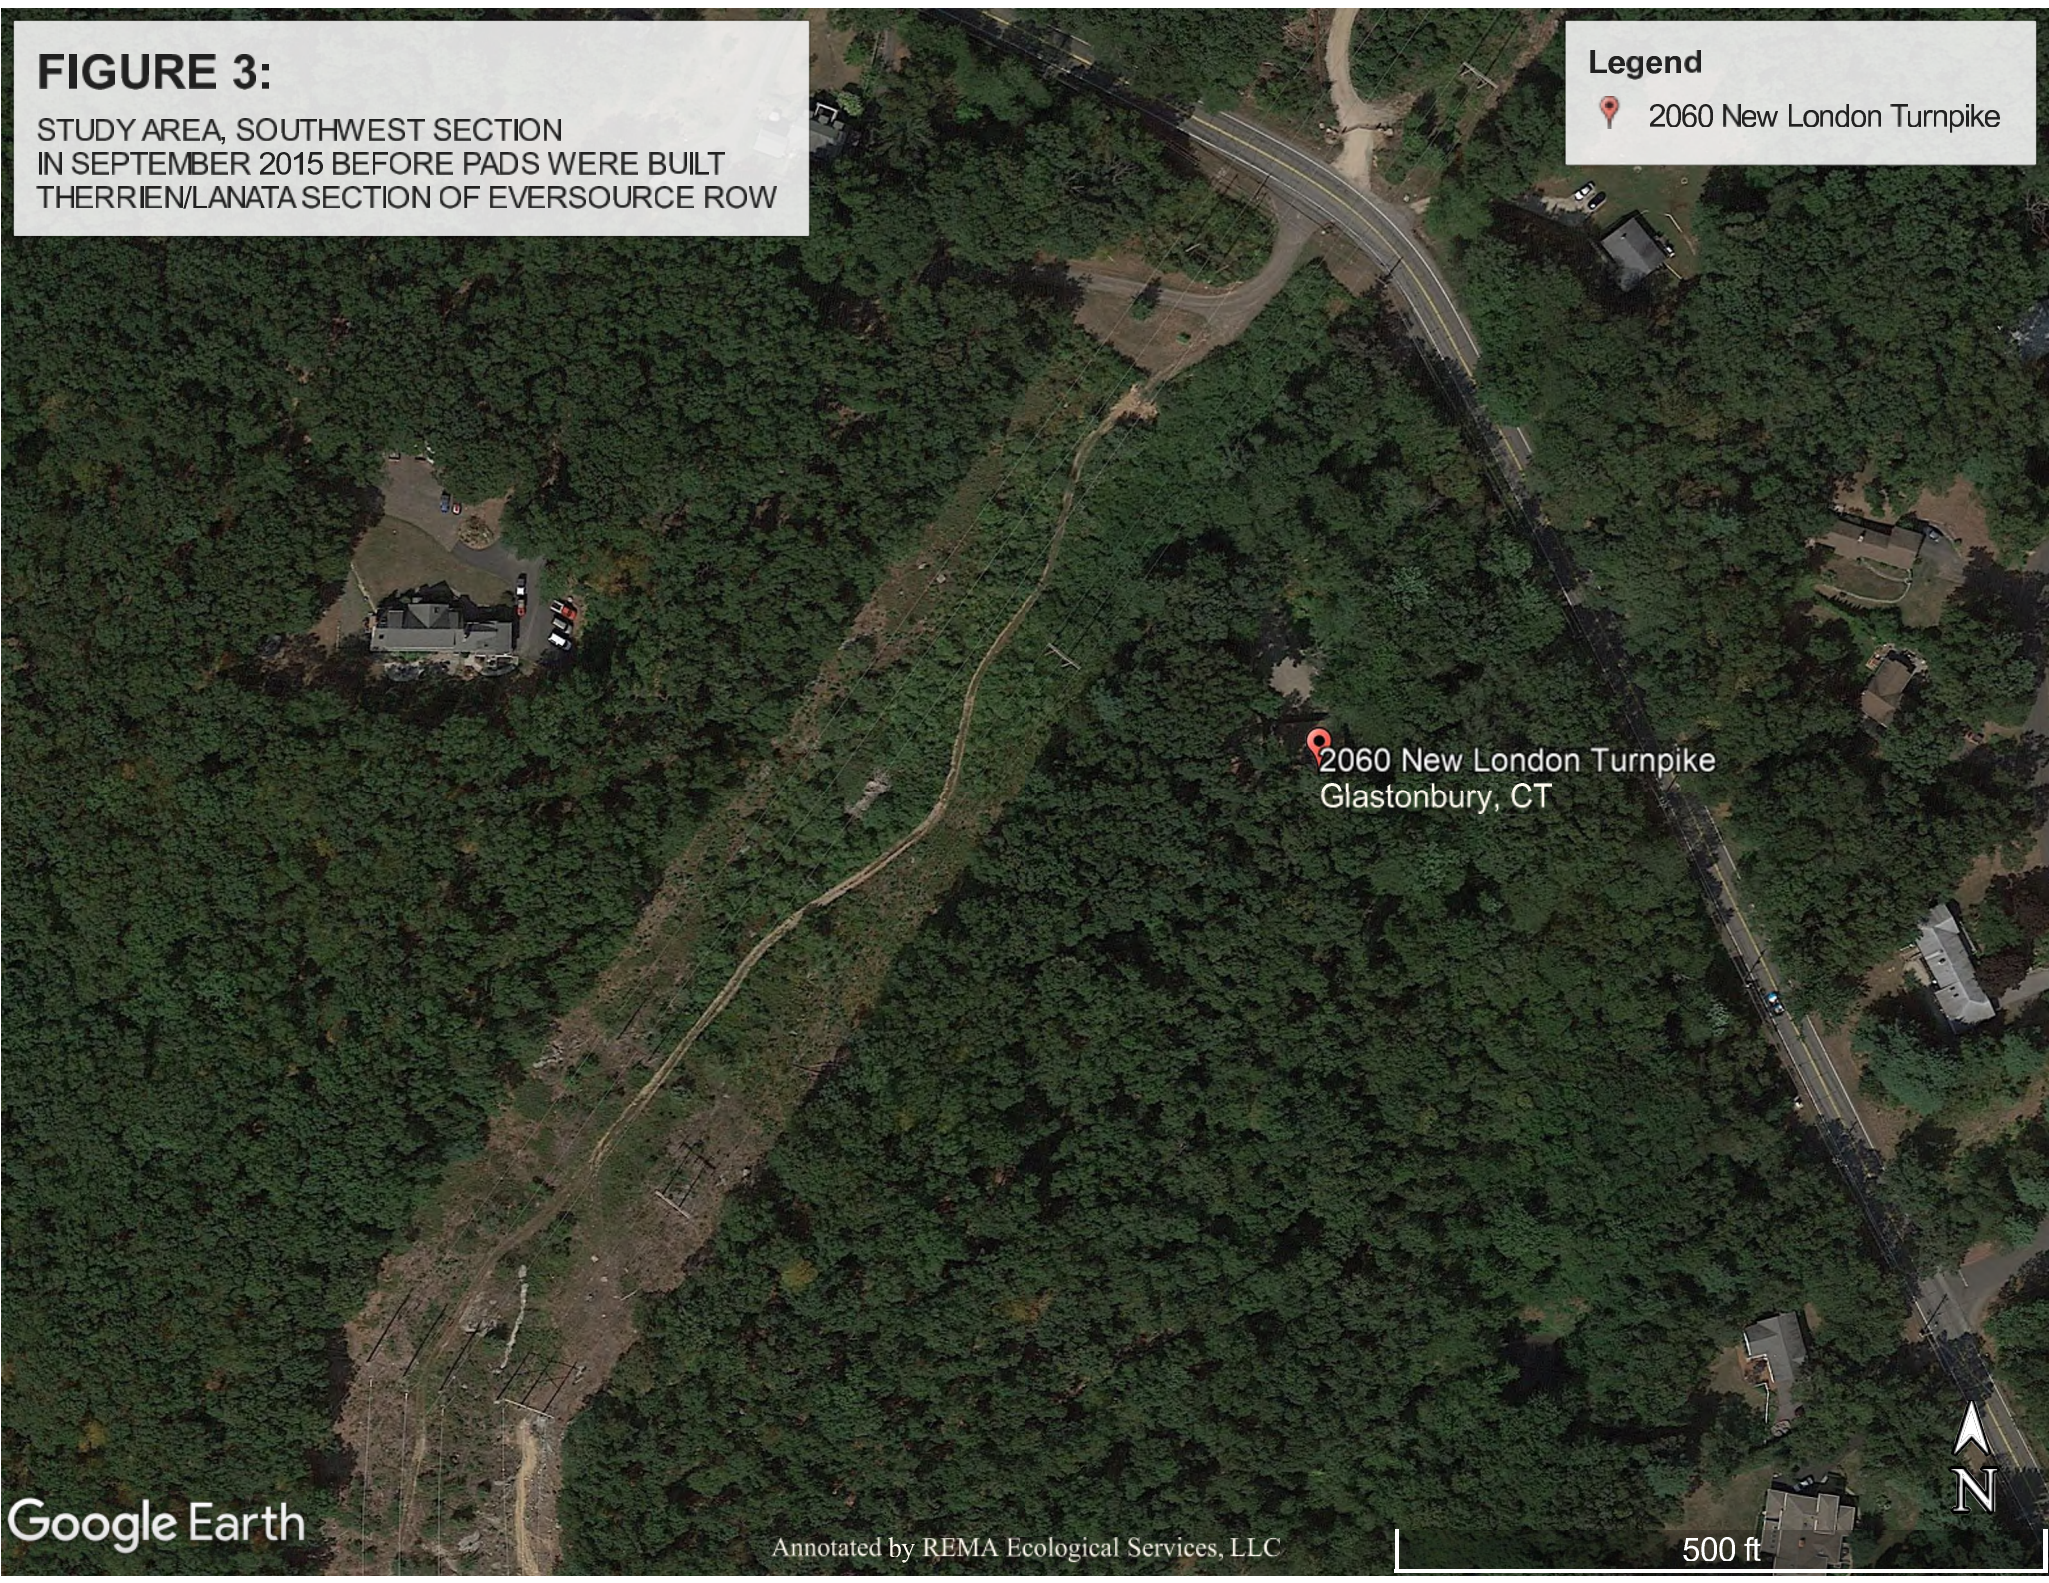
# FIGURE 3:

STUDY AREA, SOUTHWEST SECTION  
IN SEPTEMBER 2015 BEFORE PADS WERE BUILT  
TERRIEN/LANATA SECTION OF EVERSOURCE ROW

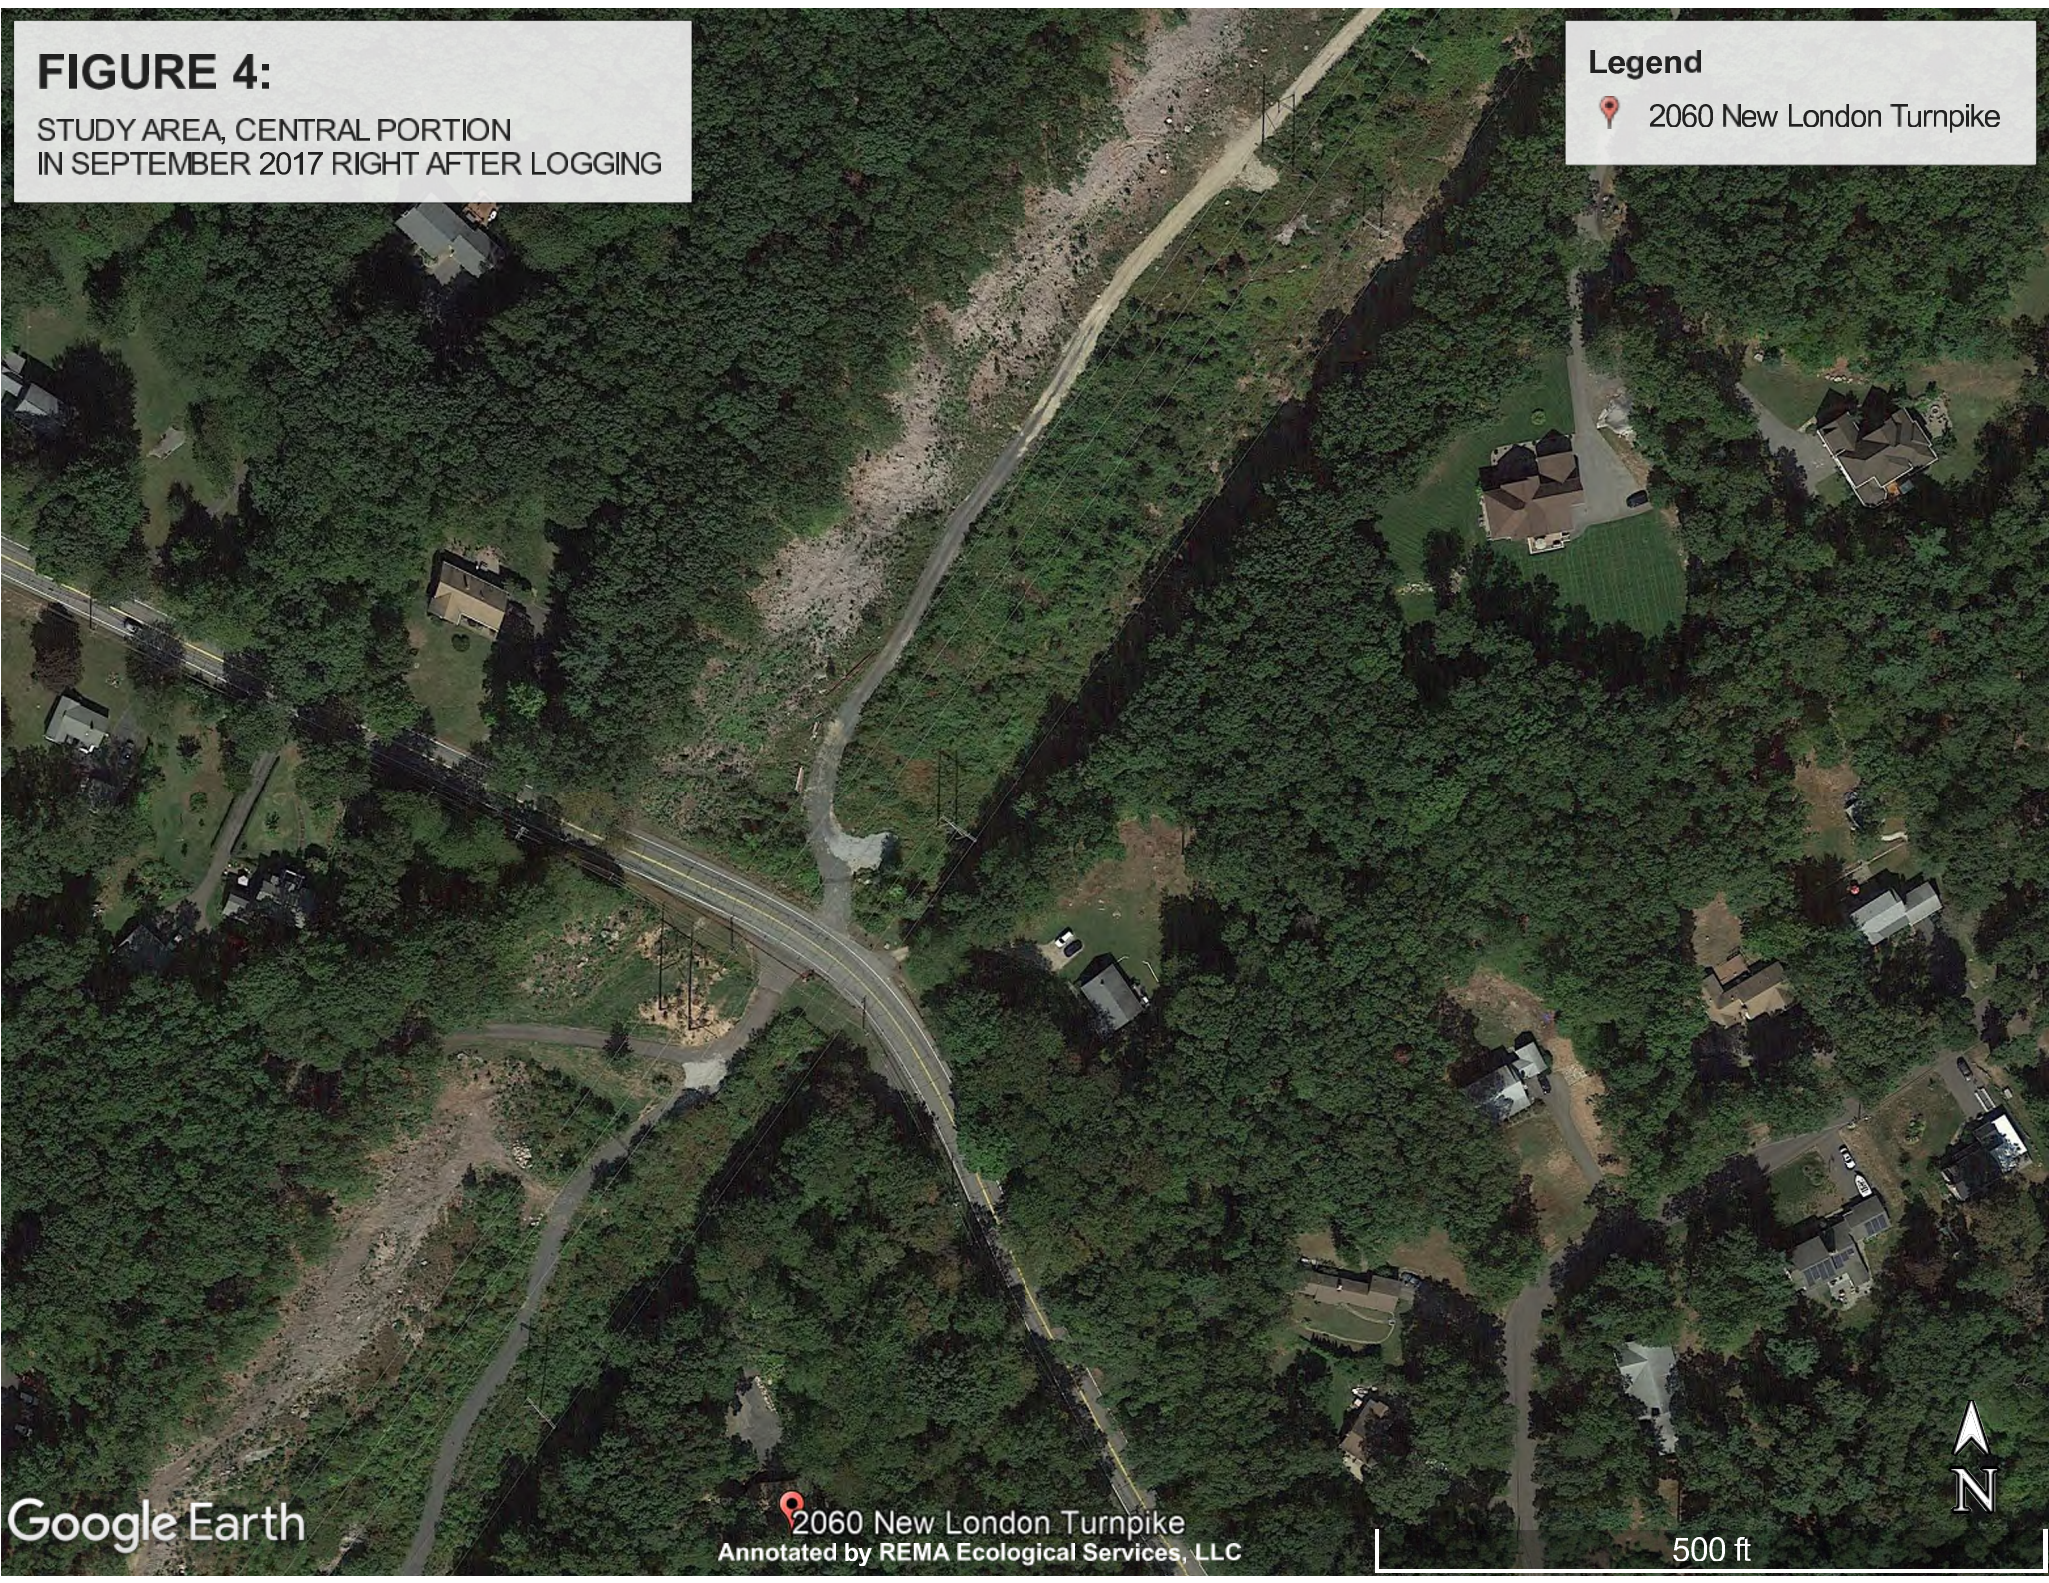
# FIGURE 4:

STUDY AREA, CENTRAL PORTION  
IN SEPTEMBER 2017 RIGHT AFTER LOGGING

**Plot 4** was established in the wetland area, not shown on the NRCS-USDA soils map, that occupies the south side of the northeastern Eversource-owned ROW segment, mostly under the wires. The wetland habitat in Plot 4 was not buried by thick wood chips, as shown in Figure 4.

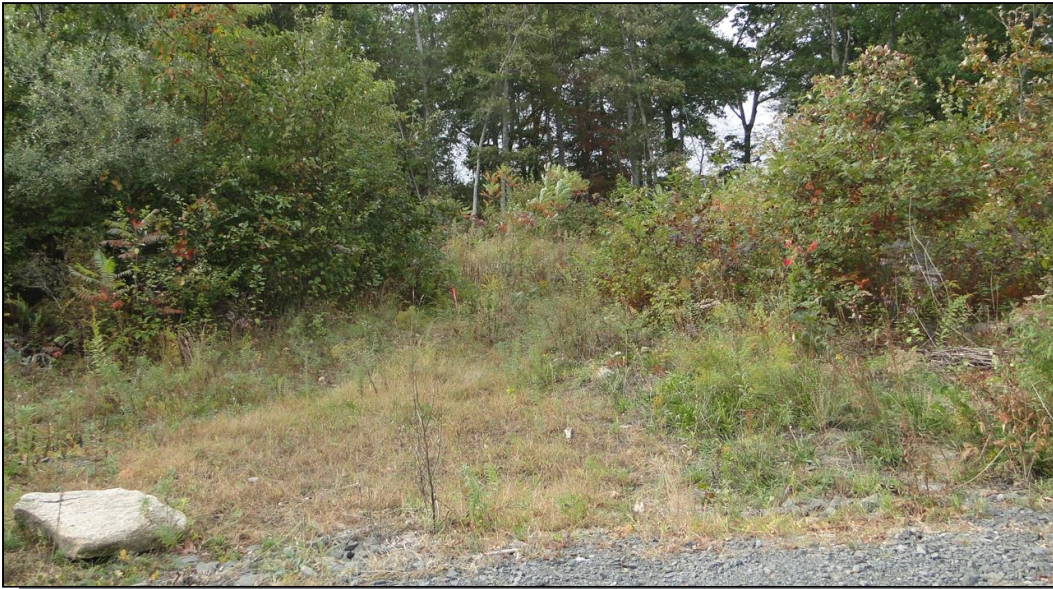
Photo 5: Mosaic of low shrub, meadow & high shrub cover types in Plot 1 in the southwestern ROW segment, on Lanata property, facing northwesterly. 10-7-19.

**Plot 1**, on both sides of the service road on the lower slope in the southwestern ROW segment includes minimally disturbed, and areas shaded by tall shrubs, and several moisture regimes. A strip of blooming forbs is on each side of the service road, and along one access path. Plot 1 has high density, complex structure and high species diversity: 19 woody species and 40 herb species. A robust population of the round-fruited rosette panicgrass, *Dicanthelium sphaerocarpon* is dominant in a hillside meadow; a variety of this grass is listed as a CT *Species of Special Concern*, likely to be extirpated. (See Photos 5 and 6, Attachment B.) Woody species include several regularly topped red cedars, oak saplings less than 15 feet tall, and invasive glossy buckthorn. This buckthorn is considered invasive, though it provides good cover, is an excellent nectar source, and is the larval host plant for several native butterflies (e.g., Henry's elfin, common brimstone) (See Table 3, Attachment C). Oaks serve as larval hosts for diverse butterflies and moths; they are cut down before non-compliance. The red cedars provide winter cover, perches, and are an important winter food source.

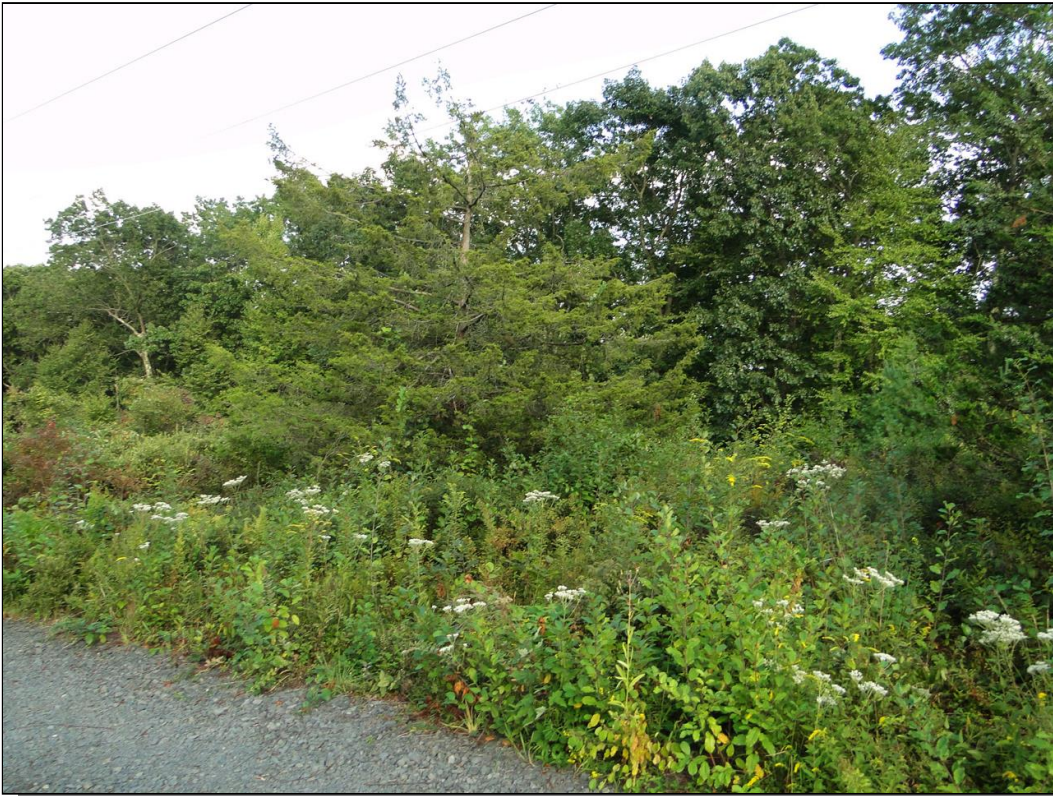
*Photo 7:* Study area, southwestern ROW segment; low shrub-meadow cover type on hillside, facing easterly. Note topped red cedar and blooming rough boneset 9-10-19.

A service road with a bluestone (crushed traprock) surface averages about thirteen feet wide. On the upper hillside of the southwestern segment, and on the hillside in the northeastern segment the service road largely follows the natural grade. (Photos 7 and 8, Attachment B.) However, substantial grading occurred in 2014 on the east side of the lower slope on the Therrien-Lanata segment, creating a steep fill bank, and changing the hydrology, as noted in a previous section of the report. Moist areas with facultative wetland plants occur west of the road where seepage and drainage are now impeded. A channelized ditch has replaced a broad, natural drainageway, likely degrading former herptile habitat. Grading has also eliminated the natural topsoil horizons on the southeastern side of the service road, on the lower hillside, creating conditions suitable for colonization by weedy pioneer species. Loss of herptile fauna may be related to this roadbuilding activities.

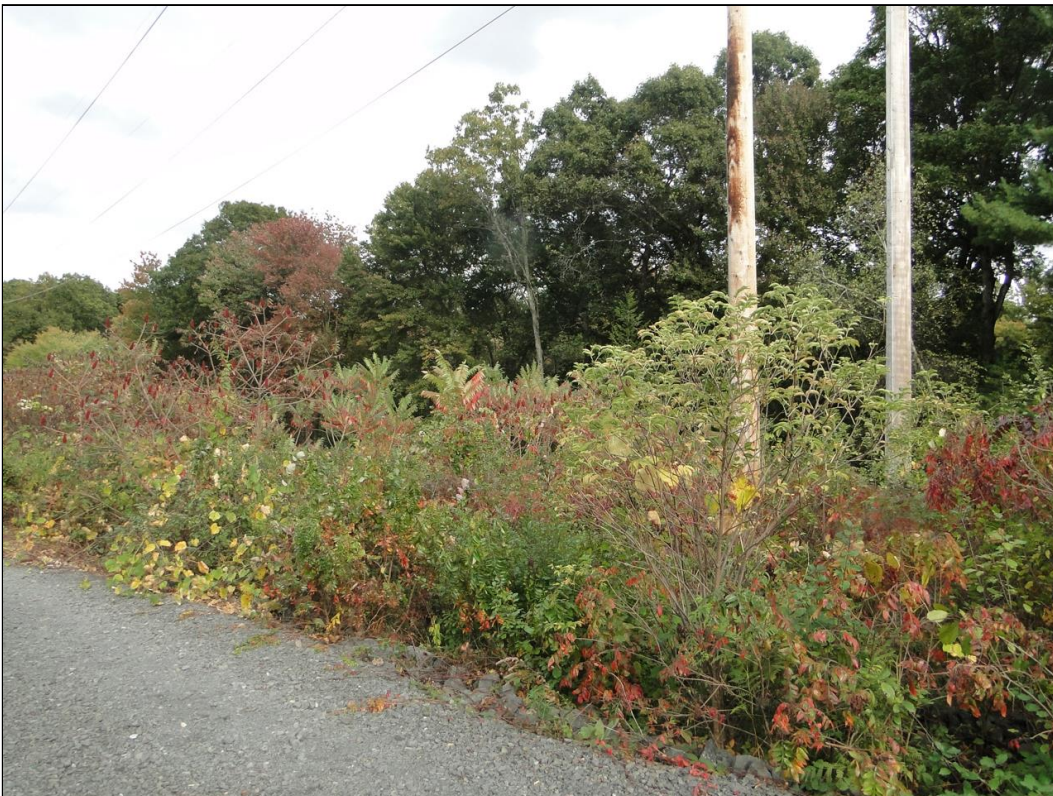
*Photo 8:* Mid slope shrub thicket, with elderberry, grape, and winged sumac, facing easterly, on Therrien property; low shrub-meadow cover type; 10-7-19.

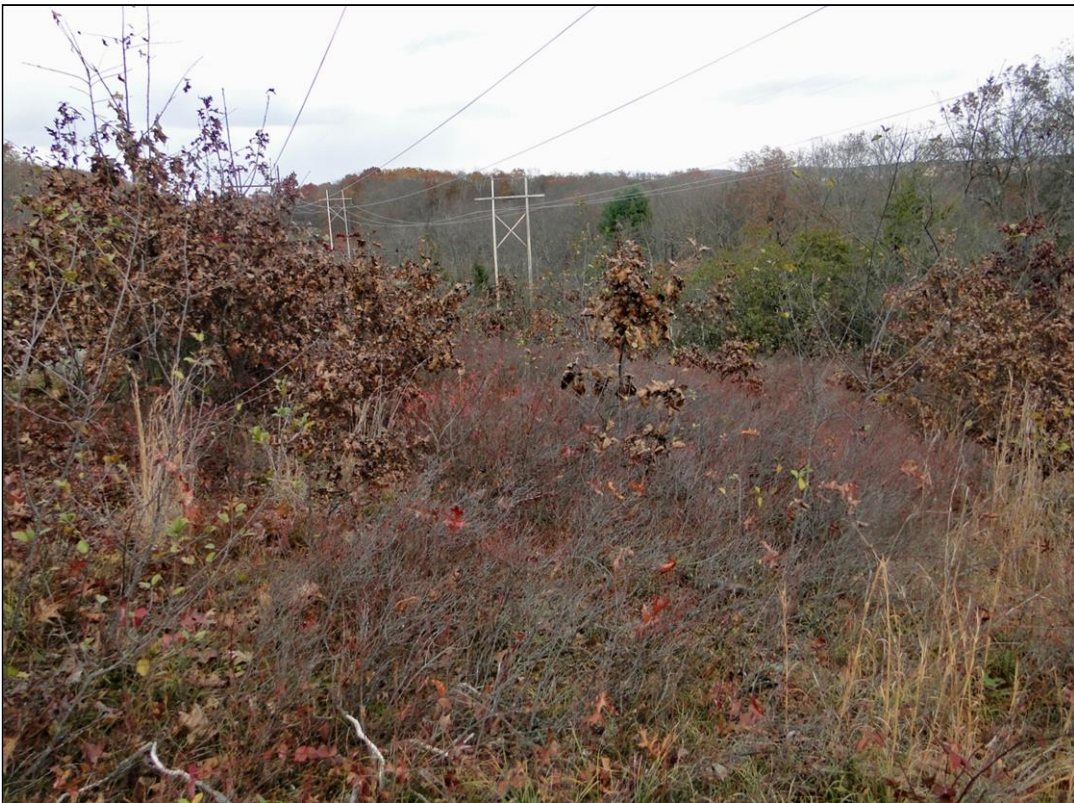
*Photo 18:* Large hillside area of low ericaceous shrubs (huckleberry & blueberry); oak saplings are on the perimeter, but not within the patch. Facing northeasterly. 10-7-19.

Many oak saplings have already colonized the area logged in 2016, on the west side of the southern ROW segment. Their distribution is noteworthy: oak saplings are entirely absent from patches of blueberries or huckleberries and also from groundcover patches, but plentiful in bare areas lacking other vegetation and on/near stumps, where soil has presumably fertilized by wood chips and by decomposing tree roots. (See Photo 18, Attachment B.) The dense mat of rhizomes and roots beneath patches of huckleberries and both lowbush blueberry species effectively resists tree seedling establishment (Reinter 1965, Sullivan 1996). Clonal spread by each these three low shrub species also allows them to fill in gaps following tree sapling removal, reducing the frequency and extent of maintenance needed. This is a reason to spare low shrub patches, to avoid close mowing or herbicide treatment, and not to cover shrub patches with thick chips.

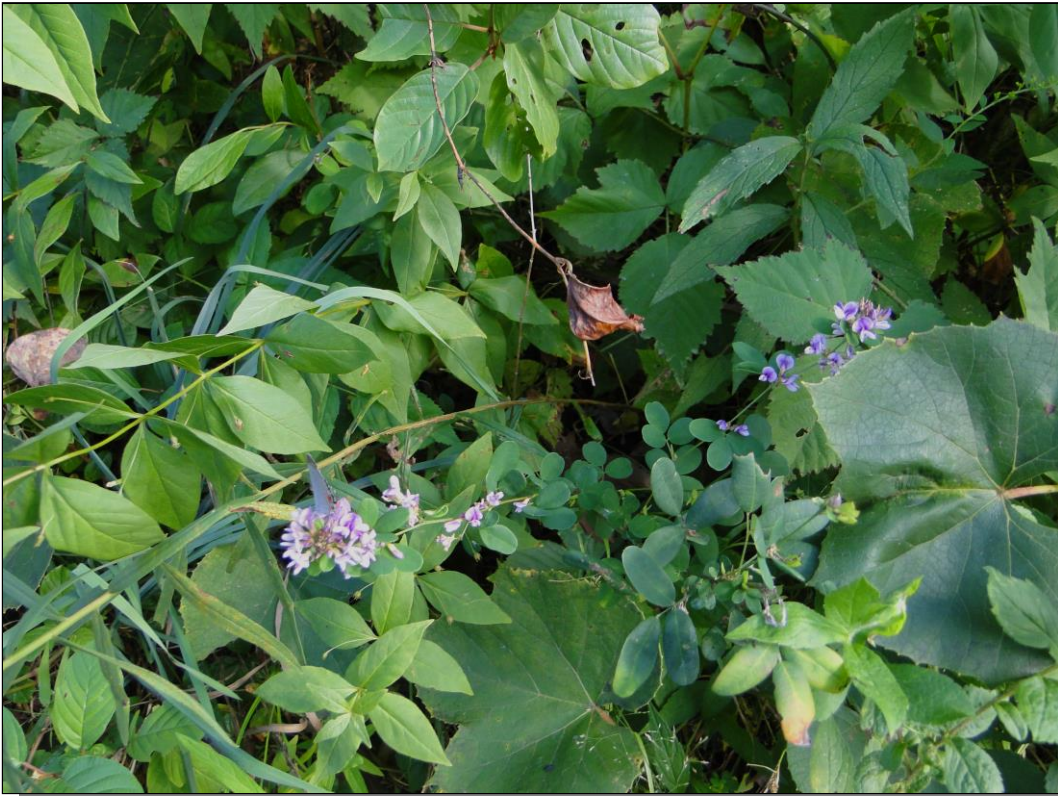
Photo 21: SW ROW segment; diverse roadside plants on lower hillside (Plot 1) with whorled loosestrife, violet bush clover, an uncommon tick trefoil, *Desmodium ciliare*, fox grape, and glossy buckthorn (top center, with feeding holes) (8-16-19).

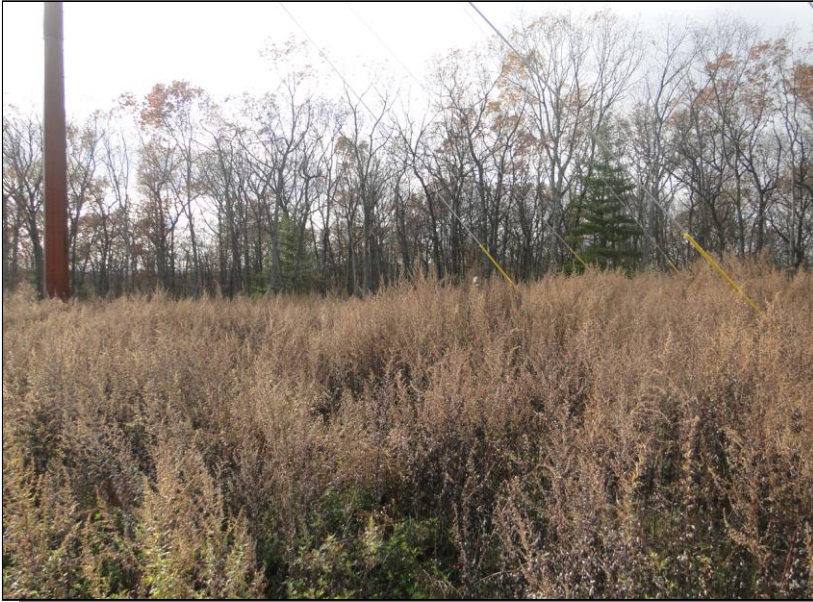
Photo 23: Replacement of wooden poles with steel poles resulted in a 3/4-acre stand of dense mugwort, *Artemisia vulgaris*, on Work Pad # 1.

Mugwort is currently sparse in the study area, except where it has been introduced to the pole replacement pads. It has high potential for continued adverse impacts to the entire ROW ecosystem. Seeds are too tiny to have nutritional value for birds and rodents. Its inconspicuous flowers are wind pollinated and lack nectar, of low value to pollinators. Foliage contains aromatic oils, repellent to most herbivorous insects in the United States. It effectively

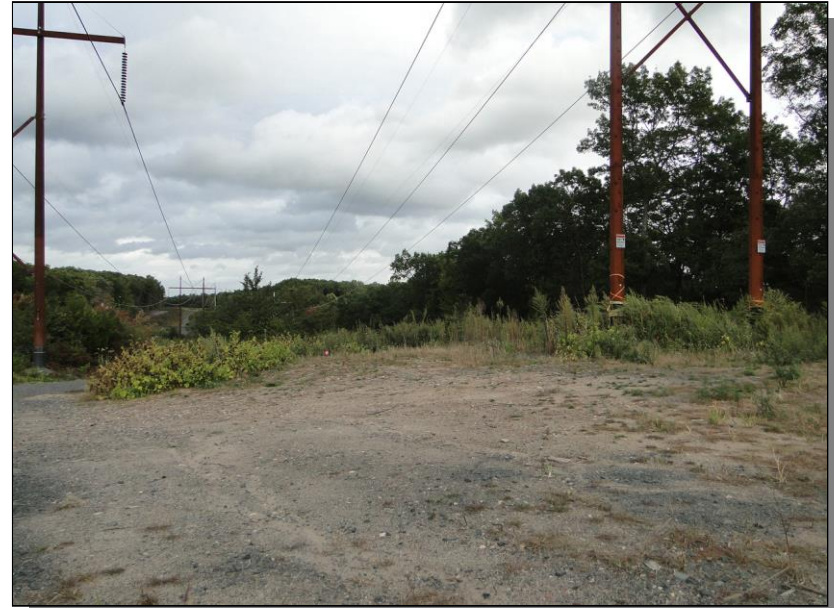
Photo 24: Part of Pad #3 received fertile topsoil & sprouted mugwort & other tall weeds, like toxic Jimson weed. Rest is bare & poorly permeable.

Timber matting was used for pole replacement at Pad #4 in 2019. (See Photos 24 and 27-30, Attachment B) Turning off the power for one approximately six-hour period, meant that one large crane and one excavator could do the work, rather than two cranes and one excavator, which are needed when wires remain live through the replacement process. Minimal damage was done to the preexisting high quality shrub community, with pasture juniper, mountain laurel, and little bluestem. Topsoil placement was limited to one small area where the soil had been disturbed by heavy equipment. Here again, a weed infestation resulted; topsoil must have been contaminated by jimsonweed seeds. Gary Therrien cut down the whole patch before seeds were ripe.

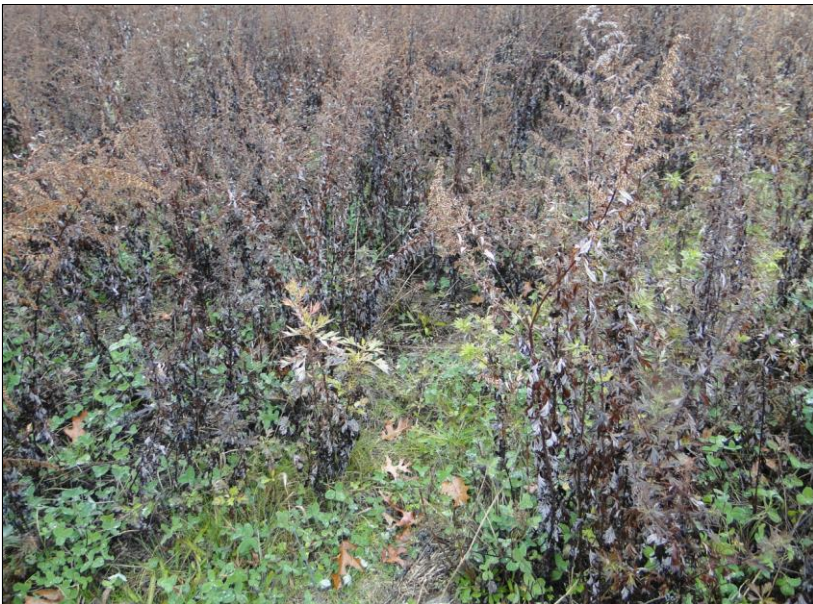
Photo 25: On Pad # 1 thick impervious stone process fill was covered with 2-4" of fertile, garden-type topsoil that contained mugwort seeds. It was seeded with clover & grasses, soon overtopped by mugwort.

- ❖ It is strongly recommended that fertile garden-type soil not be spread over work pads built for pole replacement, with the intent of planting a suitable growing medium for flowering native species, to benefit pollinators. They are likely to be overrun by nutrient-loving weeds.

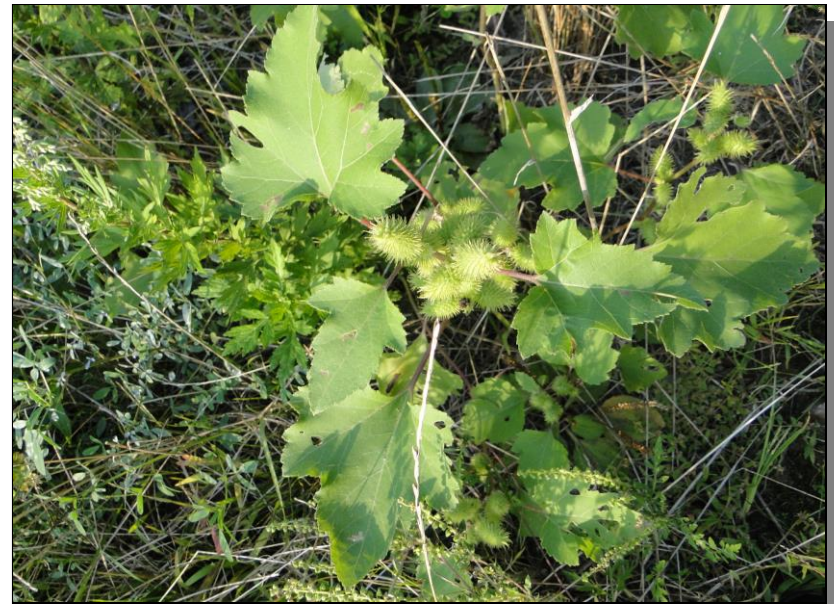
Photo 26: ~ 200 sf of the poisonous Jimson weed were cut down from Pad #3 and a part of Pad #4, before seeds were ripe, & bagged by Mr. Therrien. However, seed from mugwort on Pad #1 washed down the hill.

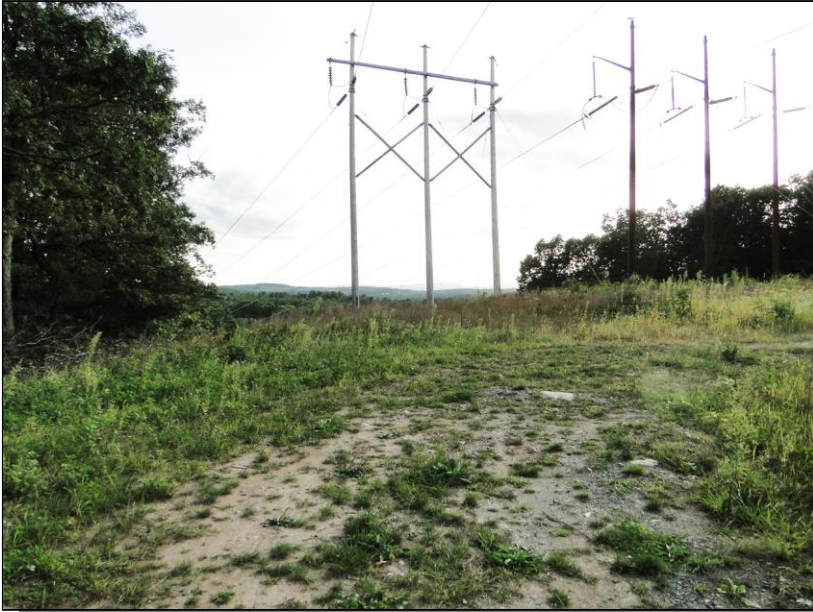
*Photo 27:* Most of the native shrub & grassland cover has been lost, & over 2 acres of dense fill was added for service roadways & work pads.

Aside from their harmful vegetation, the dense fill work pads for pole replacement, as well as the gravel roadways, create downgradient erosion problems, because infiltration of rainwater is minimal, resulting in increased volumes of flashy, erosive runoff. (See Photos 31 and 32, Attachment C) The steep hill to the southwest of the Therrien-Lanata ROW segment has a deep, recently formed gully at the base. This hillside is more vulnerable to erosion than in prior decades, because its protective cover of red cedars was removed in January of 2019. Eastern red cedars have dense and widely spreading root systems, which results in very effective soil stabilization, something which is much needed in the rocky and shallow soils that often characterize many ROWs, including the one associated with your property. (See Photos 24 and 27 to 30, Attachment B.)

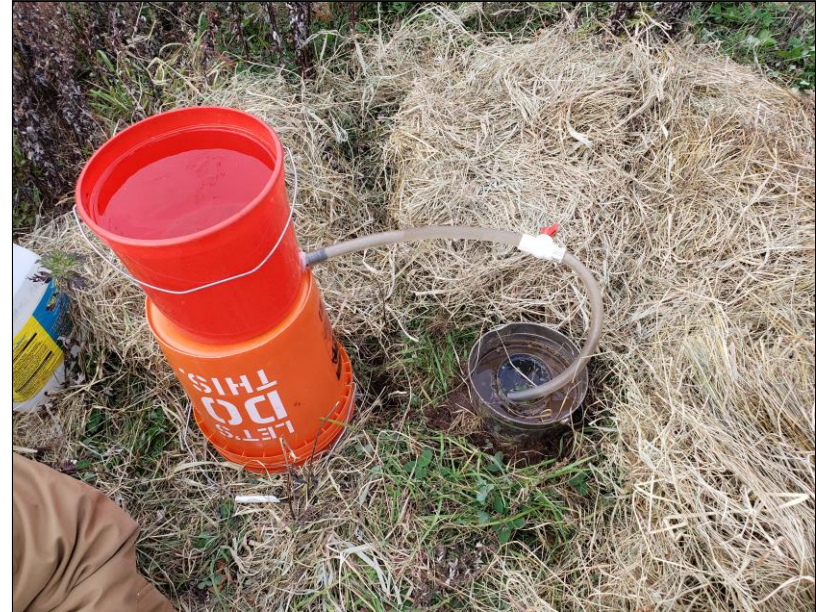
*Photo 28:* A double ring infiltrometer used to confirm that substrate on Work Pad #3 is much less pervious than natural hilltop soil. 11-11-19.

An in-field infiltration test, with a double ring infiltrometer, showed a significantly lower infiltration rate in the topsoil portion of Pad #3 (with stone process fill), versus a portion of Pad #4 with natural hilltop soils, minimally compacted by timber matting. In Pad #4, each one-inch drop in water level took between one and two minutes (mean of 1.56) throughout the test. In the filled Pad, #3, the initial rate was 3.3 minutes; by the fourth drop this had increased to 9.5 minutes for a one-inch drop.

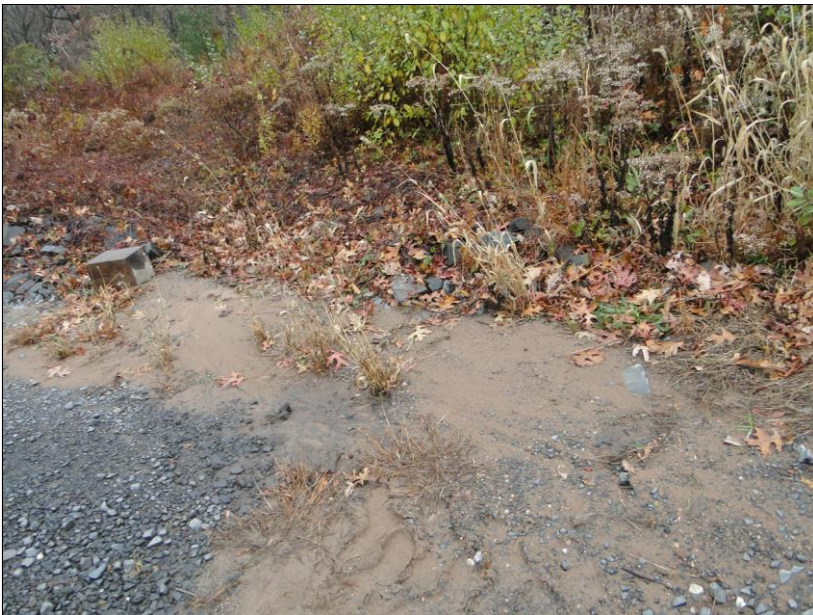
*Photo 29:* Observations during a minor rain event on 11-12-19, showed that runoff begins early in the event, & dislodges nutrient-laded fine soils, washing them N down the hill. This will alter naturally infertile soils.

Pads were closely observed during the onset of a low intensity rain on the day after the infiltration test; puddling and dislodging of fine soil/stone dust particles was observed already, before 0.25 inches of rain had fallen. The fine silt is carried by runoff into a drain on the east side of the service road.

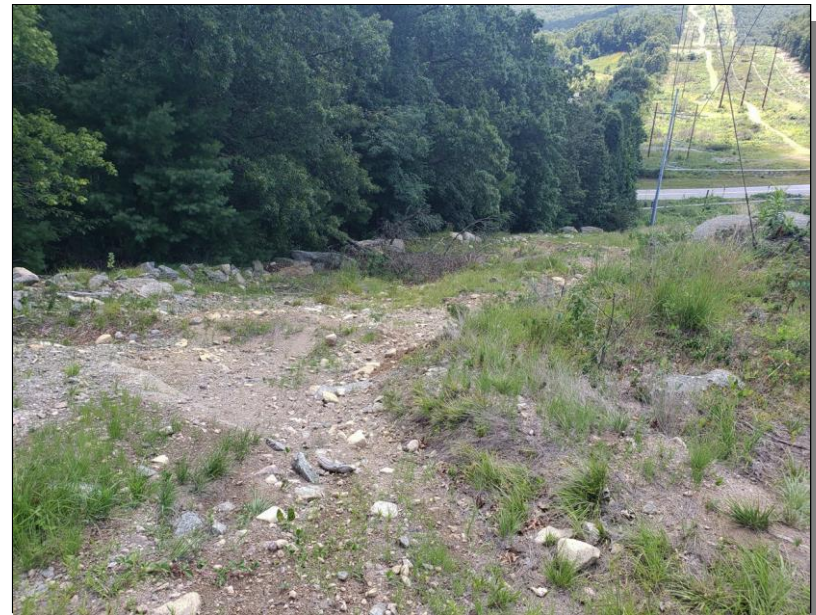
*Photo 30:* Runoff has already caused substantial erosion on the steep south-facing hill below the new pads on the hilltop. It was worsened by cutting multiple red cedars that had anchored the hillside soil. 8-16-19.

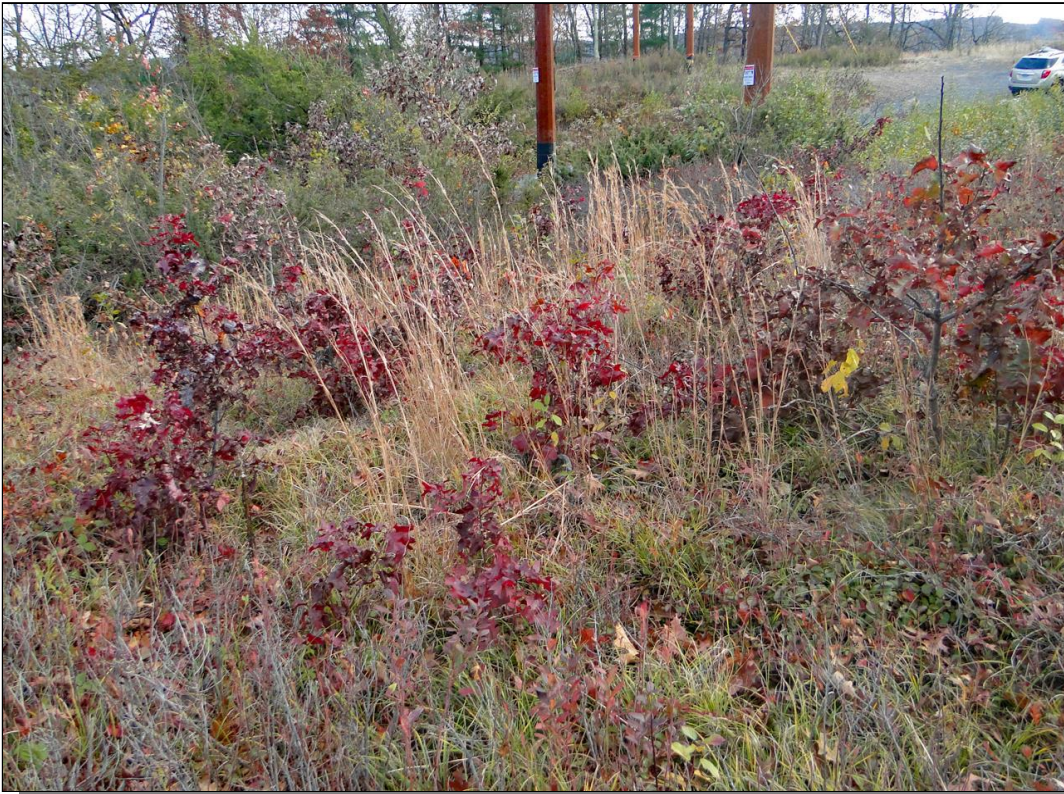
*Photo 30:* Southerly view. Timber matting was used over a small area, instead of placing impervious fill. Much natural vegetation remains around Work Pad #4.11-8-19.

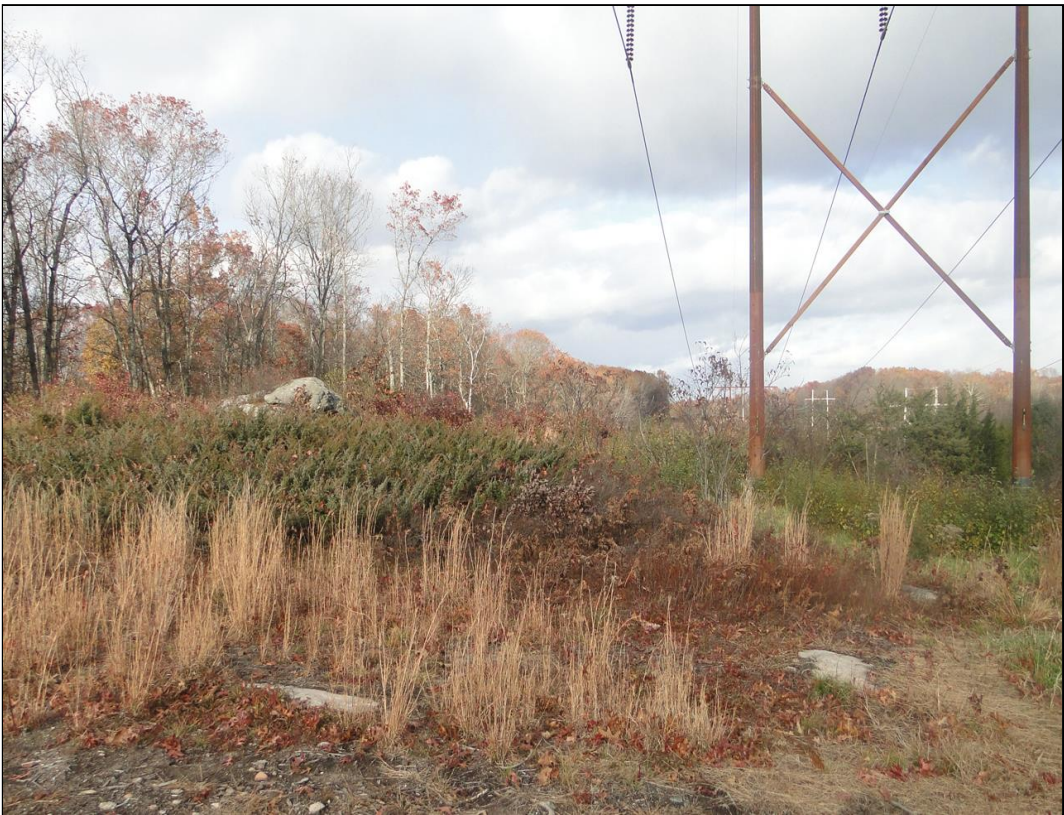
*Photo 31:* Northwesterly view of Pad #4. Heavy equipment clearly operated from this side. Permeability was good, averaging 0.56 minute for each 1" drop in water level.

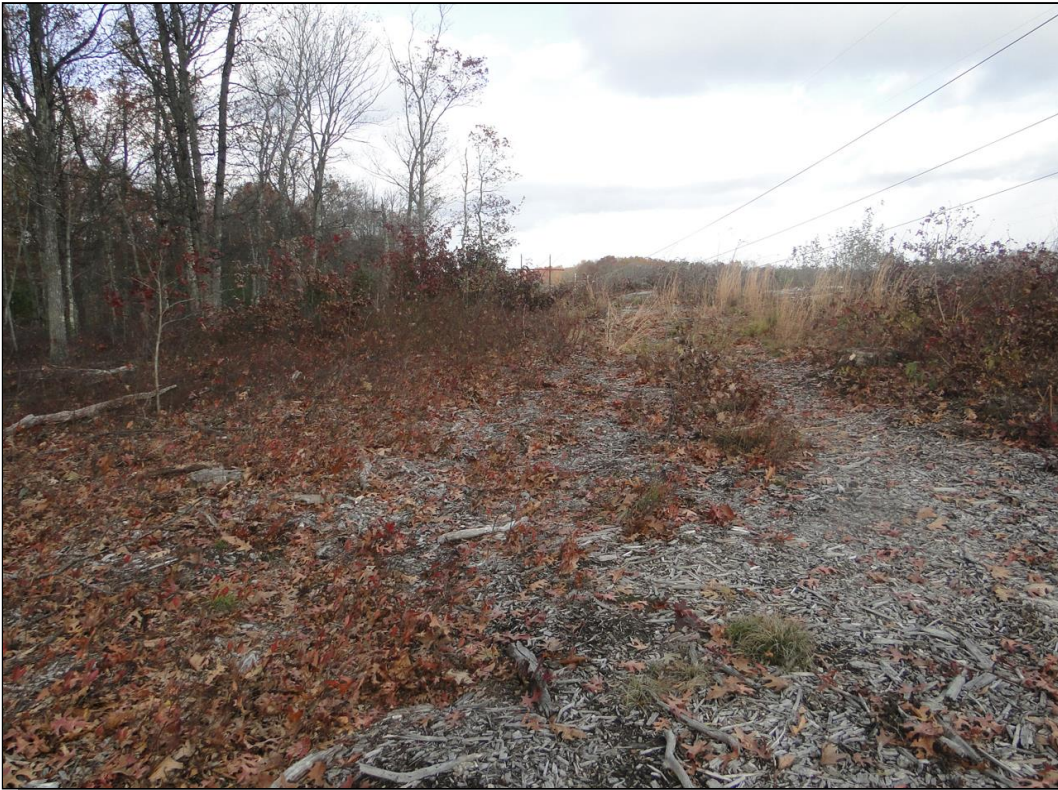
*Photo 33:* Northeasterly view. Wood chips were irregularly distributed after logging along west side of ROW in 2014. Where chips were thick, herbs are sparse in 2019.

Wood chips were spread irregularly in the logged area owned by the Lanatas. They were reported to have been locally thick, but not as widespread and thick as the mulch layers found on the Eversource-owned segment to the northeast. Extensive cover, over 40%, of low ericaceous shrubs of huckleberry, low-bush blueberry, sweet fern, and mountain laurel, is present in the Lanata logged area. Virtually no oak seedlings have sprouted within the continuous low shrub patches, but young oaks are abundant in adjacent otherwise bare areas. However, cover and diversity of low ericaceous shrubs is very low on the recently logged west side of the northeastern ROW segment.

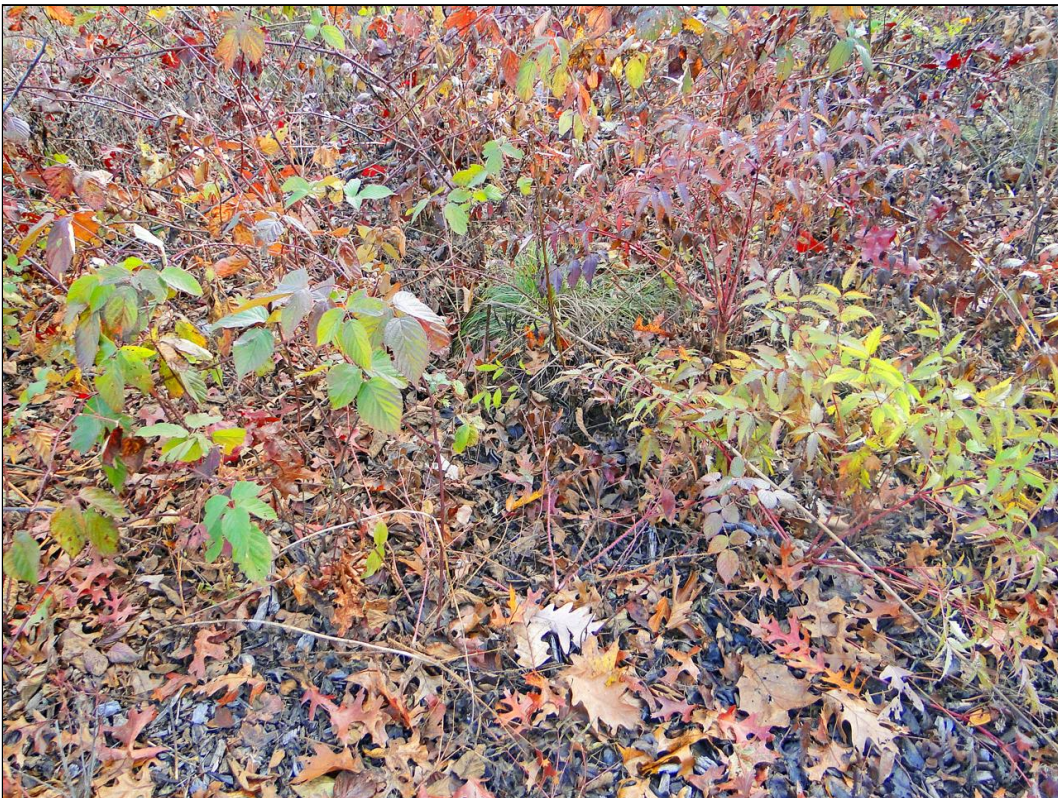
*Photo 34:* Blackberries and bristly sarsaparilla have colonized areas with thin chips along the edges of chip piles. 11-8-2019.

*Thick wood chip deposition* during clear-cutting has virtually eliminated the diverse hilltop/upper slope low shrub/groundcover vegetation from the north side of the ROW; living blueberry and maple-leaf viburnum are the dominant forest understory shrubs in the adjacent forest, and could have formed the core for post-logging low vegetation in this area. This native low shrub community is still found about fifty feet further east, under the wires. Wood chips function not only as a mulch, blocking light and air, they exude phytotoxic compounds as they decompose (Rex, 2016). (See Photo 34, Attachment B)

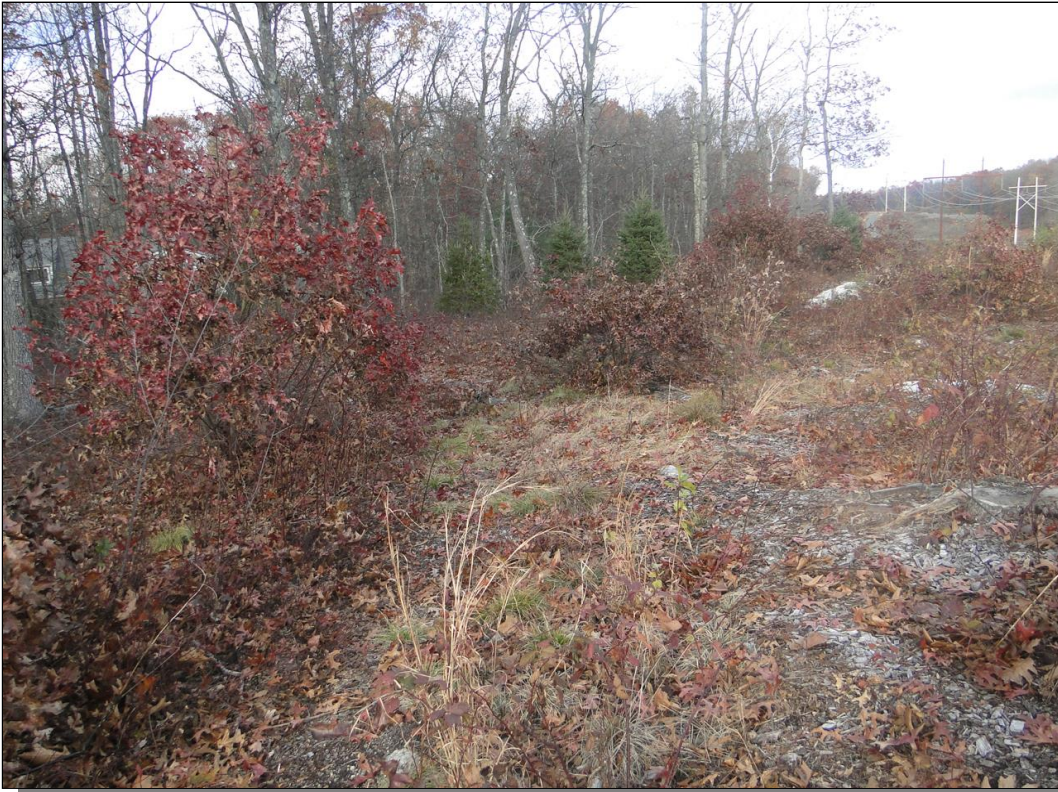
Photo 35: Northeasterly view. Where wood chips were thin or absent, native grass cover is now established, mostly, rosette panic grasses (*Dicanthelium* spp.) and some little bluestem grass.

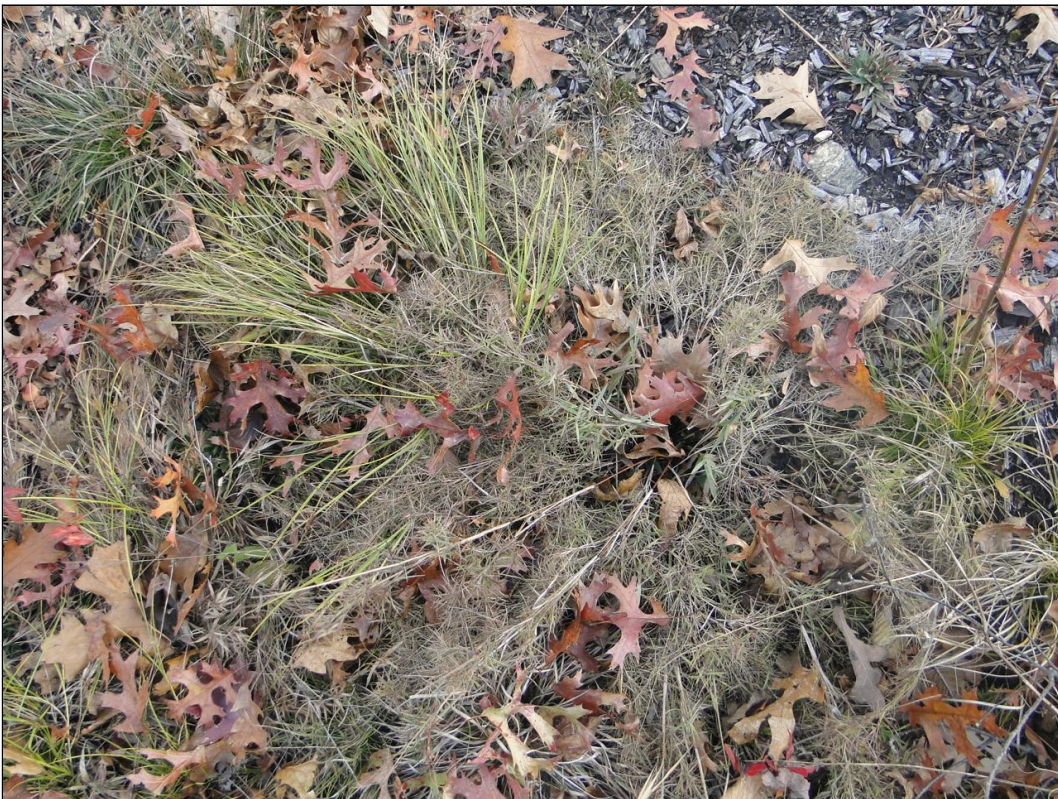
Photo 36: *Dicantheliums* have a low, spreading growth form. Heavy seeders, they have been major colonizers after the logging in 2014, and provide wildlife food/cover. However, herb layer diversity is far lower than in unlogged areas of the ROW. 11-8-19.
