**TERRIEN-LANATA STUDY**  
of an  
**Eversource Right-Of-Way**

**2042 & 2060 NEW LONDON TURNPIKE  
GLASTONBURY, CONNECTICUT**

**April 2020**

### **THERRIEN - LANATA STUDY OF AN EVERSOURCE RIGHT-OF-WAY SEGMENT**

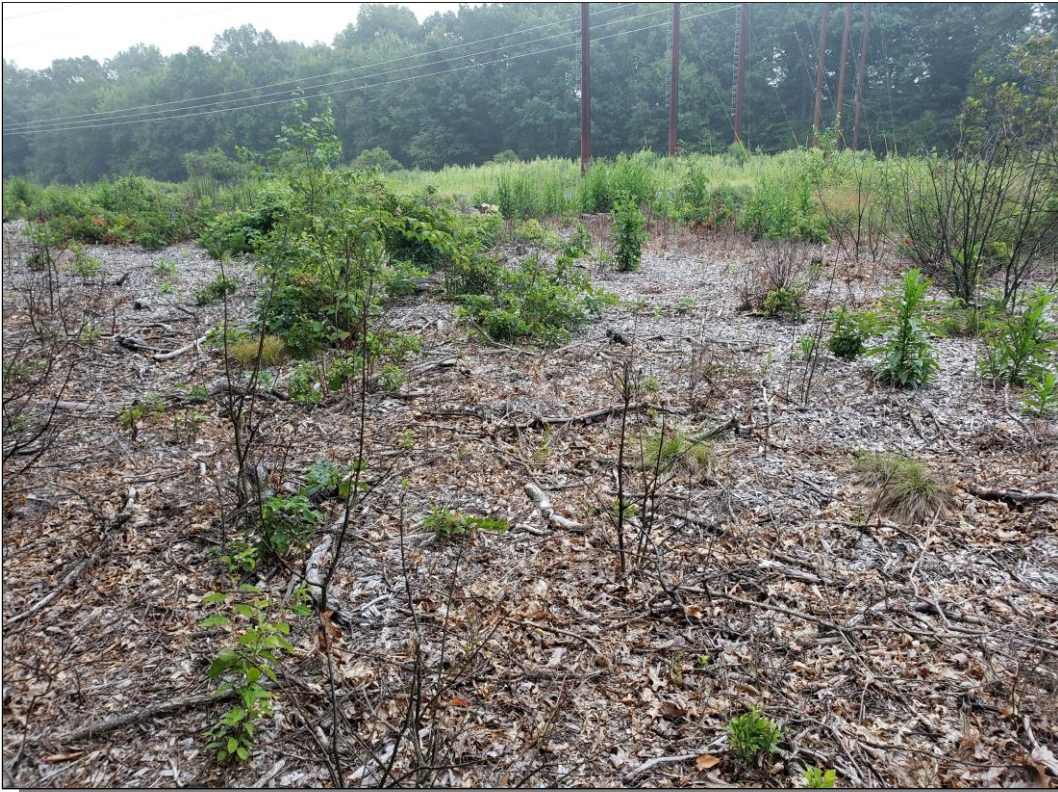
Photo 37: More recent logging along the N.E. ROW segment of the study area was accompanied by widespread, thick chip deposition, and understory death.8-14-19.

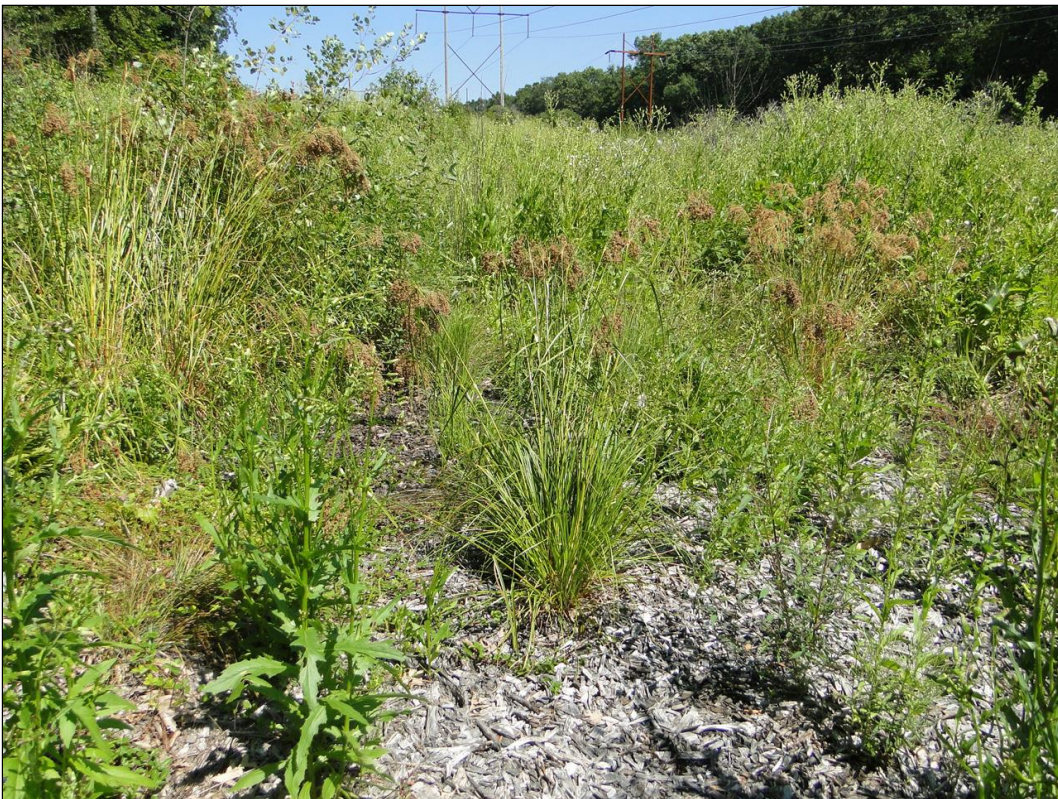
Photo 38: Although no chips were spread in wetlands near New London Tpke., 4-5" layers are in several small slope wetlands. Larger sedges with tussock growth form survive, & pilewort colonizes (*Erechtites hieraciifolia*), left foreground, right.

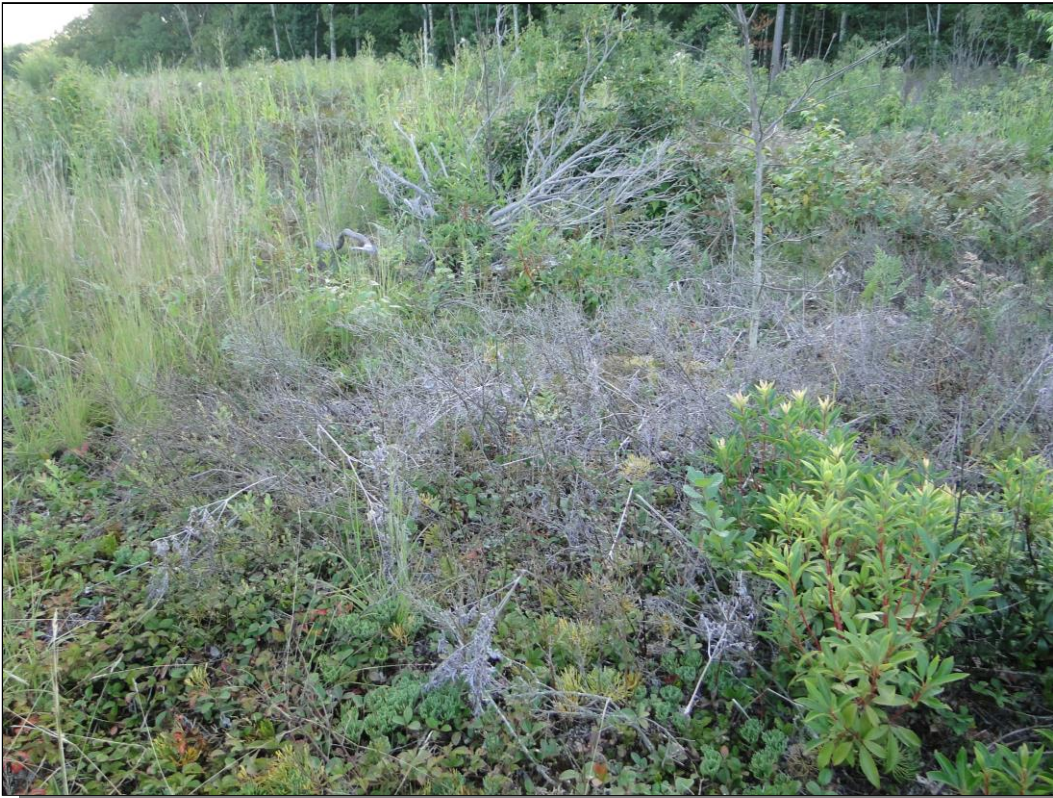
*Photo 45:* On hilltop of NE segment lowbush blueberry or huckleberry has been treated with herbicide, likely glyphosate, based on absence of grasses in treated area. 8-26-19.

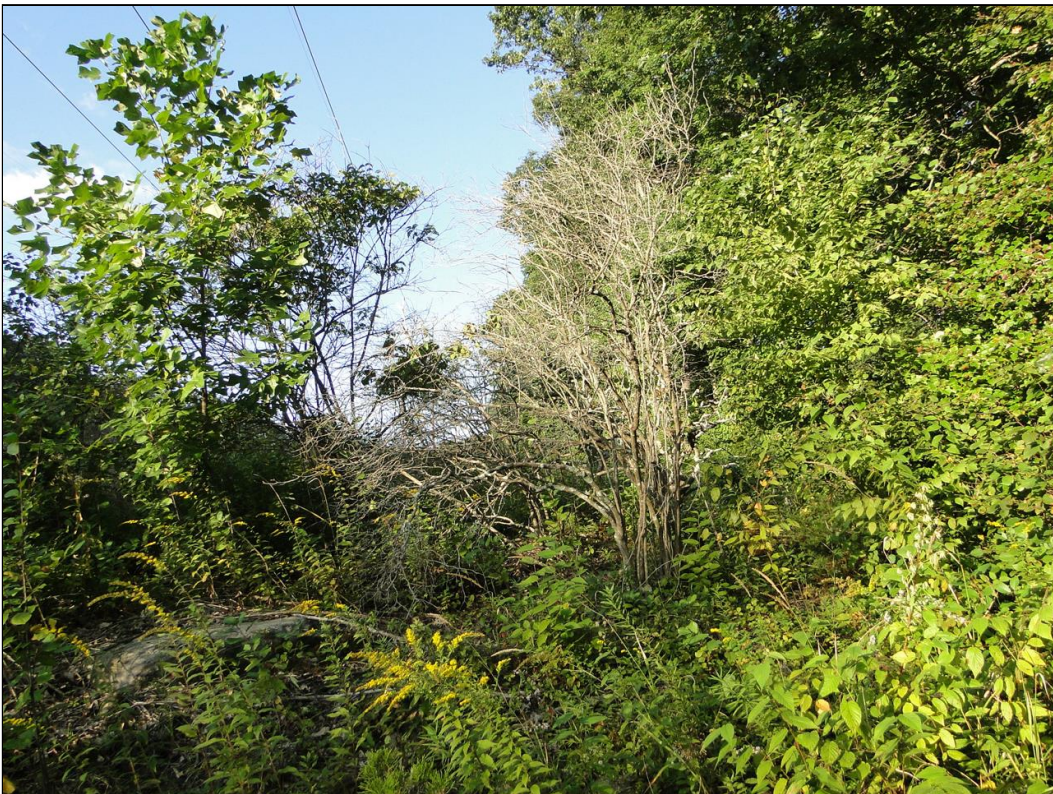
*Photo 46:* Northeastly view. Highbush blueberry shrubs (center right, at the species' maximum height), were treated with herbicide, while a sapling of fast-growing tulip tree (left) was spared. 8-26-19.

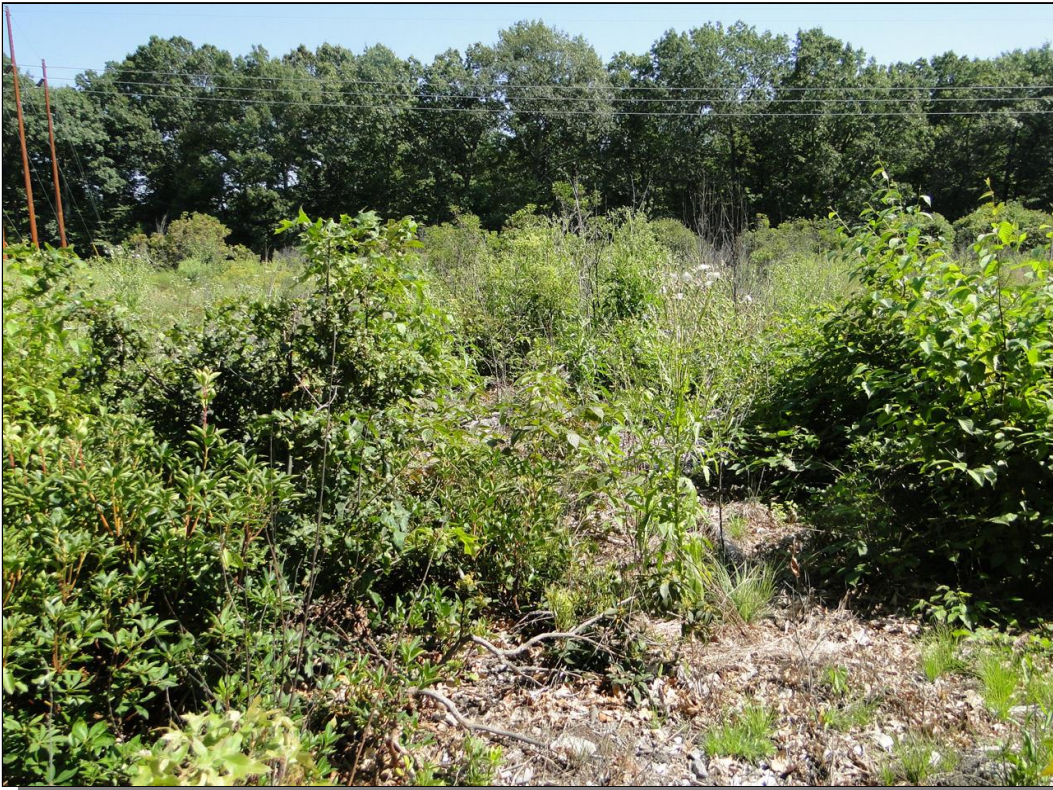
*Photo 47:* On upland hilltop of NE ROW segment vegetation has been managed using selective herbicide treatment. Herb layer has poorly developed grasses. 8-26-19.

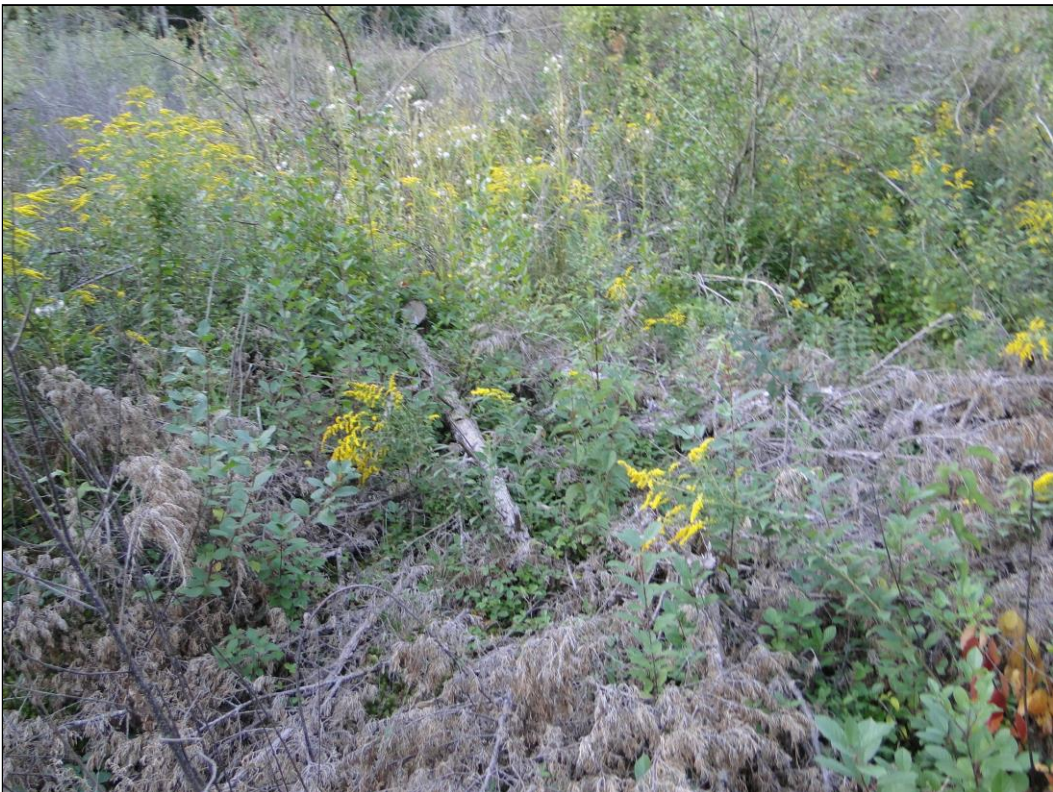
*Photo 48:* Invasive buckthorns have sprouted under red cedar debris. Red cedars were cut in 2018 in Eversource-owned NE segment. Pilewort & goldenrod in background.

- ❖ Killing shrubs and tree saplings does fertilize the soil, as the roots decompose and release nutrients. Woody colonizers, both invasives and trees, were often observed around and on stumps, woody debris, or herbicided sapling stems.

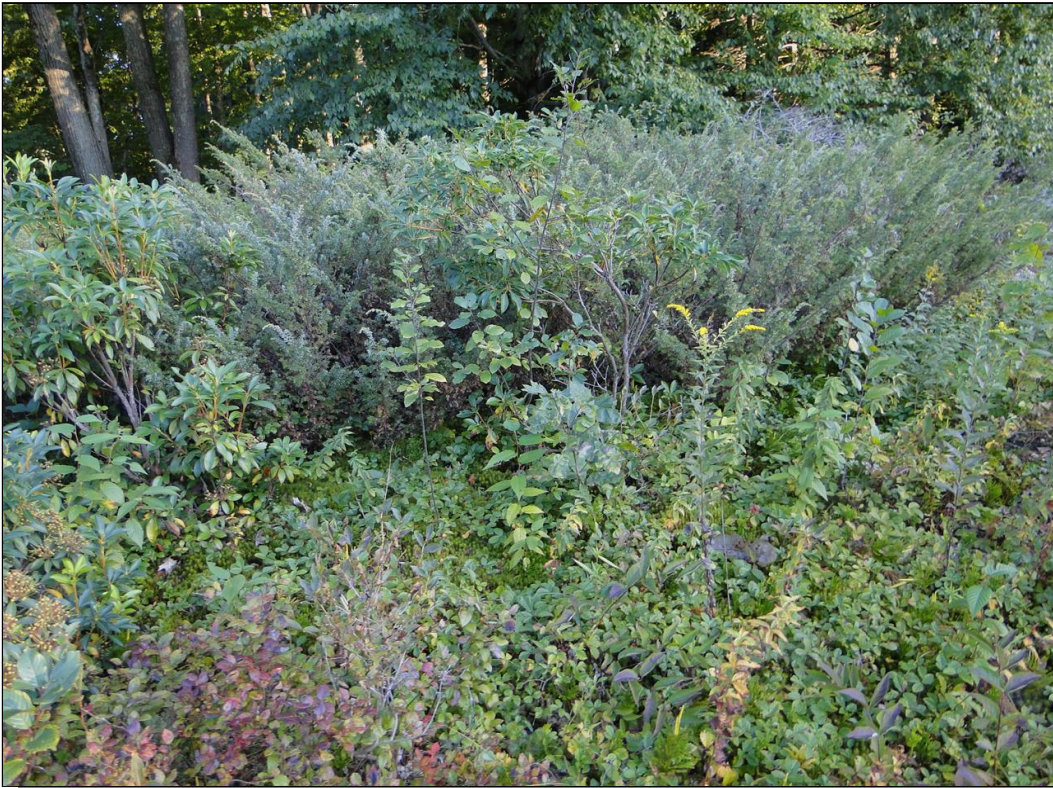
Photo 49: Stable forest edge (not logged) in NE ROW segment; pasture juniper, mountain laurel, & native groundcover inhibit tree seedlings establishment. 9-18-19.

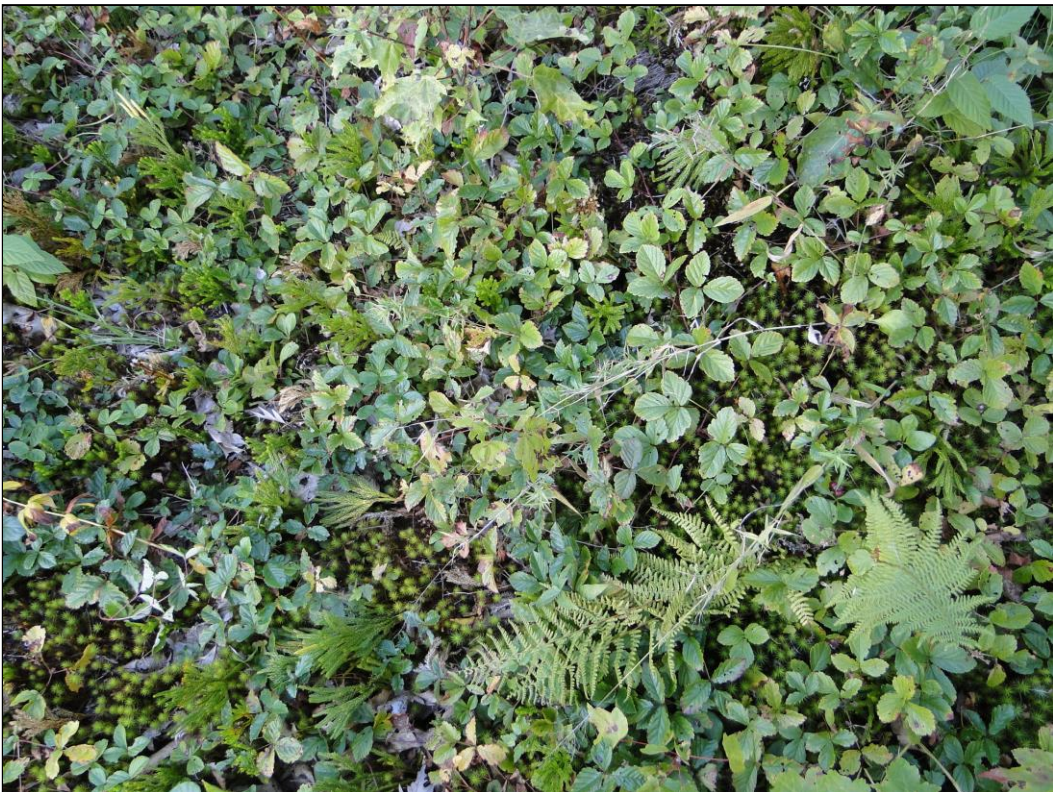
Photo 50: Typical native groundcover on acidic infertile soil in the study, with haircap moss, princess pine (*Paralycopodium obscurum*) & bristly dewberry. 9-18-19.

By contrast, the few upland areas not covered with wood chips supported healthy stands of ericaceous plants and the characteristic groundcovers, with clubmosses, dewberry, wintergreen, and haircap moss. The huckleberries, low-bush blueberries and running pine were present in the forest understory, prior to logging. Those species still grow in the adjacent forest. A groundcover of rosette panic grasses, cinquefoils, prickly dewberry, and haircap (*Polytrichum*) mosses also thrived in logged areas where chips were not deposited. (See Photo 50, Attachment B.)

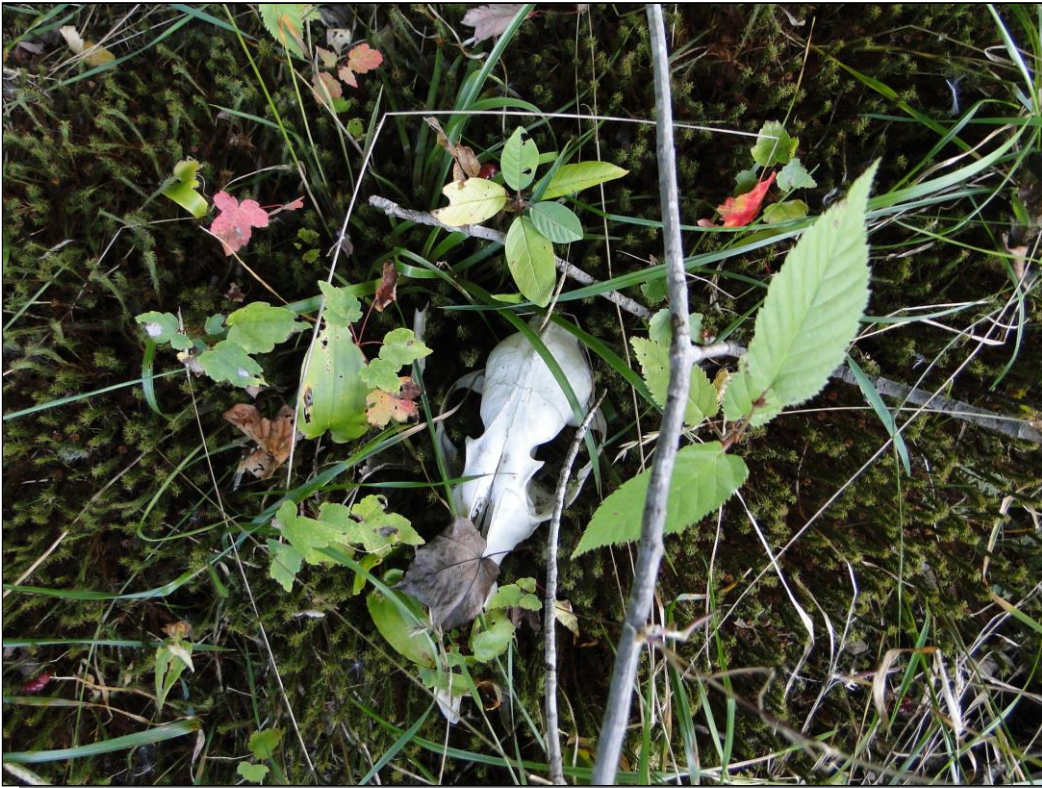
*Photo 51: Observation of multiple undesirable seedlings (birch, red maple, and buckthorn) in soil that has presumably been enriched by decomposition of a deer head. Nitrates are known to trigger seed germination of many plant species (Fenner 1985). Nutrients are also released by herbicide-killed vegetation. This photo taken at the eastern edge of the NE ROW segment represents a vegetation management question raised by the Therrien-Lanata study: how and to what extent does “fertilization” by decomposition of wood chips, sapling roots, & woody debris, and topsoil from offsite affect ROW colonization by trees & invasives?*
