Pearl Beach Lagoon Condition Study and Community Uses Report

Final Report September 2014

Prepared For: Gosford City council

Prepared By: BMT WBM Pty Ltd (Member of the BMT group of companies)

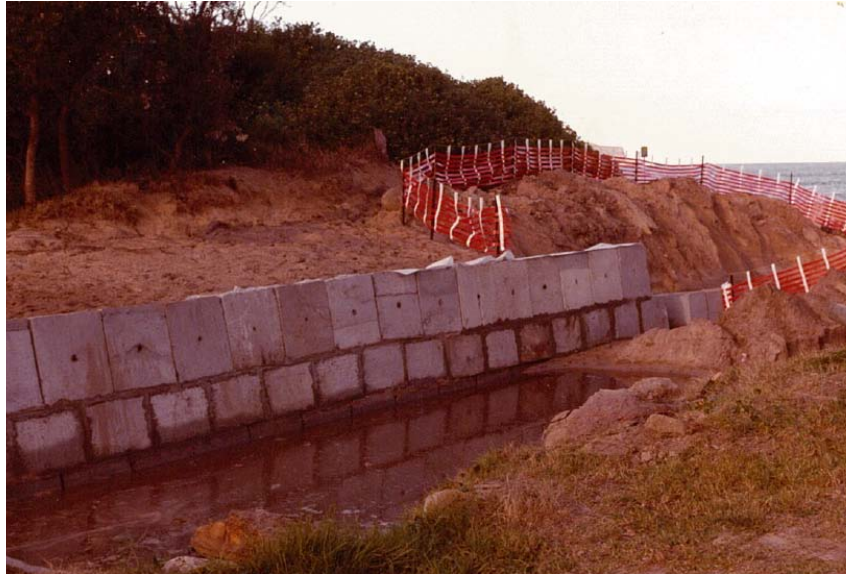
Figure 2-1 Construction of the entrance training wall at Pearl Beach Lagoon (Source Peter Bayliss)

A concrete block retaining wall (Figure 2-1) constructed in c. 1983 has also been constructed on the north side of the entrance channel. This wall limits further channel migration.

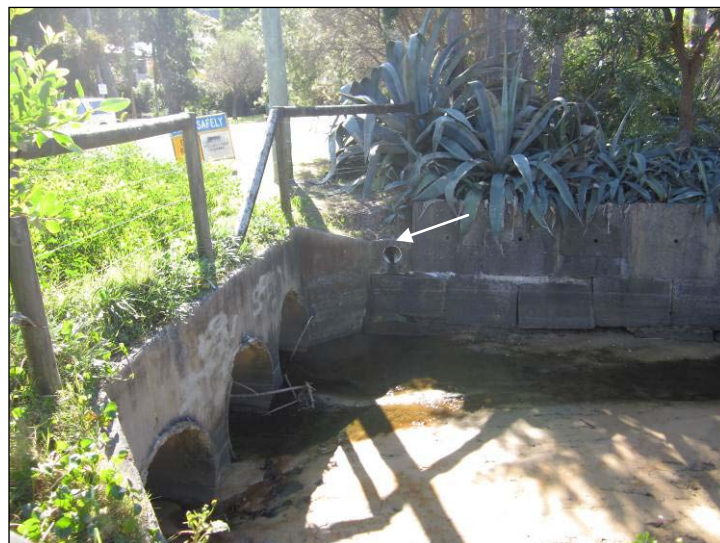
Figure 2-2 Culvert on lagoon entrance with arrow indicating entrance opening trigger

Pearl Beach Entrance is, on occasion, artificially opened by Council to reduce the flood threat along Coral Crescent and adjacent properties. It is understood that a formal procedure for this process does not yet exist. The trigger for opening the lagoon is marked by a white line on the concrete block retaining wall on the northern side of the entrance channel. This line has not been surveyed and its elevation is not known. It is approximately the same height as the top of the culverts (refer Figure 2-2). Council does not routinely monitor the level of water in the entrance channel. Entrance openings are therefore triggered by staff inspections or notification by local residents. The decision by Council to open the lagoon is made based on a combination of the trigger level being reached and the berm being high. It is understood that mechanical openings of this nature occur once or twice a year. Manual openings are carried out by excavator or backhoe depending on the beach / erosion conditions.

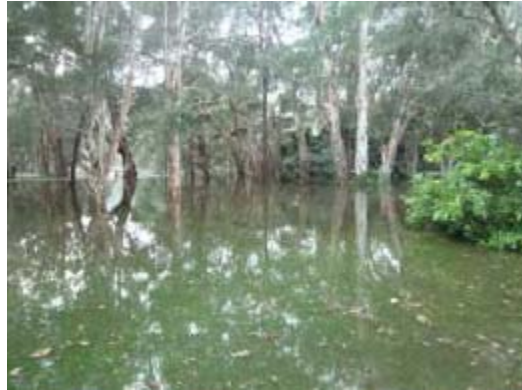
Figure 2-3 Extensive inundated of Melaleuca Swamp Forest around Pearl Beach Lagoon following a large rainfall event on June 6 2012

A significant catchment rainfall event occurred during the preparation of this study, with 38 mm of rain being recorded at the Gosford rain gauge and 26mm at the Peats Ridge gauge, on June 6 2012. Council used heavy machinery to initiate an artificial opening at around 3:30pm on that day. An extensive photo record of this event was undertaken by local resident Ann Parsons and this is included in Appendix D.

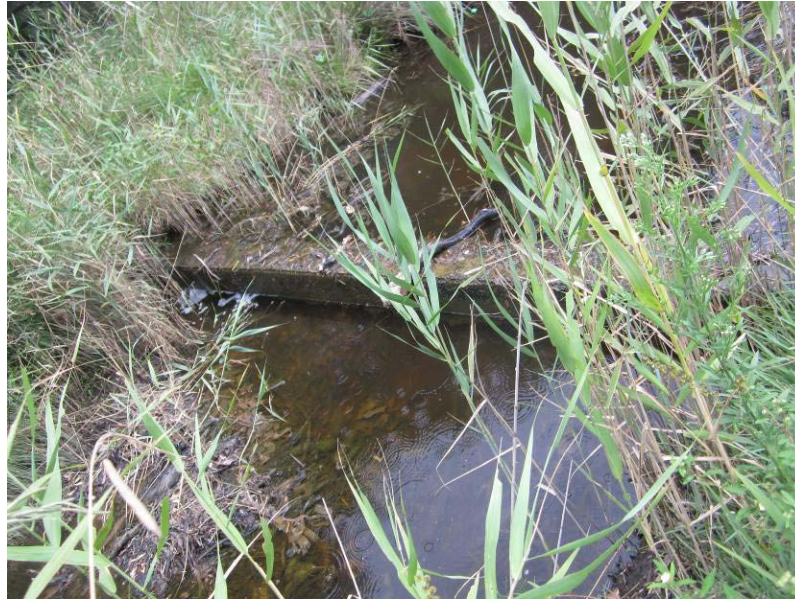
Figure 2-4 The weir on the entrance channel (photo taken March 2012)

The weir is likely to have changed the lagoon conditions and its ongoing role in influencing hydrodynamics, and hence ecology, will be an important consideration for future management.

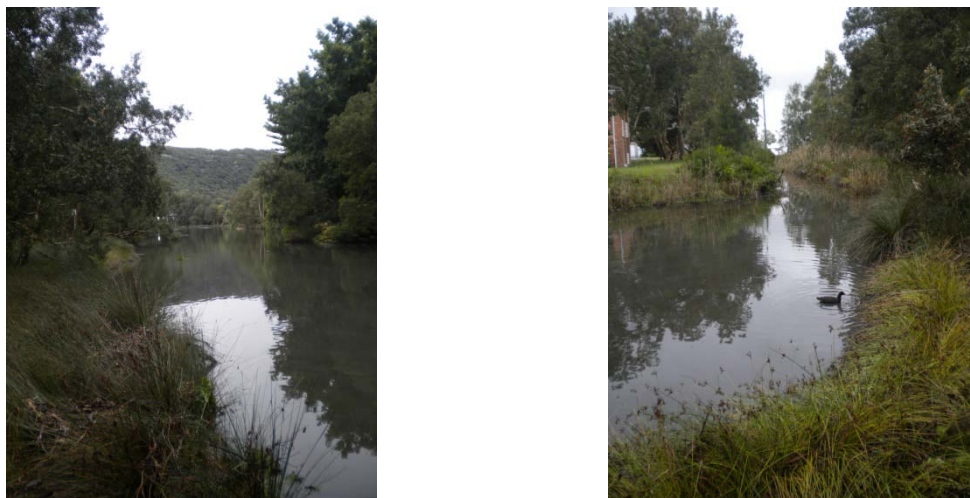
Figure 2-9 Sedgelands Fringing Pearl Beach Lagoon

The sedgelands fringing the lagoon foreshore provide water quality filters for freshwater runoff from adjacent properties and stabilise the banks from erosion. These fringing communities also provide foraging and nesting habitat for the local bird assemblages. Sedgelands are inhibited from colonising several sections of the lagoon foreshore due to bank infilling and erosion. This is particularly evident along the eastern bank of the *Study Site*.

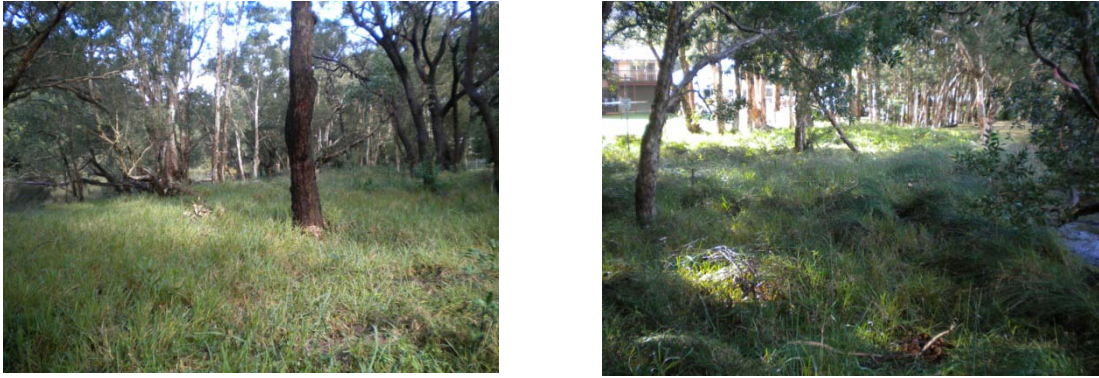
Figure 2-10 Melaleuca Wetland Adjacent To Pearl Beach Lagoon

Land adjacent to the open water body supported Melaleuca wetland habitat of varying condition. The majority of property owners maintain their lagoon frontages. This generally includes mowing above the level of inundation, planting of garden varieties and turfing to the water's edge in some areas. Regular mowing within the wetland habitat has significantly reduced habitat diversity of the wetland by reducing floristic and structural diversity of the ground and shrub layers and reducing recruitment of canopy species.

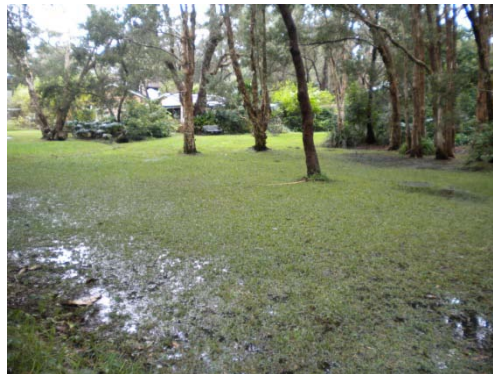
Figure 2-12 Melaleuca Wetland with mown groundcover

Upslope of the periodic soaks the groundcover was predominantly mown by adjacent landowners. However in the south-west of the lagoon, which was less impacted by adjacent landholders, groundcover species recorded on the landward edge of the wetland included *Imperata cylindrica* and *Cynodon dactylon* with sparse *Paspalum* sp., *Lomandra* sp., *Dianella* sp., *Cyperus* sp., *Asparagus densiflorus**, *Commelina cyanea*, *Conyza* sp*., *Passiflora* sp*., *Hydrocotyle bonariensis**, *Rumex* sp*., and *Viola hederacea*.

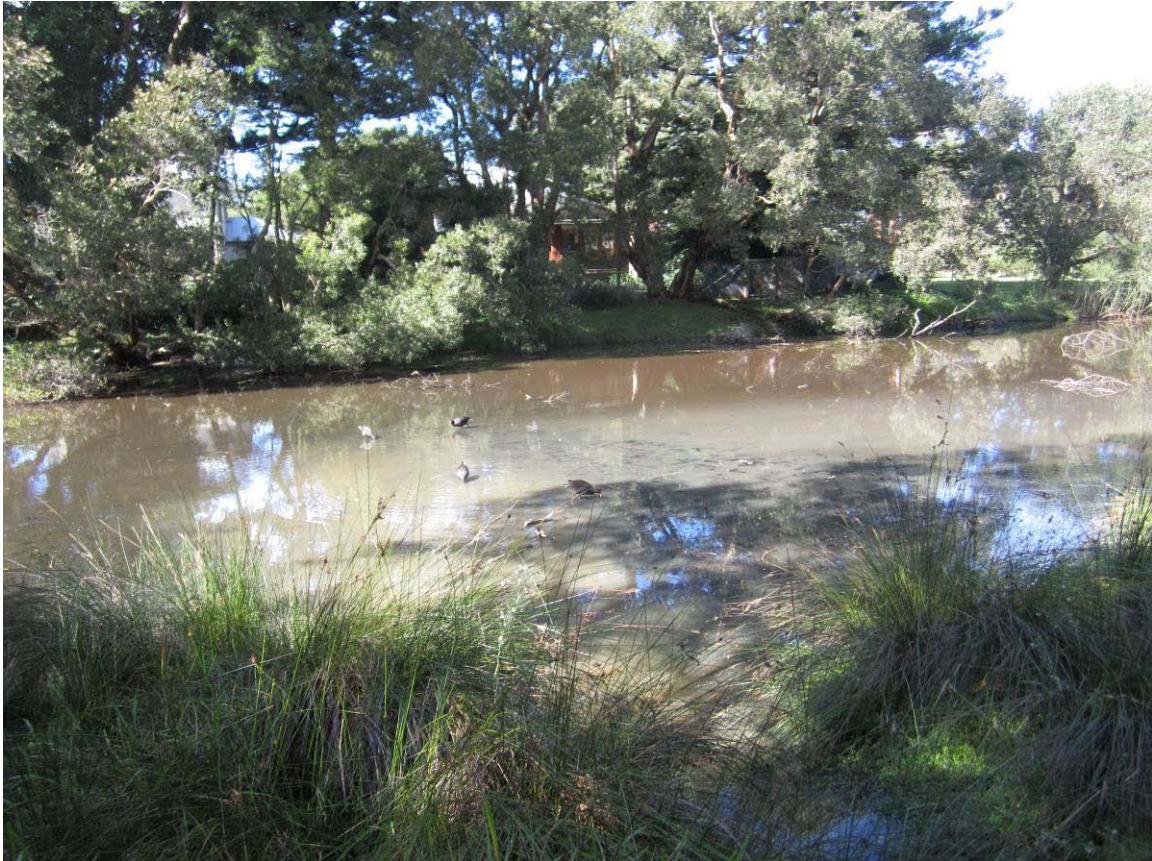
Figure 2-17 Stormwater plume observed after rainfall

Plumes of fine sediment can be observed discharging into the Lagoon following catchment rainfall, and understandably of concern to local residents.

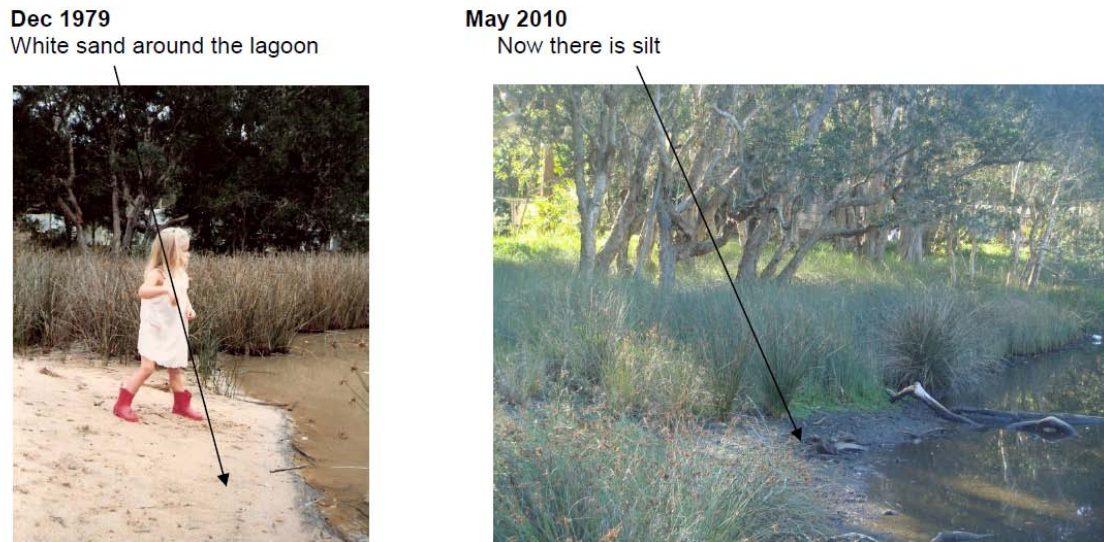
Figure 2-18 Family photographs showing the presence of marine sand in 1979 and fine silt in 2010 (photos: Ann Parsons)

A photo set submitted through the community consultation is included as Figure 2-18. The photographs show a similar location within the lagoon, characterised by marine sand in 1979 and fluvial sediments in 2010. It is considered that different conditions in 2010 have allowed finer sediment to remain on the foreshore surface of the lagoon. Generally, wave action (including small wind-generated waves) is sufficient to prevent silts from deposition around lagoon fringes. Therefore, it is possible that growth of vegetation around the lagoon has created a more 'depositional environment' within the lagoon that is now more conducive to settlement over the whole waterway area, including the shallow fringe areas.

Periods of open entrance conditions will result in a proportion of finer sediments discharged out of the lagoon, however, it is considered that a large proportion of the total sediment generated from the catchment is retained in Pearl Beach Lagoon. The ability of the lagoon to retain sediments has been increased through the construction of the weir. As the weir truncates the drainage of the lagoon, it limits how much sediment gets scoured and conveyed to the sea during breakout conditions.

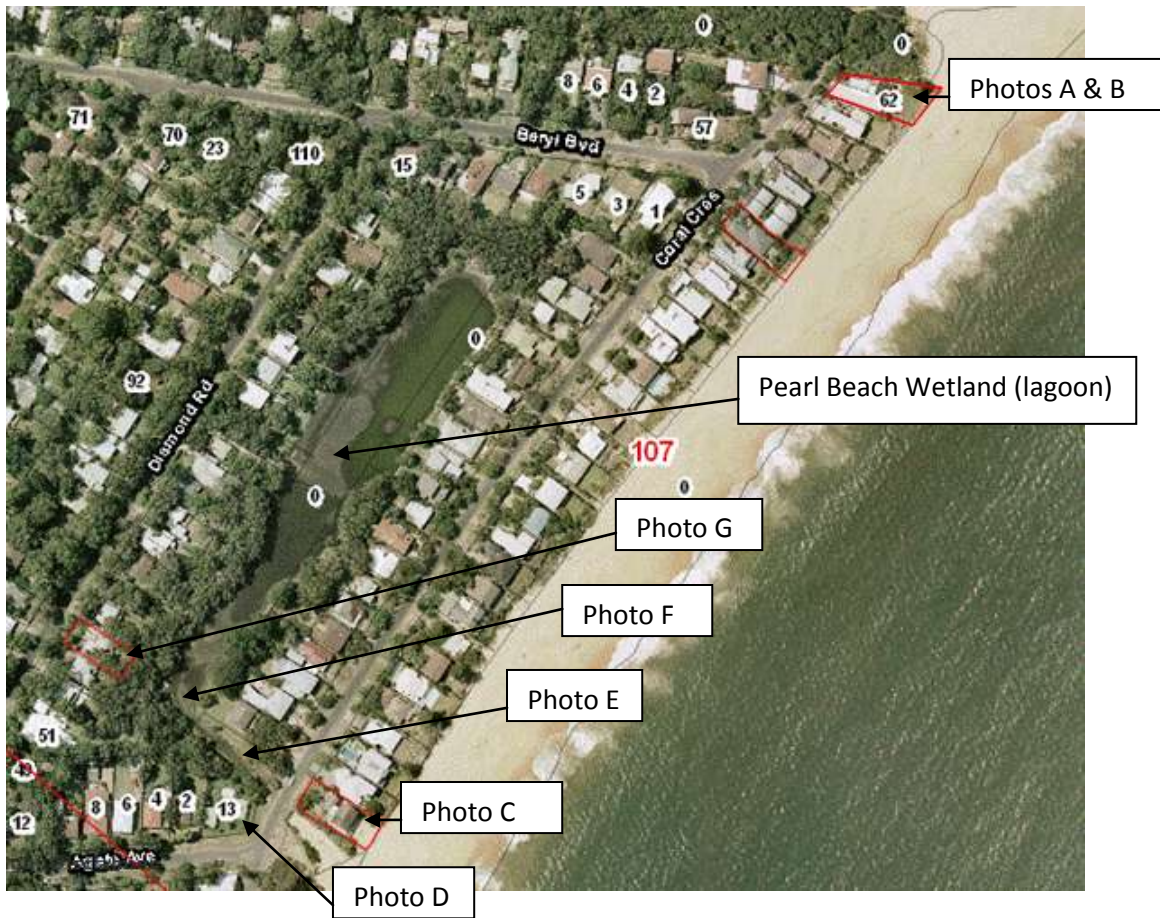
- A. Beach front properties on Coral Cres where sand dunes have been severely eroded and vegetation designed to hold the bank removed by the sea. (Photo taken next to 62 Coral Cres).

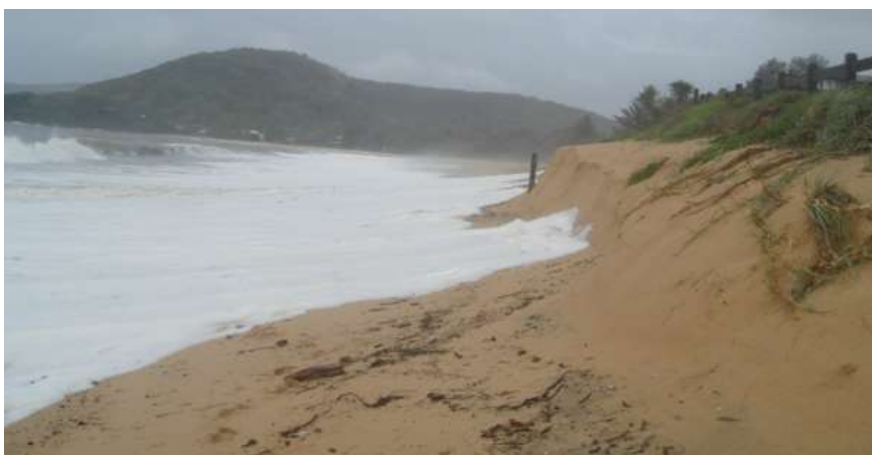
B. Waves have come into the back garden of 62 Coral Cres as seen by the wet sand outline.

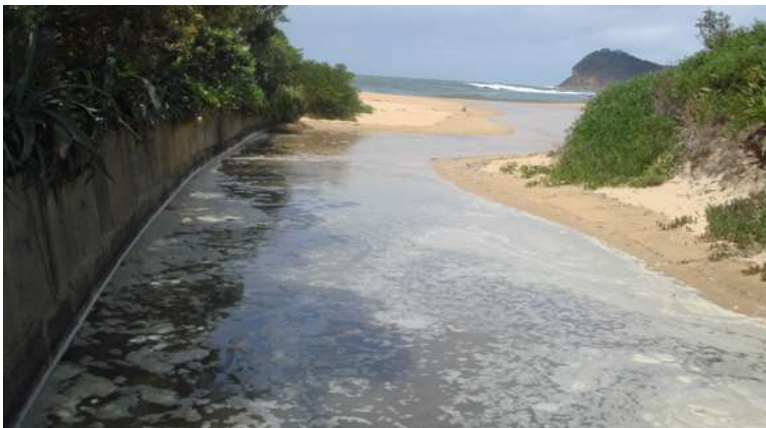
D. 13 Agate Ave across the road from 4 Coral Cres
Drain full of sea water leading to Pearl Beach Wetland (lagoon)

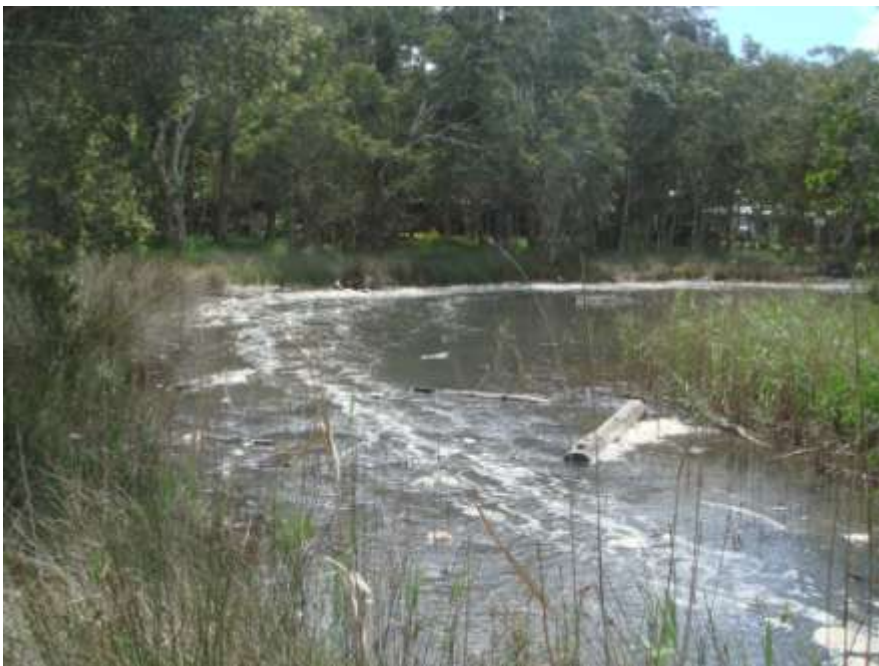
G. 57 Diamond Rd Pearl Beach. Water from the lagoon is on the back boundary of the property. Seawater coming into the lagoon at the point could flood this and nearby properties which has happened historically and affect the Swamp mahogany – paperbark (*Melaleuca quinquenervia*) Ecological Community.

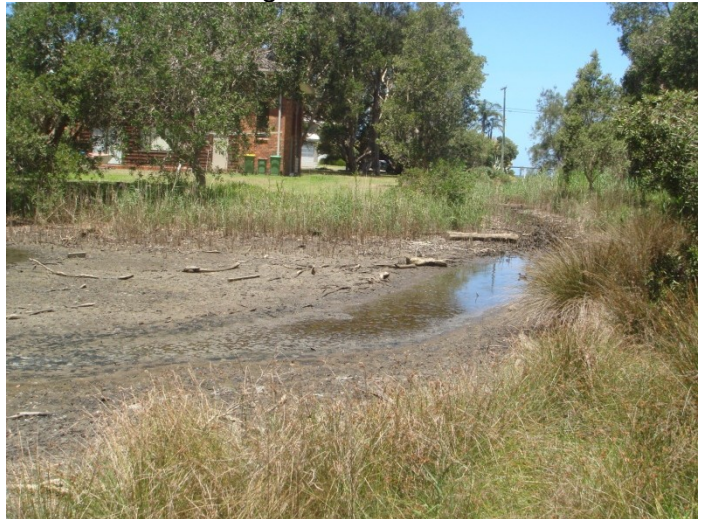
Silt build up and algae.
Northern end of lagoon
