Native Vegetation Clearance Data Report

Talia Farms – Irrigation Infrastructure Development

Clearance under the *Native Vegetation Regulations 2017*

5/07/22

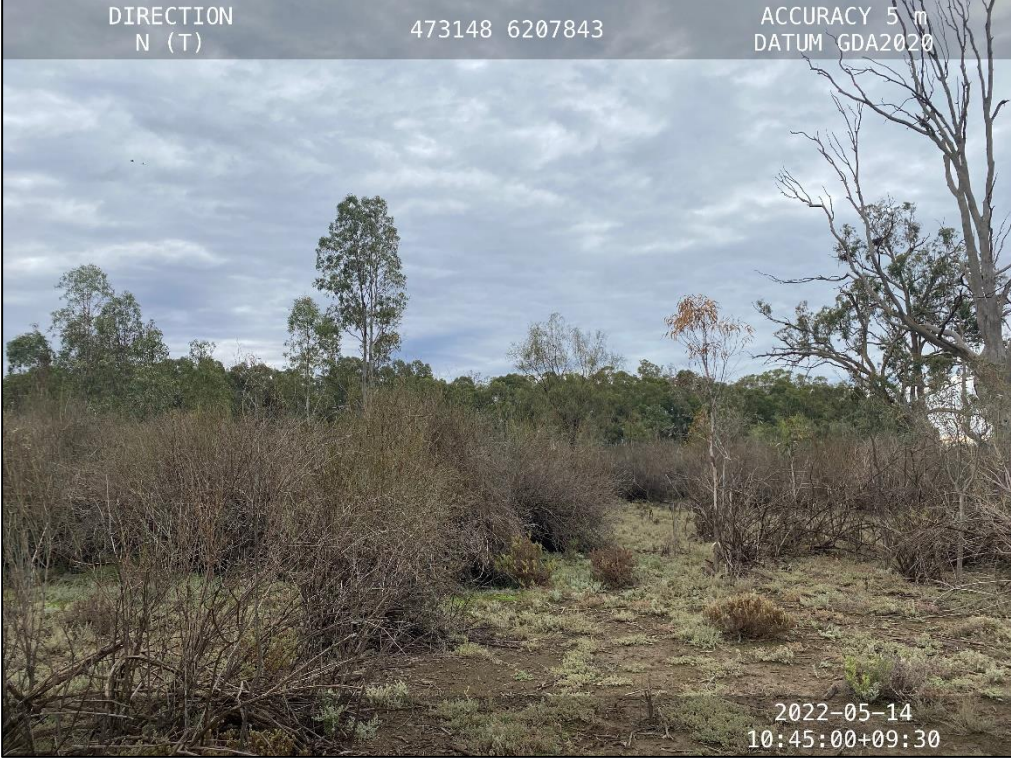
Vegetation Association	A1: <i>Eucalyptus camaldulensis</i> var. <i>camaldulensis</i> mid woodland over +/- <i>Acacia stenophylla</i> over <i>Duma florulenta</i> tall shrubs over +/- <i>Setaria jubiflora</i> , +/- <i>Cyperus gymnocaulos</i> low tussock grasses
	<div style="display: flex; justify-content: space-between; align-items: center; background-color: #cccccc; padding: 5px;"> DIRECTION N (T) 473148 6207843 ACCURACY 5 m DATUM GDA2020 </div>

<div style="text-align: right; padding-right: 10px;"> 2022-05-14 10:45:00+09:30 </div>
General description	Open woodland vegetation, fringing the River Murray. The impact site has been minimized to exclude a section of regenerating <i>Eucalyptus camaldulensis</i> ssp. <i>camaldulensis</i> where an individual <i>Myoporium parvifolium</i> (Creeping boobialla) plant was recorded during the site assessment. The Creeping Boobialla is rated Rare in SA. This area will be protected against impacts during construction by using bunding. The vegetation is patchy and has long dead

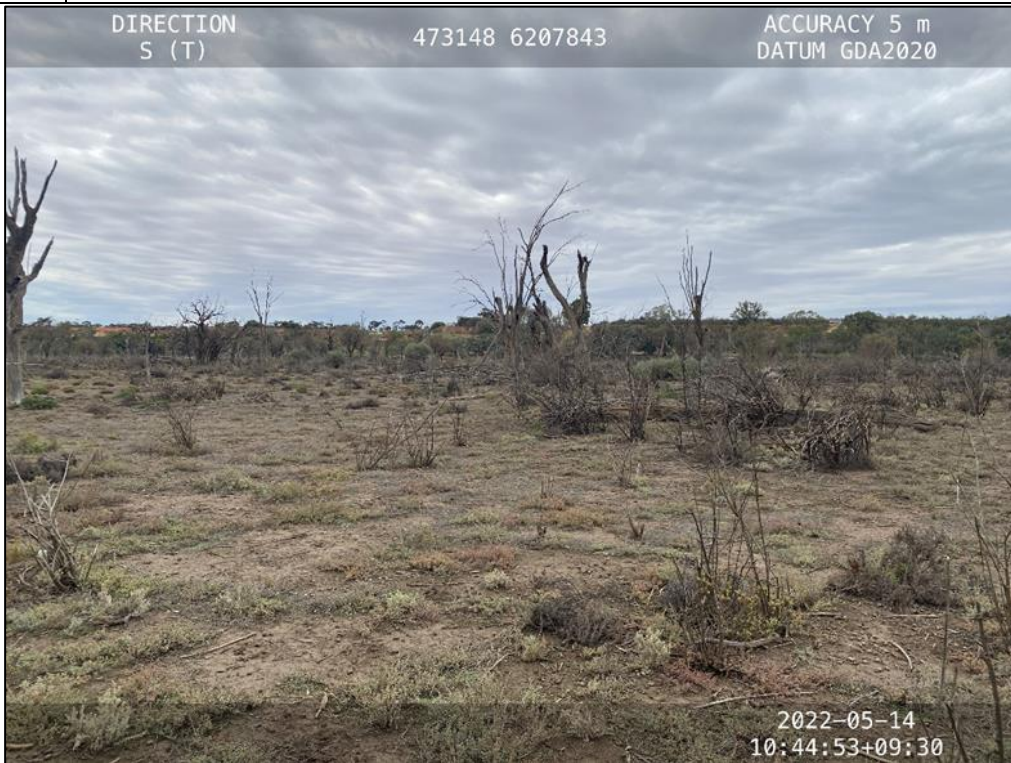
Vegetation Association	<i>B1: Duma florulenta</i> mid open shrubland over low grasses				
------------------------	--	--	--	--	--

General description	The vegetation is patchy and has long dead standing <i>Eucalyptus camaldulensis</i> ssp <i>camaldulensis</i> present. Some trees will be protected against impacts during construction by using bunding – refer to the plans for specific area. The ground cover is consistent across the site and dominated by chenopods and annual ephemeral species. Die back of <i>Duma florulenta</i> observed across the site, consistent with a seasonally inundated vegetation community. This vegetation is benchmarked against: <u>MDBSA 10.3: Freshwater/ Brackish Tall Herblands/ Emergent Shrubs and Trees</u>				
Threatened species or community	No threatened flora or fauna under the NP&W Act or EPBC Act listed species or community observed during the site assessment.				
Landscape context score	1.17	Vegetation Condition Score	54.39	Conservation significance score	1.10
Unit biodiversity Score	44.80	Area (ha)	0.64	Total biodiversity Score	70.00

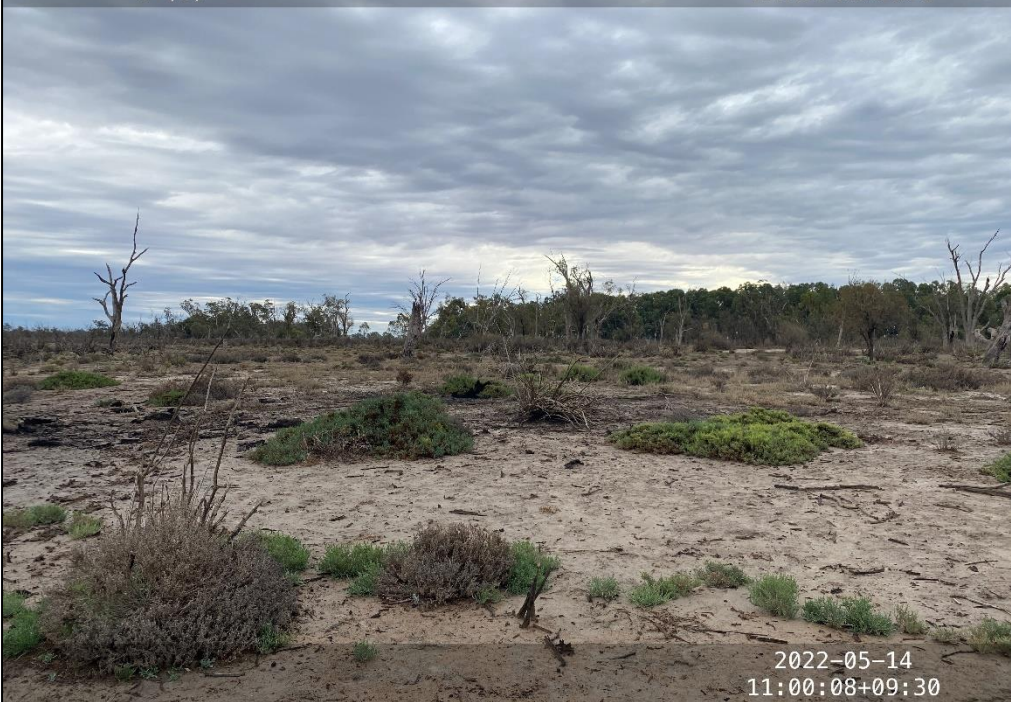
Vegetation Association	C1: <i>Tecticornia pergranulata</i> ssp. low samphire shrubland				
	<div style="display: flex; justify-content: space-between;"> DIRECTION N (T) 473093 6207677 ACCURACY 4 m DATUM GDA2020 </div>

<div style="text-align: right; margin-top: 10px;"> 2022-05-14 11:00:08+09:30 </div>				
General description	<p>The ground cover is sparse and consistent across the site and consists of only three plant species. Long dead <i>Duma florulenta</i> observed across the site. Large open areas of muddy flats, inter-dispersed with vegetated clumps and woody debris.</p> <p>This vegetation is benchmarked against: <i>MDBSA 11.1: Low Samphire Shrublands with Tidal Inundation/ Hypersaline Soils</i></p>				
Threatened species or community	No threatened flora or fauna under the NP&W Act or EPBC Act listed species or community observed. Refer to the threatened species assessment.				
Landscape context score	1.17	Vegetation Condition Score	41.59	Conservation significance score	1.08

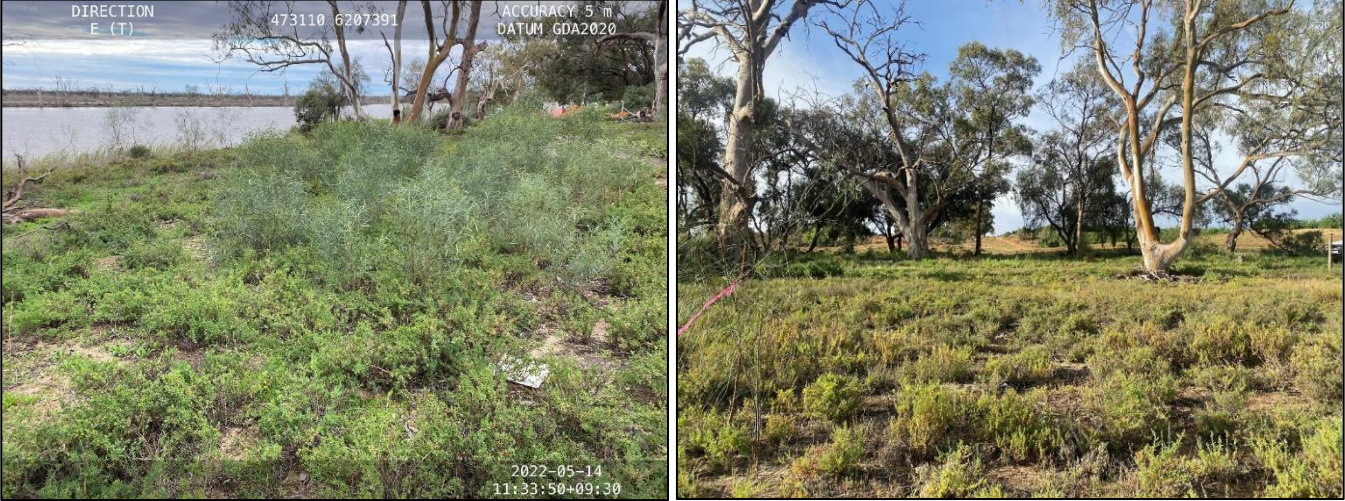
Vegetation Association	<i>D1: Enchylaena tomentosa</i> shrubland with emergent <i>Acacia stenophylla</i> , fringing <i>Eucalyptus largiflorens</i>

General description	The ground cover is regenerating low shrubs with areas of <i>Eucalyptus largiflorens</i> and <i>Eucalyptus camaldulensis</i> ssp <i>camaldulensis</i> fringing the proposed clearance site. There is a small patch of <i>Acacia stenophylla</i> regenerating. NOTE: This is an additional area – which is adjoining a site which already has approval to be cleared. Refer to plans and maps for details.				
Threatened species or community	No threatened flora or fauna under the NP&W Act or EPBC Act listed species or community observed. Refer to the threatened species assessment.				
Landscape context score	1.13	Vegetation Condition Score	23.28	Conservation significance score	1.08
Unit biodiversity Score	28.66	Area (ha)	0.05	Total biodiversity Score	1.43
