# Native Vegetation Clearance

## Maralinga Site Remediation – Debris Pits

### Data Report

Clearance under Section 28 of the Native Vegetation Act 1991

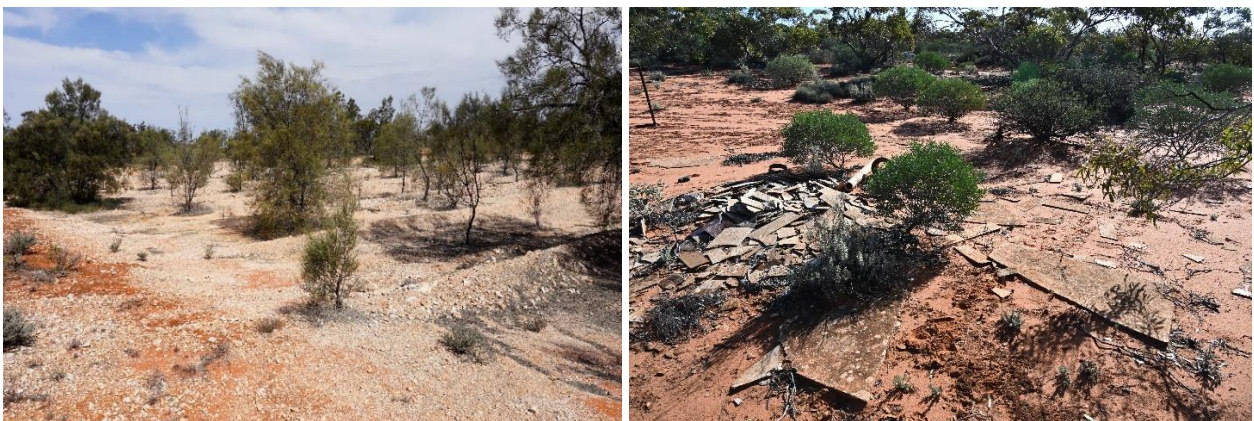
*Figure 3: Images of vegetation at the proposed waste repository (left) and one of the debris pits to be remediated (right).*

Most of the vegetation present at these debris sites are highly degraded and sit within a modified landscape (Figure 3).

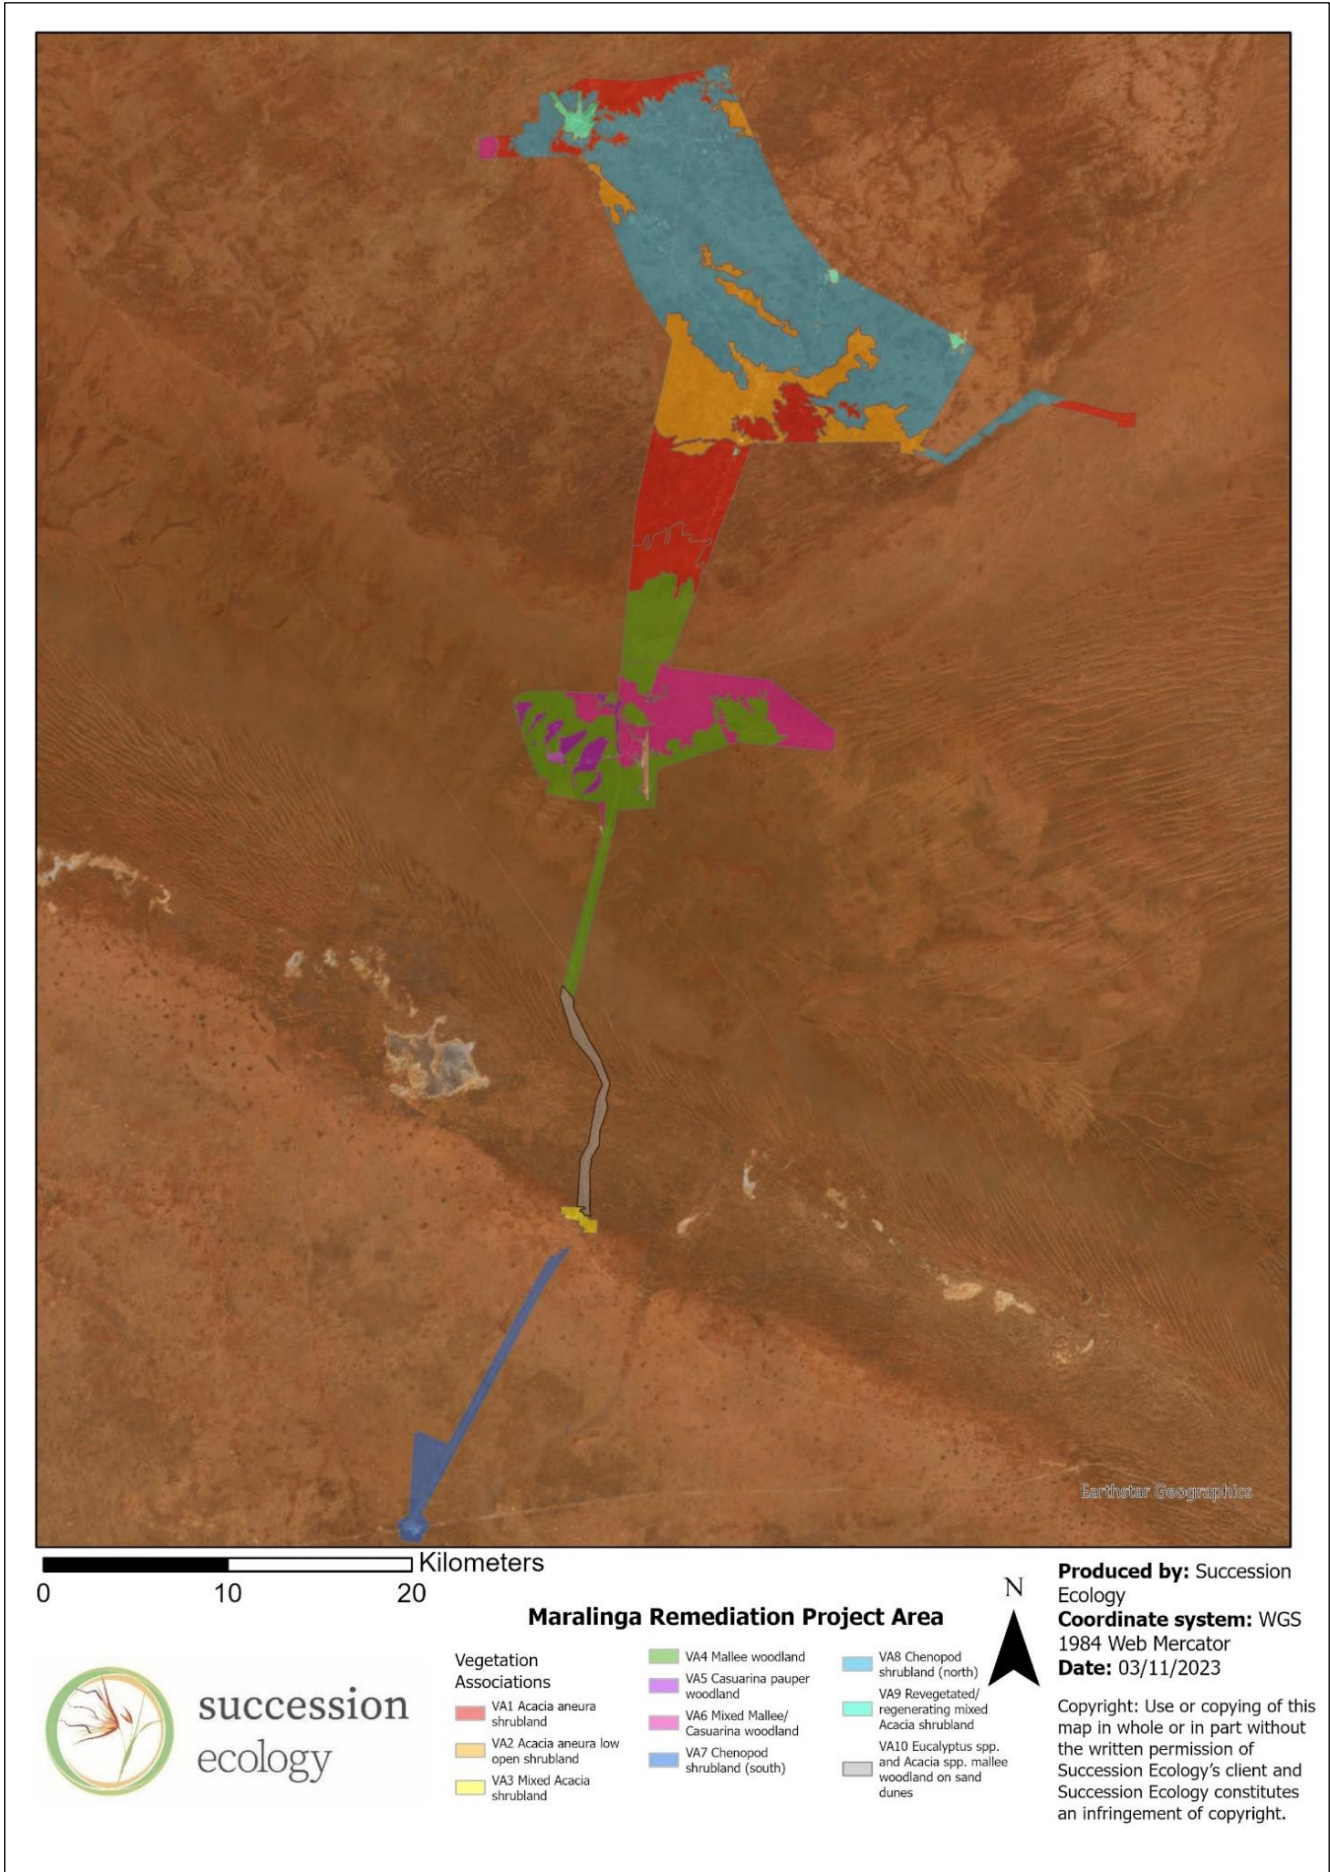
Figure 4: Distribution of Vegetation Associations across the remediation area as mapped and described by Succession Ecology.

the time of the survey, many species were in flower or setting seed. From the assessment sites a total of ten native vegetation associations (Figure 4) were described. Nine vegetation associations contained sites where remediation activities are going to take place (Table 4). Only the nine vegetation associations relevant to the proposed clearance will be discussed in this report. VA1 is the only vegetation association found within both the Maralinga and Yellabinna subregion. Due to it being on the very edge of the Yellabinna subregion, the landscape vegetation and conservation scores being very close or identical and minimal sites, for the clarity this application it has been scored on the same data sheet and recorded as the one vegetation association in the Maralinga region in the score sheets.

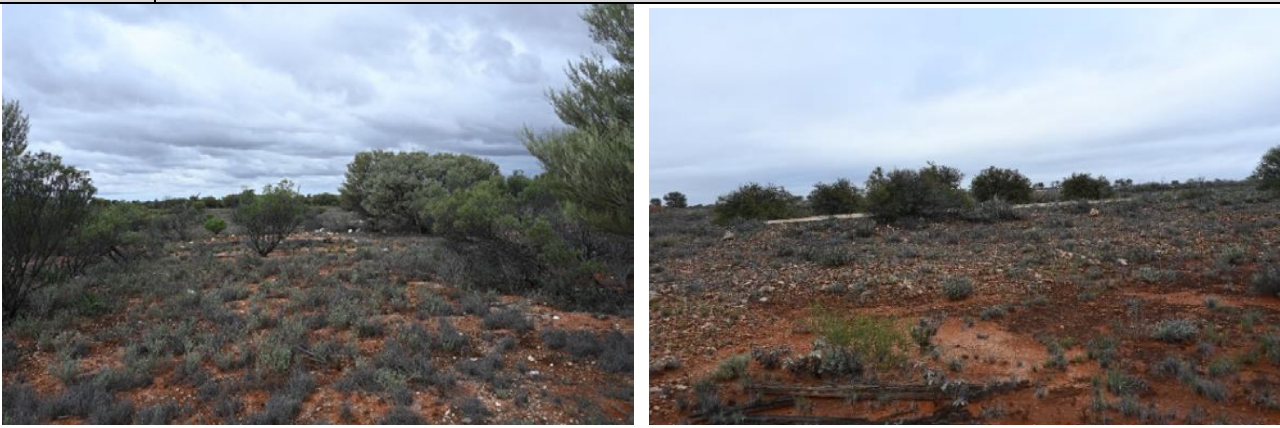
<p data-bbox="119 622 1436 689">Figure 6: Representative photographs of <i>Acacia aneura</i> overstorey with chenopod and shrub understorey with varying levels of disturbance (Succession Ecology September 2022).</p>	
<b>General description</b>	<p>Overstorey was dominated by <i>Acacia aneura</i> with multiple age classes represented. A semi-dense midstorey of <i>Senna artemisioides</i> ssp. <i>zygophylla</i> was present, as well as a high diversity of other shrub species such as <i>Acacia burkittii</i>, <i>A. minyura</i>, <i>A. calamifolia</i>, <i>Myoporum platycarpum</i>, <i>Pittosporum angustifolium</i> and <i>Eremophila longifolia</i>. Understorey species included <i>Maireana sedifolia</i>, <i>Ptilotus obovatus</i>, <i>Rhagodia spinescens</i>, <i>Atriplex vesicaria</i> and <i>Enneapogon</i> species. This vegetation type occurred within a landscape that had high levels of historical disturbance but there was little to no invasive weeds present.</p>

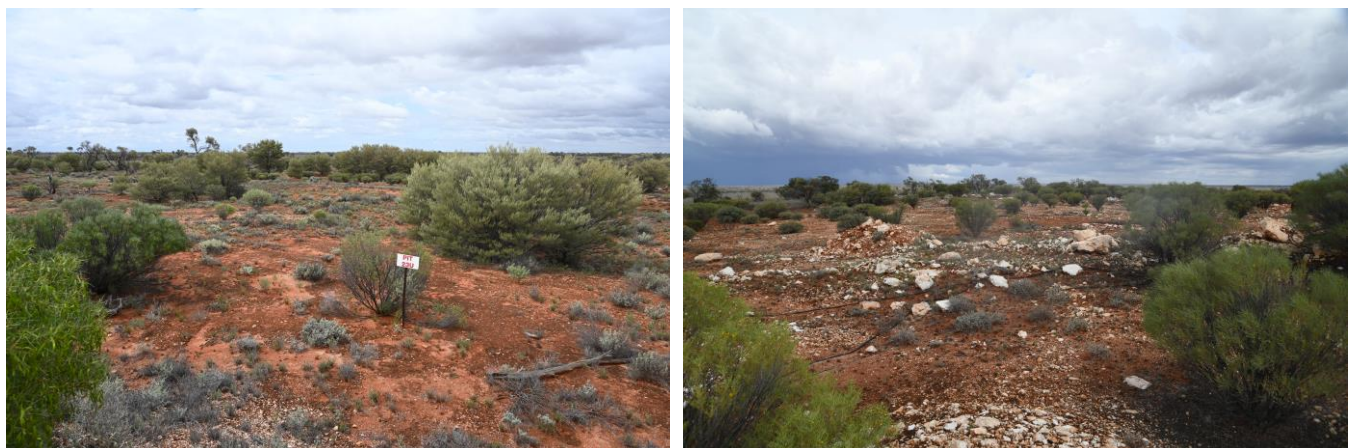
Figure 8: Representative photographs of an *Acacia aneura* low open shrubland (Succession Ecology September 2022).

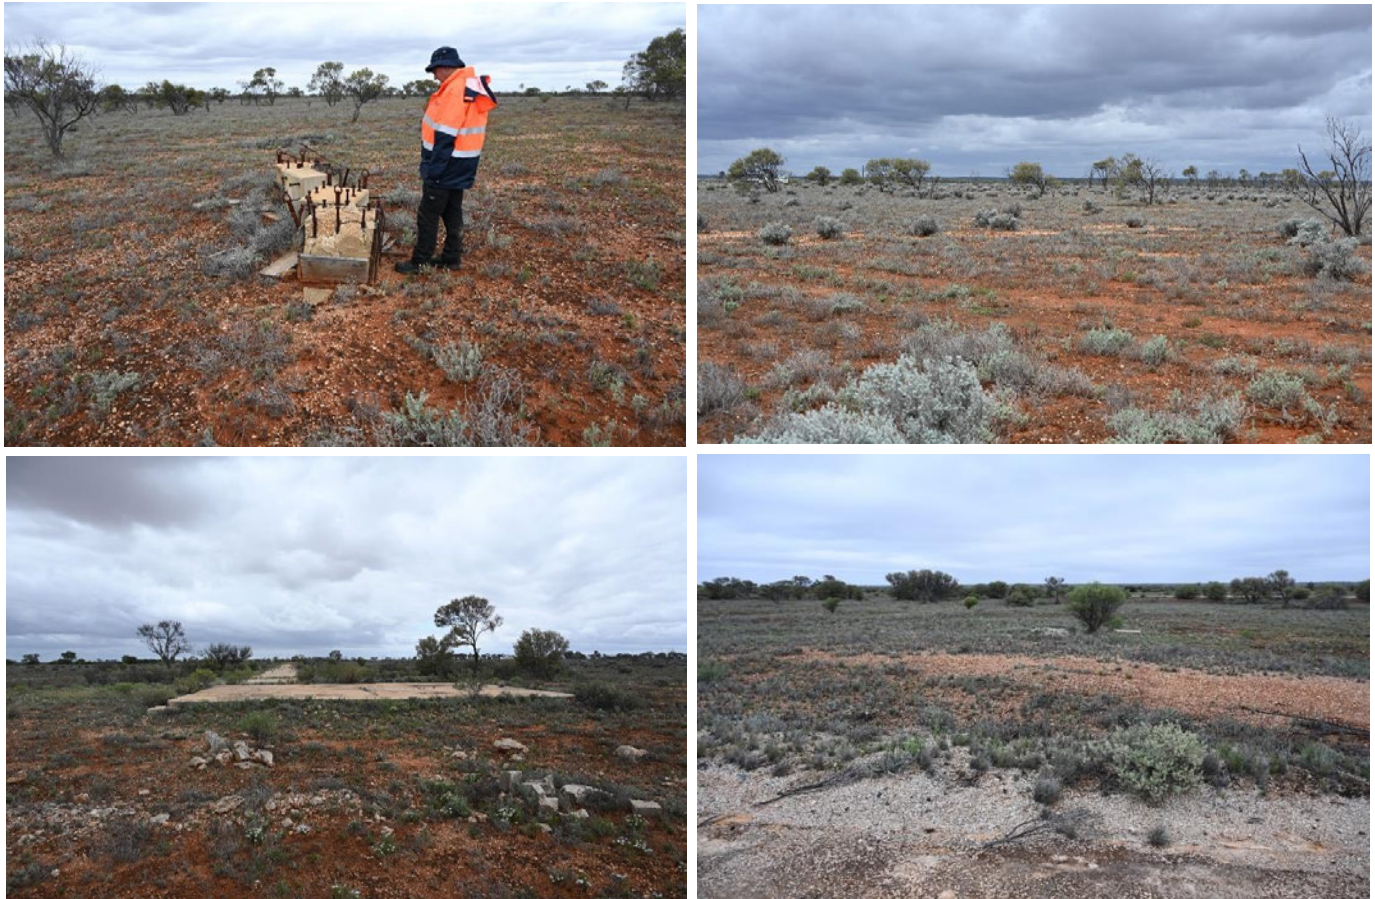
Figure 9: Examples of disturbance and surface debris within VA2 (Succession Ecology September 2022).

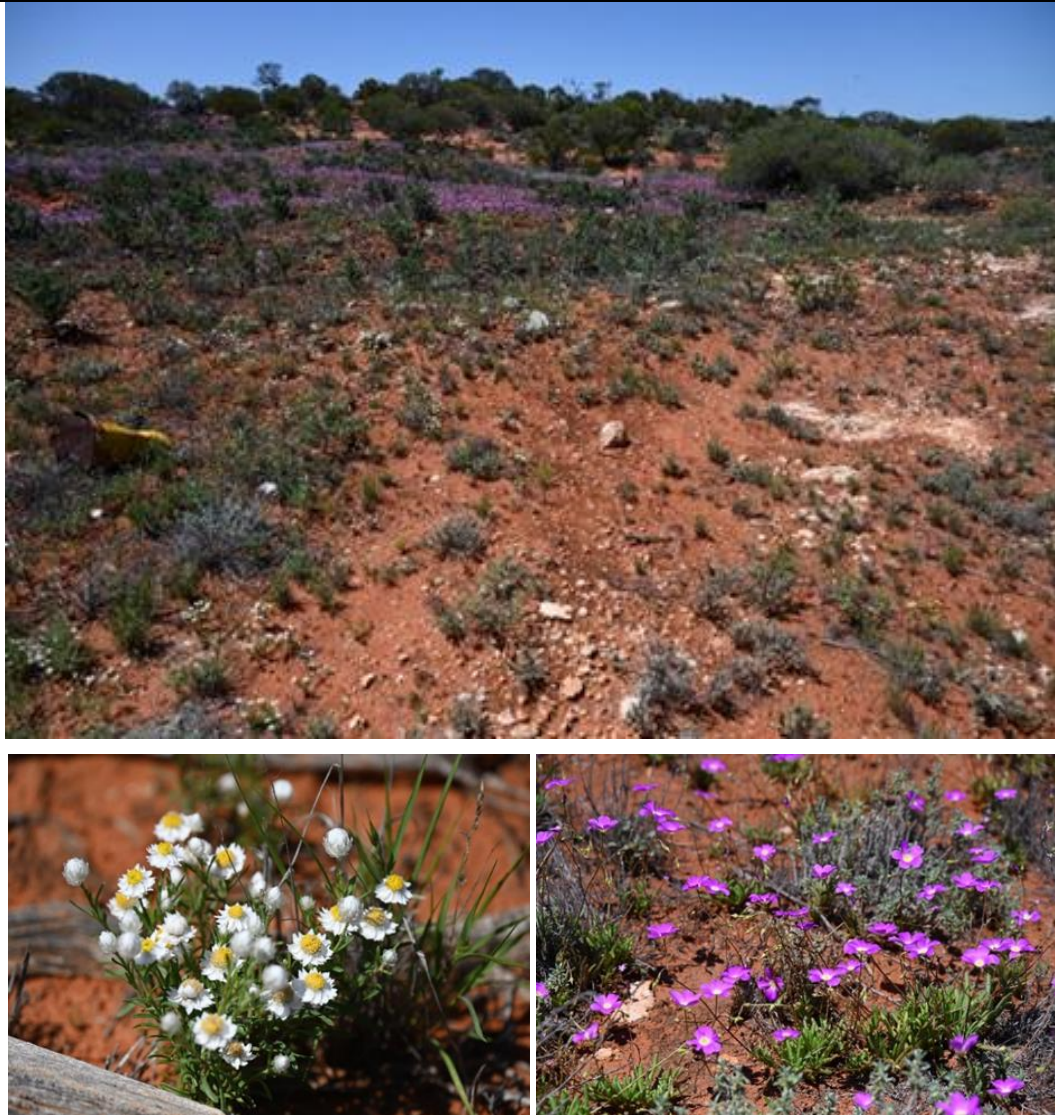
Figure 11: Plant species occurring at DP66 and DP67 including flowering *Calandrinia* (Succession Ecology September 2022).

<b>General description</b>	<p>One vegetation assessment was completed for the debris sites in this vegetation association described as Mixed <i>Acacia</i> Shrublands. The site was located one south of the village near the Ceduna turnoff, on the southern edge of a large dune field that extends 10 km north towards the Oak Valley turnoff. A total of 50 native and three introduced plant species were recorded for this association.</p> <p>The dominant overstorey species were <i>Acacia burkittii</i> and <i>A. kempeana</i>, with a range of mid-storey plants including species from the genera <i>Maireana</i>, <i>Solanum</i> <i>Sclerolaena</i> and <i>Dodonaea</i>. This was the only assessment site where two species of annual wildflowers, <i>Calandrinia eremaea</i> and <i>Calandrinia remota</i> were seen (Figure 11). The <i>Acacia</i> Shrubland association was in good condition with minor signs of physical disturbance, such as erosion from vehicle tracks and old wires running across the site. Signs of rabbits and camels were also recorded. Weeds recorded in this association were Indian Hedge Mustard. At all sites they accounted for less than 5 % of the vegetation cover.</p>

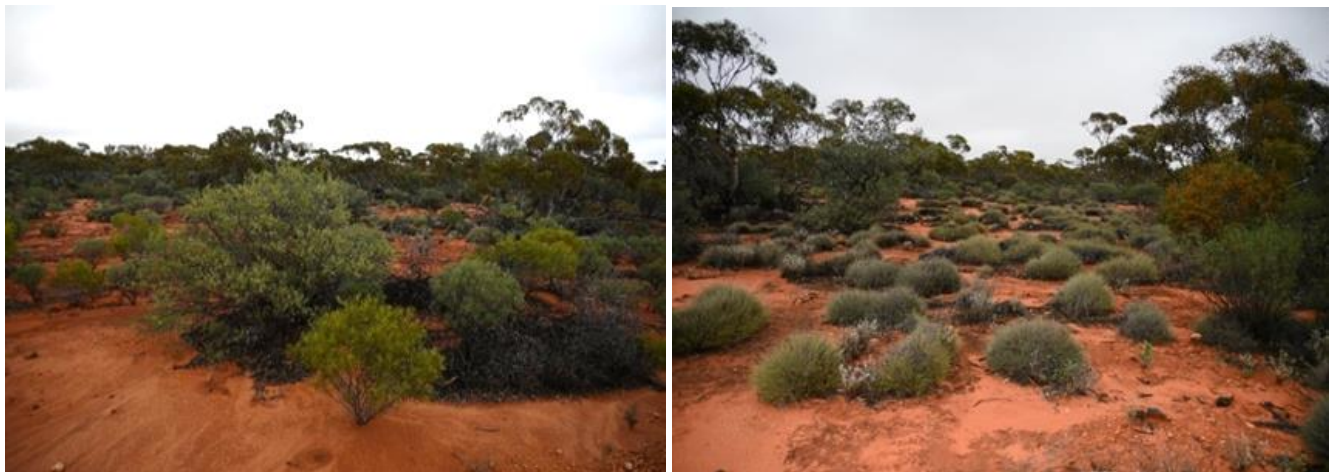
Figure 13: Examples of the Mallee woodland in VA4 with tussock grasses in the foreground (Succession Ecology September 2022).

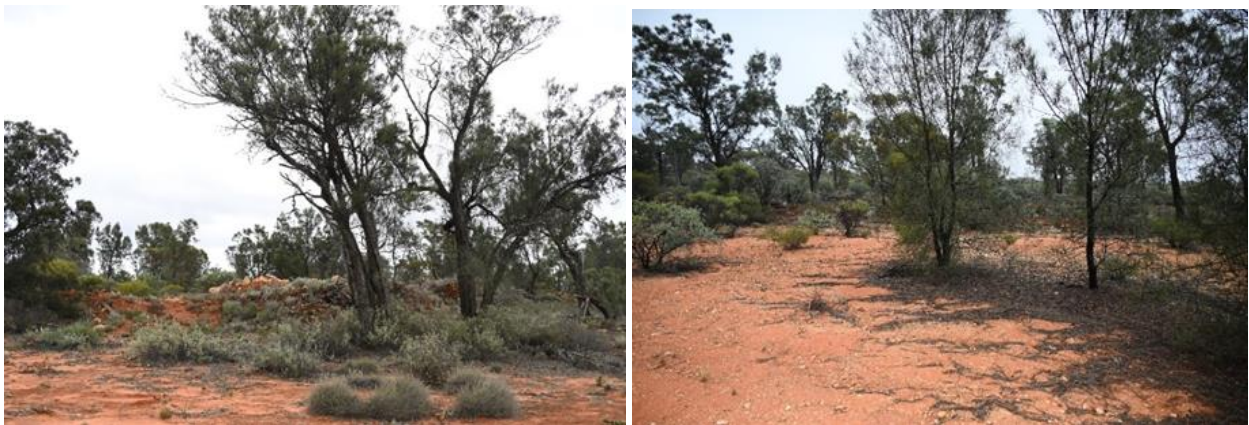
Figure 15: Examples of the vegetation types in *Casuarina pauper* woodland vegetation association (Succession Ecology September 2022).

<b>General description</b>	The <i>Casuarina pauper</i> woodlands were found near the Maralinga Village at five assessment sites. The overstorey in this association is dominated by adult <i>Casuarina pauper</i> tree but also includes <i>Eucalyptus concinna</i> and <i>E. oleosa</i> . The midstorey was a combination of <i>Acacia</i> , <i>Eremophila</i> and <i>Senna</i> species, and the understorey was a mix of <i>Maireana</i> and <i>Solanum</i> species combined with grasses from the <i>Austrostipa</i> and <i>Enneapogon</i> genera (Figure 15).
----------------------------	--

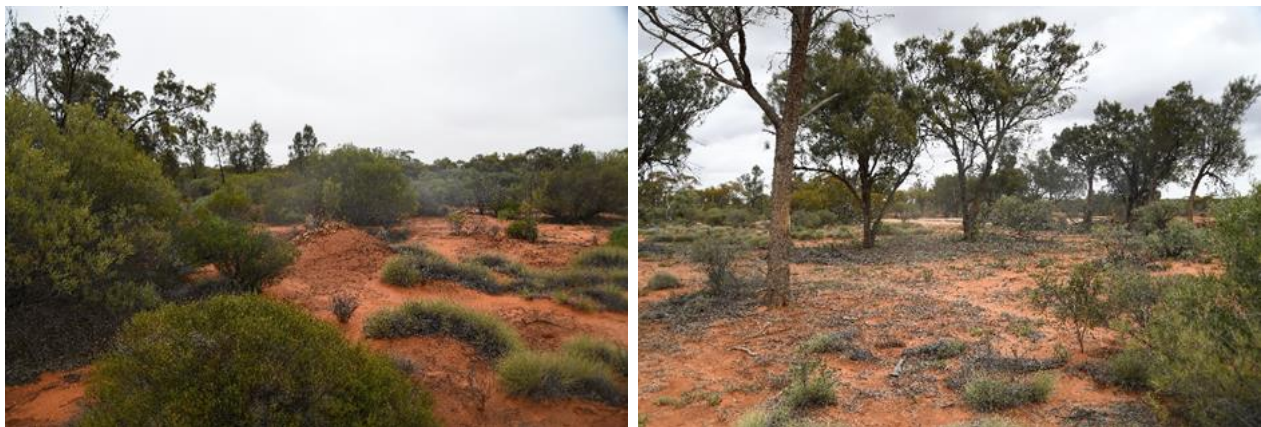
Figure 17: Example of the vegetation found within the Mixed Mallee/*Casuarina* Woodland (Succession Ecology September 2022).

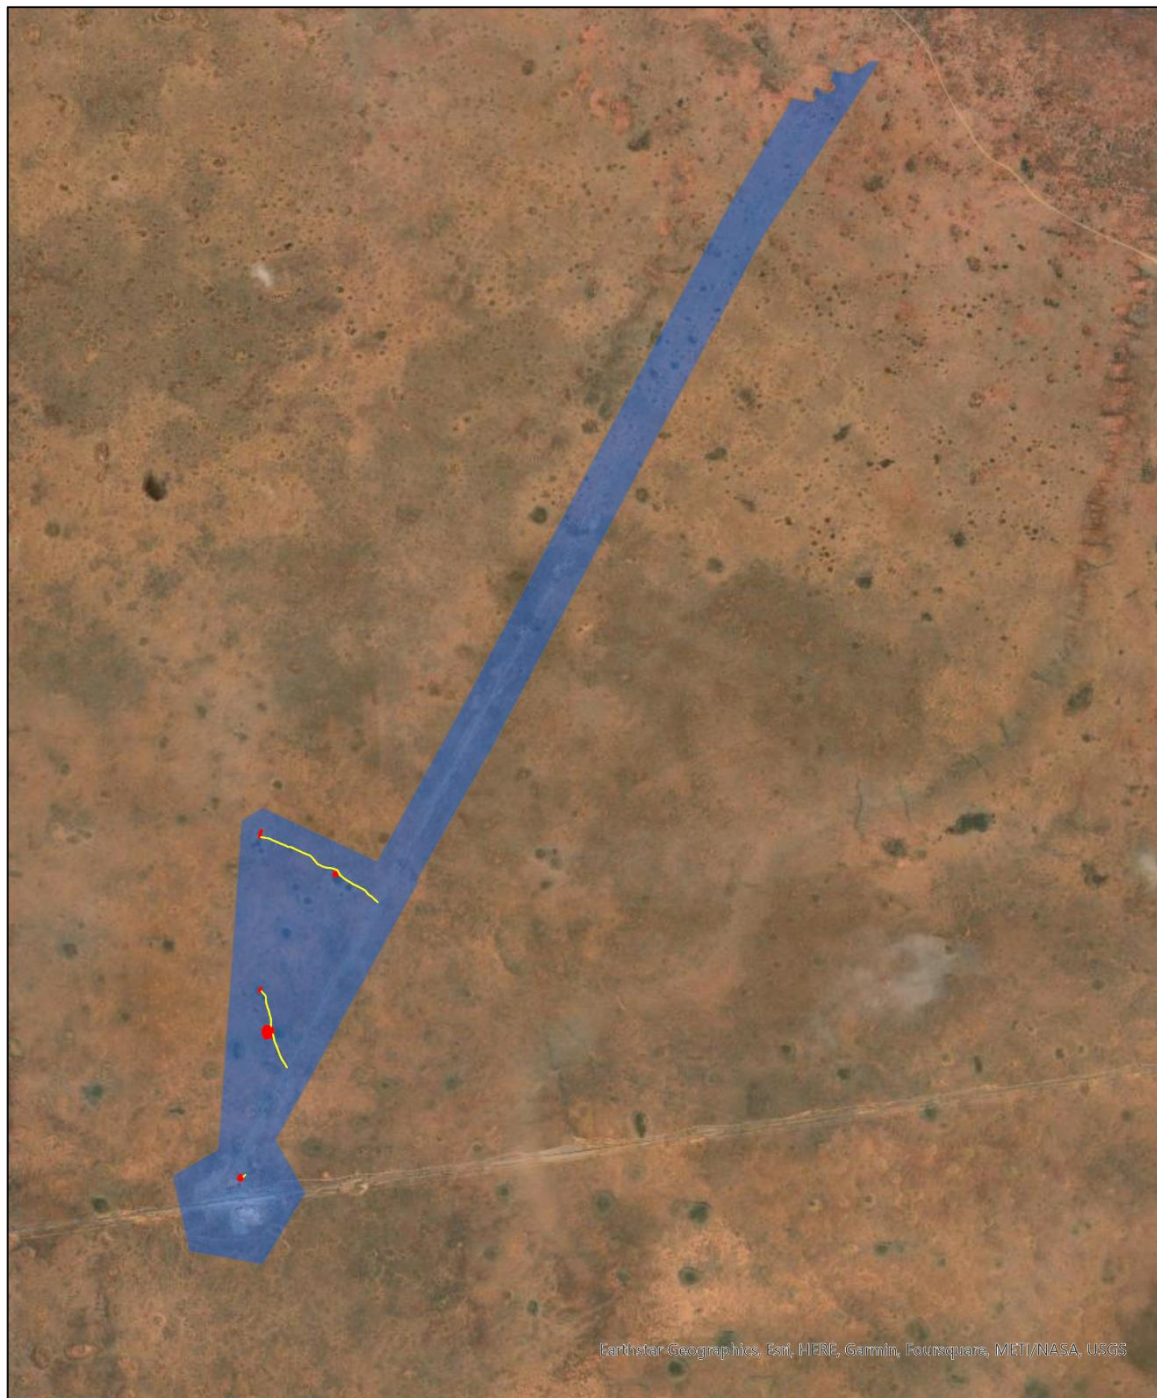
Figure 18: Extent of VA7 Chenopod Shrubland including debris sites.

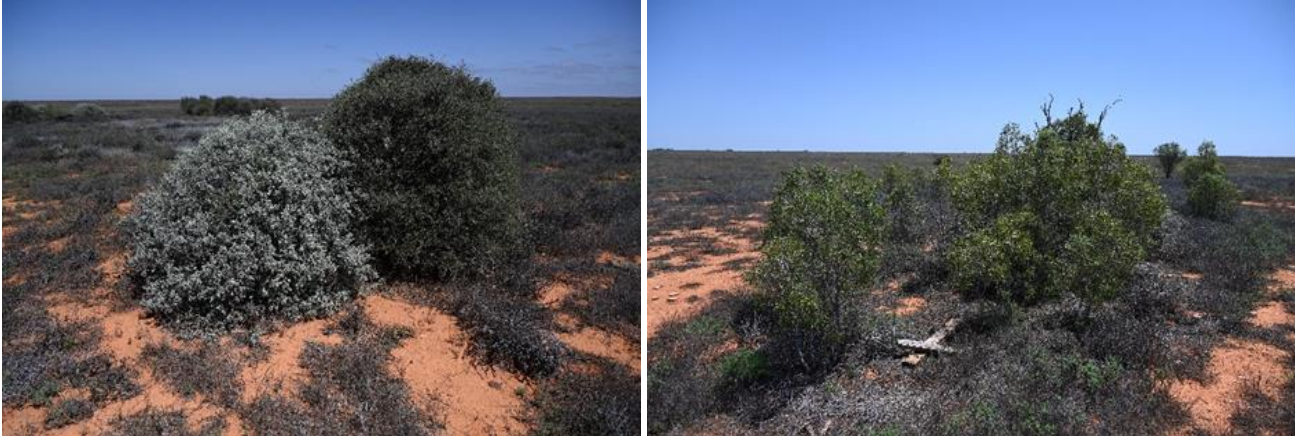
Figure 19: Examples of the vegetation types in VA7 (Succession Ecology September 2022).

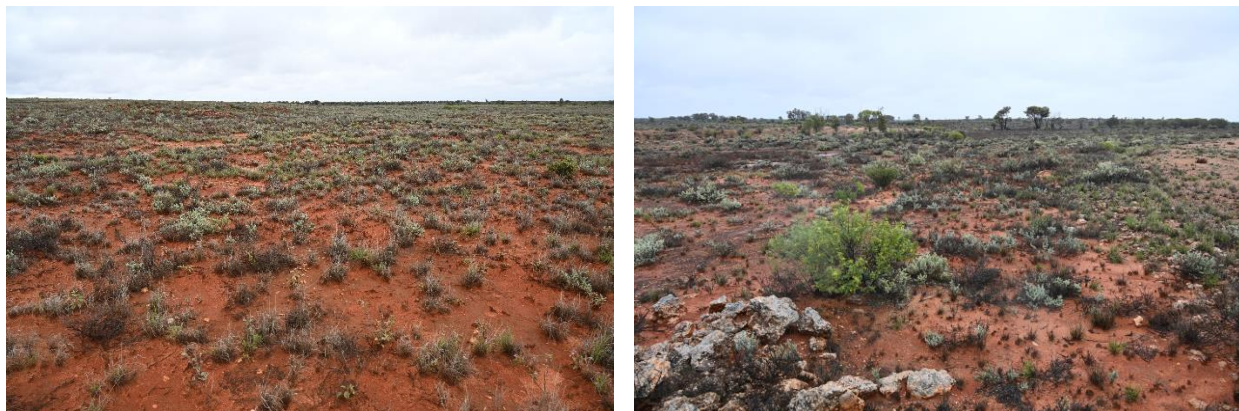
Figure 21: Examples of the vegetation types in VA8 (Succession Ecology September 2022).

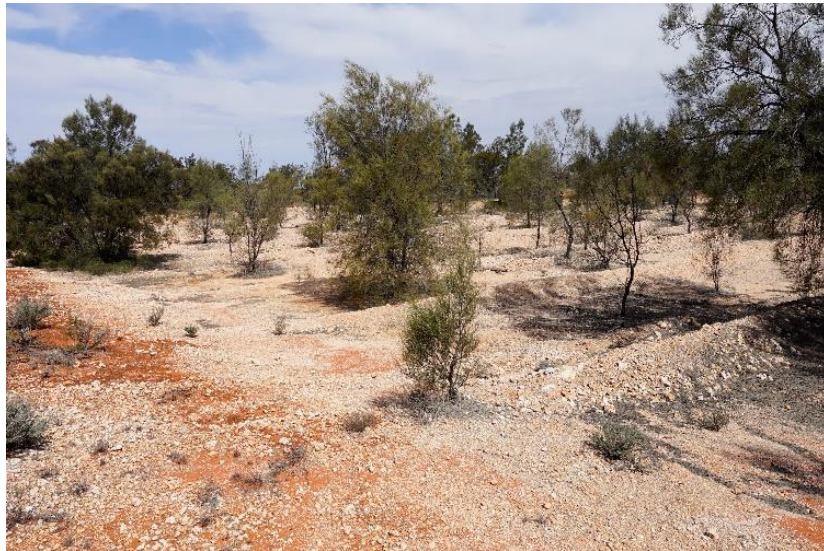
Figure 22: Waste repository location showing the disturbed and modified condition of this area (supplied by DISR).

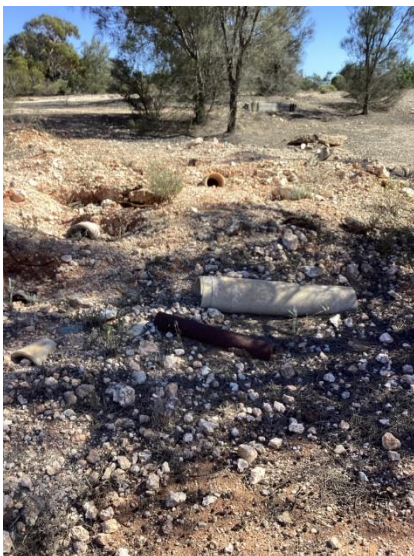
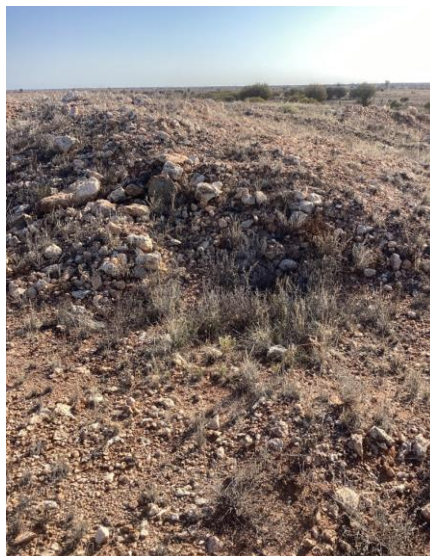
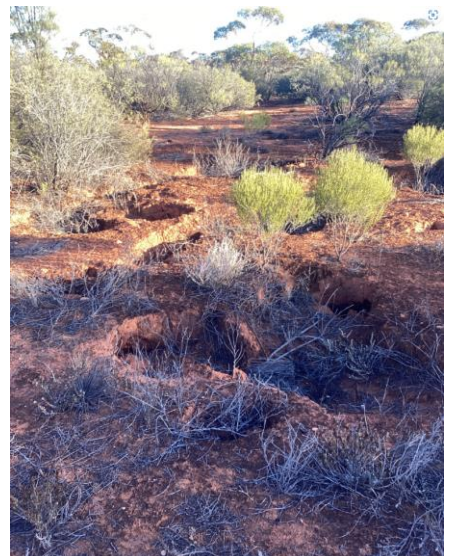
Figure 23: Examples of highly disturbed and modified condition of debris pits (supplied by DISR).

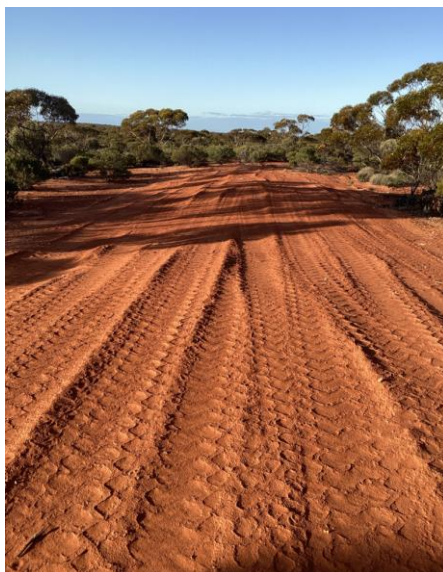
Figure 24: Most debris pits are accessible by existing roads as the one above (supplied by DISR).
