# Native Vegetation Clearance

## Uley South Bore Sites

### Data Report

Clearance under the *Native Vegetation Regulations 2017*

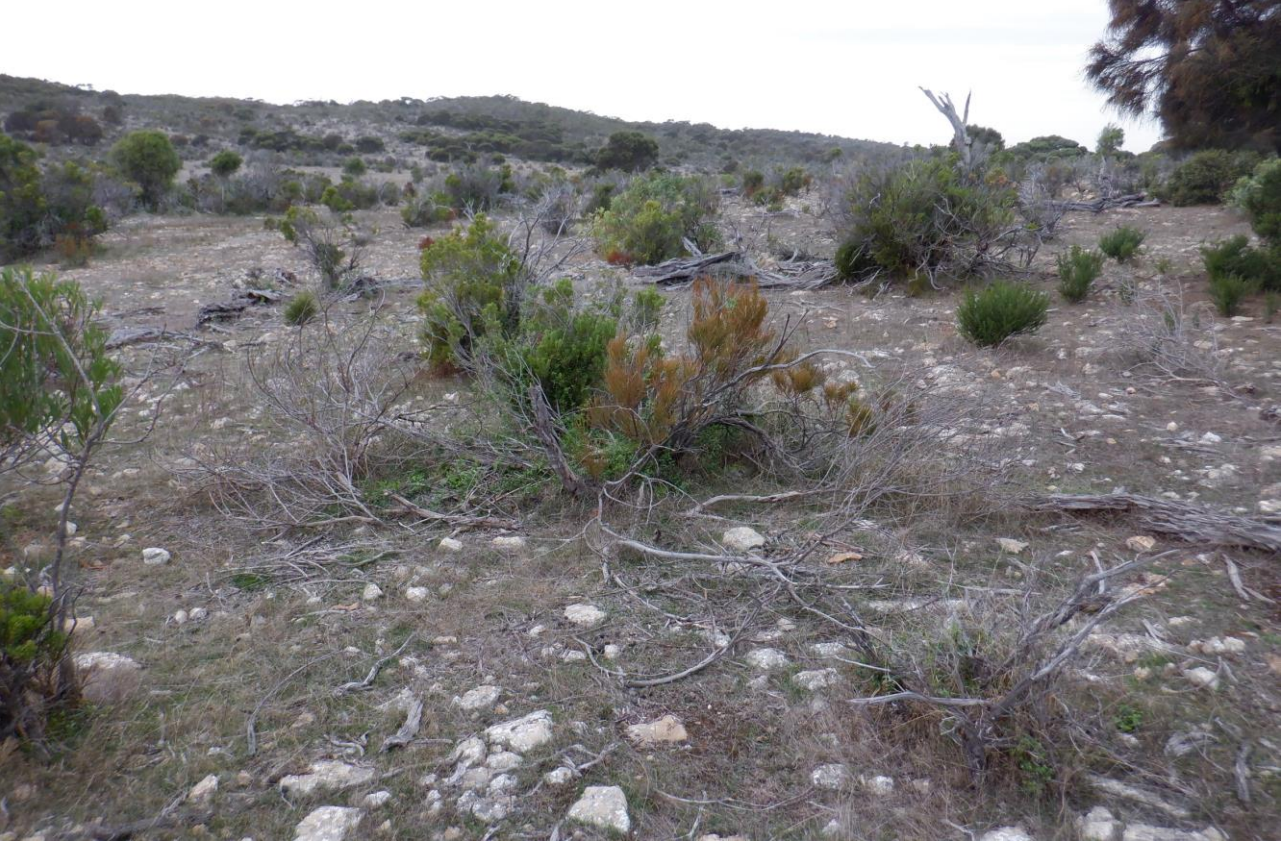
Vegetation Association	Vegetation Association A1. <i>Leucopogon parviflorus</i> shrubland over native grasses and forbs

Photo 4159 looking along the proposed clearance corridor south-east from Waypoint 54					
General description	<p>The sparse shrub overstorey is dominated by <i>Leucopogon parviflorus</i>, <i>Acacia longifolia</i> ssp. <i>sophorae</i> and <i>Exocarpus aphyllus</i> with scattered <i>Pittosporum angustifolium</i>. Understorey species include small native shrubs and forbs such as <i>Leucopogon cordifolius</i>, <i>Clematis microphylla</i>, <i>Acacia triquetra</i>, <i>Nicotiana velutina</i> and <i>Olearia axillaris</i>. The pest plant <i>Asparagus asparagoides</i> was present at the base of several shrubs.</p> <p>There is sparse regeneration from these species.</p> <p>The understorey is heavily grazed, dominated by native wallaby grasses <i>Rytidosperma</i>. Other ground layer species include <i>Austrostipa</i> sp. <i>Dichondra repens</i>, <i>Geranium</i> sp., <i>Acaena</i> sp., <i>Vittadenia</i> sp., as well as a number of exotic grasses and forbs such as <i>Avena barbata</i>, <i>Lagurus ovata</i>, <i>Dittrichia graveolens</i>, <i>Lysimachia arvensis</i> and <i>Centaurium tenuiflorum</i>.</p>

Threatened species or community	The vegetation is sparse and unlikely to provide critical habitat for rare and threatened fauna species. The vegetation does not support threatened plant species and is not part of a threatened plant community.				
Landscape context score	1.06	Vegetation Condition Score	36.03	Conservation significance score	1.00
Unit biodiversity Score	38.19	Area (ha)	0.608	Total biodiversity Score	23.22

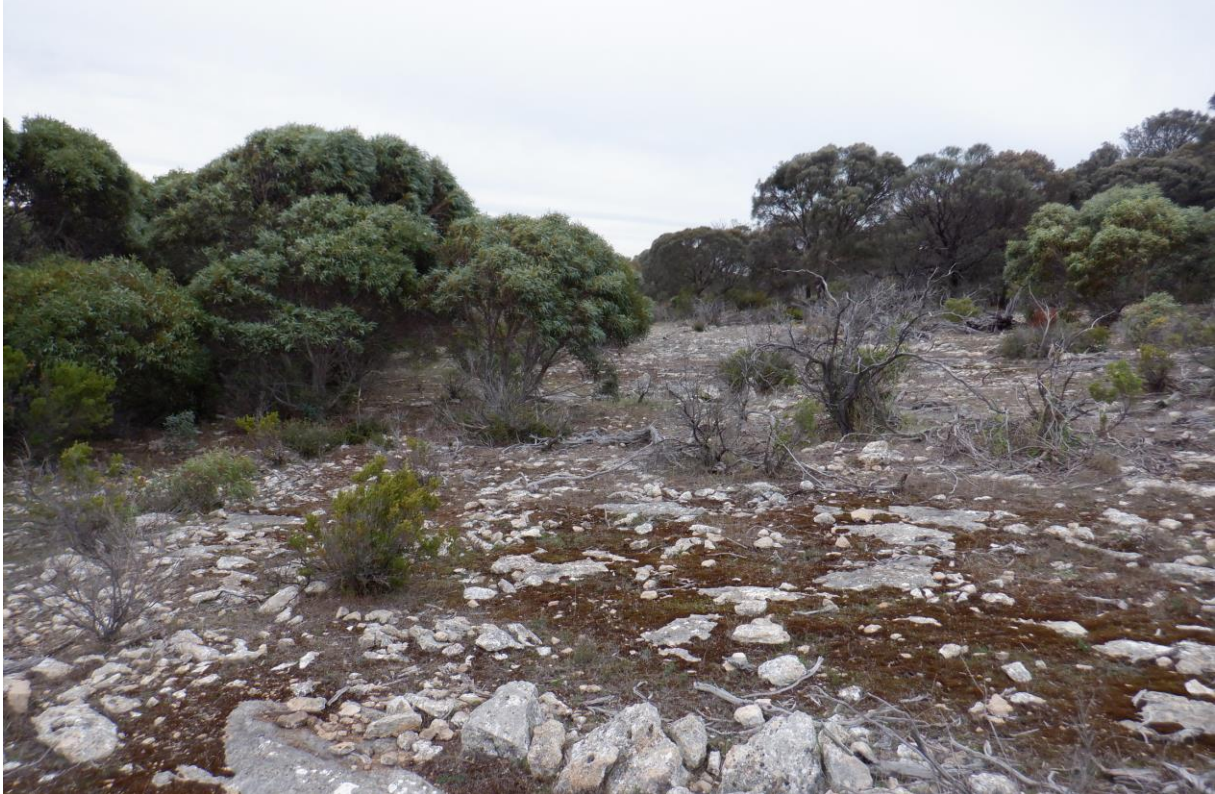
Vegetation Association	Vegetation Association A2. <i>Eucalyptus diversifolia</i> / <i>Allocasuarina verticillata</i> mallee over <i>Leucopogon parviflorus</i> shrubland

Photo 4160 looking along the proposed clearance corridor south-east from Waypoint 55.					
General description	<p>The tree overstorey is dominated by <i>Allocasuarina verticillata</i> and <i>Eucalyptus diversifolia</i> ssp. <i>diversifolia</i> with scattered <i>Eucalyptus albopurpurea</i>. Midstorey species include <i>Leucopogon parviflorus</i>, <i>Acacia longifolia</i> ssp. <i>sophorae</i>, <i>Melaleuca lanceolata</i>, <i>Exocarpus aphyllus</i>, <i>Hakea vittata</i>, <i>Pittosporum angustifolium</i>, <i>Dodonaea viscosa</i> ssp. <i>spatulata</i>, <i>Olearia axillaris</i> and <i>Beyeria lechenaultii</i>. The understorey consists of small native shrubs, sedges and forbs such as <i>Acacia rupicola</i>, <i>Hibbertia devitata</i>, <i>Correa pulchella</i>, <i>Clematis microphylla</i>, <i>Acacia triquetra</i>, <i>Goodia medicaginea</i>, <i>Gahnia deusta</i>, <i>Dianella</i> sp., <i>Nicotiana velutina</i> and <i>Pimelea glauca</i>. Seedlings of many of these species are present indicating regeneration of overstorey and midstorey species</p> <p>The pest plant <i>Asparagus asparagoides</i> was present at the base of several shrubs.</p> <p>The ground layer is heavily grazed, dominated by native wallaby grasses <i>Rytidosperma</i>. Other ground layer species include <i>Austrostipa</i> sp., <i>Microlaena stipoides</i>, <i>Dichondra repens</i>, <i>Geranium</i> sp., <i>Kennedia prostrata</i>, as well as exotic grasses and forbs such as <i>Avena barbata</i>, <i>Lagurus ovata</i>, <i>Dittrichia graveolens</i>, <i>Lysimachia arvensis</i> and <i>Centaurium tenuiflorum</i>.</p>

Threatened species or community	<p>Several plants of the threatened forb <i>Phyllanthus calycinus</i> (Sea Spurge) (SA Rare) were recorded within the ground layer.</p> <p>The vegetation may provide critical habitat for the following rare and threatened fauna species:</p> <ul style="list-style-type: none"> <li>• <i>Stipiturus malachurus parimeda</i> (Southern Emuwren) - (EPBC Vulnerable, SA Endangered)</li> <li>• <i>Psophodes leucagaster leucogaster</i> (White-bellied Whip-bird) - (EPBC Vulnerable, SA Endangered)</li> </ul>				
Landscape context score	1.06	Vegetation Condition Score	62.76	Conservation significance score	1.14
Unit biodiversity Score	75.84	Area (ha)	0.603	Total biodiversity Score	45.73

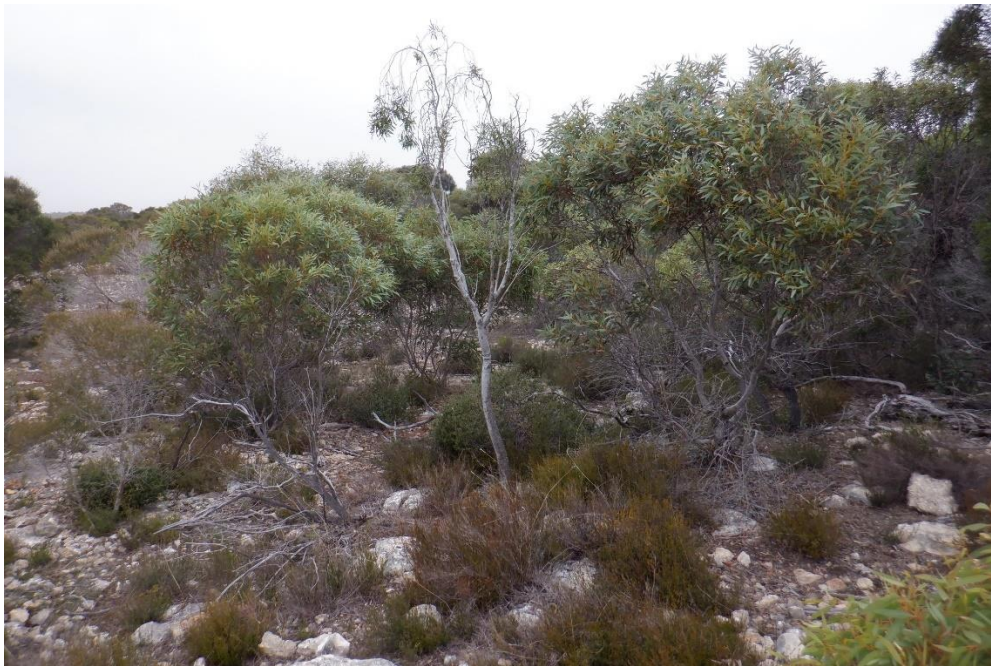
Vegetation Association	Vegetation Association A3. <i>Eucalyptus diversifolia</i> mallee over <i>Melaleuca lanceolata</i> shrubland
------------------------	---

Photo 4165 looking along the proposed clearance corridor south-east from Waypoint 61.

General description	<p>Association A3 is located within a Heritage agreement Area (HA 1291) and is assigned a loading for Clearance of Protected Areas.</p> <p>The overstorey is dominated by <i>Eucalyptus diversifolia</i> ssp. <i>diversifolia</i> and <i>Melaleuca lanceolata</i> with <i>Leucopogon parviflorus</i>, <i>Acacia longifolia</i> ssp. <i>sophorae</i>, <i>Pittosporum angustifolium</i>, <i>Allocasuarina verticillata</i> and <i>Exocarpus aphyllus</i>.</p> <p>Understorey species include <i>Hibbertia devitata</i>, <i>Leucopogon cordifolius</i>, <i>Acacia triquetra</i>, <i>Hardenbergia violacea</i>, <i>Beyeria lechenaultii</i>, <i>Orthrosanthus multiflorus</i>, <i>Dianella</i> sp. and <i>Lepidosperma</i> sp. Seedlings of many of these species are present indicating regeneration of overstorey and midstorey species.</p> <p>The ground layer contains several species of native grasses and forbs, such as <i>Rytidosperma</i>, <i>Austrostipa</i> sp., <i>Linum marginale</i>, <i>Nicotiana velutina</i>, <i>Vittadenia</i> sp. and <i>Geranium</i> sp. and sparsely introduced species (<i>Avena barbata</i>, <i>Lagurus ovata</i>, <i>Lysimachia arvensis</i>, <i>Marrubium vulgare</i> and <i>Asparagus asparagoides</i>).</p> <p>Grazing of the ground layer is relatively low, compared to that observed in Associations A1 and A2.</p>

Threatened species or community	<p>The vegetation may provide critical habitat for the following rare and threatened fauna species:</p> <ul style="list-style-type: none"> <li>• <i>Stipiturus malachurus parimeda</i> (Southern Emuwren) - (EPBC Vulnerable, SA Endangered)</li> <li>• <i>Psophodes leucogaster leucogaster</i> (White-bellied Whip-bird) - (EPBC Vulnerable, SA Endangered)</li> </ul>
---------------------------------	--

Landscape context score	1.06	Vegetation Condition Score	55.09	Conservation significance score	1.10
Unit biodiversity Score	64.23	Area (ha)	0.1715	Total biodiversity Score	11.02

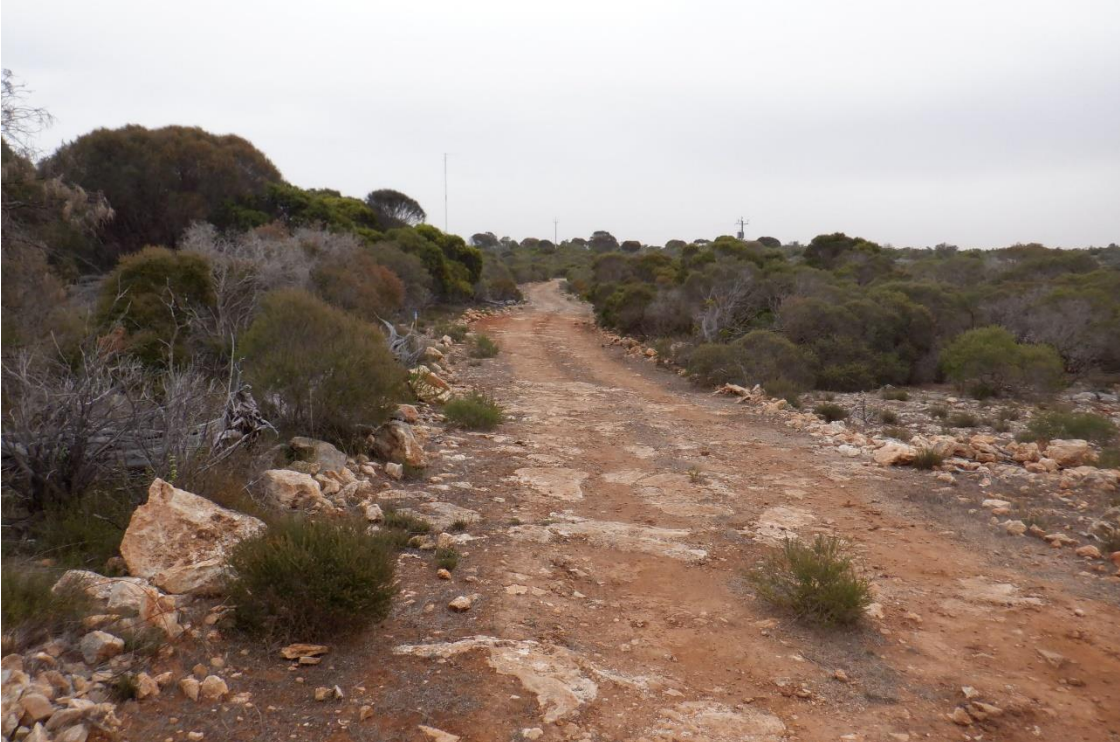
Vegetation Association	Vegetation Associations A4. <i>Eucalyptus diversifolia</i> mallee over <i>Melaleuca lanceolata</i> shrubland

Photo 4167 looking north from Waypoint 64, along the proposed clearance area required to straighten and widen an existing track.					
General description	<p>Association A4 is located outside of the Heritage agreement Area and consists of the same vegetation community as A3.</p> <p>The overstorey is dominated by <i>Eucalyptus diversifolia</i> ssp. <i>diversifolia</i> and <i>Melaleuca lanceolata</i> with <i>Leucopogon parviflorus</i>, <i>Acacia longifolia</i> ssp. <i>sophorae</i>, <i>Pittosporum angustifolium</i>, <i>Allocasuarina verticillata</i> and <i>Exocarpus aphyllus</i>.</p> <p>Understorey species include <i>Hibbertia devitata</i>, <i>Leucopogon cordifolius</i>, <i>Acacia triquetra</i>, <i>Hardenbergia violacea</i>, <i>Beyeria lechenaultii</i>, <i>Orthrosanthus multiflorus</i>, <i>Dianella</i> sp. and <i>Lepidosperma</i> sp. Seedlings of many of these species are present indicating regeneration of overstorey and midstory species.</p> <p>The ground layer contains several species of native grasses and forbs, such as <i>Rytidosperma</i>, <i>Austrostipa</i> sp., <i>Linum marginale</i>, <i>Nicotiana velutina</i>, <i>Vittadenia</i> sp. and <i>Geranium</i> sp. and sparsely introduced species (<i>Avena barbata</i>, <i>Lagurus ovata</i>, <i>Lysimachia arvensis</i>, <i>Marrubium vulgare</i> and <i>Asparagus asparagoides</i>).</p>

Threatened species or community	<p>The vegetation may provide critical habitat for the following rare and threatened fauna species:</p> <ul style="list-style-type: none"> <li>• <i>Stipiturus malachurus parimeda</i> (Southern Emuwren) - (EPBC Vulnerable, SA Endangered)</li> <li>• <i>Psophodes leucagaster leucogaster</i> (White-bellied Whip-bird) - (EPBC Vulnerable, SA Endangered)</li> </ul>				
Landscape context score	1.06	Vegetation Condition Score	55.09	Conservation significance score	1.10
Unit biodiversity Score	64.23	Area (ha)	0.117	Total biodiversity Score	7.52

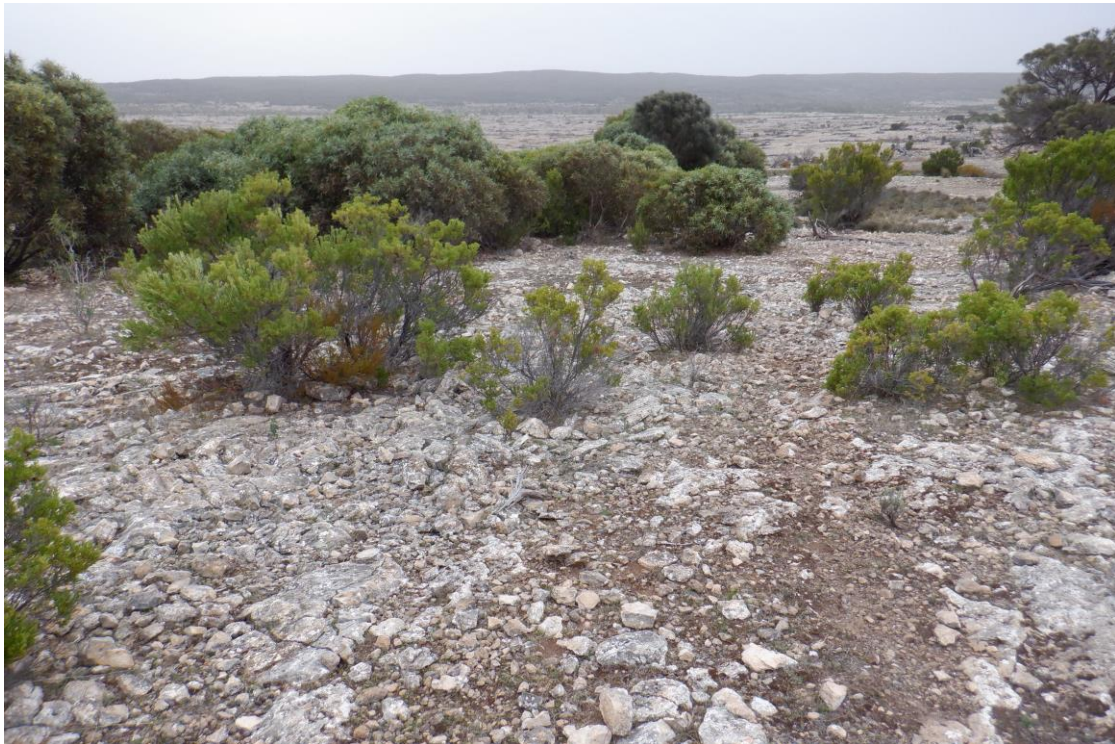
Vegetation Association	Vegetation Associations B1. <i>Eucalyptus diversifolia mallee</i> over <i>Leucopogon parvifolius</i> , <i>Acacia longifolia</i> and <i>Exocarpus aphyllus</i>
------------------------	---

Photo 4169 looking south-west from Waypoint 66, across undisturbed mallee shrubland surrounding the limestone extraction sites.

General description	The overstorey is dominated by regenerating <i>Eucalyptus diversifolia</i> ssp. <i>diversifolia</i> with <i>Leucopogon parviflorus</i> , <i>Acacia longifolia</i> ssp. <i>sophorae</i> , <i>Pittosporum angustifolium</i> , <i>Allocasuarina verticillata</i> and <i>Exocarpus aphyllus</i> . Understorey species include <i>Lasiopetalum discolor</i> , <i>Adriana quadripartita</i> , <i>Clematis microphylla</i> and <i>Olearia axillaris</i> , with a ground layer containing <i>Rytidosperma</i> , <i>Auistrostipa</i> sp., <i>Nicotiana velutina</i> , <i>Vittadenia</i> sp., <i>Oxalis perennans</i> and <i>Geranium</i> sp. and introduced species such as <i>Avena barbata</i> , <i>Lagurus ovata</i> , <i>Lysimachia arvensis</i> , <i>Hypericum perforatum</i> and <i>Asparagus asparagoides</i> .				
Threatened species or community	The vegetation is sparse and unlikely to provide critical habitat for rare and threatened fauna species. The vegetation does not support threatened plant species and is not part of a threatened plant community.

Landscape context score	1.06	Vegetation Condition Score	34.5	Conservation significance score	1.00
Unit biodiversity Score	36.57	Area (ha)	0.18	Total biodiversity Score	6.58

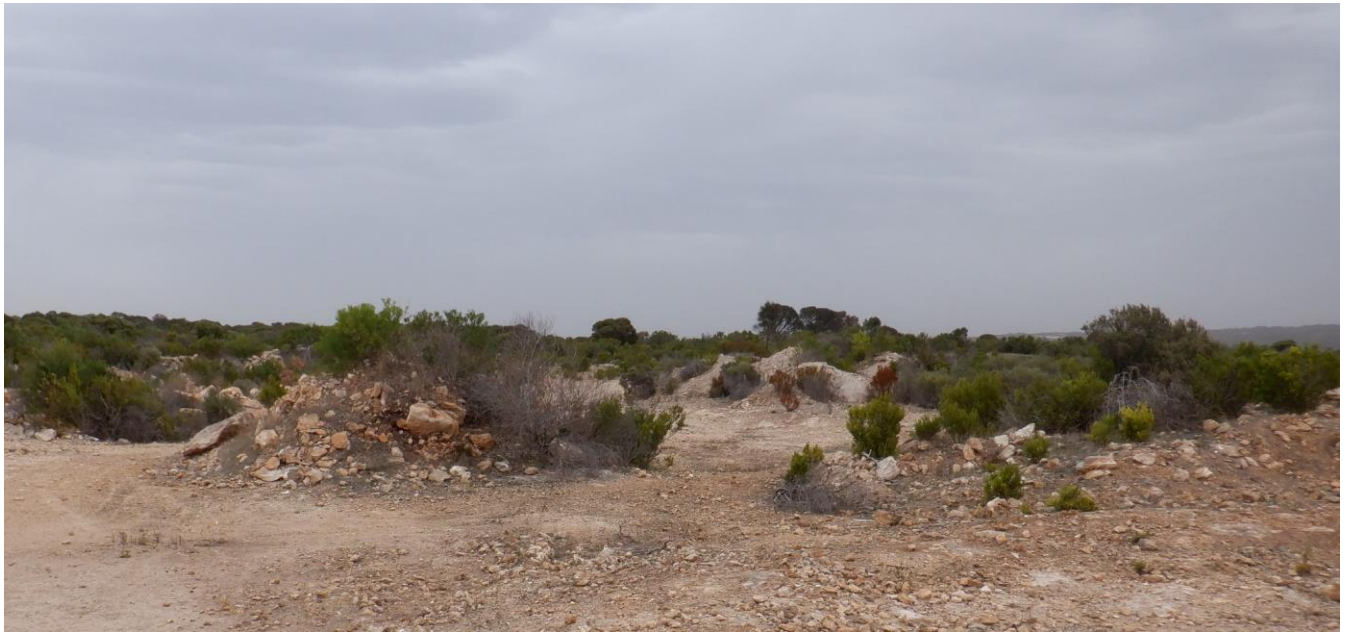
Vegetation Association	Vegetation Associations B2. Degraded (previously mined limestone Quarry) with regenerating <i>Leucopogon parviflorus</i> shrubland
------------------------	--

Photo 4168 looking south-west from Waypoint 65, across shrubland previously disturbed for limestone extraction.

General description	The vegetation consists of a highly degraded shrubland with regenerating <i>Leucopogon parviflorus</i> , <i>Olearia axillaris</i> and <i>Allocasuarina verticillata</i> and understory species including <i>Rytidosperma</i> sp., <i>Vittadenia</i> sp. and <i>Clematis microphylla</i> . The sites contain exotic grasses and herbs such as <i>Asphodelus fistulosus</i> , <i>Senecio pterophorus</i> , <i>Dittrichia graveolens</i> , <i>Echium plantagineum</i> , <i>Marrubium vulgare</i> and <i>Asparagus asparagoides</i> .				
Threatened species or community	The vegetation is sparse and unlikely to provide critical habitat for rare and threatened fauna species. The vegetation does not support threatened plant species and is not part of a threatened plant community.				
Landscape context score	1.06	Vegetation Condition Score	20.54	Conservation significance score	1.00
Unit biodiversity Score	21.77	Area (ha)	0.232	Total biodiversity Score	5.05

The quarries support the declared weeds *Asphodelus fistulosus*, *Marrubium vulgare*, *Asparagus asparagoides* f. SA Water should take appropriate measures to prevent the dispersal of weeds from these sites in soil or on machinery.

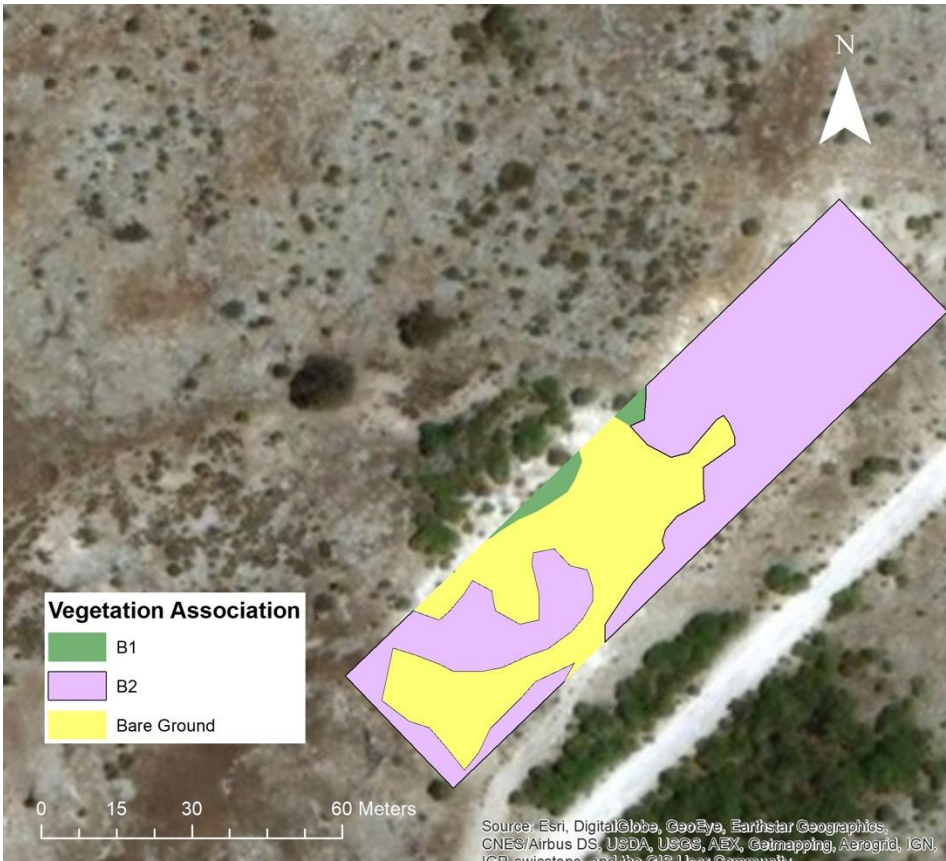
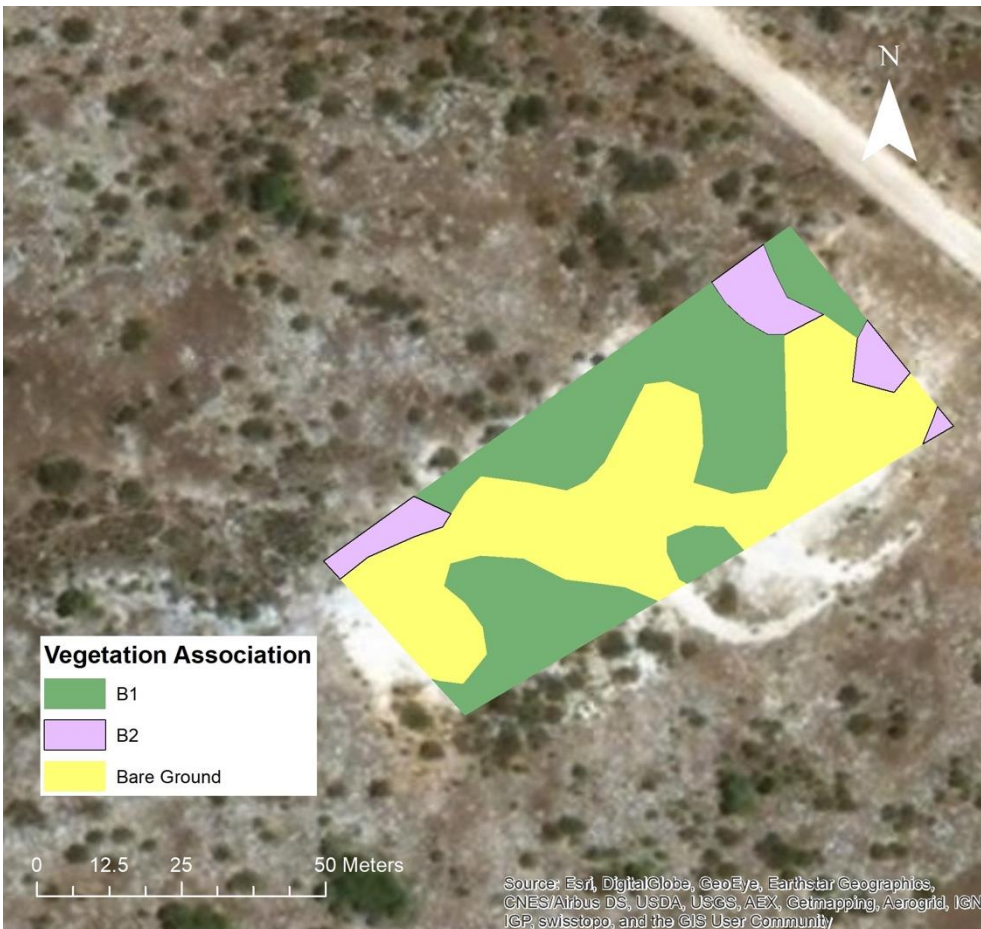
**Figure 3. Vegetation associations and clearance requirements for the new bores**

**Site map showing areas of proposed impact**

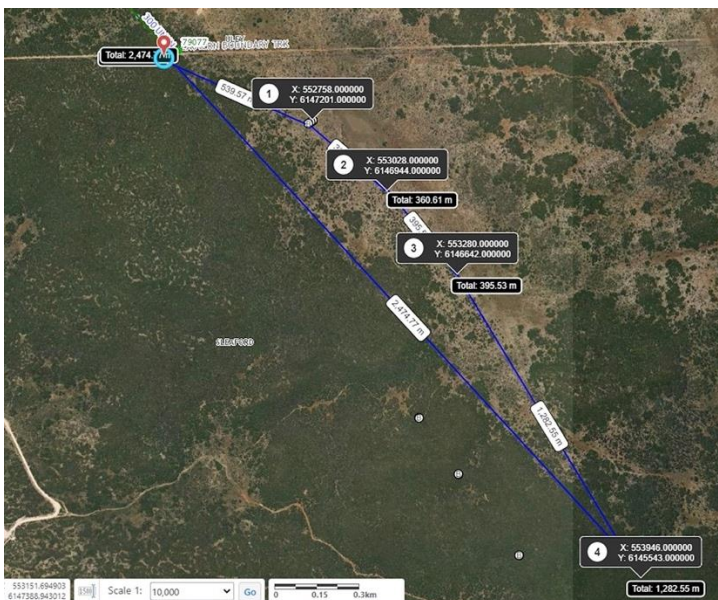
The proposed bores arrangement was changed to minimise impacts on native vegetation. The original scope was to construct four bores over a distance of 2.4 km. This was reduced to three bores over 1 km to reduce impacts on native vegetation and costs.

Vegetation clearance for limestone extraction (Block B) will be restricted to areas that have been previously mined, and 45% of the proposed clearance area is bare ground.
