APPENDIX 3.1: BOTANICAL ASSESSMENT

Revised Botanical Impact Assessment
for proposed borrow pits and quarry sites
for the upgrade of the N1 Section 4
between Matjiesfontein and Laingsburg.

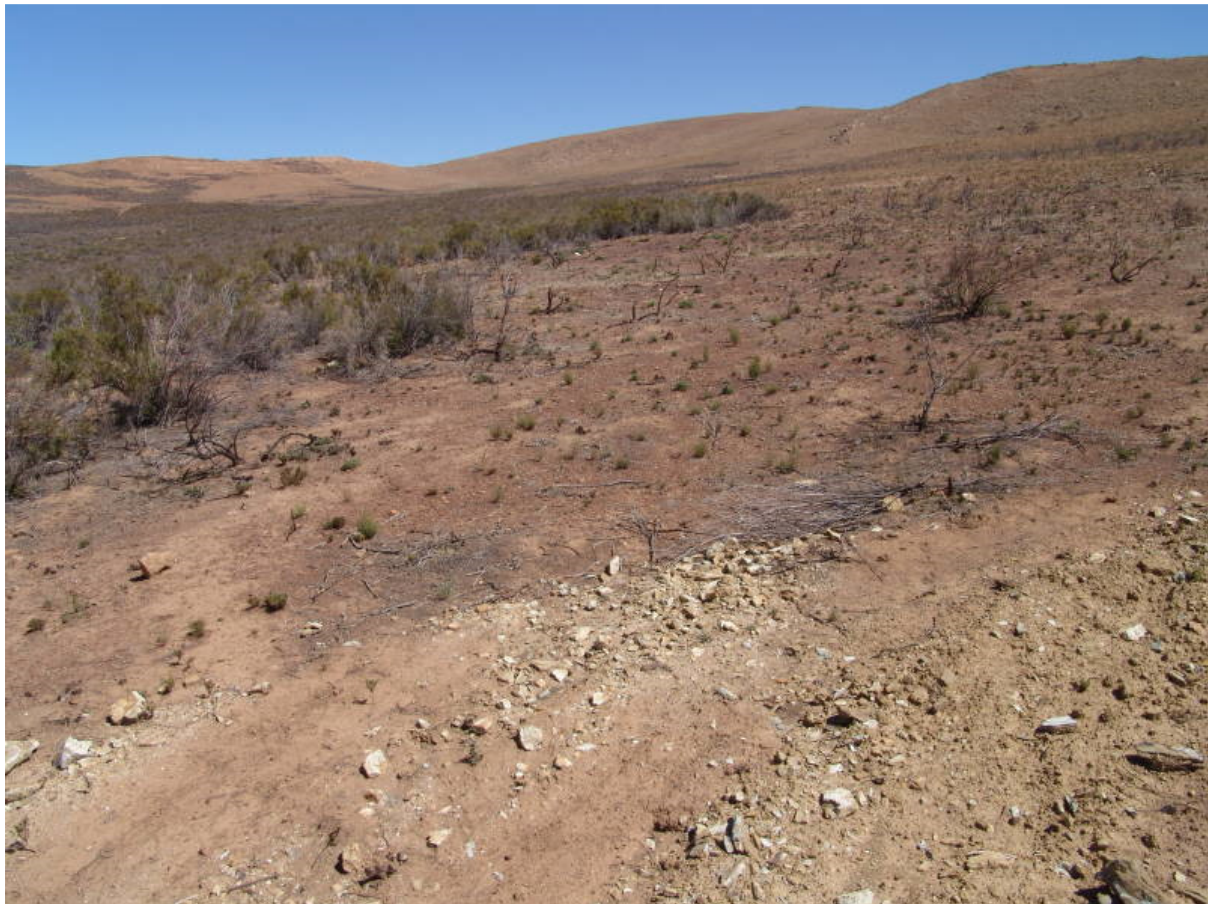
The area consists of Renosterveld (correctly mapped as Matjiesfontein Shale Renosterveld), with about half of the site recently having burnt (see Photo 1). The area is not rich in species, in part since about half the site consists of old agricultural land where mostly just Renosterbos (*Elytropappus rhinocerotis*) re-established, but also since the area has been heavily grazed by domestic stock for many years. The latter is evident through the homogenous nature of the communities, paucity of palatable species and relative abundance of unpalatable species. The following 35 species were recorded in the ca. 7 ha area that may be disturbed to establish the borrow pit.

Rare and Threatened species: The only uncommon species present is *Relhania tricephala*, which has a status of Near Threatened. No other threatened species were found in the proposed development area and none are expected to occur here, even after good rain.

Photo 1: Site of the proposed Borrow Pit 1. Note that part of the site was recently burnt.

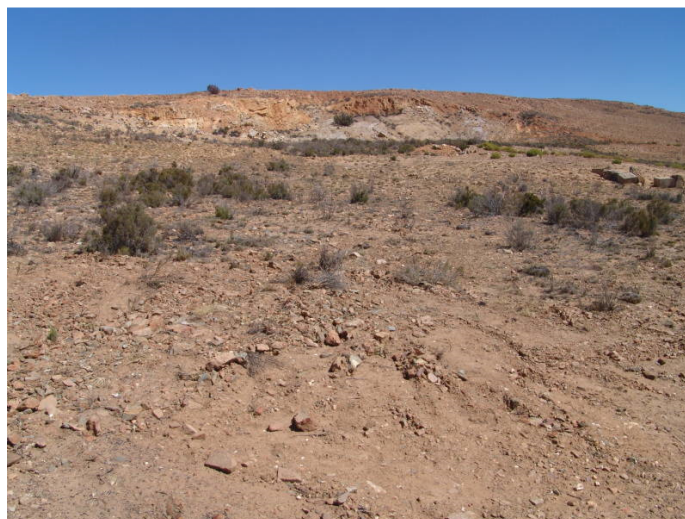
An access road is already established to the site as it abuts an old quarry (see Photo 2). Most of the vegetation at this site is severely disturbed due to previous activities around the quarry.

The vegetation consists mostly of Renosterveld (but was mapped as Matjiesfontein Quartz Fynbos), with most of the site recently burnt. The area is poor in species due to the previous disturbance of the site and current heavy grazing pressure. The following 33 species were recorded in the ca. 7 ha area that may be disturbed to establish the borrow pit.

Photo 2: The proposed Borrow Pit 2 site. Note that part of the site burned down recently.

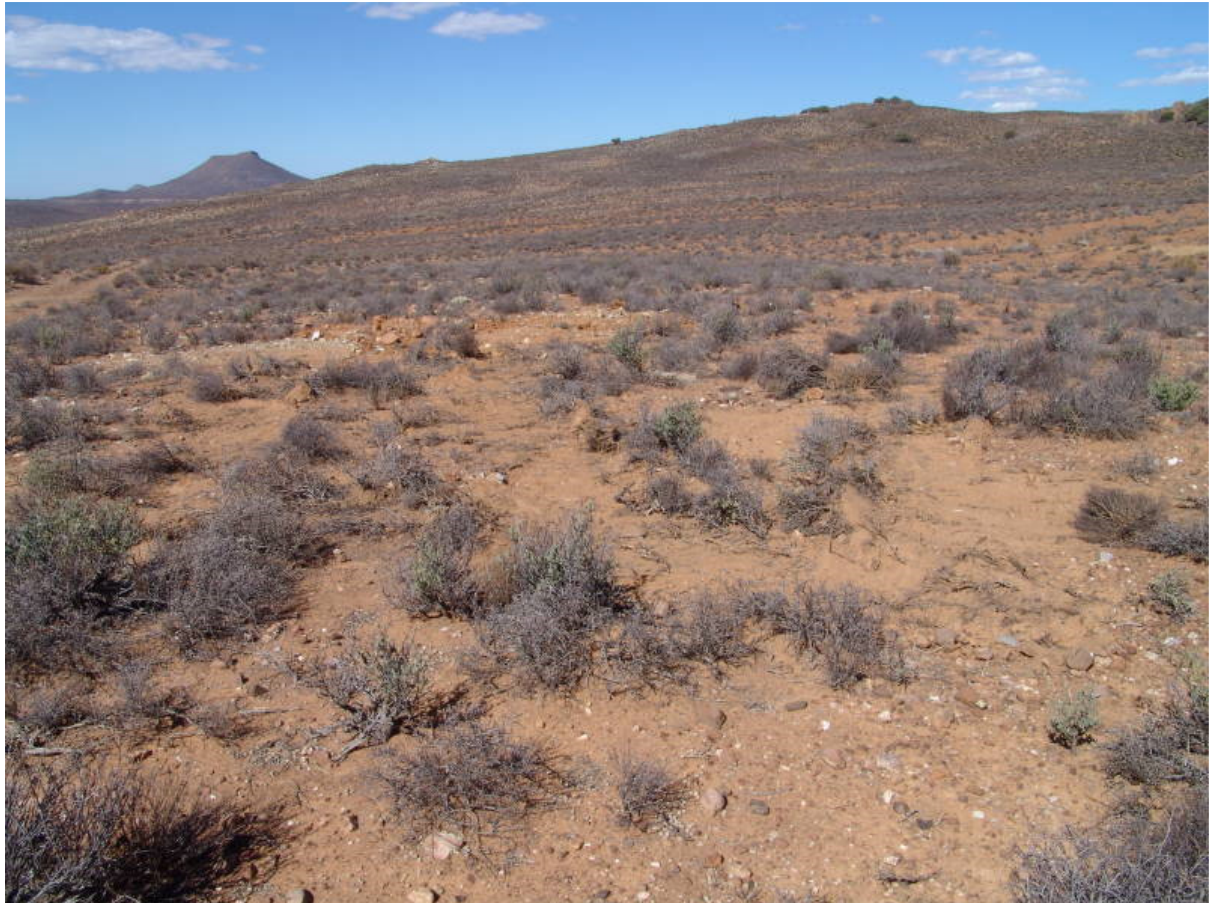
An access road is already established to the site as it is adjacent to a kraal and watering point for domestic stock. The site intersects a minor water drainage line and thus an ESA1. The vegetation is moderately to heavily disturbed through grazing and consists of Succulent Karoo vegetation (Koedoesberg-Moordenaars Karoo), although it was mapped as Matjiesfontein Renosterveld (see Photo 3). In being heavily grazed in the area closest to the kraal, the site is also not very rich in species and the following 50 species were recorded in the ca. 7 ha area that will be used for the borrow pit.

Photo 3: Succulent Karoo vegetation at the proposed Borrow Pit 3.

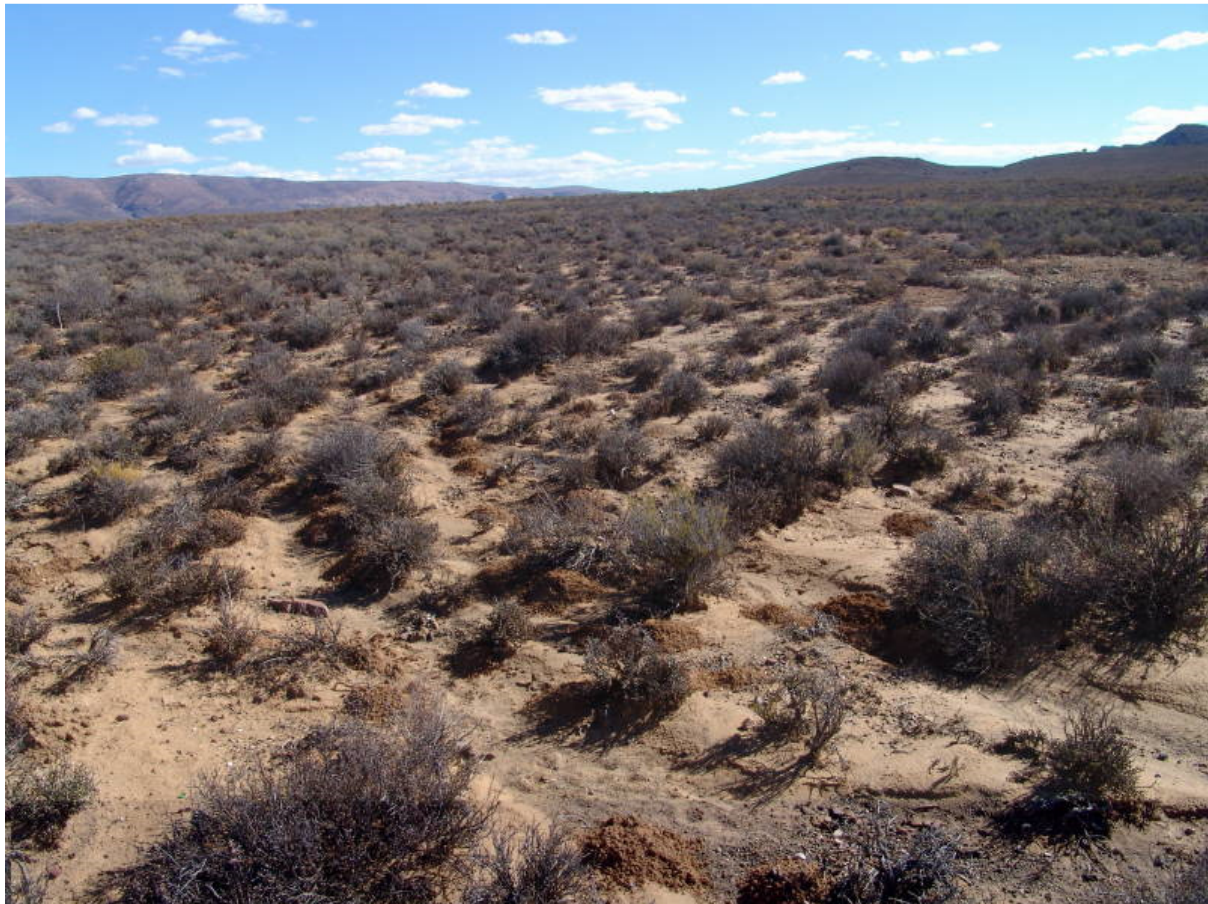
An access road is already established to within about 100 m from the center point of the site. The affected area consists of Succulent Karoo vegetation (Koedoesberg-Moordenaars Karoo) (see Photo 4). The area is not very rich in species, mostly since the area has been heavily grazed by domestic stock for many years. The following 45 species were recorded in the ca. 7 ha area that may be disturbed to establish the borrow pit.

Photo 4: Site of the proposed Borrow Pit 4.

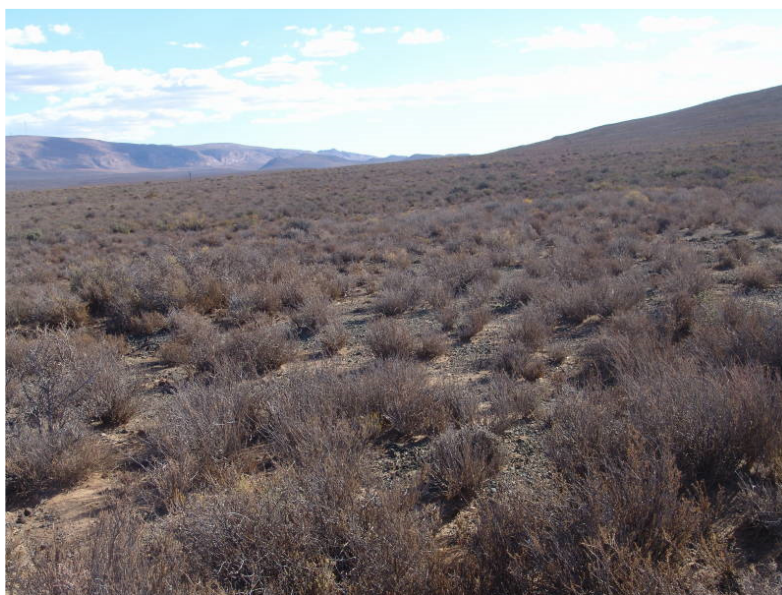
This site is close to Borrow Pit 4, it is in the same grazing camp and the vegetation and its condition is hence very similar to those of Site 4. An access road is also already established to within about 100 m from the center point of the site. The affected area also consists of Succulent Karoo vegetation (Koedoesberg-Moordenaars Karoo) (see Photo 5) and the following 31 species were recorded in the ca. 7 ha area that may be disturbed to establish the borrow pit.

Photo 5: Site of the proposed Borrow Pit 5. This site is poorer in species than Site 4.

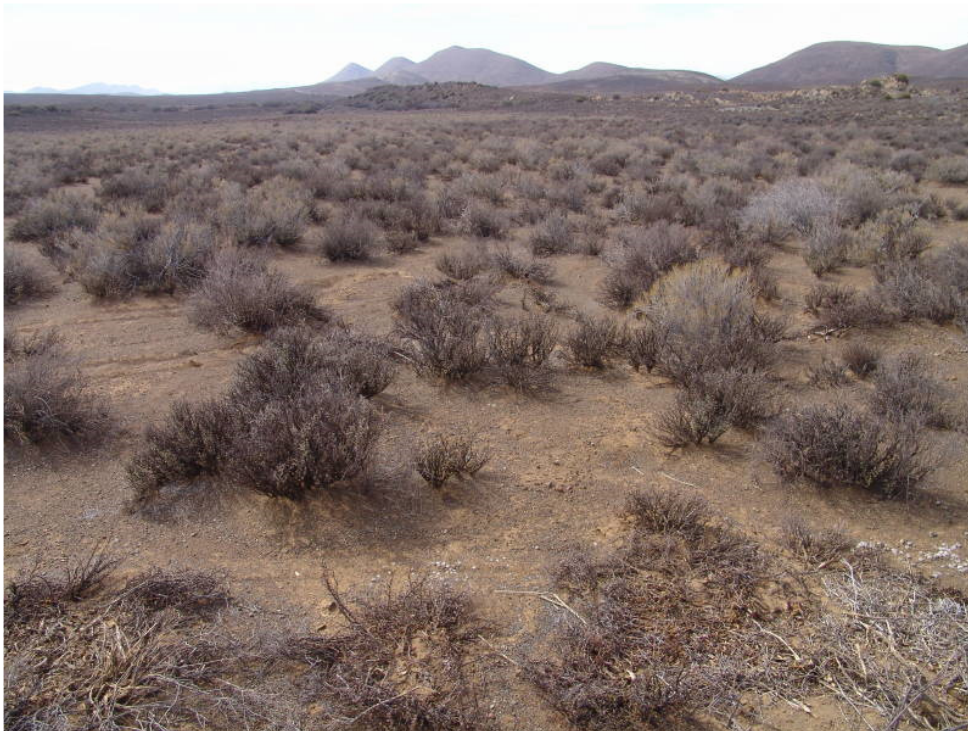
An access road is also already established to within about 100 m from the center point of the site. The affected area also consists of Succulent Karoo vegetation (Koedoesberg-Moordenaars Karoo) with the local community varying little over the terrain (see Photo 6) and the following 27 species were recorded in the ca. 7 ha area that may be disturbed to establish the borrow pit.

Photo 6: Site of the proposed Borrow Pit 6. Note the evenness of the plant communities.

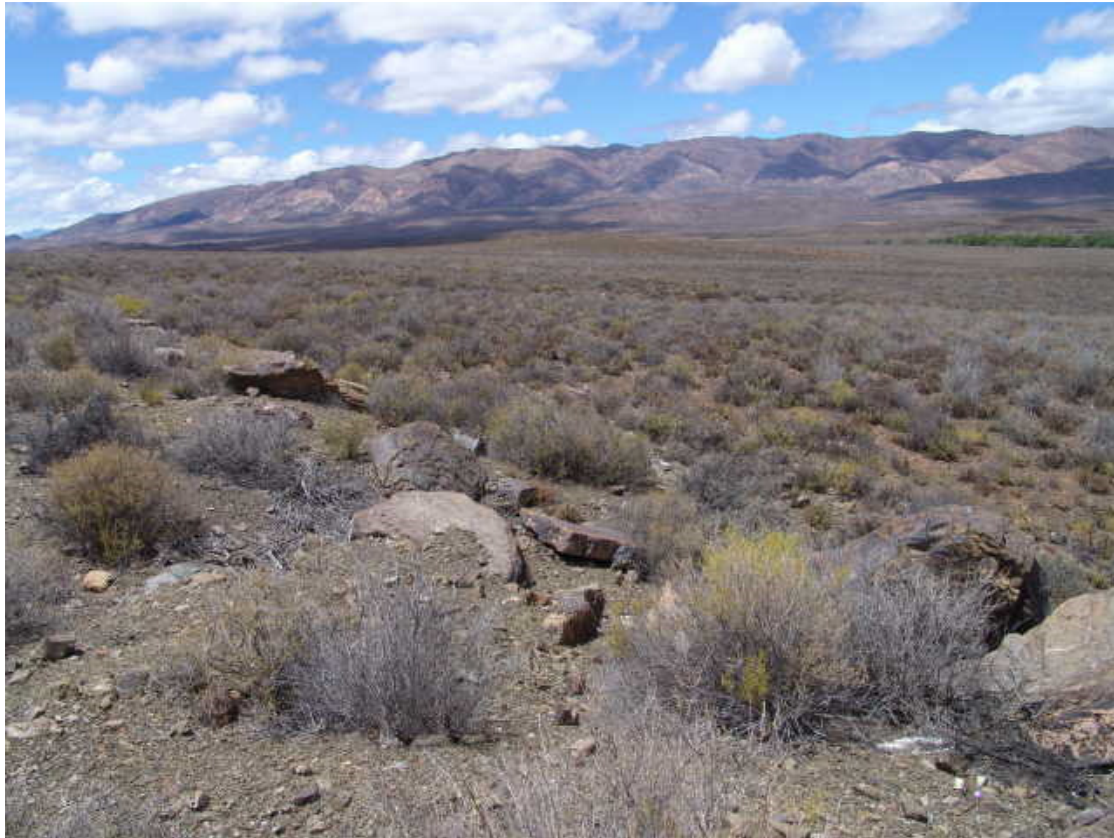
There is no access road to this site and the affected area consists of near pristine Succulent Karoo vegetation (Koedoesberg-Moordenaars Karoo; see Photo 7) which is rich in species, especially in the vicinity of a quartz band that transects the area. The following 56 species were recorded in the ca. 2 ha area that may be disturbed to establish the borrow pit, but many more species may appear after good rain.

Rare and Threatened species: *Geissorhiza karooica* (Status = Near Threatened), *Haworthia nortieri* var. *pehlemanniae* has no formal status due to taxonomic uncertainty, but should be regarded as a threatened species. I suspect that several other rare or threatened species will be found at this site after good rain.

Photo 7: Near-pristine Succulent Karoo vegetation at proposed Borrow Pit 7. Here only a narrow band of vegetation (in the foreground) next to the N1 is disturbed. Some rare and threatened species are present at this site, but several more may appear after good rain.

1. Sites DT4 and BP7 should not be developed. If possible DT2 should also not be developed.
2. The water drainage areas (ESA1) should not be negatively affected by the development of the sites, including access roads.

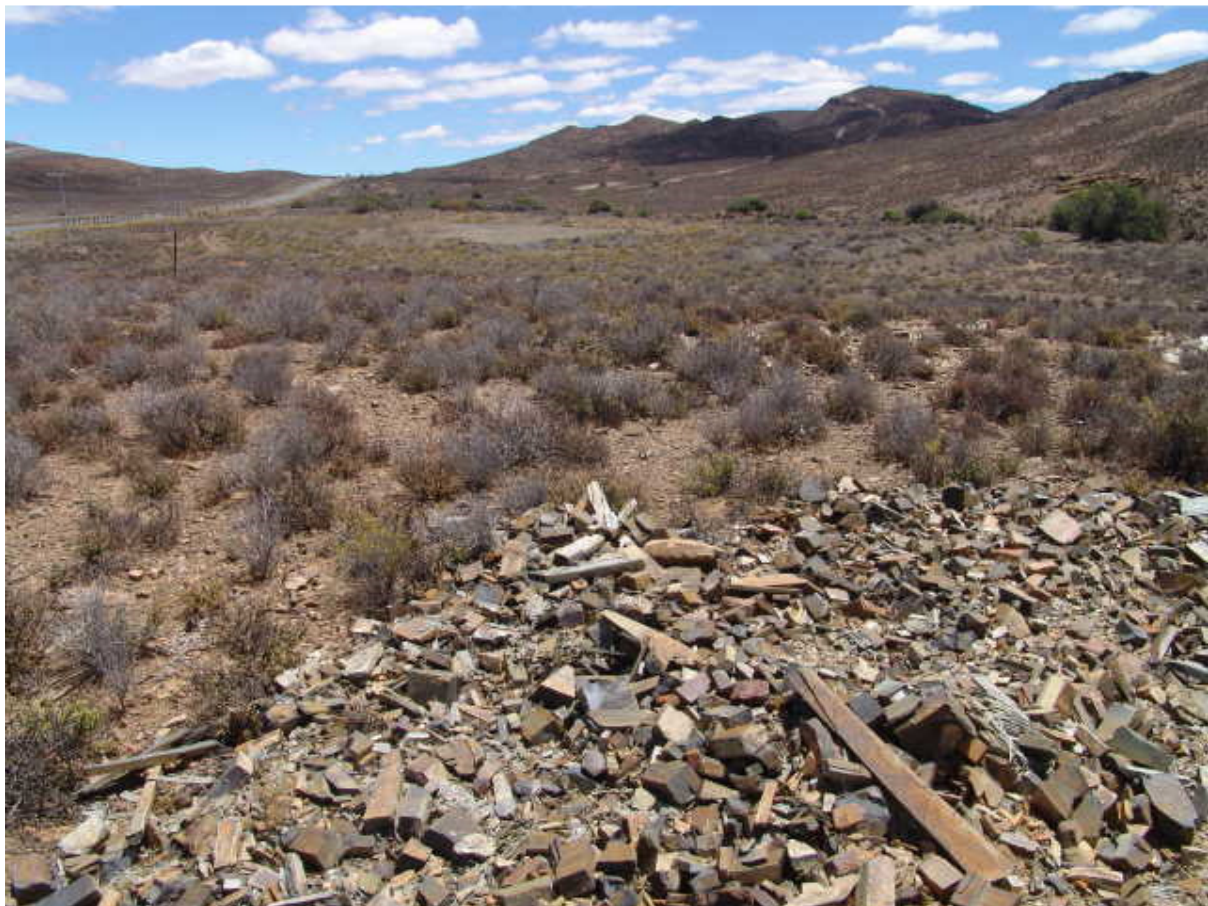
This site is located adjacent to an old quarry site (see Photo 8) and an access road is already established to the site. The vegetation consists of moderately to severely disturbed Succulent Karoo vegetation (Koedoesberg-Moordenaars Karoo). The proposed borrow pit is located between two water drainage areas (ESA1), but the proposed mining area does not intersect the water drainage areas. The following 45 species were recorded in the ca. 0.43 ha area that may be disturbed to establish the borrow pit.

Photo 8: Vegetation at the proposed Borrow Pit 8. The greyish area in the central background is part of the previous borrow pit area.

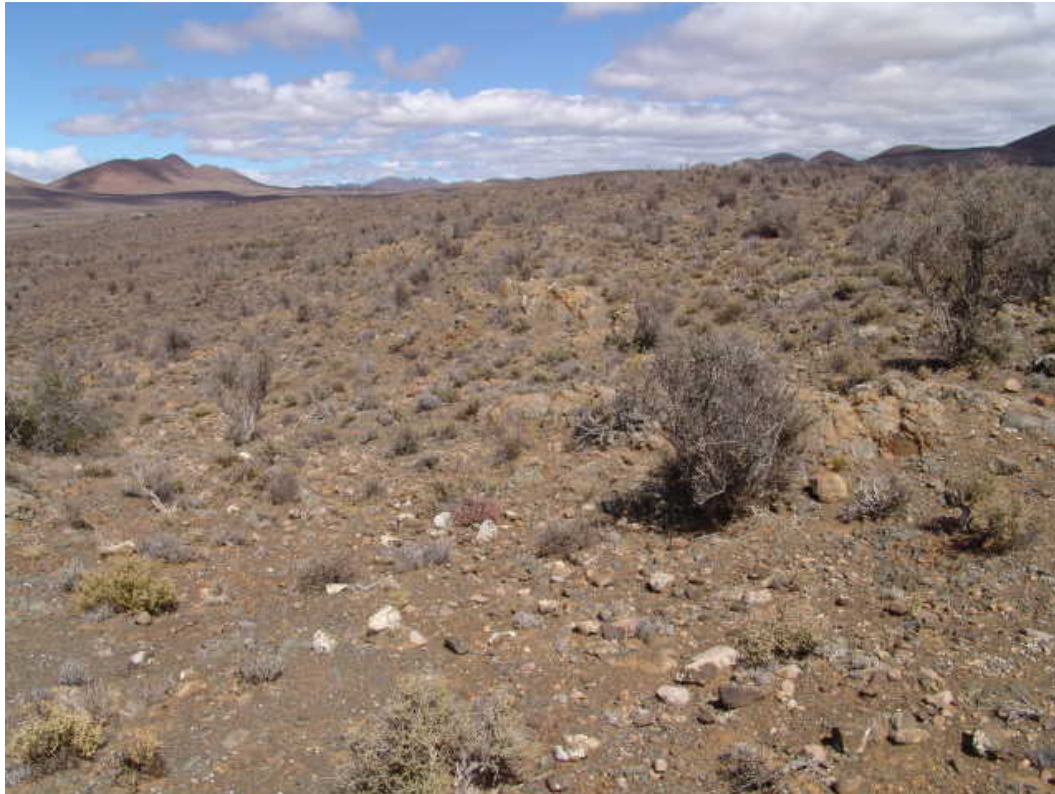
An access road is established almost to the site, but the vegetation consists otherwise of near pristine Succulent Karoo vegetation (Koedoesberg-Moordenaars Karoo) on tillite hills (see Photo 9). The affected area is rich in species, with the following 81 species recorded in the ca. 5 ha area that may be disturbed to establish the quarry.

Rare and Threatened species: None of the above are threatened species, but the fern *Pellaea rufa* is a naturally rare species with a restricted distribution. Some threatened species may appear after good rain at this site.

Photo 9: Vegetation of the proposed site DT 4.

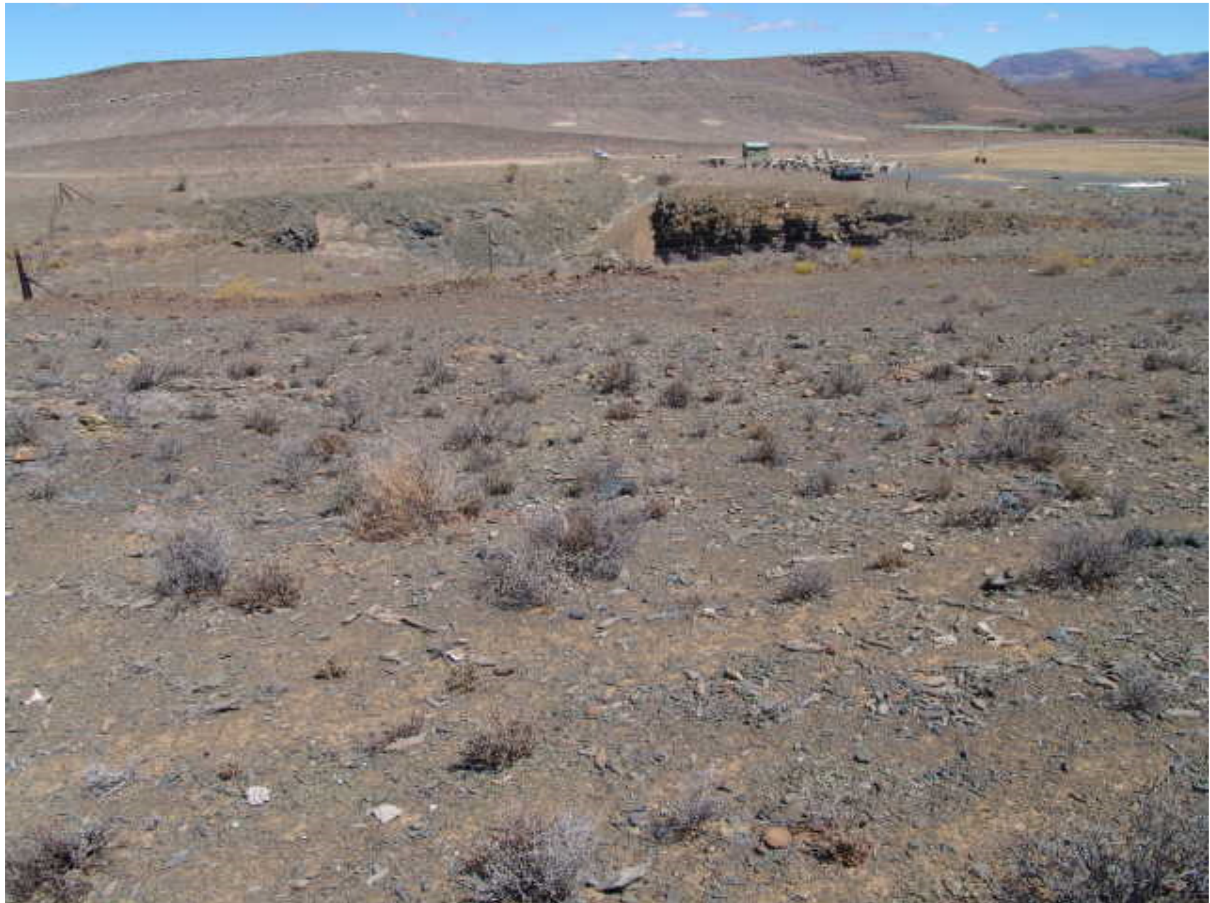
This site is an extension of an existing quarry that is located within an intensively farmed area with an existing access road to the site. The remaining natural vegetation consists of highly disturbed Succulent Karoo vegetation (Koedoesberg-Moordenaars Karoo; see Photo 10). The site falls within a CBA, which is clearly a mapping mistake as even the pivot point irrigated lands were included in the CBA. The site is poor in species and only the following 42 species were recorded in the ca. 7 ha area that may be disturbed to establish the borrow pit.

Photo 10: Vegetation at the site named RT 15. The old quarry will be extended towards the foreground.

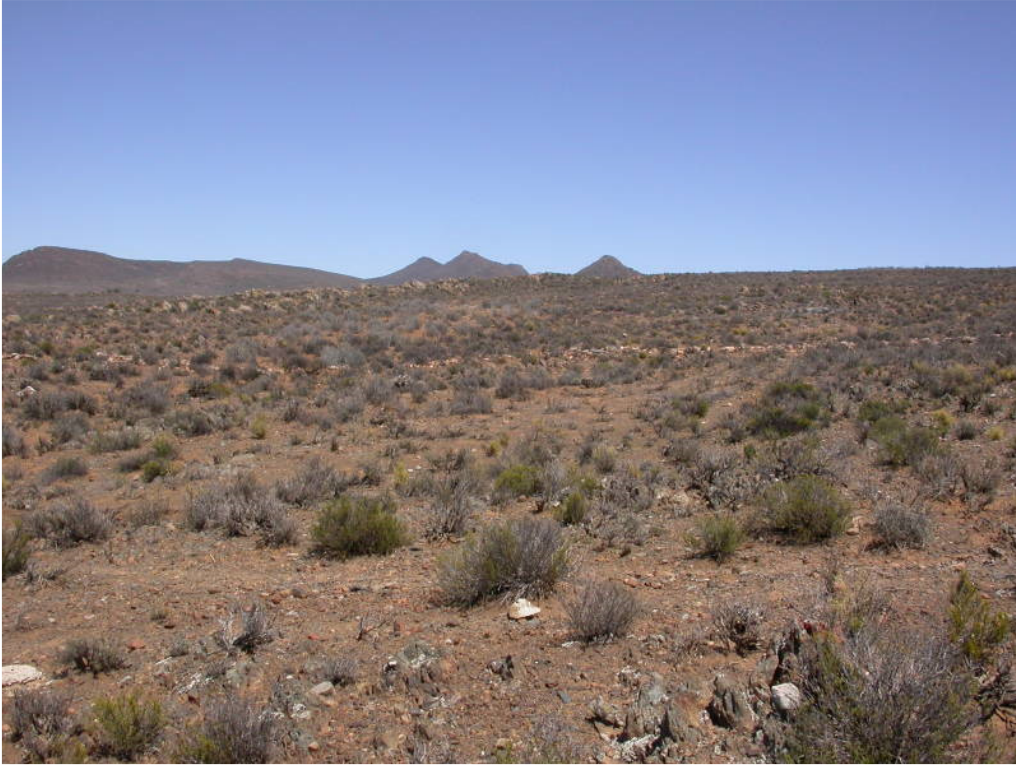
Although the affected area is relatively close to Borrow Pit 4, with a similar national vegetation type (Koedoesberg-Moordenaars Karoo) and conservation status, the vegetation is quite different as it occurs on a different geology formation (Tillite).

On this site the vegetation is still quite rich in species as it is only moderately transformed through grazing impacts by domestic stock. The following 47 species were recorded in the potentially affected area.

Rare and Threatened species: *Lotononis exstipulata* (Status = Endangered).

Photo 11: The moderately transformed vegetation of site DT2.
