Thermal Cycling, Air In-Leakage & Impact On Heat Rate, Emissions and Cost of Compliance

By Patrick T. Fitzgerald, High Temperature Technologies, patrick@isomembrane.com, 704-621-2465
Jenifer Gelorme, High Temperature Technologies, jenifer@isomembrane.com, 704-375-2111

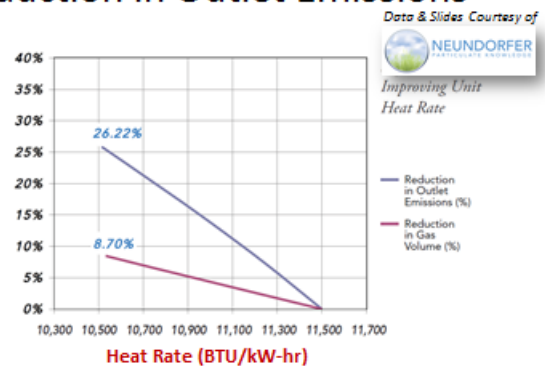
Reduced Heat Rate
 = Reduced Gas Volume
 = Reduction in Outlet Emissions

A heat rate improvement that significant today would be very difficult. However, extrapolating from the data one could expect, in this case, a ~16.5% emission reduction for a 600 Btu/kWh (5%) improvement, or a ~11% emissions reduction for a 400 Btu/kWh (~3.5%) improvement

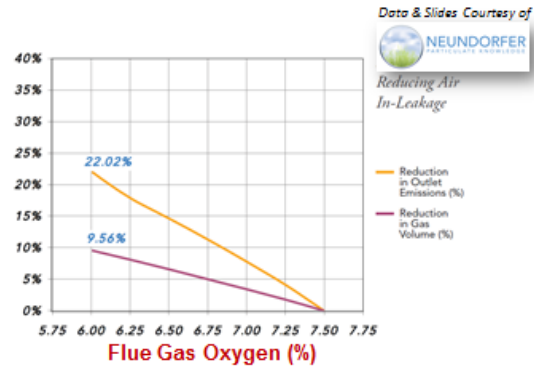
**Reduced Air In-Leakage
= Reduced Flue Gas Oxygen
= Reduction in Outlet Emissions**

Next let's look at air in-leakage and its effect on oxygen levels. As the graph demonstrates, the purple line shows an example where reducing the O₂ concentration to the stack from 7.5% to 6% reduces the treated gas volume by 9.5%, resulting in a 22% reduction in outlet emissions.

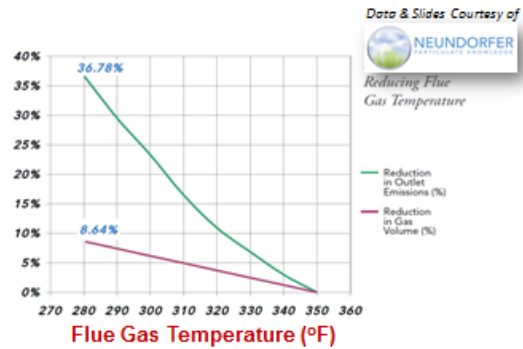
**Reduced Flue Gas Temperature
= Reduction in Outlet Emissions**

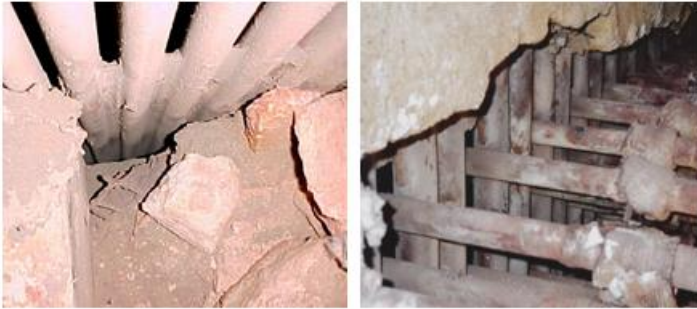
- Weld Repair
 - **Refractory**
 - Doing Nothing
- Lack of predictability can cause sudden spikes in excess air that can jeopardize emissions compliance*

2. Refractory simply begins crumbling again, providing little or no sealing benefit.

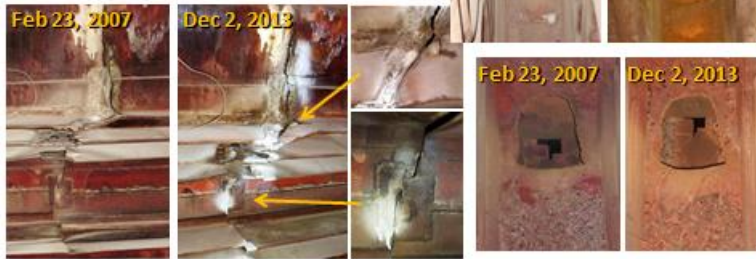
- Weld Repair
- Refractory
- **Doing Nothing**
 - Universally, this has been a function of **budget restrictions**

3. Doing Nothing – These photos are from an inspection I conducted on December 2, 2013. When I returned to the office, I went through the files and found these photos from an inspection we conducted in February 23, 2007, almost 7 years earlier.

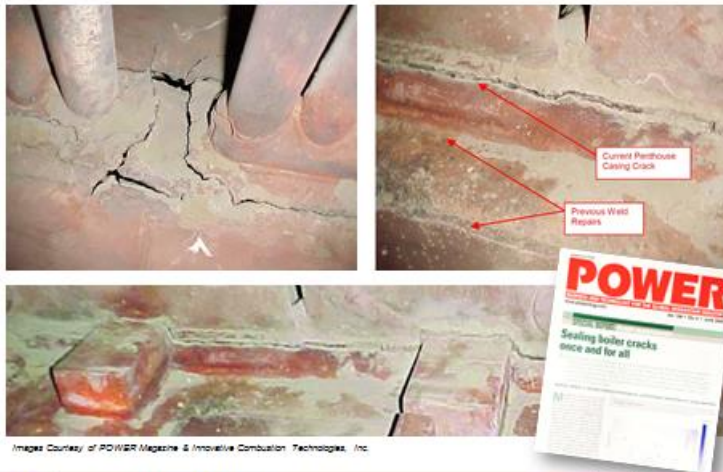
Case Study: Gorgas Electric Generating Plant – Unit 10 Penthouse

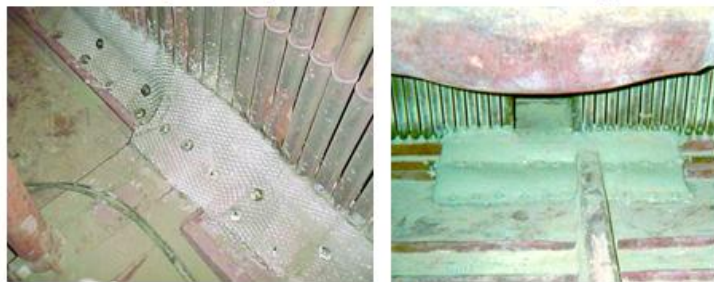
select penthouse locations to gauge the performance of the sealing technology. The system was installed in areas with the most significant casing damage, specifically, along the 25' long crack above the convection pass and between tube penetrations on the Pendant Superheater.

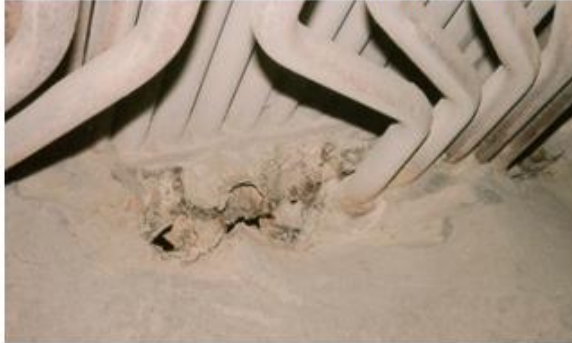
Prior to installation of ISOMEMBRANE® in 1994

- Unit 4: 650 MW Supercritical Unit
- 5 feet of ash accumulation
 - approximately 100 tons
- Ingress of flyash caused typical problems
 - Safety
 - Reliability
 - Efficiency
 - Housekeeping

Deterioration of the original penthouse roof seals resulted in air in-leakage in the penthouse, as evidenced in large accumulations of flyash in the penthouse. Ash dunes of up to five feet in depth were measured. The bulk volume of the flyash in the penthouse approached 100 tons. If a tube leak had occurred, the added weight could have created a dangerous situation.

This ash remained hot, well after shutdown of the boiler, slowing access to conduct repairs. (This can be a huge issue for plants in a forced outage that need access to the penthouse quickly.)

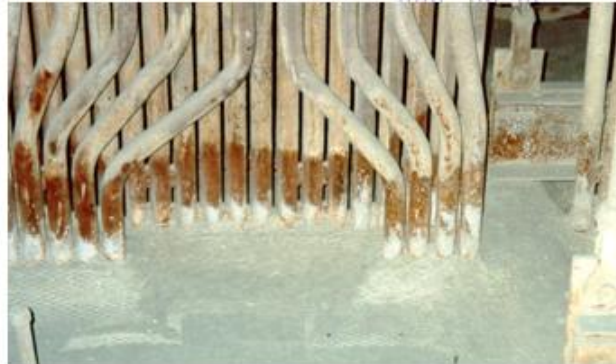
CASE STUDY: Duke Marshall Penthouse -After 1 Year in Service

- No vacuuming required
- Reduced outage requirements
- Reduced costs and labor requirements

The air in-leakage (and associated impacts to heat rate), the ash accumulations, and the inability to gain rapid access to in the event of a tube failure in the penthouse, were the principal justifications for correcting the roof seal leakage. Additionally, there were safety concerns for the maintenance personnel not having to contend with large accumulations of flyash that would hold the heat for days.

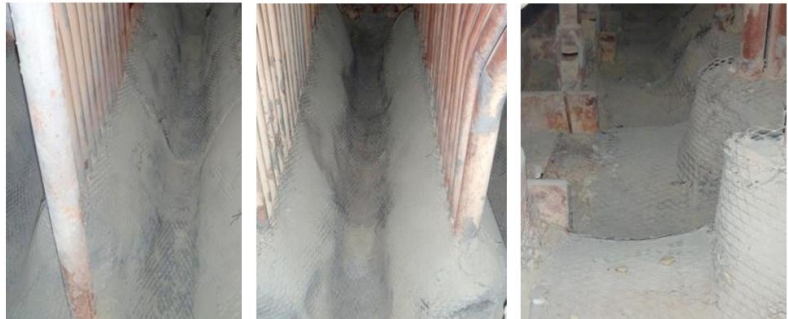
CASE STUDY: Duke Marshall Penthouse - After 19 Years

- No ISOMEMBRANE® maintenance required
- Improved outage effectiveness, safety, and time & budgetary savings

Original ISOMEMBRANE® Installation in 1994, photos taken May 2013

In 2013, we had the opportunity to inspect some of the areas where tubes had not been replaced and found the ISOMEMBRANE® fully intact and sealing.

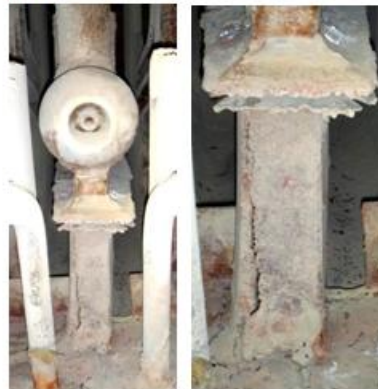
Center Waterwall Header

ISOMEMBRANE® in the 4th & 5th stages of installation

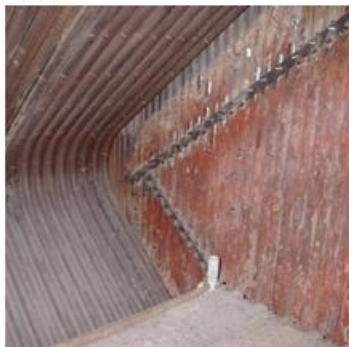
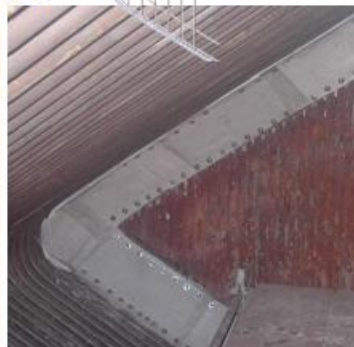
Nose Arch – Side Wall Seals

The dissimilar movement of the waterwall panel to the nose arch creates another area prone to leakage.

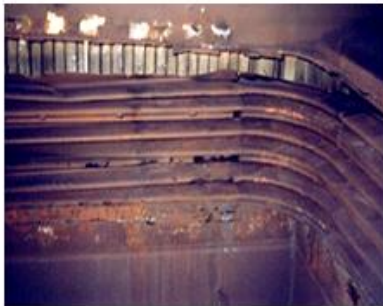
Retire Existing Joint In-place – Capital Budget Item

- Expensive & time-consuming to replace.
- **NOT** required with ISOMEMBRANE®: Demolition, flange/metal repair & fabrication
- No pre-engineering or detailed specs required.

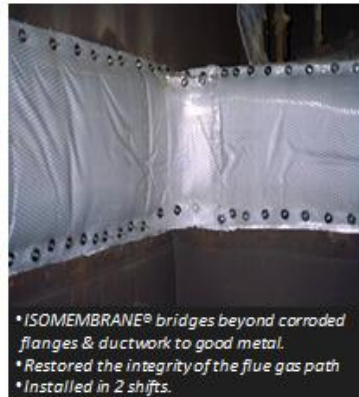
- ISOMEMBRANE® bridges beyond corroded flanges & ductwork to good metal.
- Restored the integrity of the flue gas path
- Installed in 2 shifts.

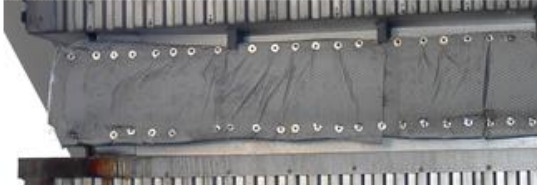
Case Study: Expansion Joint ON-LINE Installation, ID Fan

- SCR system installed
- Joint blew when unit came on-line.
- Derate of 20MW
- The operating pressure was negative 20-25”H₂O.
- The plant dialed down the draw to about 6-8” H₂O.
- Installed in 1 ½ shifts, (in 20 degree weather), which is why it's not the prettiest installation.)
- After 1st layer of ISOMEMBRANE® was installed, the plant returned to full load
- Immediately recovered 20MW
- Project Cost: \$21,000

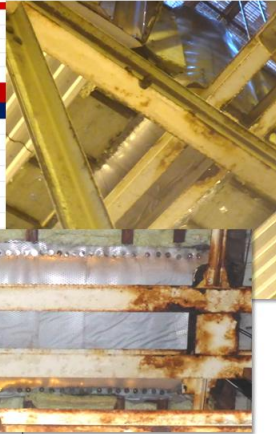
Case: 53 MW B&W Mass Burn Waste-to-Energy Boiler

This Northeast waste-to-energy was experiencing fan limitations due to a leaking expansion joint and corroded adjacent ductwork upstream of the baghouse inlet. ISOMEMBRANE® was installed over the 12' joint breach and 2 feet beyond either side of the joint, encapsulating the joint and corroded ductwork. The plant immediately noted a decrease in fan pressure from 16"WC to 12"WC, and the amp draw went from 64 amps to 54 amps. Not only did the plant eliminate their fan limitations, it is projected the annual savings in reducing the excess parasitic fan power consumption equals about \$38,000/year (@8cents/KWh). The capacity they recovered was worth just under \$250,000 the following year. The ISOMEMBRANE® system was installed in 2 shifts. The unit was online during this installation.

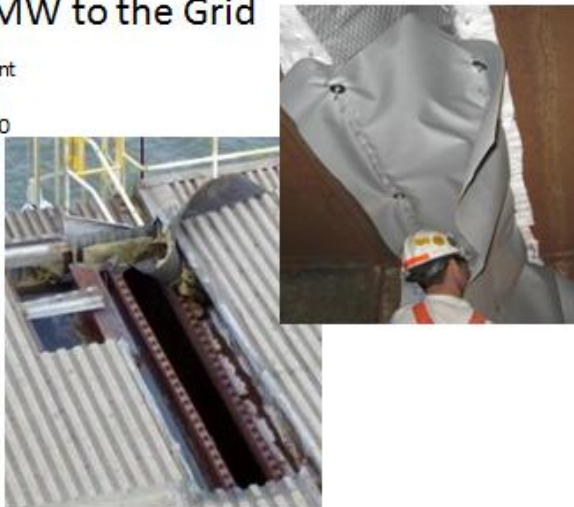
Case Study: Customer Reported Results Restored 68MW to the Grid

- FD Fan Expansion Joint
- Decreased output from 198 MW to 130 MW
- Decreased duct pressure from 54"H₂O to 30"H₂O
- Installed 1 ½ shifts
- Project Cost: \$25,000

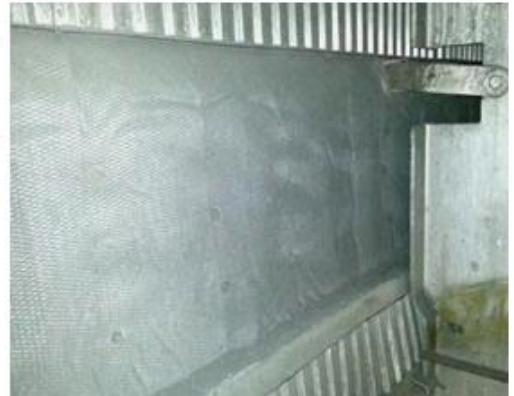
Case Study: 125MW CE Coal Tangential-Fired, operating at 138MW

- LOI decreased on “A” side from 8% to 6% for a heat rate improvement of 0.1%
- MS & RH temperatures improved by 5°F for a heat rate improvement of 0.12%
- Electrical auxiliaries decreased for a heat rate improvement of 0.05%
- Decreased average coal feeder speed from 8.2 to 7.8 rpm
- Total 0.27% effect on heat rate: \$50,000/year at 60% capacity factor
- Project Cost: \$30,000

Here are the customer reported results after they conducted a number of performance tests after an ISOMEMBRANE® encapsulation of the economizer gas outlet expansion joint. They evaluated LOI samples, main steam temperatures, reheat temperatures, draw on electrical auxiliaries, and a variety of other performance parameters.
